HISTORIC STRUCTURES REPORT

GARDENER'S COTTAGE & POTTING SHED, BLDG. #11  
GREENHOUSE, BLDG. #14

EDISON NATIONAL HISTORIC SITE

HISTORIC STRUCTURES REPORT - PART I  
GREENHOUSE, BUILDING NO. 14, AND  
GARDENER'S COTTAGE AND POTTING SHED, BUILDING NO. 11

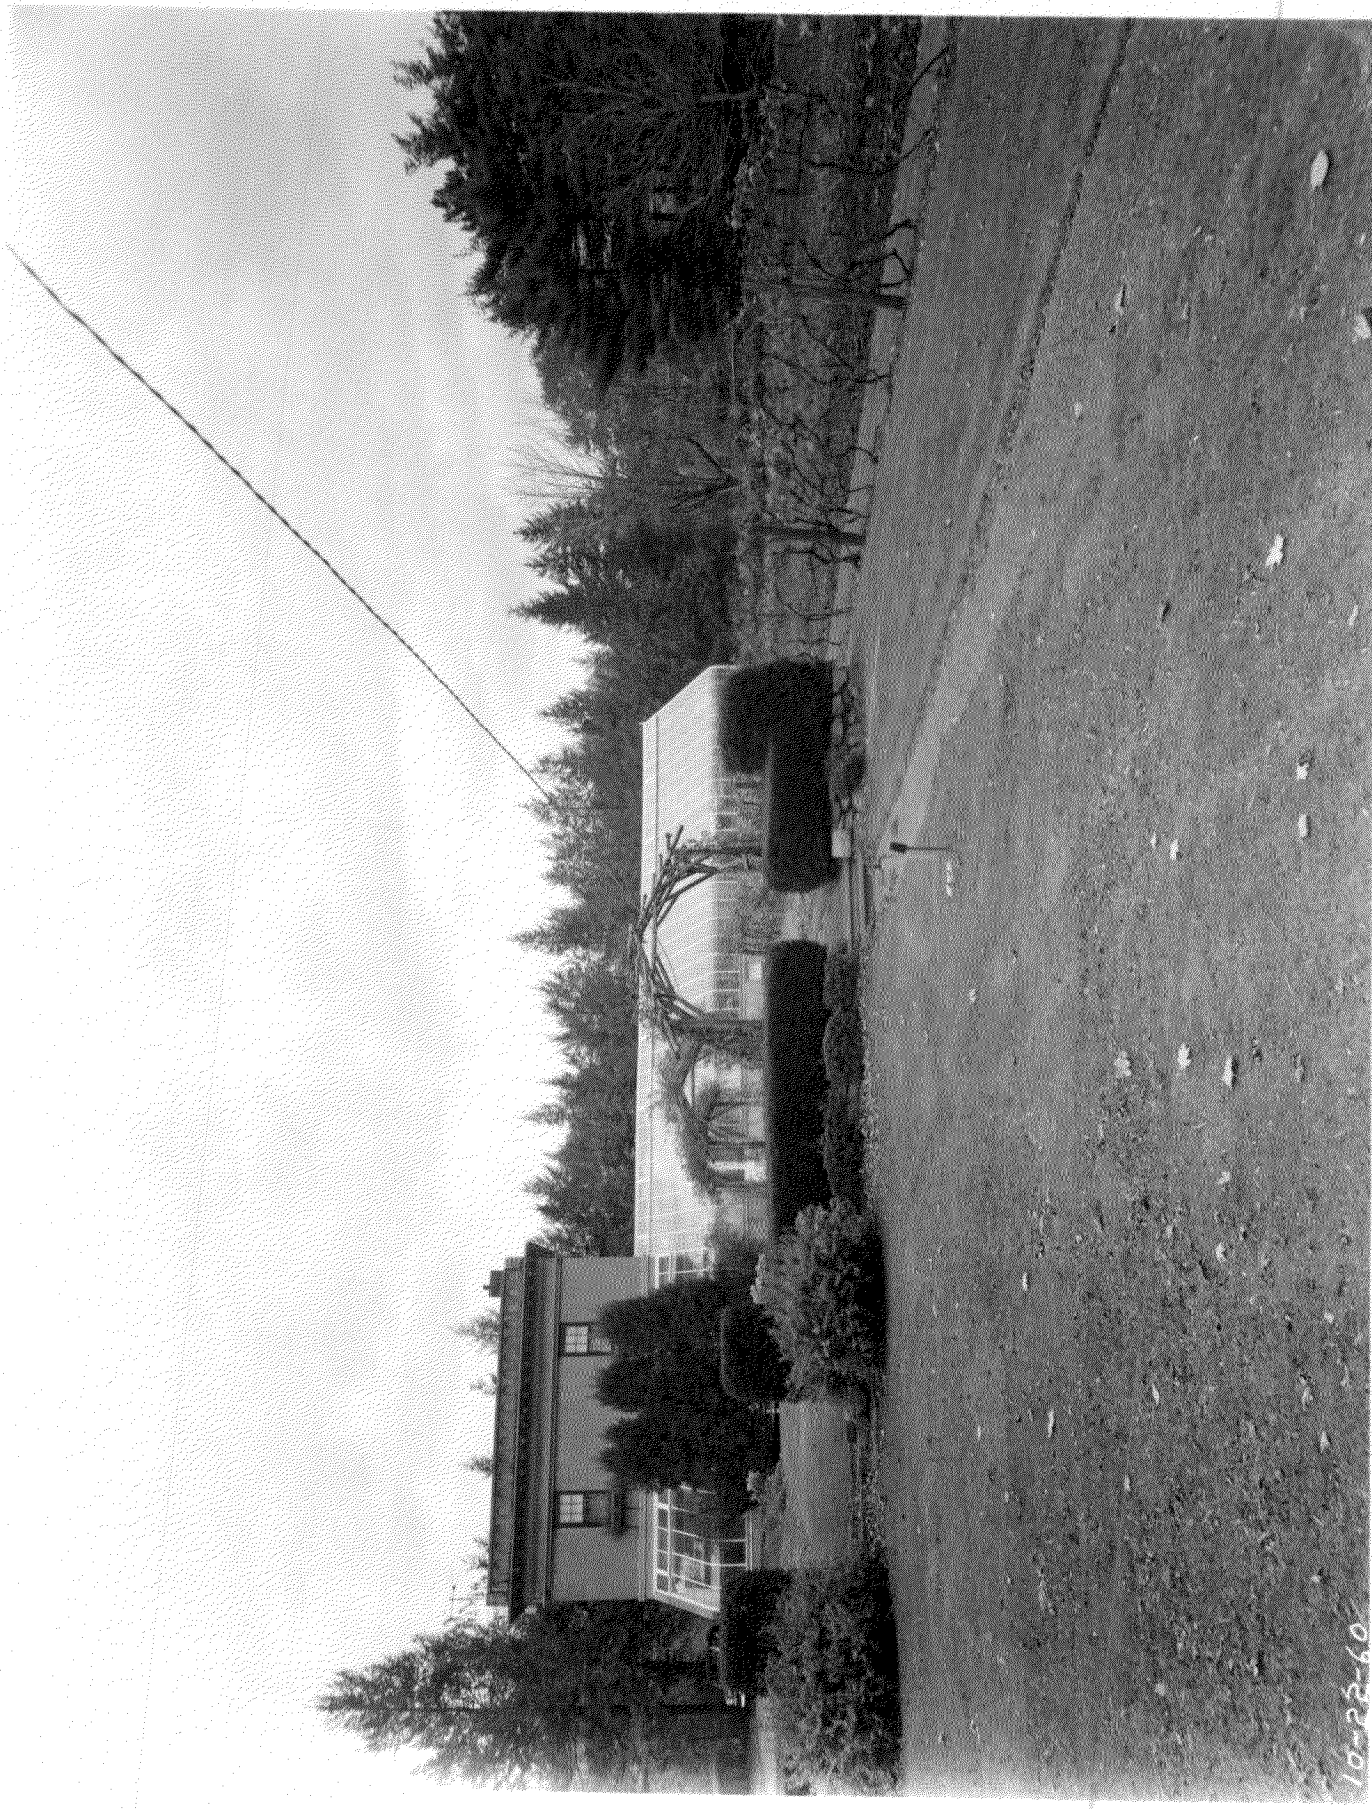
EXHIBIT 1

Photograph of the south side of  
Gardener's Cottage and Potting  
Shed, Building No. 11, and  
Greenhouse, Building No. 14,  
taken August 28, 1947.  
Negative No. 6828

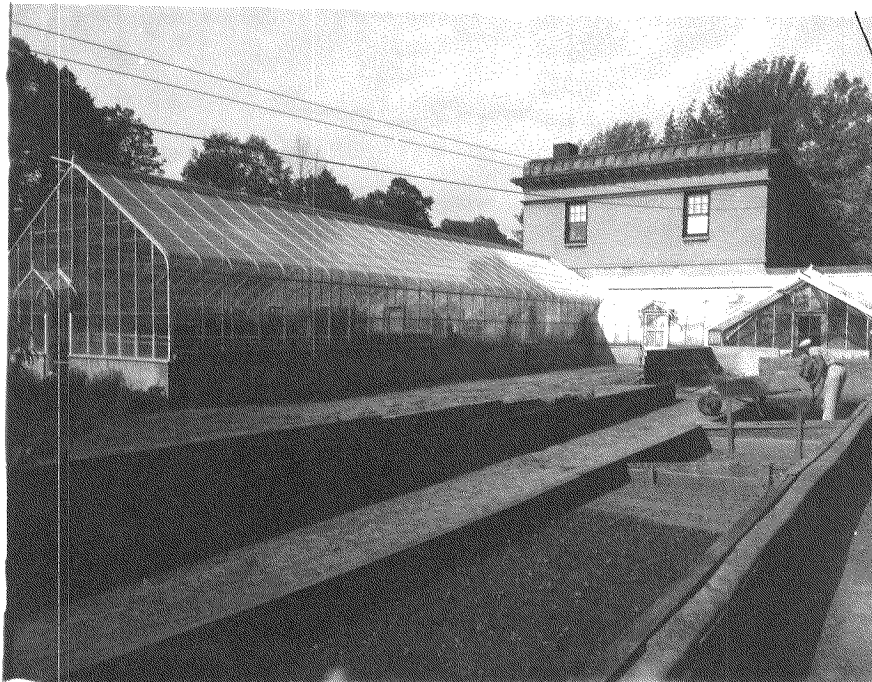
Photograph of east side of  
Gardener's Cottage and Potting  
Shed, Building No. 14, showing  
original walls of earlier green-  
house. Taken September 24, 1964.

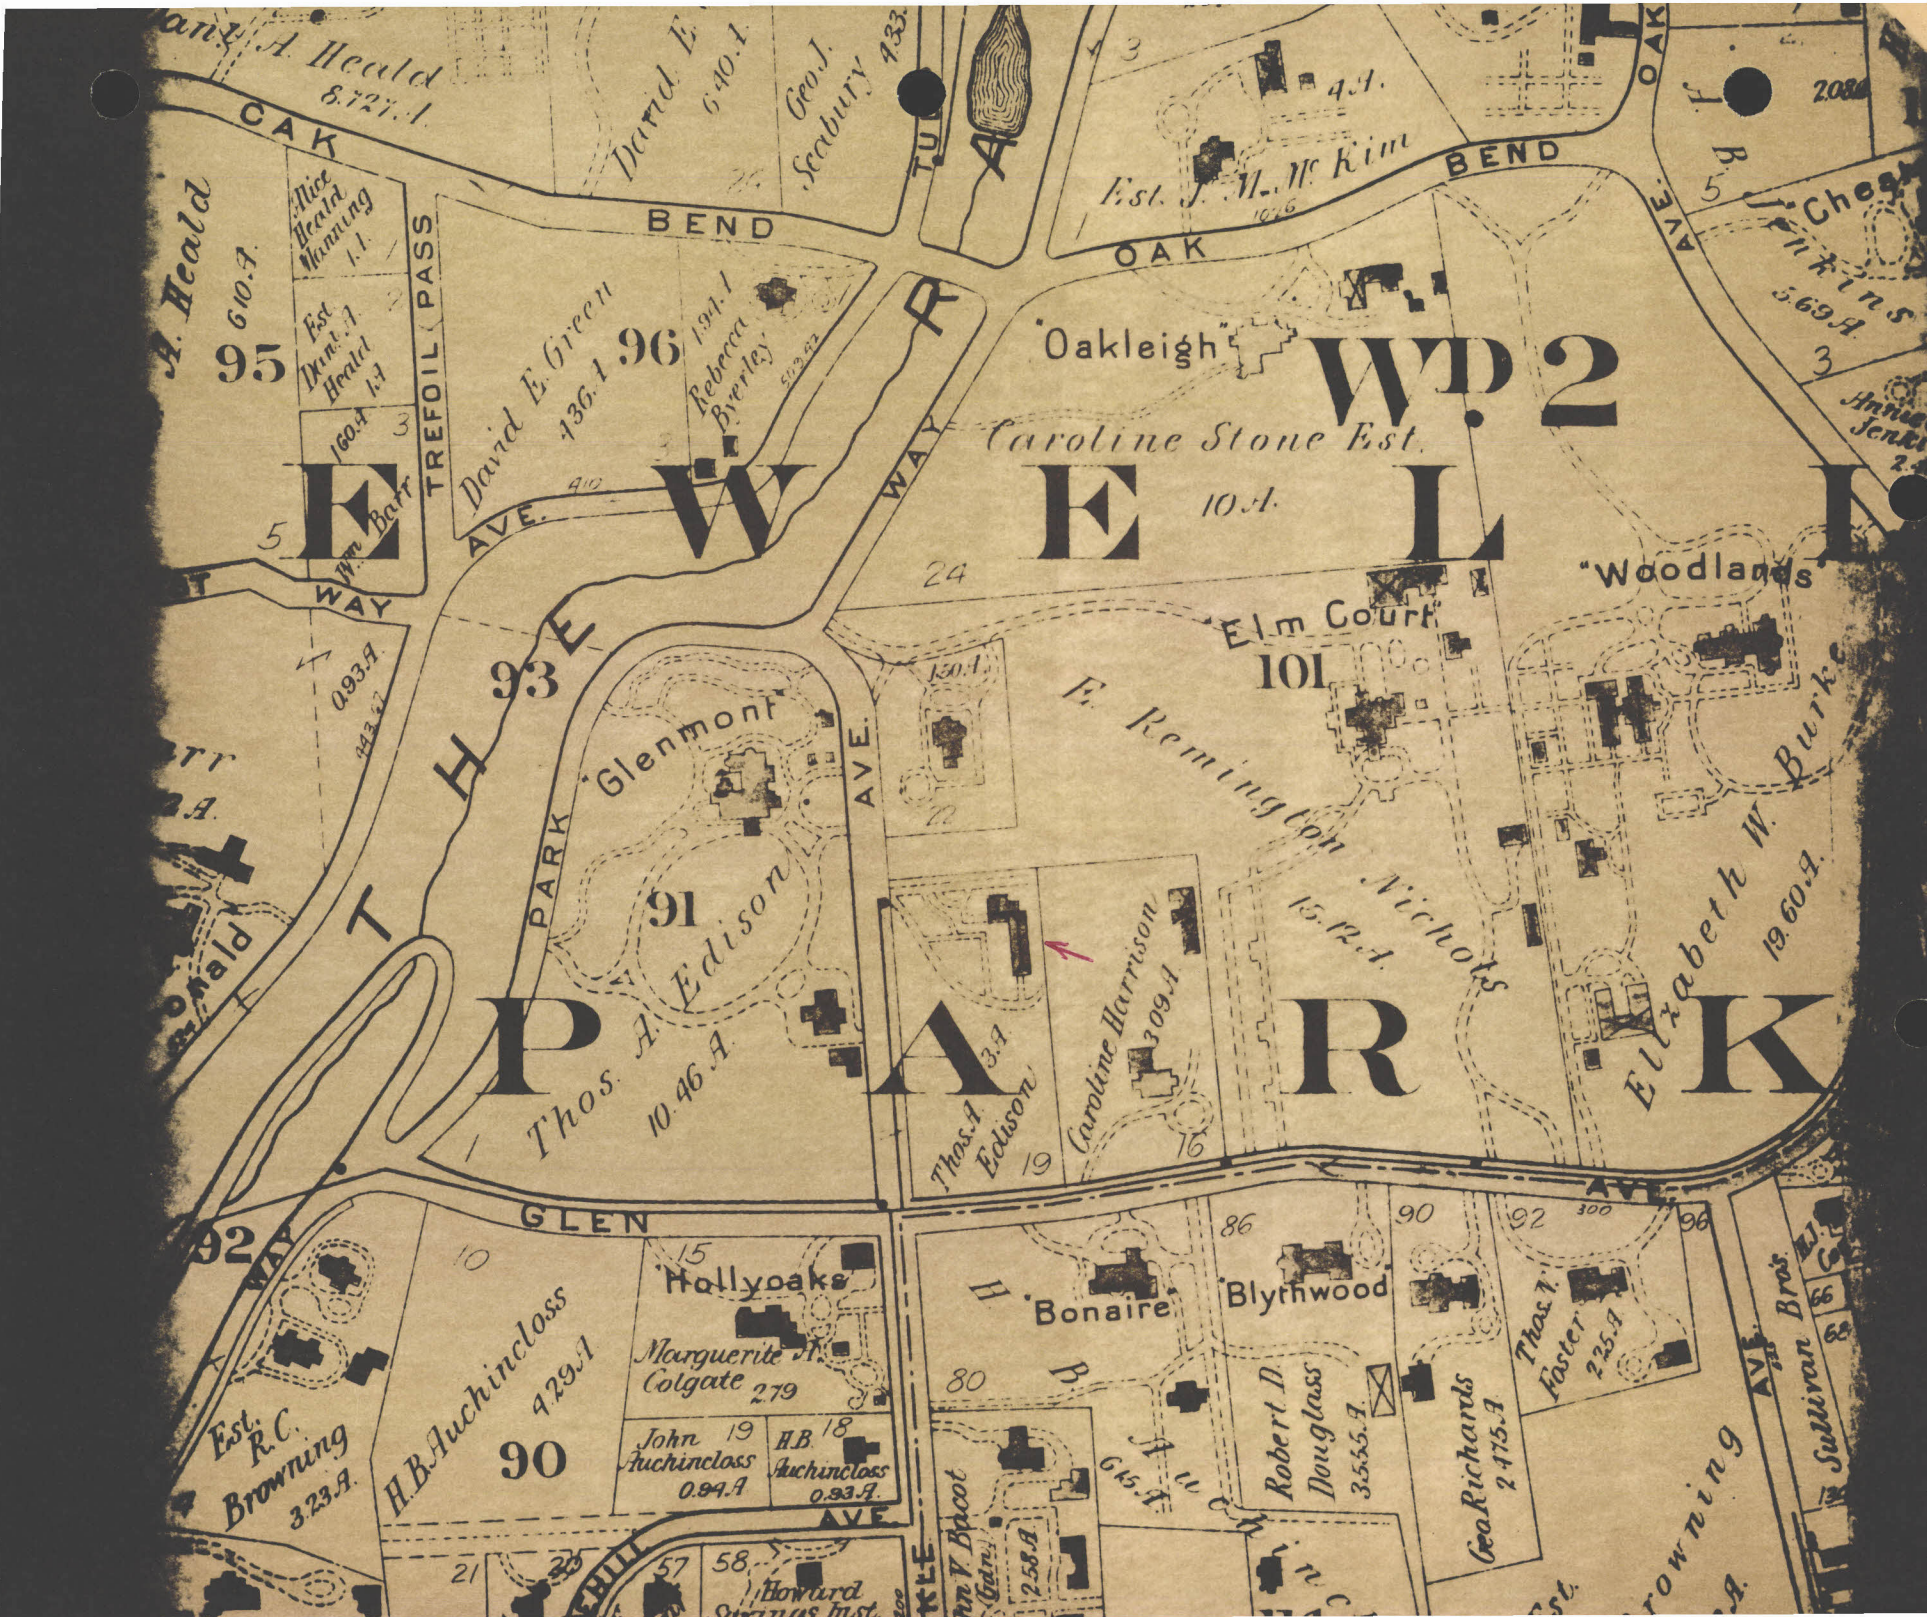
EXHIBIT 5

Photocopy of West Orange Atlas of  
1904 in the Town Engineer's Office,  
West Orange, New Jersey, showing  
location of earlier greenhouse and  
potting shed.

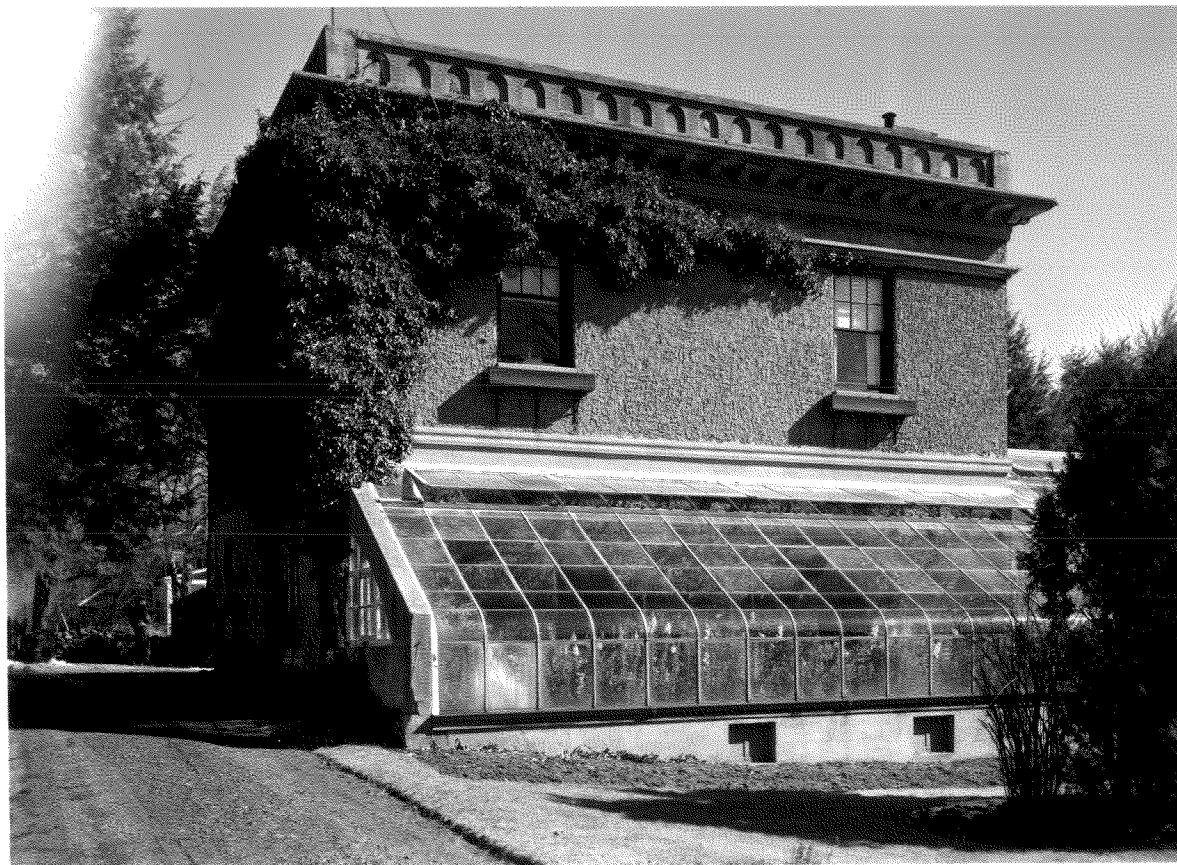
ILLUSTRATION NO. 2

The southwest corner of the Gardeners Cottage and Greenhouse. This photograph illustrates the concrete cornice and arcaded parapet in detail. The entrance to the workroom on the first floor is on the west wall at the left.

1. Repairs to the spalled concrete especially on the cornice, parapet and coping.
2. Repairs to window frames and replacement of several rotted window sash on the second floor.
3. Repairs to chimney - recommend the insertion of flue liners and fitting the opening around the liner with a waterproof cap.
4. Providing venting to space between second floor ceiling and roof slab.
