HISTORIC STRUCTURES REPORT - PART I  
BUILDING NO. 7A, WOOD STORAGE BUILDING  
EDISON NATIONAL HISTORIC SITE  
(ADMINISTRATIVE, HISTORICAL, AND ARCHITECTURAL DATA)

July 28, 1964

REPORT ON PHYSICAL CONDITION AND RECOMMENDATIONS FOR RECONSTRUCTION  
OF BUILDING NO. 7A, WOOD STORAGE BUILDING.

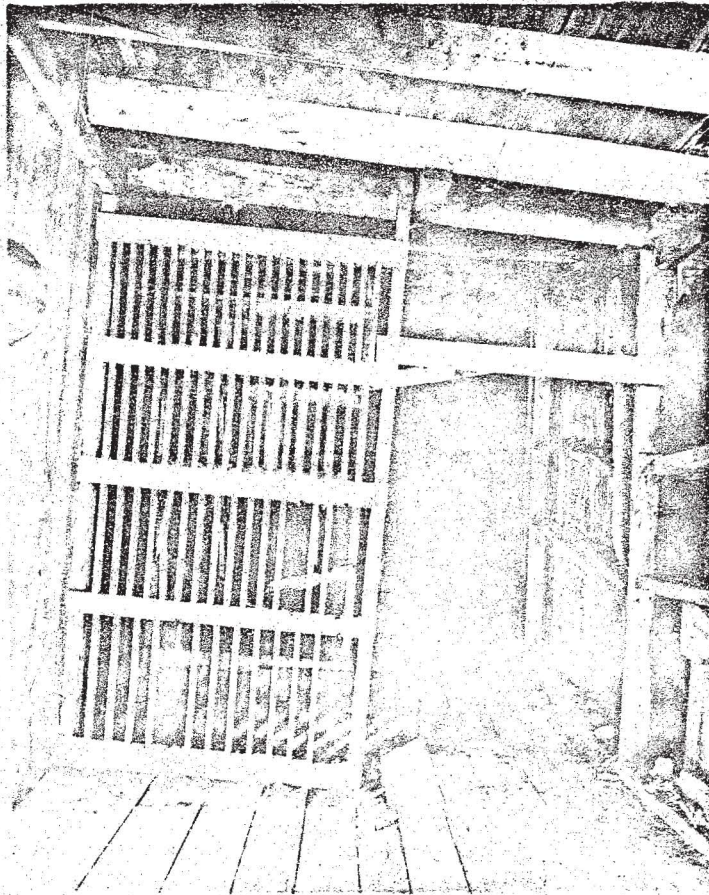
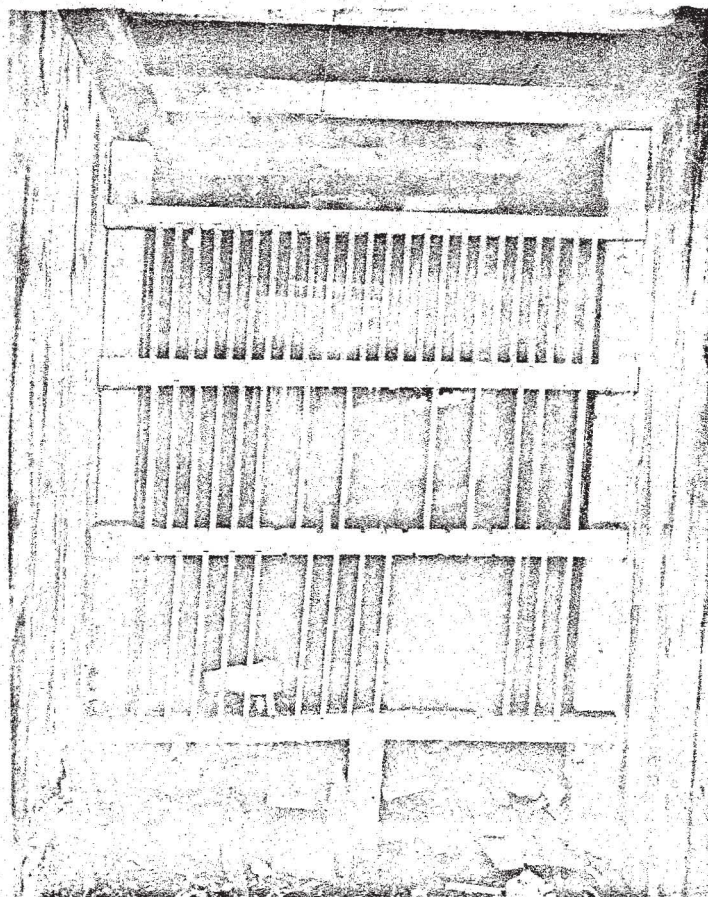
EXHIBIT NO. 5

On yet another map, presumably also of December 27, 1919, Building No. 7A is identified as a "Wood Storage Shed" (see Exhibit No. 4) and that it was used for the purpose implied by this name is certain from the lumber storage racks still in place before the structure was recently taken down for reasons of safety (see Exhibit No. 5).

Photographs of the interior of  
Building No. 7A, showing racks  
for storing lumber, taken on  
October 23, 1963, Negatives Nos.  
O-1378 and O-1379.

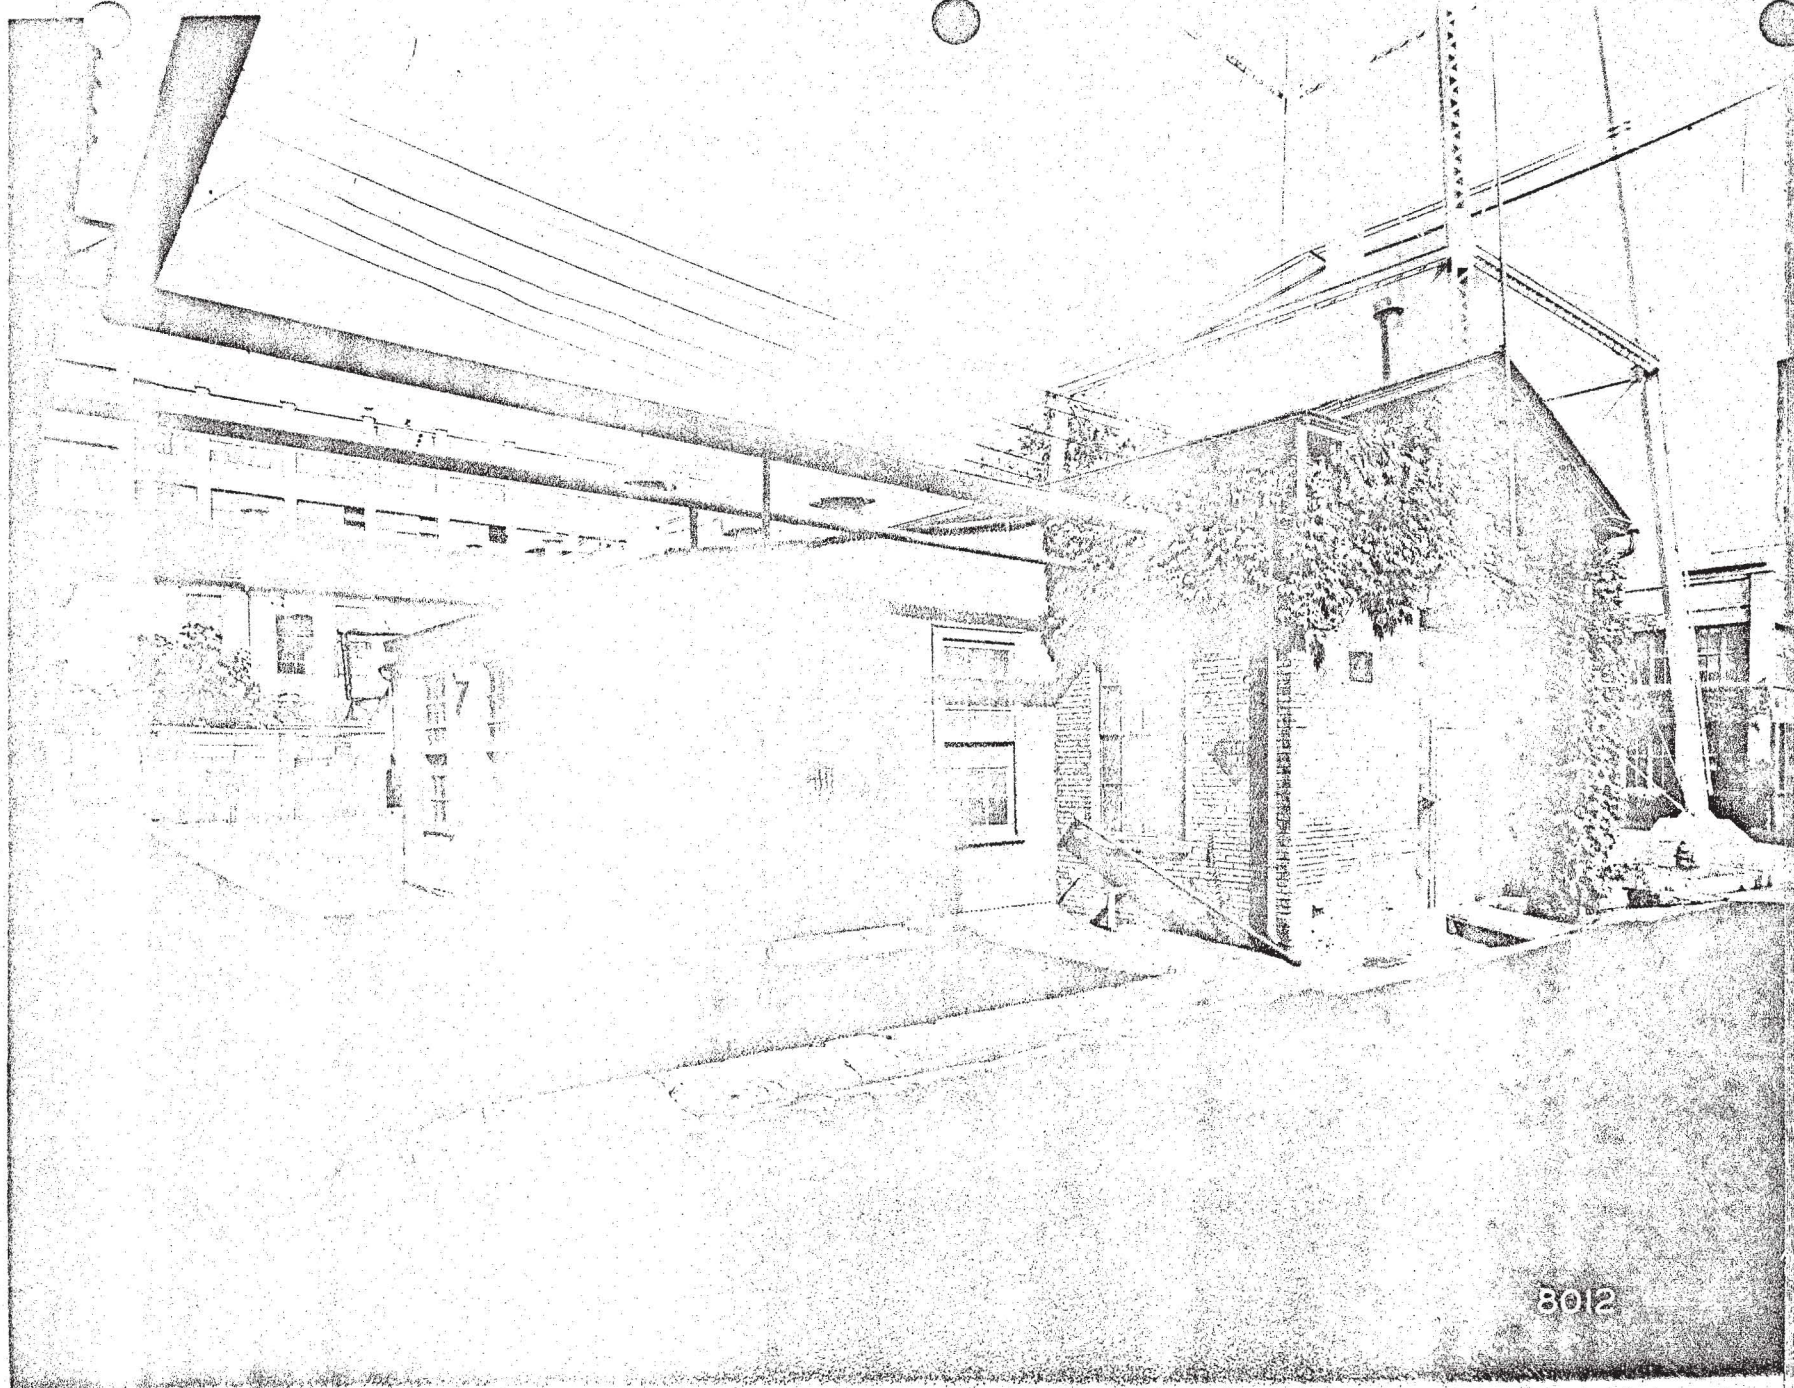
EXHIBIT NO. 6

Building No. 7A appeared different in 1963, before its removal, than in 1939, as may be observed by comparison of Exhibits Nos. 6 and 7. The windows shown in the 1939 photographs of the southwest side, facing Building No. 6, were only partially in evidence by the later date, the right-hand section having been boarded up after 1939. The 1939 photograph probably shows Building No. 7A as it appeared in the last years of Edison's life, since the old Laboratory group was shut down shortly after the inventor's death in 1931.

Photograph of exterior of Building No. 7A,  
at left and far rear, taken September 7,  
1939, Negative No. 8012.

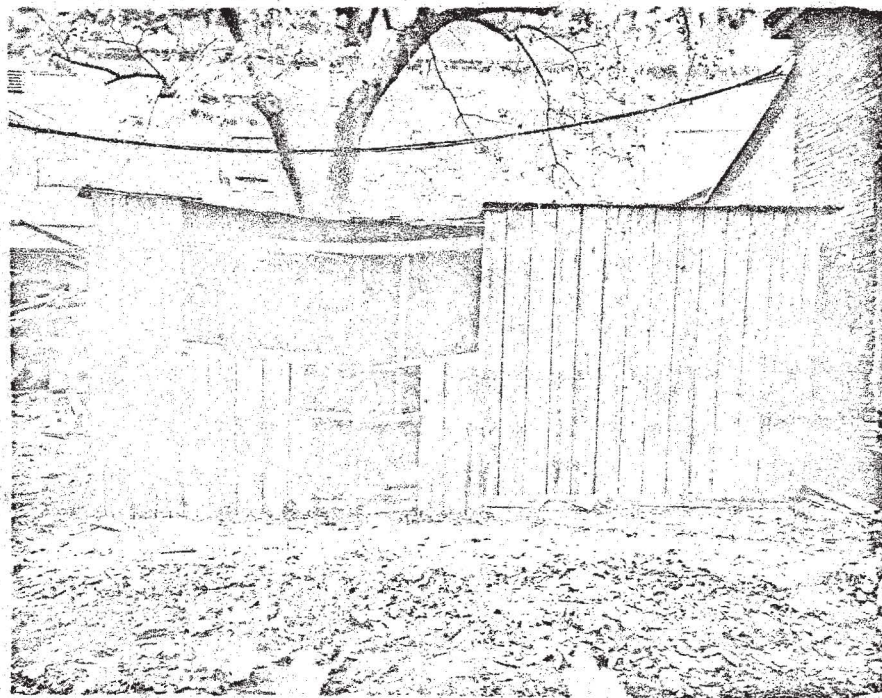
EXHIBIT NO. 7

Photograph of the exterior of Building No. 7A,  
taken October 25, 1963, Negative No. C-1380.

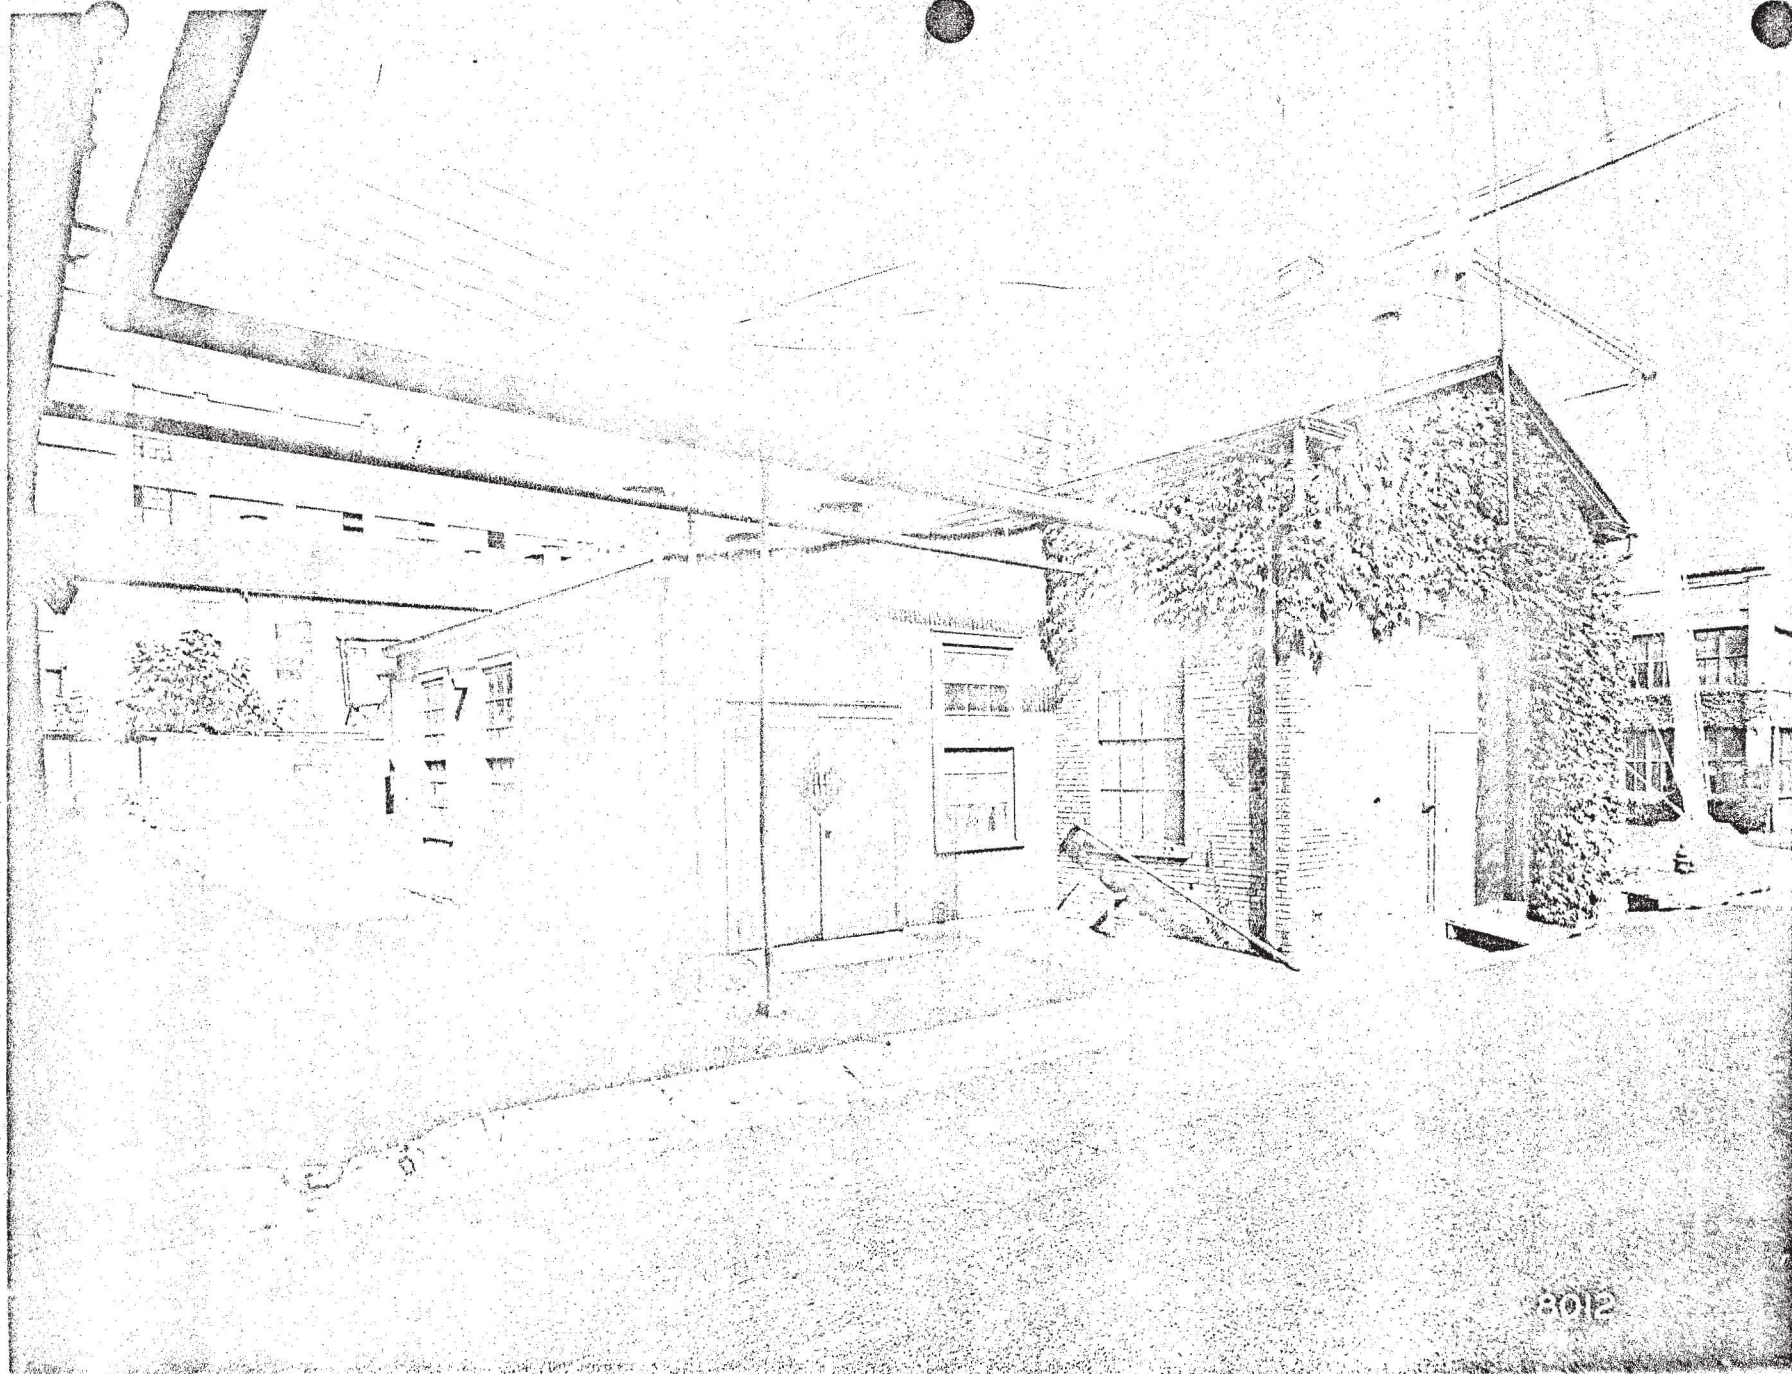
PHOTOGRAPH NO. 1

Photograph No. 1, dated September 1939, shows the building as being in good condition. By comparison Photograph No. 2, dated September 1956, shows the right-hand window boarded up, and all vertical wallboards, beginning at the lower left-hand side of the window to the right-hand side of the structure, have been replaced. By the time Photograph No. 2 was made, decay was well on the way again. Note the roof sagging, as also the sash, one wallboard missing, and the trim across the lower edge of the window has let go (note the shadow in Photograph No. 2).

Building No. 4 at right, and Building No. 7A,  
Wood Storage Building, at left rear, taken  
September 7, 1939. Negative No. 8012.

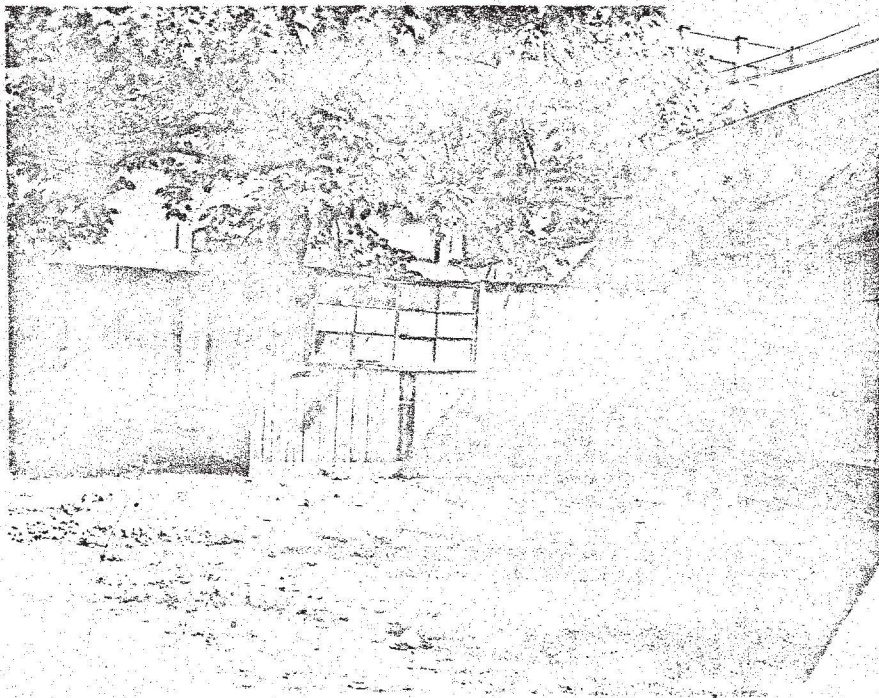
PHOTOGRAPH NO. 2

Building No. 7A, Wood Storage Building, as  
it appeared September 19, 1956, some time  
after alterations or repair. Negative No.  
O-274.

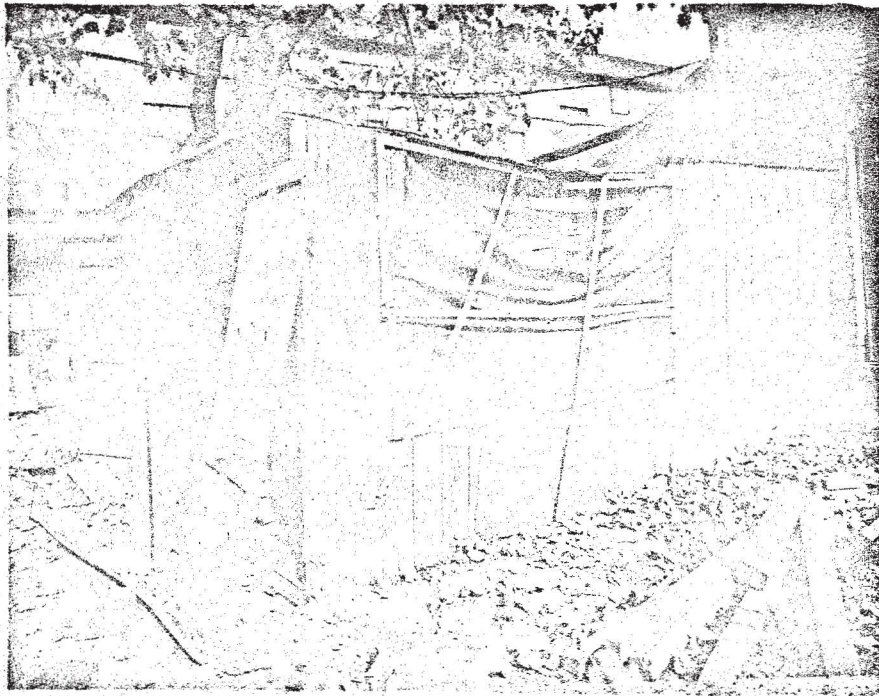
PHOTOGRAPH NO. 3

A thorough study of the building necessitated removal of non-historical patterns by the dozen and several hundred board feet of partially decayed lumber before one could enter the structure without risk of being trapped should the contents shift. Note Photograph No. 3 dated October 22, 1963, just prior to removal of the debris from inside. This shows rotten plate, sagging roof, fallen door, tar paper over missing wall boards and window opening. In Photograph No. 4 dated October 24, 1963, just after the contents were removed, part of contents may be seen in the left background. It should be noted here that the window sash was removed by the writer at an earlier date for reproduction purposes, while enough material could be salvaged to make reproduction possible. Two sashes are on hand to be installed in the reconstructed building.

Building No. 7A, Wood Storage Building,  
as it appeared prior to removal of its  
contents, October 22, 1963. Negative  
No. O-1382.

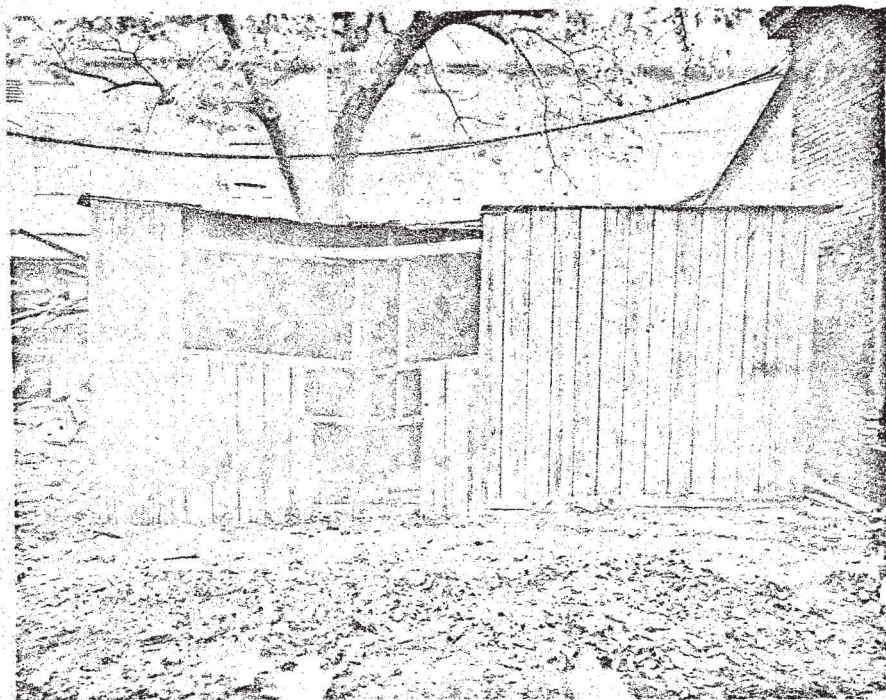
PHOTOGRAPH NO. 4

By the fall of 1963 the building was so deteriorated that it was depending upon its contents for support. It started swaying dangerously when the contents were removed. It became apparent at this time that only a light wind would topple the structure. Therefore a decision to take the building down before someone could be injured was reached by Superintendent Weig and the writer. Photographs were made of the interior first, and then the building was easily pushed over by hand. Photographs Nos. 5 and 6 were made with the camera at level. Note amount of sway in the walls.

Building No. 74, Wood Storage Building,  
immediately after removal of its contents,  
October 24, 1963. Negative No. O-1380.

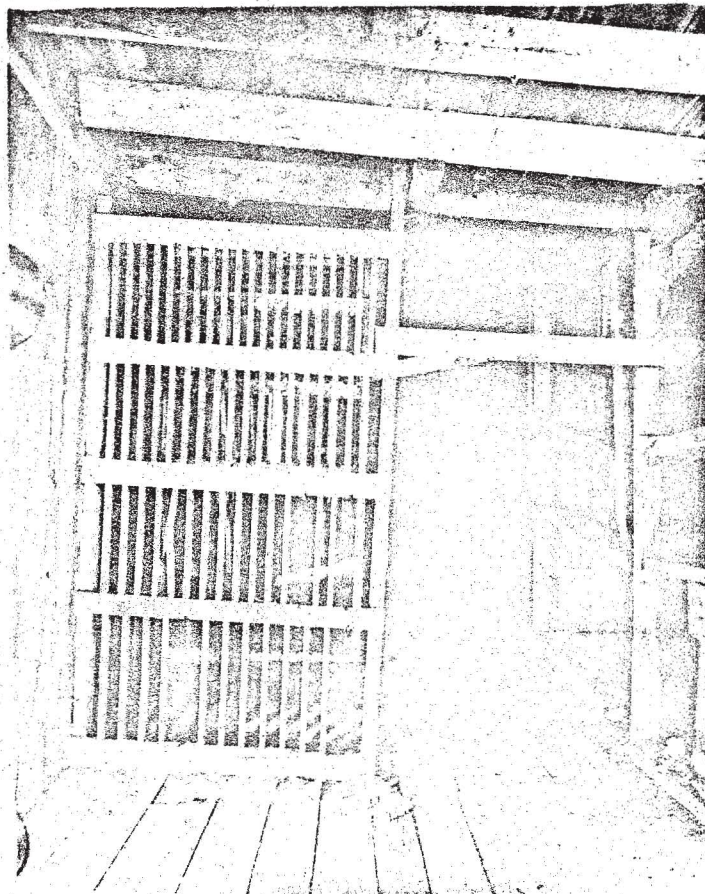
PHOTOGRAPH NO. 5

Building No. 7A, Wood Storage Building,  
interior view of the earlier section  
showing the lumber drying rack and also the  
leaning condition of the structure. Picture  
taken October 23, 1963, with camera level.  
Negative No. O-1378.

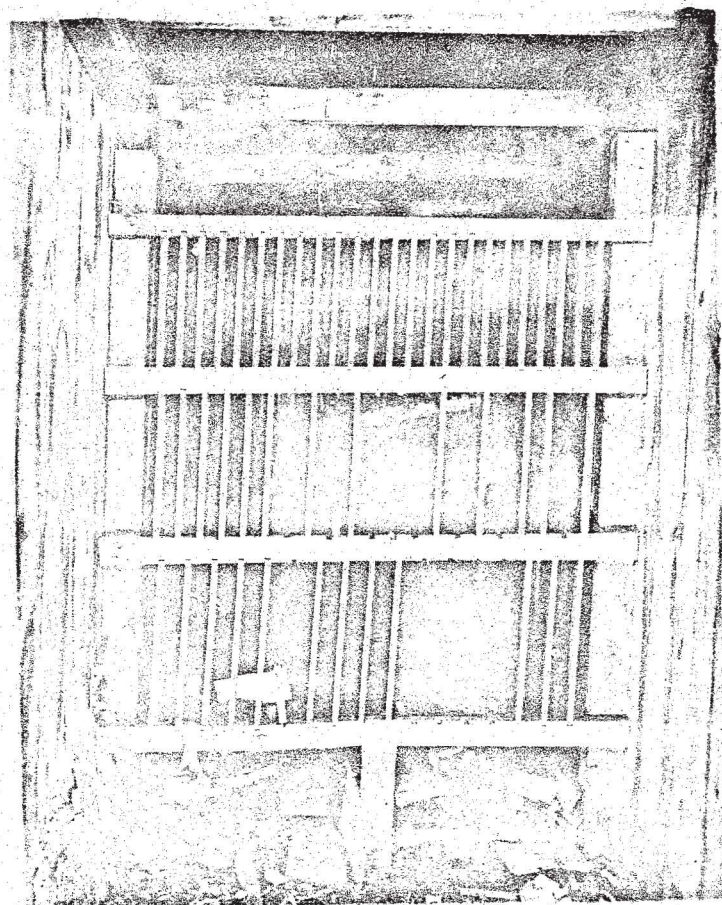
PHOTOGRAPH NO. 6

Building No. 7A, Wood Storage Building,  
interior view of the addition showing lumber  
drying rack and leaning condition. Picture  
taken October 23, 1963, with camera level.  
Negative No. O-1379.
