# **Review of Potential Rockfall Hazards at El Morro National Monument, New Mexico**

**William L. Ellis**

***Administrative Report***

***December 2000***

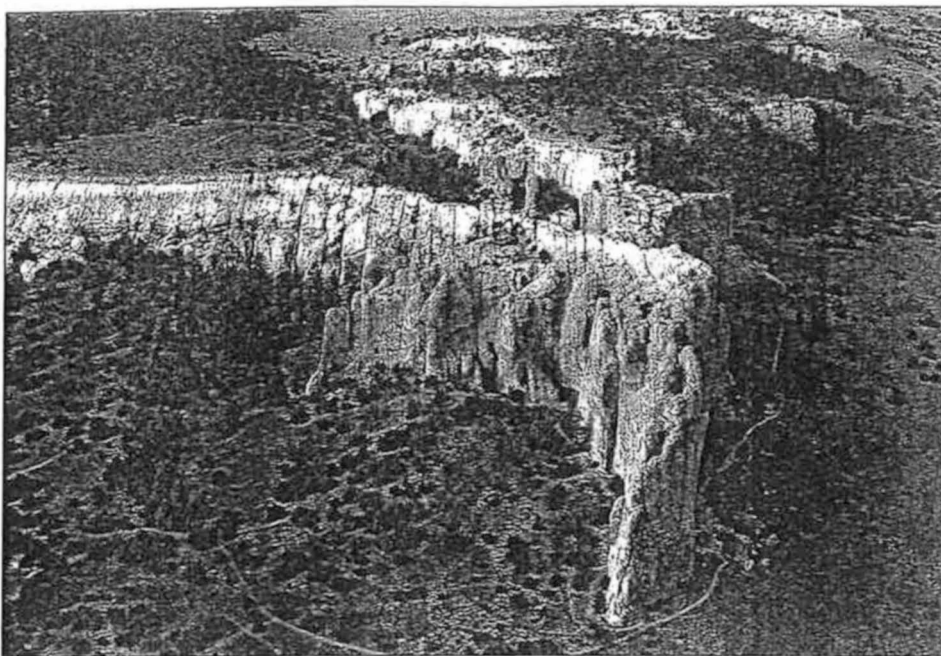
At El Morro, the Zuni Formation exhibits a very well defined and prominent northeast-trending vertical joint system (fig. 3). It is these predominant northeast-trending joints that form many of the cliff exposures at El Morro. Smooth remnants of the old joint surfaces, composed of joint infilling material up to several centimeters thick, are exposed at several locations on the cliff face. Another well-defined but less prominent vertical joint system trends perpendicular to the main set. A third, very poorly defined and inconsistent set of near-horizontal joints and planes of weakness, probably related to depositional sequences in the sandstone, is sometimes visible. Such near-horizontal weakness planes can sometimes be the locus of failure of large, overhanging rock slabs, such for the June 1999, rockfall (fig. 2). Because the weakness planes are often hidden, it is difficult to identify specific areas of potential failure or to predict when and where failure might occur.

*Figure 3. Cuesta that forms Inscription Rock at El Morro National Monument. Inscription Rock is in right center to foreground with visitor trail visible around base. View is to southwest. Note prominent northeast-southwest-oriented vertical joint set. The pool is visible at the curve in the base of the cliff just below and to the right of the center of photograph. [Photograph by Douglas E. Enry]*

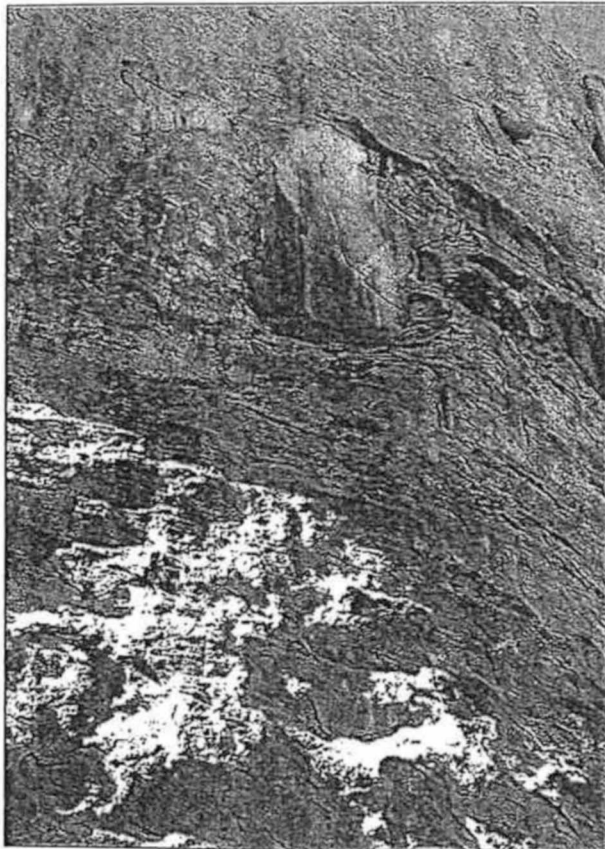
*Figure 4. View of portion of cliff face between pool and marker 4, showing thin slabbing and flaking of rock surface. Also shown in top part of photo are remnants of old joint surface and joint infilling material (dark patches) typical of several locations on the southeast-facing cliff.*

At several locations along the southeast-facing cliff are patches of dark, smooth, remnants of joint surfaces (fig. 4). These patches are up to several centimeters thick and several square meters in area, and occur high on the cliff. Although the stability of these remnant joint surfaces/infilling patches is difficult to assess, they

represent potential slab detachment. Periodic inspection and scaling of these old remnant joint surfaces could be done to identify and remove any loosened material.

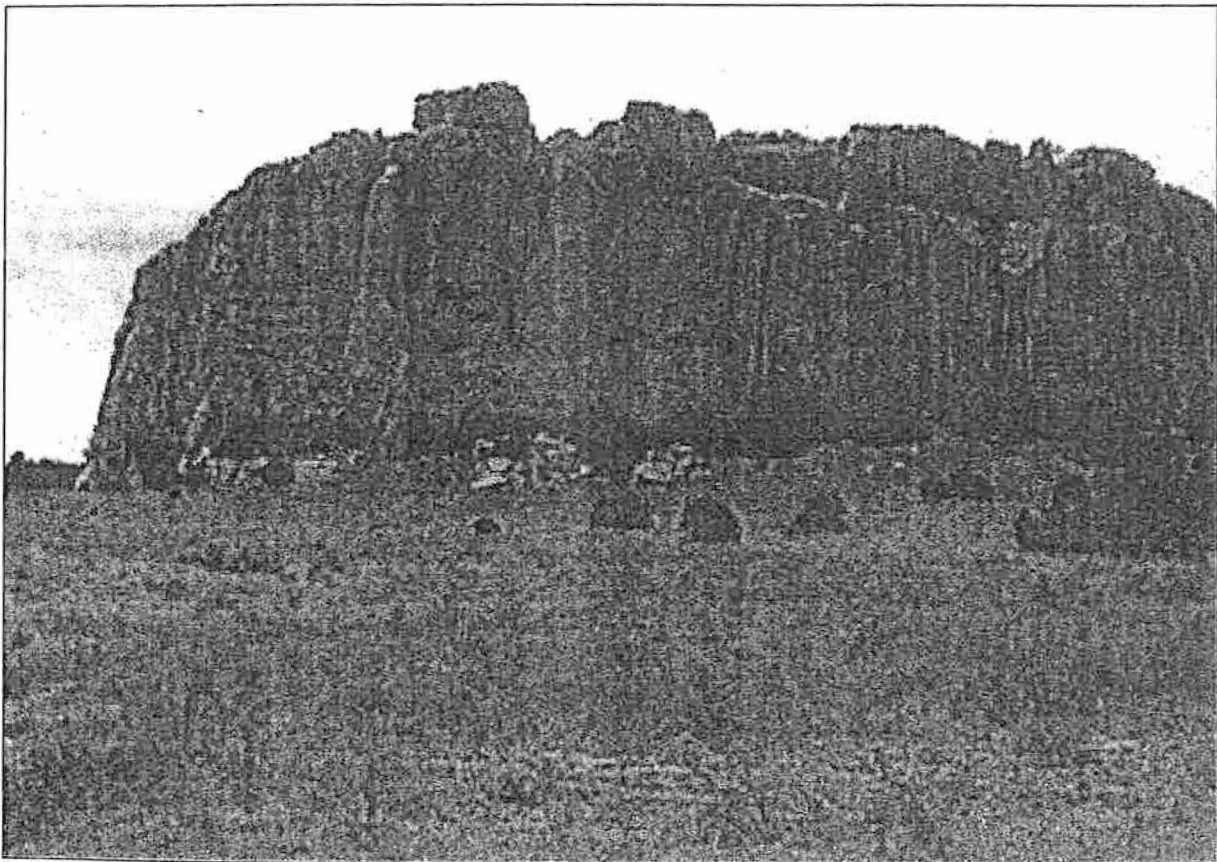
The north-facing cliff of Inscription Rock, between markers 14 and 21, is also an area of active rockfall, as indicated by the accumulated deposit of sandstone blocks and slabs ranging from a few centimeters to several meters in thickness. Numerous overhanging slabs can also be seen on the cliff above the trail where it passes very near the base of the cliff. The spalling and slabbing that is occurring here may be enhanced by more pronounced freezing and thawing action on the north-facing exposure. The area is also the location of a large rockfall that can be seen in the right foreground of figure 3 and in the center of figure 5. Inscriptions along the cliff above the old rockfall debris date to the early 1600's, indicating that the rockfall is older than 400 years.

**Figure 5. North-facing cliff of Inscription Rock. Note abundant dark staining caused by flow and seepage of water on older cliff exposure. Rockfall debris can be seen in center of photo below where dark staining is absent.**

The recommendations of previous investigators that this portion of the trail be closed during periods of freeze and thaw are probably the best approach to reducing risk to visitors in this area. According to Park officials, this part of the trail is usually closed until late spring owing to the presence of ice on the trail surface. Careful inspection of the cliff face should be done each spring prior to opening of the trail to look for the presence of slabs that may have been loosened over the winter and early spring months.

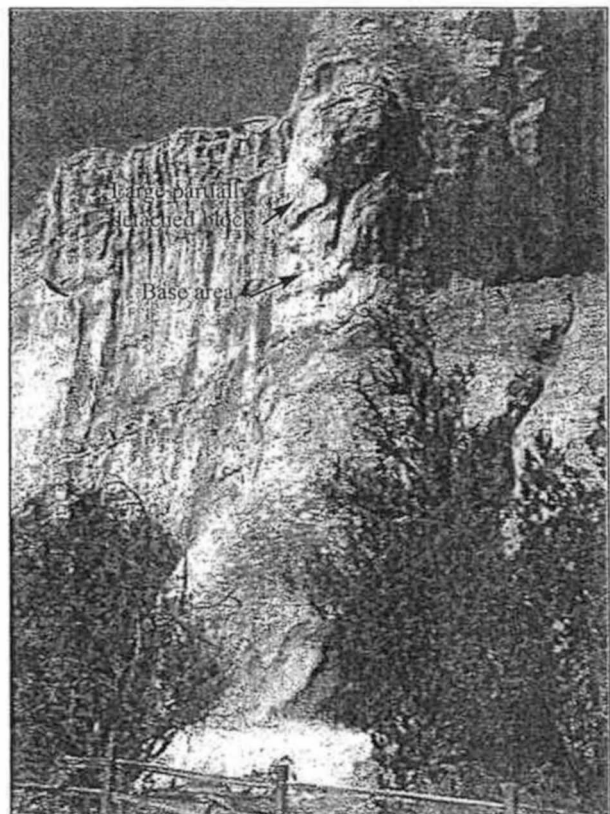
### Trail Marker #1

A large, partially detached block sits about midway up the bluff above marker #1 (fig. 6). Although the block appears to be stable, its mass is supported by a small base that could be susceptible to shear failure. The block should be examined periodically by Park staff for any signs of developing instability, such as new fractures or deterioration in the base area of the block. Because the visitor trail is located several meters from the cliff at this location, the risk from possible failure of the block is primarily limited by how far the block might travel after impacting the ground surface. A detailed analysis of the possible roll-out distance would be required to assess the risk, but because the trail is removed from the likely impact area the risk is considered to be low.

Figure 6. Large, partially detached block on bluff near trail marker #1.

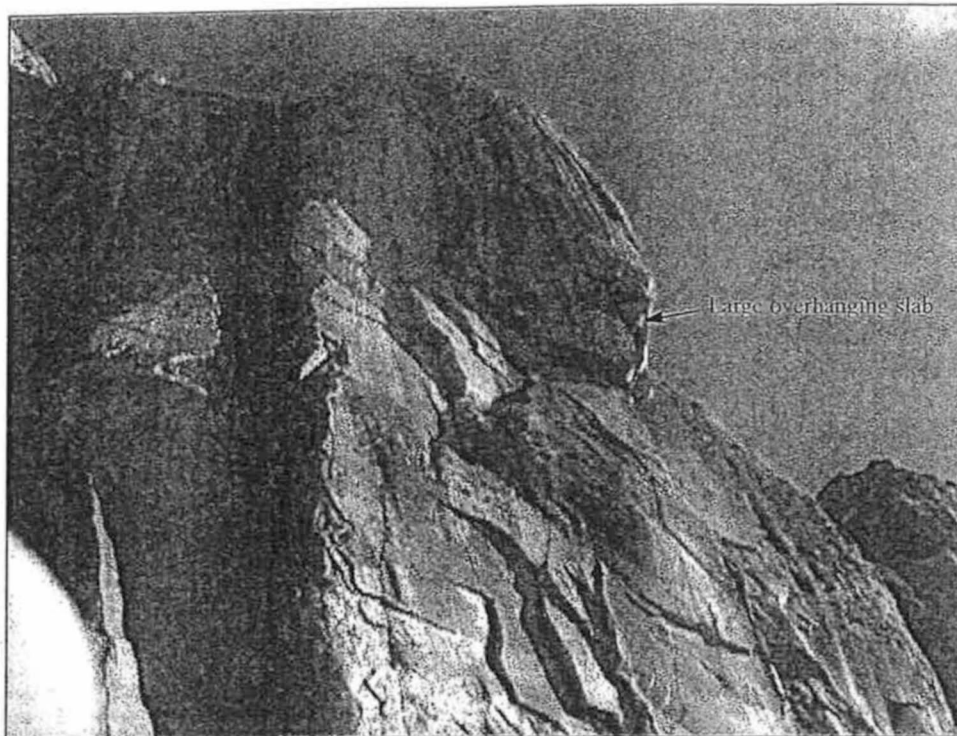
### Trail Marker #4

Above trail marker #4, near the top of the cliff, there is a large overhanging slab with no support from below (fig. 7). Some fracturing is

**Figure 7. Large overhanging slab near top of cliff above trail marker #4. Numerous thin slabs are also present in this area.**

apparent within the slab, but the presence of mud from swallow nests below the slab make it difficult to determine by visual inspection from the trail if fracturing occurs behind the slab. Several thinner slabs also are present on the cliff face in this area, but appear to be well attached to the cliff. The critical concern for the overhanging slab is its location above the trail. Separation of any part of the slab would impact the trail directly with little or no warning. No inscriptions are present in the area directly beneath the overhanging slab, so this is one area where the trail could be re-routed away from the cliff to reduce the risk. Careful inspection by a climber rappelling from above to determine if the slabs are firmly attached to the cliff may be warranted. Tapping along the outer surface of the slab with a hammer or pry bar is a method often used by experienced rock scalers to detect the presence of open fractures behind rock faces. Scaling could be done to remove unstable parts of the slab(s).

3. The areas of concern for possible slab failure noted above trail markers #4 and #11 should receive a closer inspection by a climber suspended by rope from above. Soundings by tap-

ping with a hammer or pry bar can be used to distinguish if the slabs are firmly attached or perhaps contain significant fracturing behind the slab. Any slabs found to be unstable should be scaled from the cliff. Re-routing of the existing trail below the slab area near marker #4 to bypass the area directly below the slabs is a practical alternative to reduce potential risk, as no inscriptions are present at that location. However, because the locations of the slabs are high on the cliff and increase the potential for rock bounce, it is probably not practical to re-route the trail far enough away to eliminate the hazard altogether.

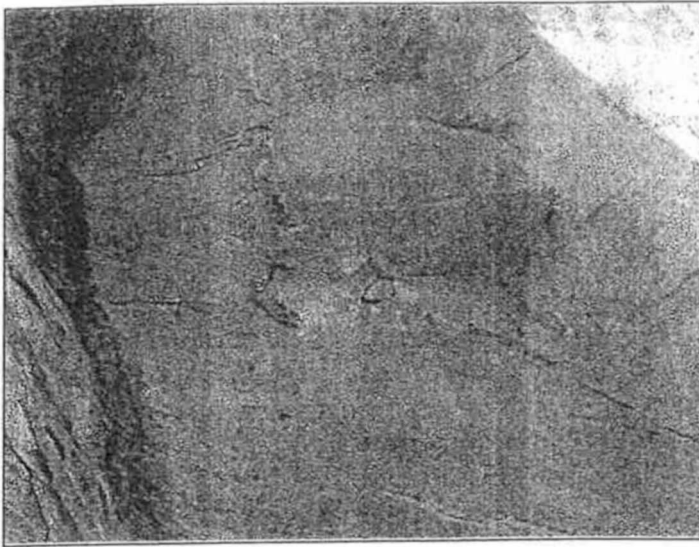
### **Trail Marker #11**

A potential rockfall exists above trail marker #11, where a relatively large wedge-shaped slab is

unsupported from below (fig. 8). A fracture can be seen behind the slab indicating that it is partially detached from the cliff face. Relocation of the trail is not practical in this area. Inspection by a climber rappelling from above could determine if the slab is firmly attached to the cliff or is partially detached and thus represents a threat. If determined not to be solidly attached, scaling by a climber to remove the slab is recommended.

**Figure 8.** Telephoto view of relatively large, wedge-shaped slab above trail marker #11. Note fracture between bottom of slab and cliff face.

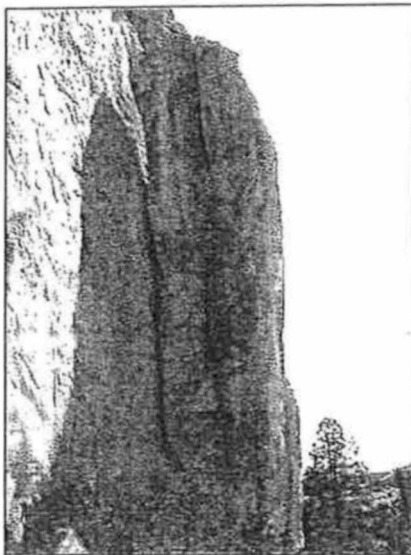
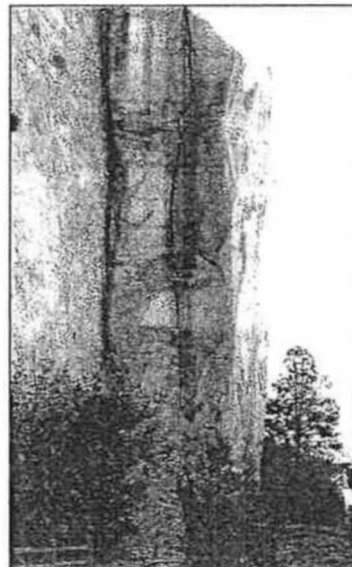
Near trail markers #12 and #13 is one of the most dramatic features with respect to potential rockfall hazards in the Park. This feature is a very large, approximately 50-m-high column of rock that is split by a vertical fracture (fig. 9). The fracture appears to be 10-15 cm wide near the top of the column, and disappears into hairline fractures near the base. The geometry of the fracture indicates that the outer part of the column has rotated outward relative to the inner part, and that the motion is hinged near the base of the column. The sharp, angular edges of the fracture indicated that it is much younger than the separation between the main column and the cliff. The defor-

**Figure 9A and 9B.** Two views of large split column of rock located between trail markers #12 and #13. Visitor trail, visible in view B, passes next to the base of the column.

mation that produced the fracture could therefore be relatively recent and perhaps ongoing. The rock column and fracture are very prominent and often prompt concern and questions from Park visitors about the column's stability and possible danger.

The fracture appears in 1929 photos and again in a 1978 photograph taken by Wachter (1978). Although it is difficult to determine, the fracture appears to be wider in the 1978 photo, suggesting that there has been recent outward rotation of the outer portion of the split column. Such rotation could be a gradual, ongoing process. Inspection of the fracture for this review indicates a small, wedge of rock about mid-way up the column has separated and fallen downward a few centimeters within the fracture since the 1978 photograph was taken (fig. 10). While the separation and downward movement of this small wedge does not necessarily mean the fracture has widened since 1978, it does indicate that geologic processes are actively at work along the fracture surface.

Although there is no reason to expect that failure of this rock column is imminent, its size, location, and indication of possible ongoing movement make it advisable to re-initiate a monitoring effort to determine if movement or further separation of the fracture is occurring. Because any further movement or fracture separation leading up to potential failure is likely to be gradual, instrumental monitoring is a viable and potentially valuable alternative at this site. Obtaining long-term baseline data is critical to assessing current or future hazard potential from this feature. Details of the recommended instrumental monitoring are discussed later under *Suggested Actions*.

7. Instrumental monitoring of the large, split monolith between markers #12 and #13 should be re-initiated as soon as practical. Although there is no evidence that the central fracture is currently widening, this is one area of the Park where instrumental monitoring could be of possible value in assessing the potential hazard. Long-term background data is necessary to

A combination of both mechanical measurement and electronic sensors is recommended. The installation of an array of six monitoring pins, three on each side of the central fracture, should be installed on the south face of the column. The distance between the pins would be measured periodically by a sensitive dial or LCD display gage (accurate to 0.02 mm). The pins should be arranged in a rosette pattern, such that the distance between three sets of pins would be measured. In this way the amount and direction of relative movement in the plane of the pins (approximately perpendicular to the fracture) can be determined. The pins should be placed as high as can safely be installed and subsequently reached for measurement using an extension ladder (approximately 10-12 m above the ground surface). While measurement of fracture separation would be best made near the top of the column, the accuracy and resolution of the instrument is sensitive enough that movement can be detected at heights reachable by extension ladder, thus eliminating the need of a technical rock climber.

In addition to the mechanical pins, it is recommended that a dual-axis inclinometer be installed on the north face of the outer rock column. It appears that access to a suitable location for mounting the inclinometer on the rock surface can be gained through the large fissure just behind trail marker #13. The services of a professional rock climber would be advisable to complete the installation. Lead wires for readout of the inclinometer could be located at the base of the cliff behind the fence at marker #13. The location of the inclinometer on the north side of the monolith will shield it from daily exposure to the sun, and thus reduce the effects of daily temperature excursions on the instrumental readings.

Depending on availability of funds and feasibility, the installation of a cable-extension position transducer (wire extensometer) should also be considered for installation across the fracture on the north side of the monolith. Both the inclinometer and extensometer would be read periodically with a hand-held readout unit from the base of the cliff near the trail.

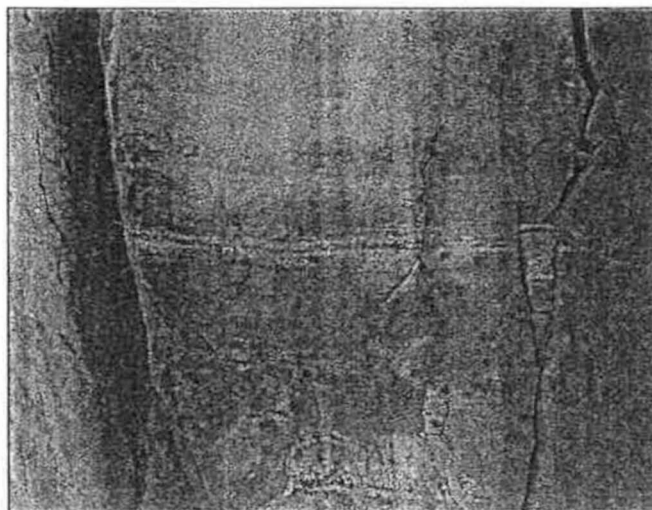
**Figure 10.** Small wedge of rock that has separated and down-dropped along the central fracture of the large rock column of figure 9. The wedge is not present in the 1978 photo of the rock column.

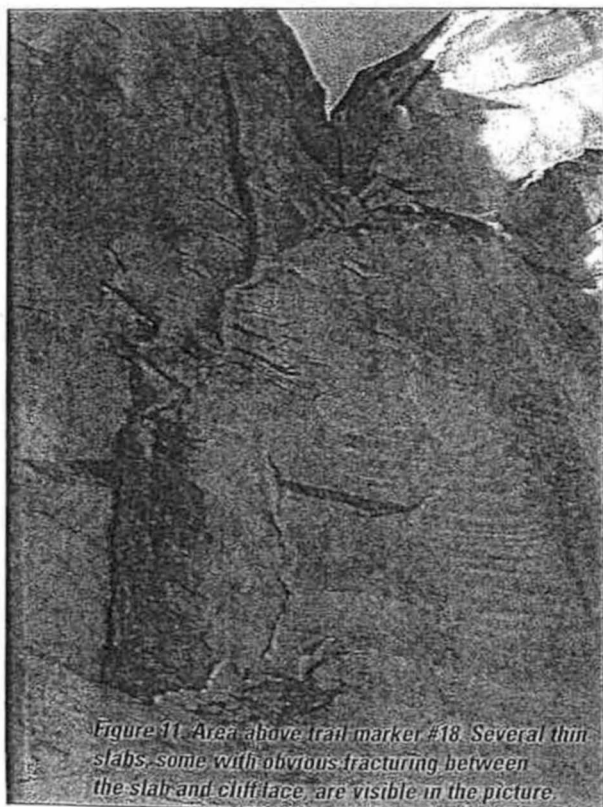
### **Marker # 18**

Above trail marker #18 is an area of several thin to moderately thick slabs, many with little or no support from below and with obvious fracturing between the slab and cliff face (fig. 11). This is within the area previously described in *Areal Rockfall Hazards* and is shown in figure 5 above the rockfall debris along the north-facing part of Inscription Rock. Figure 12 shows a close-up of another relatively large slab near the top of the cliff and just to the right of the area shown in figure 11. Here the trail passes very near the base of the cliff, which increases the hazard posed by these potentially unstable slabs. This is another area where close inspection by a climber rappelling from the top of the cliff could determine if any of the slabs are unstable. Scaling of any loose, unstable slabs would reduce the potential hazards in this area.

Figure 11. Area above trail marker #18. Several thin slabs, some with obvious fracturing between the slab and cliff face, are visible in the picture.

2. As noted in previous correspondence, the north-facing cliff of inscription rock between about markers 17 and 20 is considered a relatively high risk area because of the presence of relatively fresh slabbing and the assumption of more pronounced freeze and thaw action on the north-facing exposure. The Park should maintain the existing policy of restricting access to this portion of the trail during periods of freezing and freeze and thaw activity. Careful visual inspection of the cliff face by trained Park staff should be done prior to re-opening the trail in the Spring, and following any periods of freeze and thaw or extreme temperature variation. Consideration should also be given to temporarily closing this portion of the trail during and following periods of heavy rain.

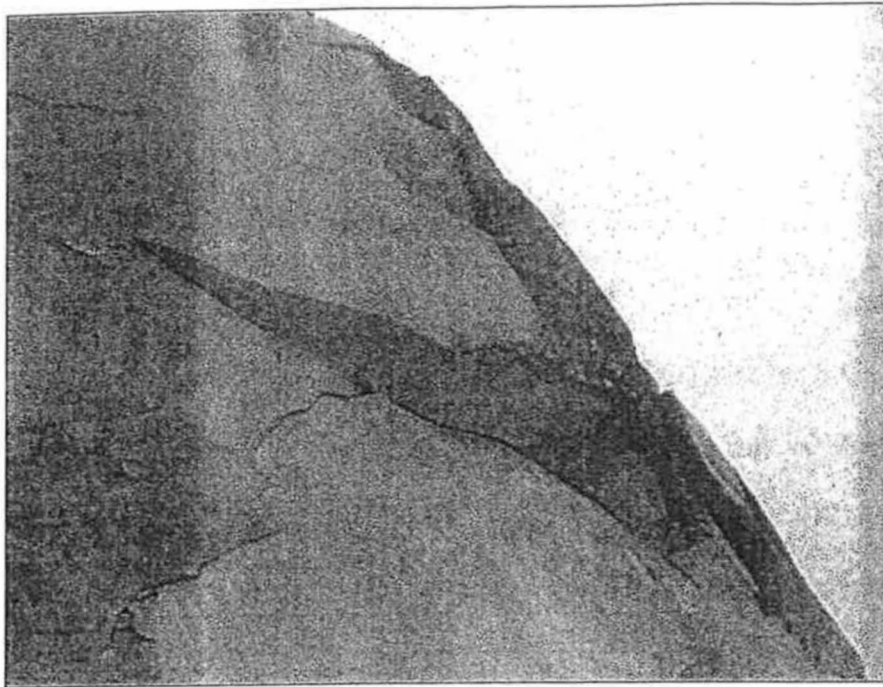
**Figure 12. Close-up photo of large slab near top of cliff above trail markers #18 and #19. Note fracturing behind slab.**

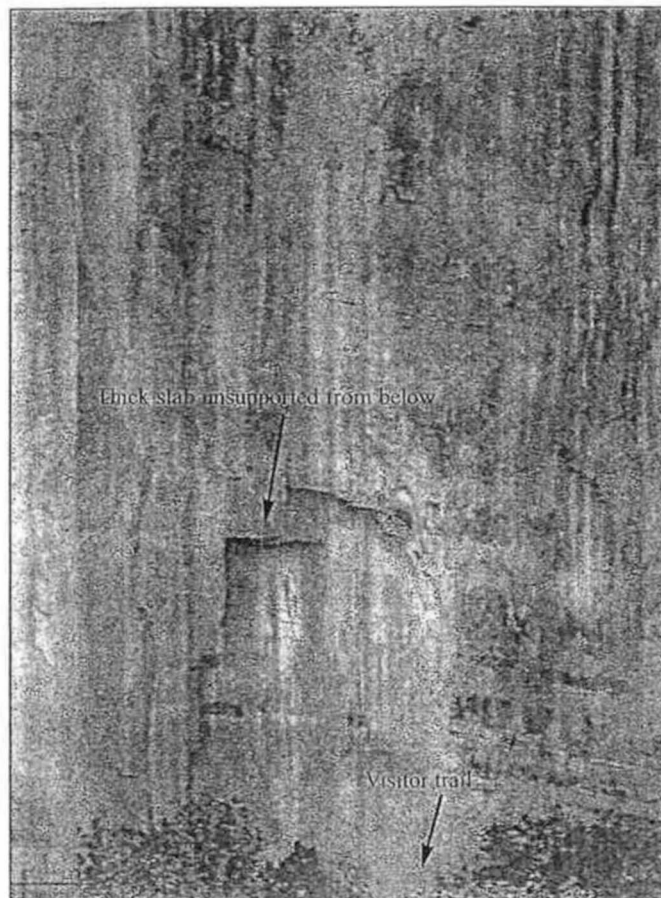
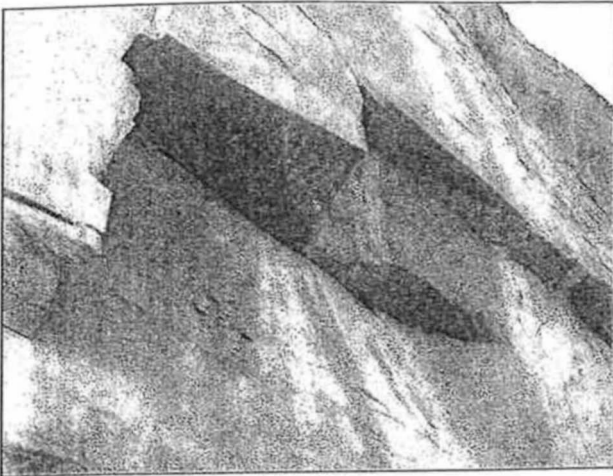
### **Markers #20 and #21**

Directly above the trail between markers #20 and #21 is a large, approximately 1-m-thick slab

**Figure 13. Large, overhanging slab directly above visitor trail between trail markers #20 and #21.**

**Figure 14.** Close-up view of slab in figure 13. Note presence of fracturing behind and on left side of slab. A horizontal weakness plane, exposed by previous slab failure, can be seen above and to right of slab. This weakness plane probably extends into the inplace slab.

unsupported from below (figs. 13 and 14). This slab is perhaps the most ominous threat to visitors on the trail below. The slab overhangs directly above the trail, and any failure would be sudden and without warning. The consequences would most certainly be deadly for anyone located beneath the slab.

Other than removal, there is little that can be done to eliminate the hazard posed by this slab. Removal of the slab would likely just expose yet another section of the overhanging rock to potential slab failure. Rock bolting of the slab and the surrounding area would stabilize the potential failures, but is considered dangerous and impractical.

Fortunately, this potential hazard is in an area where trail relocation can mitigate the risk to visitors. The trail in this area contains steps as it traverses up and over the boulders and debris left from the old rockfall discussed previously and visible in Figures 3 and 5. Apparently, this section of the trail is under consideration by Park management for re-routing in order to improve accessibility for disabled visitors. Relocation of the existing trail in this area would therefore serve dual purposes; provide handicapped accessibility to marker #21 and a greater length of the Mesa Top Loop Trail, and also eliminate visitor traffic directly below the potential rockfall hazard. A portion of the existing trail to marker #20 could

remain open as a dead-end spur of the trail, with the new section of trail traversing around the old rockfall debris. Another dead-end spur could then extend to marker #21. The area directly under the overhanging slab, where no inscriptions are present, would then be closed to public access. Because of the potential seriousness of a rock failure at this location it is recommended that trail re-routing be implemented as soon as possible

1. Re-routing of the visitor trail near markers 20 and 21 is considered a high priority. The existing trail between markers 20 and 21 should be closed, thus eliminating public exposure to the overhanging slab directly above the trail. As noted earlier, re-routing of the trail would also provide handicapped accessibility to marker 21 and further reaches of the trail. As no inscriptions are present between markers 20 and 21, the only inconvenience to the public is a small amount of additional walking to gain access to the inscriptions at marker 21.

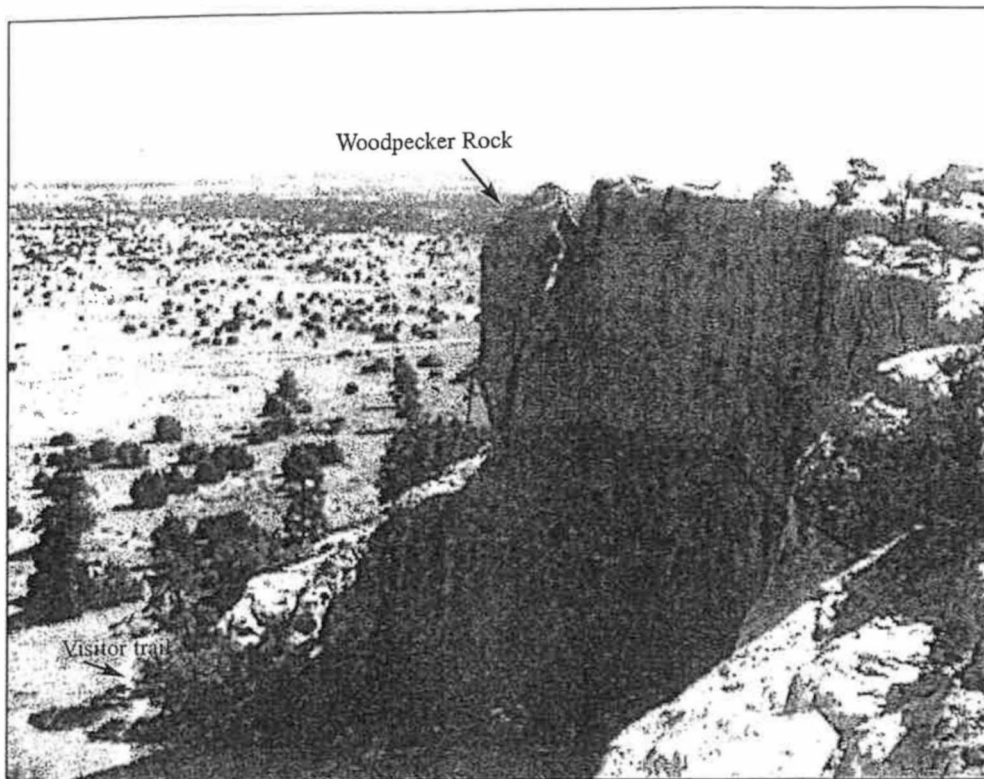
### **Woodpecker Rock**

Woodpecker Rock (fig. 15) is located along the Mesa Top Loop Trail about mid-way between trail markers #22 and #23. The rock is a spectacular feature in that it is a large, approximately 30- to 40-m-tall fragment of the mesa front that is completely detached except for a very narrow intact base. The rock appears to be very precariously balanced on the small base. As noted by Wachter (1978), the rock does not show any signs of recent movement, but that the narrow base appears to be weathering and contains some diagonal fracturing. The feature appears in a historic 1929 photo from nearly the same camera location as in figure 15. No noticeable changes in the geometry or configuration of the rock are detectable between the two photos. I agree with Wachter's observation that failure would most likely be sudden, and that instrumental monitoring for motion would therefore be of little or no value.

Toppling of Woodpecker Rock is not considered likely, as the center of gravity of the rock mass is toward the cliff face. The most likely mode of failure for the rock would be shearing across the narrow pedestal base. Motion resulting from such shearing would be a downward sliding of the entire rock mass, which would likely be arrested by the ledge located below the rock. Sideways toppling of the rock might then occur.

**Figure 15.**  
*Woodpecker rock, looking northeast from upper section of Mesa Top Loop Trail. Rock is completely detached from the mesa except for the small base on which it rests. Note location of visitor trail in lower part of photo.*

Because the trail is somewhat removed from the base of the cliff at this location, the potential hazard imposed by Woodpecker Rock is not considered as severe as for some of the other locations described in this report. It would, however, be a relatively simple matter to relocate the trail further from the mesa in this area in order to bypass possible impact areas should the rock fail

and topple sideways. Park staff should periodically inspect the base area of the rock from the trail to look for any signs of new fracturing or fresh spalling that might indicate further deterioration of the base.

4. Woodpecker Rock is not considered by this review to be as serious a risk as other areas, primarily because of the location of the trail relative to the rock feature. However, re-routing of the asphalt-surface trail further to the north and west of the existing trail would be a relatively simple matter. Such re-routing would provide a larger buffer zone between visitors and the potential impact area should sideward toppling of the large rock formation occur.

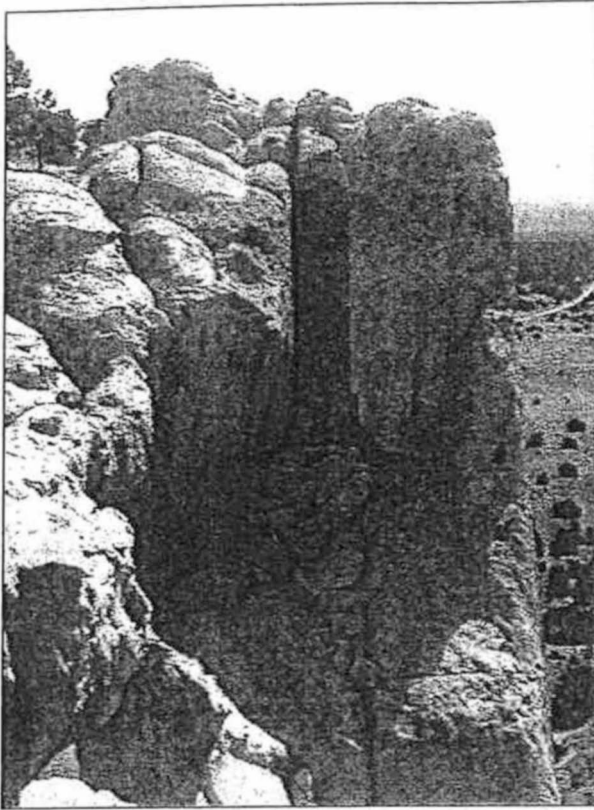
The source area for the 1942 rockfall that filled the historic pool was examined to determine if any further instabilities were present or developing. The 1942 rockfall included or was later followed by the outward toppling of an approximately 1-m-thick tabular section of rock between two vertical joints near the top of the mesa (fig. 16). Toppling was probably promoted by weathering-induced undercutting in a thin weaker layer of sandstone.

Although a number of boulders and smaller rock fragments remain on the ledge just below the original failure, the rocks appear to be stable with further movement unlikely. No fresh jointing or separations were observed behind the existing intact rock exposures.

**Figure 16. Source area of 1942 rockfall above pool. Failure and outward toppling of tabular section of rock bounded by vertical joints resulted in rockfall that filled historic pool below. Note remaining boulders and rock fragments from the original failure.**

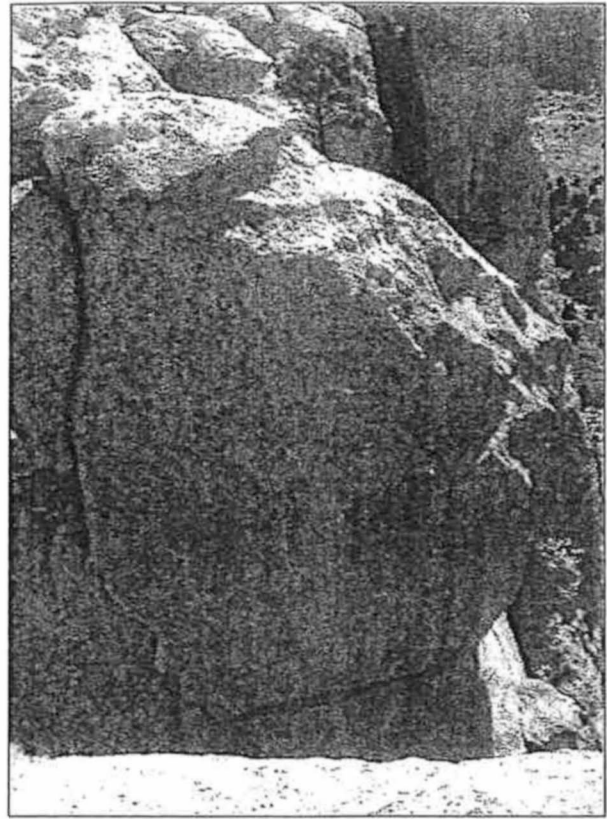
Large, overhanging sections of sandstone visible above the pool area were also examined for any evidence of impending instability. Although the overhanging rocks appear ominous from below, their center of gravity is located behind the cliff face (fig. 17). Although jointing is present behind the cliff, no open or fresh jointing that would indicate developing instabilities in the overhanging sections of sandstone were observed. In summary, nothing was evident on the mesa top above the pool area to prompt concern for potential rockfall hazards to the area below.

**Figure 17. Section of overhanging mesa rim above pool area. Center of gravity of rock mass is well behind cliff face, indicating that topping failure is unlikely. Joint behind large section of rock shows no indication of recent movement.**
