HISTORIC STRUCTURES REPORT

FORT HANCOCK QUARTERMASTER STRUCTURES, 1900-1918

SANDY HOOK UNIT, GATEWAY NATIONAL RECREATION AREA

April 1979

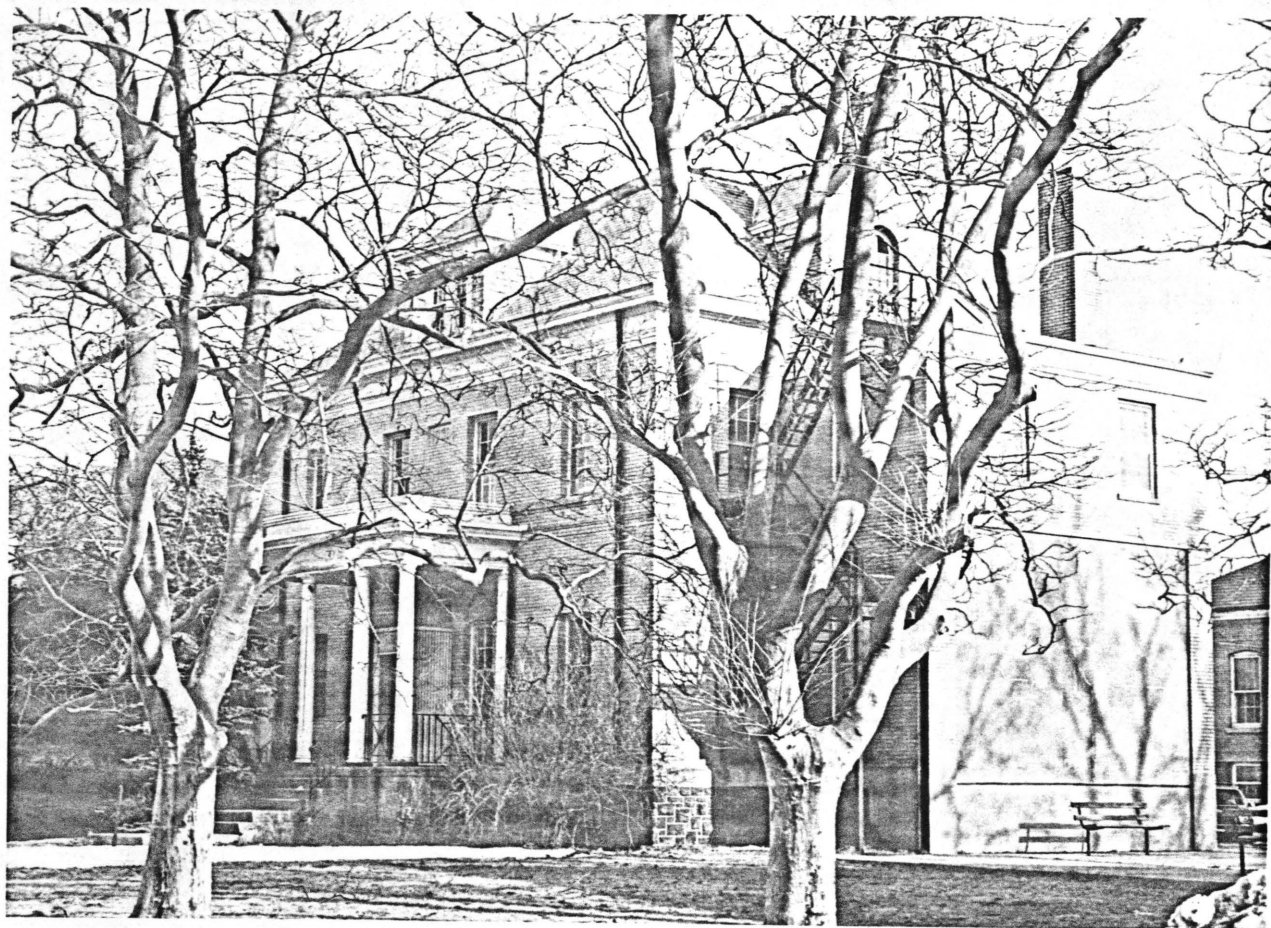
Building 40, Y.M.C.A., from the southwest. 1/78 DW

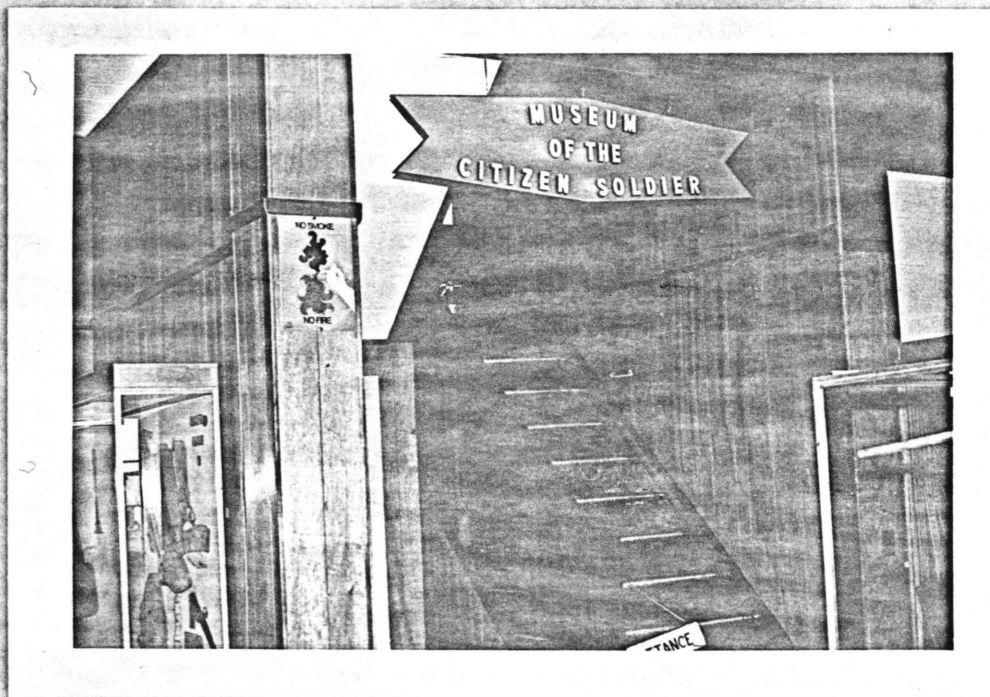
Building 40, Y.M.C.A., first floor interior, with modern wood paneling.

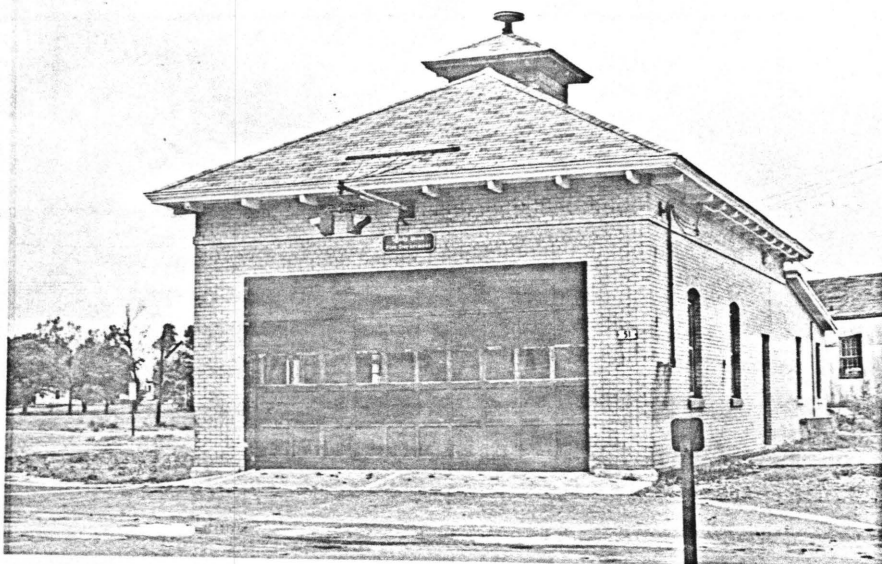
The historic appearance of this structure has been heavily altered. Slate shingles are gone on all but the sides of the tower and have been replaced with asphalt shingles. The large west doors were removed along

Mortar is loose and separating from bricks and between limestone in the water <sup>table</sup>. Doors are partially bare of paint and cracking; plywood infills <sup>are</sup> being warped.

Building 51, Firehouse, west elevation. S-1 29

1. When present asphalt roof deteriorates, replace with grey slate-colored asphalt roofing, to approximate the historic appearance through correct color.
2. Repoint brickwork and water table.
3. Prepare and paint damaged or exposed wood surfaces at doors, windows, and eaves.

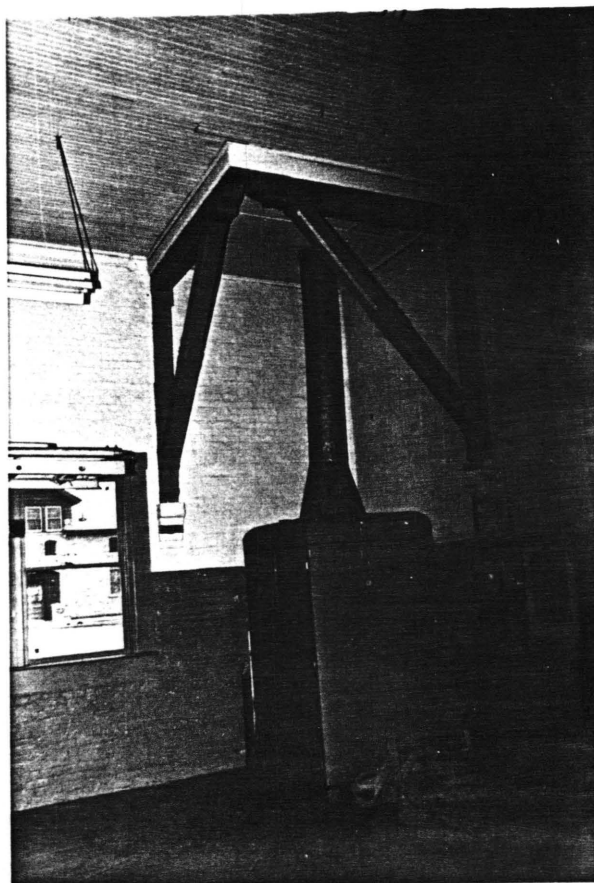
Hose Tower Support  
Brackets. Tower now  
used as chimney chase  
4/79 FH1

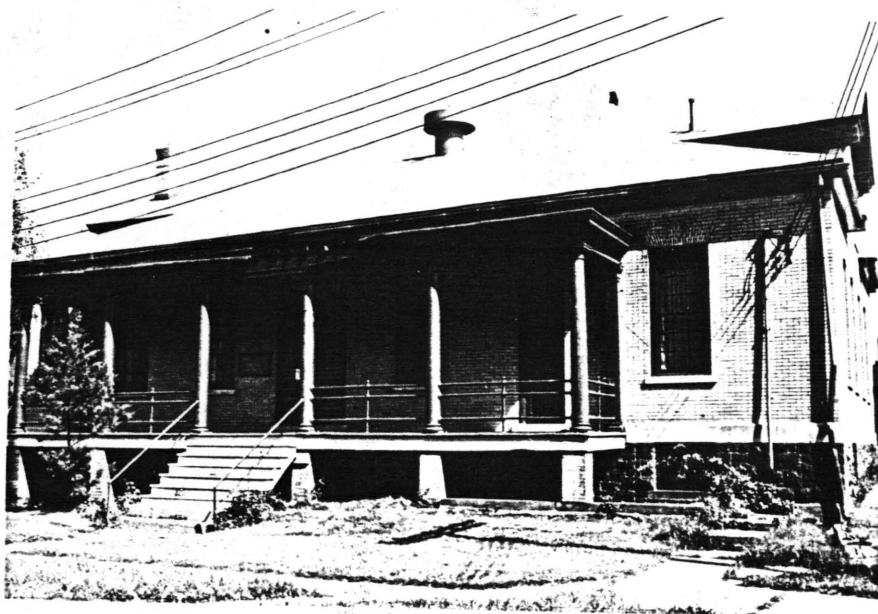
Building 56, Mess Hall, west side. Note condition  
of porch cornice. S-4 16

1. When present roofing deteriorates, reroof with slate grey asphalt shingles.
2. Repair/replace gutters and downspouts. Restore cornice.
3. Repoint eroded masonry.
4. Repair east and west porches.
5. Replace rusting steel lintels.
6. Provide wood storm windows and wood screens.
7. Prepare and paint all exterior wood and metalwork.

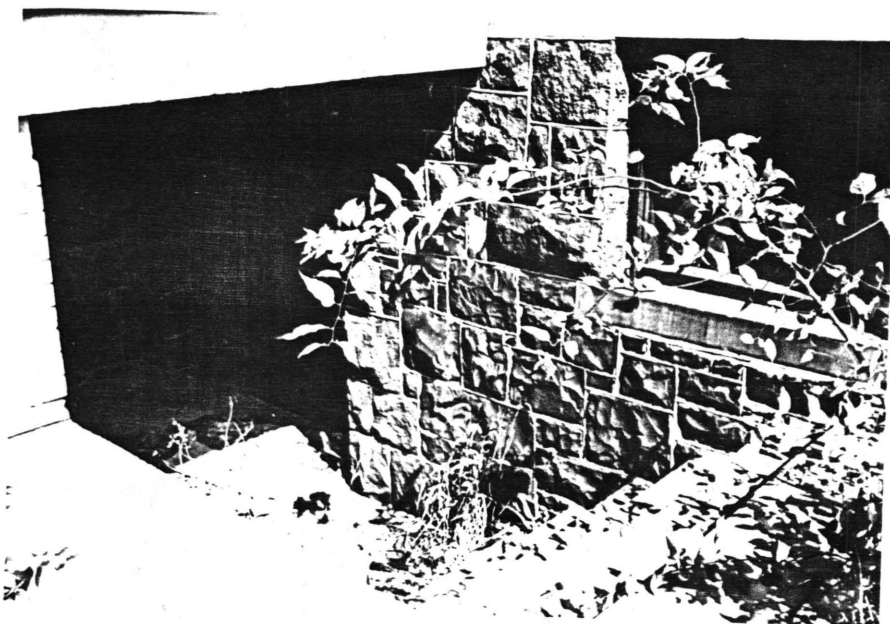
Detail, basement areaway.

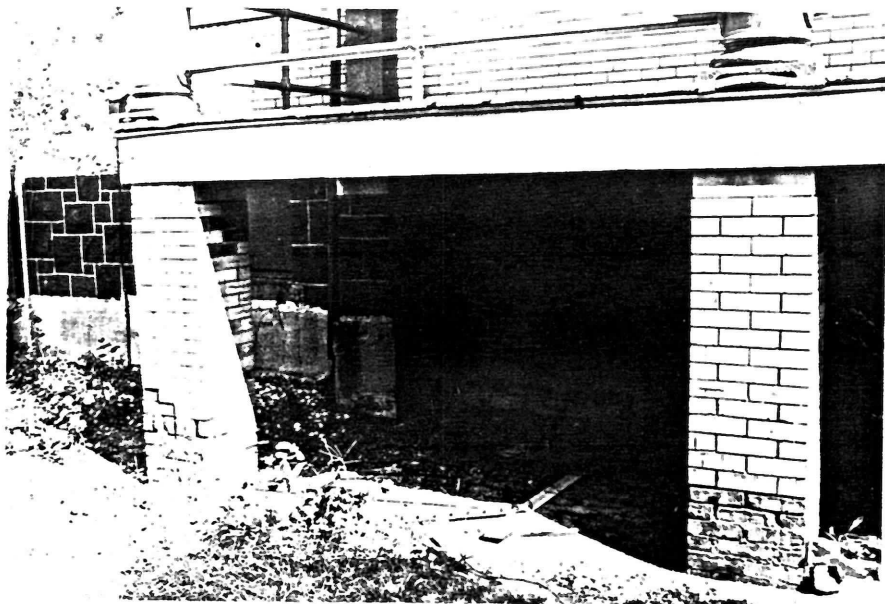
Building 56, west porch, showing condition of  
brickwork piers. S-4 19

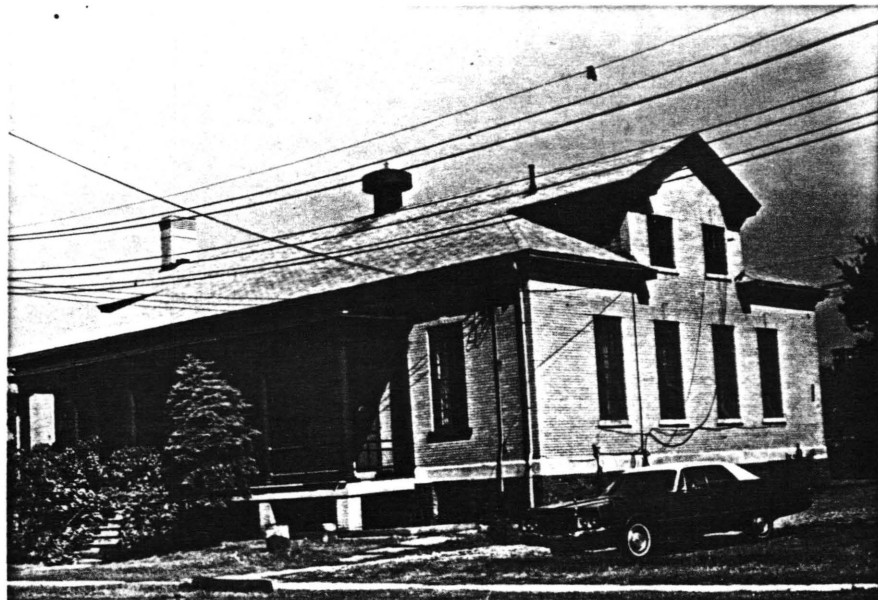
Building 57, Mess Hall, southwest view, showing makeshift window screens.  
FH 9/78 B-5 6

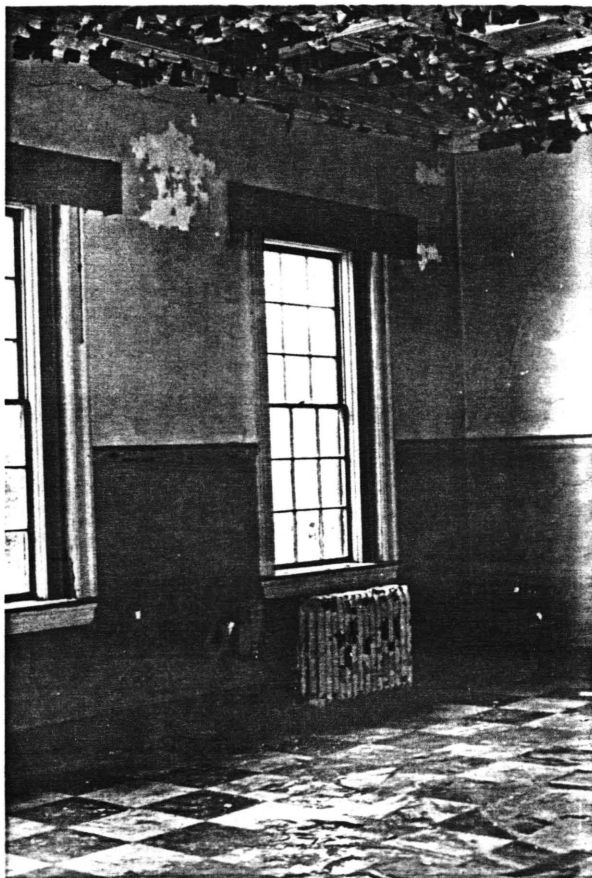
Interior, showing paint failure on ceiling due to lack of heat.

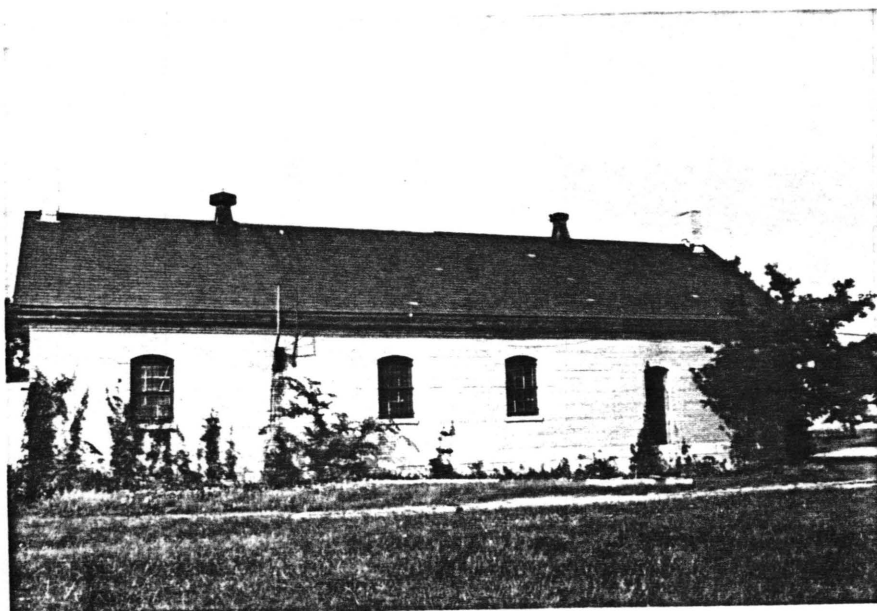
East elevation, showing roof damage and missing stairs.

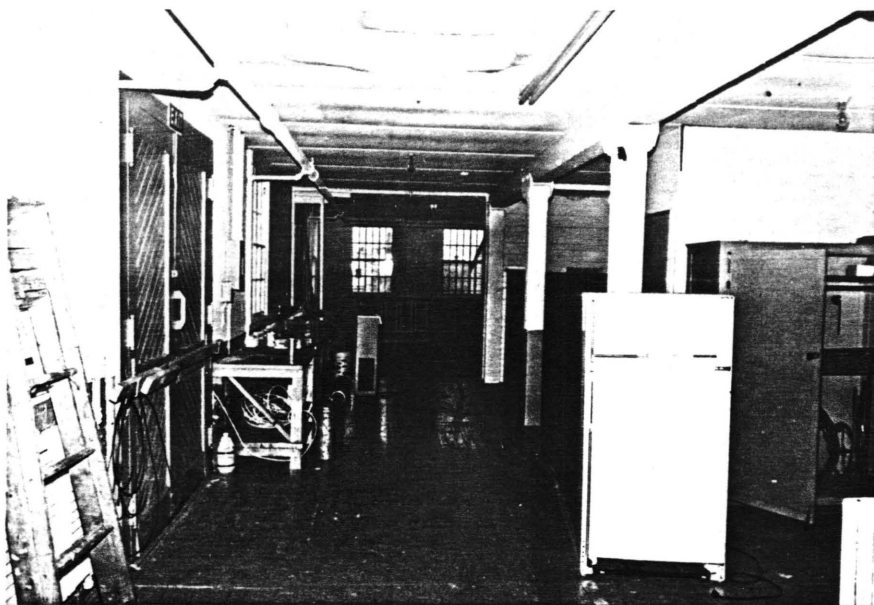
Building 65, first floor interior. Excellent example of sympathetic re-use respecting original room finishes by park maintenance. 4/79 FH6

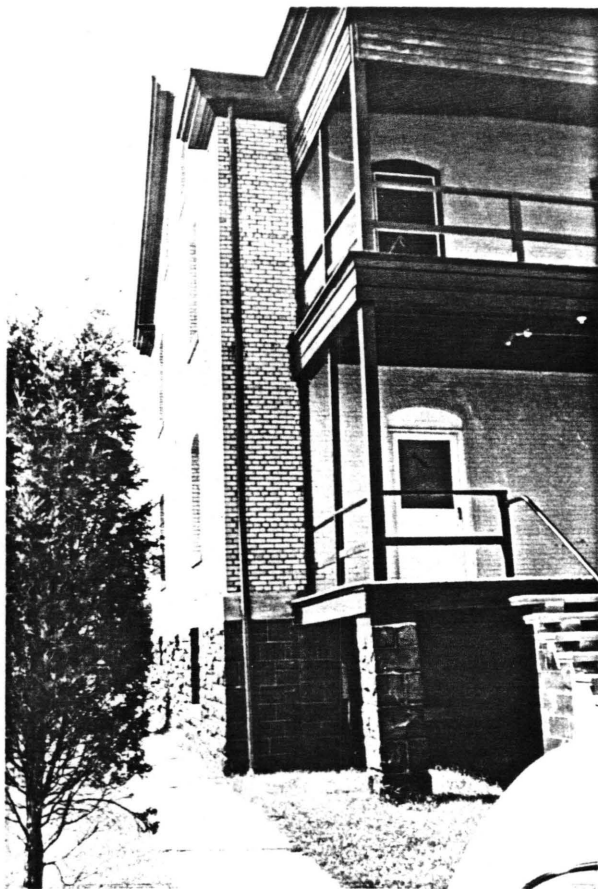
Building 74  
Two-Company Barrack,  
rear (east) porch.  
Railings and columns are  
World War II replacements,  
while the floor and roof  
framing is original.  
Note the skewed support  
pier. S-3 33A

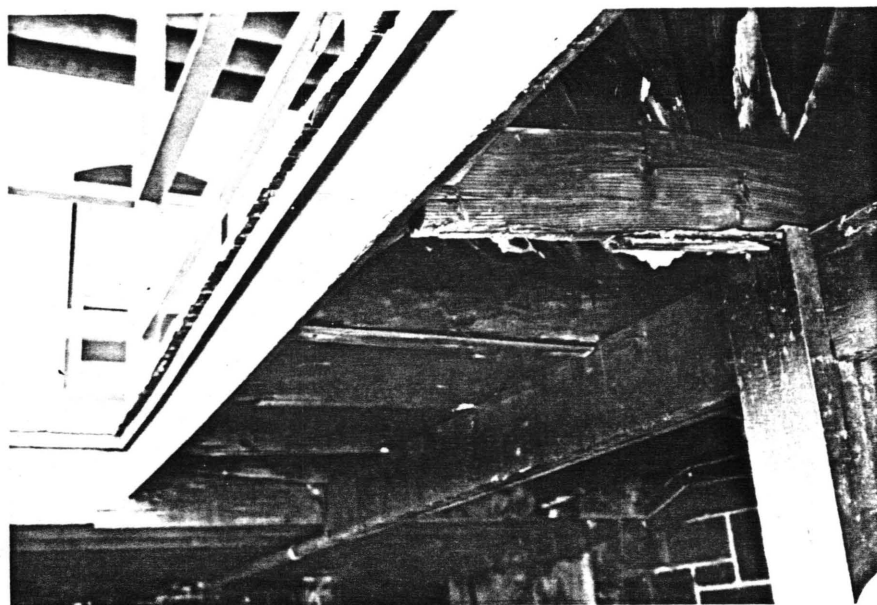
Detail, porch deck framing. This is the World War II  
infill portion, and is recommended for removal.

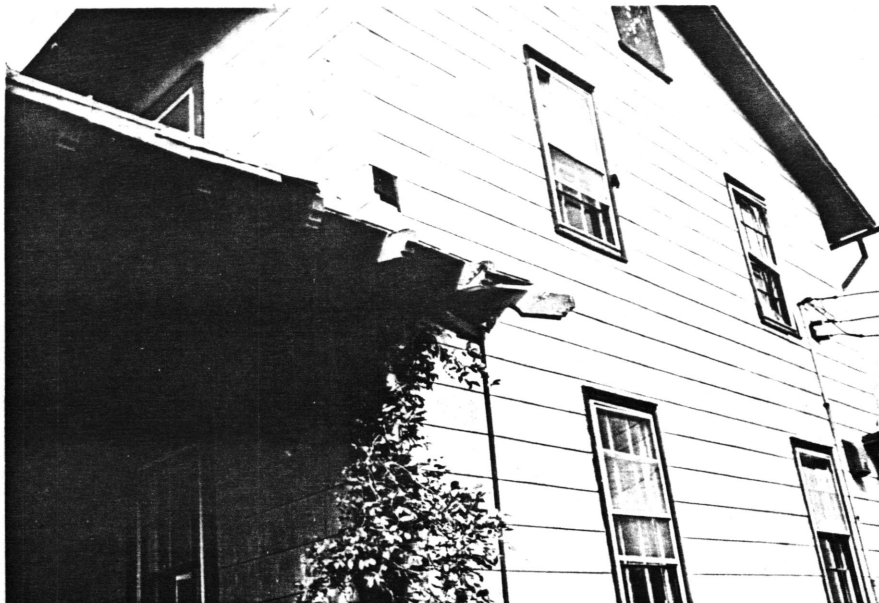
Building 75, Duplex N.C.O. Quarters, detail of front porch eave damage. Note also typical condition of aluminum storm sash, installed circa 1973. S-79

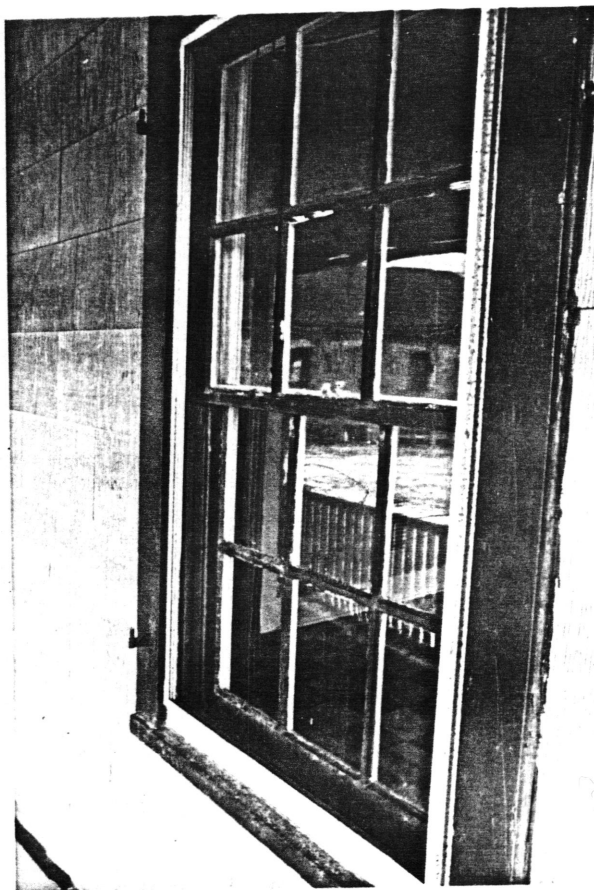
Living room window, south unit. Note shutter pintles on window frame. 4/79 FH2

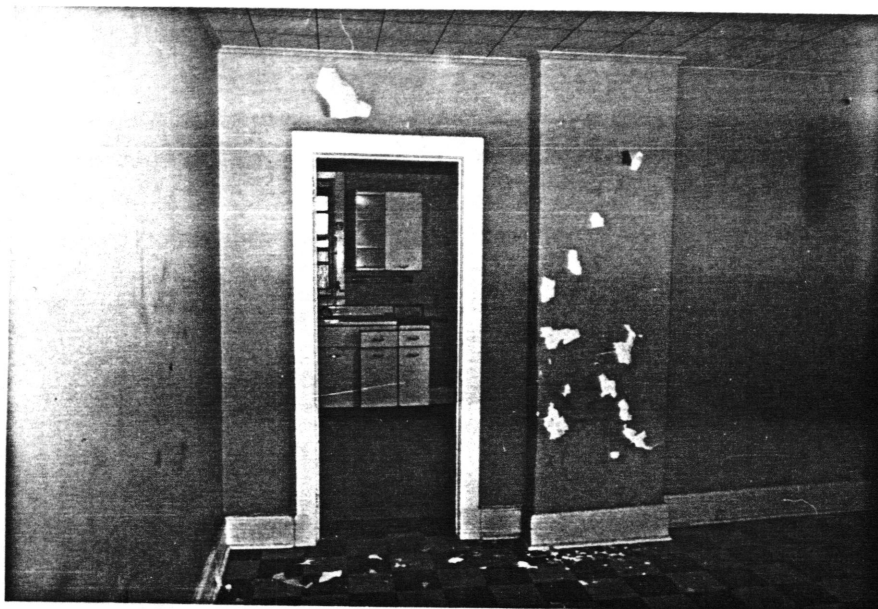
Building 75, Duplex N.C.O. Quarters, view from  
living room to kitchen. Typical room finishes and  
condition. 4/79 FH2

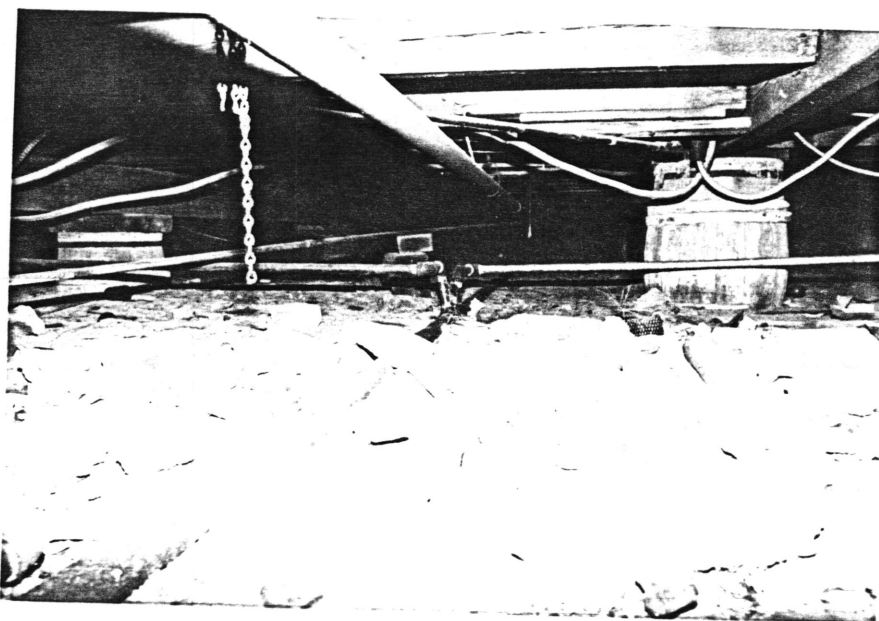
Crawl space under original structure. Note unusual foundation piers.

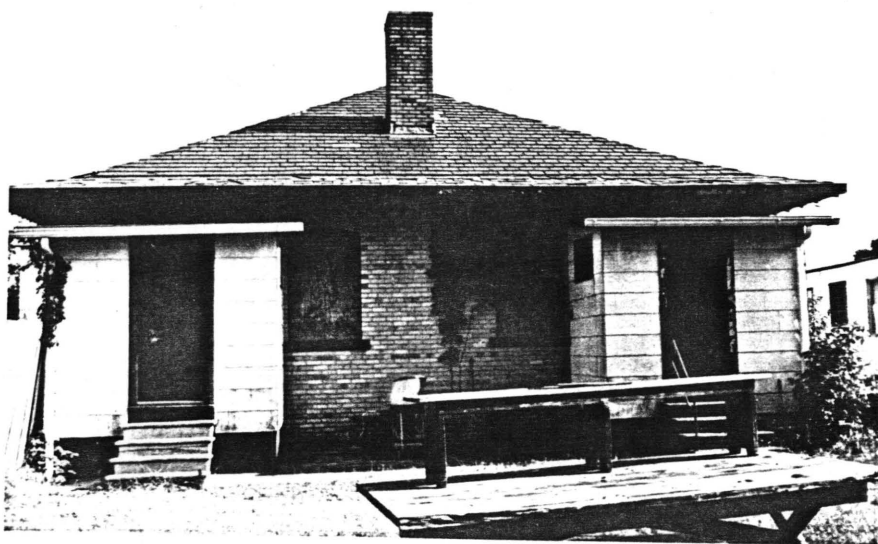
Rear. Note roof damage, particularly on flared eave.  
S-4 29

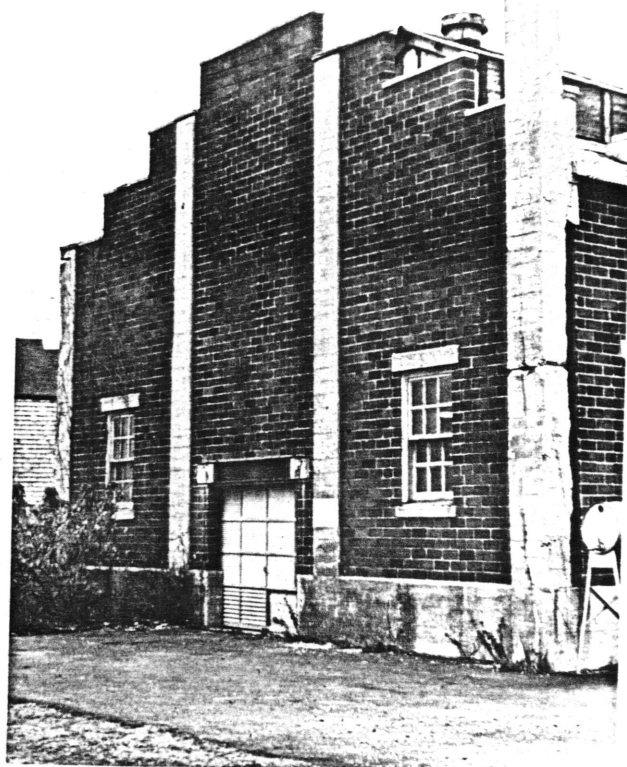
Building 503, Railroad Engine House, north wall,  
showing spalled concrete on corner column.  
DW 9/78 FH1

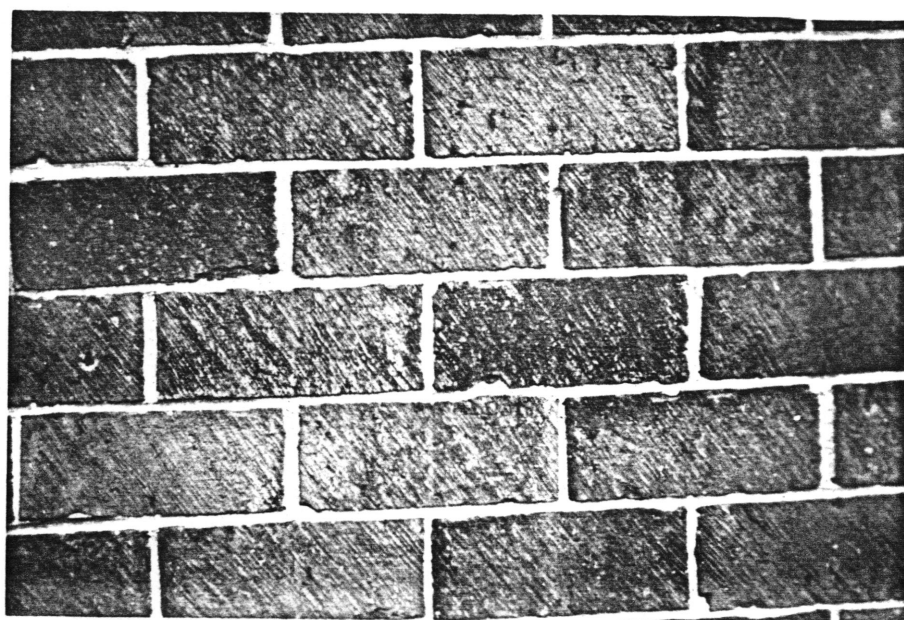
Close-up of cut wall tiles. DW 9/78 FH1

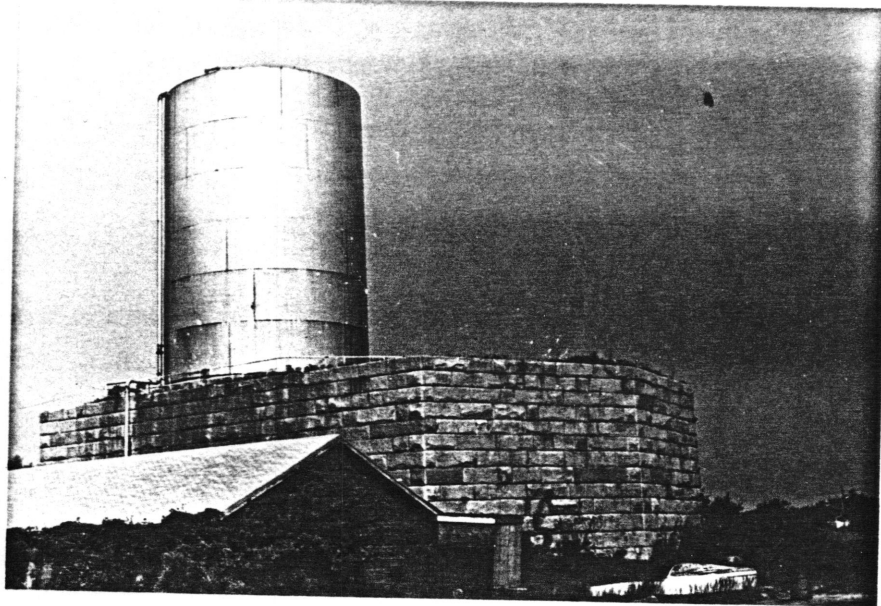
Structure 523, Water Tank.

The tank is painted silver, but shows rust at its welded joints. The railings and ladder are severely rusted and are unsafe for use. Condition of the tank should be evaluated by an engineer and recommendations be made by the engineer for repair work necessary. \*

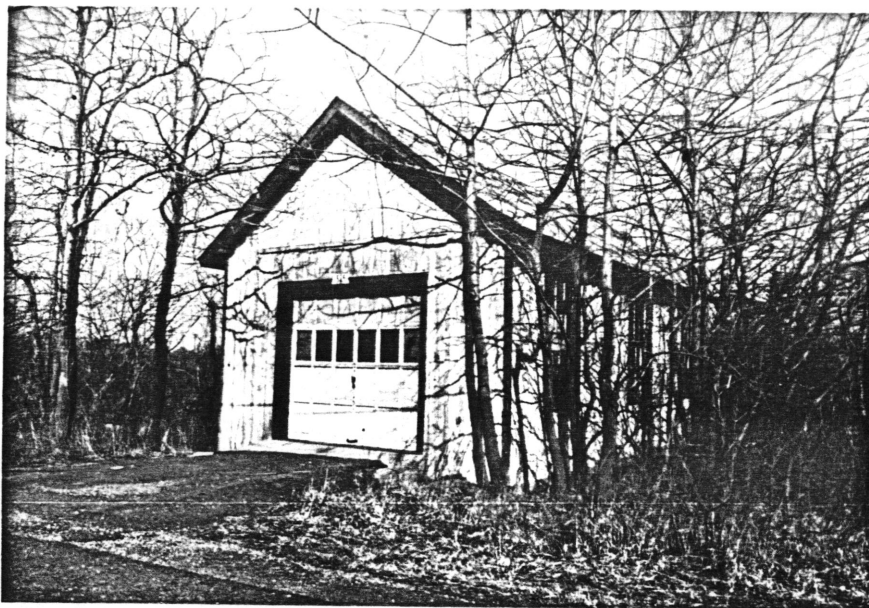
Building 525, Garage, southwest view. Overhead door is a modern improvement. 4/79 FH3

Continued use as a garage is historically correct. It is expected that the U.S. Coast Guard will continue this use and perform required maintenance, such as repainting, as necessary.

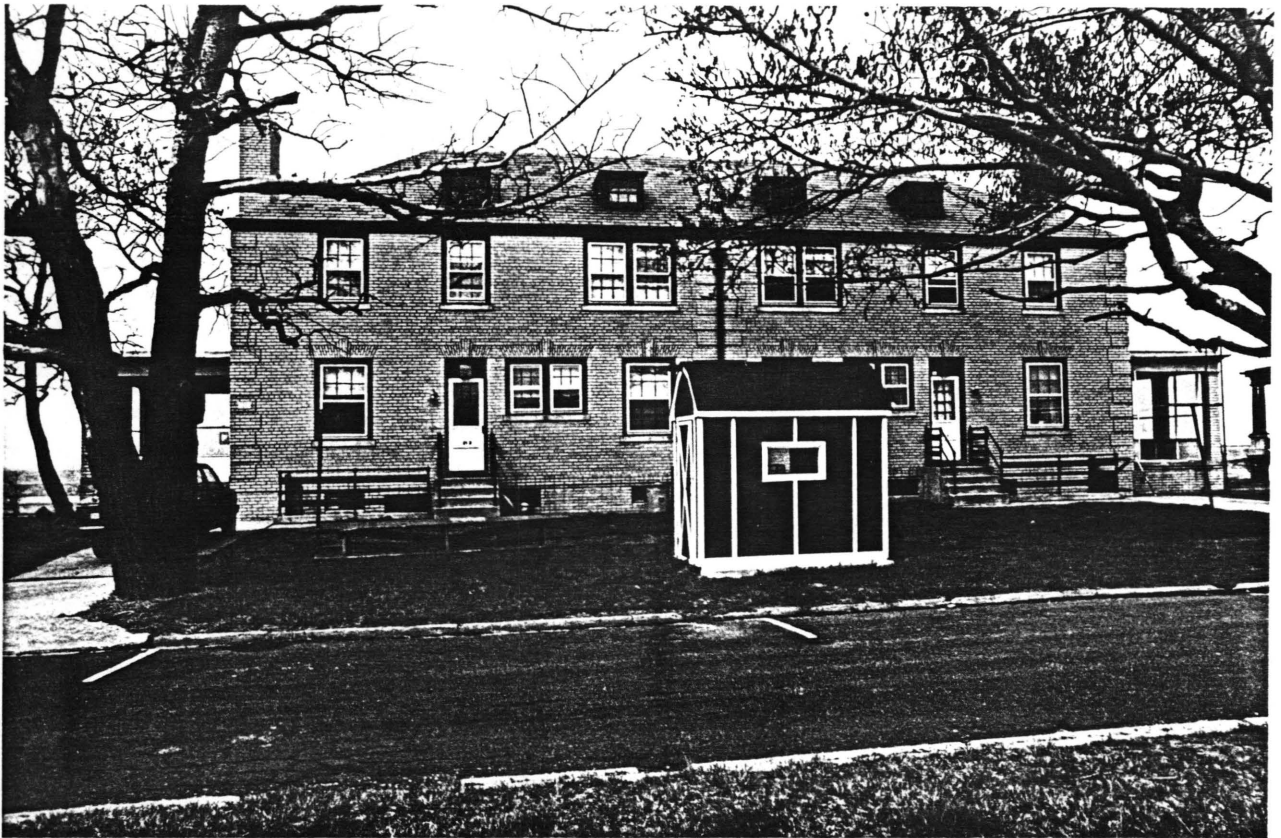
REAR OF BUILDING 21,  
FROM THE NORTH PARADE GROUND,  
APRIL, 1979 4/79 FH2

This Neo-Dutch Colonial garden shed, and another like it behind Building 145, were erected in 1978. They are an intrusion on the historic and aesthetic scene, and their removal is recommended. The Secretary of Interior's Standards of Rehabilitation would not allow such a structure to be added to a historic district. If the Park Service is not willing to honor the character of the district, why should any of their leasees or permittees? Since these quarters have full basements, the need for such an auxiliary structure is questionable.
