# MESS HALL BUILDING #58 FORT HANCOCK, NEW JERSEY

## Historic Structure Report

March 2011

JOHN MILNER ASSOCIATES, INC.

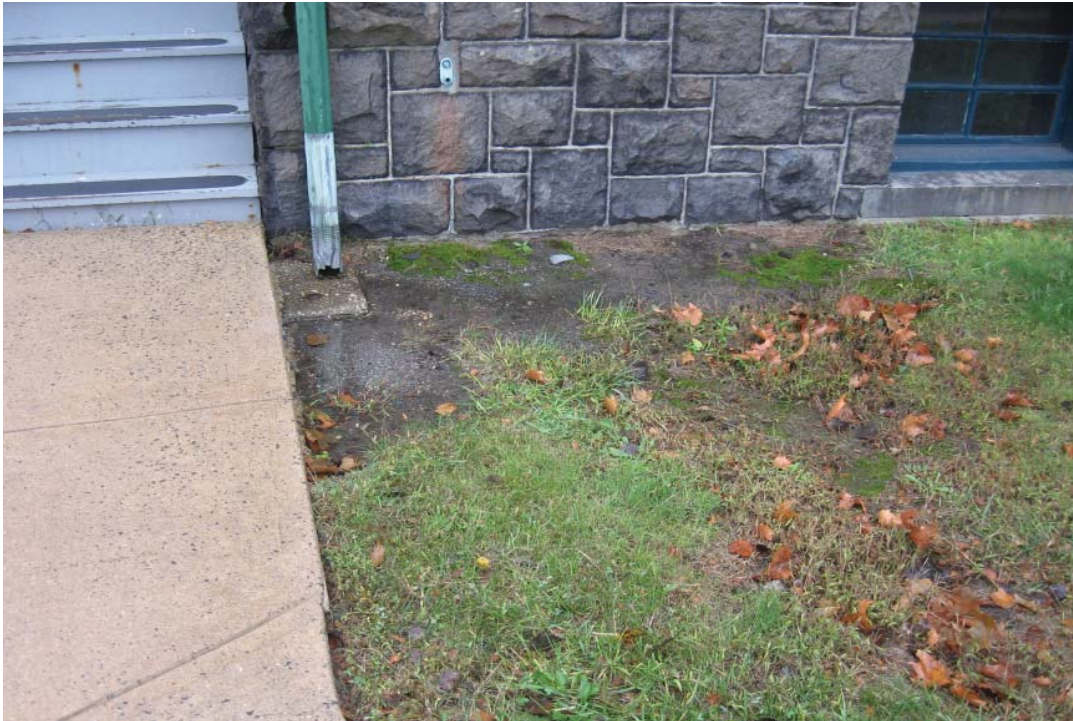
Photo 55. Detail of site drainage at the northeast corner. Note the eroded soil and moss growth that indicates poor site drainage. (JMA, October 2009)

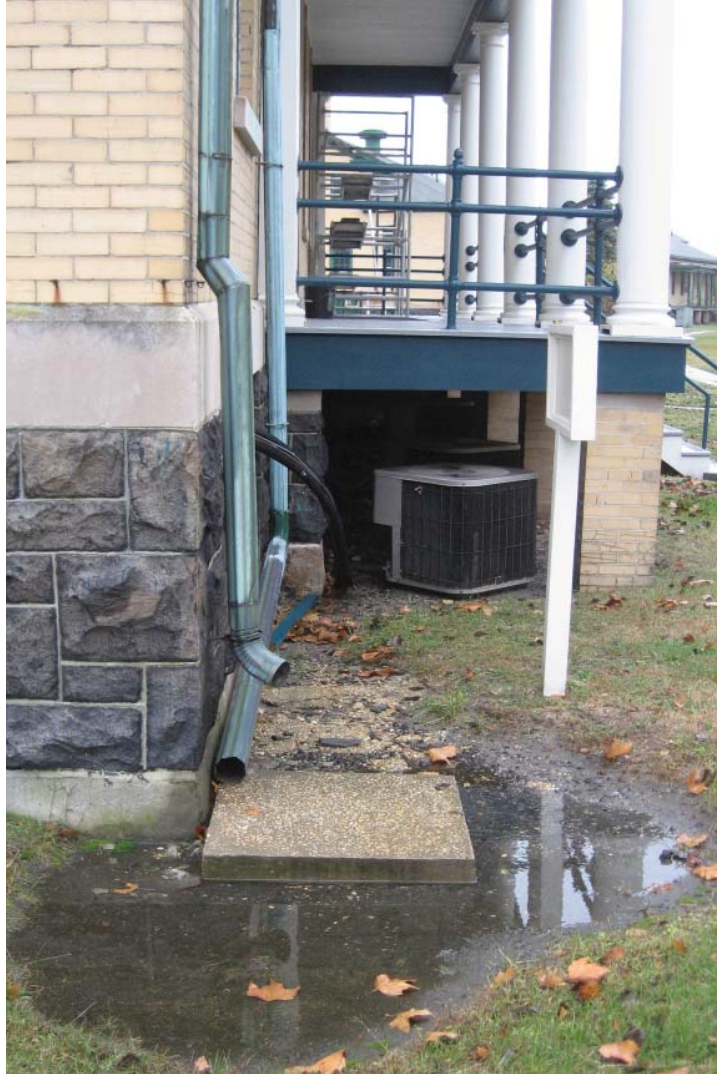
Photo 56. Condition of site drainage at the northwest corner. Note the discharge of two downspouts and ponding water. (JMA, October 2009)

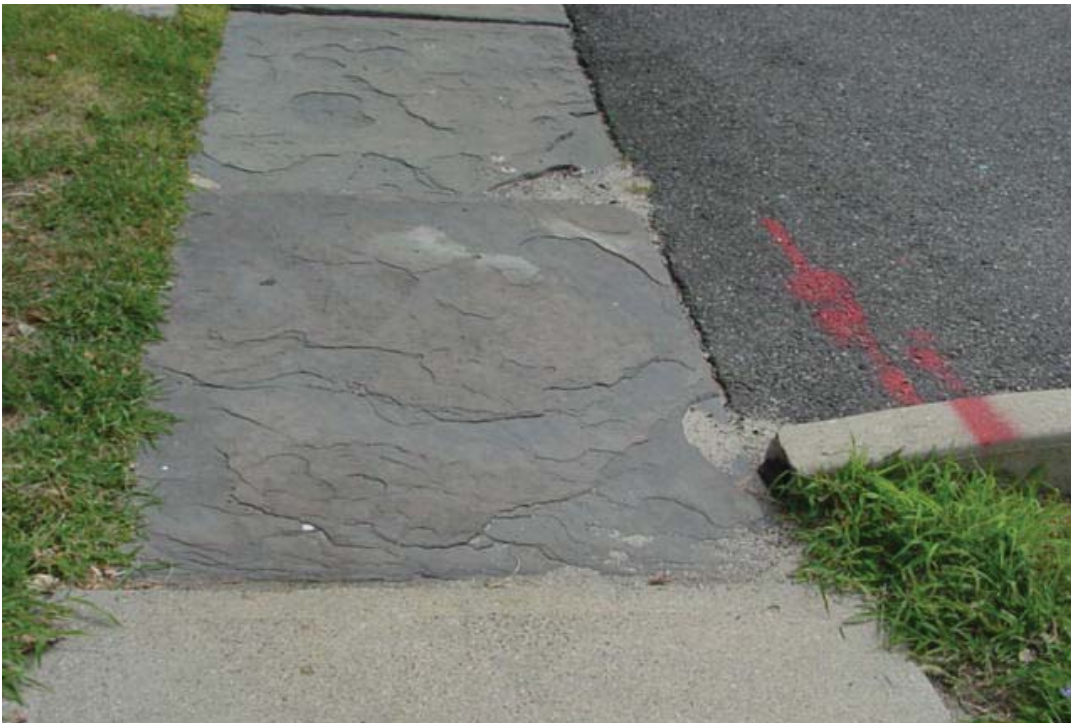
Photo 57. Detail of historic slate paving at southwest portion of the site. Note delamination and lipping between slabs. (JMA, August 2010)

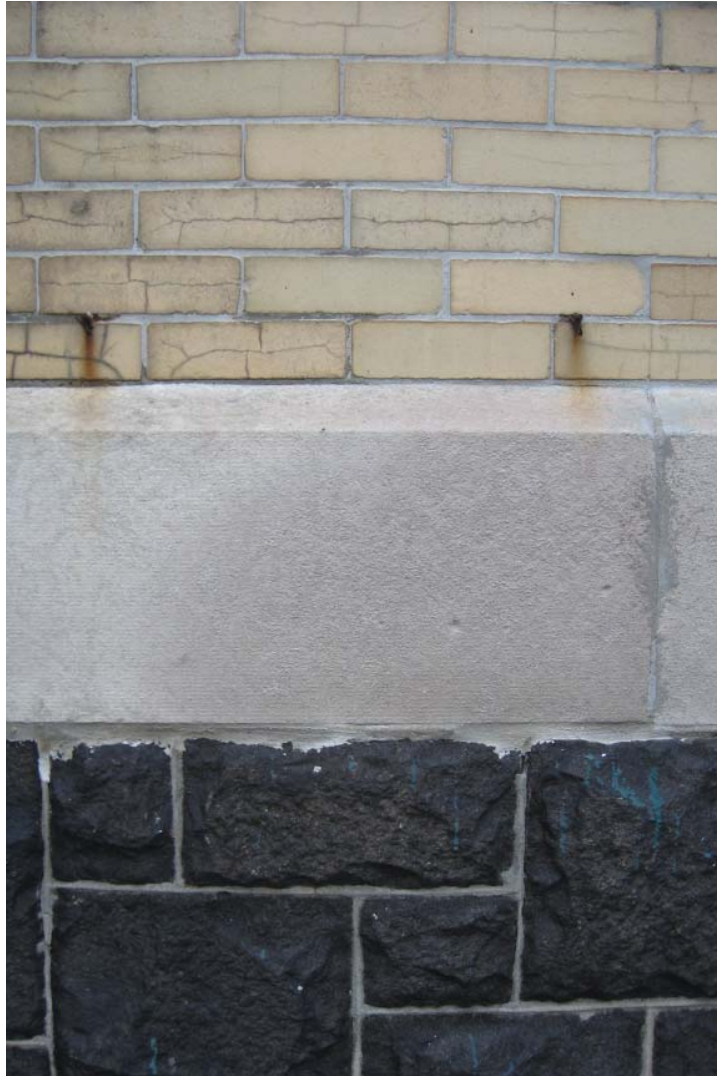
Photo 58. Detail of the masonry at Building #58. Buff colored brick at the top with characteristic hairline cracks. Light limestone trim at center. Dark diabase ashlar masonry at the foundation. (JMA, October 2009)

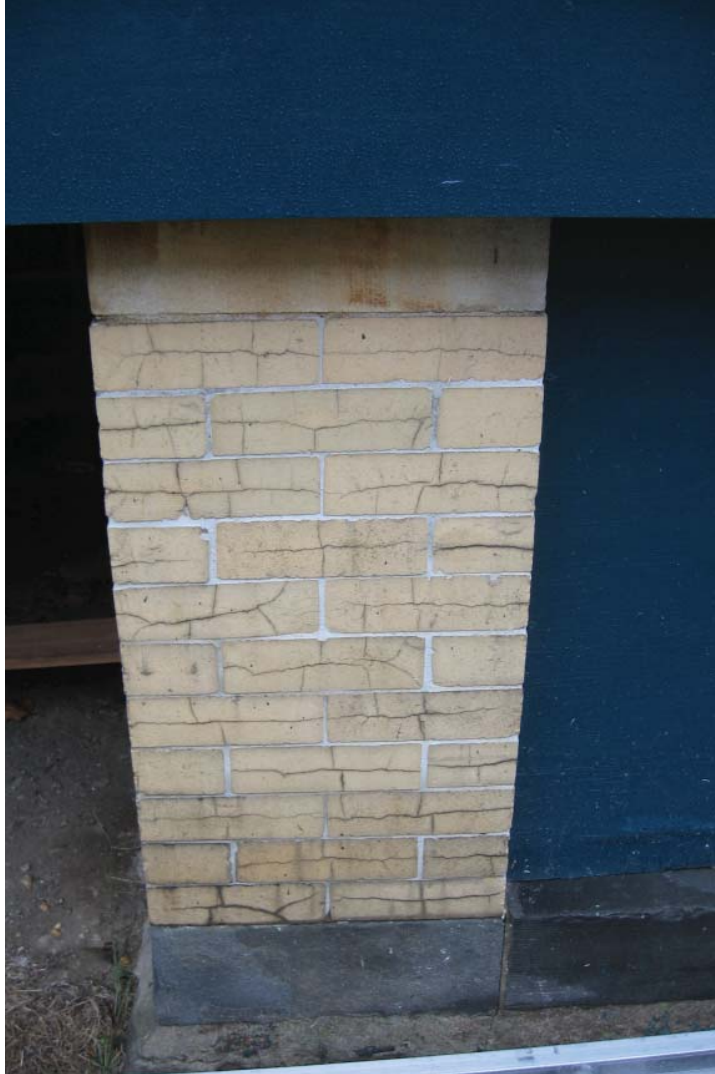
Photo 59. Detail of hairline cracks at the brick masonry at the west porch piers. The cracking is typical of almost all brick units regardless of location. (JMA, October 2009)

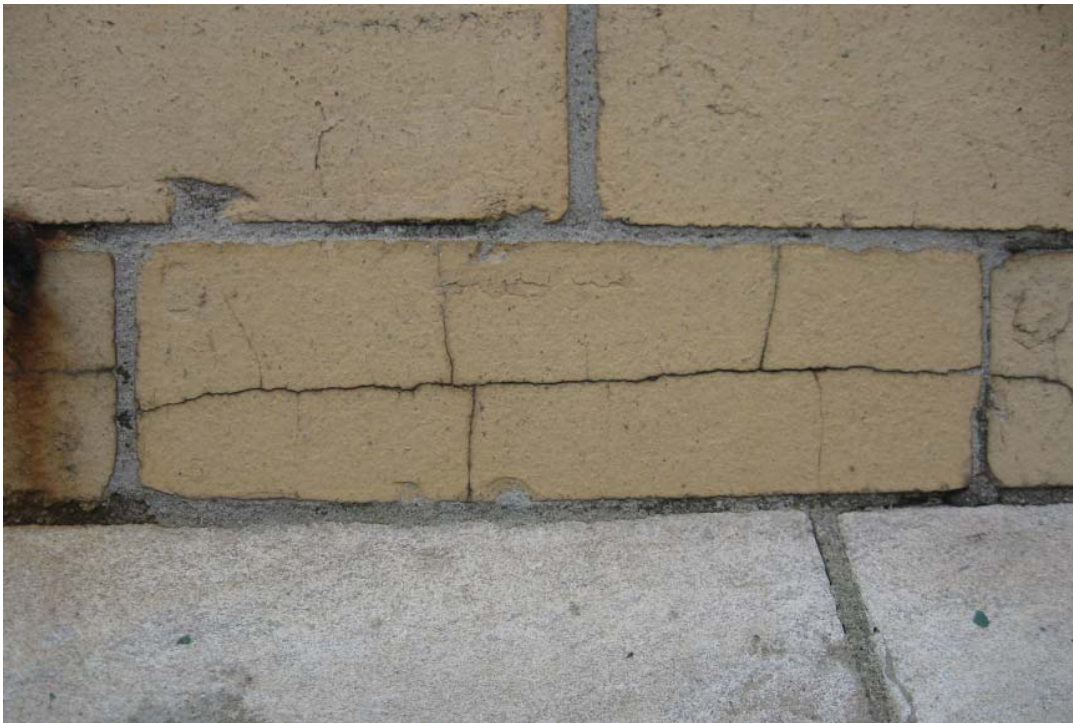
Photo 60. Detail of typical cracked brick unit with a crack through the long axis of the face and smaller cracks radiating up and down. (JMA, October 2009)

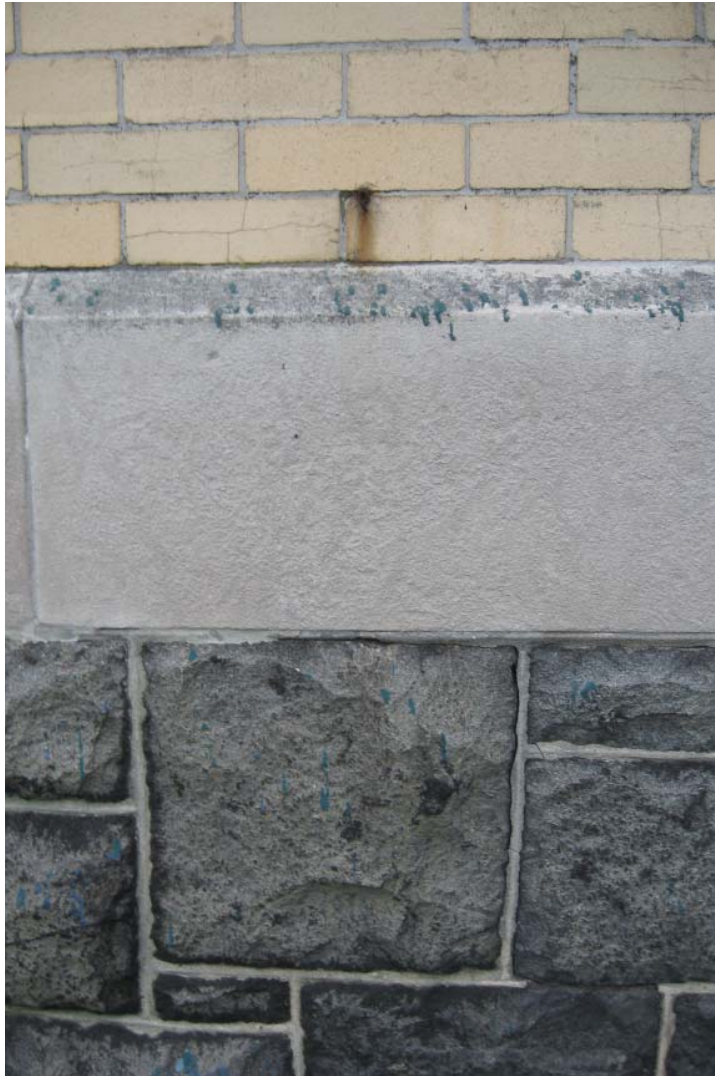
Photo 61. Note the green splashes of paint on the limestone and diabase masonry. (JMA, October 2009)

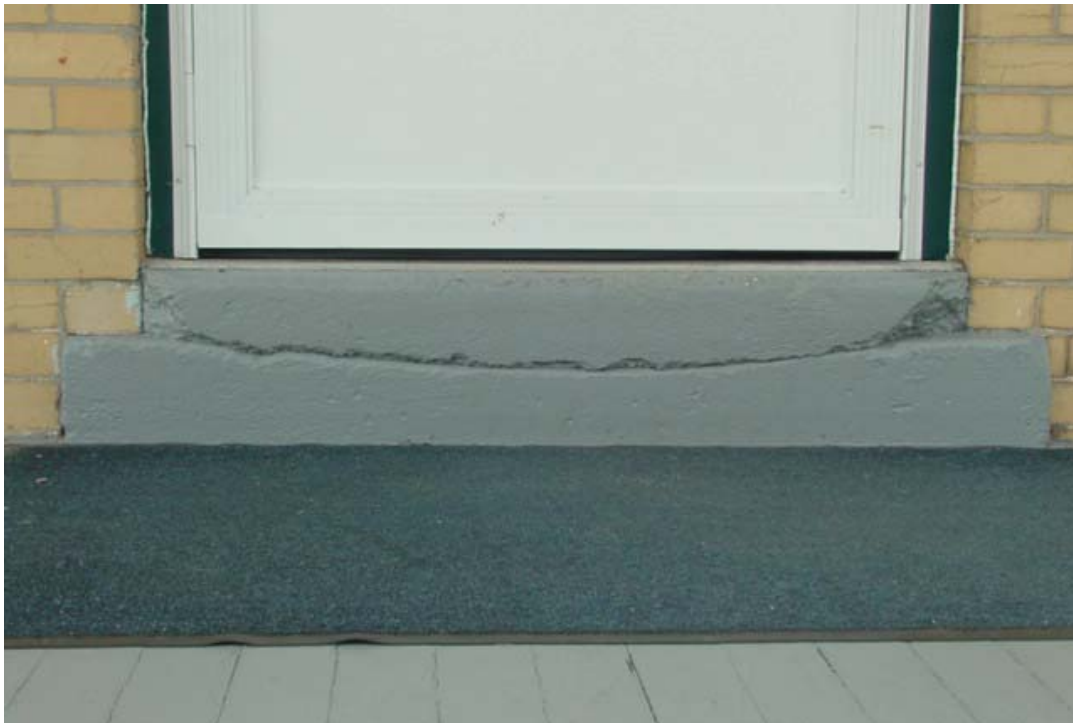
Photo 64. Detail of the east entrance door sill. Note the thick concrete topping, which extends across the kitchen and pantry floors. The concrete topping was placed on top of a well worn door sill. The gray paint is recent. (JMA, August 2010)

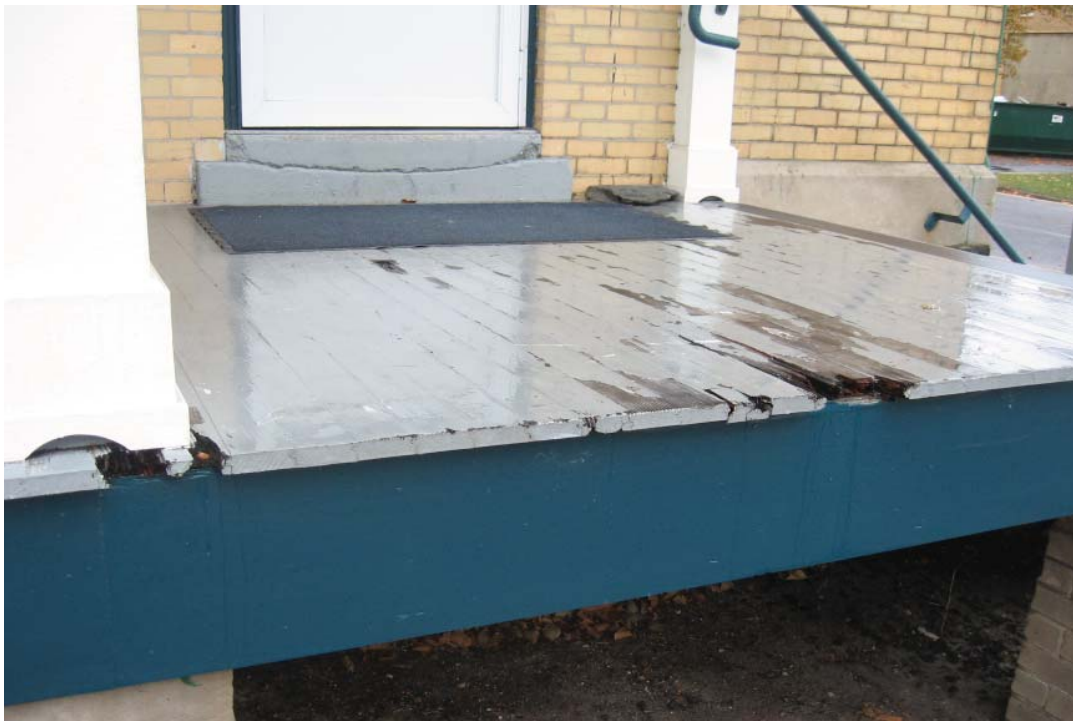
Photo 65. East porch floor. Note the deterioration at the exposed ends of the floor boards. (JMA, October 2009)

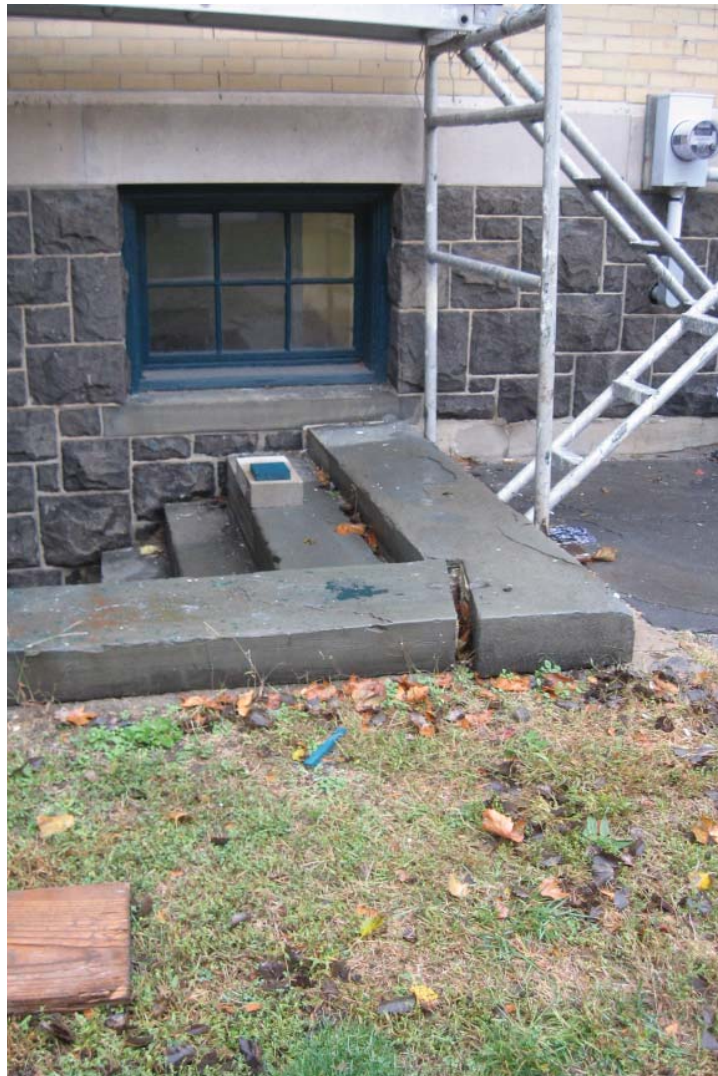
Photo 66. West basement entry stair. Note the gap between the slate curb and the rectangular slot where a cramp once held the stones together. (JMA, October 2009)

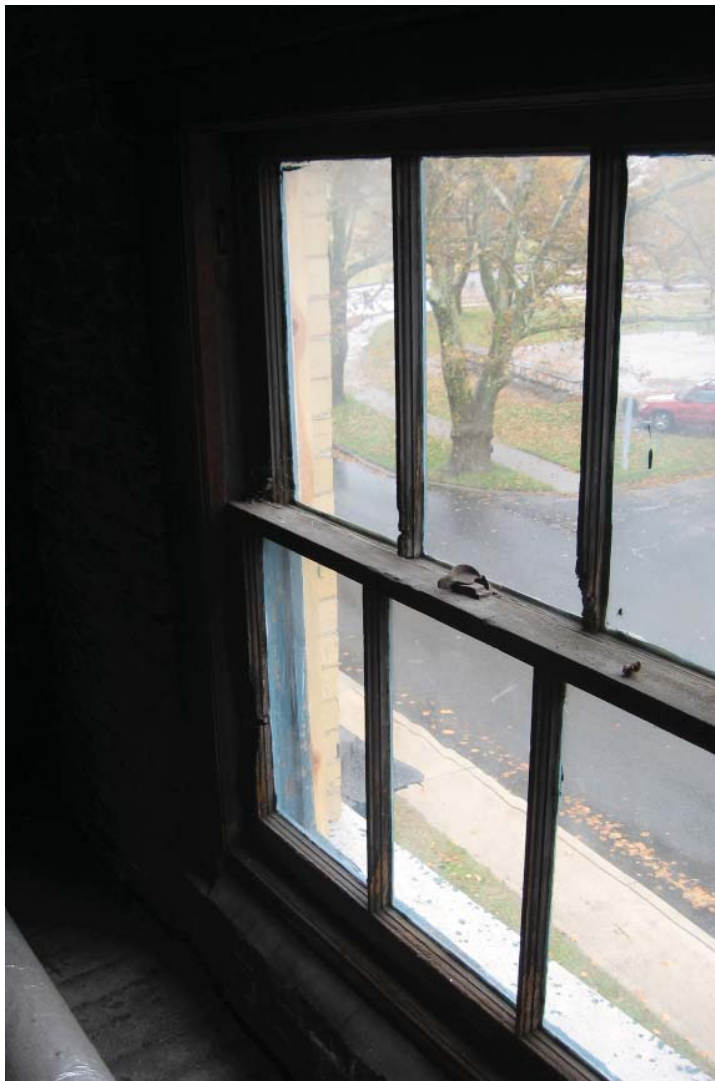
Photo 67. Interior detail of the northwest attic window (201D). Note the damage at the interior muntins. (JMA, October 2009)

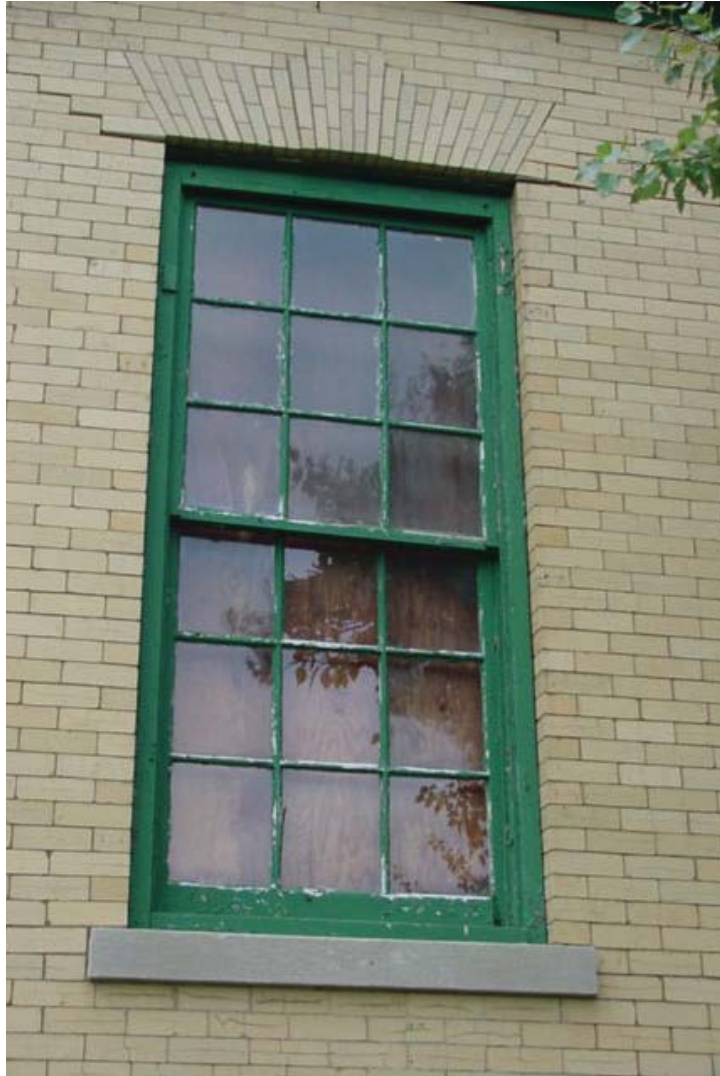
Photo 68. Original nine-over-nine window at Building #57 with a thinner casing and wider sash. Note the disruption of the masonry caused by the corroding lintel. (JMA, August 2010)

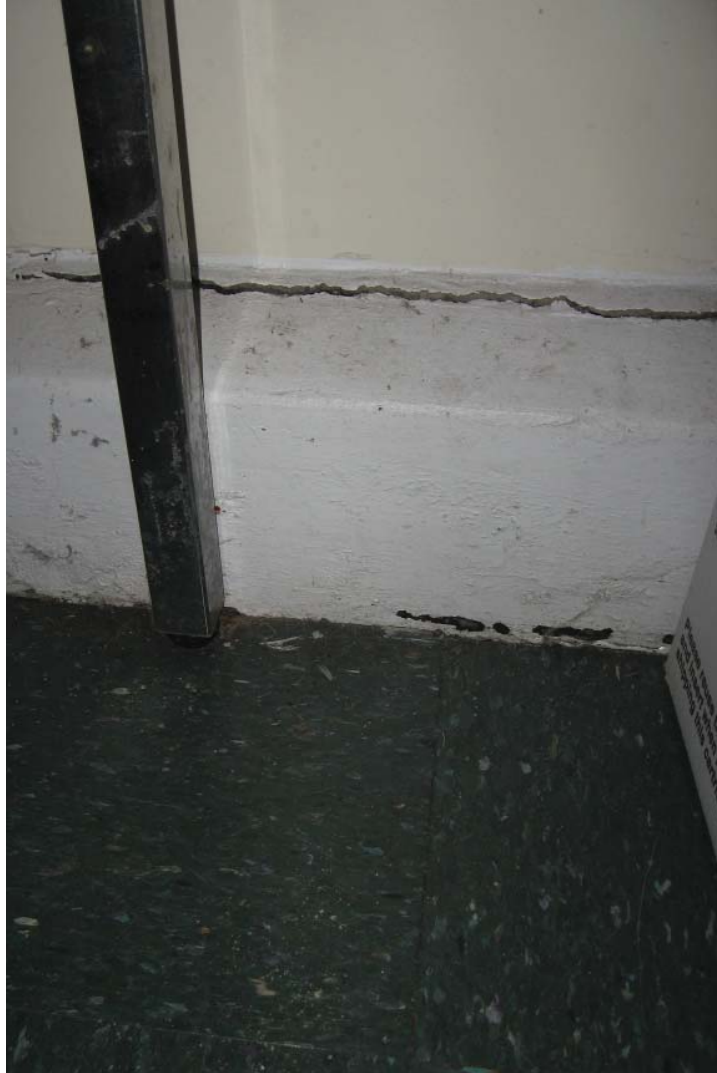
Photo 77. Detail of the masonry curb at the northeast corner of the historic kitchen area. Note the gap between the wall and the curb. (JMA, October 2009)

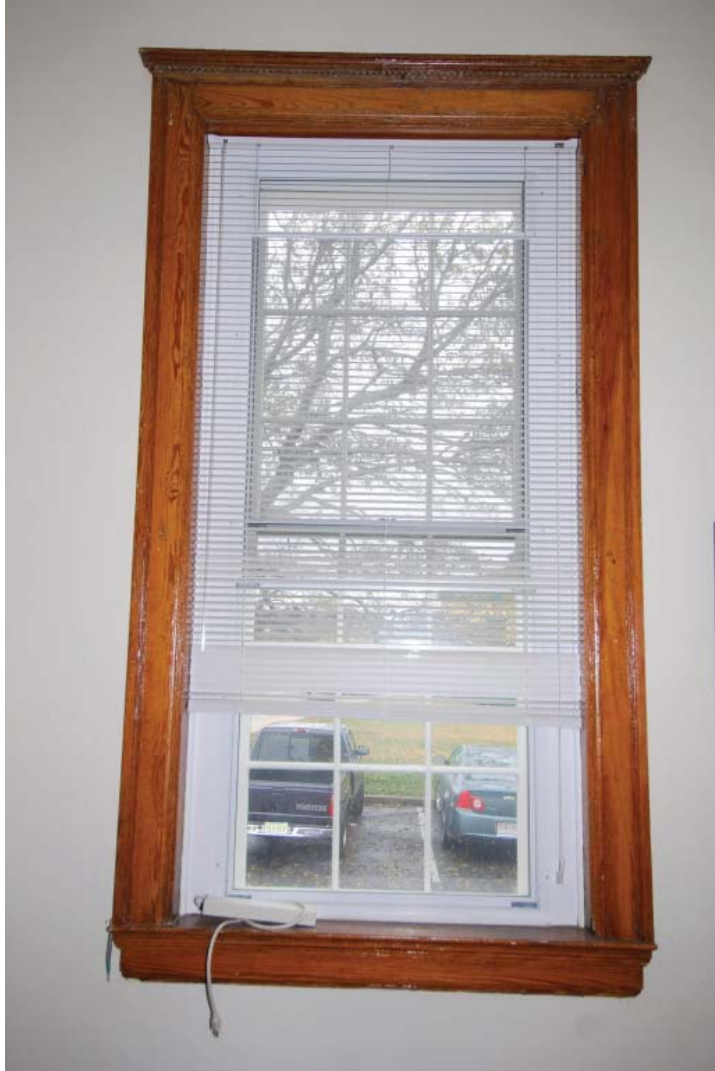
Photo 78. Interior view of a typical first floor replacement window. Note the wide casing and the interior trim, which has been stripped of its paint. (JMA, October 2009)

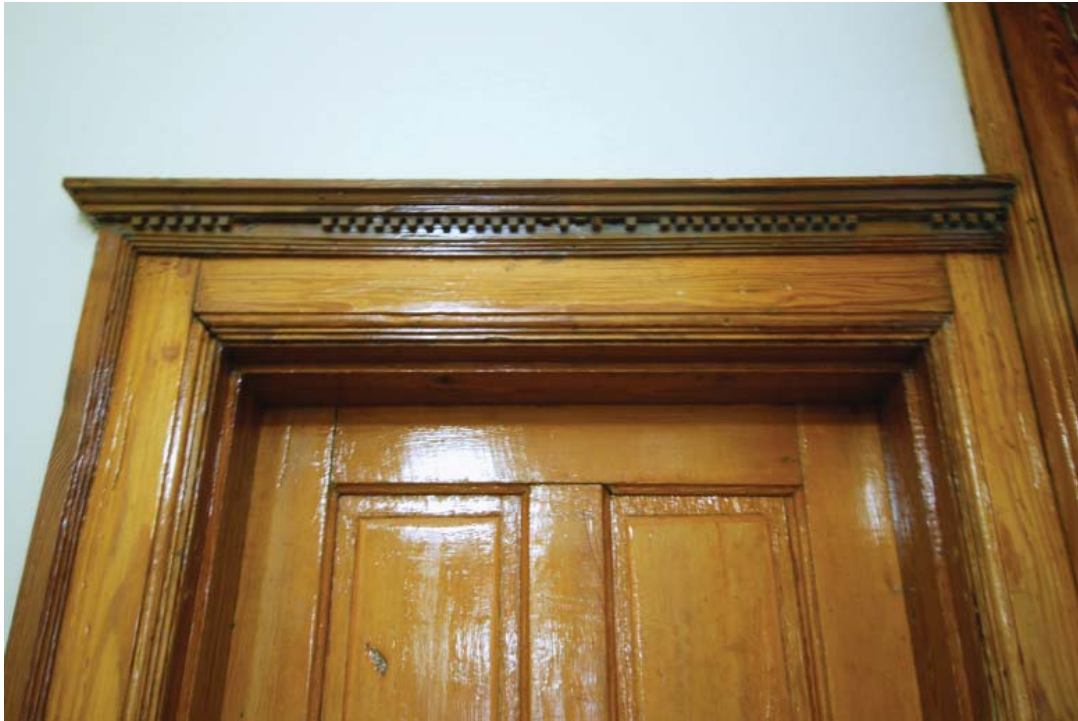
Photo 79. Detail of the wood trim at the door to Office 108. Note the missing dentils, the lack of paint, and the shiny polyurethane coating. (JMA, October 2009)

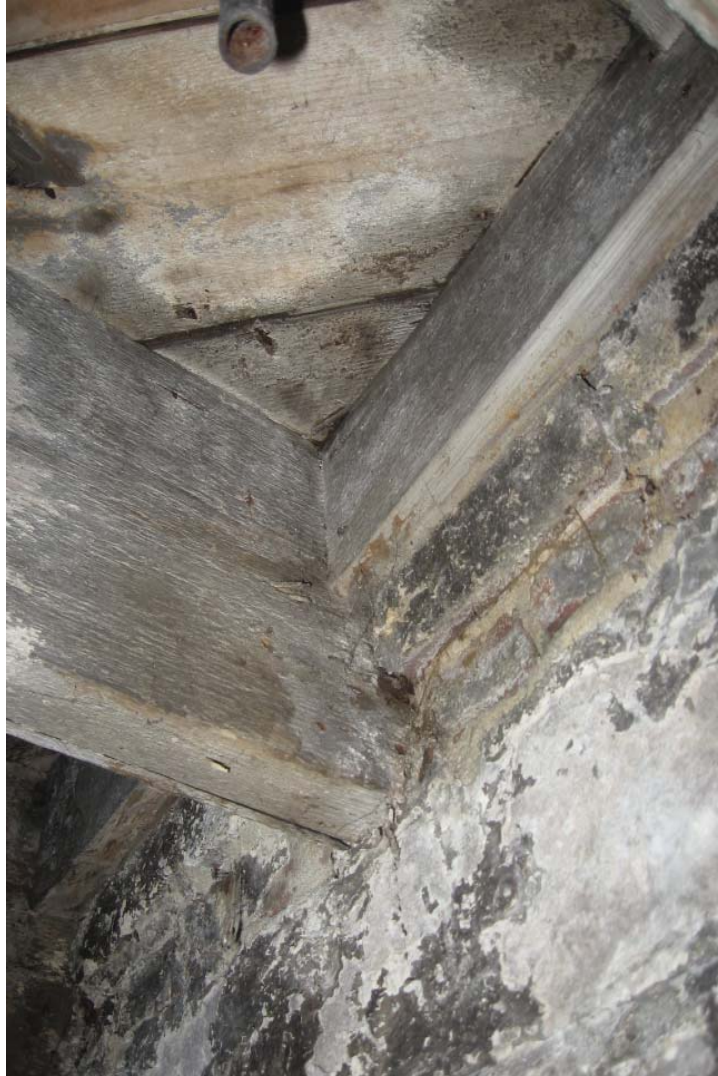
Photo 81. Detail of the floor joists supporting the northeast corner of the former kitchen floor. Note the damage where the wood sits in the masonry wall. (JMA, October 2009)

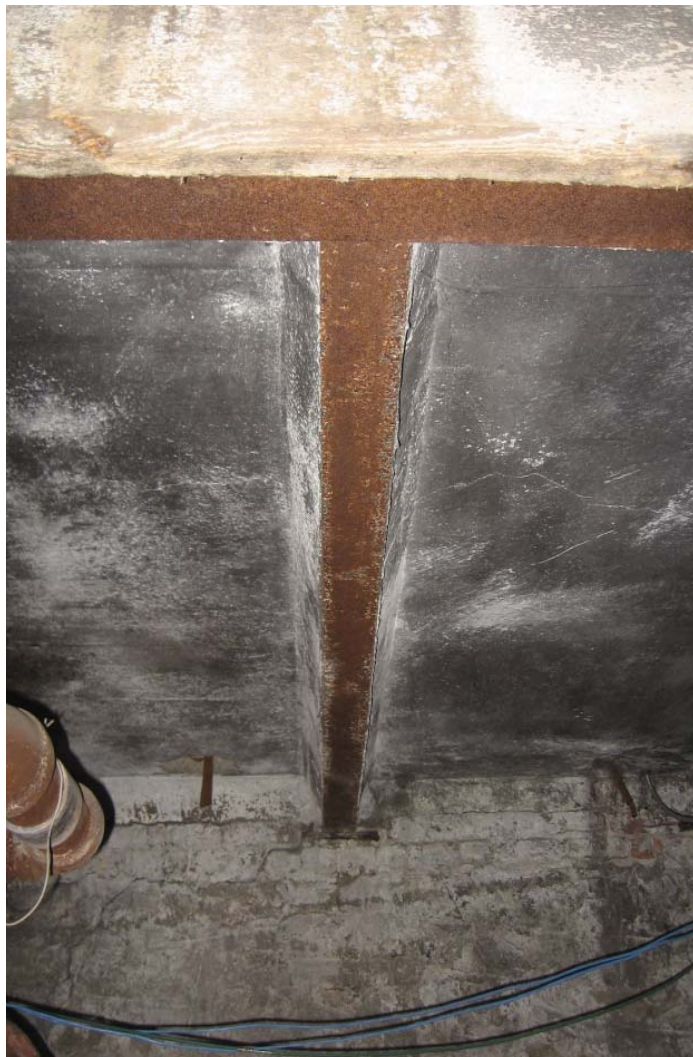
Photo 82. Detail of the steel framing and cement parged panels at the north end of the Boiler Room. Note the corrosion of the steel beams. (JMA, October 2009)

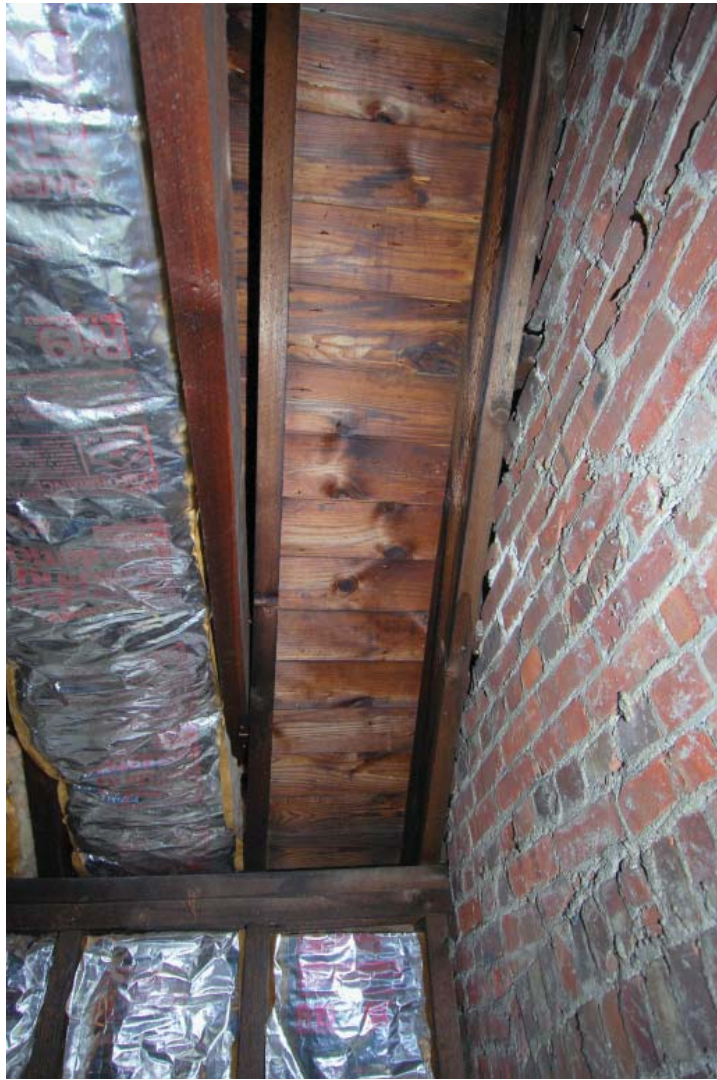
Photo 83. Detail of the underside of the roof at the north dormer end. Note the lack of insulation at the dormer roof. (JMA, October 2009)

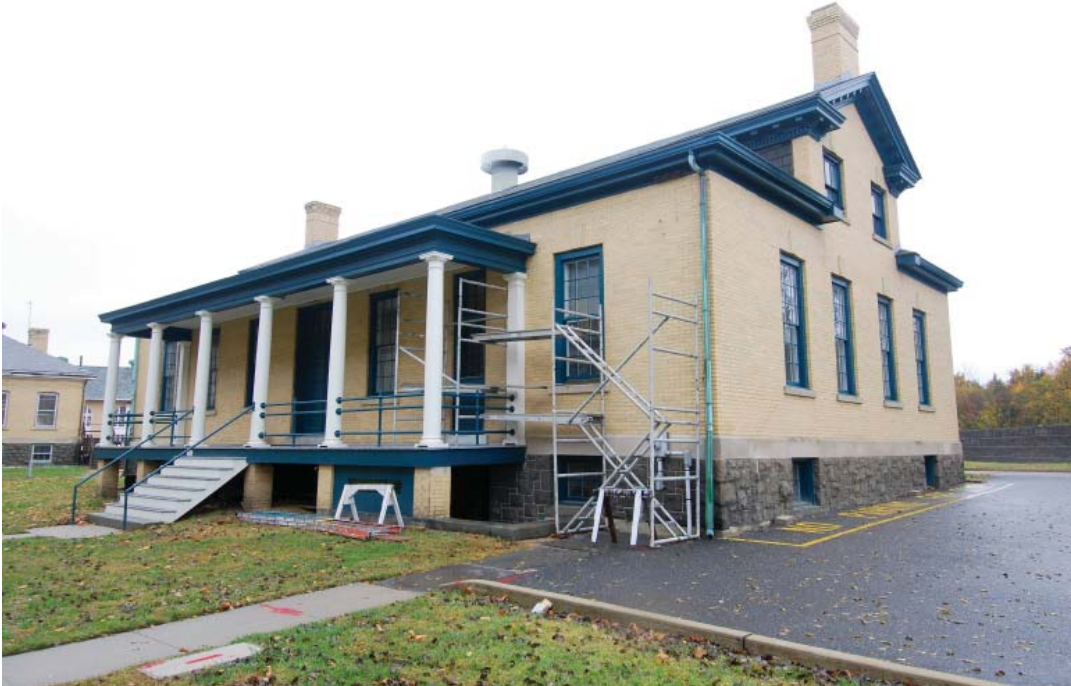
Photo 84. Overall view of Mess Hall Building #58 from the southwest. Note the lack of a continuous path and accessible entrance (JMA, October 2009).

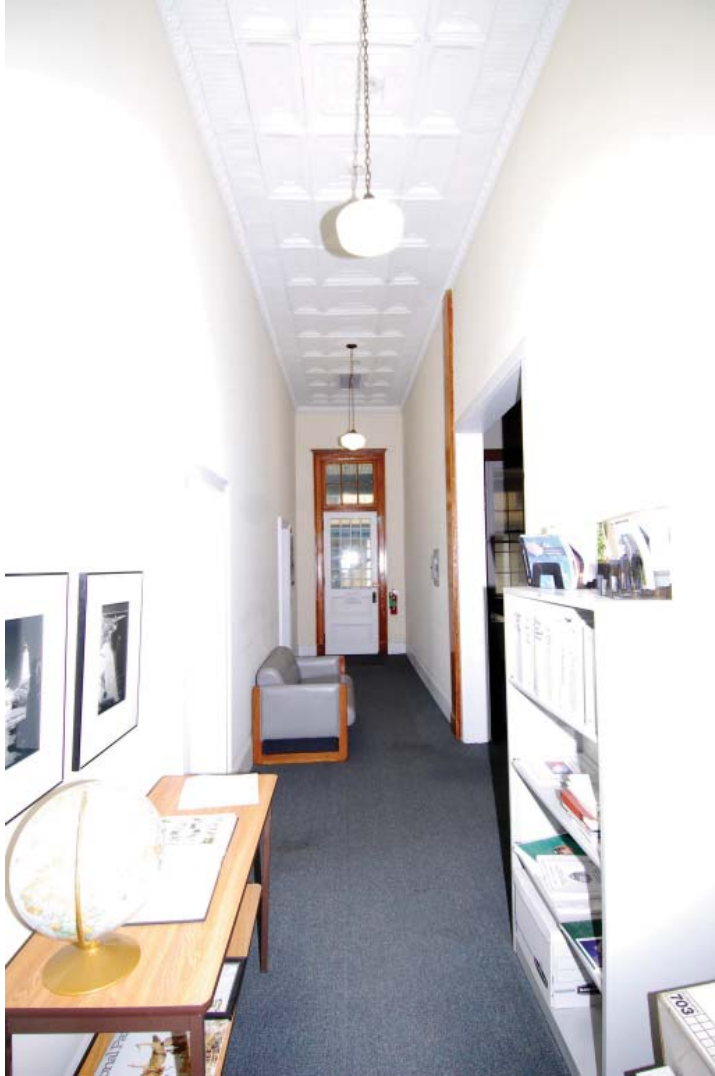
Photo 86. View of southern hall looking west. The existing Hall provides an accessible circulation path. Existing furniture currently located along the Hall should be relocated to keep the path open (JMA, October 2009).

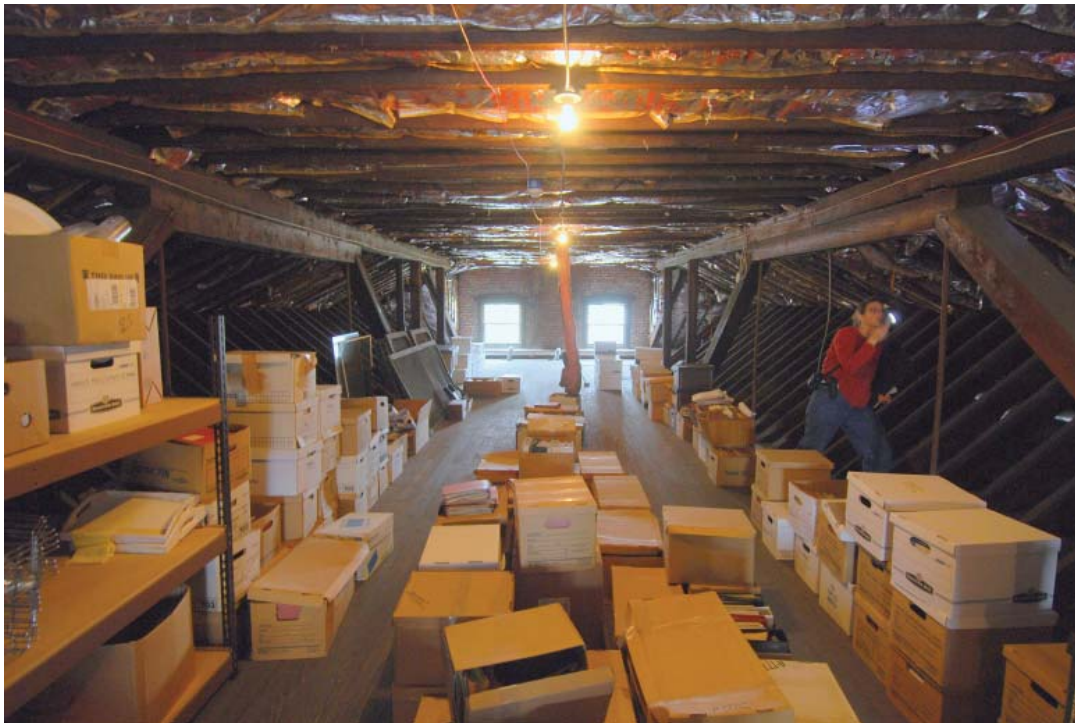
Photo 97. Overview of the attic looking north. The debris and miscellaneous items in the attic are a fire hazard (JMA, October 2009).

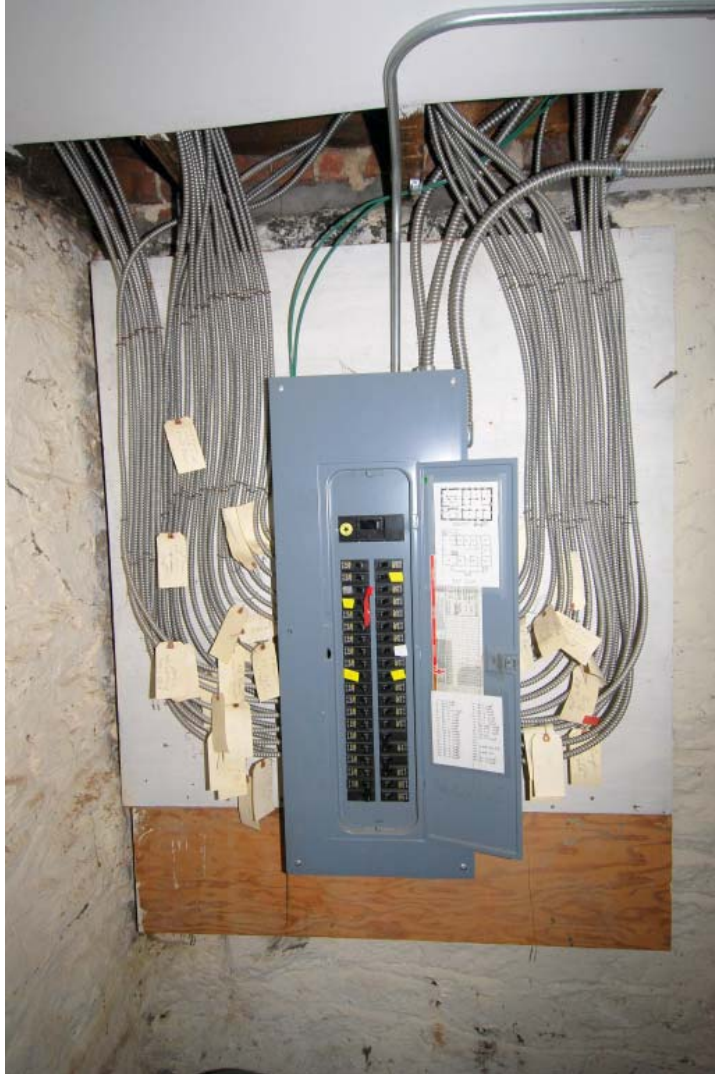
Photo 98. Detail of holes in the ceiling of the electrical room at the basement level. Holes in the Electrical Room ceiling disturbs the integrity of the fire-rated ceiling plane (JMA, October 2009).

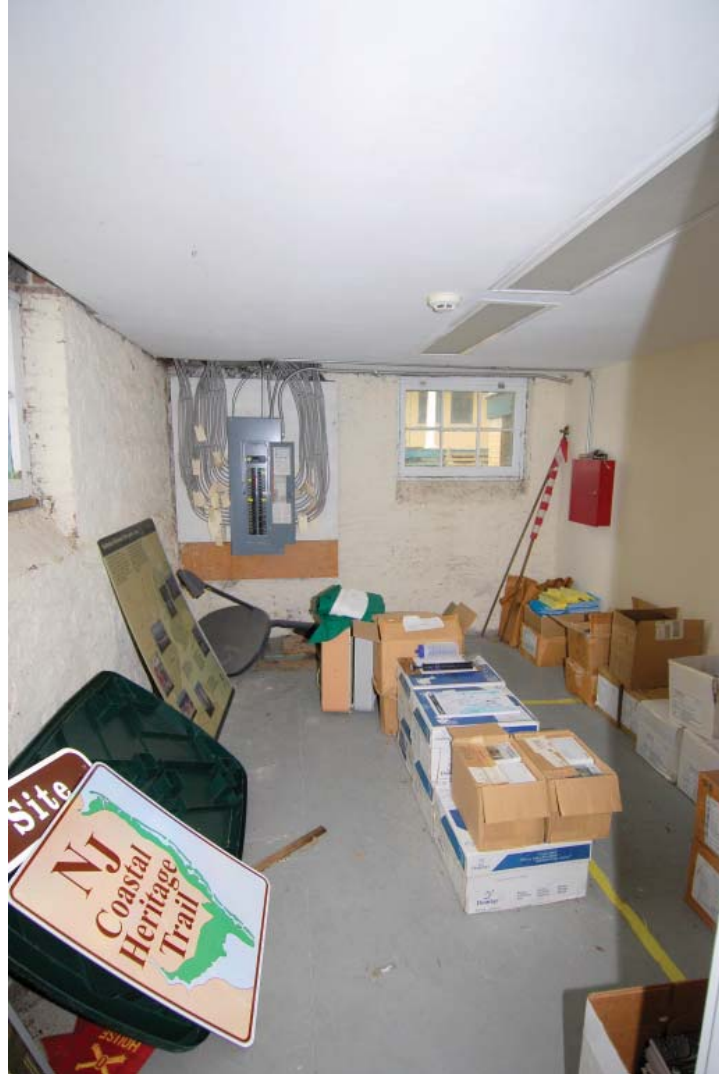
Photo 99. Overview of the electrical room looking west. The debris and miscellaneous items in the Electrical Room are a fire hazard (JMA, October 2009).

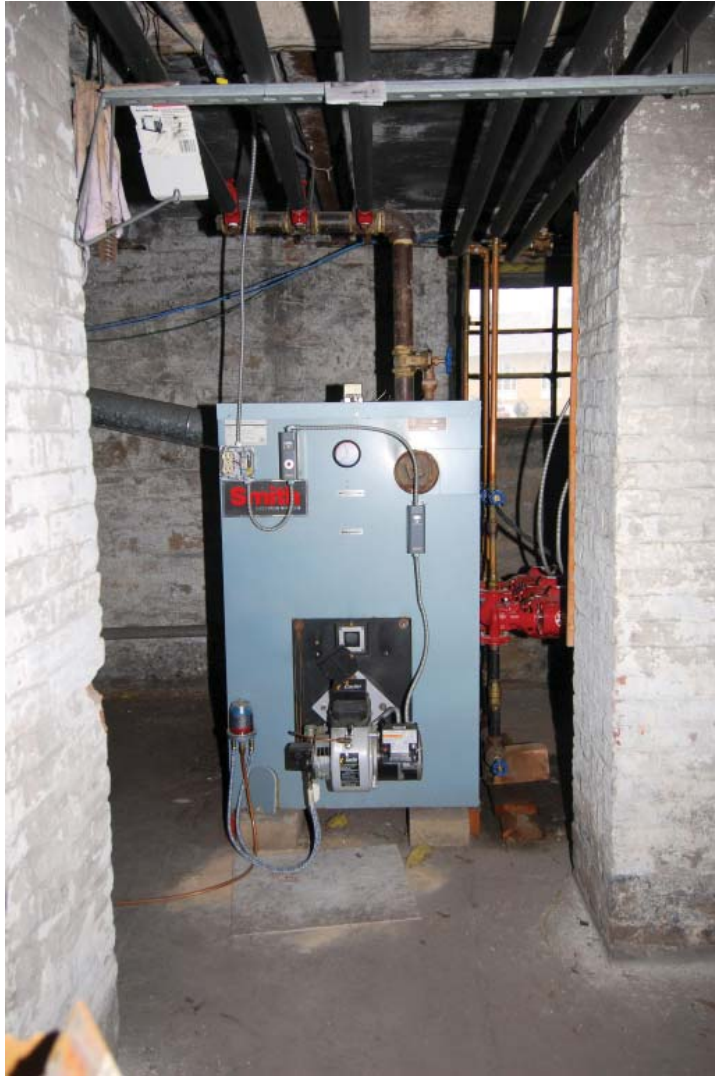
Photo 100. Detail of heating equipment in the boiler room.  
Heating equipment residing in the main portion of the boiler room  
should be enclosed by fire rated partitions as an additional safety  
precaution (JMA, October 2009).

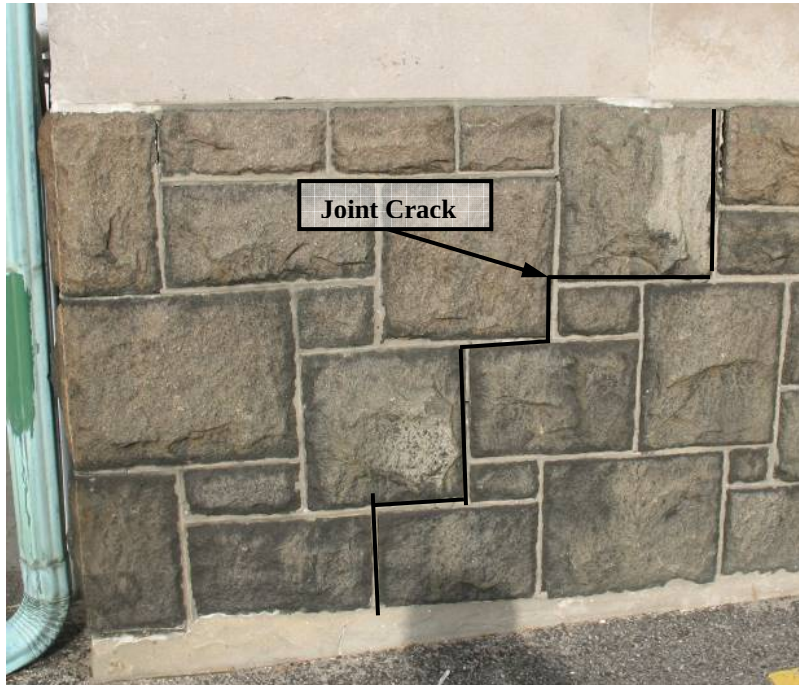
*Photo 1:* Crack in south wall at west corner. Crack extends through wall.

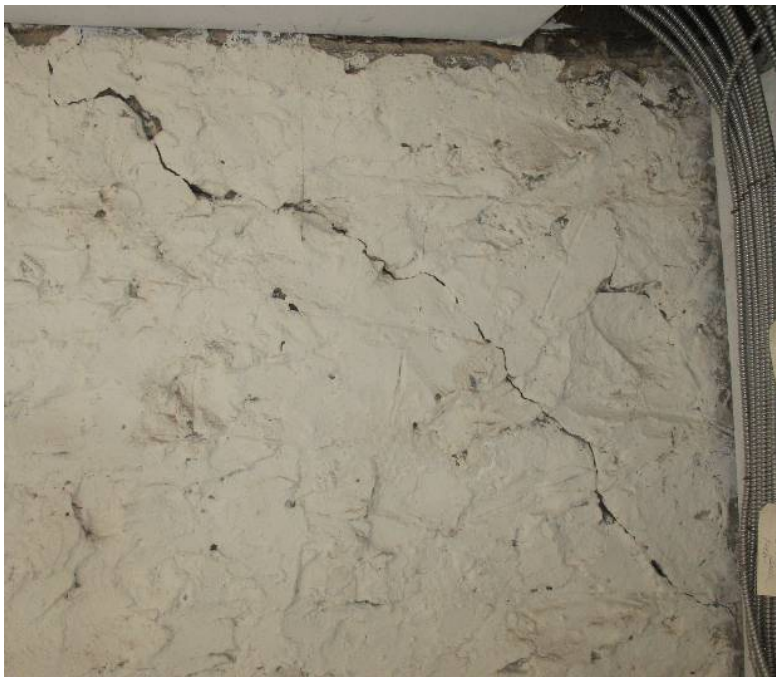
*Photo 2:* Crack in south wall at west corner from inside.

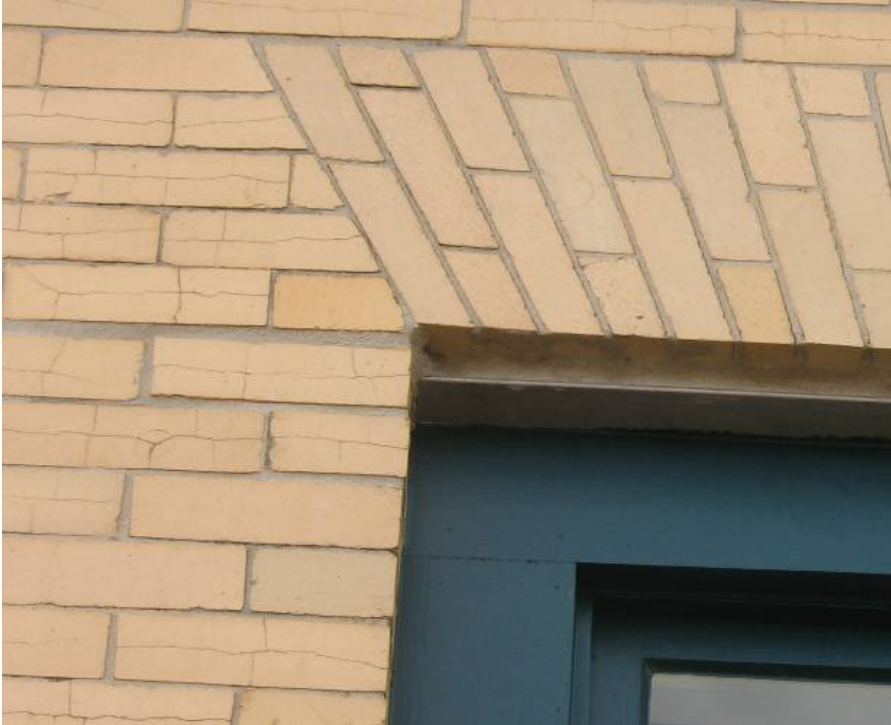
*Photo 3:* Lintel Replacement. Notice distortion of wall due to rust jacking from previous lintel.

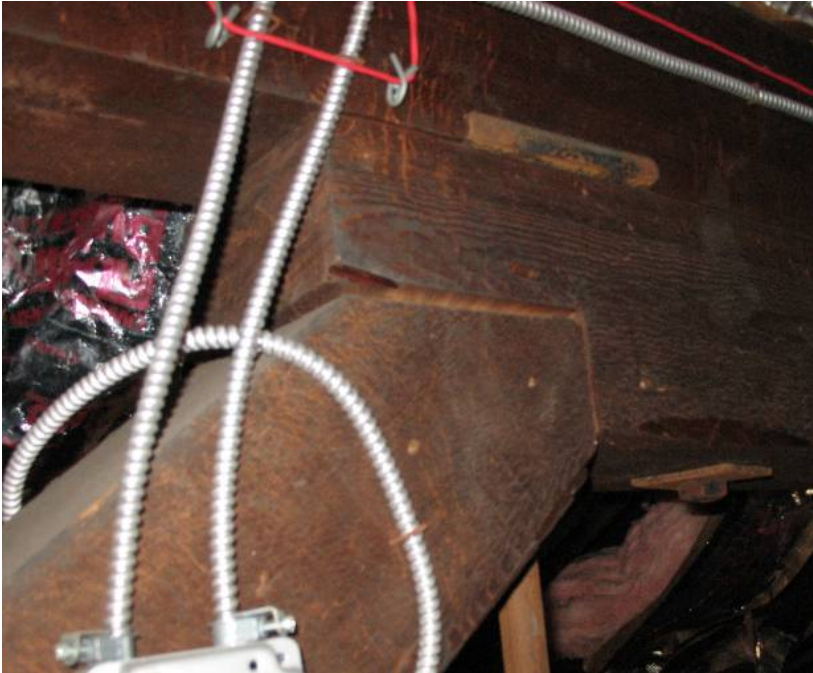
*Photo 5:* Truss diagonal to top chord connection. Notice gap in top chord caused by warping of the diagonal member.

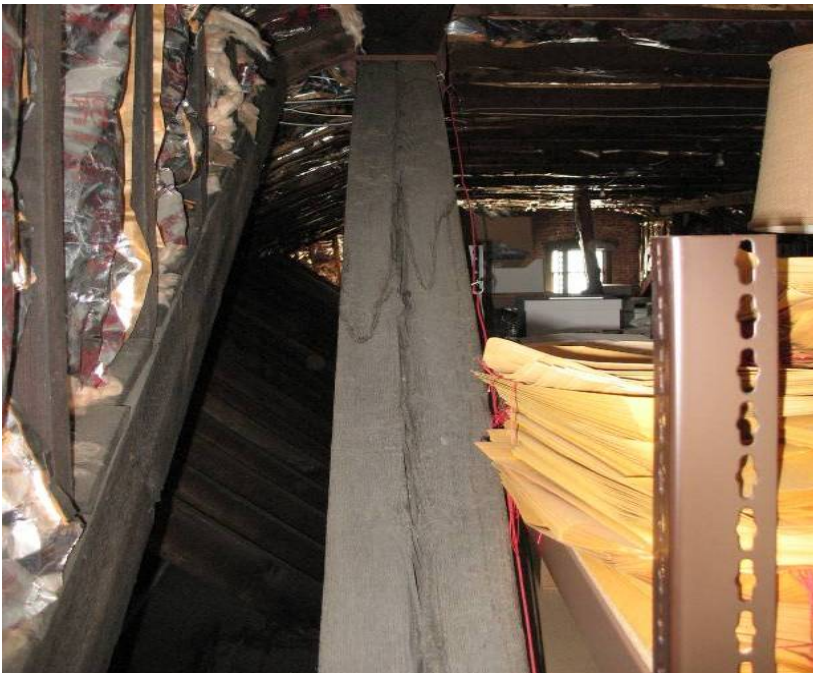
*Photo 6:* Check in sloping timber top chord of east truss – north end.

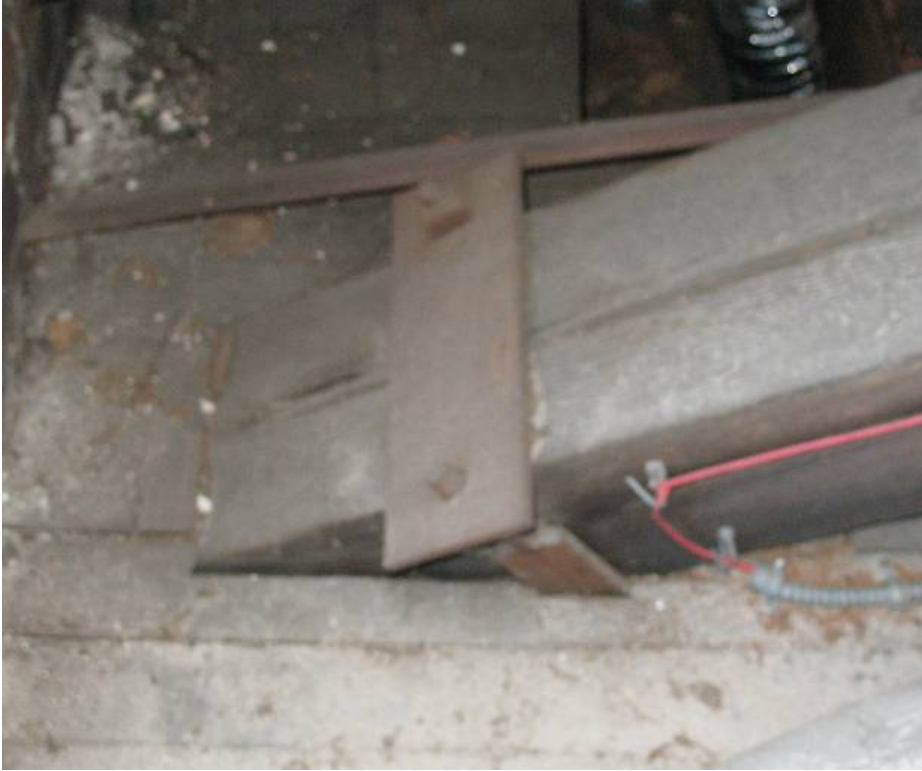
*Photo 7:* Strap at heel joint where top and bottom chords connect. Nut is missing from strap as noted in text above.
