FORT TOMPKINS  
GATEWAY NATIONAL RECREATION AREA

*Historic Structures Report*

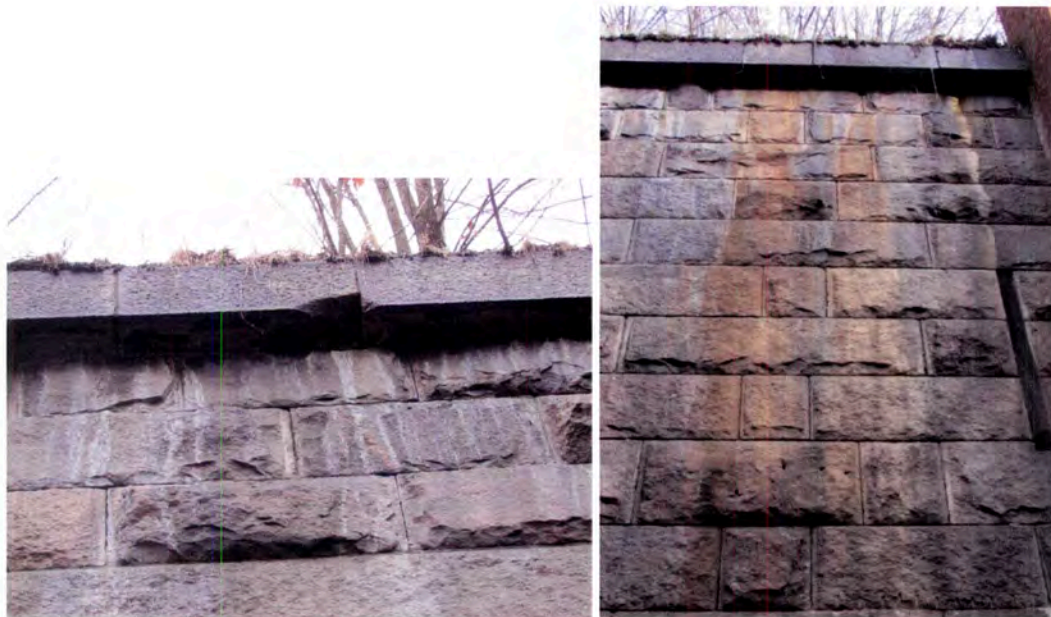
There is minor vegetation on the structure, and biological growth throughout, particularly in the pointing and along the coping on each elevation. There is also an abundance of efflorescence and rust stains throughout, typically towards the tops of the walls and near ground level. The rust stains are typically located below the masonry openings. There is water damage in several areas of the exterior, with active water and staining. The condition appears to be serious, and is likely caused from issues on the roof.

*Figure 1: Piece of broken granite coping and water stains (left) and severe rust stains (right) on south section of west elevation.*

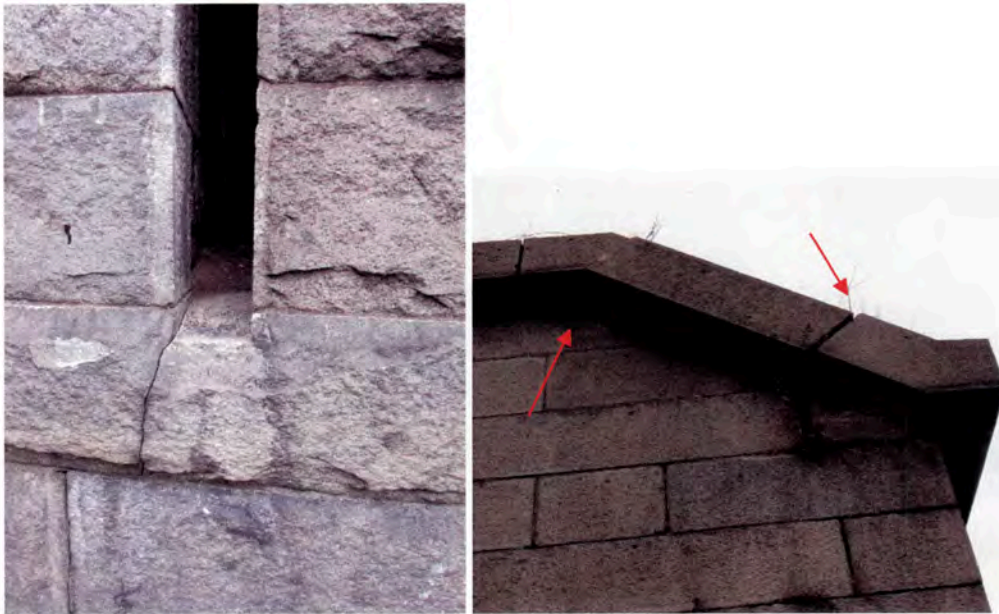
granite coping is missing or broken, particularly around the chimney, and the coping appears to be shifting on the east side of the elevation. Generally 10% of the elevation requires repointing, and the east end requires approximately 50%.

Figure 3: Minor crack under masonry opening (left) and shifting coping stones (right) on the south elevation.

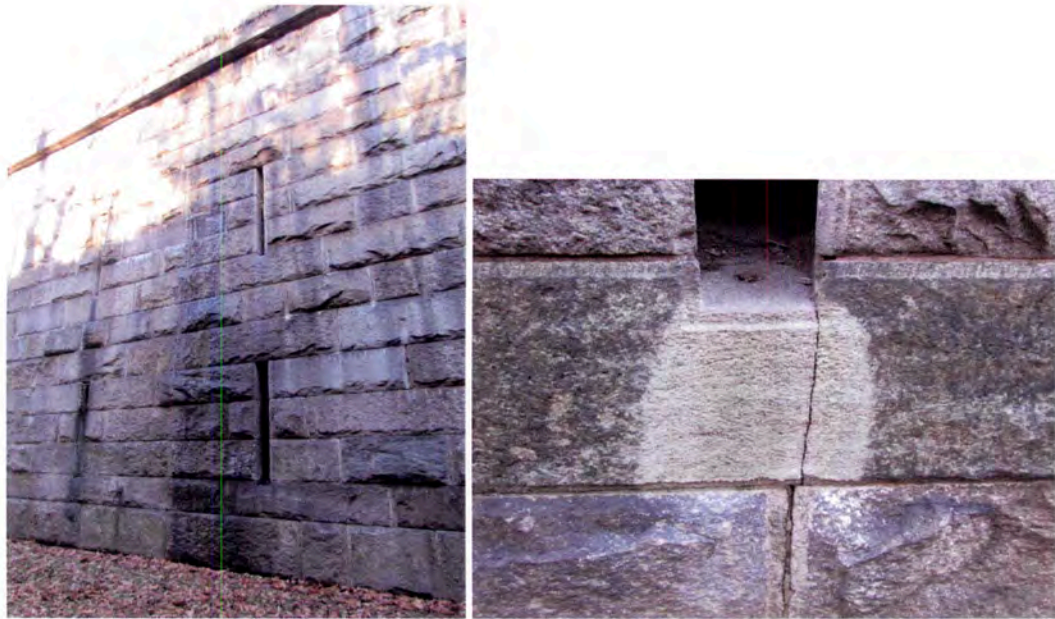
On the north section of the west elevation, there are several areas where active water is present. The areas exhibiting active water are the north end, on the north side of the chimney, and towards the south end of the section. There are minor cracks on the north end of the section, typically under the masonry openings. There are minor holes and spalling through the section. The north section requires approximately 10% repointing.

Figure 4: Active water (left) and minor crack under masonry opening (right) on the north section of the west elevation.

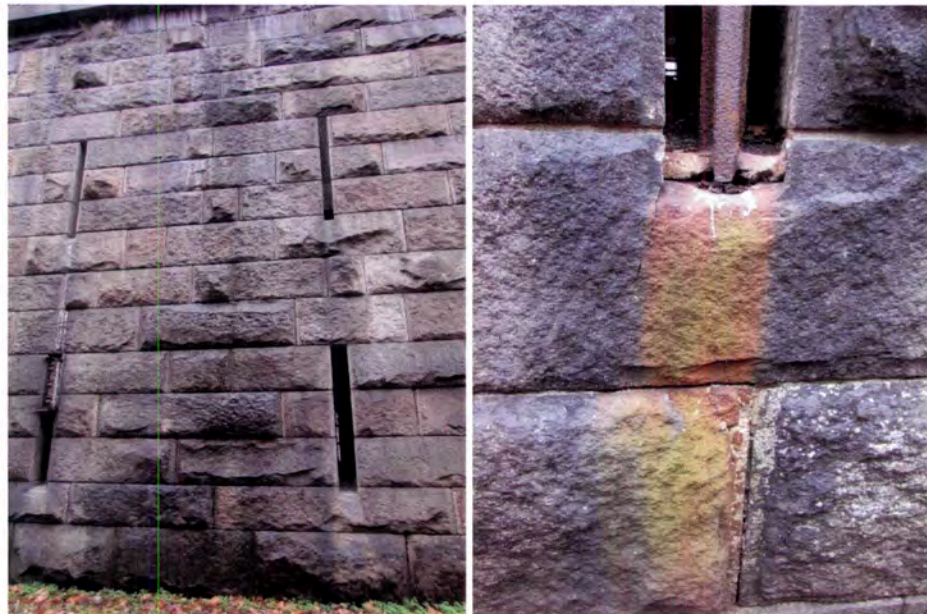
There are large areas of active water on the south section of the west elevation. The condition is most severe in the center of the section and on the north end. There are several rust, efflorescence and water stains throughout the south section. Abandoned hardware and minor holes are present at this section, and there are a few minor cracks around the masonry openings. 100% of the north end requires repointing (around the chimney and to the north) and the rest of the section requires approximately 15% repointing.

Figure 5: Active water (left) and rust stain from bar in masonry opening (right) on south section of west elevation.

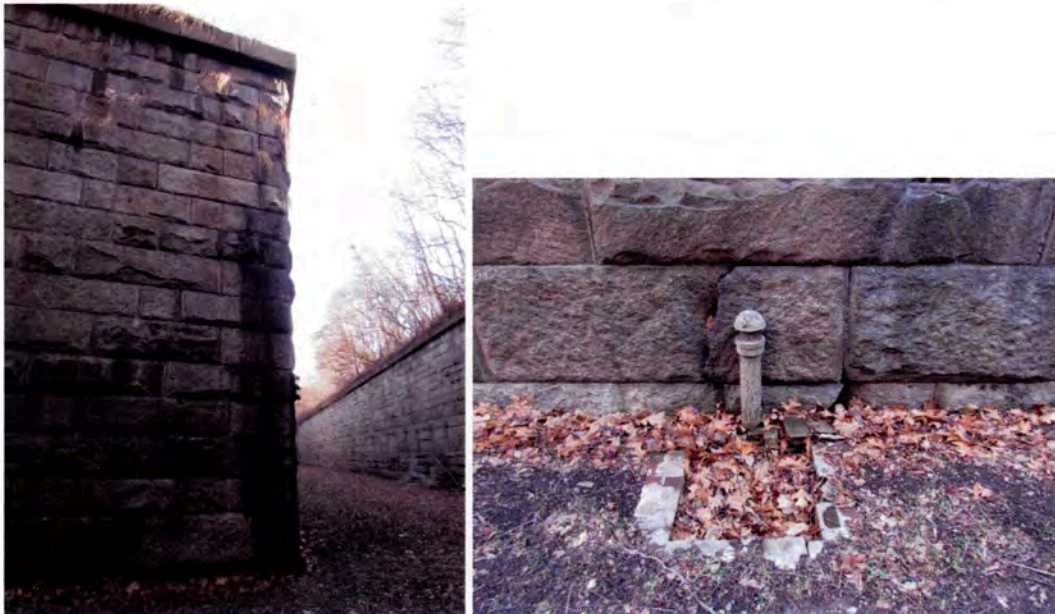
There is vegetation and biological growth throughout the north elevation. There are also efflorescence and rust stains that are more severe around the chimney and at the west end. Evidence of active water is visible on the north elevation, particularly serious in center of the elevation and at the west end. There are minor cracks on the north elevation, and it requires approximately 10% repointing.

*Figure 7: Active water on west end of north elevation (left) and minor crack in masonry (right).*

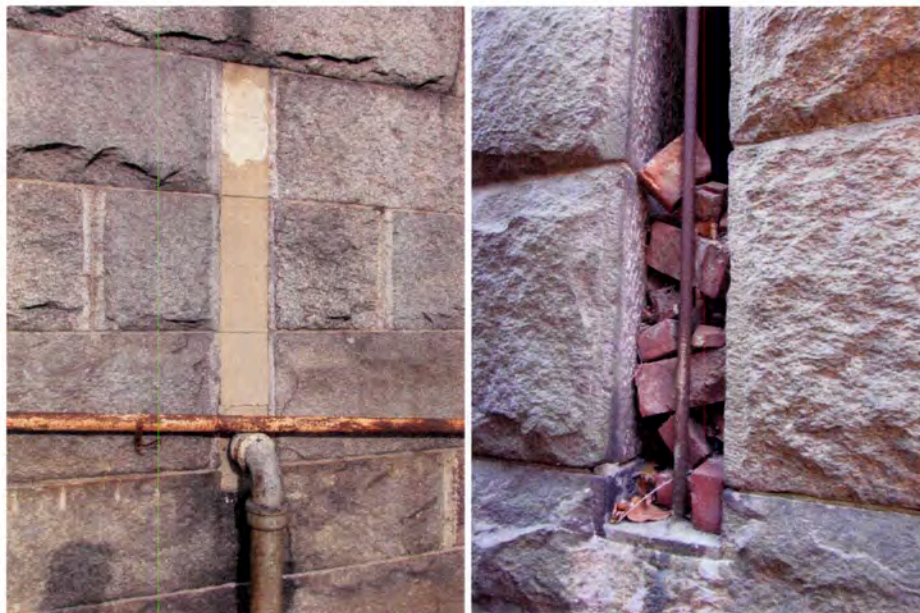
*Figure 9: Embrasure infilled with concrete and a pipe (left) and embrasure infilled with debris (right).*

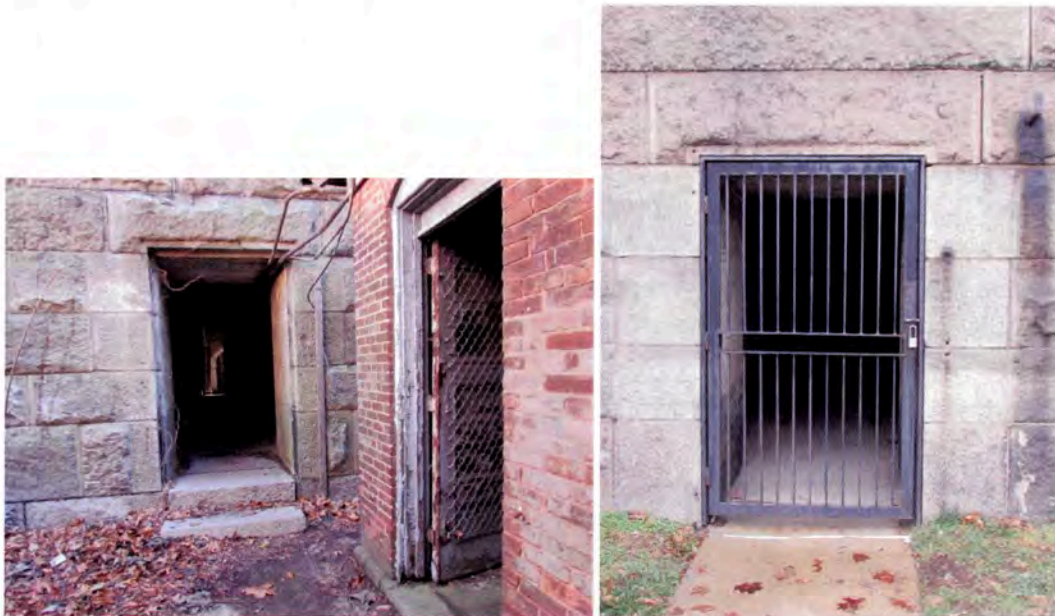
The door on the south façade is similar to the north, and also in good condition. The metal gate has minor rust, and some of the hardware has been replaced. The hook plate is still extant and a modern padlock was added for security. The stone around the door opening has been cut out, which indicates that there was a door head previously located here. Holes in the stone at the top west corner of the door and abandoned hardware on the east side of the door are further evidence that a frame was removed from this doorway.

*Figure 10: Masonry opening on north elevation (left) and masonry opening with metal gate on south elevation.*

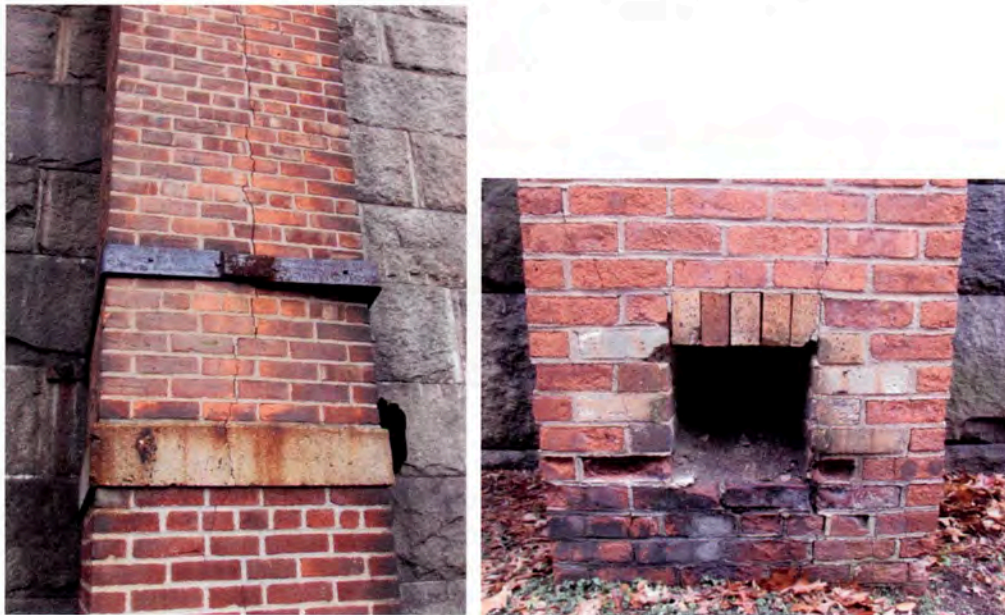
The two chimenys on the west elevation are in similar condition to the north chimneys. The chimney on the north side of the west elevation has missing pointing, particularly near the top, cracks throughout, and part of the metal frame of the cleanout opening is missing.

*Figure 13: Cracks, spalling and missing bricks on chimneys.*

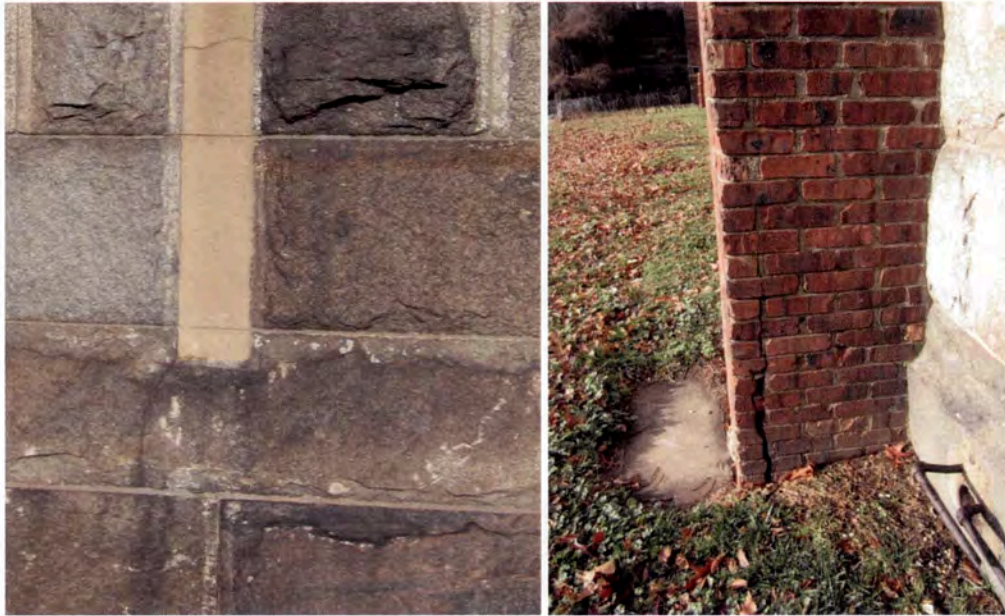
*Figure 16: Crack below masonry opening (left) and crack at base of east chimney on south elevation (right).*

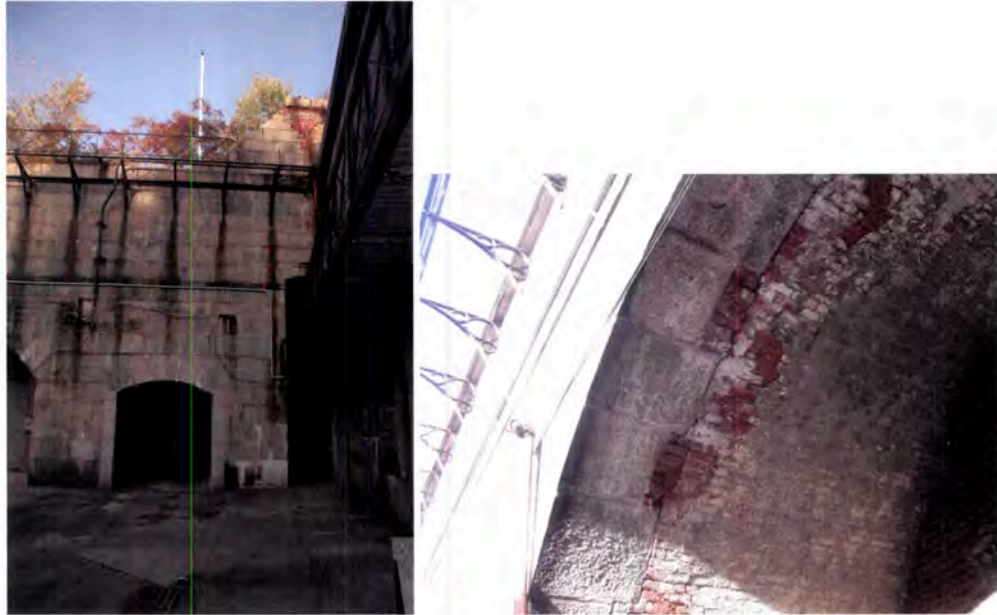
*Figure 28: Southeast corner of Parade showing staining and efflorescence on east elevation (left) and crack in masonry arch on east elevation.*

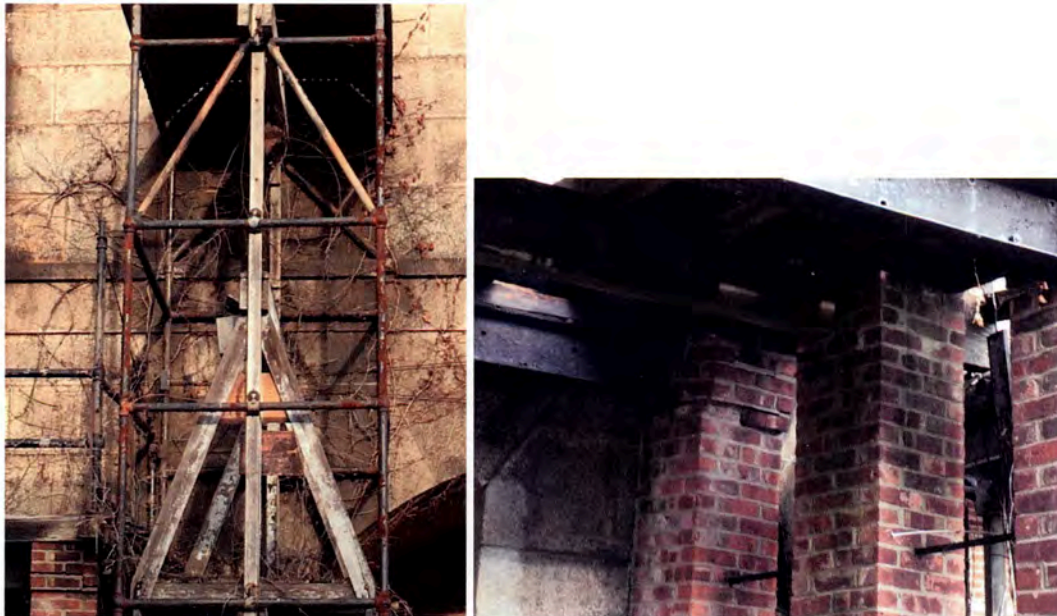
are rotting and splitting. The brick columns are cracked and displaced by the wood and metal joists above. Metal tie-rods have been installed between the columns, and are also exhibiting rust. The railing on the platform is rusted and partially missing.

Figure 29: Rusted metal framing of lift structure (left) and detail of cracked brick column supporting platform.

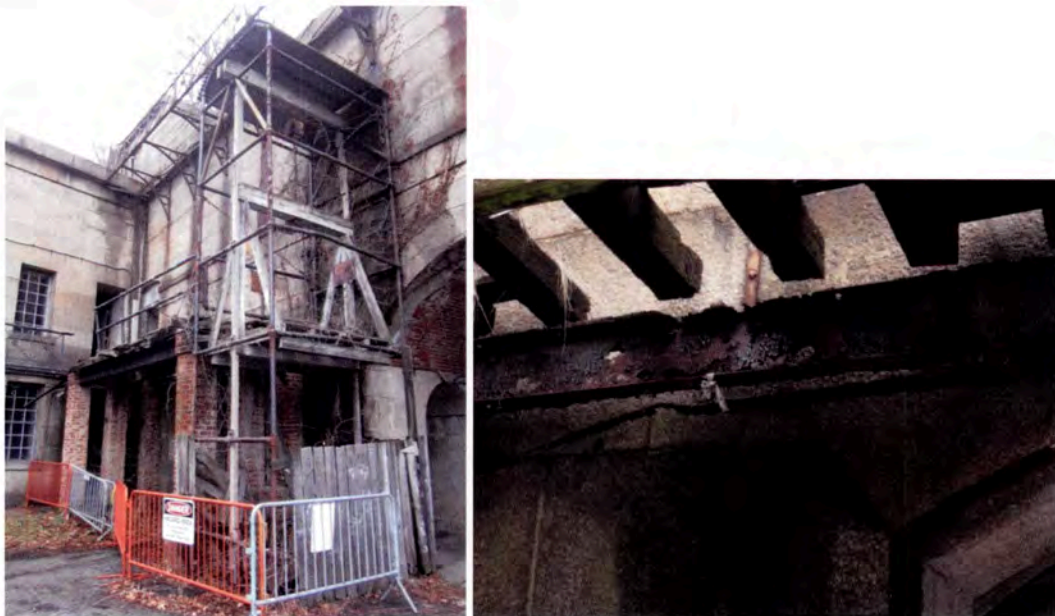
Figure 38: Hoist structure (left) corroded beam (right).

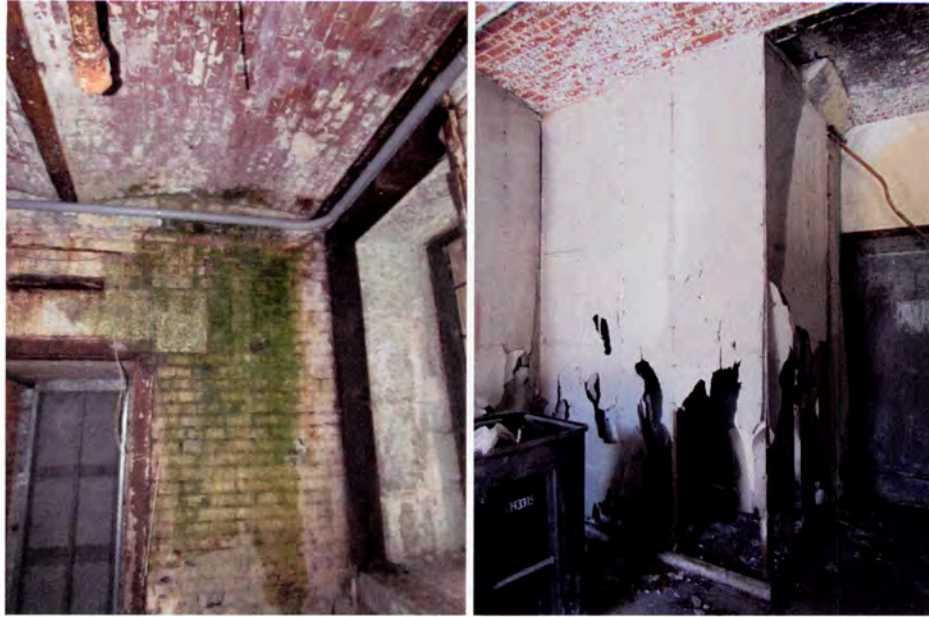
*Figure 41: Water damage and severe staining on brick wall (left) and deteriorating plasterboard partitions (right).*

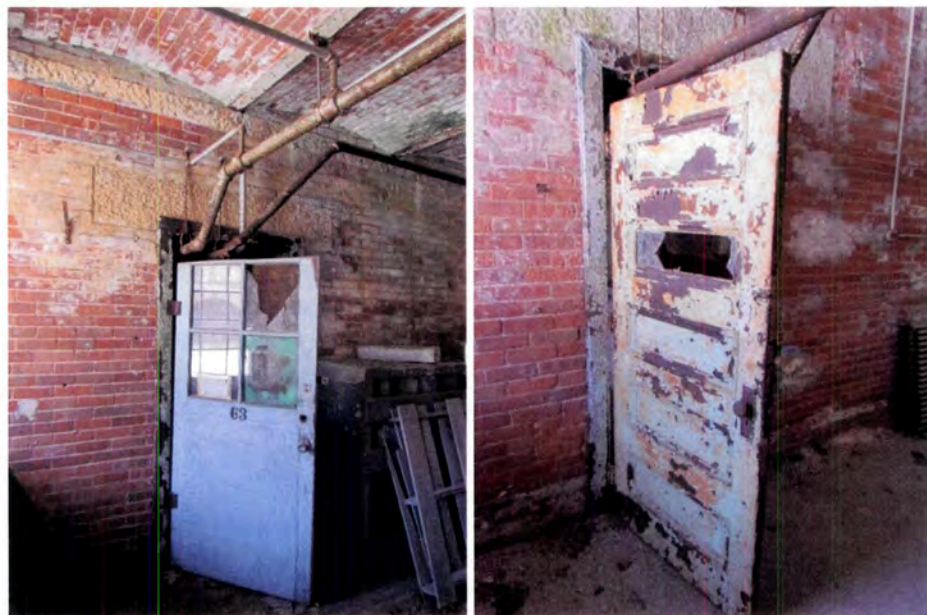
*Figure 46: Modified wood-paneled door (left) and deteriorating five-paneled metal door (right).*

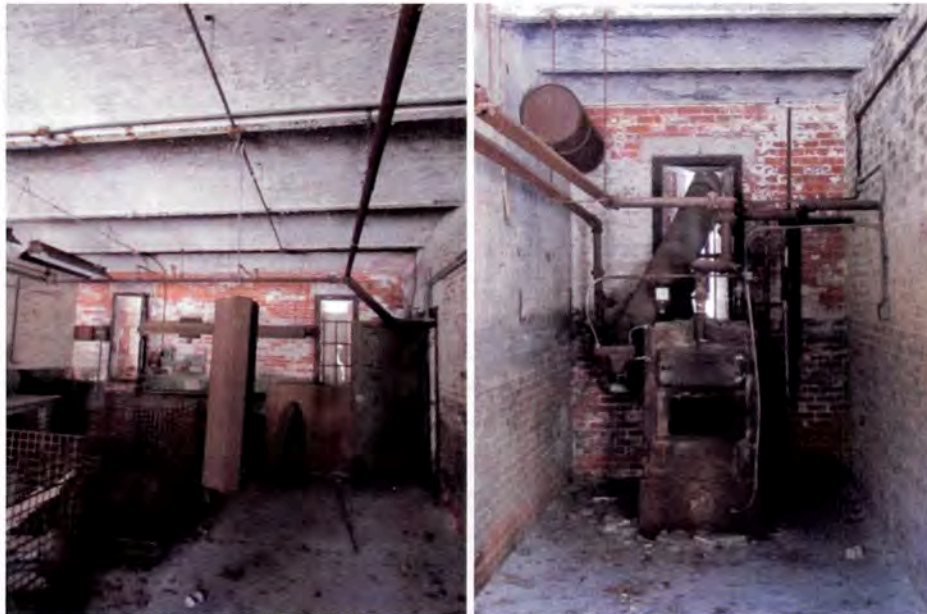
*Figure 47: Deteriorating electrical and mechanical systems of first floor.*

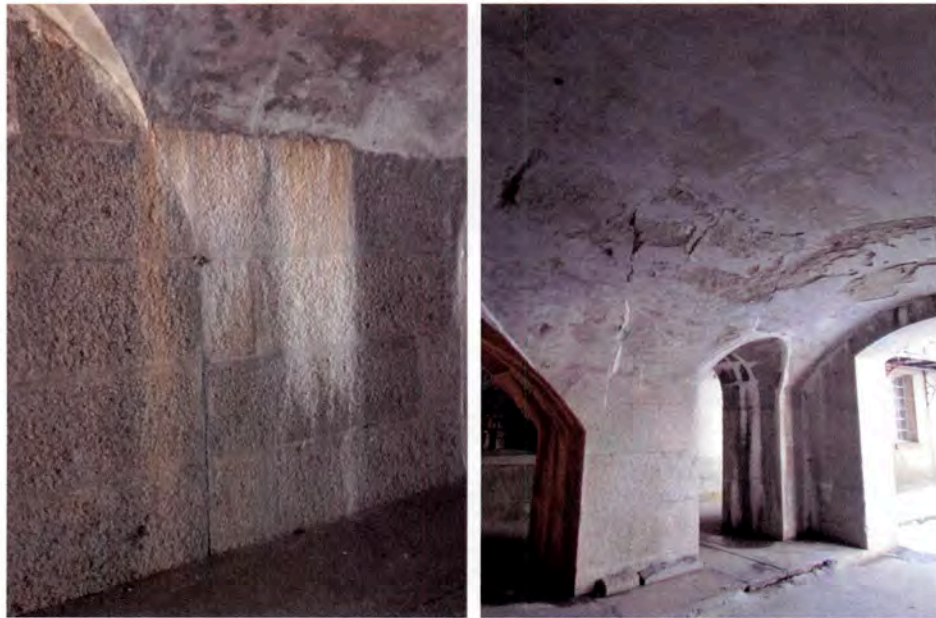
*Figure 59: Efflorescence on wall of north sally port (left) and spalling concrete ceiling in south sally port (right).*

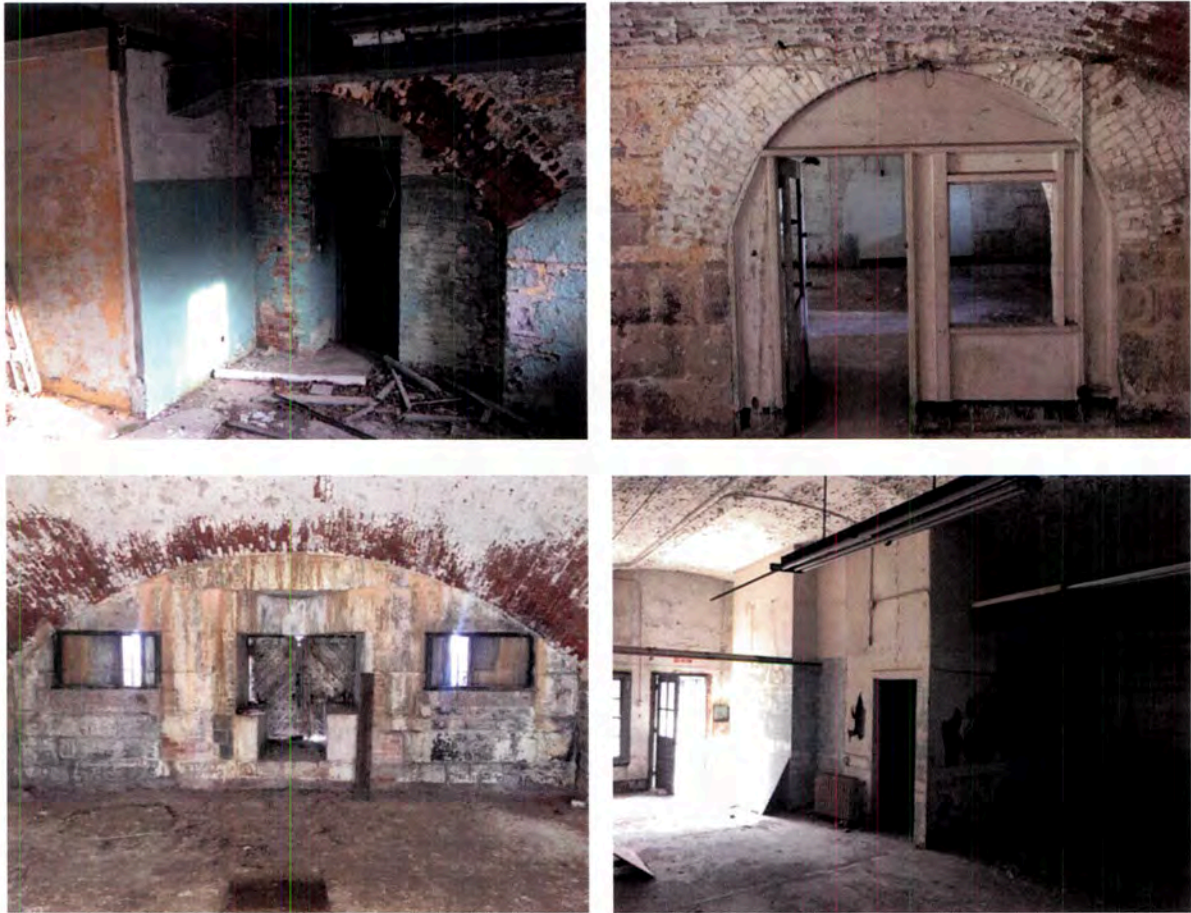
Figure 62: Various wall conditions at the east casemates. Clockwise from upper left: Casemates N, C, E, L.

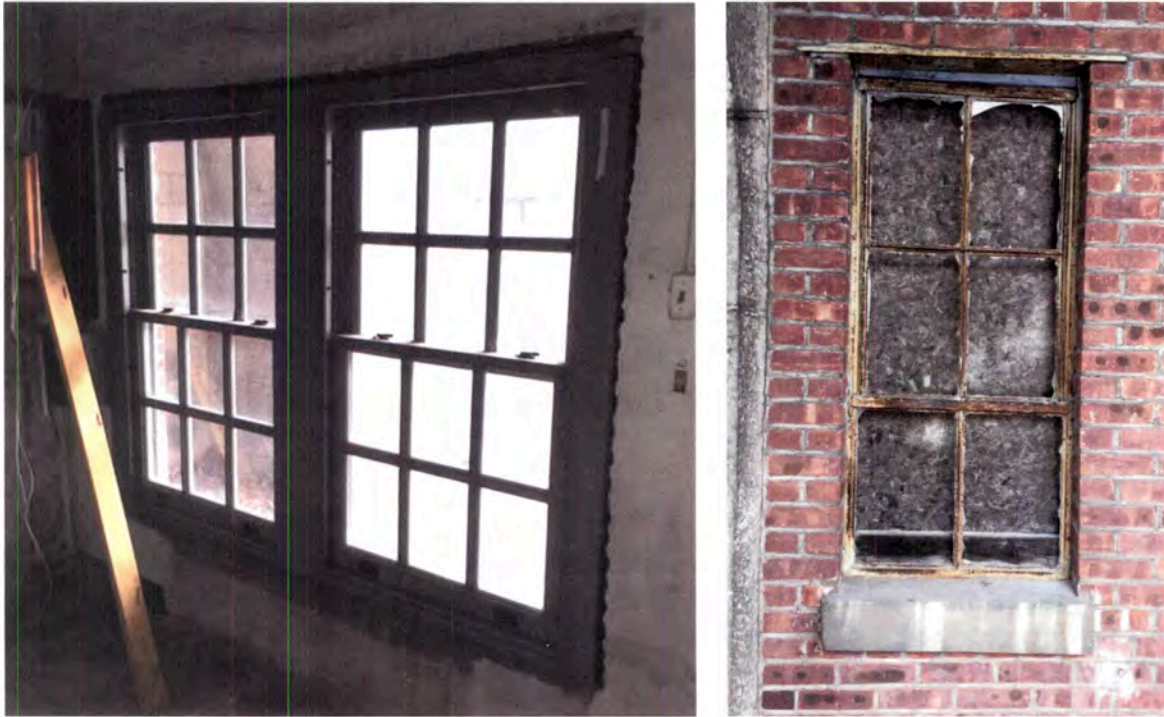
*Figure 64: Range of conditions at west end windows at the casemates.*

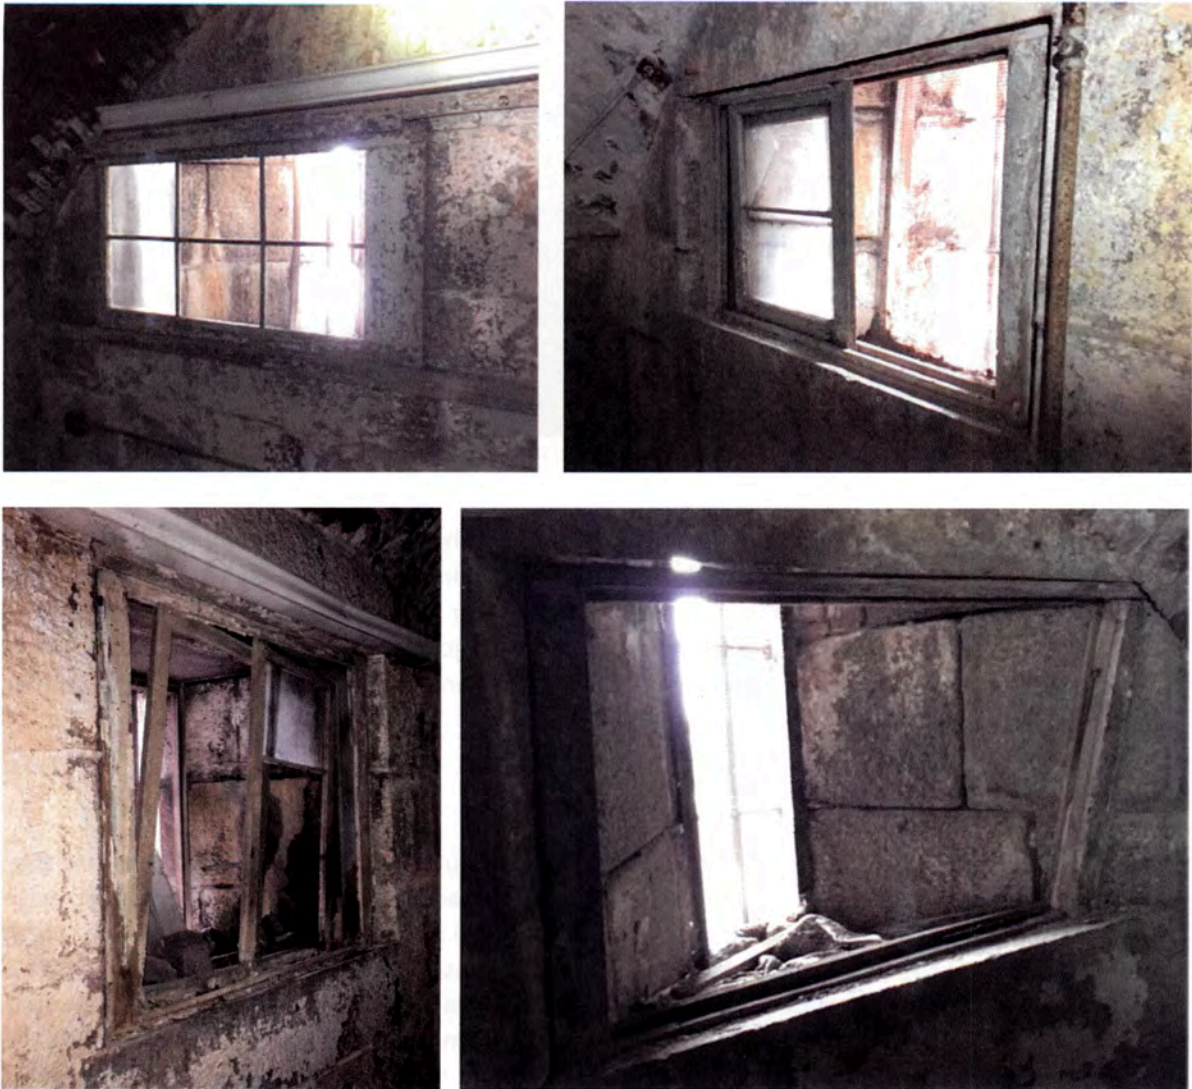
*Figure 65: Range of conditions at east end windows at the casemates.*

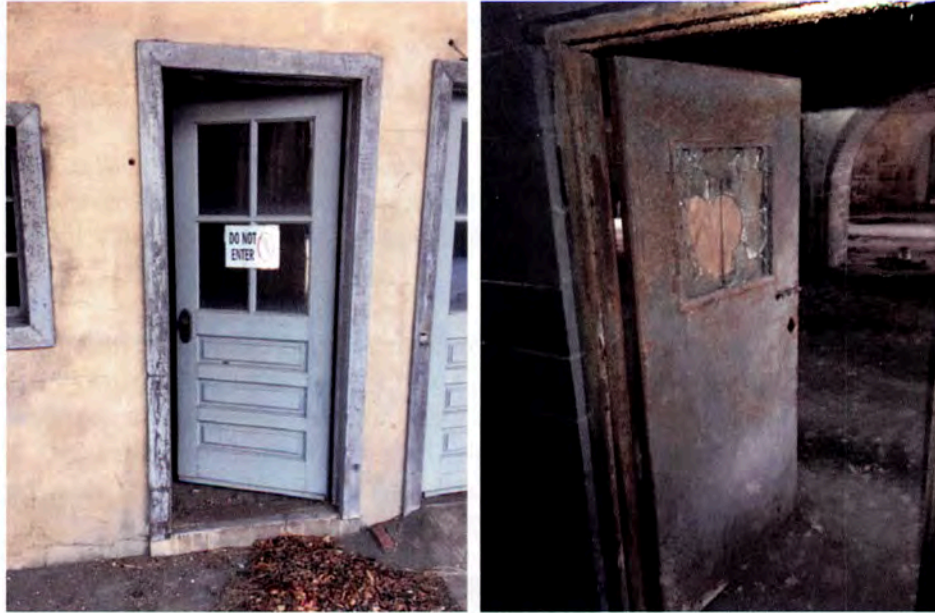
Figure 67: Modern wood replacement door (left) and significant rust and damage at hollow metal door (right).

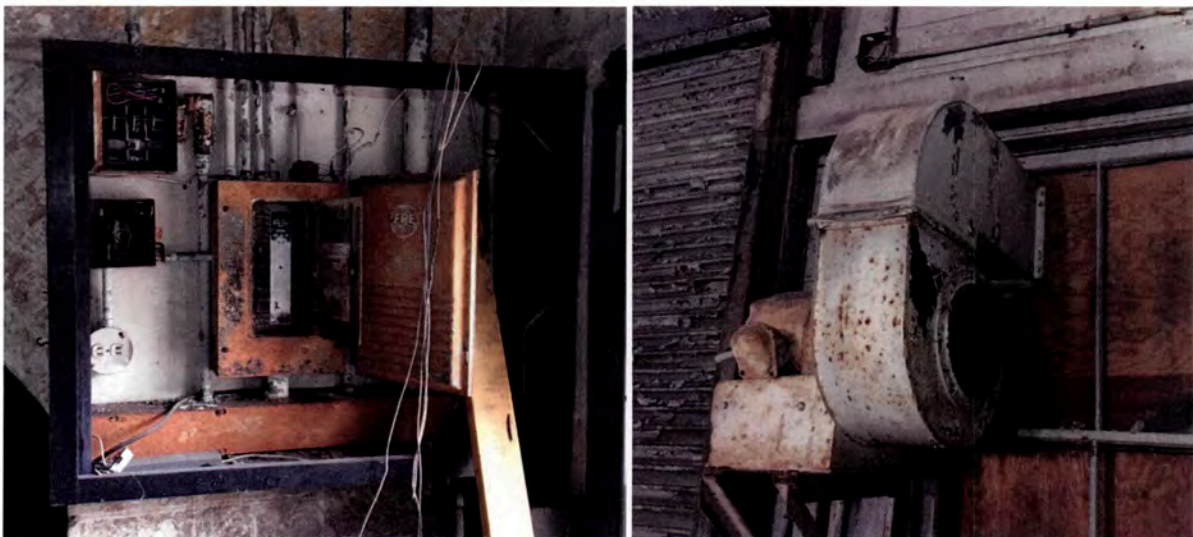
Figure 68: Damaged electrical panels (left) and rusted exhaust fan (right).

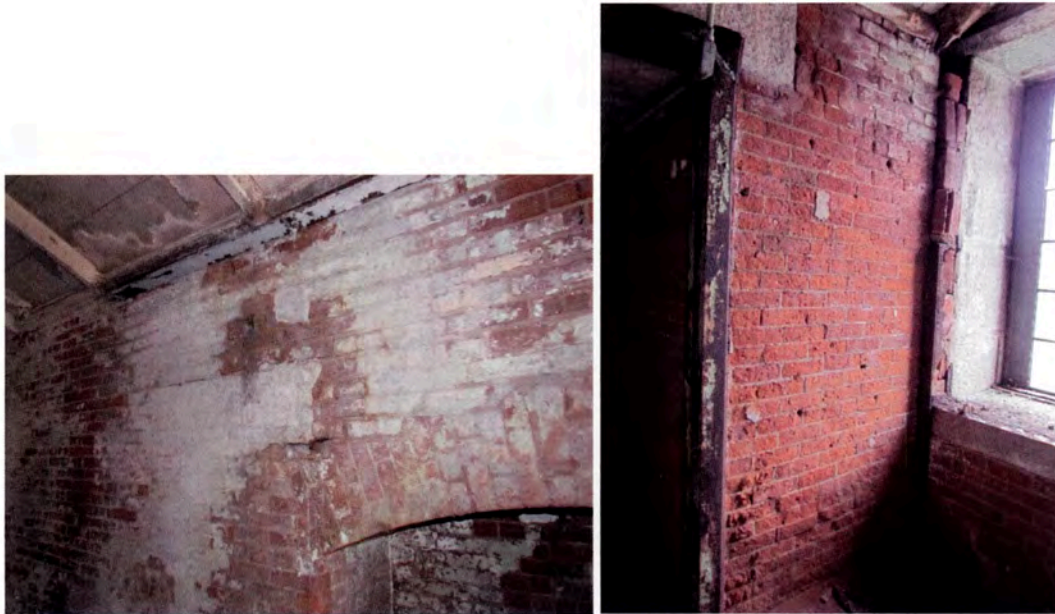
*Figure 74: Deteriorating brick walls.*

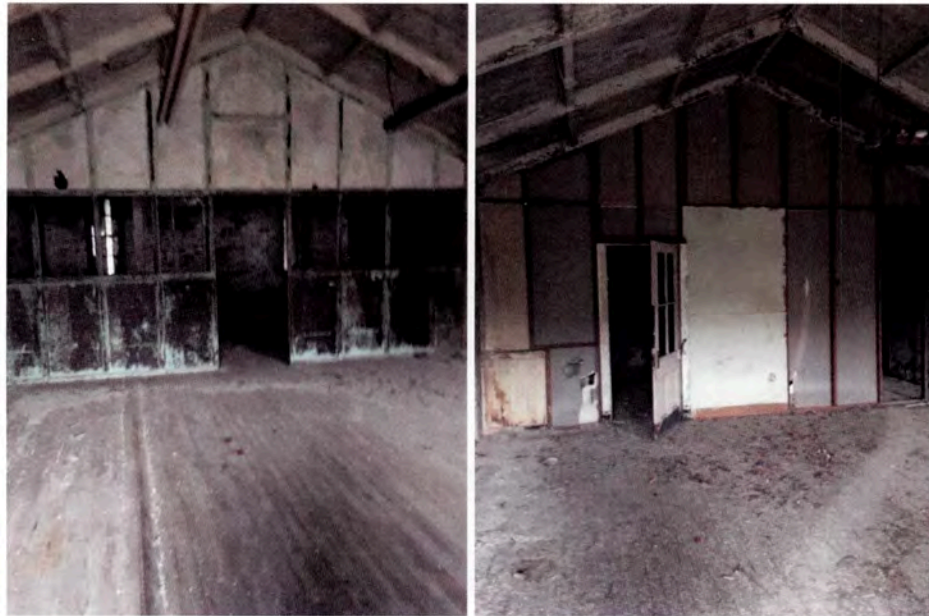
*Figure 75: Deteriorating plasterboard partitions.*

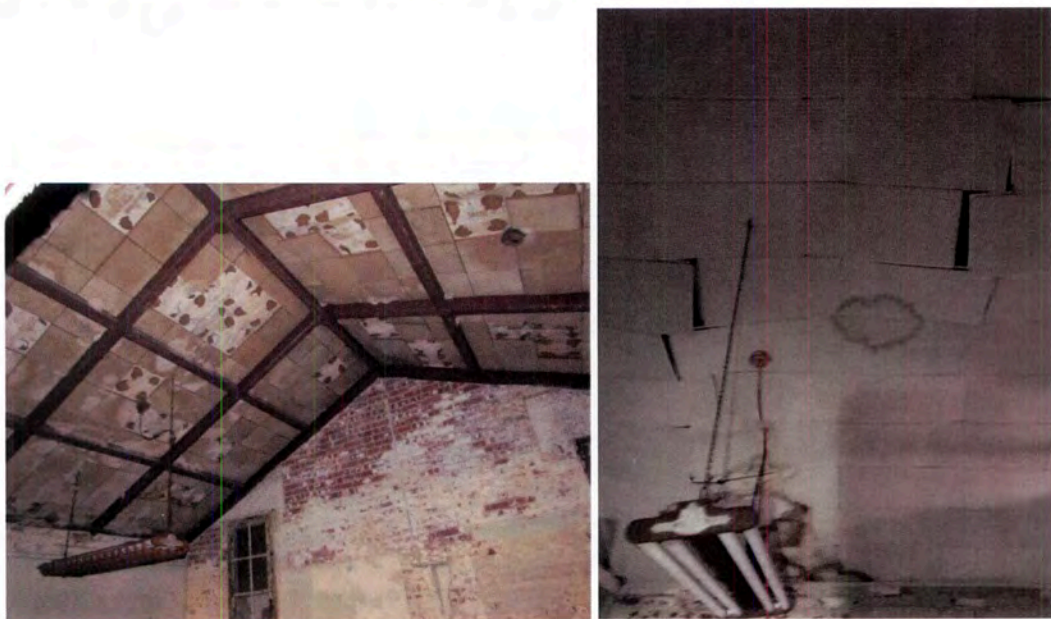
*Figure 77: Deteriorating ceiling tiles.*

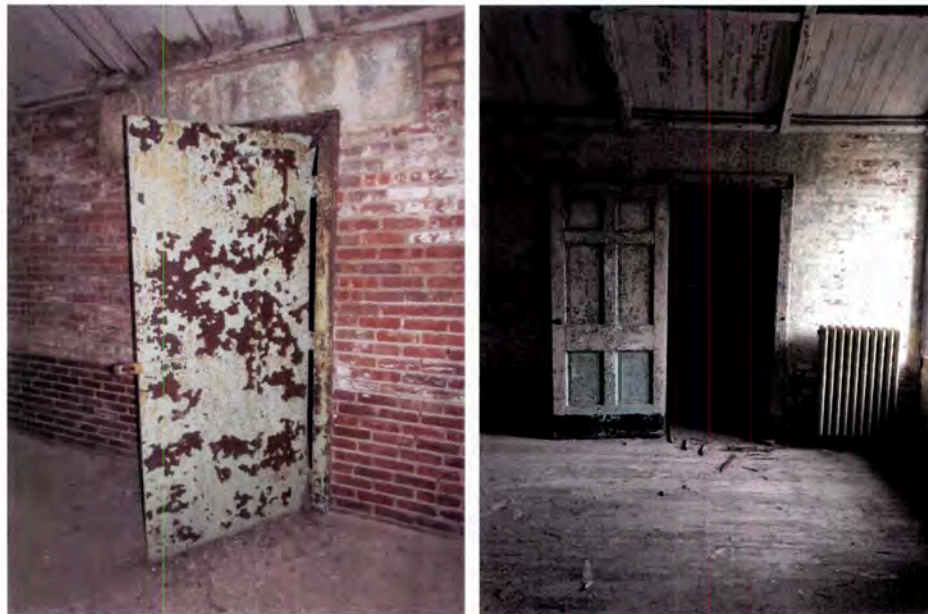
*Figure 79: Typical conditions of second floor doors.*

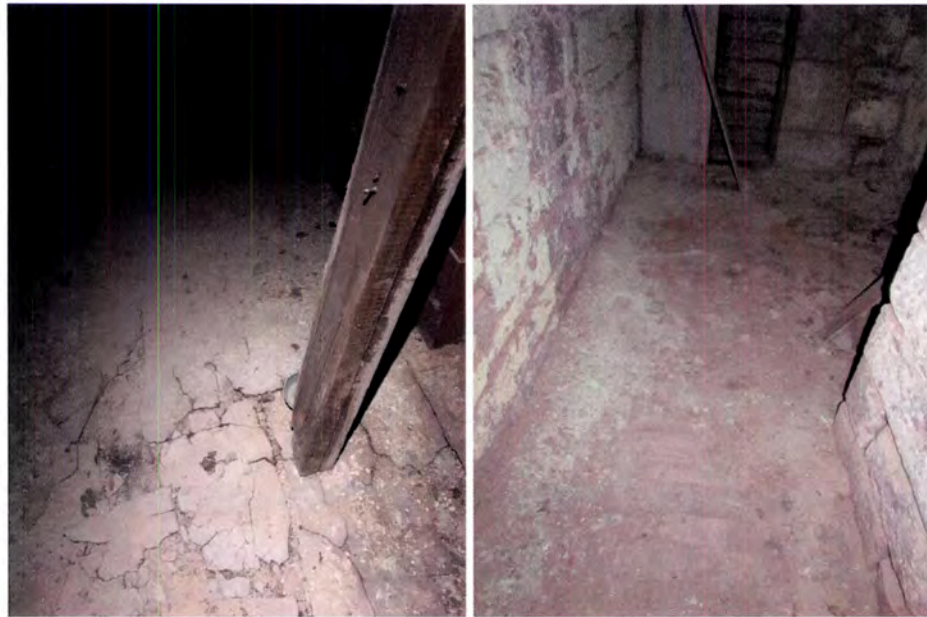
*Figure 86: Deteriorated composite sheet flooring (left) and brick floors obscured by debris (right).*

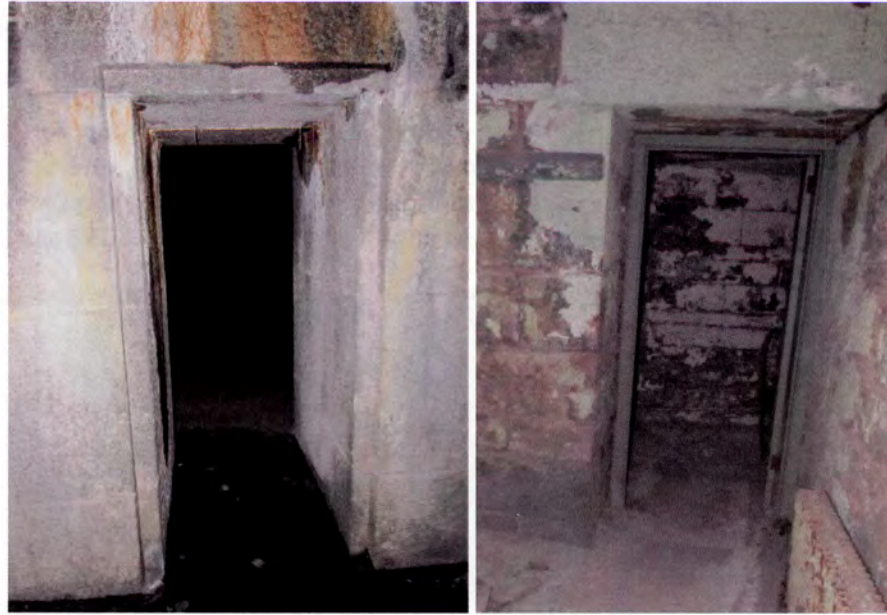
*Figure 91: Typical doors in corner sections showing water damage (left).*

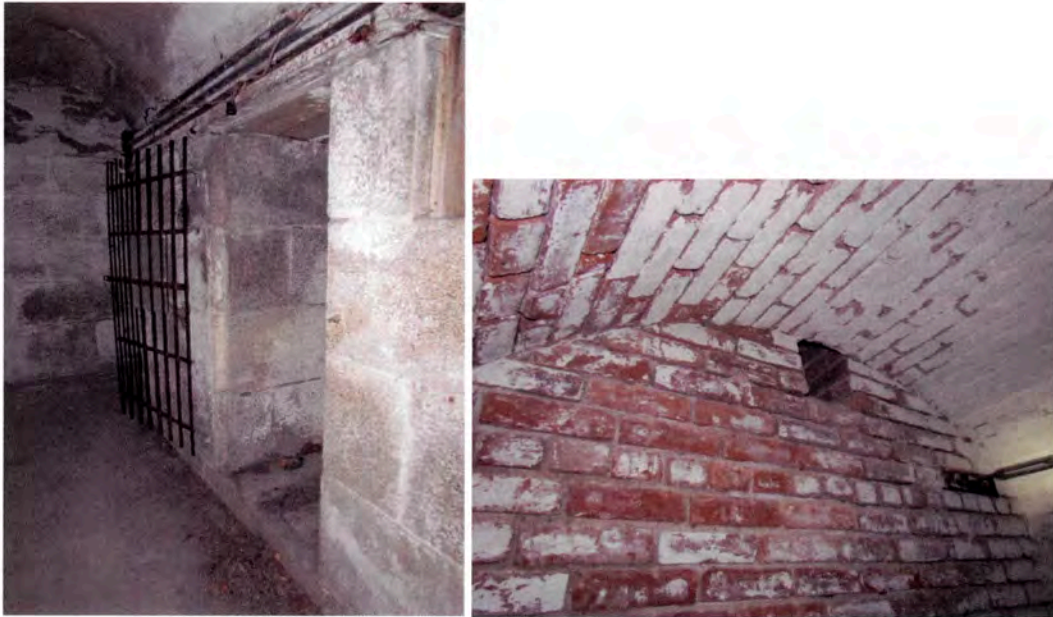
*Figure 94: Rusted security door (left) and missing pointing in brick ceiling and walls (right).*

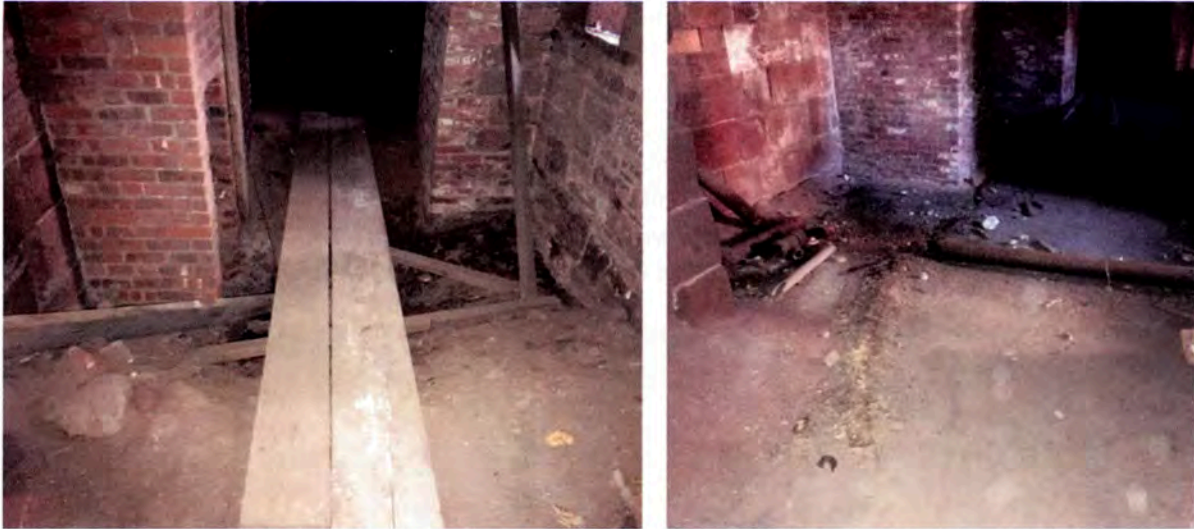
*Figure 95: Wood planks traversing the depression in the floor at C146 (left) and exposed pivot rails (right).*

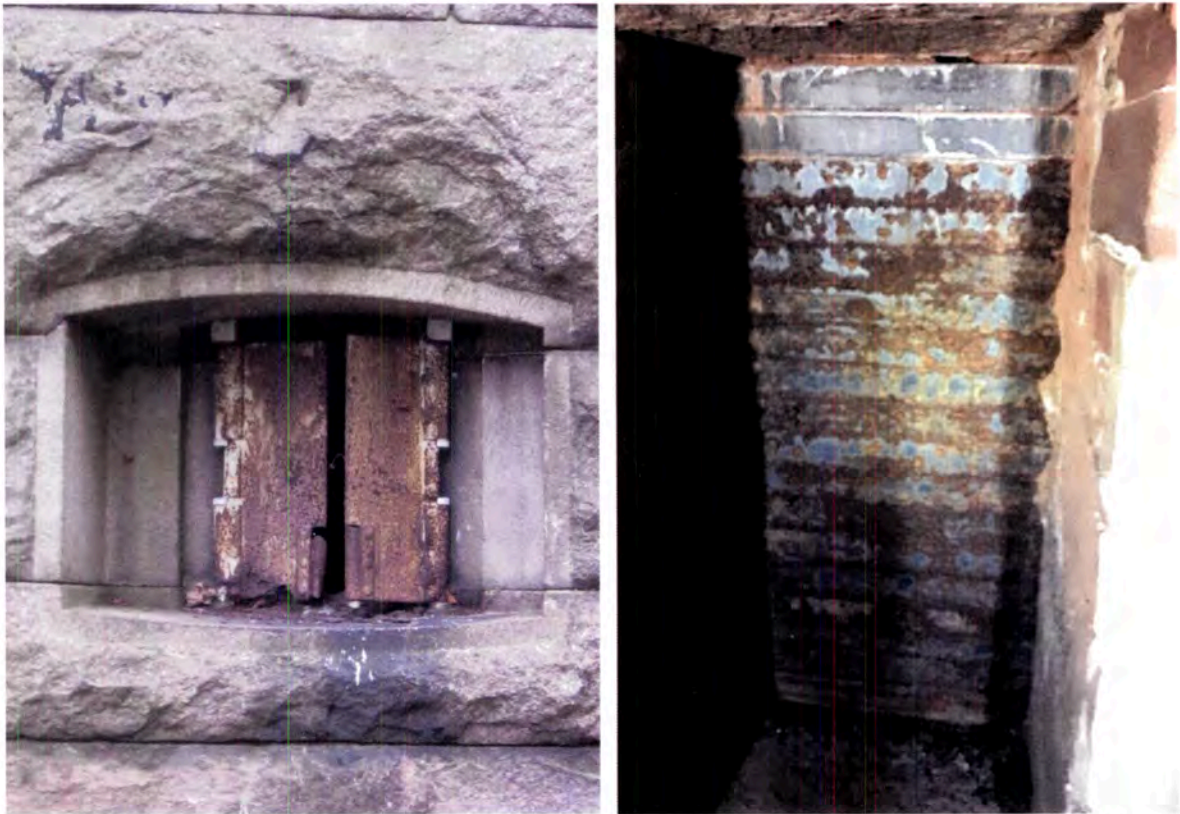
*Figure 97: Badly deteriorated embrasure shutters (left) and significant rust and door blocked with steel (right).*

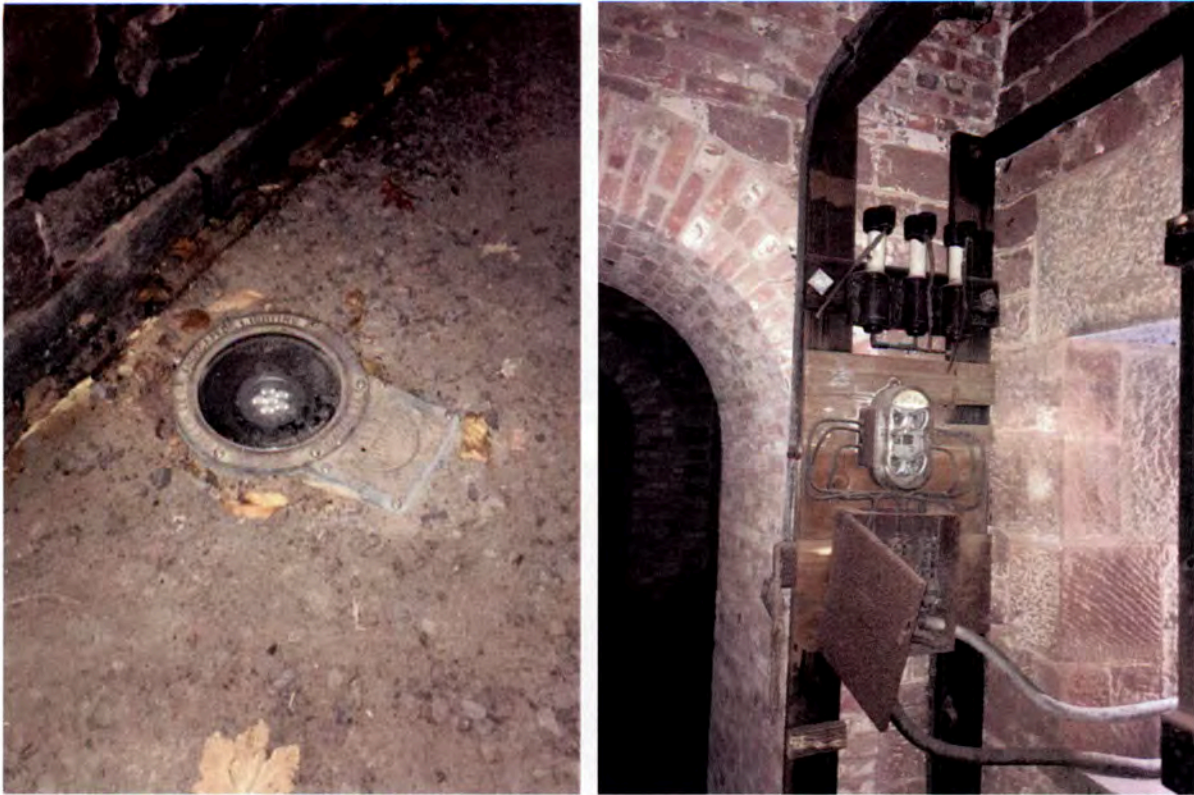
Figure 98: Modern floor light fixture (left) and badly deteriorated electrical equipment (right).

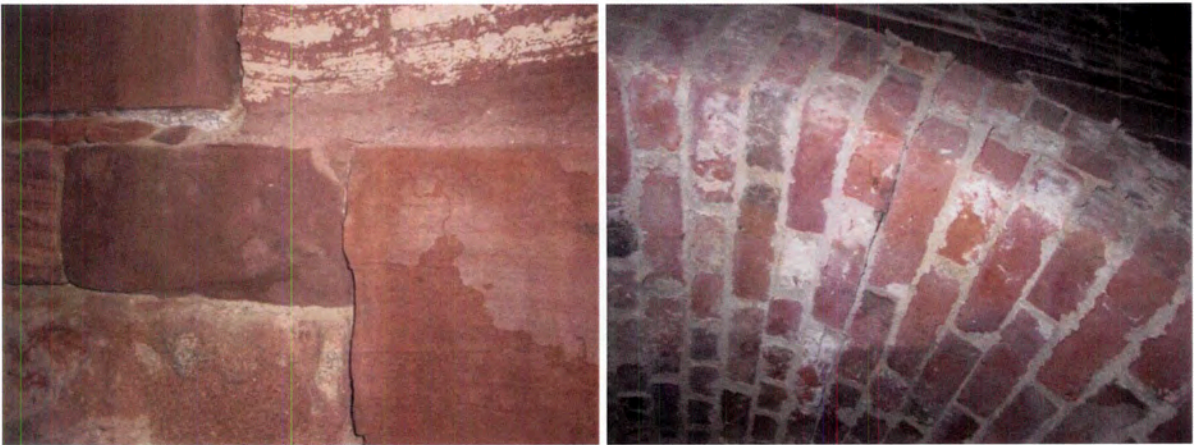
*Figure 100: Eroded sandstone (left) and crack in brick arch (right).*
