FORT TOMPKINS  
GATEWAY NATIONAL RECREATION AREA

*Historic Structures Report*

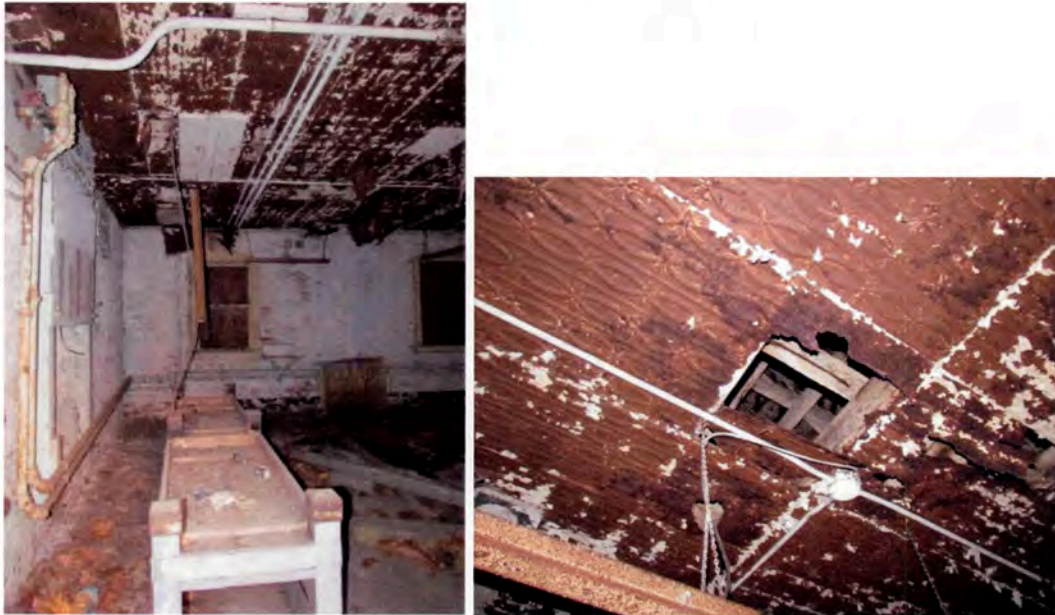
*Figure 104: Overview of interior of Building 138 (left) and deteriorating metal roof (right).*

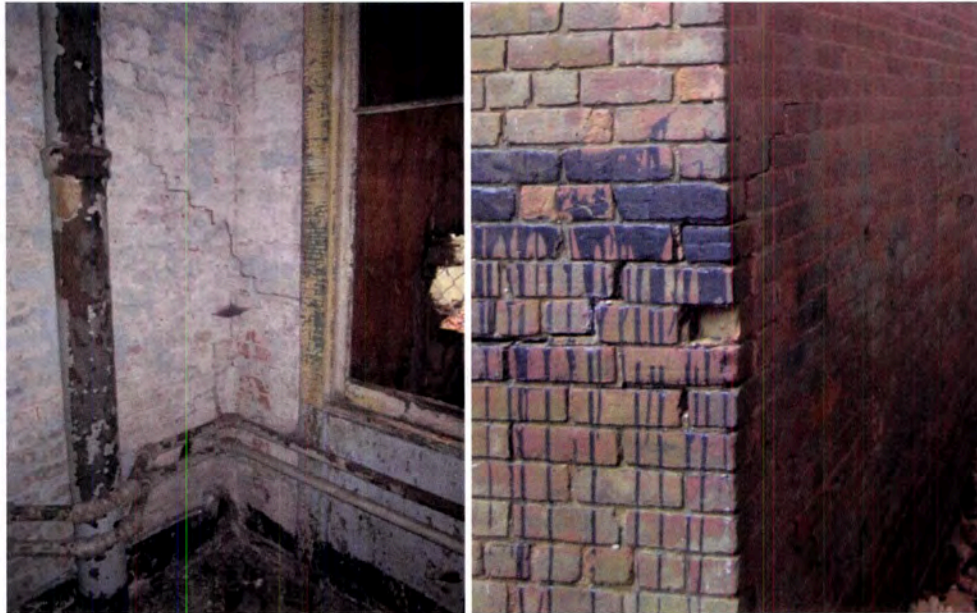
*Figure 105: Diagonal crack in northeast corner of interior (left) and exterior (right) of Building 138.*
