# Up FROM THE Ashes

## Rebuilding the Sperry Chalet: Part 2

By Ian Glaser, P.E., Jeffrey Schalk, P.E., S.E., and Michael Schuller, P.E.

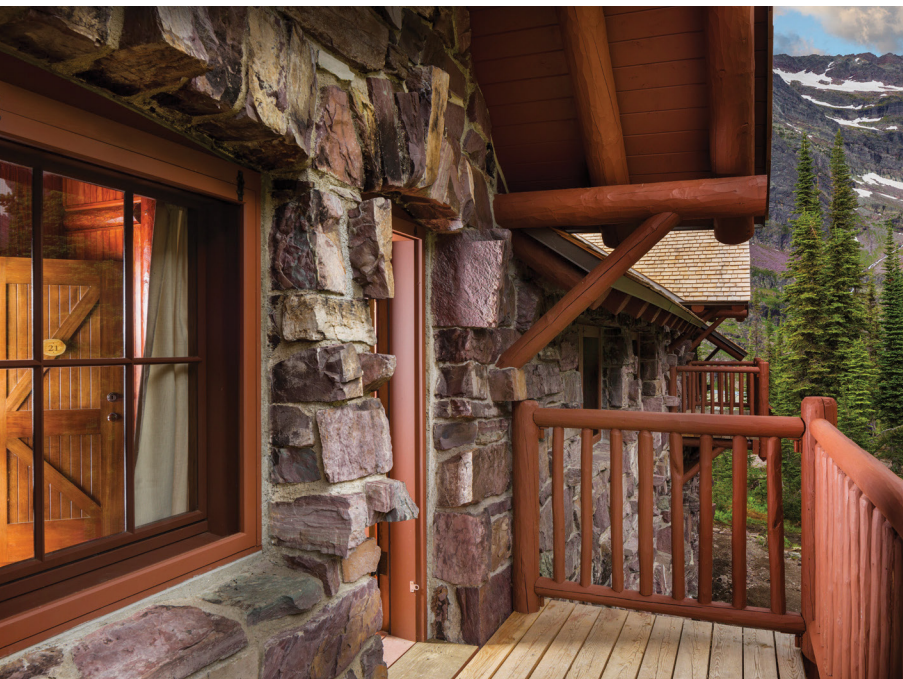
*Figure 6. Completed roof and balcony framing as well as rehabilitated masonry. Note unremovable soot stain over door. Courtesy of Mark Bryant Photographics.*

The masonry walls' inside faces were first descaled of unbonded material from top to bottom. Mortar joints were raked back to match the new inner wall plane. Jamb stones that were exposed to the fire on three sides and consequently suffered through-unit cracks were replaced. The tops of the walls were reconstructed where the setting mortar between the smaller stone units had severely degraded in the fire. Replacement stones were transported by helicopter from the original quarry to the masons.

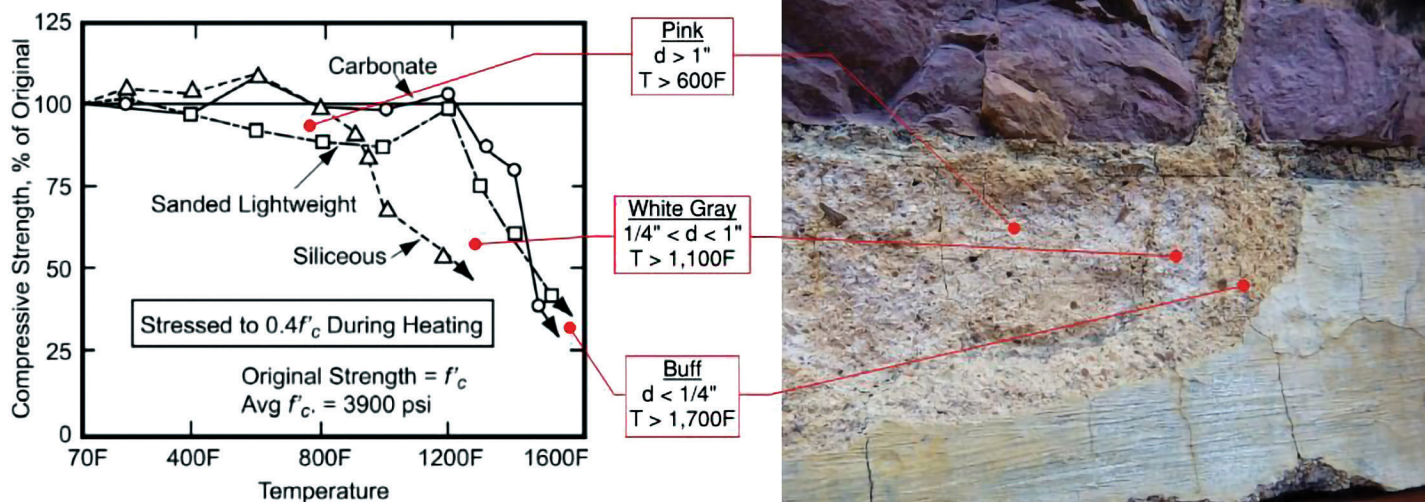
Figure 7. Color changes through the cross-section of spalled concrete lintel provides clues on the intensity and duration of fire. Effect of temperature on concrete strength keyed to observations (Chart: Bilow, S., Kamara, M. "Fire and Concrete Structures." Structures 2008: Crossing Borders, ASCE.)

Another component of the investigation was understanding the fire's effect on the concrete lintels. Concrete, mortar, and other cementitious materials undergo color changes when subjected to high temperatures. Color changes progressively from gray to a subtle pink color, white-gray, and finally to buff as the temperature rises. After the fire, the concrete lintels' faces were observed to be a buff color, suggesting that maximum fire temperatures exceeded 1700°F. In one location, the concrete spalled to reveal a multicolored cross-section that provided more clues. For concrete with siliceous aggregate, the observed depths of color gradation suggested a high-temperature duration of 1½ to 2 hours and an approximate halving of concrete compressive strength in the outer 1 inch of material (Figure 7).

The fire-weakened concrete lintels were retrofitted with galvanized steel lintels. WT webs were fit into vertical slots cut into the underside of concrete lintels, and the flanges bear on galvanized plate steel at

the jambs concealed by window trim. Spalled sections of concrete were patched with repair mortar.

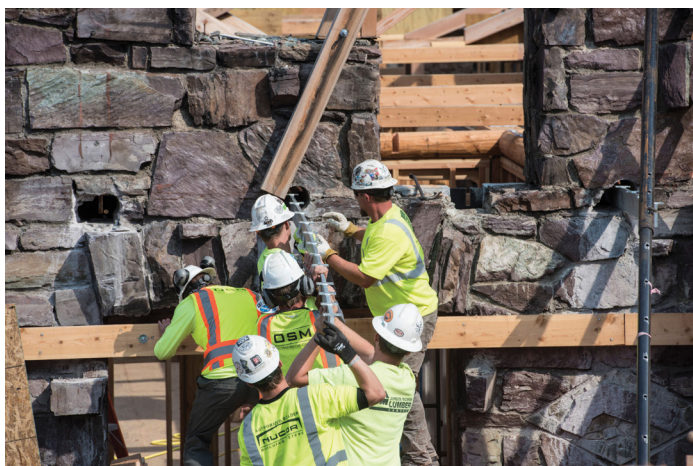
Figure 8. Construction crew fishes second-floor balcony's joist flitch through wall pocket. Courtesy of A Boring Photo.

Since the wall pockets did not align from exterior to interior, interior log joist framing was respaced to facilitate the new cantilevered joist design. The interior joists were located to exit the building in alignment with the original balcony joists to favor the historic exterior appearance. The new continuous joists are fitted with galvanized steel plate flitches (Figure 8). The flitches were designed to take the full cantilevered outer-span load, allowing the logs to stop short of the masonry where they would otherwise be prone to decay. The balcony logs act essentially as jackets that can be periodically replaced. The balcony knee braces are not relied upon for strength but are incorporated into the design to limit deflection and recreate

the exterior appearance. The flitches are grouted solid into the walls, with logs tight to masonry on either side and serve as seismic wall ties that transmit masonry anchorage into the floor diaphragm.

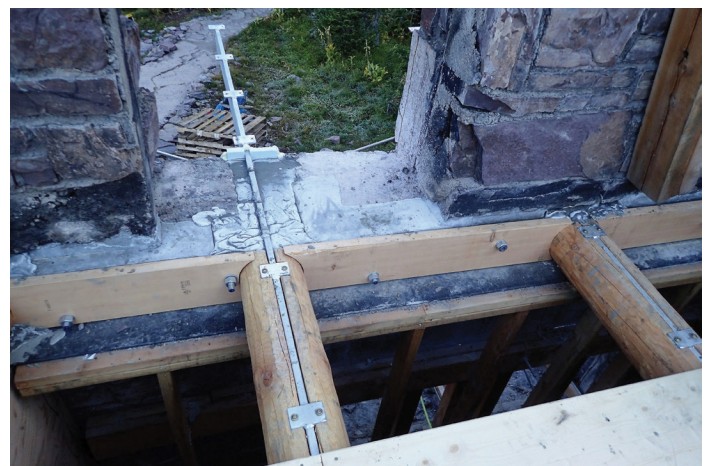
Figure 9. Second-floor balcony joist flitch grouted in wall pocket. Joists are supported on inside face of wall by a steel angle ledger.

Interior log floor joists that are not part of the balconies were sized without flitches and were held short of the wall pockets to avoid decay susceptibility, bearing instead on a ledger angle. The abandoned interior pockets were grouted solid, and the steel angle was designed to double as a continuous diaphragm chord and seismic collector (Figure 9).

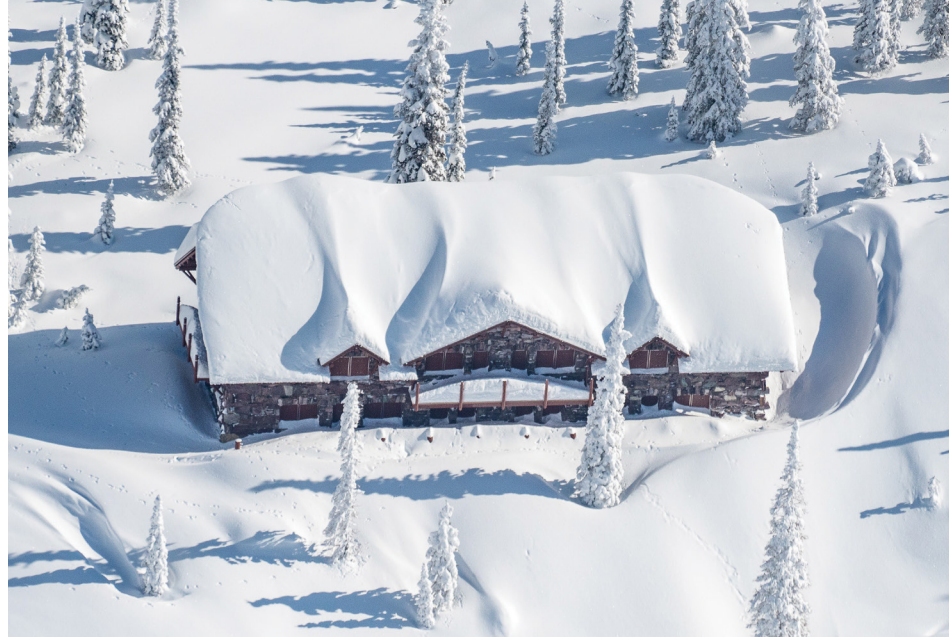
Figure 10. The roof endures its first load test after the first construction season. Courtesy of Gravityshots.com.

One of the most obvious structural challenges was the roof design, as the chalet is almost entirely buried by snow during the winter months (Figure 10). Stakeholders were clear in their desire to reframe the roof with exposed logs having the same proportionality as the original ones. The original roof framing was certainly undersized. It was later learned that the original roof survived the winter months via internal props installed during the end-of-season shutdown. The roof framing also relied on a set of interior knee braces along the heavily loaded purlin lines that induced horizontal point loads on the masonry end walls and interior posts.

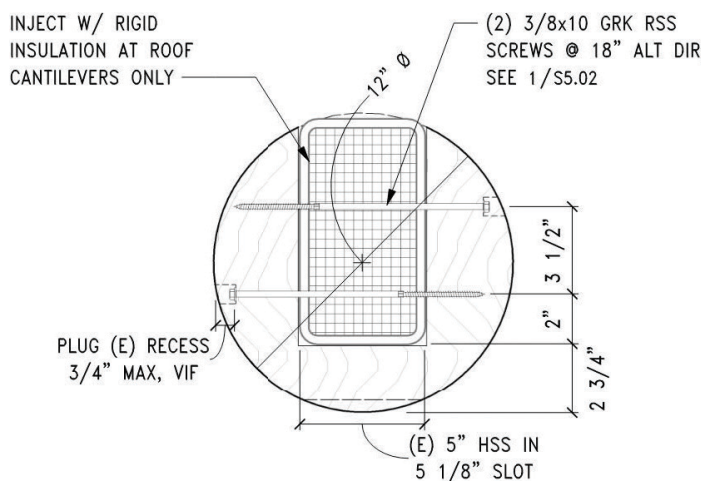
Figure 11. Tube steel purlin with log wrap.

The interior knee braces were eliminated in favor of clear-spanning HSS tube steel purlins wrapped in log jackets to create a cleaner roof framing load path. Like the balcony framing design, the purlins were designed to cantilever to the rake edges without structural reliance on the exterior knee braces. The log jacketing is omitted through the plane of the wall to avoid decay and allow for periodic replacement of the outboard ends. The purlin ends are foam-insulated to lessen the potential for condensation inside the building envelope (Figure 11). The long-span log rafters and valley beams were outfitted with galvanized steel plate flitches. Unlike the balcony logs and roof purlins, the rafters are better protected by the roof, and they run uninterrupted over the top of the walls wrapped in a vapor barrier in stone saddles.
