# Glacier Bay Lodge Complex Historic District

## *Historic Structure Report*

Glacier Bay National Park and Preserve, Alaska

2018

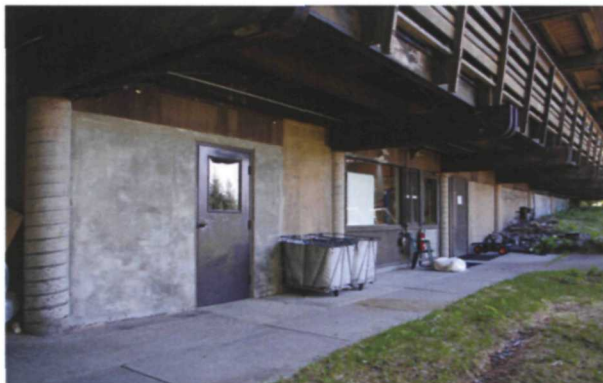
Figure 103. Plywood tops foundation on north elevation, May 2017.

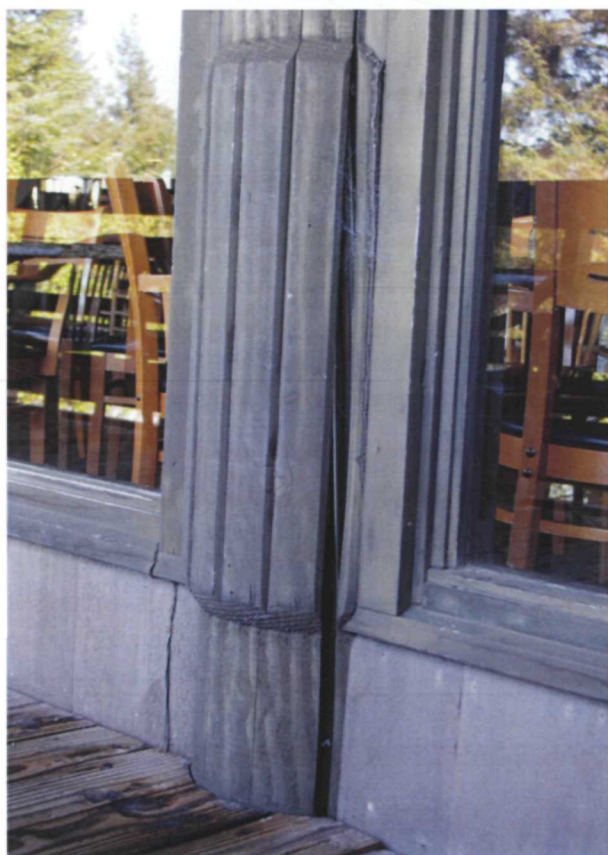
Figure 137. Crack on post, May 2017.

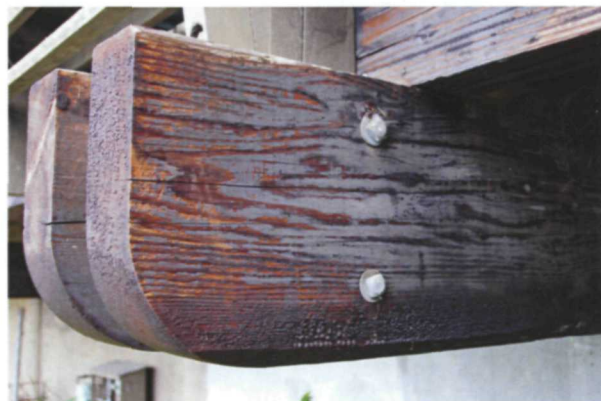
Figure 139. Moisture damage on girder, May 2017.

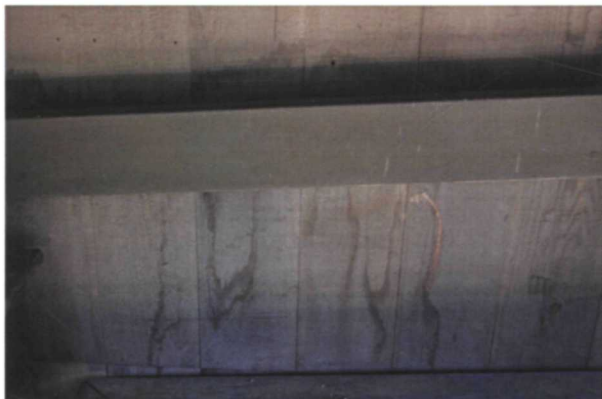
*Figure 140. Moisture damage on siding, May 2017.*

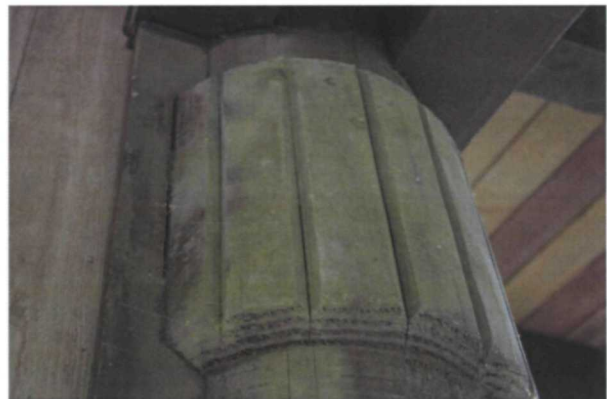
*Figure 142. Green mold on concrete pier, May 2017.*

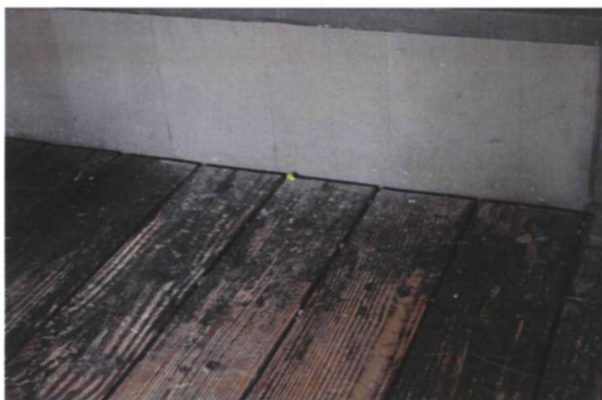
In those instances where there has been a high enough concentration of water, "cellar rot," also known as "wet rot" has affected wood. This condition only grows in extremely damp conditions. These areas are clearly identified, in that the wood is black or dark brown and

*Figure 141. Cellar rot on deck, May 2017.*

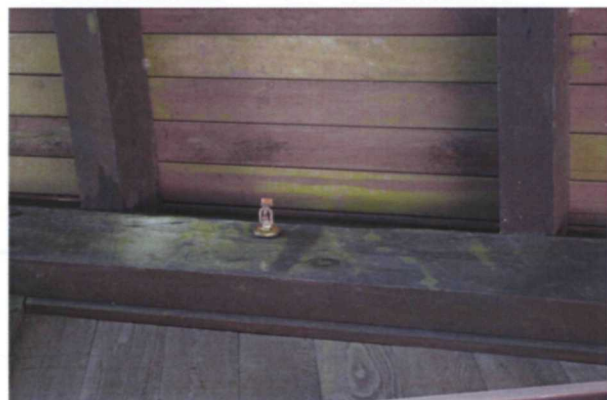
*Figure 143. Green mold beneath eave, May 2017.*

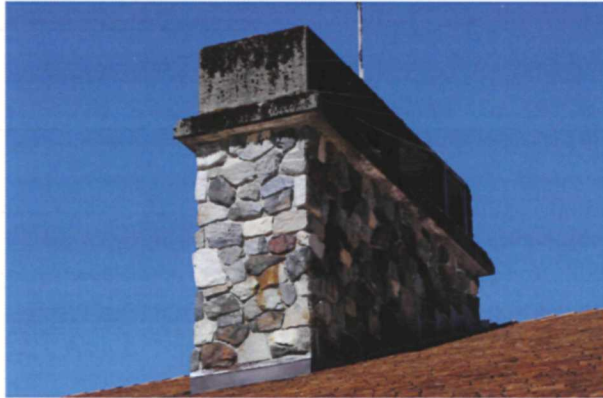
Figure 144. Biological growth on the chimney, May 2017.

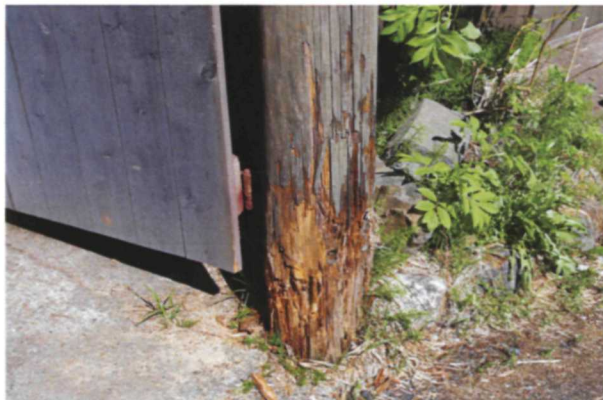
Figure 146. Damage to structural post, May 2017.

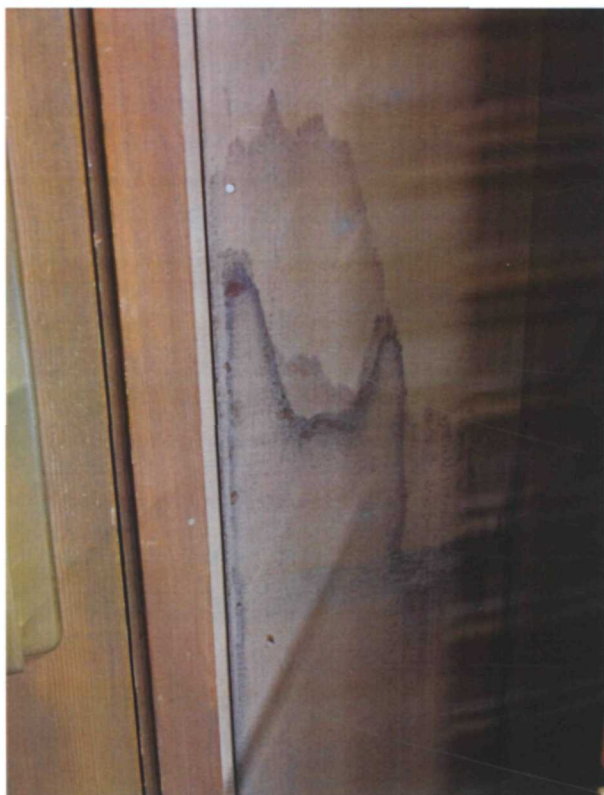
Figure 150. Water stains on cedar wall, May 2017.

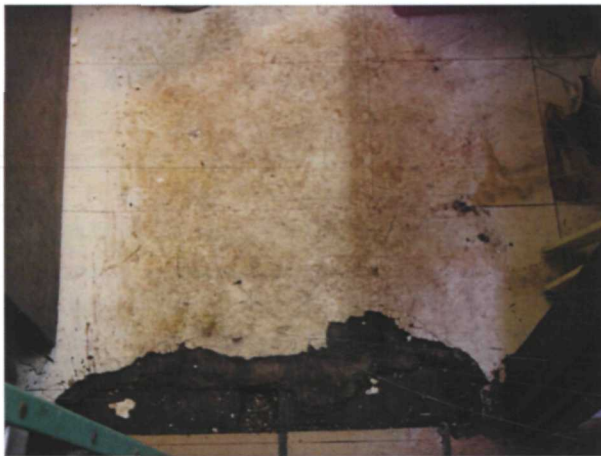
*Figure 152. Loss of linoleum tiles of kitchen bathroom floor, May 2017.*

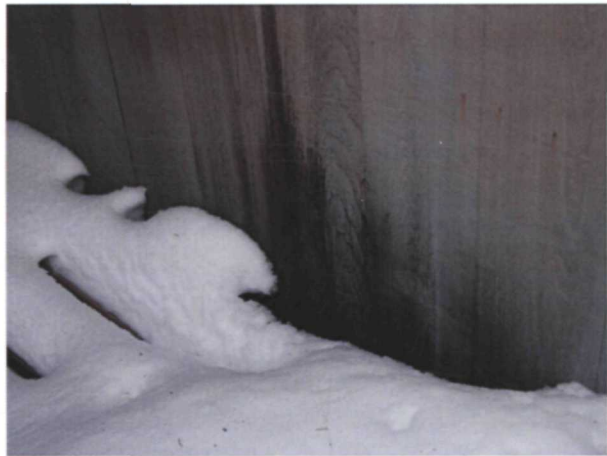
*Figure 155. Moisture damage at wall-soffit joint, March 2017.*

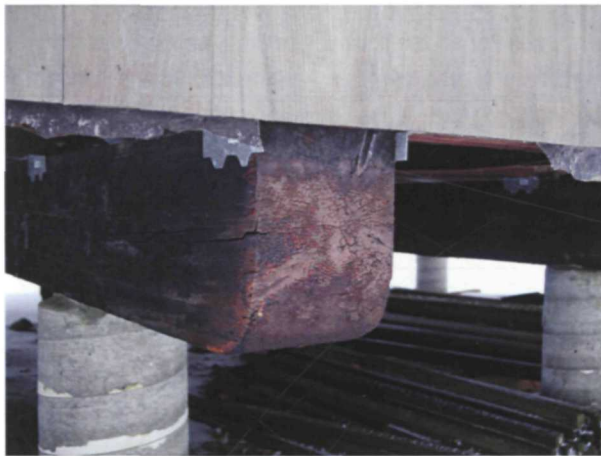
*Figure 153. Blistering stain on cabin girder, March 2017.*

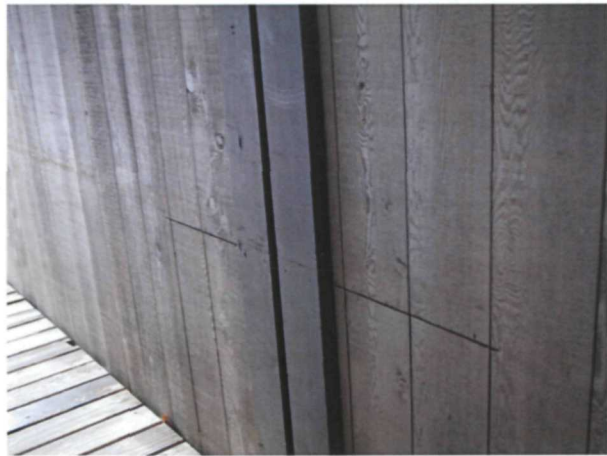
*Figure 156. Cut in siding, March 2017.*

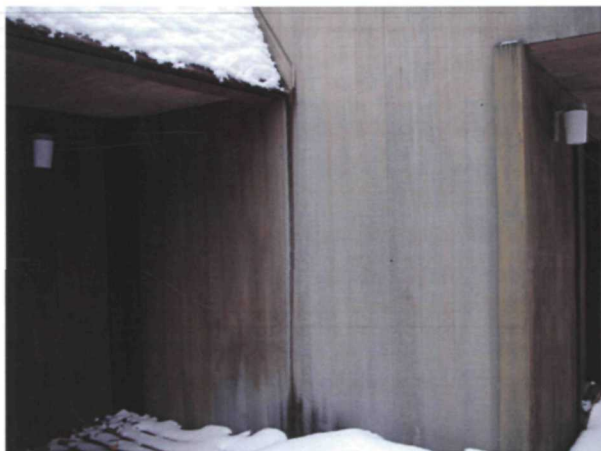
*Figure 154. Moisture damage at wall-soffit joint, March 2017.*

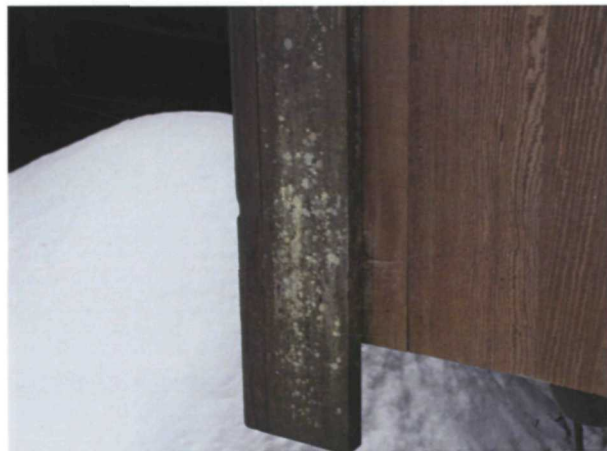
*Figure 157. Moisture damage to corner board, March 2017.*

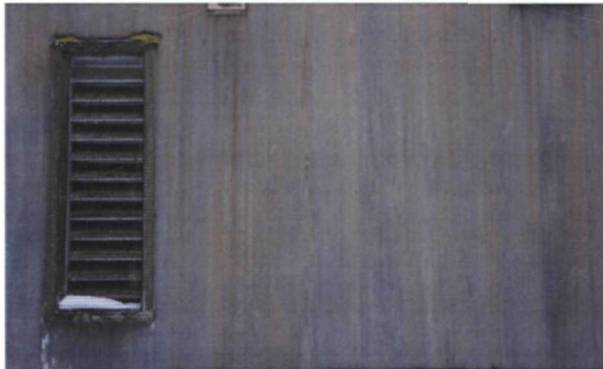
Figure 158. Biological growth, March 2017.

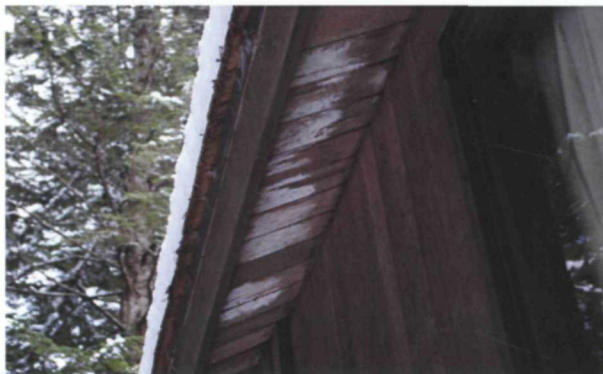
Figure 159. White stain beneath eave, March 2017.

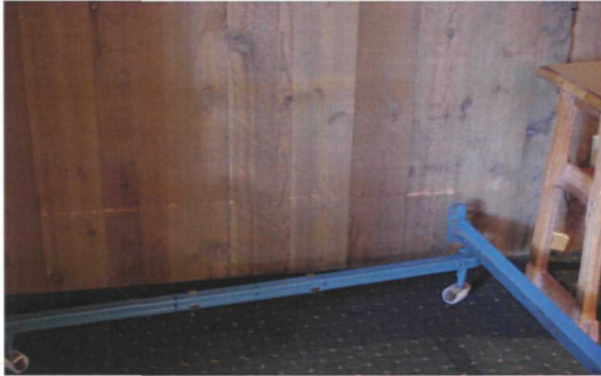
*Figure 162. Dents in cedar wall, March 2017.*

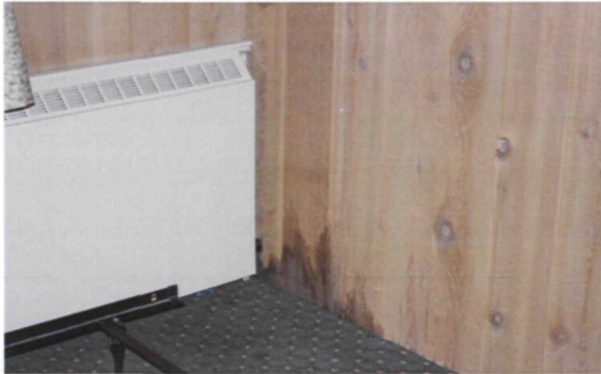
*Figure 163. Moisture damage, March 2017.*

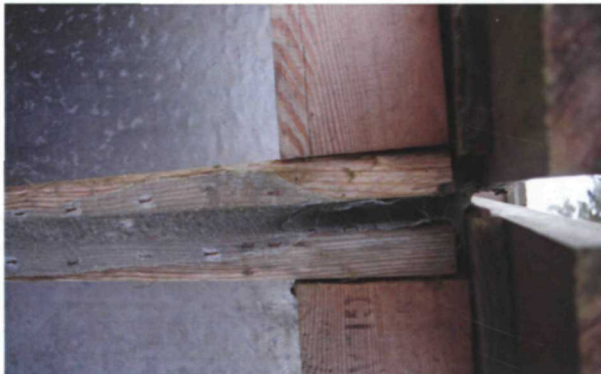
*Figure 164. Opening in battens, March 2017.*

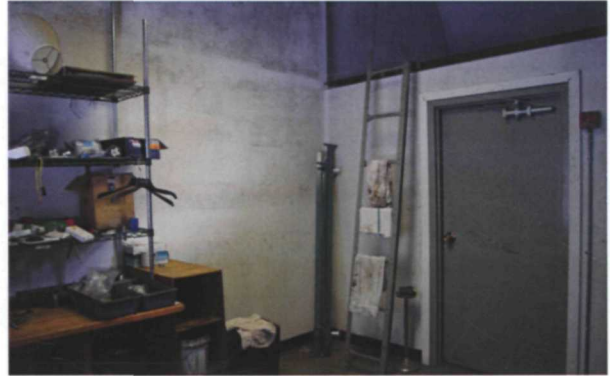
Due to a high concentration of moisture with limited ventilation in the utility rooms, black mold covers all surfaces of the interior (Figure 165). Utility panel are rusted. Paint is severely chipping and/or cracking and likely contains lead (Figure 166). It is recommended that a certified lead abatement specialist test these rooms.

*Figure 165. Mold in utility room, March 2017.*

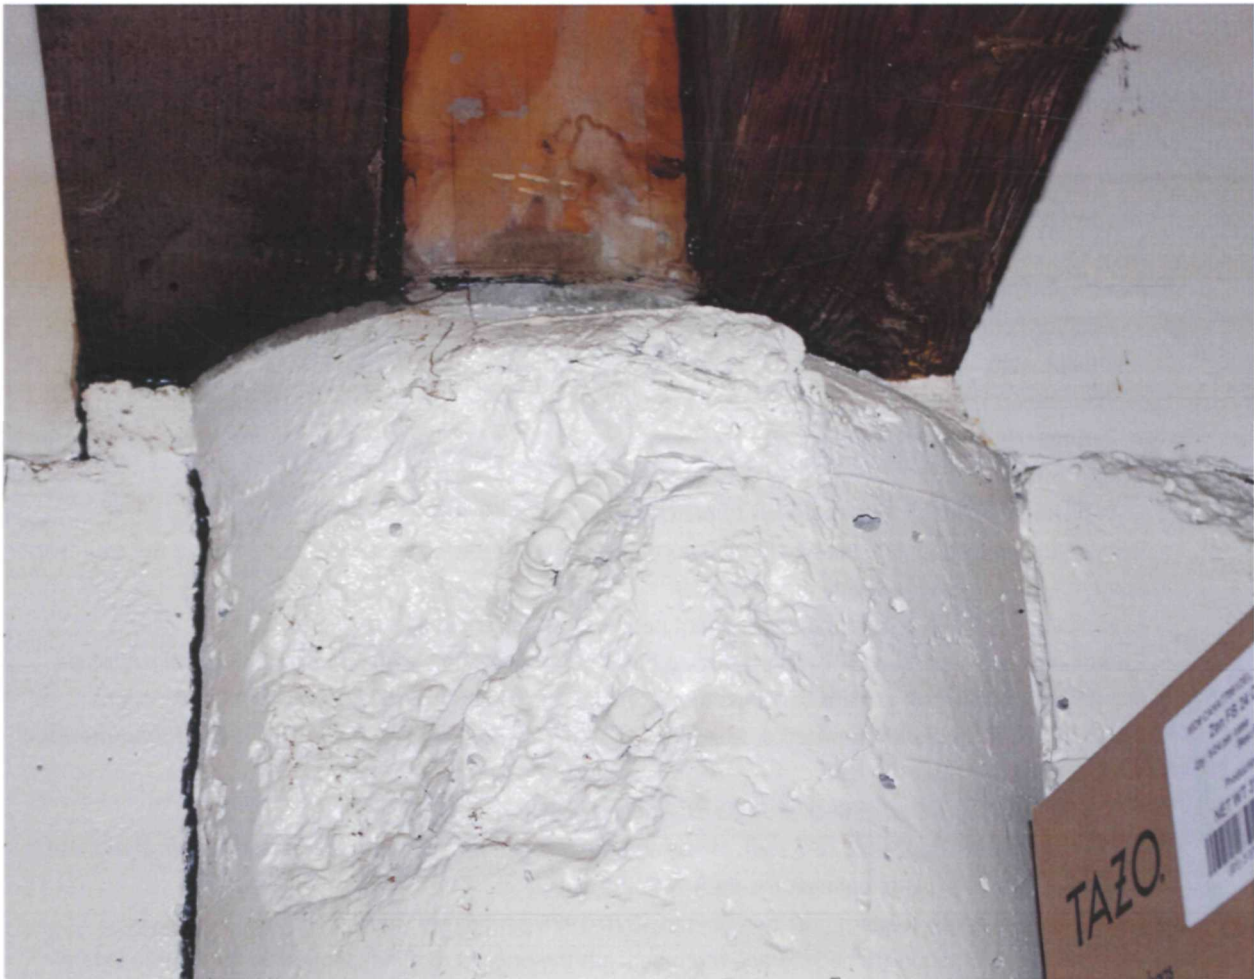
Figure 169. Spalling pier, May 2017.
