# Grand Canyon Park Headquarters

## Historic Structure Report

National Park • Arizona

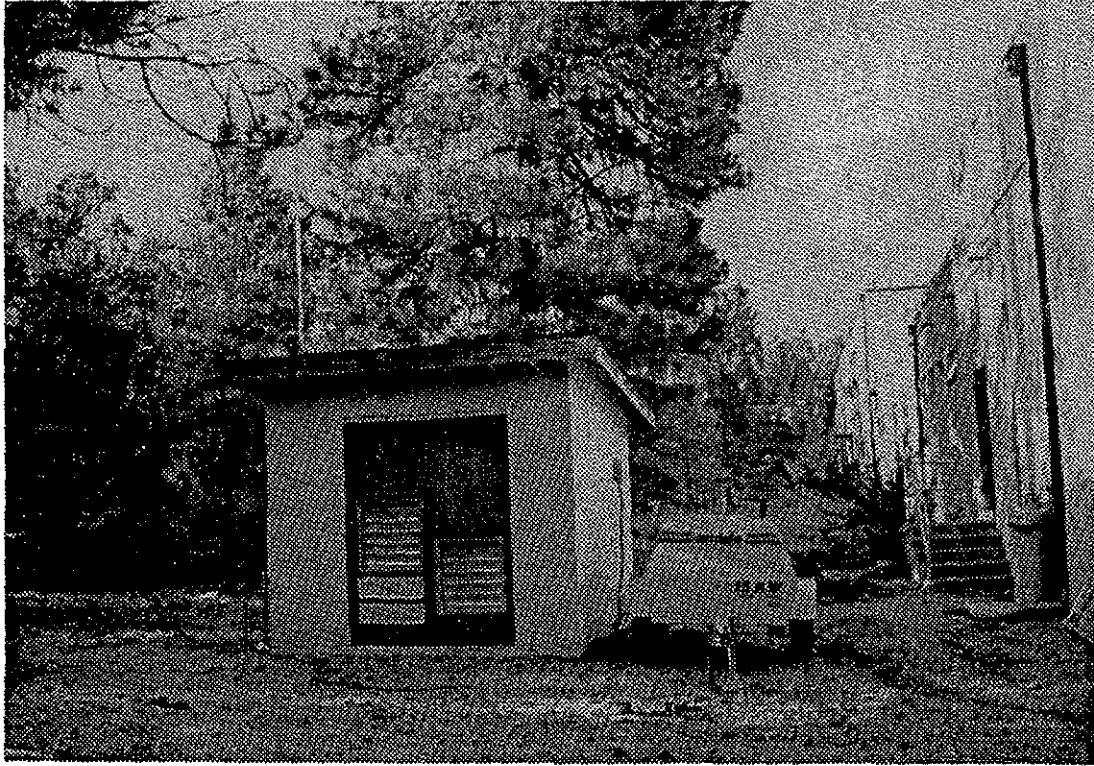
*Figure 4. Rear of building is unlandscaped and utilitarian as evidenced by shed and propane tanks behind the structure. ARG Photo, dated May, 2000.*

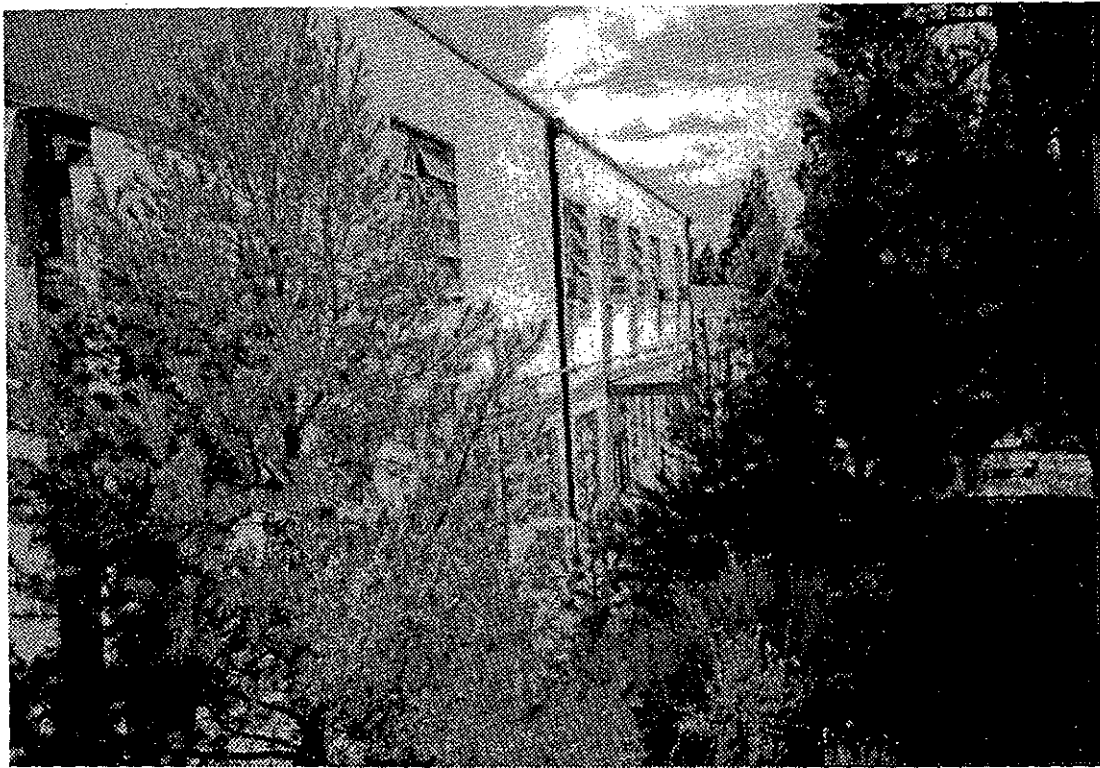
*Figure 5. Rear elevation is not landscaped. Plantings encroach on the structure. ARG Photo, dated May, 2000.*

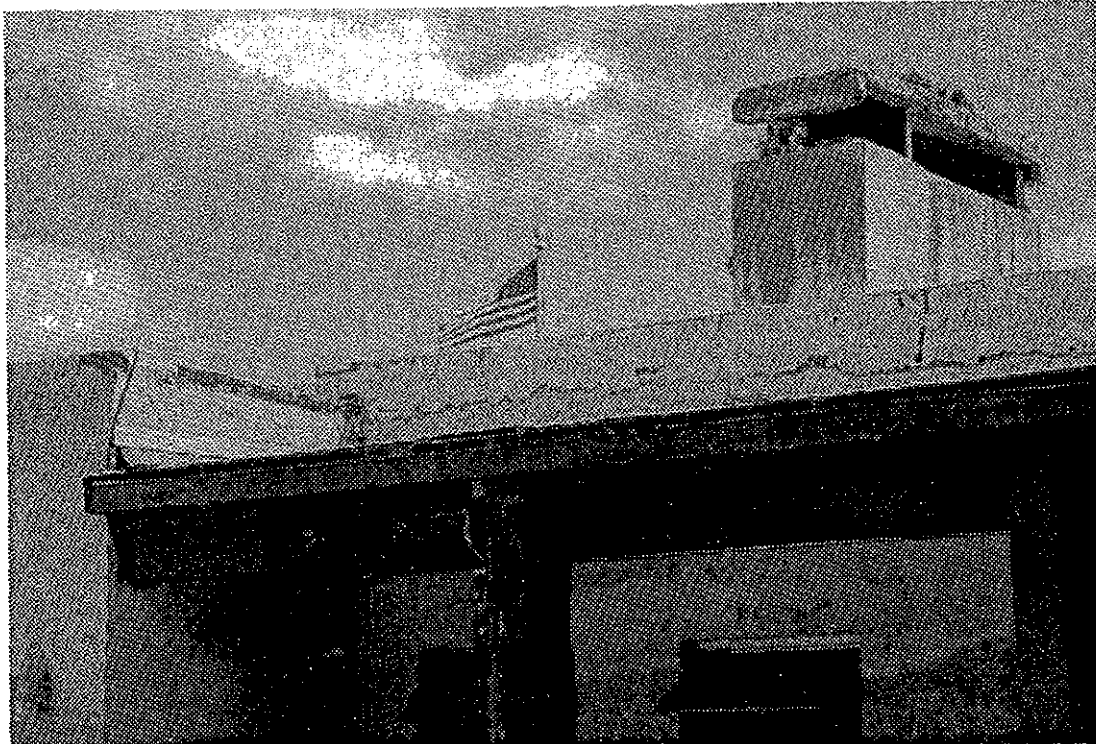
- cement stucco deterioration of the parapet, chimney and flue related to water infiltration and leading to concrete failure (See Appendix E, Figure 17) ;
- failure of the concrete ramp addition and limited concrete failure at retaining walls;
- deterioration of exterior flagstone paving stones;
- loss of mortar (See Appendix E, Figure 18);

*Figure 17. Parapet deterioration. ARG Photo, dated May, 2000.*

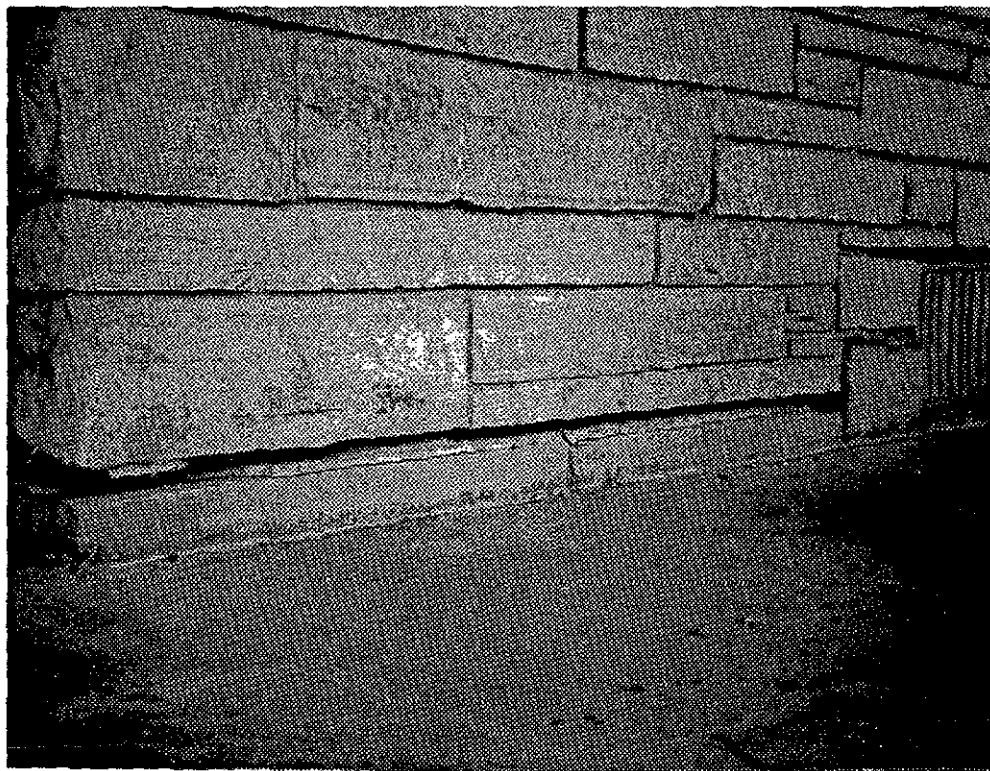
*Figure 18. Mortar loss at lower level of pier on principal elevation. ARG Photo, dated May, 2000.*

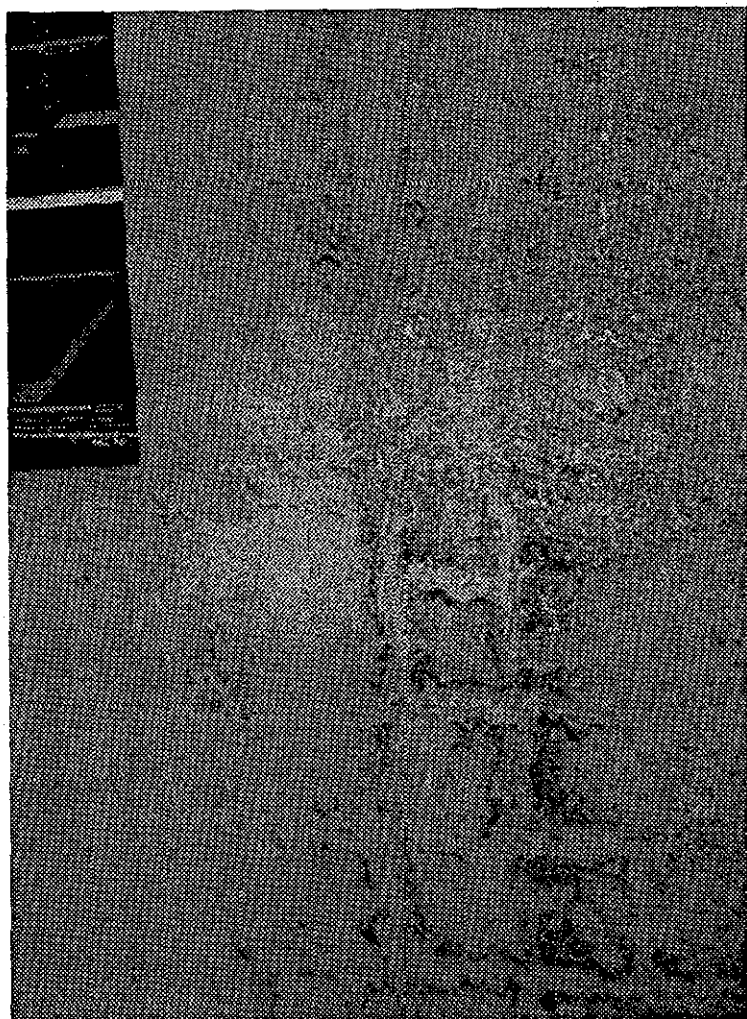
*Figure 19. Concrete block construction visible below stucco coat. ARG  
Photo, dated May, 2000.*

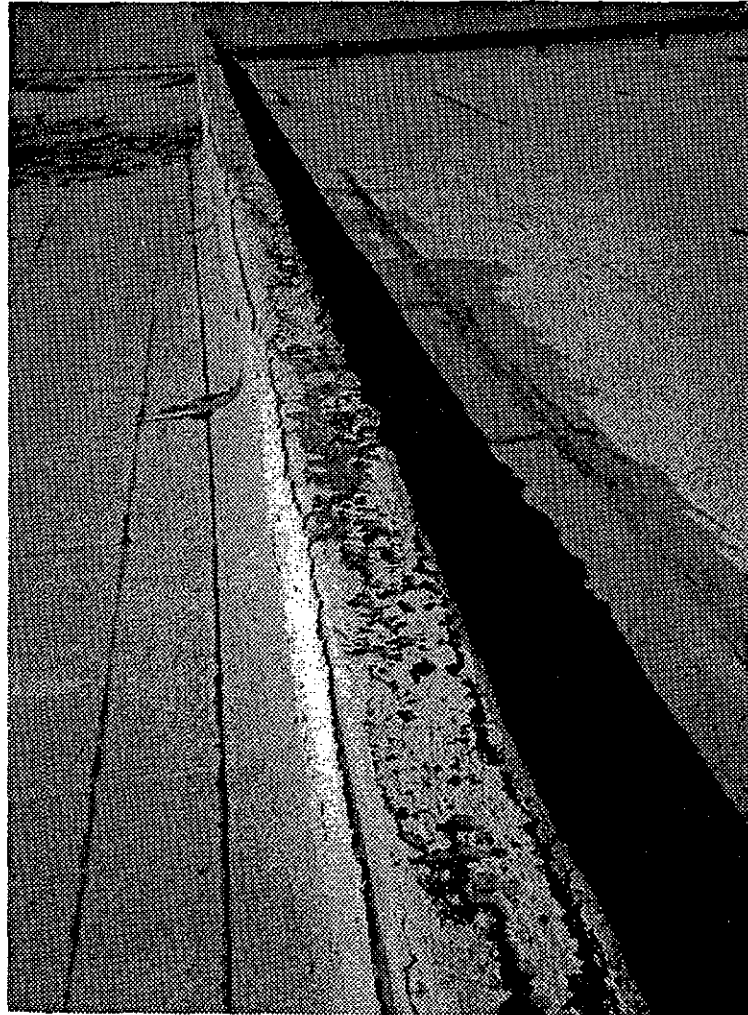
- roof membrane deterioration due to water and weathering (See Appendix E, Figure 20);
- poor drainage off roof and canopies;
- scuppers do not drain properly;
- deteriorated flat roof membrane due to weathering, flashing, persistent leakage, pooling water;
- failure of urethane sealant, yellowed, crumbling; and,
- problematic joints with flat overhangs, water problems at connections, evidence of efflorescence at entrance pier and canopy junction. (See Appendix E, Figure 21)

*Figure 20. Parapet deterioration at roof and extent of urethane repair failure. ARG Photo, dated May, 2000.*

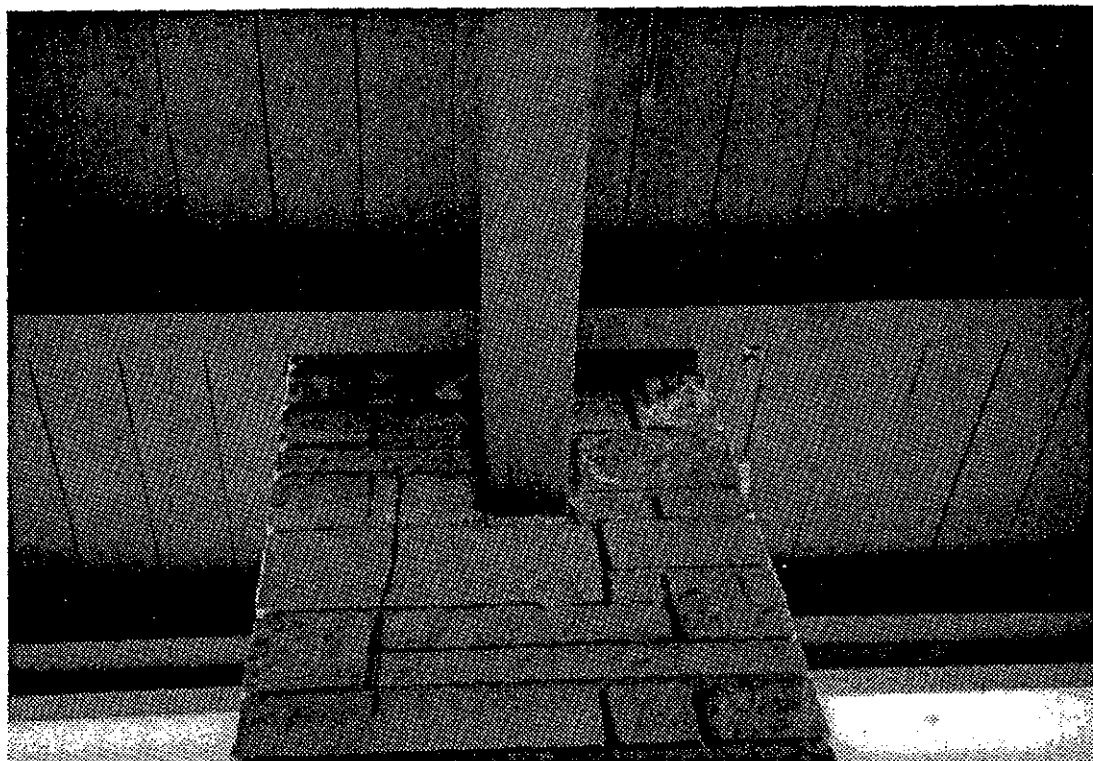
*Figure 21. Image shows efflorescence and water infiltration on pier at canopy junction.  
ARG Photo, dated May, 2000.*

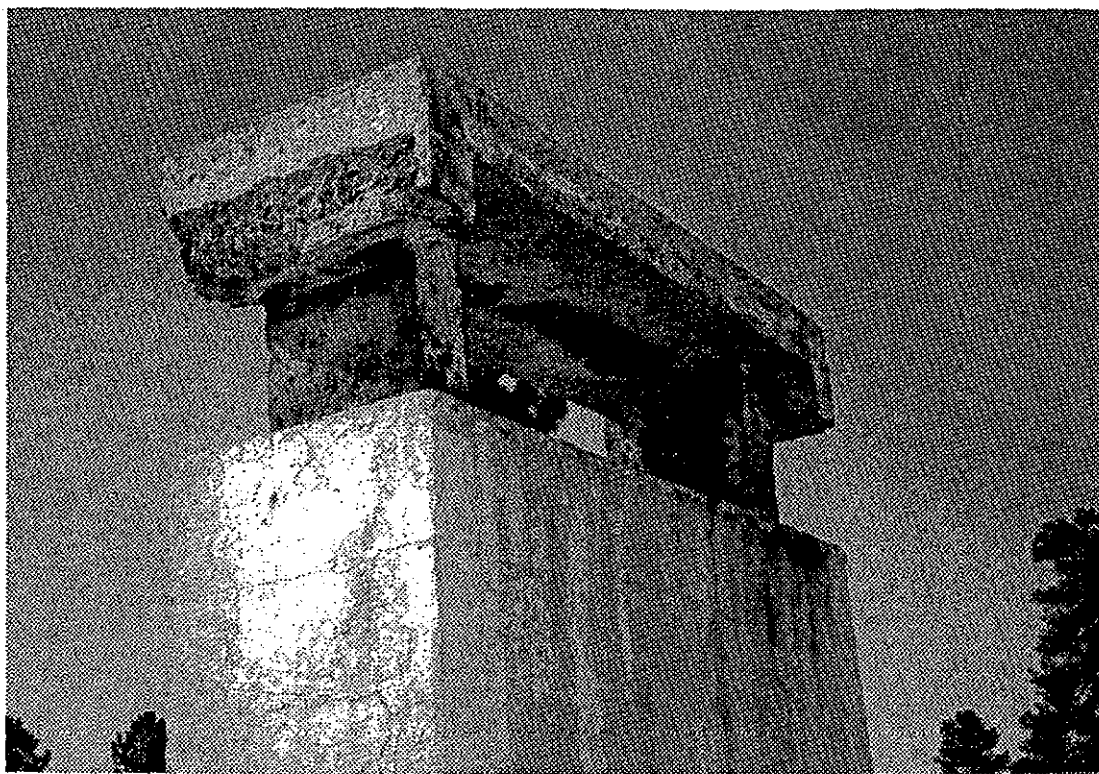
*Figure 22. Deterioration at chimney flue. ARG Photo, dated May, 2000.*

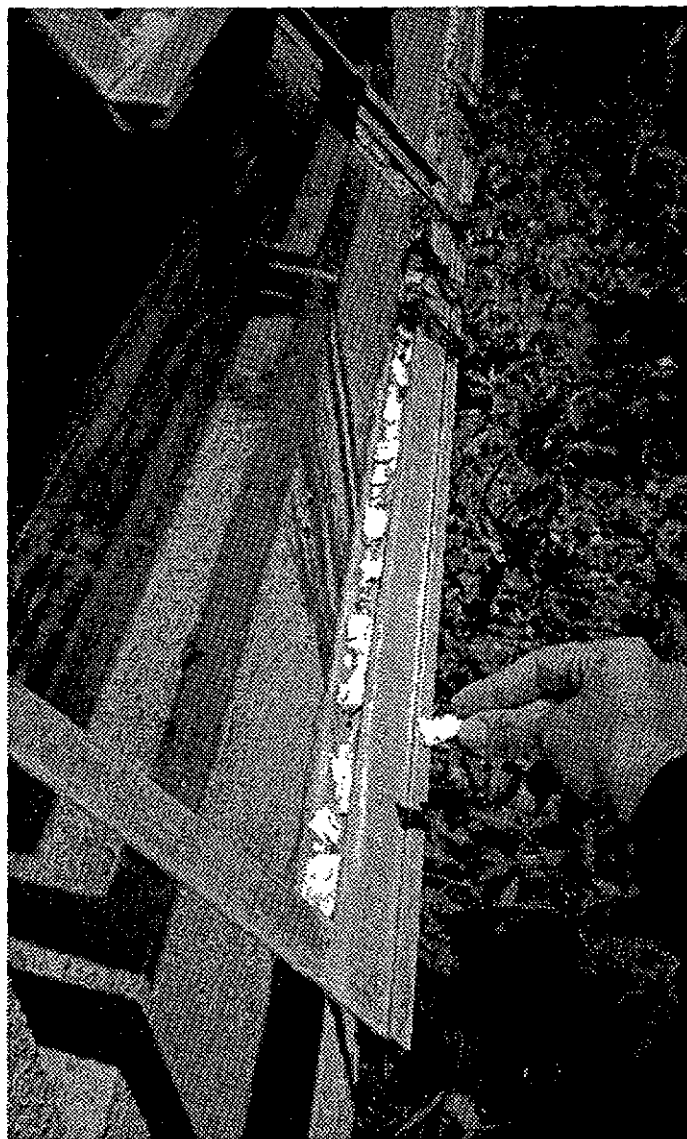
*Figure 23. Putty deterioration at window. ARG Photo, dated May, 2000.*

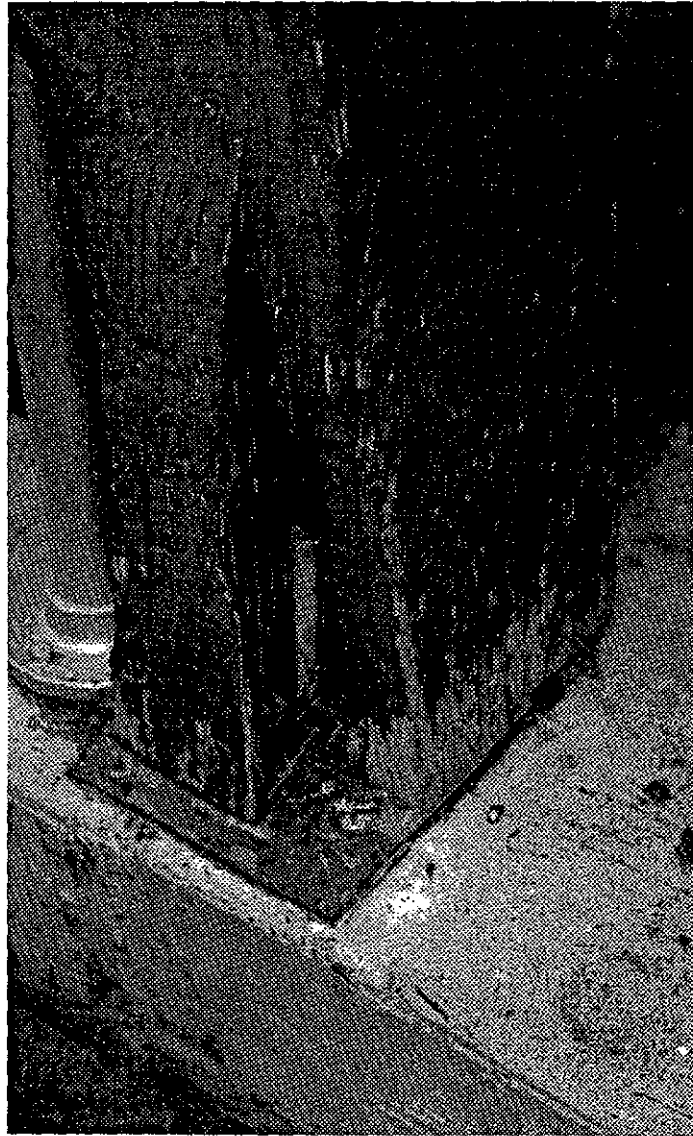
*Figure 24. Tapered column at north elevation, shifted off steel base plate, a large split at bottom and exposure of the vertical steel dowel within the column. Damage caused by car. ARG Photo, dated May, 2000.*

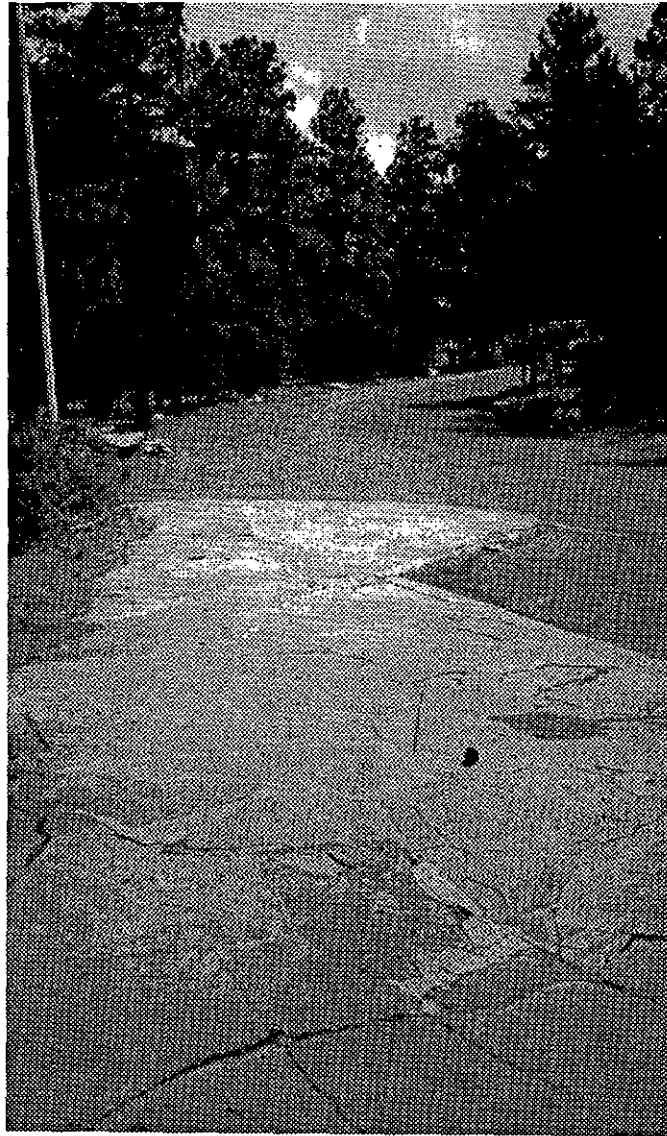
The flagstone paving at front of building and at the interior patio is worn, chipped, and damaged and in need of repair. (See Appendix E, Figure 25)

*Figure 25. Deterioration of flagstone paving at the building exterior. ARG Photo, dated May, 2000.*
