Higdon Cabin

Elkmont Historic District
Great Smoky Mountains National Park

Historic Structure Report

August 2015

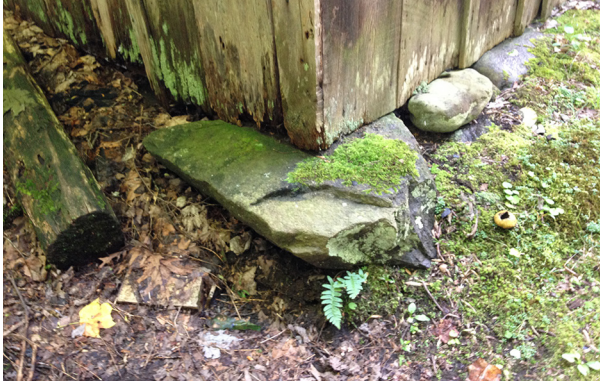
Figure 40. View of rock pier supporting foundation post at northeast corner of the original cabin.

- eliminate wood-to-ground contact under and around the cabin and/or install metal termite shields;
- monitor rear retaining wall for movement and repair as appropriate;
- improve site drainage;
- inspect foundation posts and piers, especially under Room 107, and make repairs as necessary to ensure stability;
- repair board-and-batten foundation enclosure under original cabin and the vertical-board enclosure of the rear wing, adding battens to the latter.
- stabilize mortared rock underpinning part of the front porch.

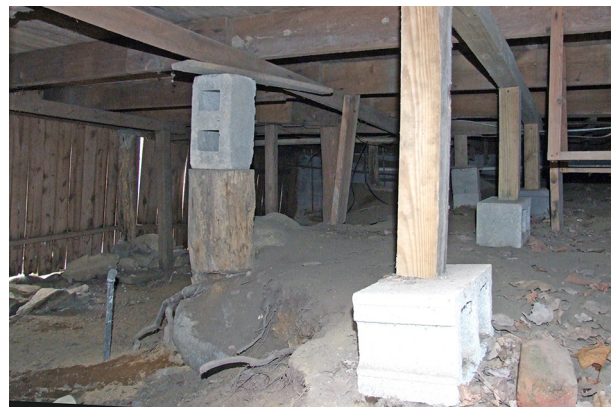
Much of the west end of the south side may have been supported by low rock piers, but whether that or wooden posts, all original foundation material on that side of the cabin has been replaced by a continuous concrete block foundation. Wicking action has kept many of the block damp and precipitated rot

Figure 44. View looking southeast under Room 107, showing some of the variety of makeshift supports that have been installed under the rear of the cabin.

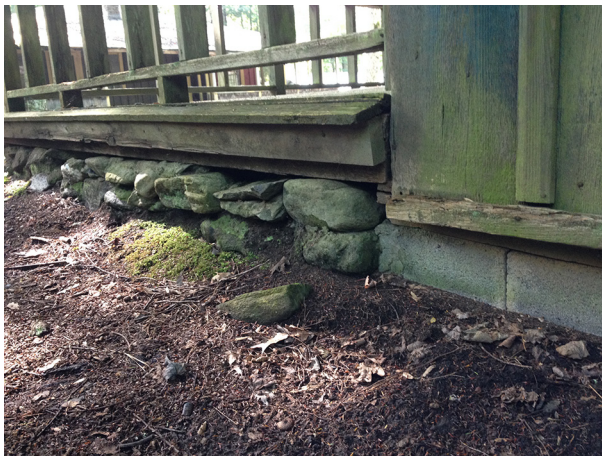
Figure 45. A view of the foundation dry-laid stone underpinning the south end of the front porch and of the concrete-block foundation on that side of the cabin.

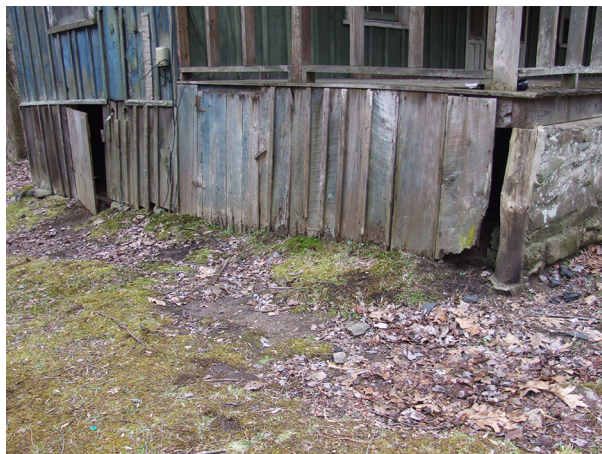
Figure 47. View of board-and-batten enclosing foundation on north side of cabin.

Some of the foundation access doors are off their hinges or otherwise rendered inoperable. Battens are missing or damaged on the board-and-batten siding enclosing the foundation of the original house. The remainder of the

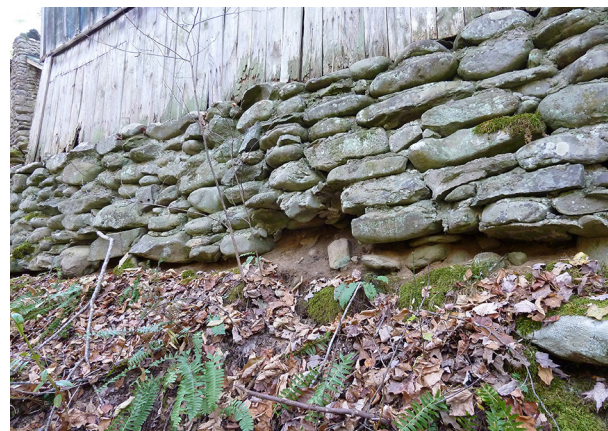
Figure 48. View of erosion threatening to destabilize the stone foundation on the near-vertical slope at the rear of the cabin.

including poor drainage around the perimeter of the cabin. Ground erosion has undermined the stone wall supporting the east end of the cabin and precipitated a significant structural crack in the concrete block foundation under the south side of Room 106. Unlike some of

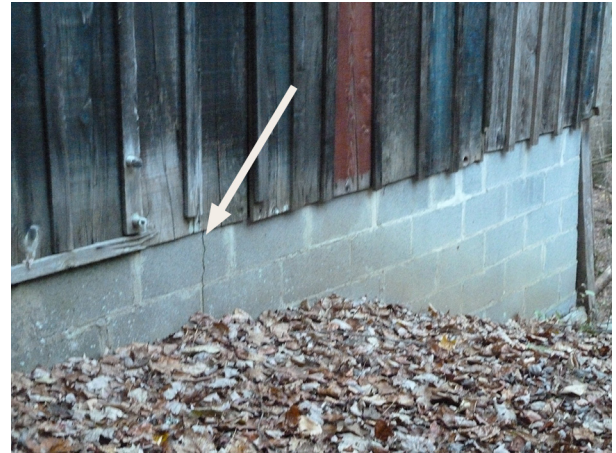
Figure 50. View of concrete block foundation at east end of the south side of Higdon Cabin, with an arrow highlighting the location of a significant structural crack in the foundation.

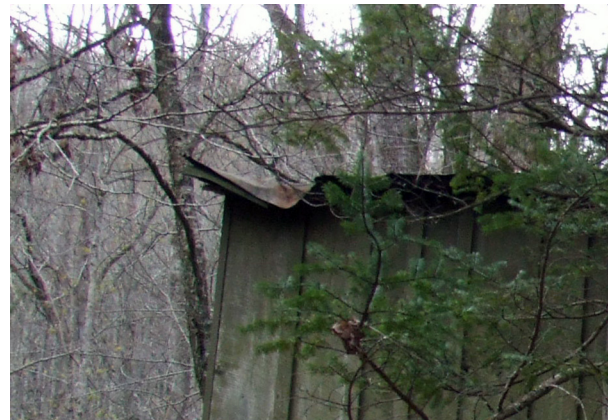
Figure 59. View of roof damage at northeast corner of Room 107.

- repair damaged roofing above northeast corner of Room 107;
- make permanent repairs to front-porch roof decking;
- install full system of unpainted, galvanized, half-round gutters and round downspouts on all sides of the house;
- plan for replacement of remaining metal roofing within five years.

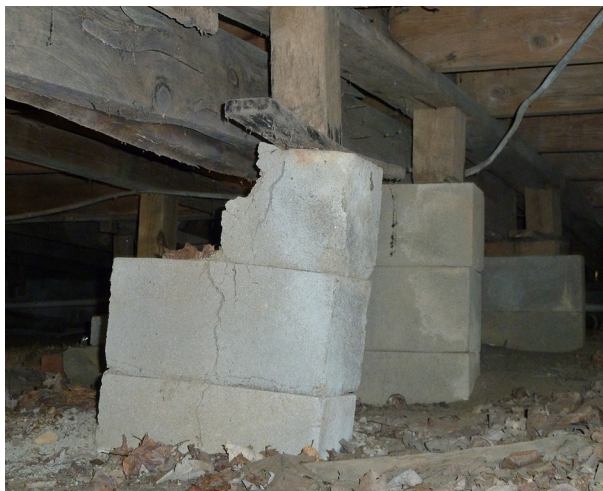
Figure 80. View of supports added beneath joists near where chimney was built on the floor above.

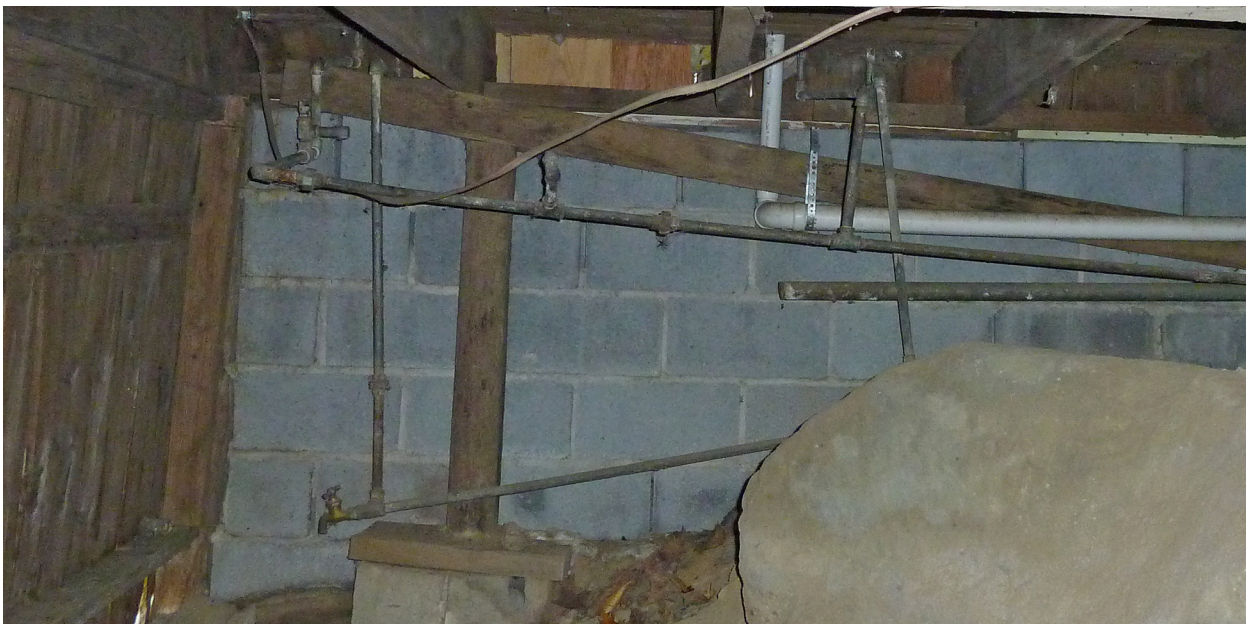
Figure 103. View of early water supply pipes to the kitchen, upper right and upper left, and a hose bib, lower left. The original cast-iron waste lines have been replaced with white PVC pipes.
