HISTORIC STRUCTURE REPORT

SUGARLANDS HEADQUARTERS

Final Report December 2019

GREAT SMOKY MOUNTAINS NATIONAL PARK

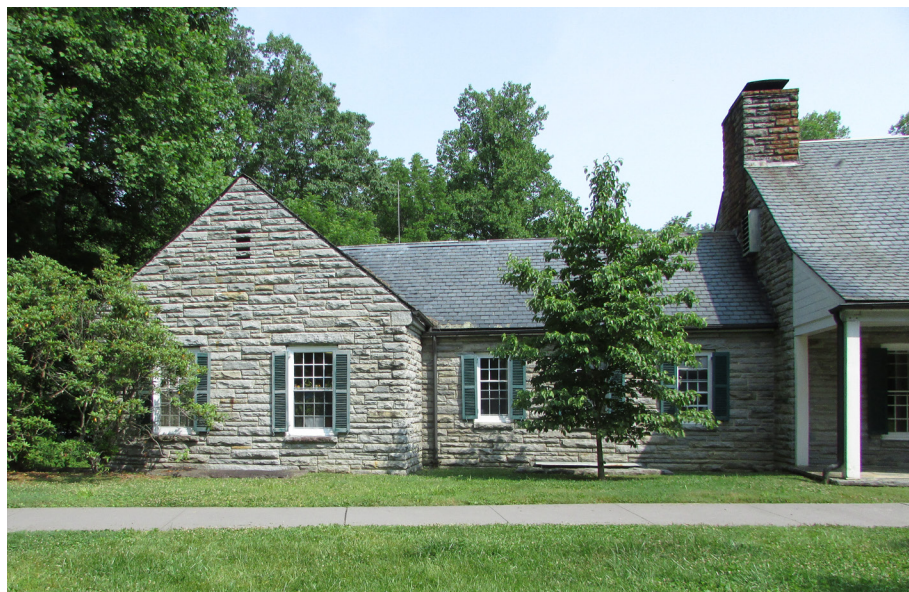
condition, intermittent loose or missing slates were observed and maintenance staff indicates that the slates can be easily lifted and removed by hand, suggesting that the fasteners and/or nailers have been compromised.

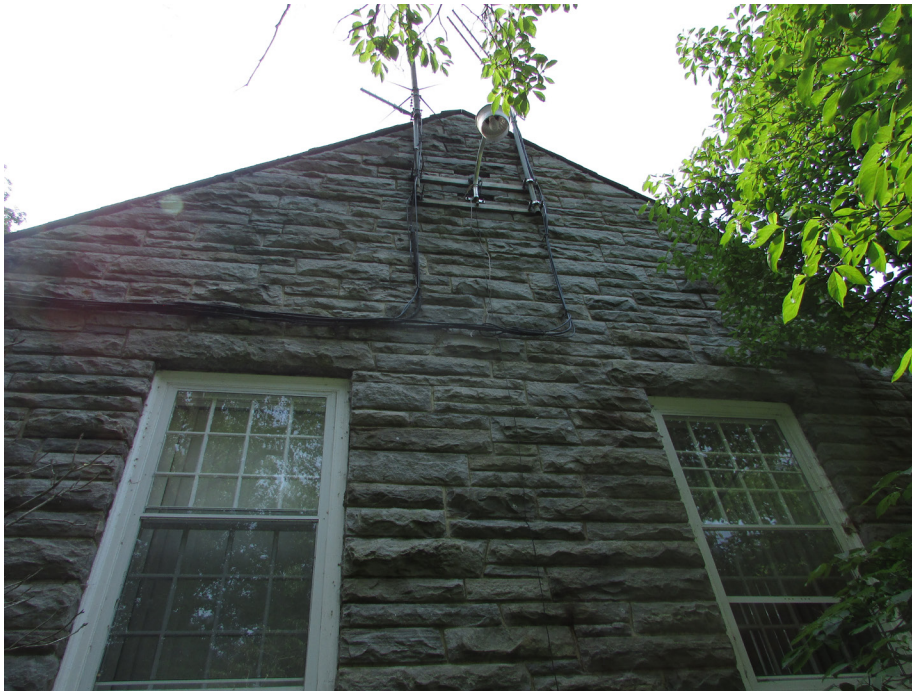
Figure 4-14. North elevation, east gable end detail (source: Quinn Evans 2019)

Overall the sandstone elevation is in fair to good condition with some areas of discoloration from rust and biological growth. Some cracking and disintegration of the mortar along the bottom edge of the wall was observed.

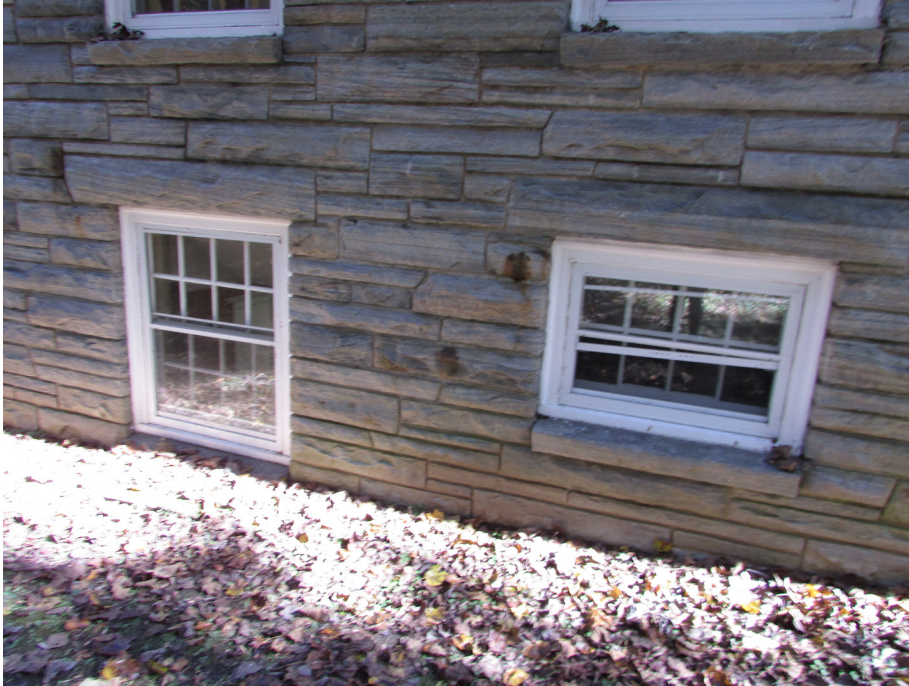
The exteriors of the main level windows were not observable up close from the ground, but in general appear to be in good condition except for some instances of dried sealant. The two southern most windows may also have water damaged wood sills. Most of the windows on the basement level are in poor condition.

Figure 4-30. West elevation basement windows (source: Quinn Evans 2018)

Aside from the dirt, the wood sills are showing signs of water damage in many locations and it appears the storm window in the fourth bay from the south has failed and left the window open to the elements.

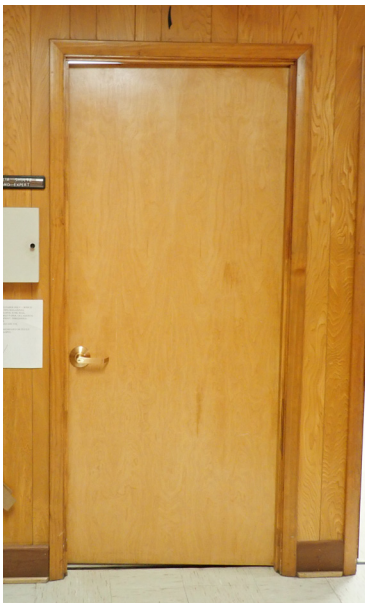
Figure 4-36. Typical hollow core wood door, upper level (source: Quinn Evans 2019)

All doors are typically hollow core wood with simple wood casing and are in good condition (figure 4-36). One door along the north exterior wall has been tapered at the top to align with the roof slope.
