**HARPERS FERRY**  
**BLDG. 3-NICHOLS/WILLIAMS BUILDING**

HARPERS FERRY  
HISTORIC STRUCTURE REPORT  
ARCHITECTURAL DATA SECTION  
NICHOLS/WILLIAMS BUILDING  
BUILDING 3

July 1981

Prepared by  
Thomas E. Fields  
and  
Susan L. Shufelt

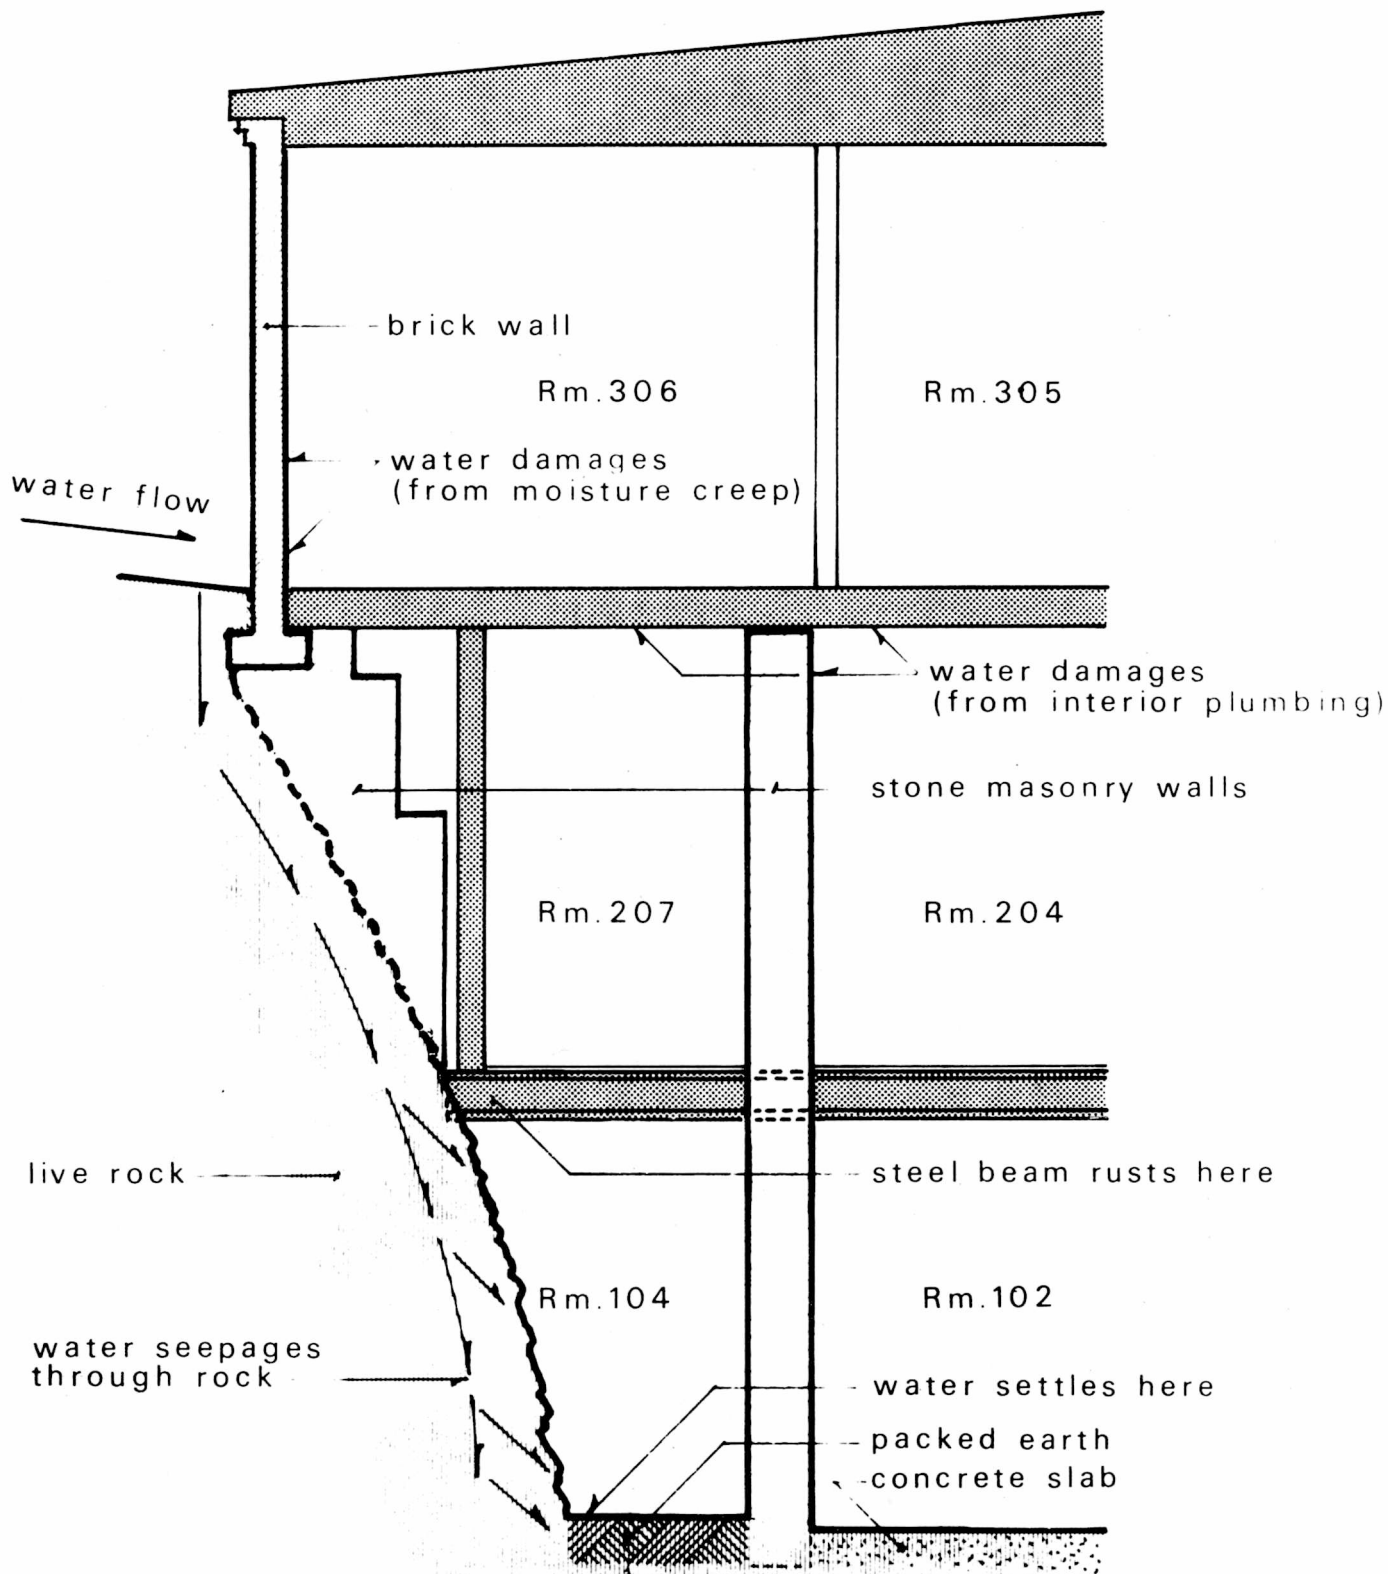
**FIGURE No. 9**  
**SOURCES of WATER PROBLEMS**  
**and DAMAGES**

Two cisterns located at the top of the cliff behind the building probably also contribute to the water problems. A sump pump is located in one cistern (on the west side) to carry the water away.

The concrete slab situated behind Building 3 causes additional water problems. This slab directs water toward the building's third floor--which is about level with the top of the cliff--rather than away from the building. Evidence of this problem can be seen on the walls of the southeastern corner of room 307 where the plaster has been damaged (see photograph 29).

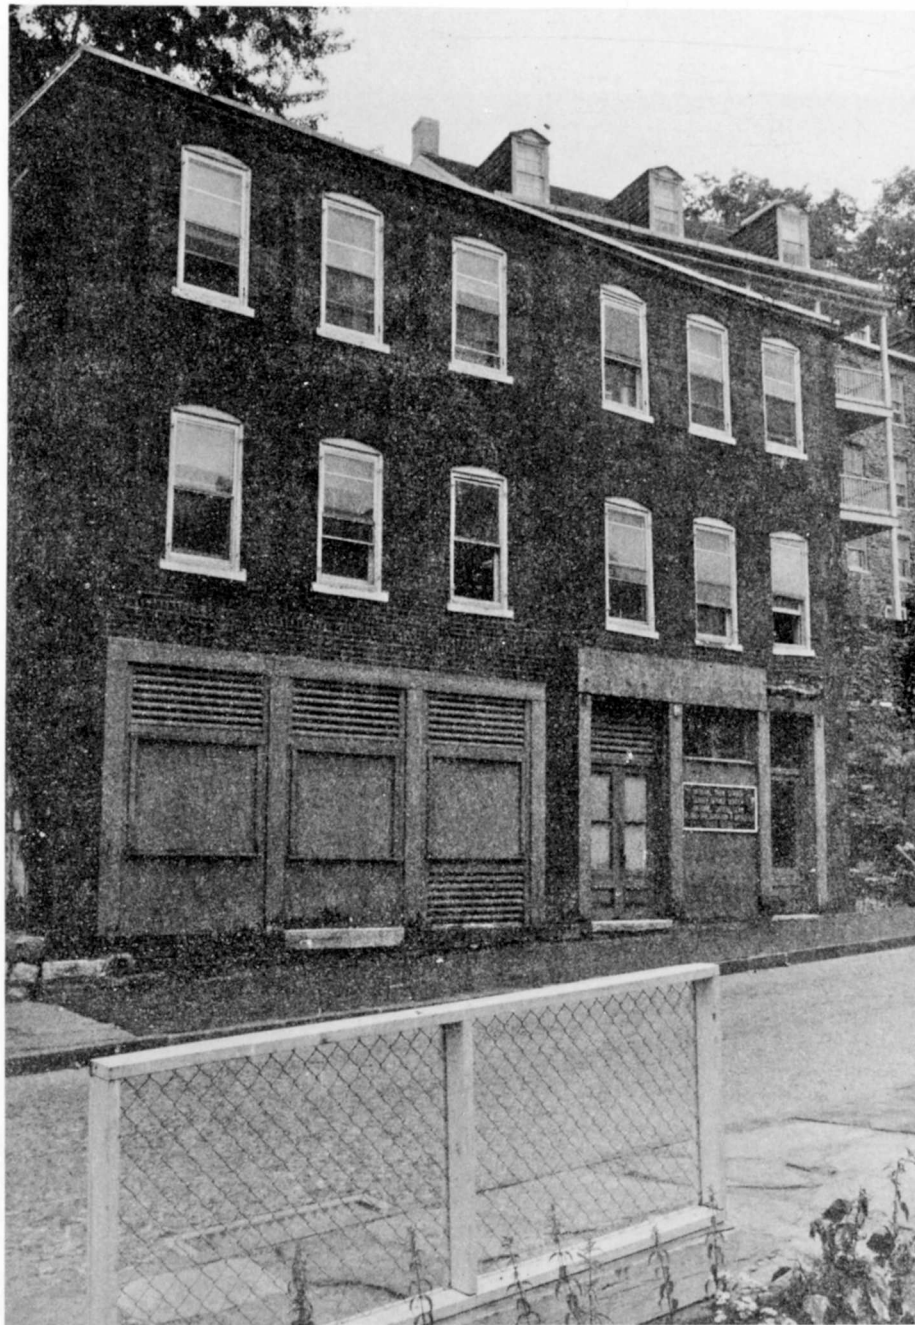
PHOTOGRAPH 1 (1980)  
North Elevation

The south elevation also needs some repointing. At the west end of the north elevation, the wood lintel above the storefront opening has failed. This has caused the second- and third-floor windows to sag approximately three to five inches (see photographs 1 and 3).

Note that the window spacing on the western portion of the building is different from that on the eastern side.

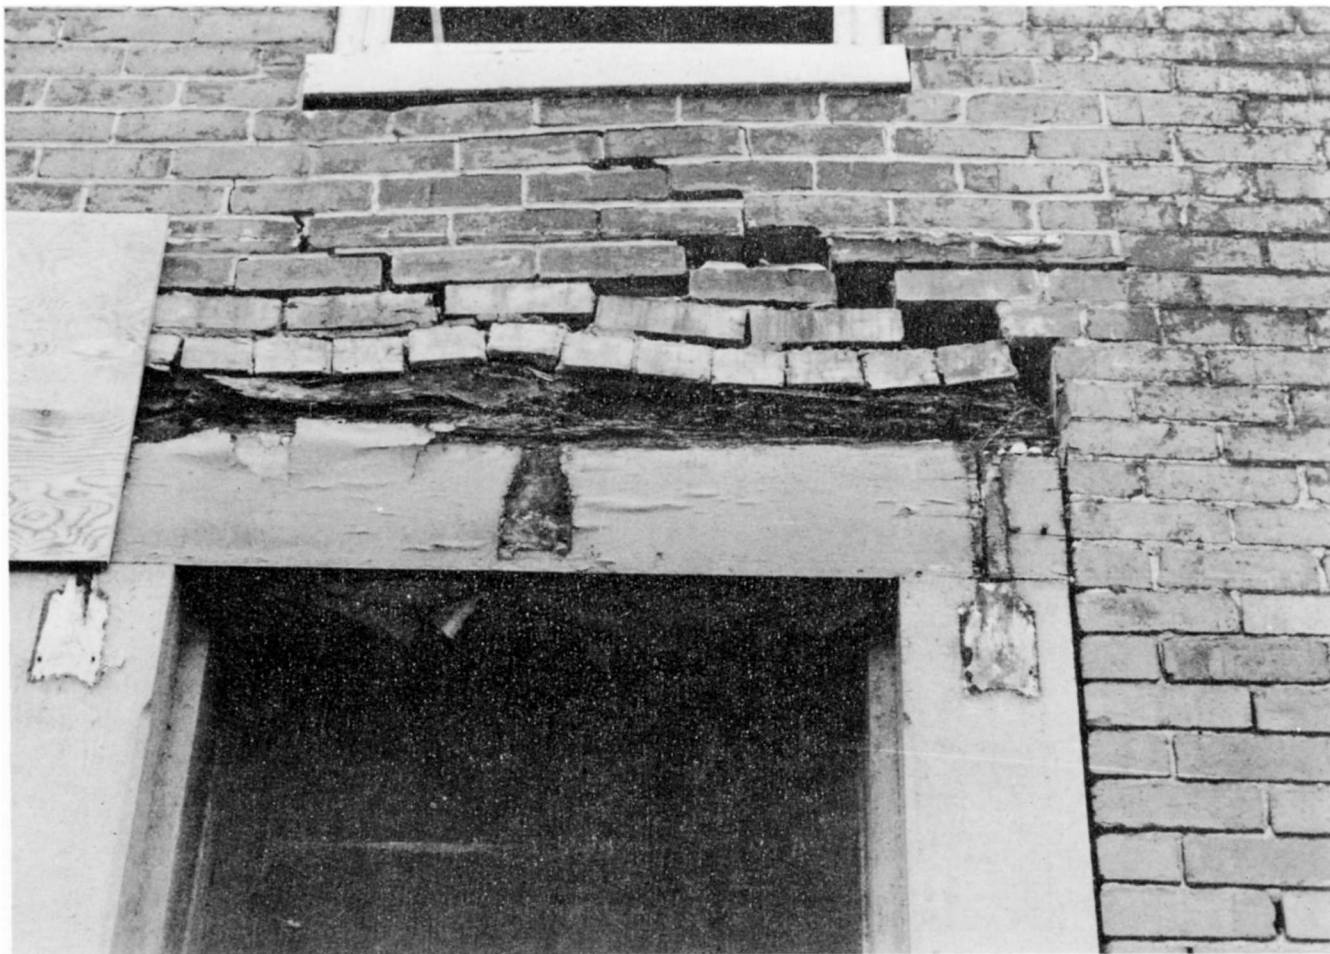
PHOTOGRAPH 3 (1980)  
Area above Western Side of Storefront

Note the deterioration of the wood beam supporting the brick wall at the second floor level.

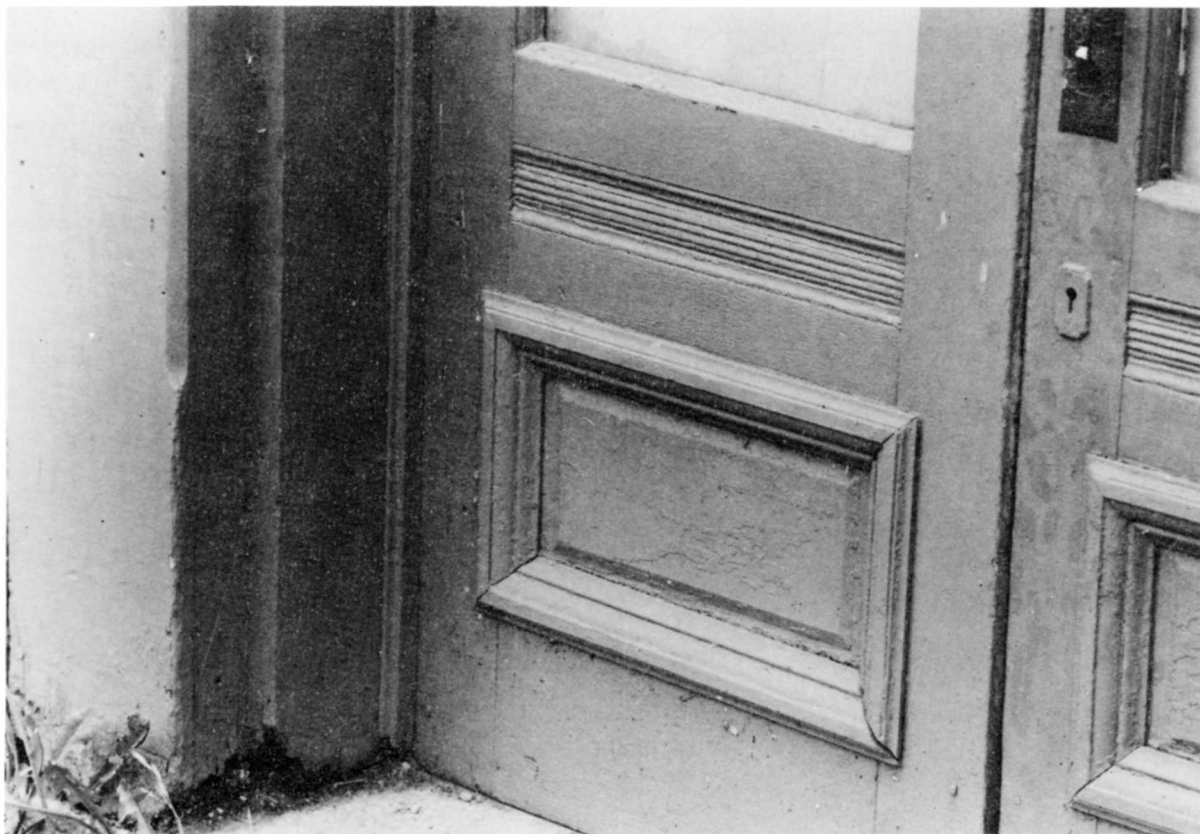
PHOTOGRAPH 4 (1977)  
Storefront Doors

Note the deterioration of the frame.

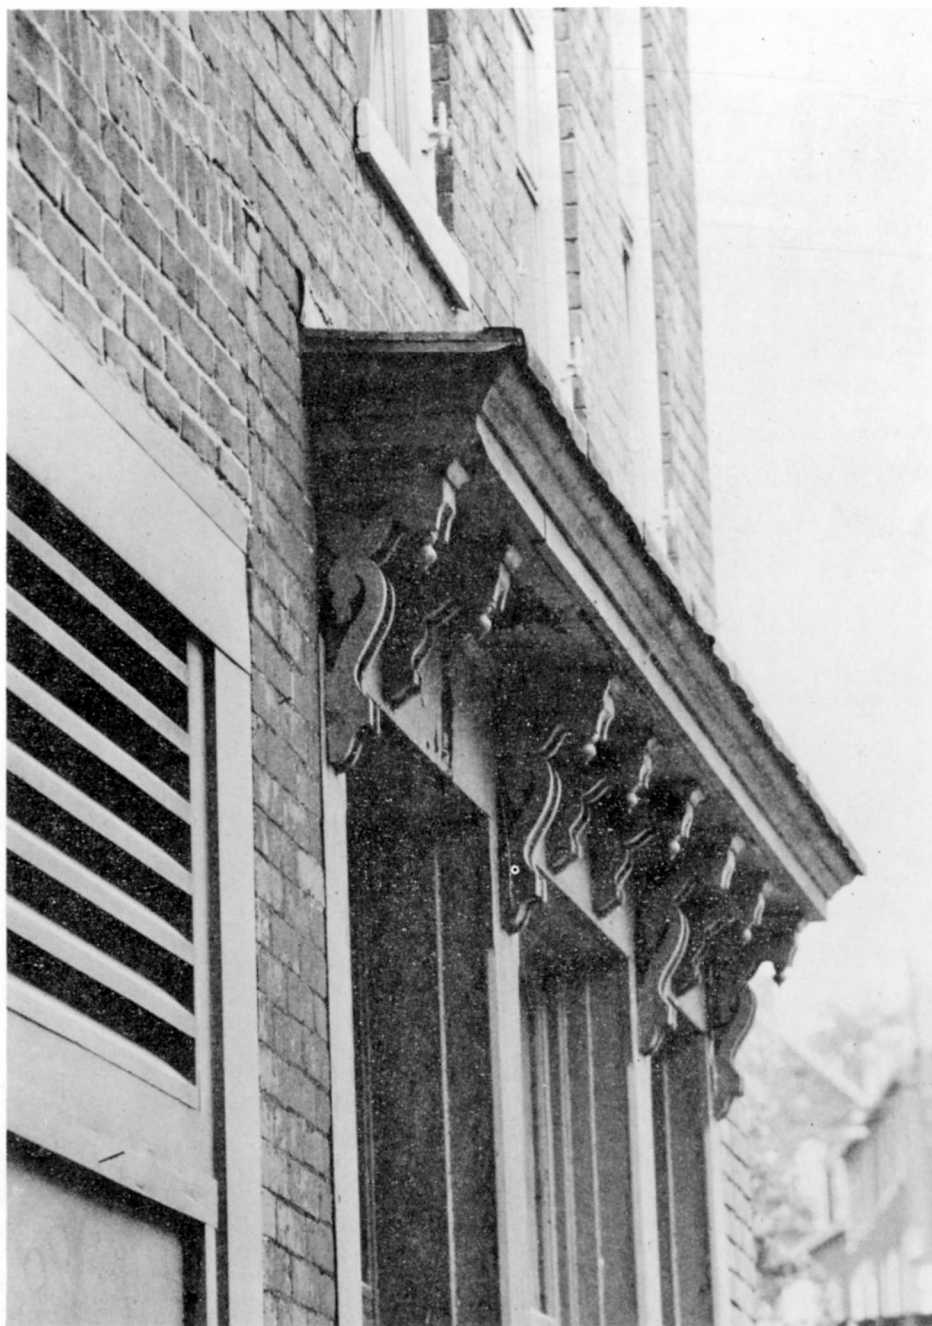
PHOTOGRAPH 5 (1977)  
Boxed Cornice over Storefront

This boxed cornice was originally above the storefront on both the east and west sections of the building. In 1977 this cornice existed only on the west section; now none of it remains.

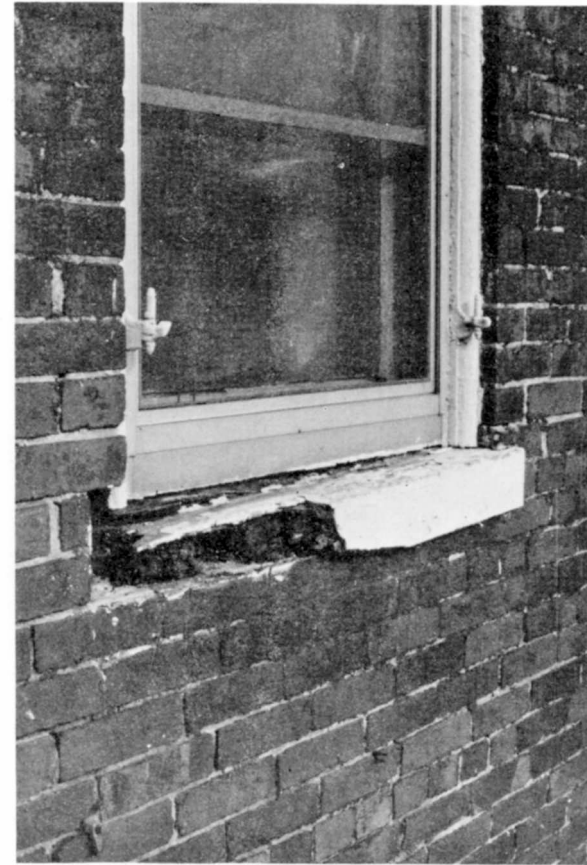
PHOTOGRAPH 19 (1980)  
Window 312

Some of the windows are in poor  
condition.

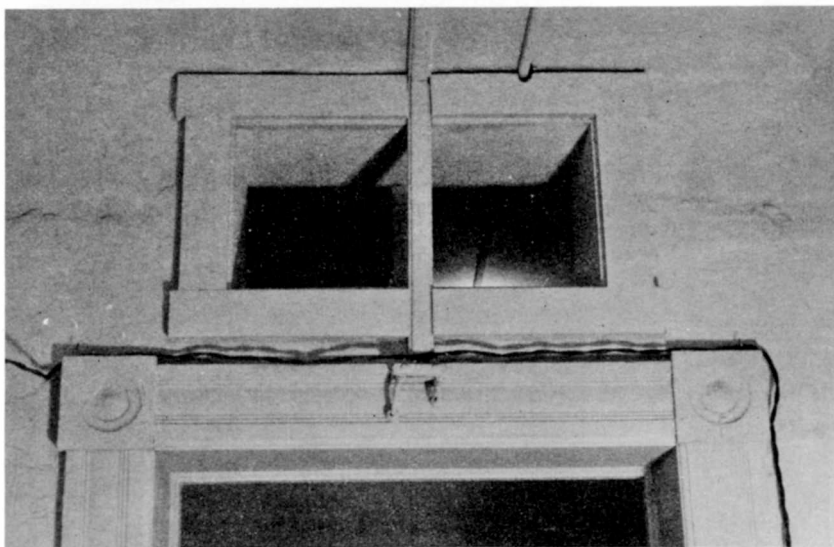
PHOTOGRAPH 35 (1980)

Rectangular openings are found in some of the interior walls on the second and third floors. These openings are located near the ceilings (see photograph 35). The purpose of these openings is not known, but it is suspected that they might have been added to aid in the circulation of heated air.

Opening above Door 313

Openings similar to this one are found in several places near the second- and third-story ceilings.
