historic structures report  
building 38

HARPERS FERRY  
TEARNEY BUILDING

Historic Structure Report  
Building 38/ Tearney Building  
Harpers Ferry National Historical Park  
Jefferson County, West Virginia

Prepared by  
Susan L. Shufelt

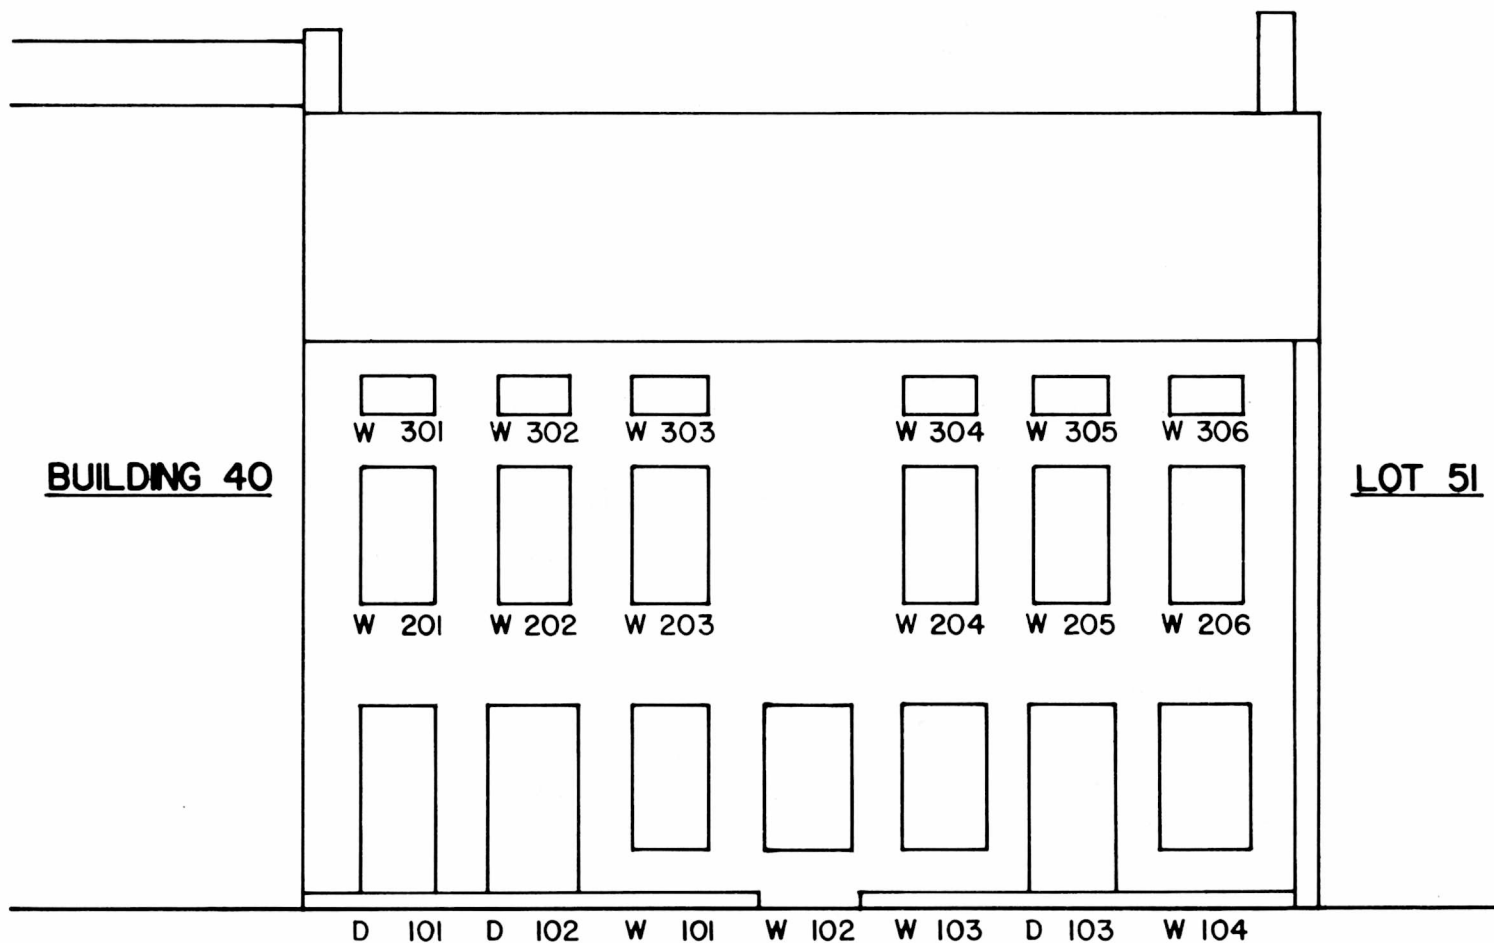
FIGURE I

BUILDING 38 (PRESENT)  
FRONT ELEVATION

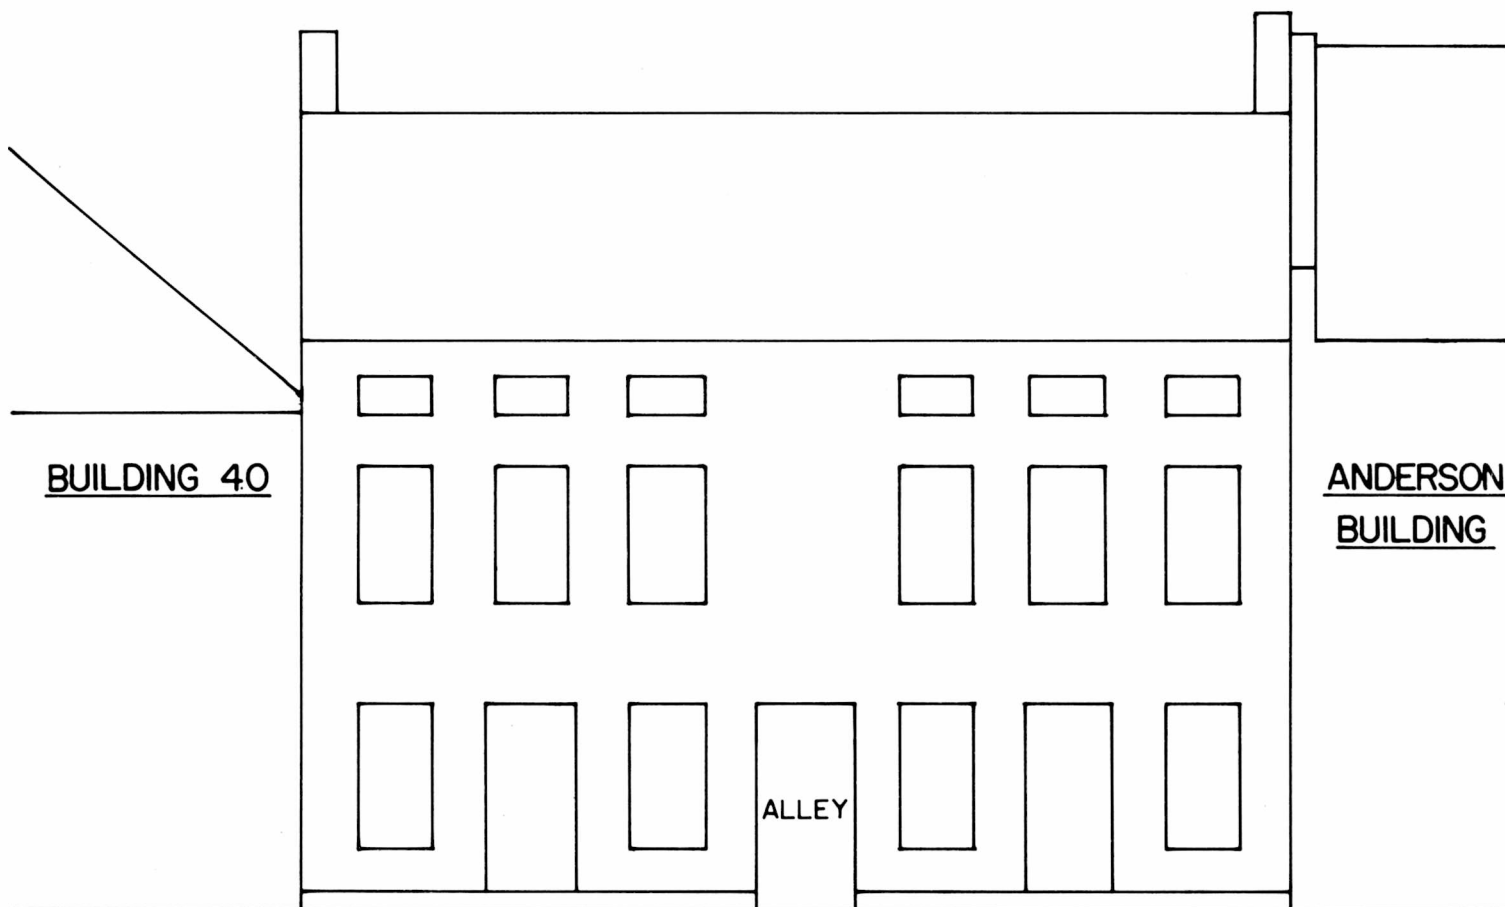
FIGURE 2

BUILDING 38 (1844 TO 1860'S)  
FRONT ELEVATION

The roof condition at the south end of building 38 also differs from the historic appearance (see figure 2 and compare photographs 4 and 13). Originally building 38's roof covered the shared wall between buildings 38 and 40. Prior to the enlargement of building 40, its eaves met the shared wall below building 38's roof line.

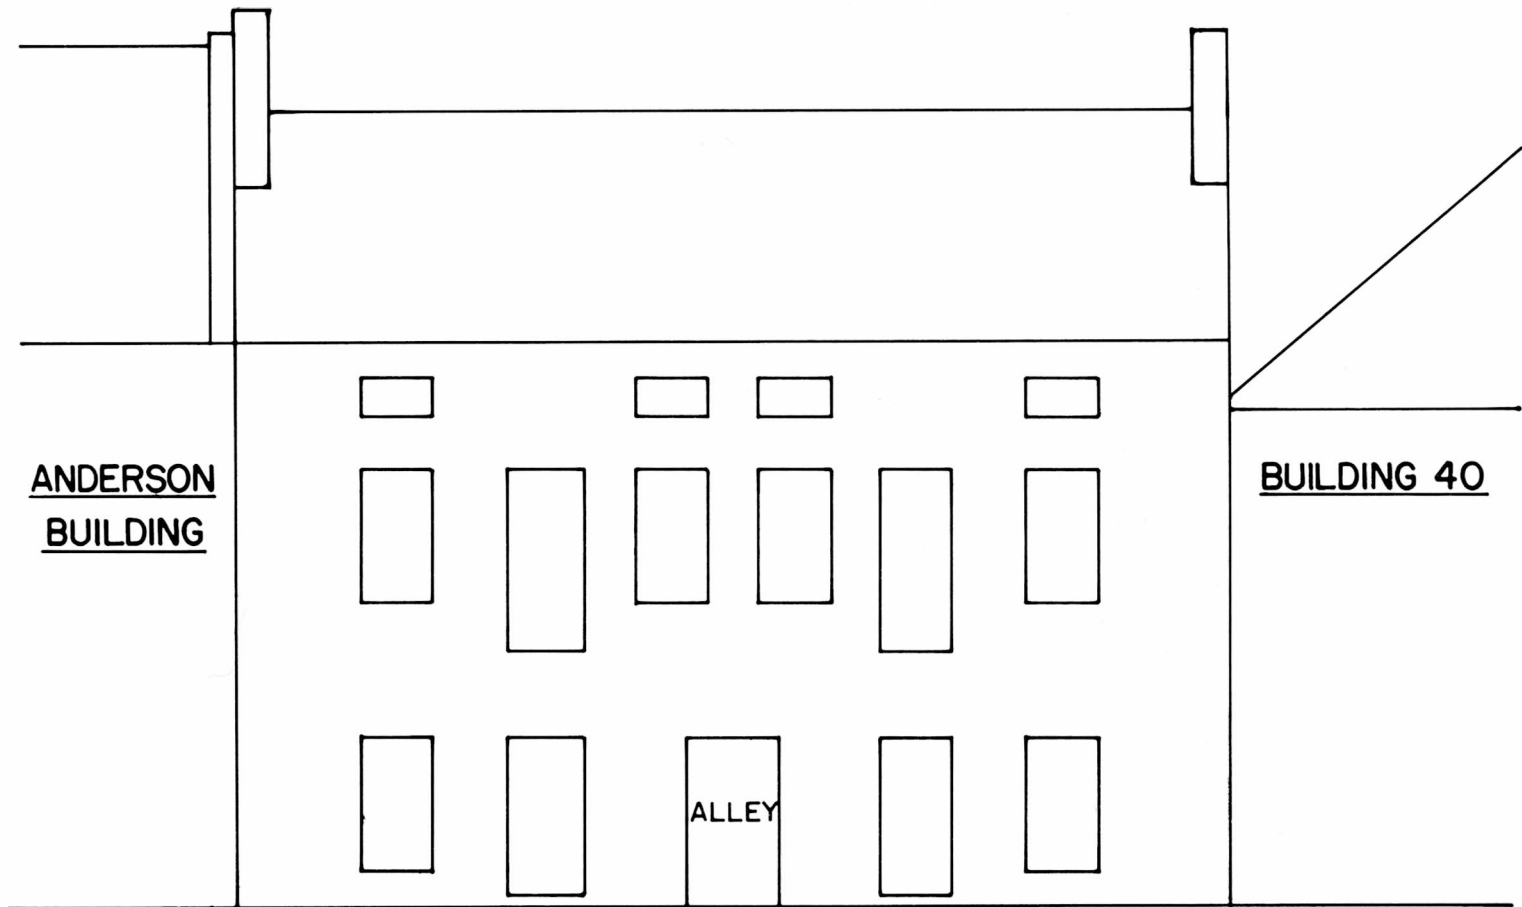
FIGURE 4

BUILDING 38 (1844 TO 1860'S)  
REAR ELEVATION

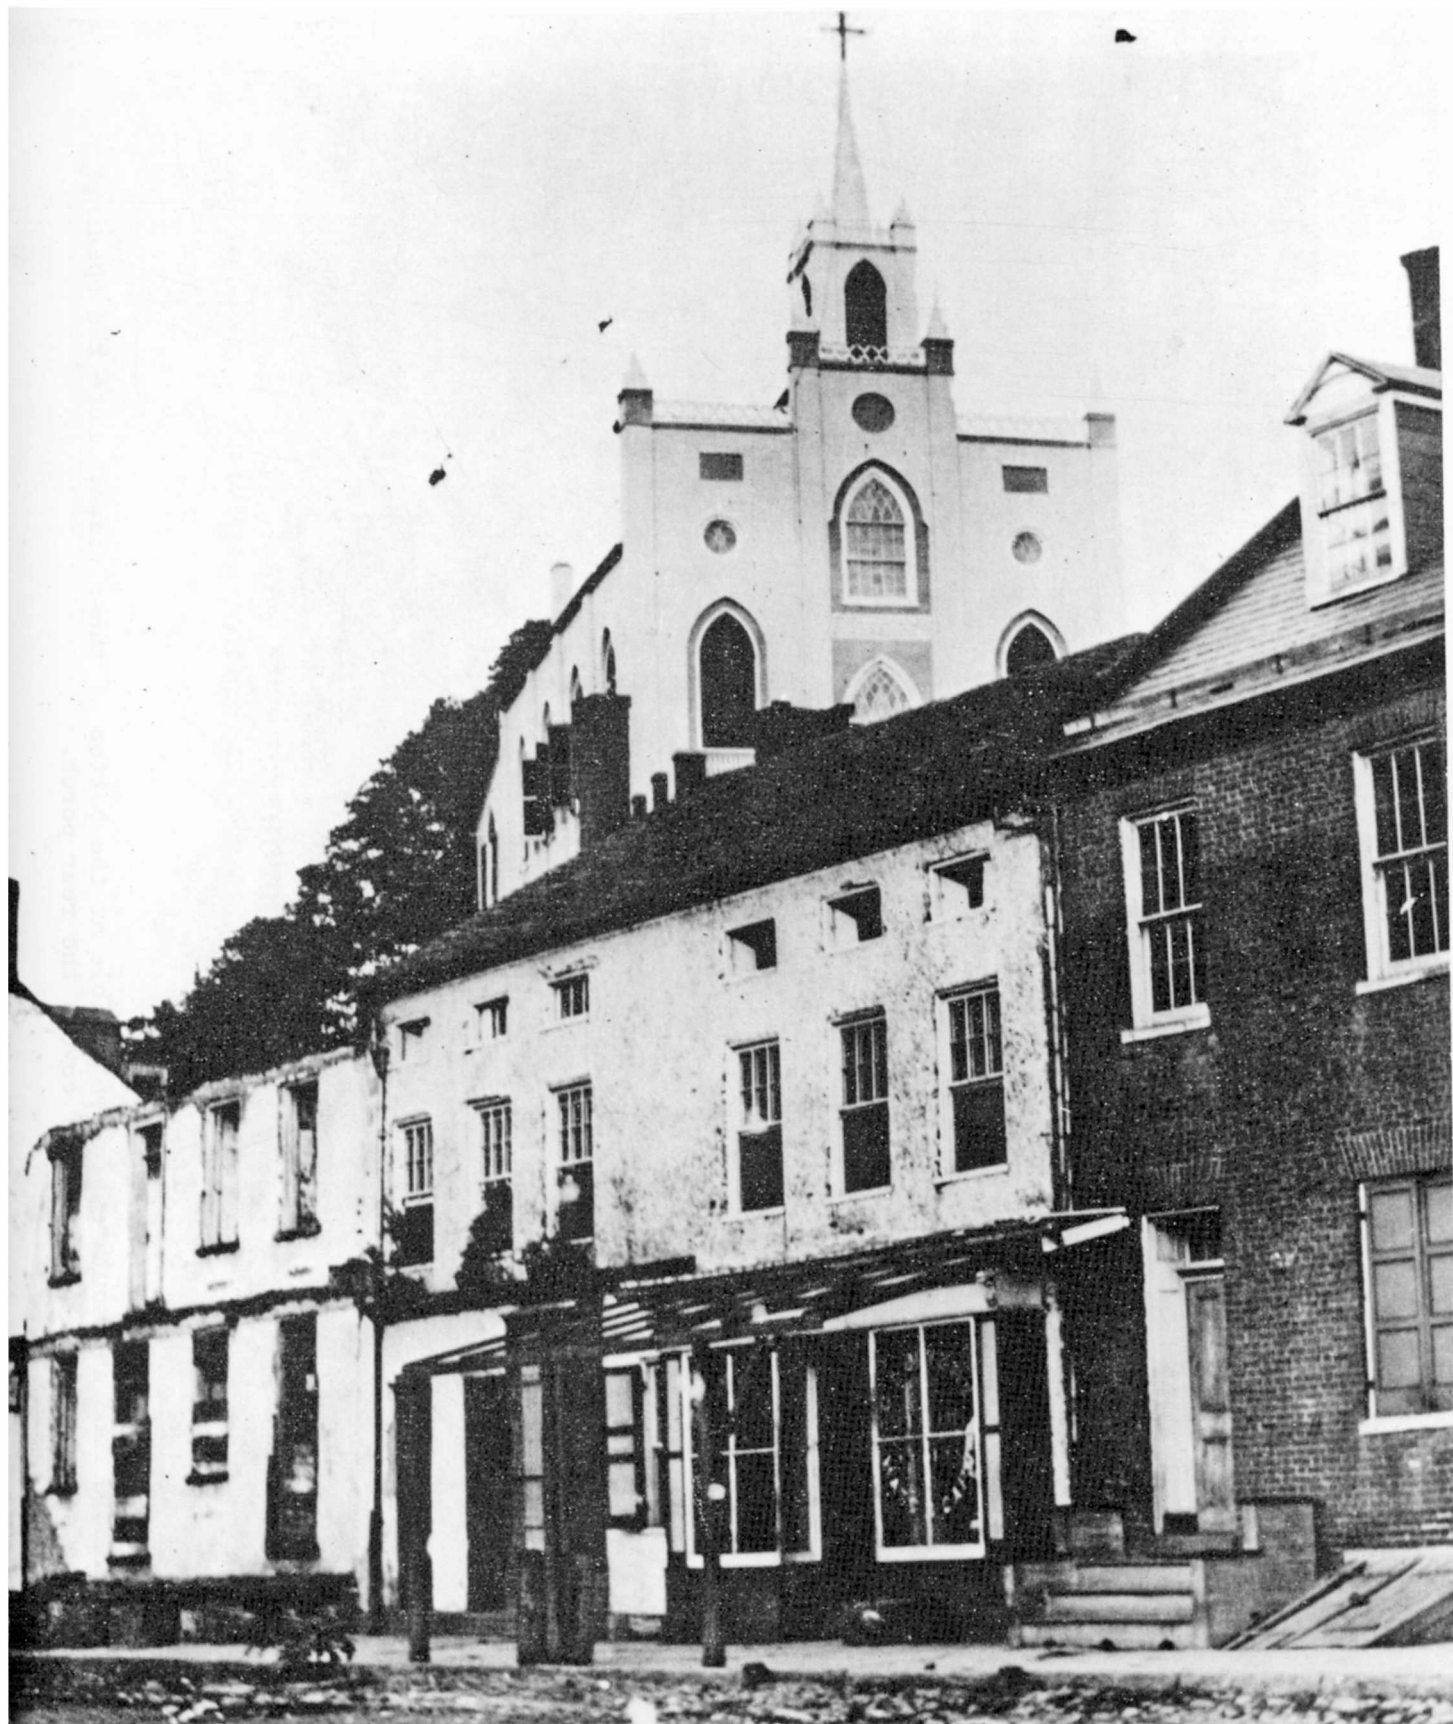
PHOTOGRAPH 3 (ca. 1865-1879)  
Building 38, Front or East Elevation

Also, like the second-story windows, these first-floor windows were probably originally six-over-six windows. In photograph 3, a horizontal muntin is visible on the upper half of window 102 (which appears to be open in the photograph), probably indicating that at one time this window was a six-over-six window. Possibly, when window 102 was installed (at the time the center alley was removed), a six-over-six window was chosen to match the other first- and second-floor windows. The first-floor windows were more susceptible to damage (flood damage, for instance) and, having been more affected by the various building alterations than the upper-floor windows, were probably later changed to one-over-one windows (a style more popular in later years).

The exterior (east and west) walls of building 38 were probably stuccoed originally, as they are today. Photograph 3 shows that, at least by the 1870s, building 38 was stuccoed and whitewashed. The original stucco was probably more like the lime-based stucco found on the rear of the building (the deteriorating condition and general appearance of this stucco indicate that it might be original) than the cement-based stucco found on the front of the building. Topping these stuccoed stone front and rear walls was the stepped brick cornice which still exists.

Since Building 40 does not have a front porch in this photograph, the photograph must have been taken after Photograph 2.

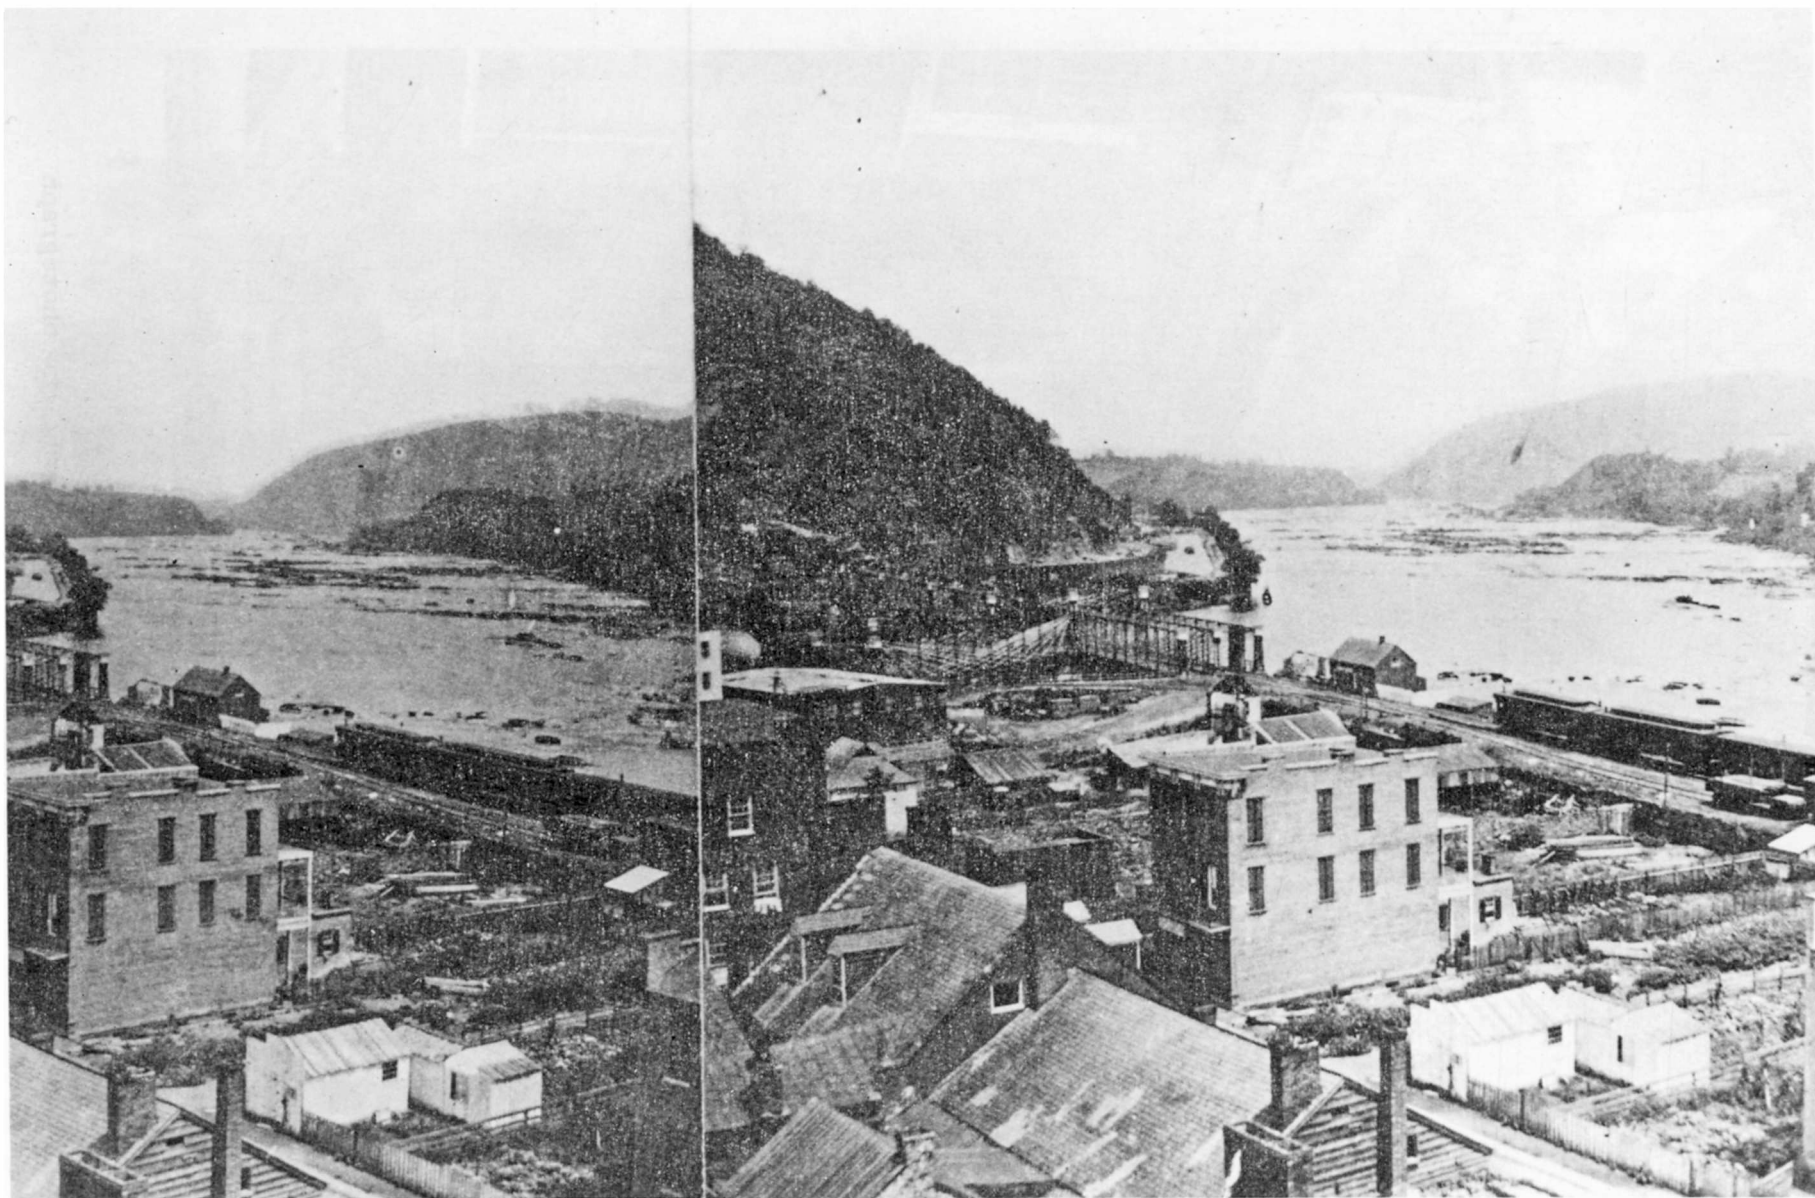
PHOTOGRAPH 4 (ca. 1877-79)  
Roof and South Gable of Building 38

Building 38's wood shingle roof and south gable are visible at the bottom of these views. Note the openings and wood siding on the south gable. Also, a roof covers the rear porch.

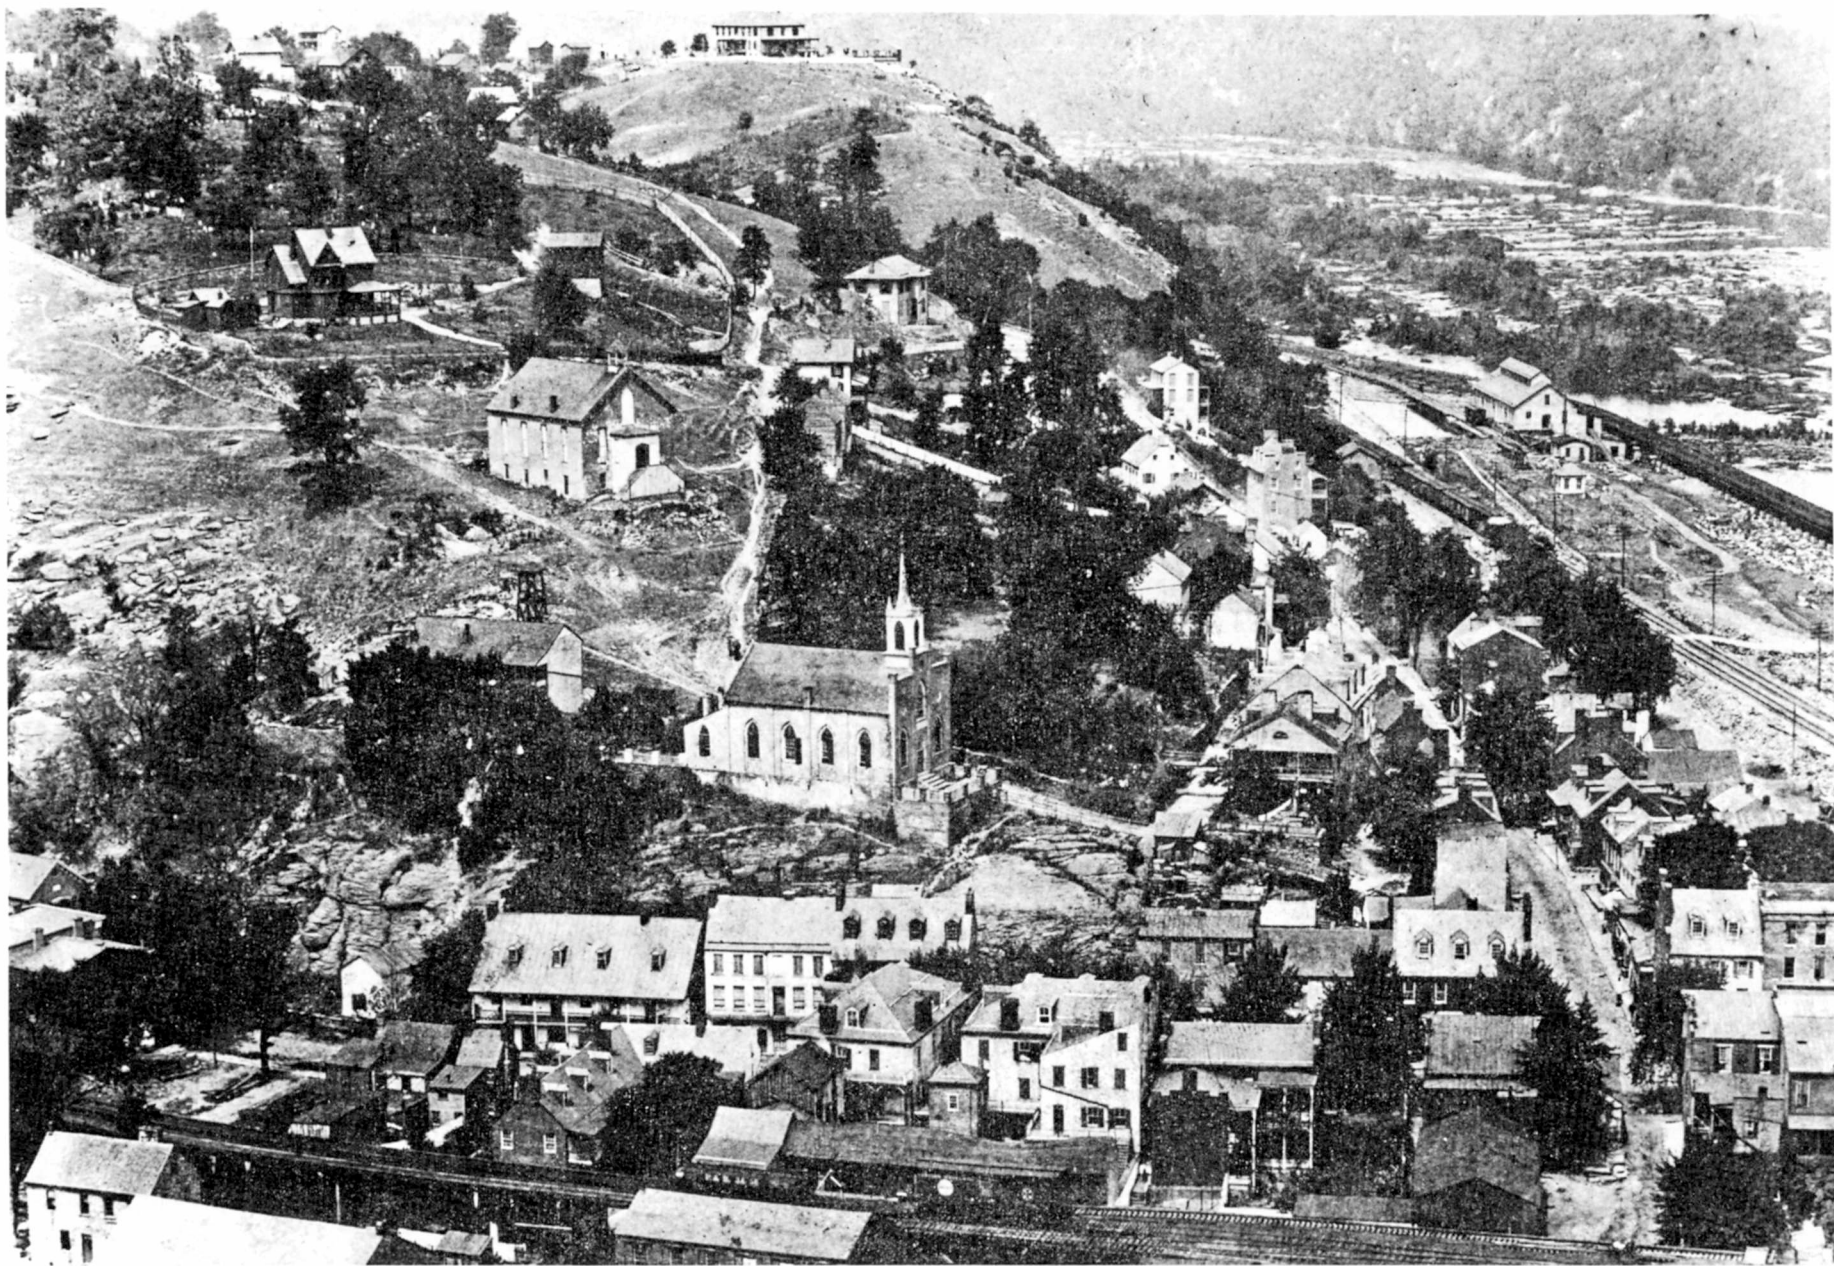
PHOTOGRAPH 5 (ca. 1892-1895)

Two of Building '38's upper-floor windows are visible in this photograph. The second-floor window is covered by shutters, but the third-floor window is not.

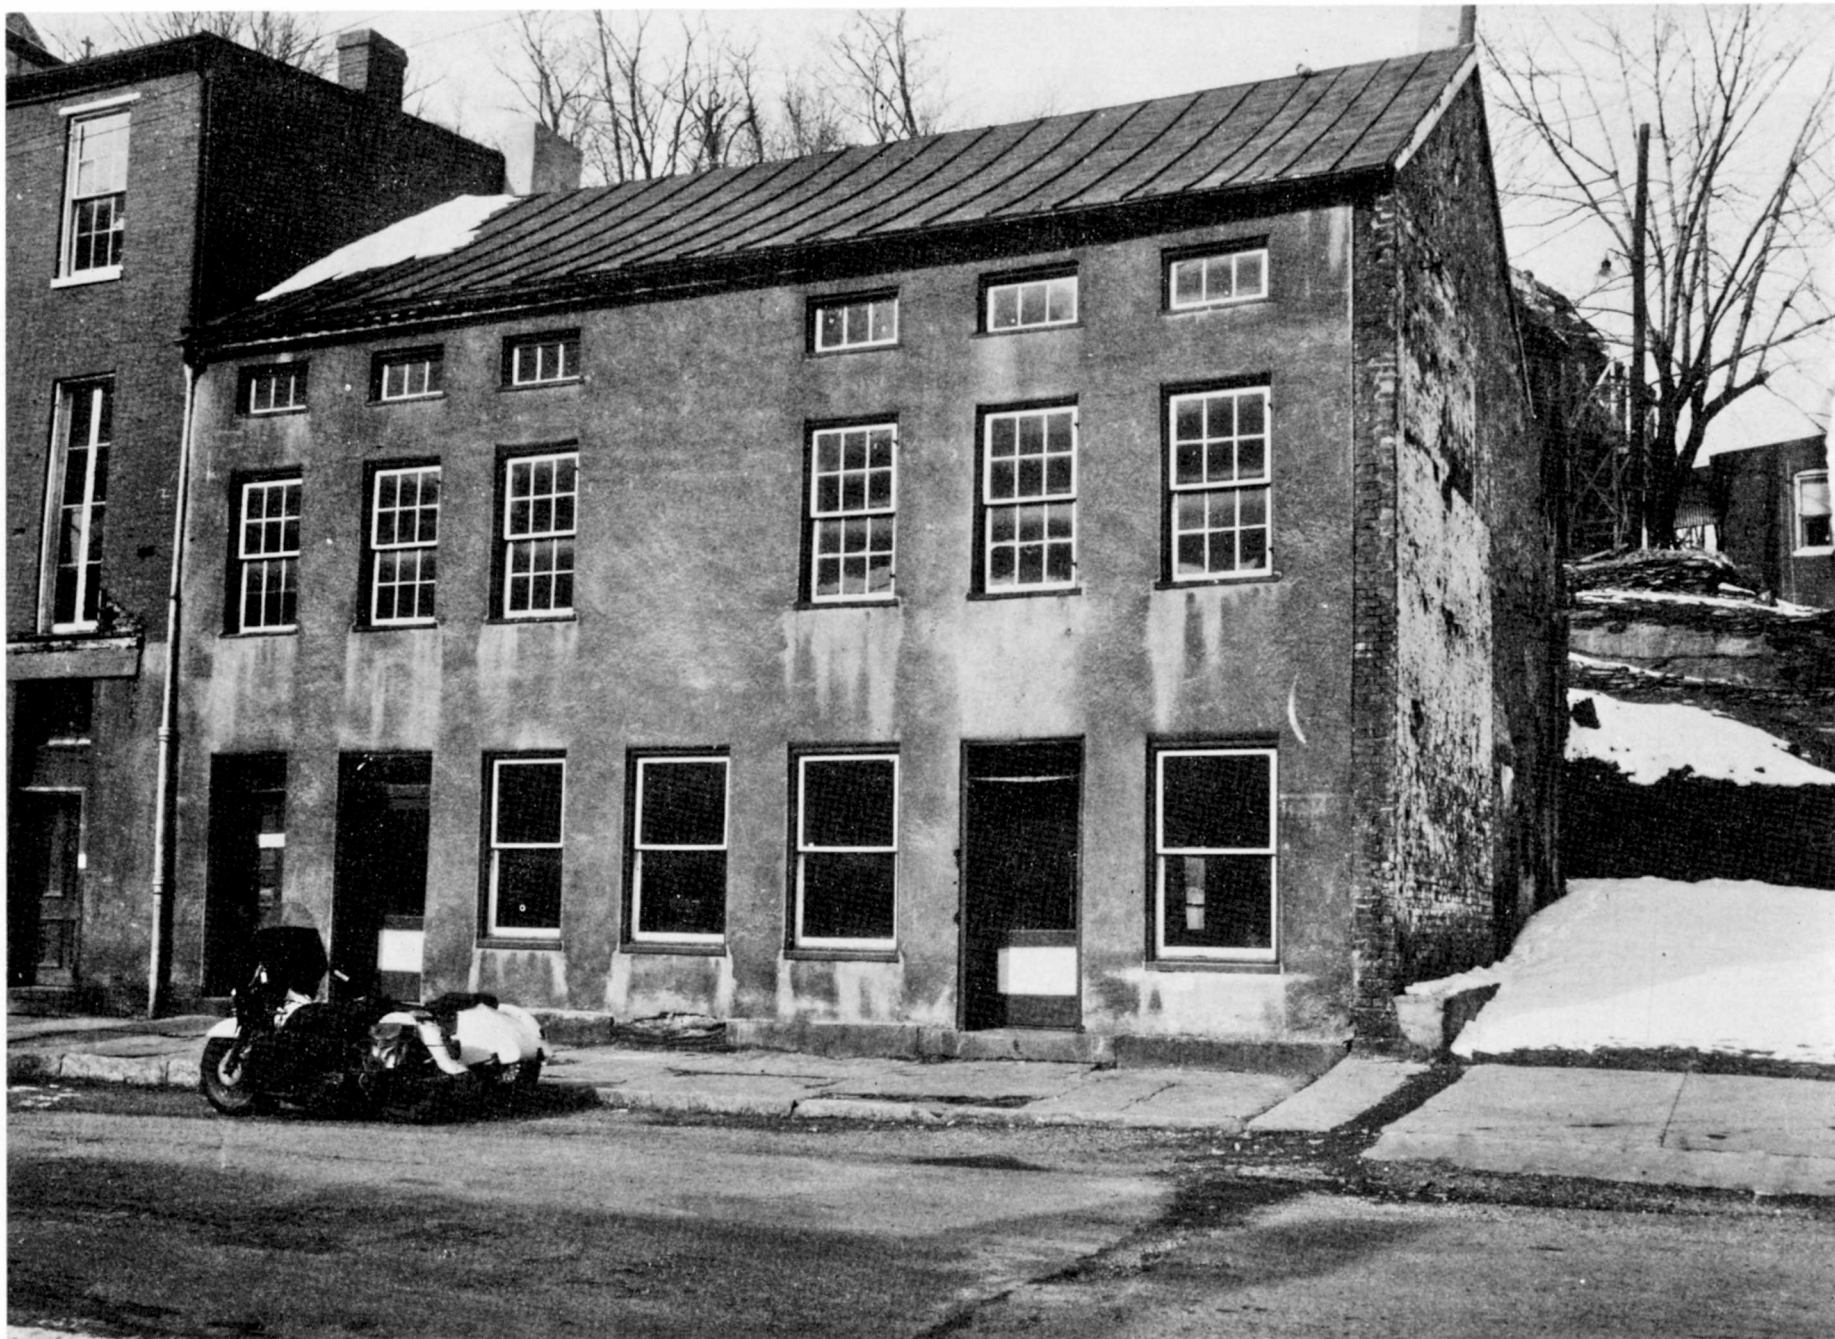
PHOTOGRAPH 7 (1955)  
Building 38

Although the evidence seems to reveal a building with a symmetrical arrangement of window and door openings, questions arise as to the original size and details of the openings. The first-floor windows vary in size (see photograph 7). The southernmost window on the front elevation (window 101) is narrower than the other first-floor windows. Window 101, however, is the same width as the upper-floor windows. Since window 102 was at one time an alley entrance and since windows 103 and 104 were at one time replaced by a storefront (see photograph 3), window 101 might well be the only window opening on the first-floor front elevation whose size has not been altered. There are no indications that the size of this window opening has been changed. Since window 101 matches the upper-floor windows (which probably have not been altered

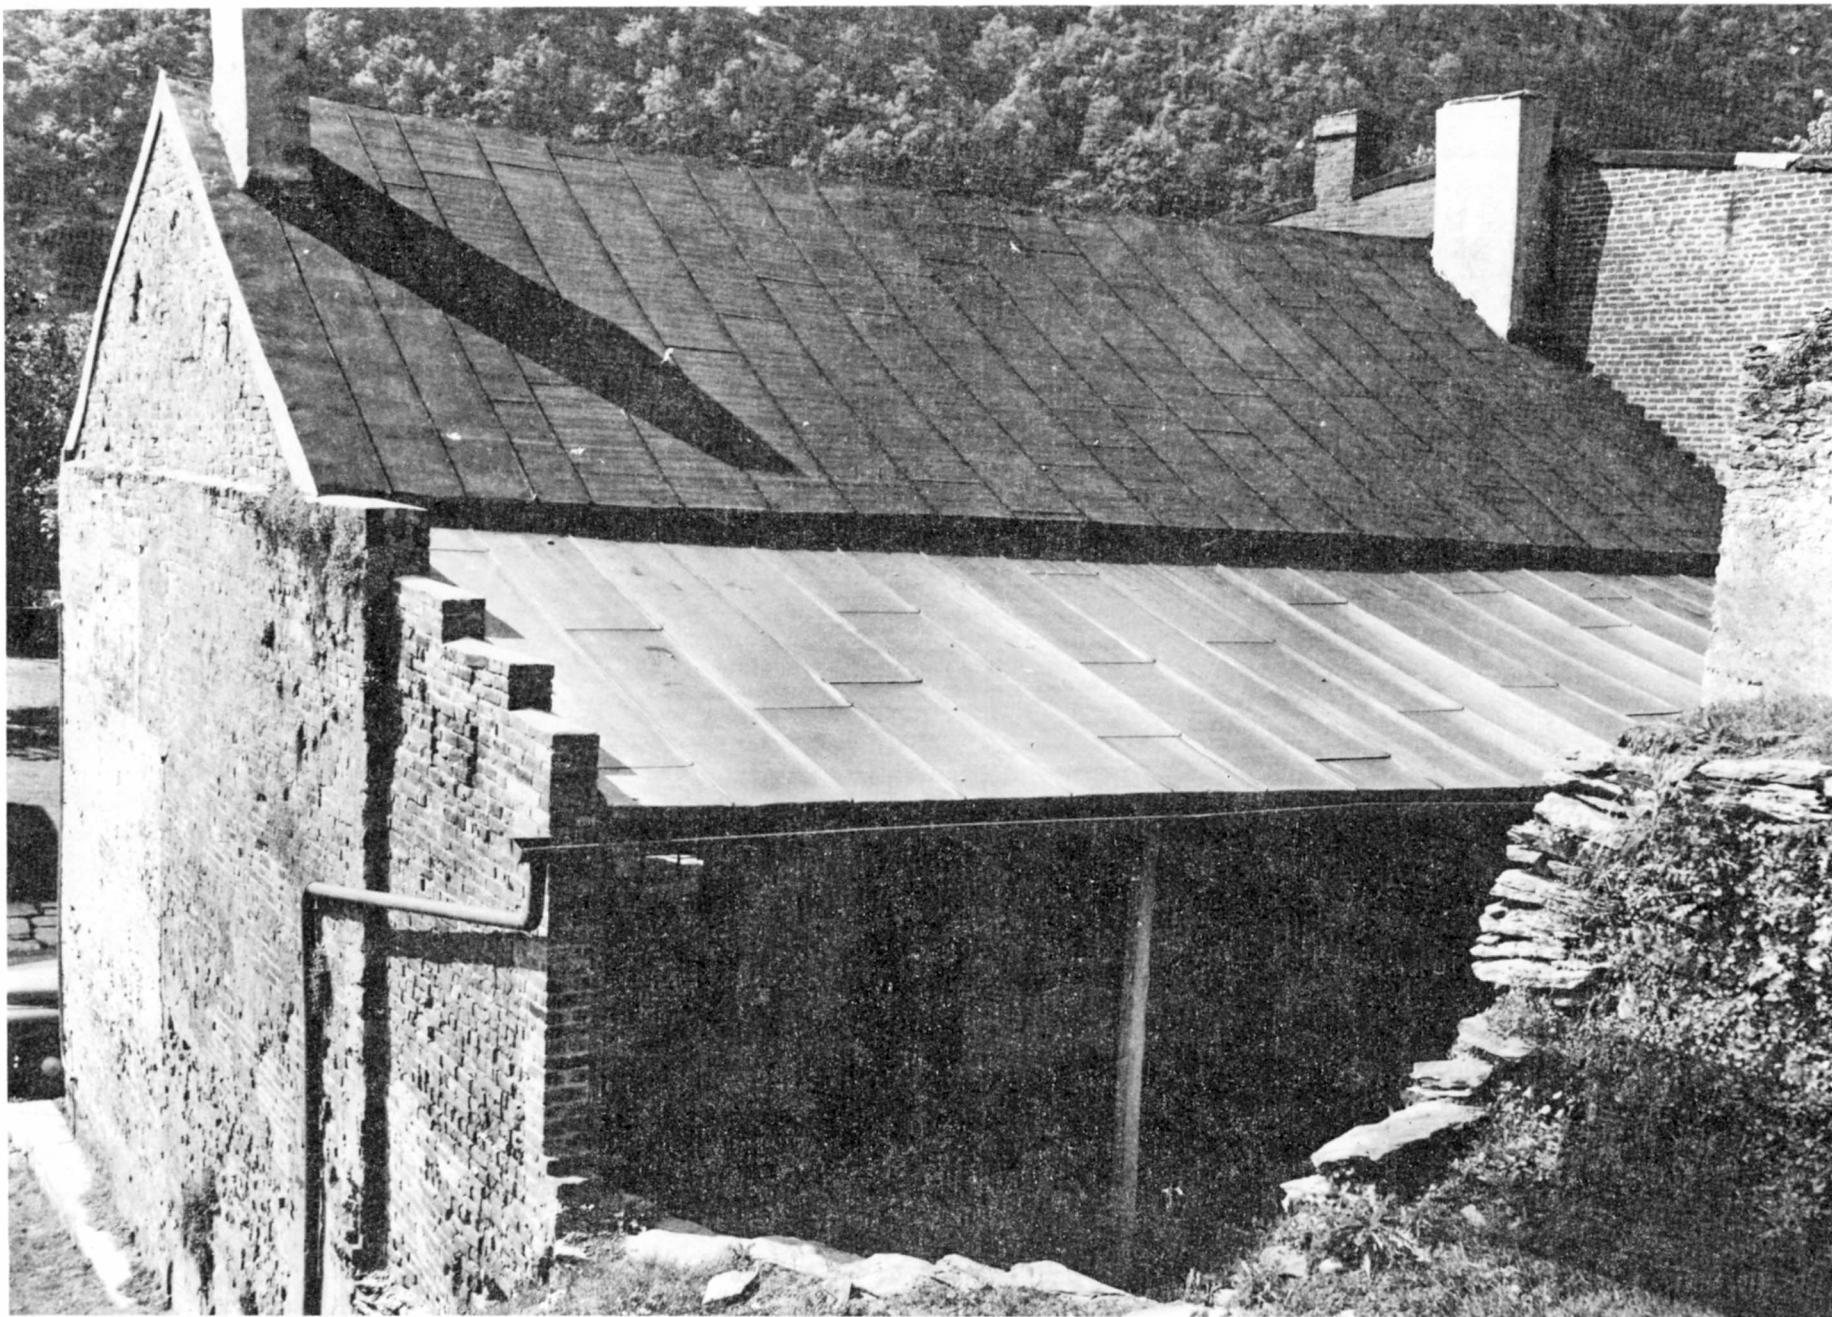
PHOTOGRAPH 8 (ca. 1958)  
Building 38, Rear or West Elevation

The north wall is a common bond brick wall with headers at every sixth course. It is three brick wythes thick to the third floor and two brick wythes to the gable peak (see photograph 8). This wall was also at one time an interior wall: it was the shared wall between building 38 and the building which occupied lot 51. However, after the Anderson Building was torn down (in the 1920s), the north side of this wall--the surface which had always been an interior, protected surface--became exposed to the elements and began to deteriorate. This deterioration, combined with the fact that this wall was originally part of the Anderson Building and tied into the front and rear walls of that building and not building 38, have caused this wall to separate from building 38, requiring shoring to be used to help hold it in place. This brick wall is unpainted and contains a few concrete patches. It extends 5 feet beyond the rear of building 38 (see photographs 4 and 20), indicating that the building on lot 51 was a deeper building. This wall meets a stone wall at the first-floor level; on top of the stone wall, an 8-foot brick addition to the brick wall has been constructed (see photographs 19 and 20). This brick addition is 4 1/2 inches narrower and contains what appears to be joist pockets on its north side at the second-floor level.

Note ledge on north wall; this ledge indicates where the wall changes from three-wythes-thick to two-wythes.

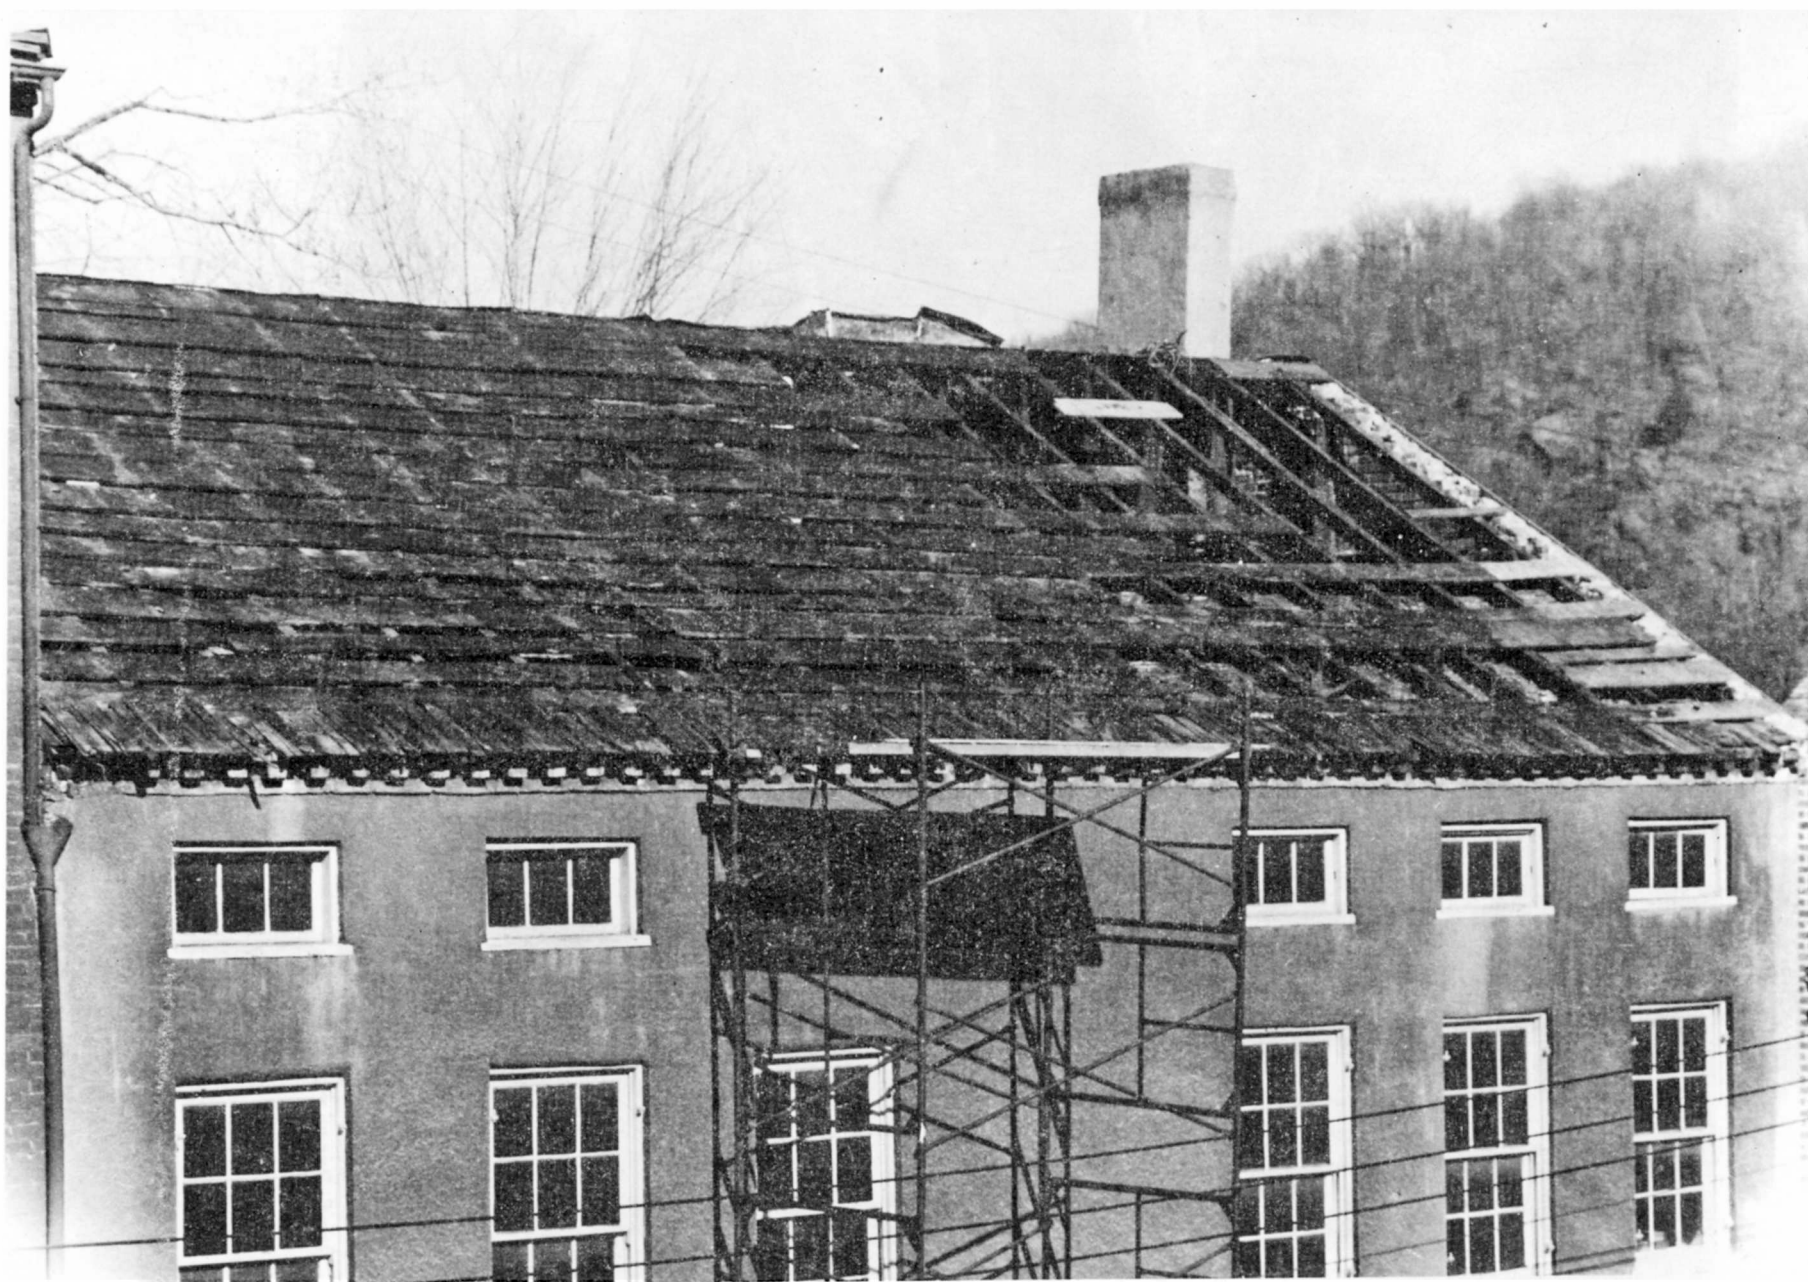
PHOTOGRAPH 9 (1964)  
Roof Repairs

A new wood shingle gabled roof was installed in 1964, when extensive repair work was done to the roof framing system. Photographs 9-12 were taken while these repairs were being made. The roof consists of wood shingles laid over underlayment and 1 1/8-inch by 12 1/2-inch spaced wood sheathing. Moss is growing on the wood shingles. The roof is supported by wood rafters which rest on the front and rear exterior walls. These rafters extend slightly beyond the edges of the masonry walls; screening covers the exposed edges of the overhanging rafters.

Following a fire and a period of neglect, repairs were made to the roof of building 38 in 1964 (see photographs 9-12). As a result of these repairs, the roof framing system is a combination of old and new. The framing system consists of wood rafters, 2 feet on center, running east and west. Some of these rafters are probably original; they are old, sagging and partially burned (these rafters are on the south 27 feet of the building). Other rafters (those on the north end of the building) are relatively new, having been installed in 1964. The original rafters taper from a section dimension of 3 inches by 5 inches (at the supporting masonry walls) to 3 1/2 inches by 3 inches (at the peak); the new rafters taper from 2 1/2 inches by 5 1/2 inches (at the supporting masonry walls) to 2 1/2 inches by 3 3/4 inches (at the peak).

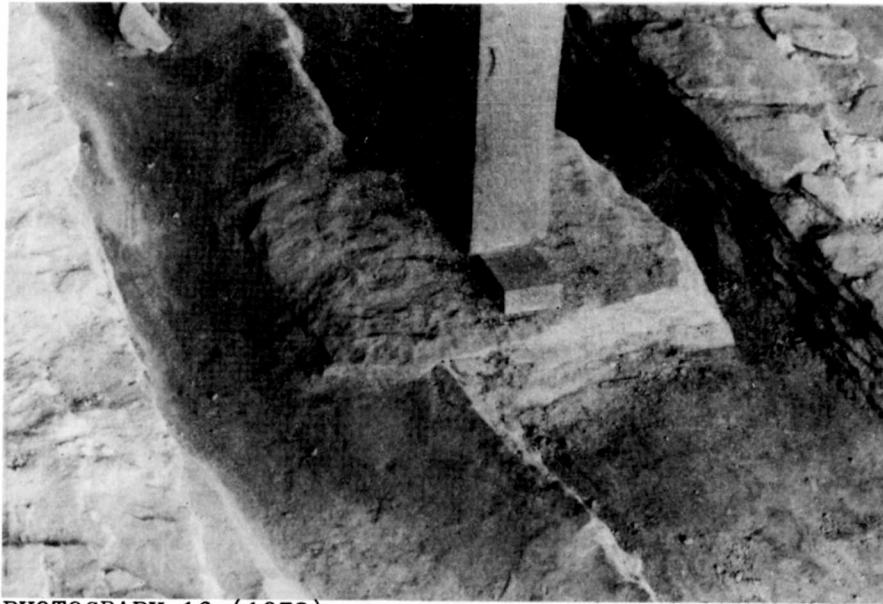
PHOTOGRAPH 16 (1978)  
Brick Drain and Foundation Walls for the Original  
Center Alley

These foundation walls,  
brick drain, and clay  
pipe were uncovered  
during the 1978 archeo-  
logical investigations.

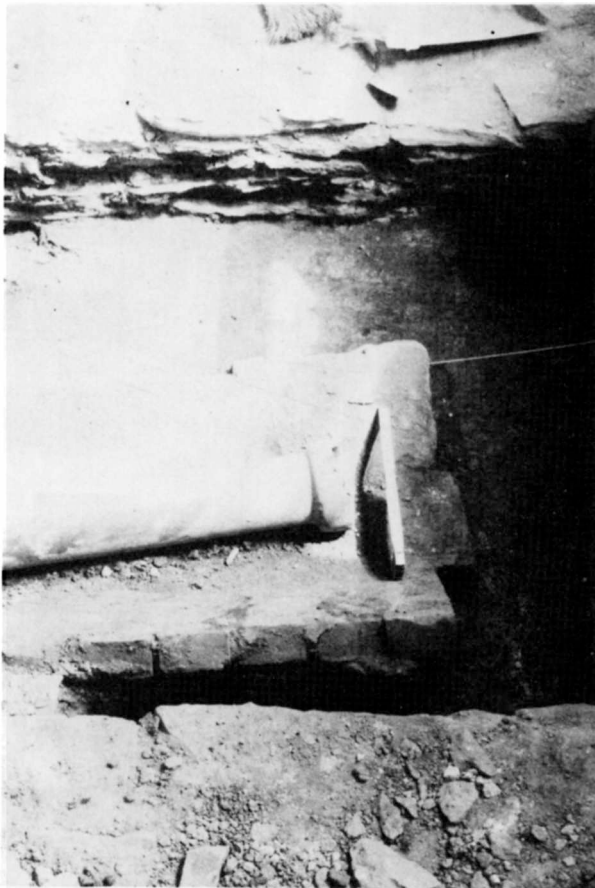
PHOTOGRAPH 17 (1978)  
Clay Pipe Found in Part of the Brick  
Drain

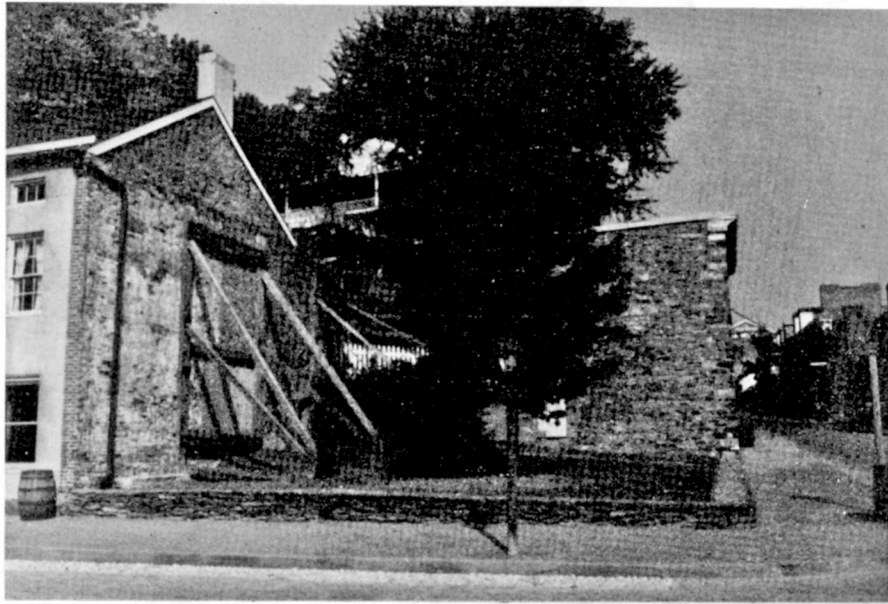
PHOTOGRAPH 18 (1981)  
Lot 51

Wood shoring has been placed along building 38's north wall (see photograph 18). After the building on lot 51 was torn down in the 1920s, the north wall of building 38 began deteriorating and falling away from the building; this shoring is an attempt to stabilize this wall.
