THE PHILIP COONS BUILDING  
SOMETIMES CALLED THE MASONIC HALL BUILDING  
(Building #44)

Harpers Ferry National Monument

Architectural Data Section

October 1962

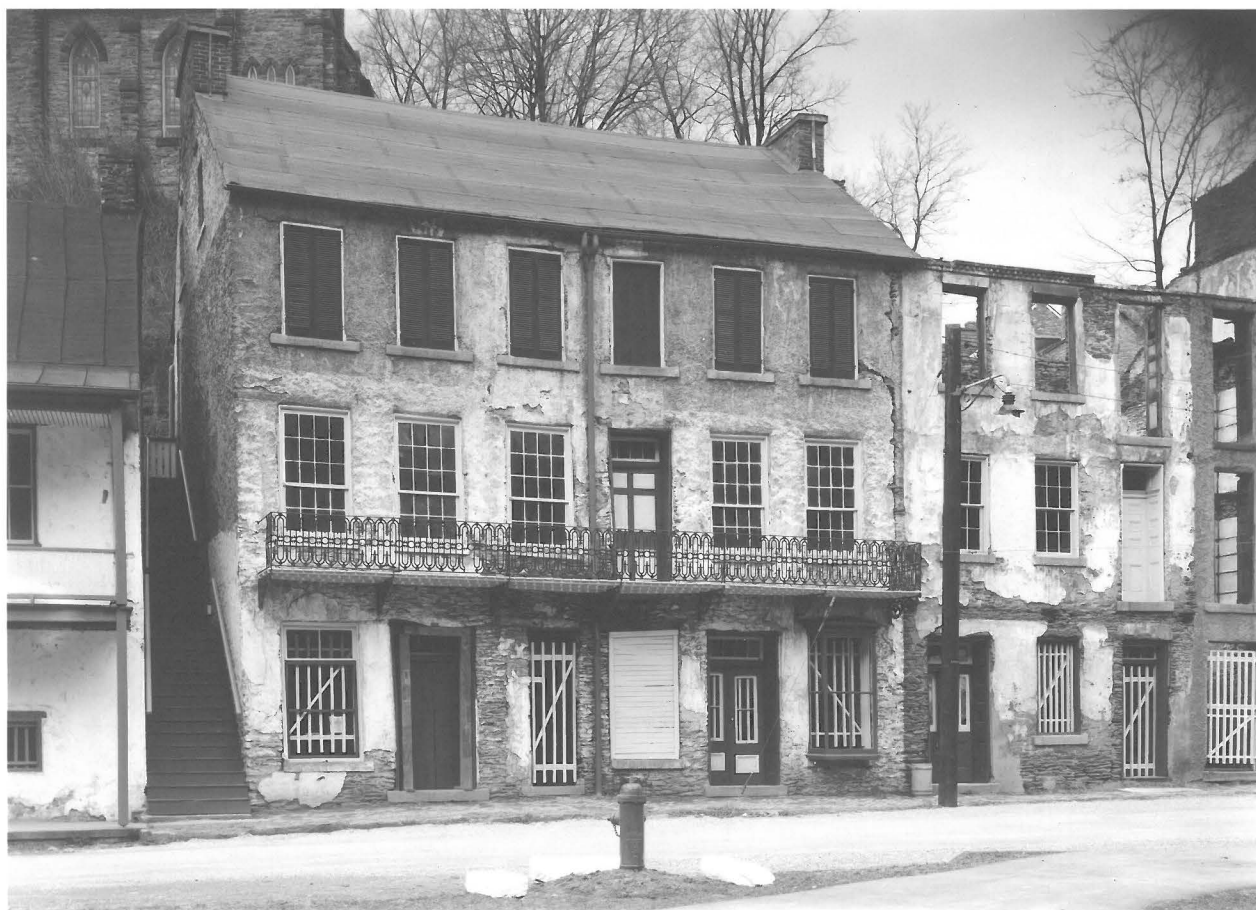
ILLUSTRATION NO. 1

SHENANDOAH STREET ELEVATION

To the left can be seen the flight of wooden steps that provided access to the second and third floors. This stairway also served the second floor of Stagecoach Inn. The second doorway from the left on the first floor level was formerly a window opening and was converted in recent years, as yet no date can be ascribed to the cast iron balcony railing on the second floor. The sash openings of the second floor windows on this elevation are smaller than the first floor windows but larger than the windows on the third floor. There are no shutter hinge mortises on the second floor window frames although they appear on the first floor frames. As can be seen the third floor windows are shuttered. The photograph shows how the pargeting has eroded from exposure to weather.

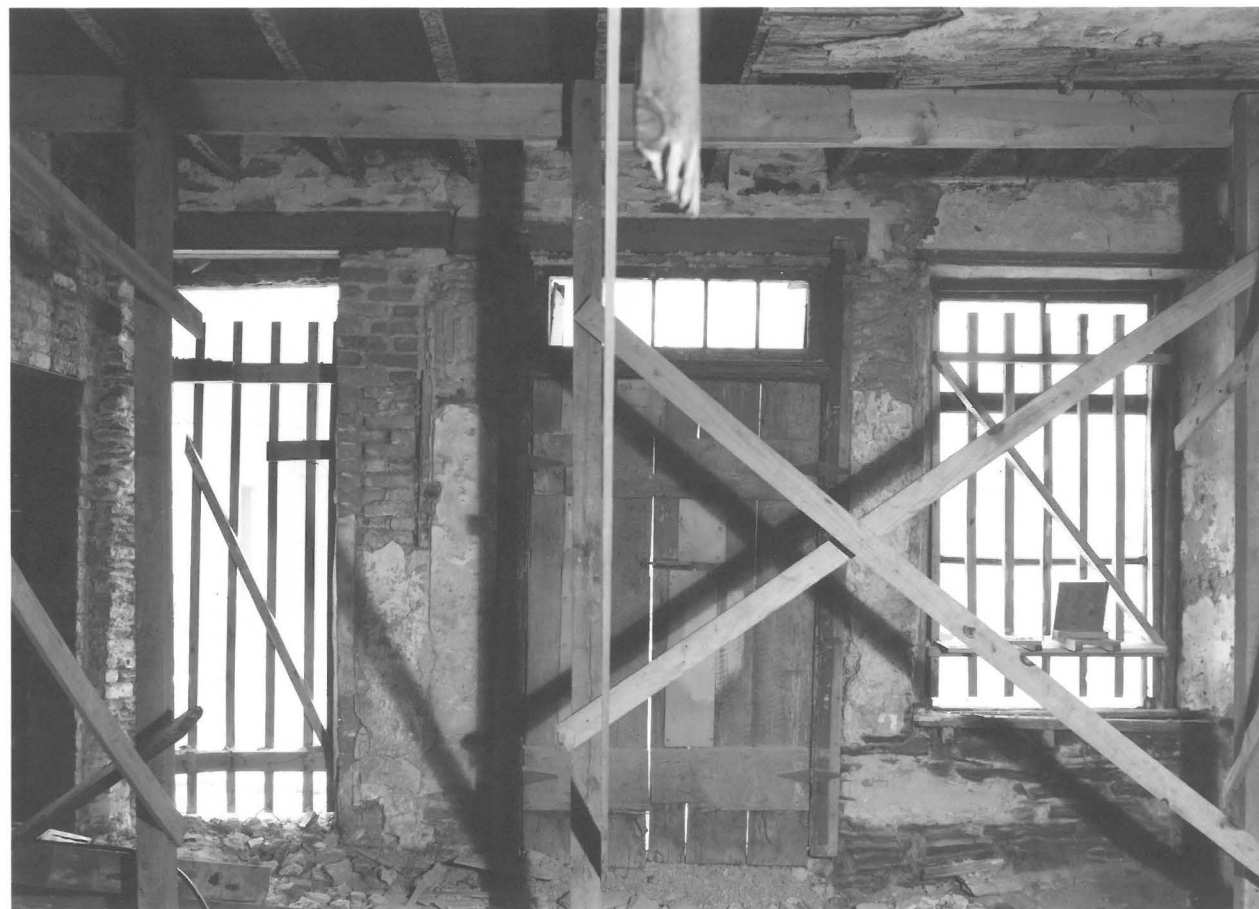
ILLUSTRATION NO. 2

CLOSEUP SHOWING INTERIOR OF SOUTHEAST EXTERIOR WALL

Floods and general neglect have all but destroyed physical evidence at first floor level. X-bracing and posts are part of shoring that had to be placed under the second floor system. Most of the doors and windows at this level are missing and will have to be reconstructed.

The interior walls and ceilings were plastered and the floor was wood flooring laid across wood joists with little space between the joists and the natural rock beneath them.

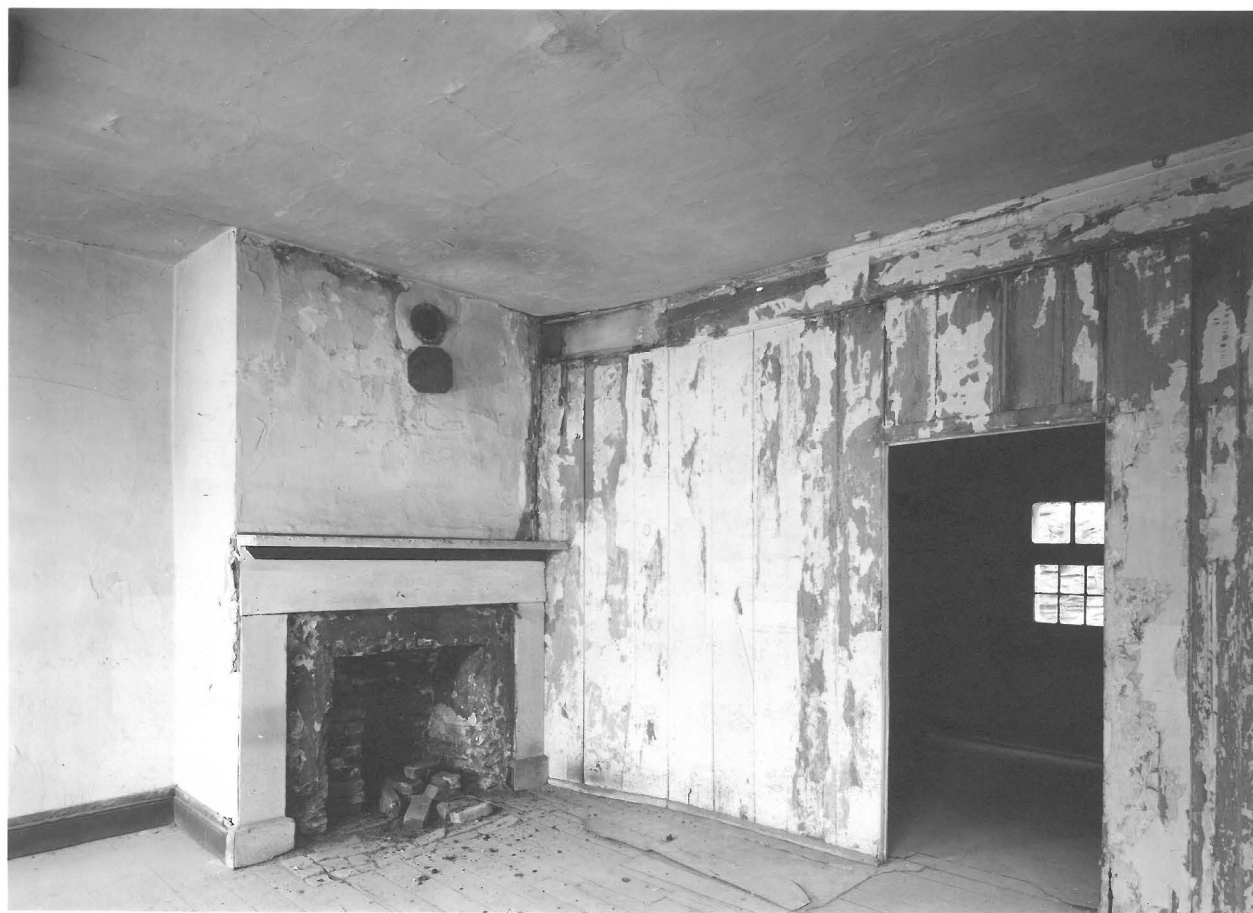
ILLUSTRATION NO. 3

INTERIOR VIEW OF SECOND FLOOR SOUTH ROOM

This floor level was divided into rooms by vertical board partitions. The boards are 7/8" in thickness, tongued and grooved with small beaded edges. Their original paint coat was a pinkish red. They were fastened top and bottom with chamfered wood strips. Only small sections of these partitions remain.

As indicated in the photograph the mantelpiece is simple to the point of crudeness. The baseboard is plain with a top beaded edge. Because of floor settlement, additional wood stripping was nailed to the top of the baseboard to close the gap caused by settlement. The flooring is tongued and grooved pine boards of random width.

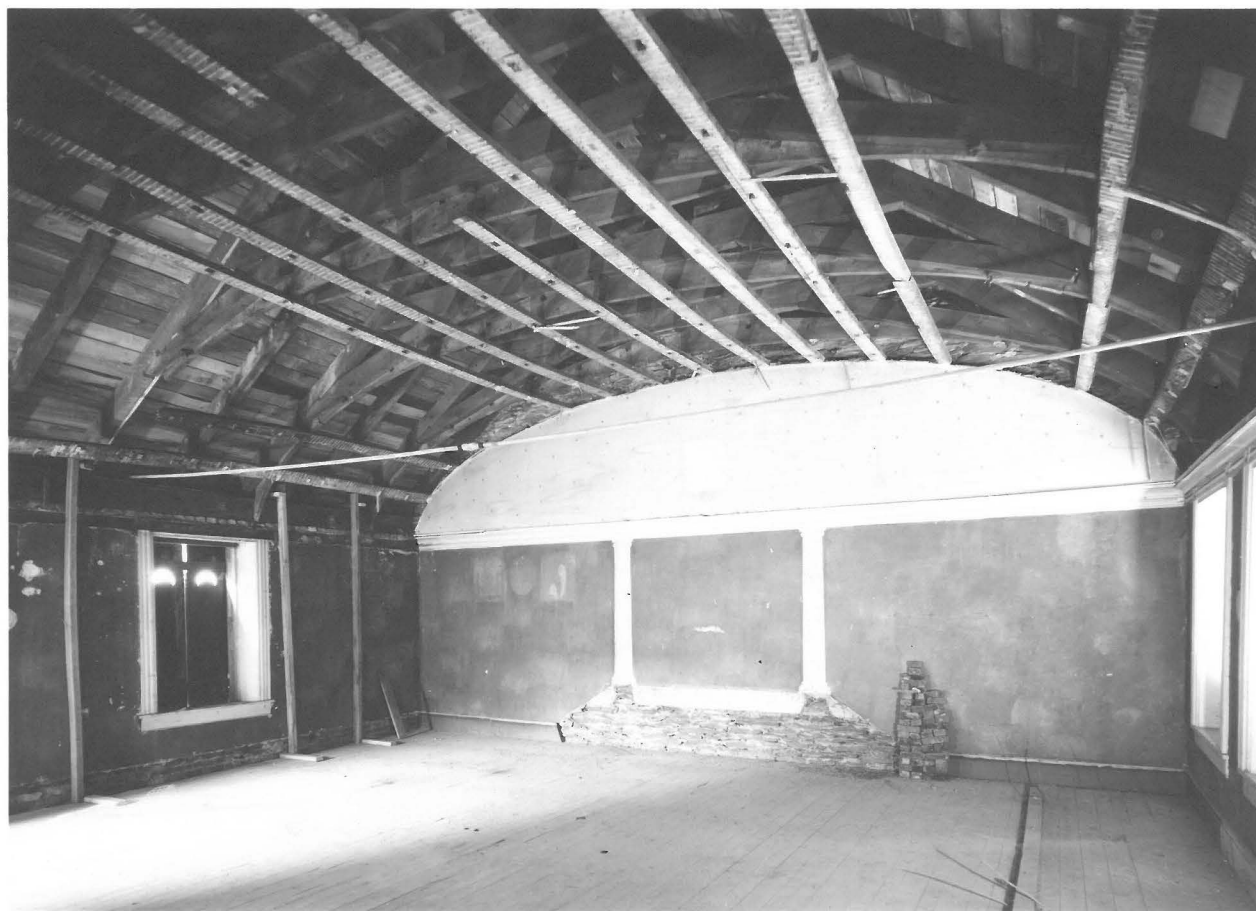
ILLUSTRATION NO. 4

VIEW OF MASONIC LODGE ROOM

The ceiling plaster was removed by the Service in 1956 when the roof structure was stabilized. The joints of the king post trusses are bolted together and it was found necessary to tighten these connections to bring the top chords into their proper position and prevent further sagging. The two tie rods, one of which appears in the photograph, were installed in 1892.

The long timbers with the mortises are reputed to be salvaged boat timbers from cargo barges floated down the rivers to Harpers Ferry and then broken up for sale.

The ceiling plaster and gable ends, down to the wood cornice line, were painted a light blue and decorated with clouds and stars.
