PRELIMINARY  
SURVEY REPORT  
(ARCHITECTURAL)

PAYMASTER'S HOUSE  
(BUILDING NO. 36, SHENANDOAH STREET)

HARPERS FERRY  
WEST VIRGINIA

by  
ARCHIE W. FRANZEN  
Architect

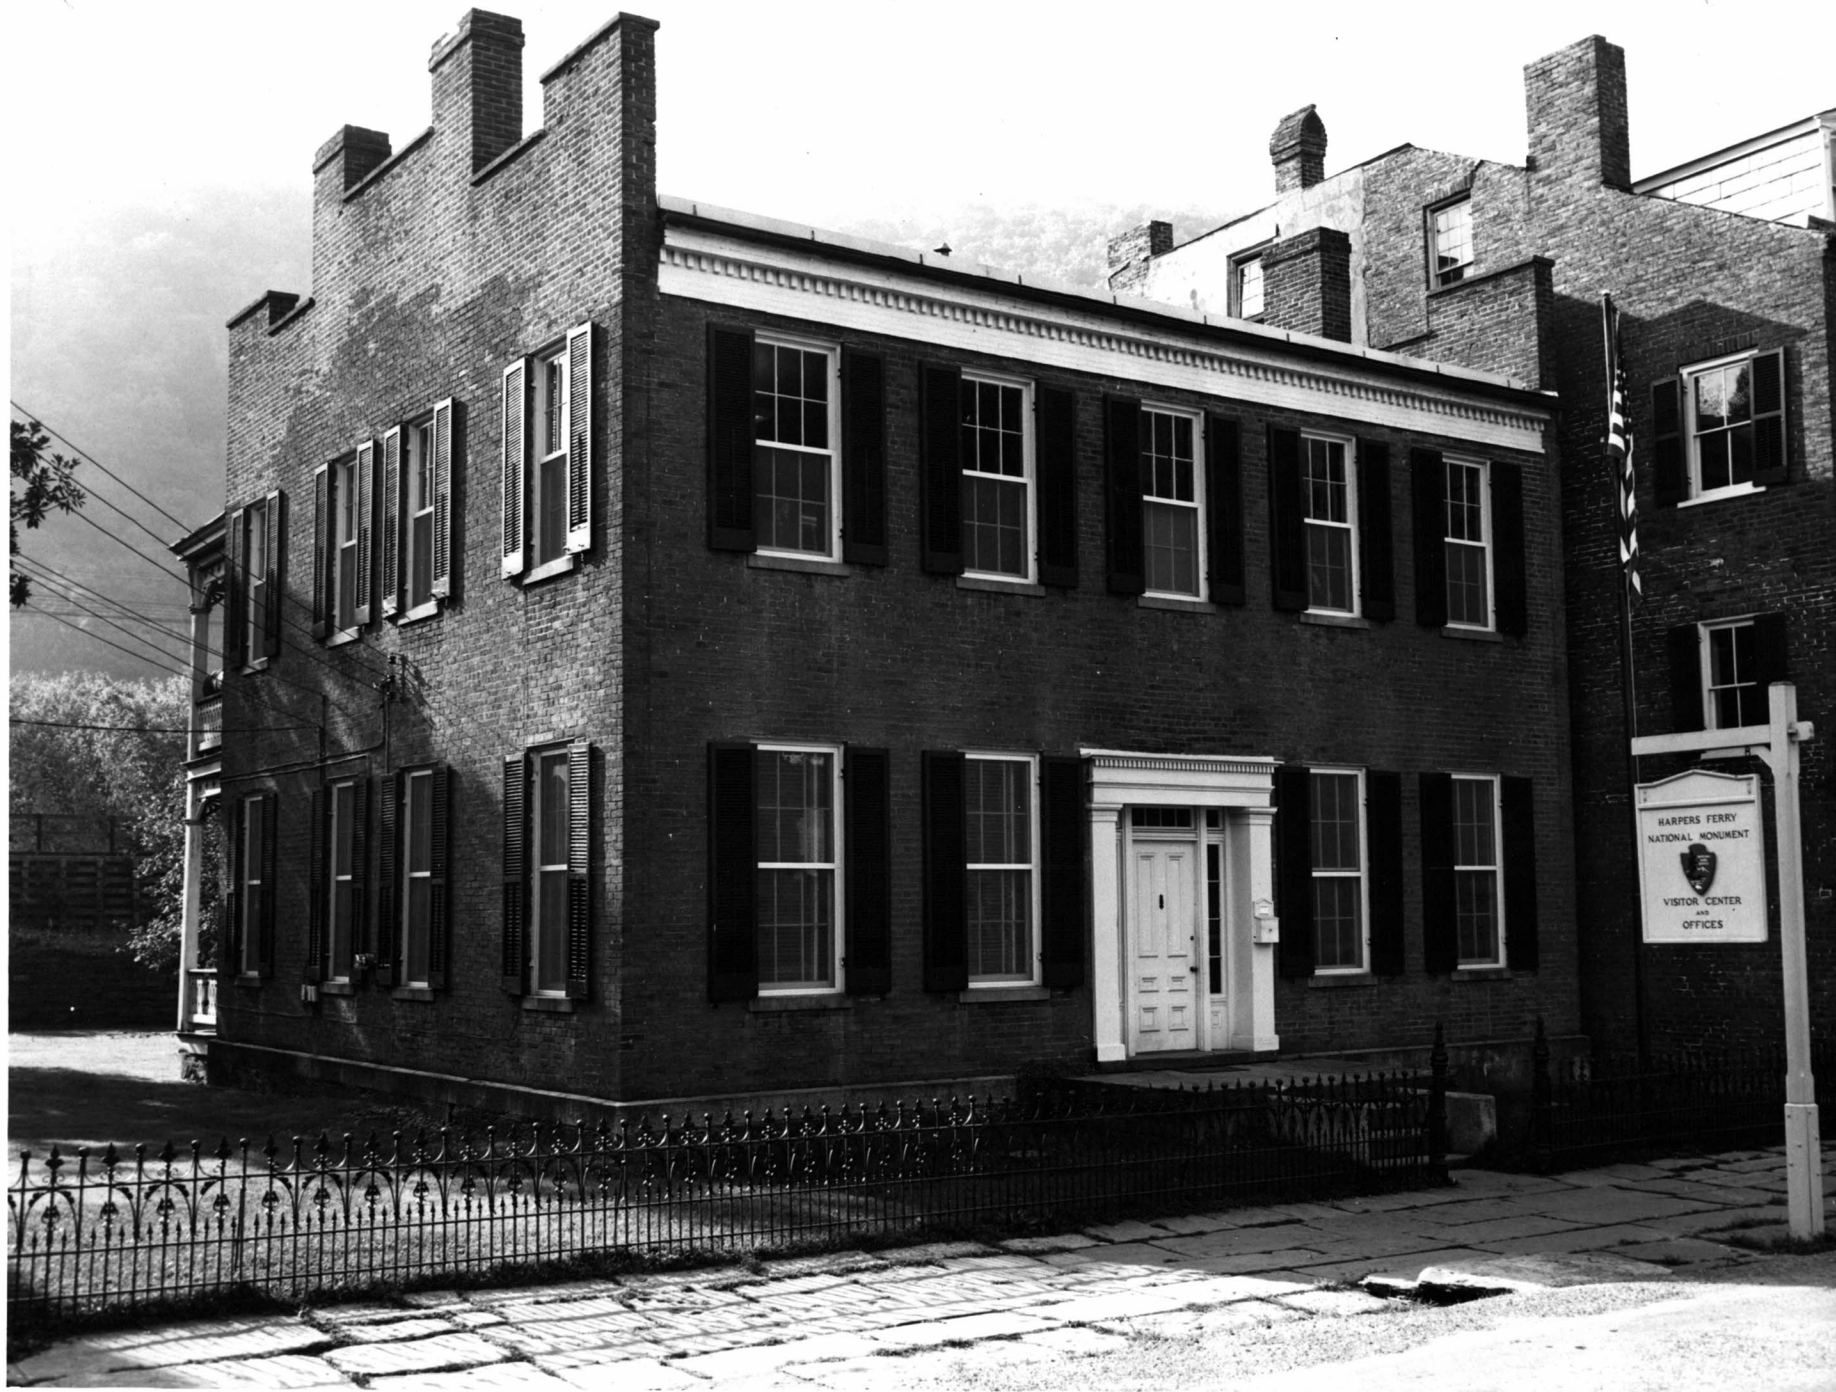
## SHENANDOAH STREET ELEVATION

Physical evidence indicates little change, if any, from the original appearance. Lintels over window openings are supported by  $3/8$ " thick by 4" by  $3-3/4$ " wrought iron angles with the exposed edge beveled to shed water. Earlier painting of the brickwork has been removed with only vestiges remaining to show that it was formerly painted. Note projecting cut stone water table and window sills. Coping stones capping the parapets are red sandstone. Brick is a mixture of soft and hard burned bricks.

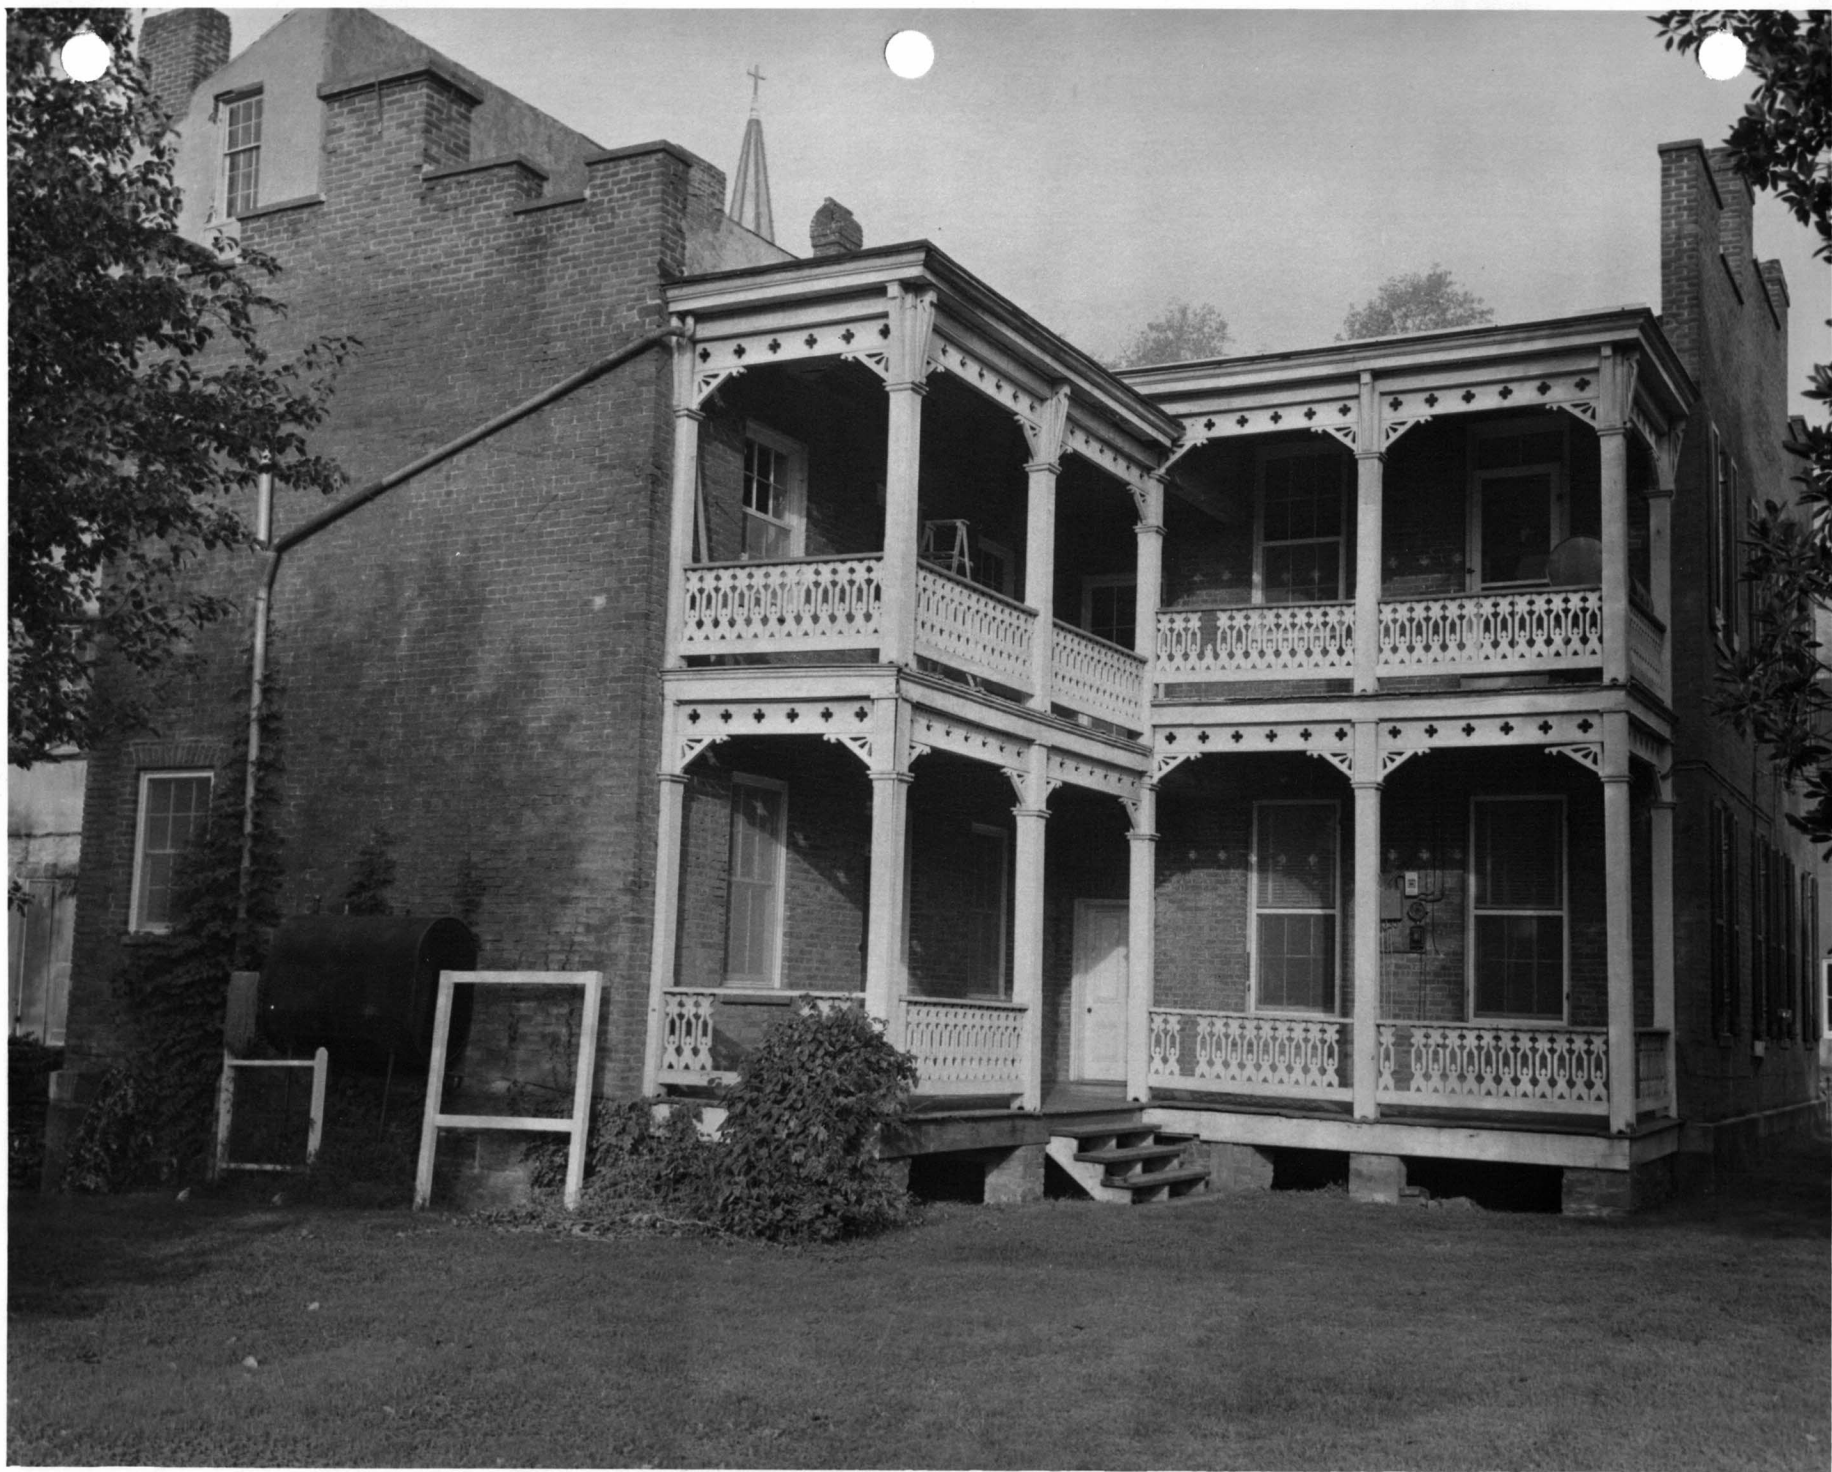
## RECENT REAR VIEW SHOWS PORCH GALLERIES

The galleries appear to have been in two stages. The two-story porch parallel to the rear portion was built first with a later connecting addition to the rear of the main portion. The door opening on to the second floor of the porch from the main portion was a window at one time. Paint scrapings from the brickwork behind the engaged porch columns show that the brickwork of both portions was originally painted a medium gray, then painted red. Decorative mouldings on the porch columns were applied after the columns had been painted an other color. Balustrading of the porch rails have no trace of an other paint having been applied.

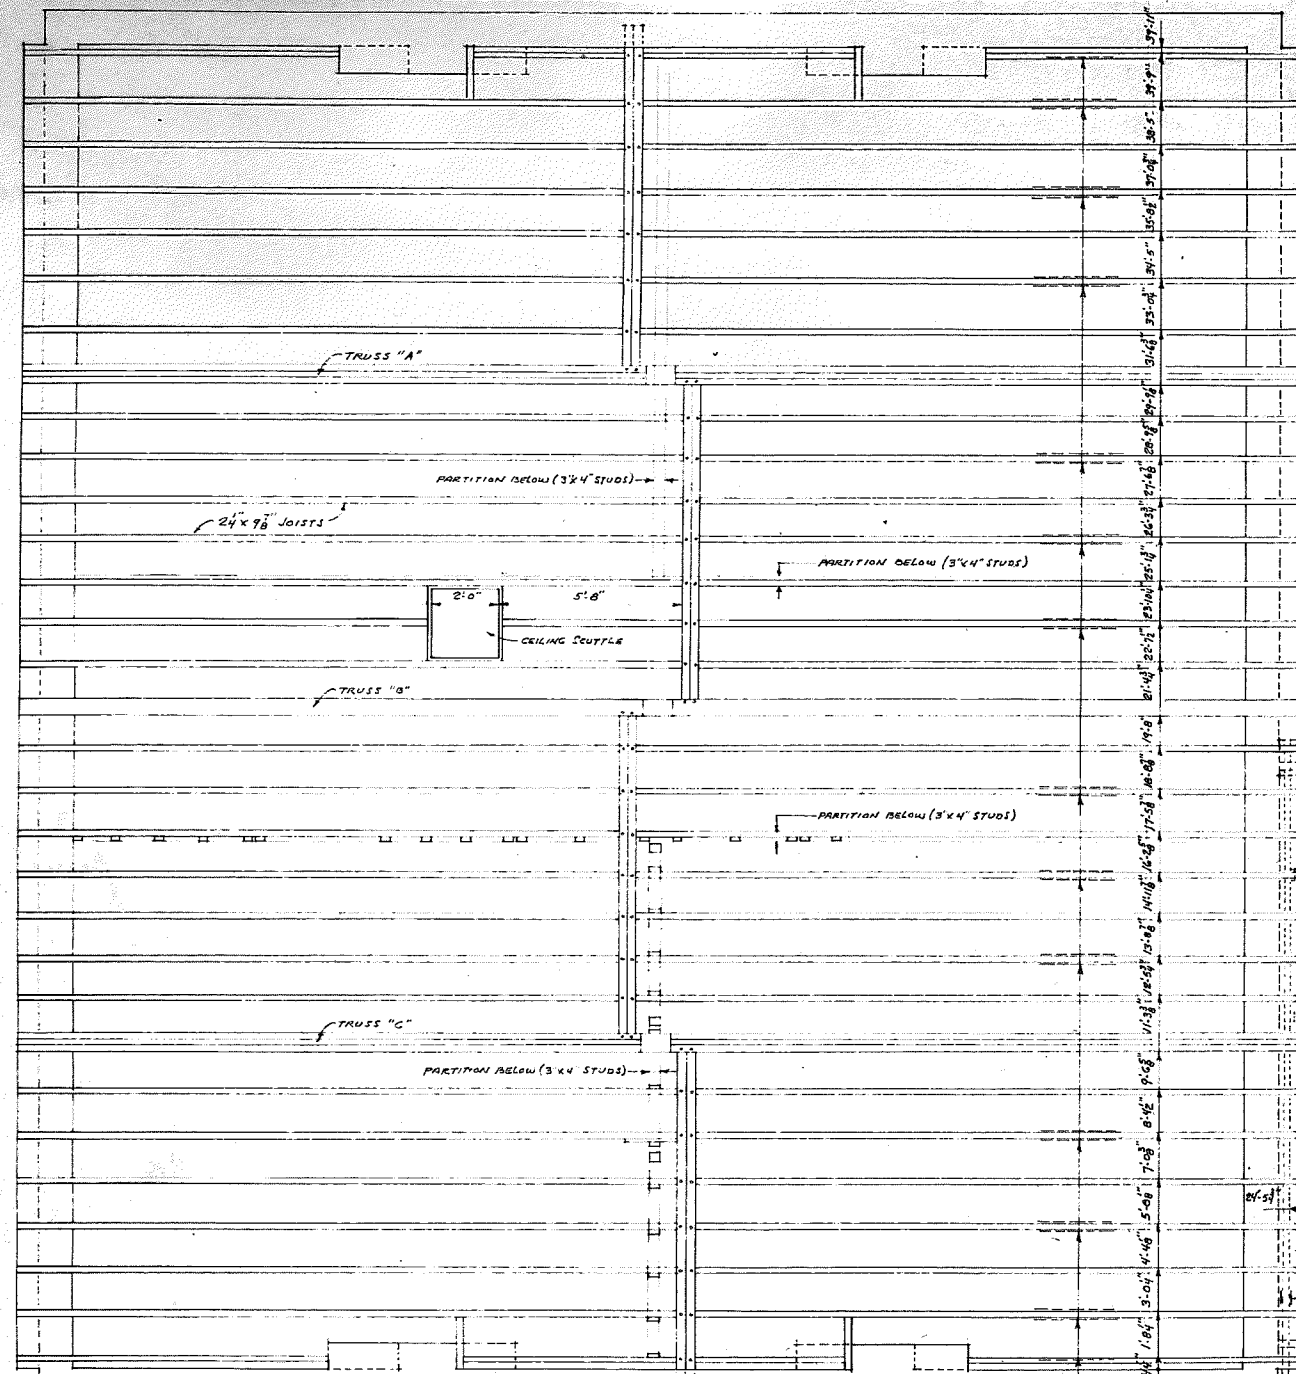
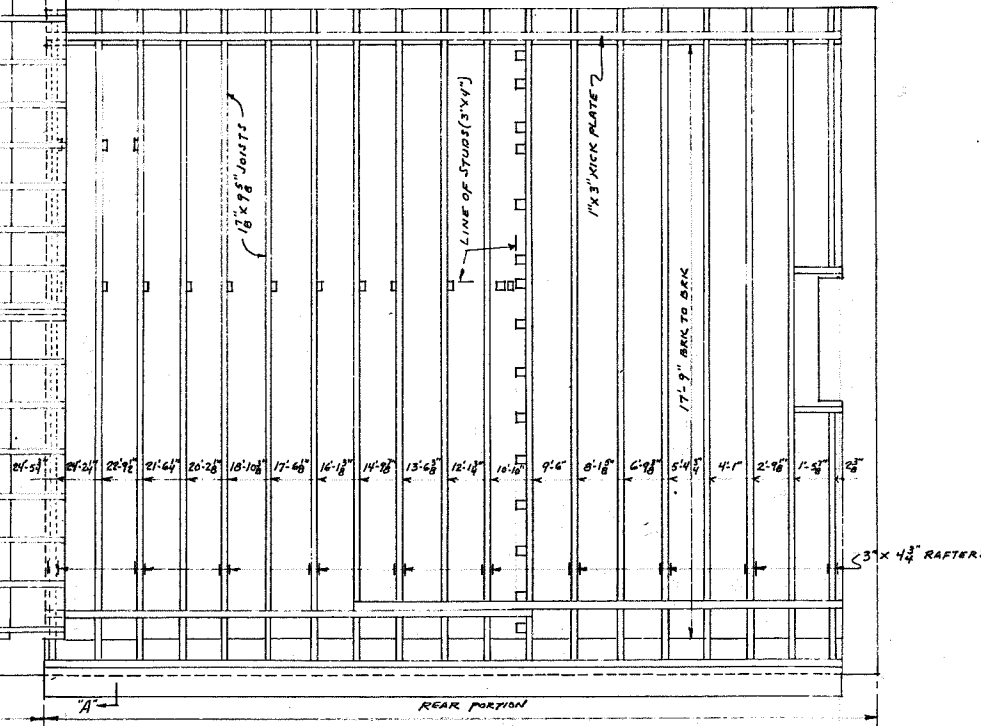
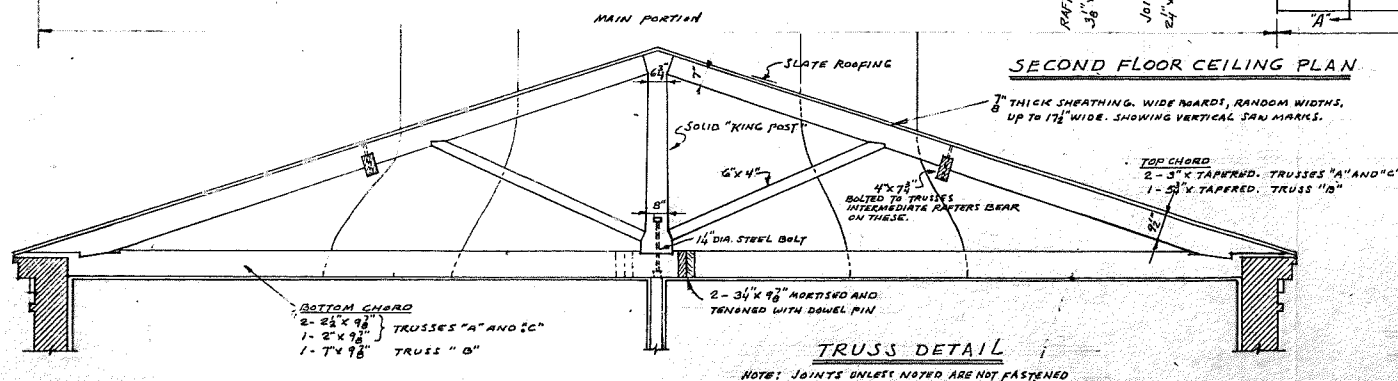
| | | JOIST, RAFTER AND TRUSS ARRANGEMENT |

Drawing NM-HF 3078 shows pertinent supplementary structural data that will affect the heating design layout. Additional information is to be found on measured drawing NM-HF 3067. It would be desirable to pass horizontal piping and ducts above the attic ceiling joists and below the first-floor joists in the basement. Vertical piping and

ducts should be run between existing interior partition wood studs and/or in inactive chimney flues.
