HOT SPRINGS NATIONAL PARK

Cultural Landscape Report and Environmental Assessment

January 2010

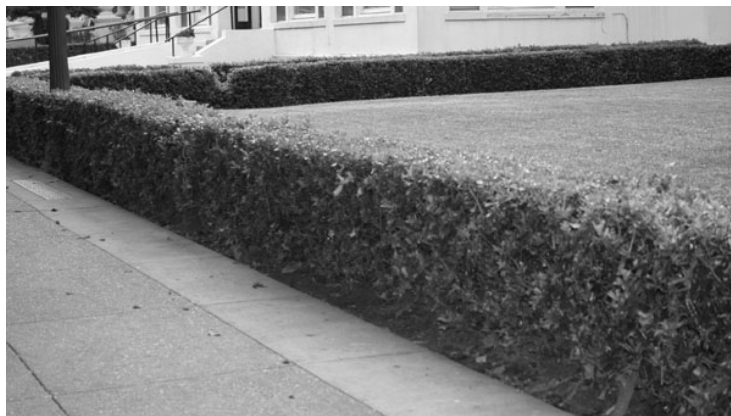
Figure 3- 7: Holly hedge (MBD, 060705-79)

<i>Landscape Feature</i>	<i>Figure Number</i>	<i>Description</i>	<i>Condition</i>
Holly hedge	3-7	The holly hedge (<i>Ilex cornuta</i>) lines the linear walk and adjacent Bathhouse sidewalks, delineating the turf lawn in the front and side yards of the Bathhouses.	Good/Fair Sections of the hedge are missing.
Magnolia Promenade/ Southern Magnolias	3-8	Southern Magnolia (<i>Magnolia grandiflora</i>) trees are planted along the raised curb in a turf grass lawn along Central Avenue. Some are more than 50 years old, and some newer plantings of the same species have been planted as in-fill trees.	Good Further evaluation by an arborist recommended.
Lawn	3-9	Turf grass lawns at the front and sides of the Bathhouses, extend to the holly hedge.	Good Some thin and damaged spots in intermittent locations.
Holly trees	3-10	Holly trees (<i>Ilex opaca</i>) are planted in some of the lawns in front of the Bathhouses.	Good

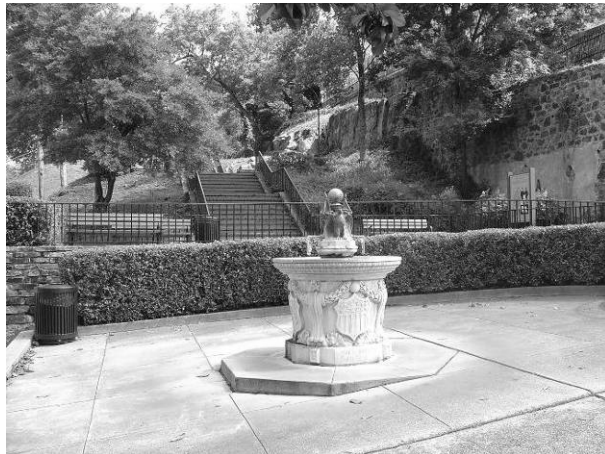
At the far southern end of the Grand Promenade, the area surrounding the Noble Fountain includes a simple hedge of holly, 3' wide by 4' high that follows the curved retaining wall. The hedge is in good condition. Another holly hedge at the western edge of the plaza above the Noble Fountain is discontinuous and in poor condition. The eastern side of the Grand Promenade in this area includes a dense groundcover of honeysuckle vine, periwinkle, and ivy in some places and turf, weeds, or bare dirt in others. The midstory and canopy contains nandina, a holly hedge, a hackberry, and a tulip tree. The hedge is in poor condition and the rest of the plants are in fair condition. The vines are climbing the hackberry trunk. From this area extending to the north the vegetation on both sides of the Grand Promenade is sparsely spaced, including leggy trees (pin cherry, hackberry, elm, cedar, oak, magnolia, redbud), occasional shrubs (holly and nandina) near seating areas, and turf, weeds, or bare ground.

Figure 3- 11: Vegetation at southern end of Grand Promenade (QEA, DSC01722)

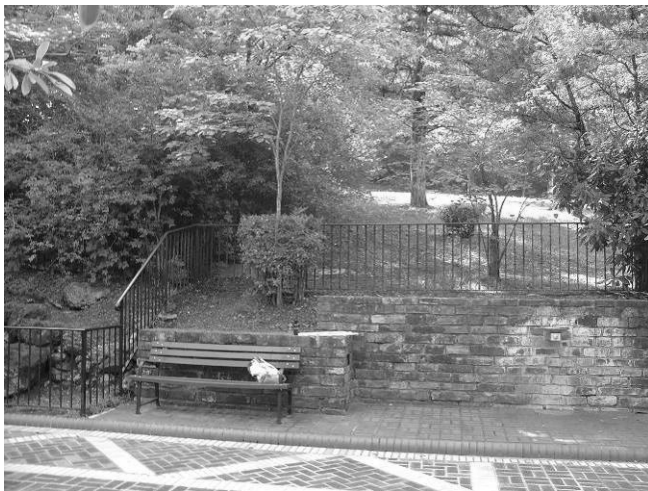
Directly across the Grand Promenade from this spot, brick plaza #3 is edged with a retaining wall and sparse, leggy trees. Kudzu and ivy are prevalent and other species are mostly absent. The ground is eroding.

Figure 3- 16: Vegetation near the Hot Water Cascade Display Spring (QEA, DSC01888, June 2005)

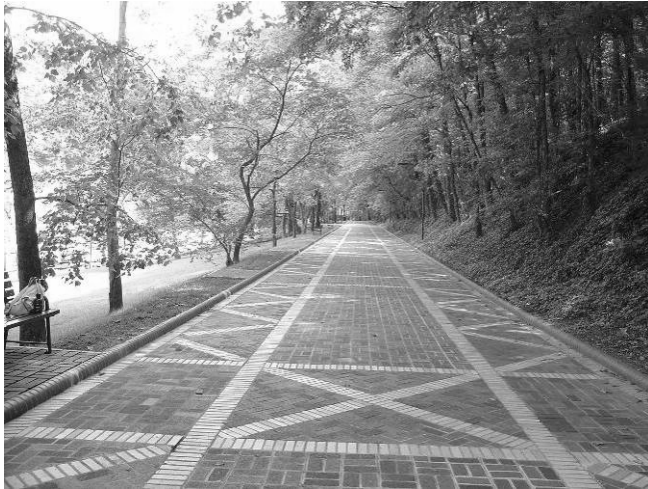
The eastern side of the promenade in this area (beginning across from brick plaza #4 and extending to Fountain Street) slopes up away from the walkway and contains dense vegetation. The groundcover is thickly coated with English ivy that is also growing up and over many of the other plants. The woody plants include white oak, elm, tulip tree, cedar, sweet gum, maple, and holly. The ivy is impacting all of the woody plants.

Figure 3- 17: Vegetation along Grand Promenade north of the Hot Water Cascade Display Spring (QEA, DSC01945, June 2005)
