# Hot Springs National Park Buckstaff Bathhouse Historic Structure Report

**June 30, 2026**

# Historic Structure Report

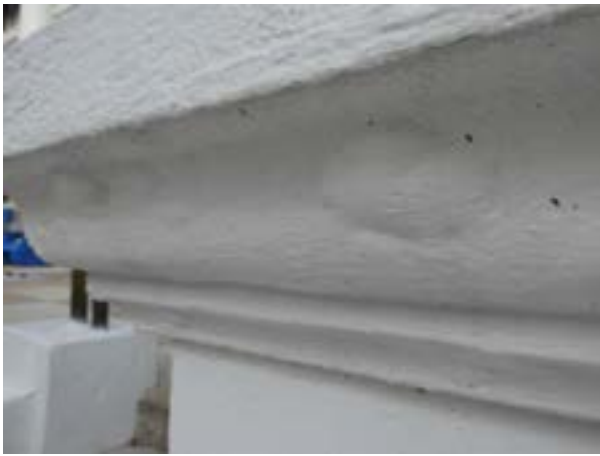
**Figure 1.D.28.** Minor cracking was observed in the concrete walls supporting the porch on the east elevation of the building.

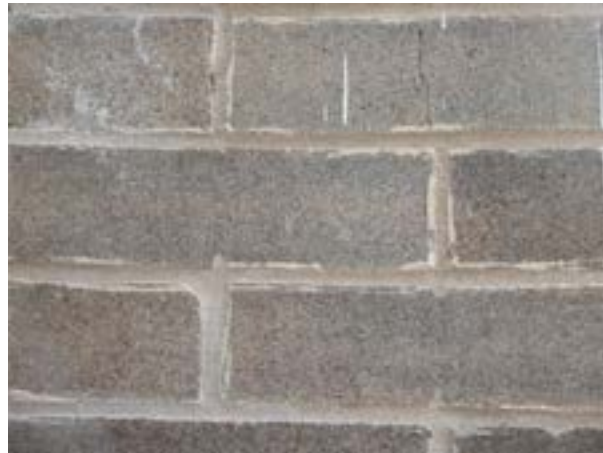
**Figure 1.D.32.** All of the mortar joints have been cut out and repointed. In general, they are in good condition but there is evidence of a lighter colored cementitious material on portions of the brick. This is probably a remnant of a previous repair effort where the mortar joints were "masked and grouted."

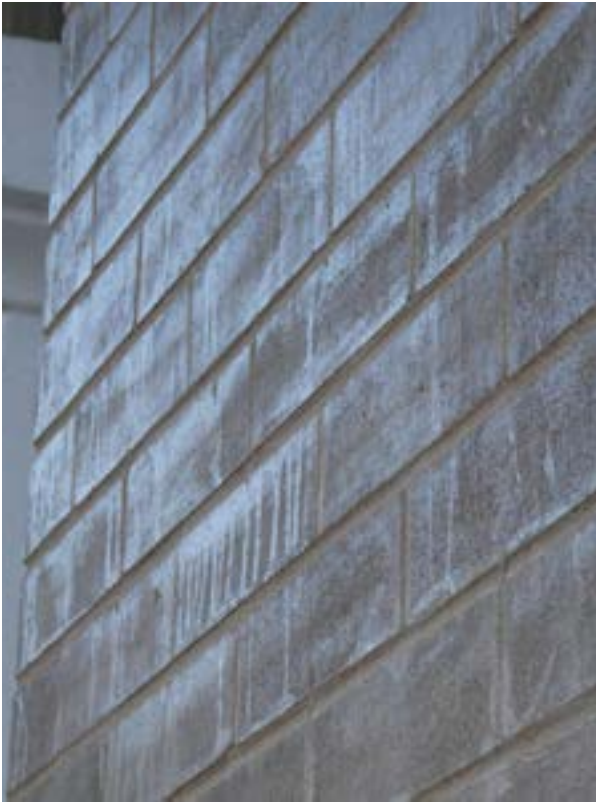
**Figure 1.D.33.** A location where the remnants of the "mask and grout" repair is much more evident.

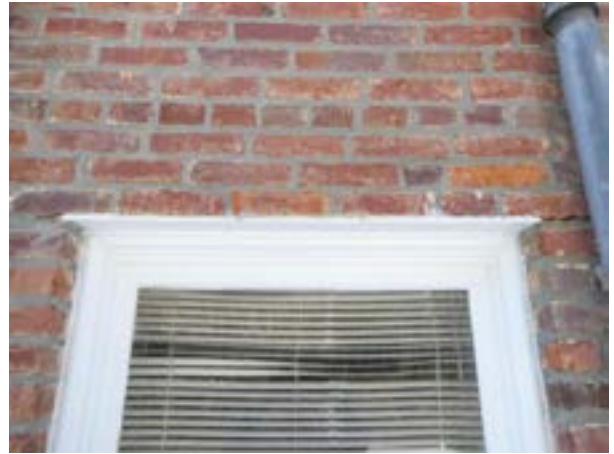
**Figure 1.D.43.** Sealant joints are often beginning to debond.

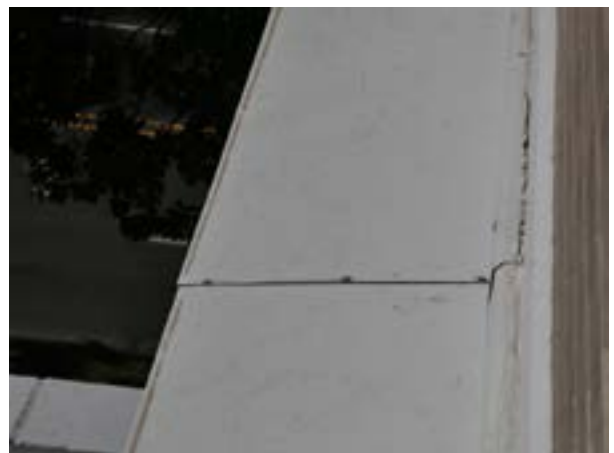
**Figure 1.D.45.** The sealant joint at this interface has typically failed.

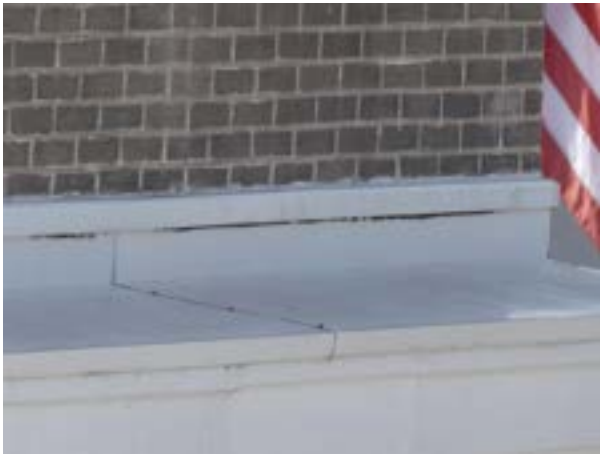
**Figure 1.D.49.** Gaps in this lap may allow wind driven rain to infiltrate under the metal.

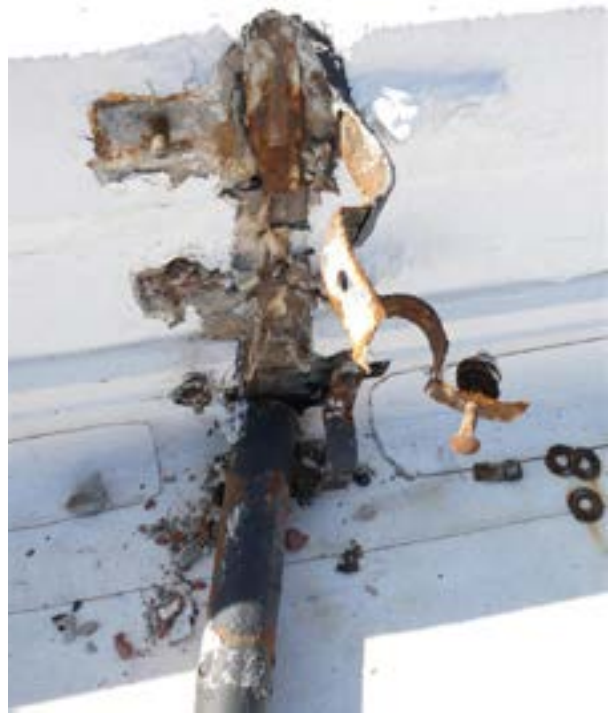
**Figure 1.D.51.** The flagpole has fallen onto the upper roof.

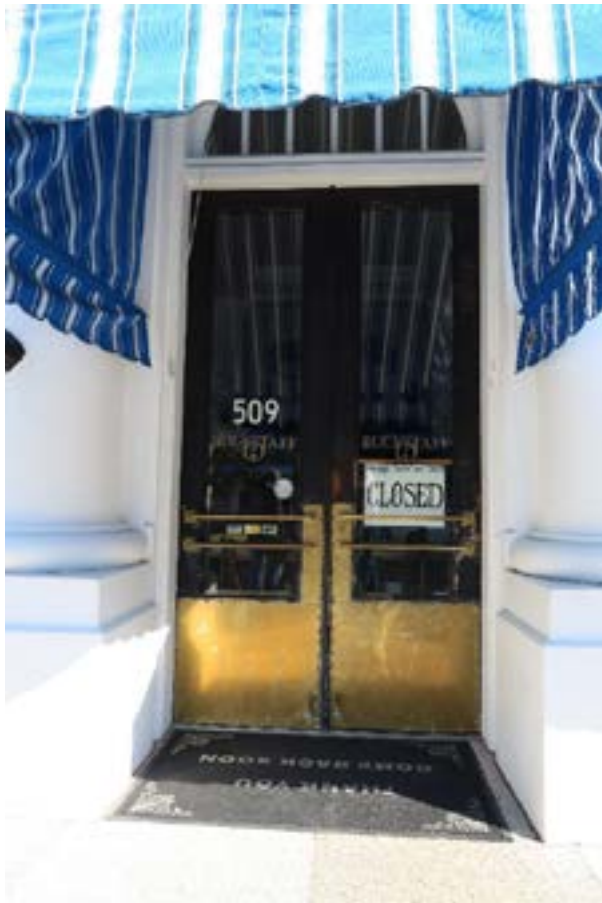
**Figure 1.D.56.** Front doors, showing wear to finishes.

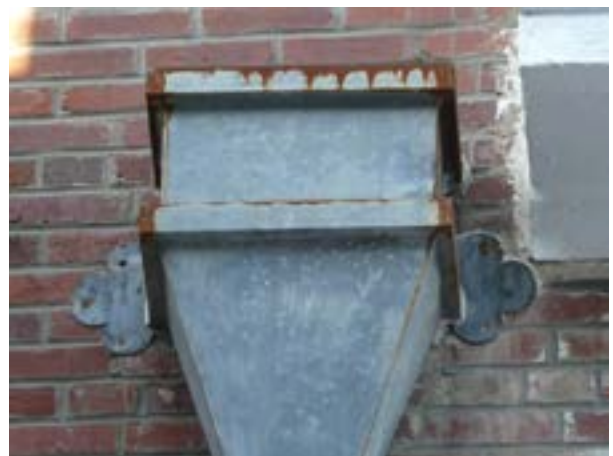
**Figure 1.D.62.** The original collector heads and downspouts are also made of terne metal. The base steel is beginning to corrode.

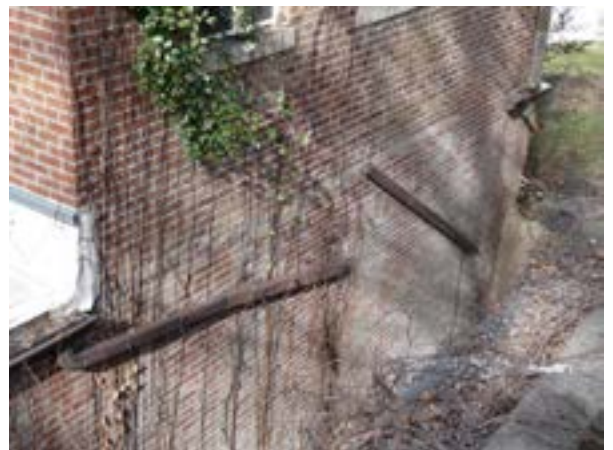
- A few of what appear to be the original collector head and downspouts still exist in the back of the building. Field swab tests reveal they are also fabricated from terne metal (Figure 1.D.62 & Figure 1.D.63).
- Newer aluminum gutters and downspouts have been installed throughout much of the building. The roofs are pitched to drain water to the east or back side of the building. Several of these newer aluminum downspouts are in disrepair (Figure 1.D.64).

**Figure 1.D.64.** One of the more recent aluminum downspouts has failed.

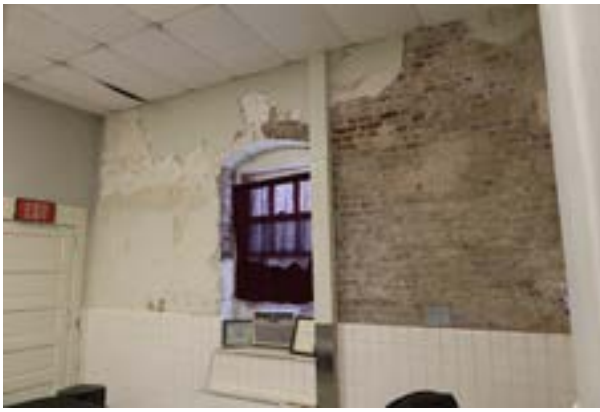
**Figure 1.D.66.** Interior plaster wall surfaces are in good condition overall except at areas where water infiltration has caused damage. The east wall of room 107 exhibits the worst plaster damage in the building. The ceramic tile wainscoting is believed to date from the 1950s and is in good condition overall.

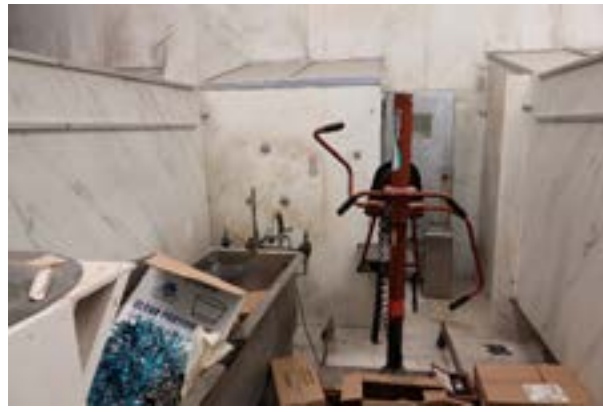
**Figure 1.D.68** Mineral accumulation and staining at marble wall panels and partitions in men's bath hall (106).

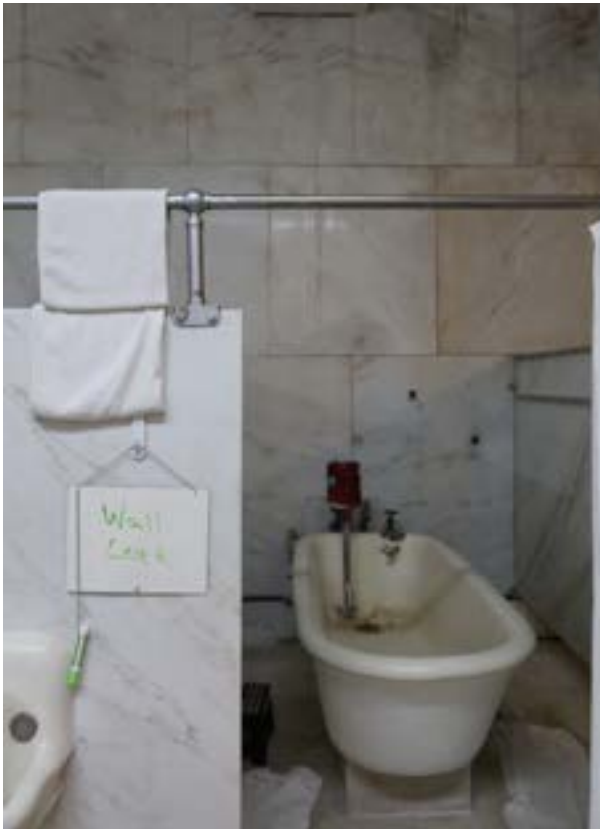
**Figure 1.D.67.** Staining of marble wall panels at north wall of men's bath hall (106) from plumbing leak.

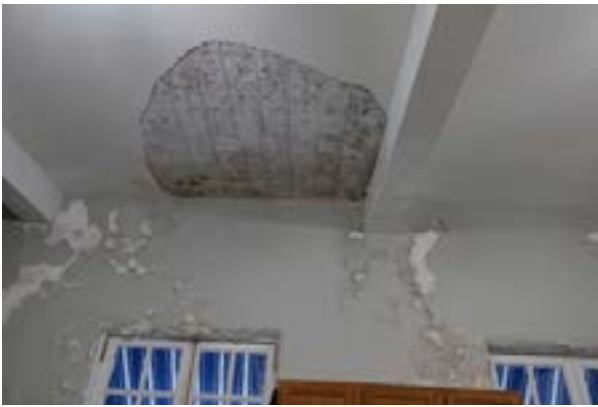
**Figure 1.D.69.** Plaster ceiling finishes are in good condition overall. This area below a major roof leak in room 300 exhibits some of the worst plaster damage in the building.

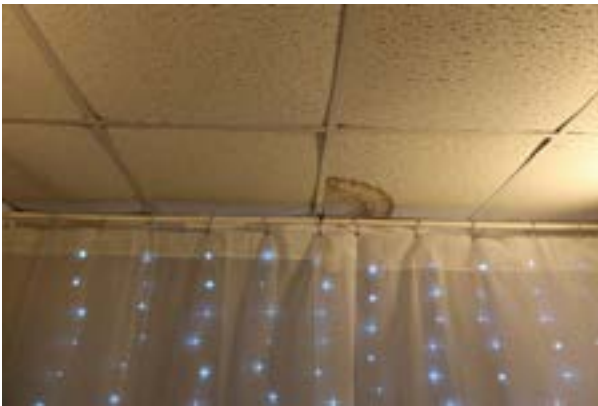
- All suspended ceilings are non-historic and are in fair condition. Leaks in room 300 have stained tiles over the partitioned massage rooms. The ceiling tiles over the office (101) are past their expected life and are sagging and cupping. (Figure 1.D.45)

**Figure 1.D.70.** Non-historic suspended ceilings are in fair condition, with staining from leaks and typical and sagging cupping of aging acoustical tiles.

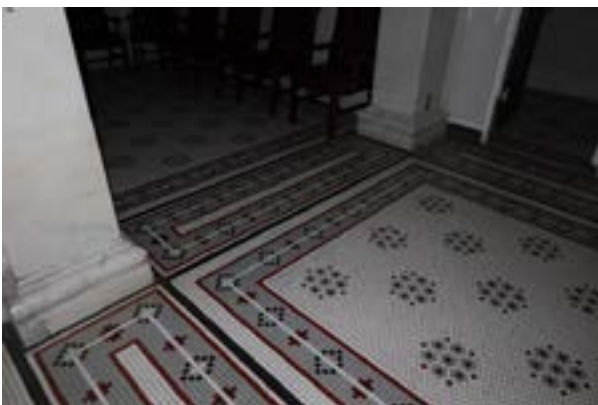
**Figure 1.D.71.** The building's original mosaic tile floor are in unusually good condition for their age, with minimal cracking damage.

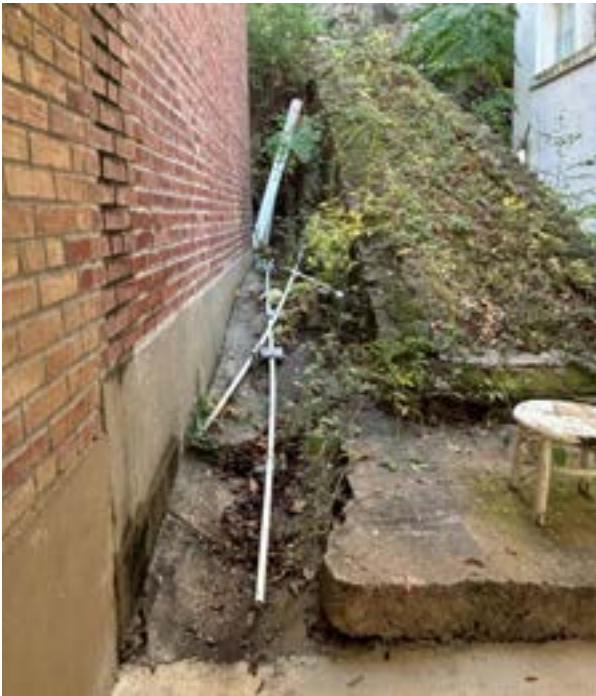
**Figure 1.D.88.** Paved area between the southeast corner of the bathhouse and the stone buttress/ramp is paved with concrete, sloped to facilitate drainage from behind the building to the surface drainage south of the building. The concrete is in fair condition with cracking and debris present (RATIO, 2025).

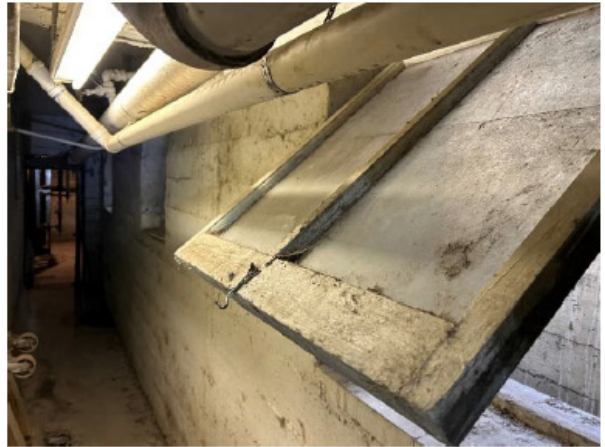
Photo 2 RACM window glazing observed on basement windows HA-7.

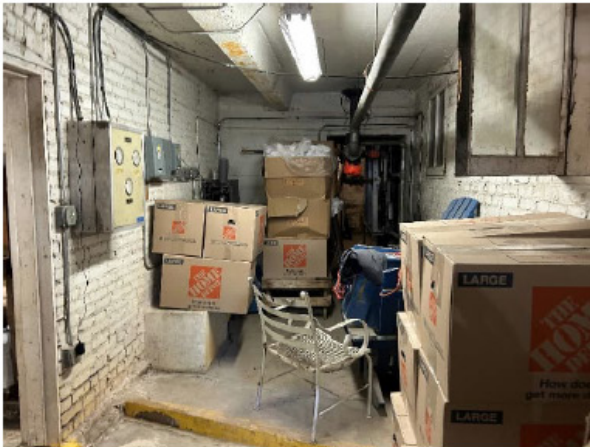
Photo 3 Basement with window with RACM window glazing HA-7.

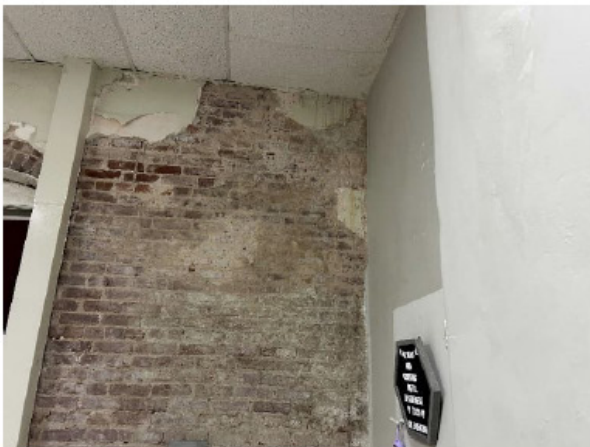
Photo 5 Damaged wall plaster
