HISTORIC STRUCTURES REPORT
HOT SPRINGS NATIONAL PARK

PREPARED FOR THE
NATIONAL PARK SERVICE
U.S. DEPARTMENT OF THE INTERIOR

CROMWELL, NEYLAND, TRUEMPER, MILLETT & GATCHELL, INC.
ARCHITECT - ENGINEER
LITTLE ROCK, ARKANSAS

NOVEMBER, 1973

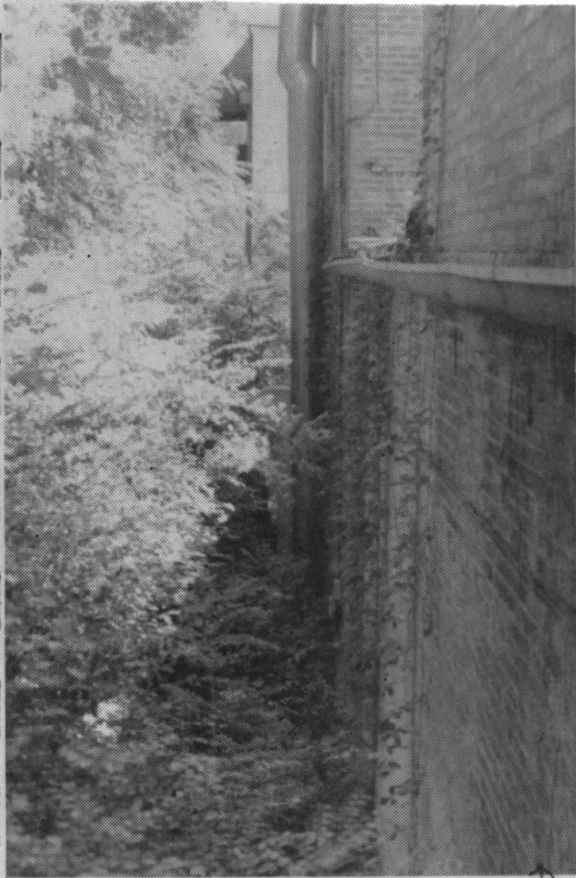
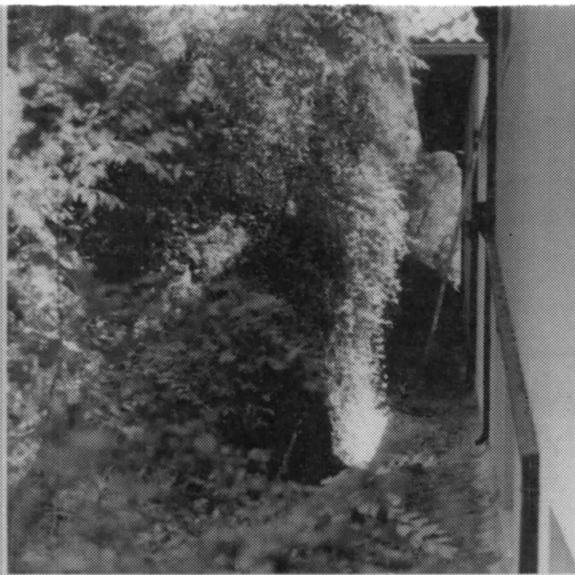
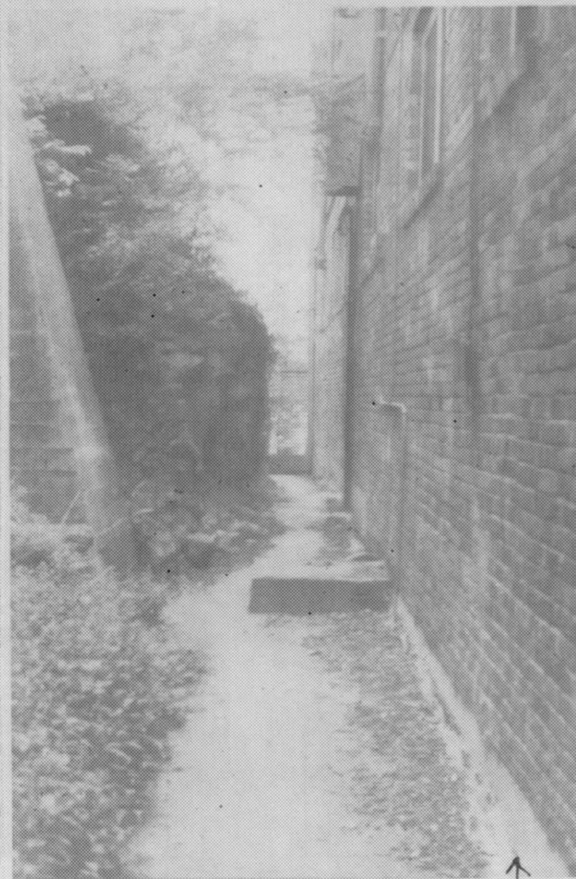
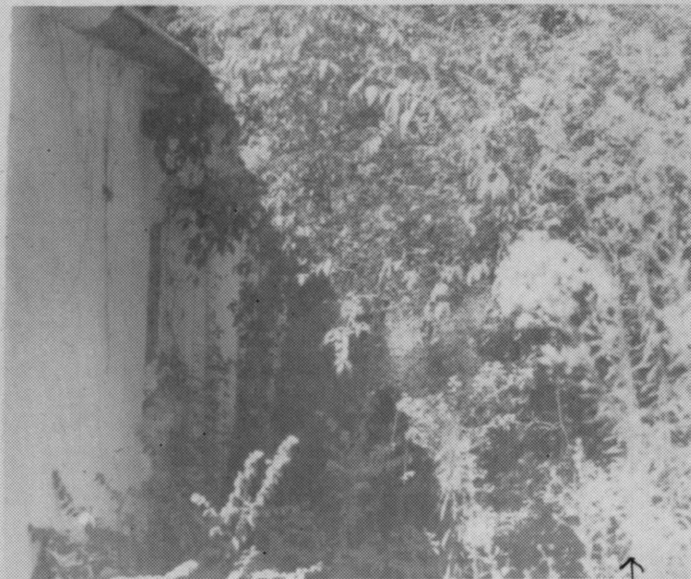
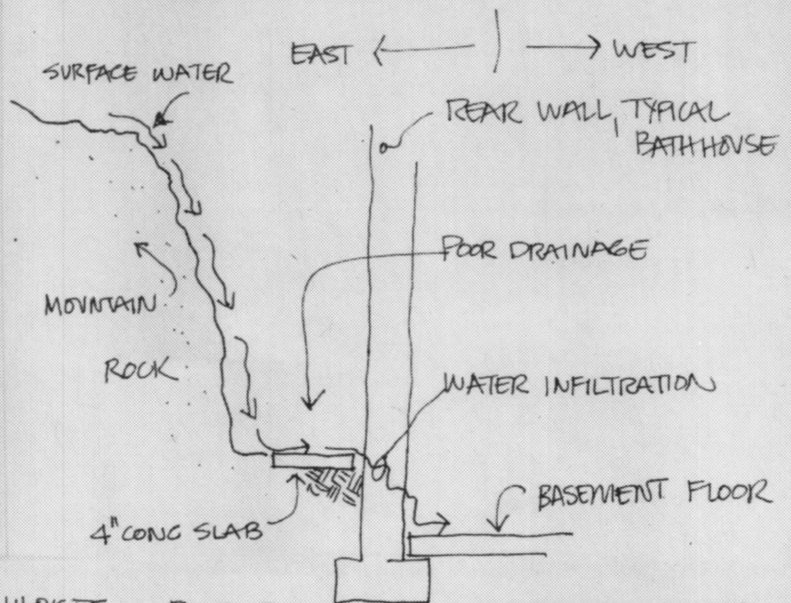
- C. Surface water which runs down the mountain in some cases runs against the rear walls of the bathhouses and in most cases this is not properly handled (see following sketch). This needs to be corrected because this water is infiltrating into the buildings and causing plaster and mortar deterioration.
- D. The roofs in all cases but the Hale and the Visitor's Center have not been maintained and have many successive layers of roofing. In order to properly remedy the leaks in all of the bathhouses except the Hale, these roofs need to be completely removed including the flashing, cleaned, the decking repaired, reroofed and reflashed, with all necessary repairs made to the downspouts. This is the major single expense to be incurred in preserving these buildings.

TYPICAL SITUATION @ REAR OF BATHHOUSES - POOR DRAINAGE OF SURFACE WATER

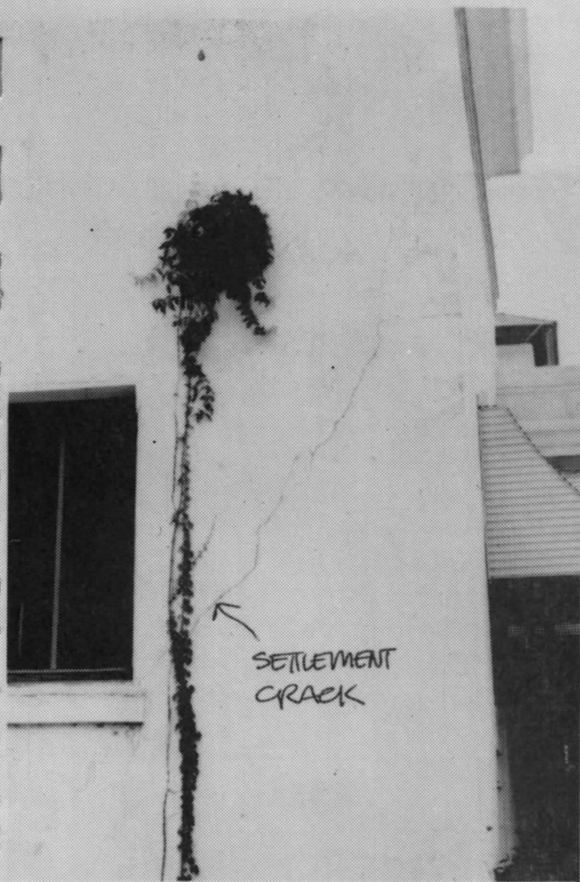
SETTLEMENT
CRACK

north side

SURFACE CRACK IN STUCCO

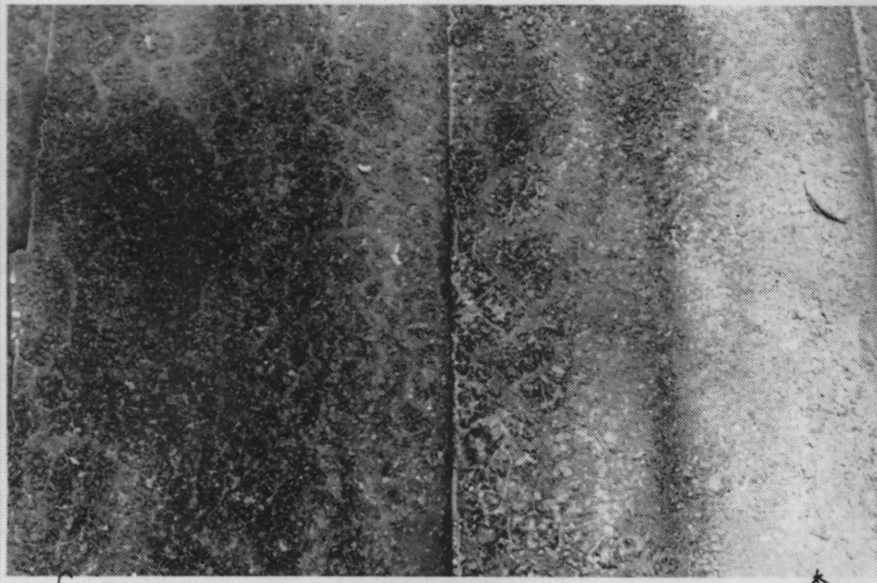
roof - NEEDS REPLACEMENT

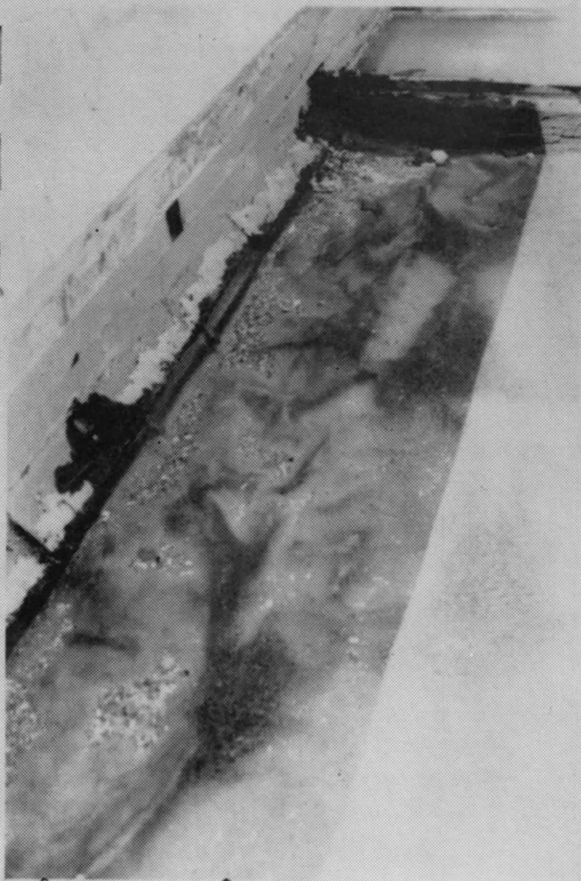
roof - no. side of skylight

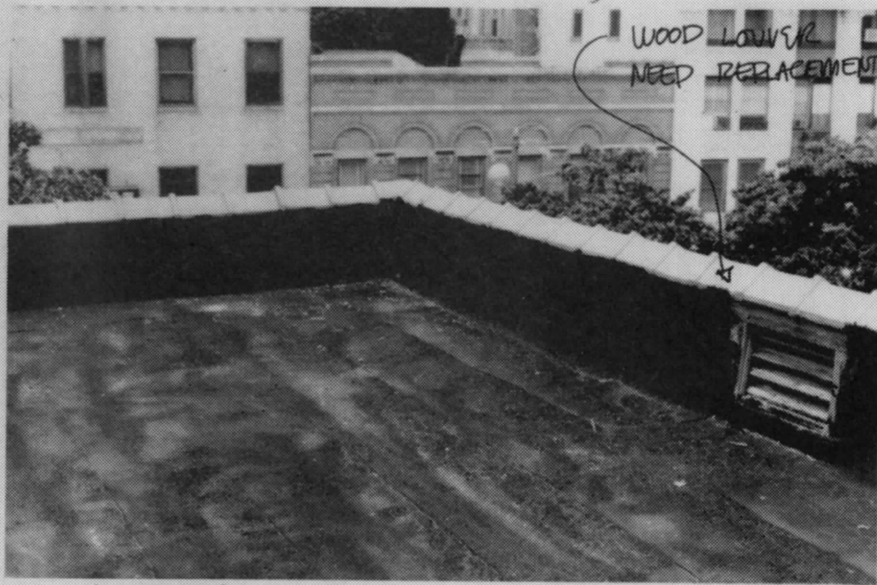
no. west corner

WOOD LOUVER
NEED REPLACEMENT

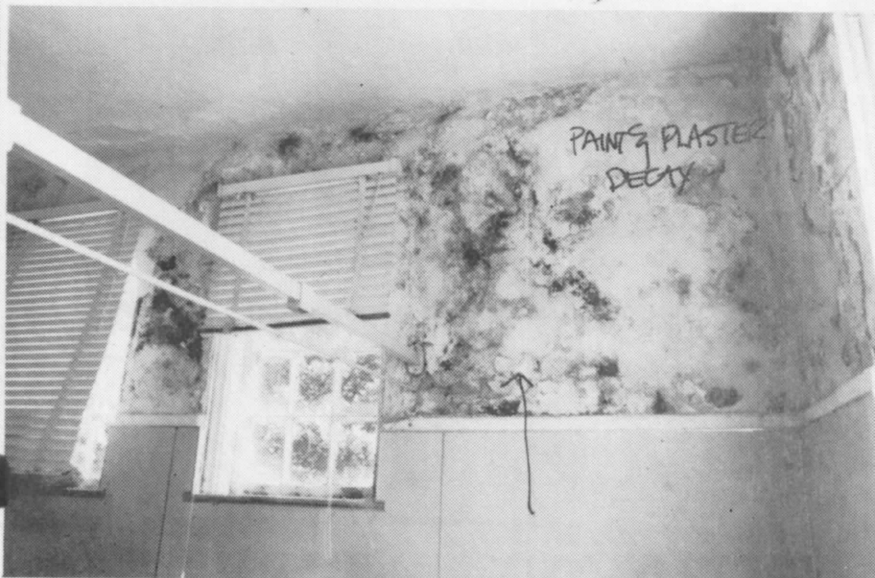
202 EVIDENCE OF ROOF LEAKS - 2ND FLOOR ↑

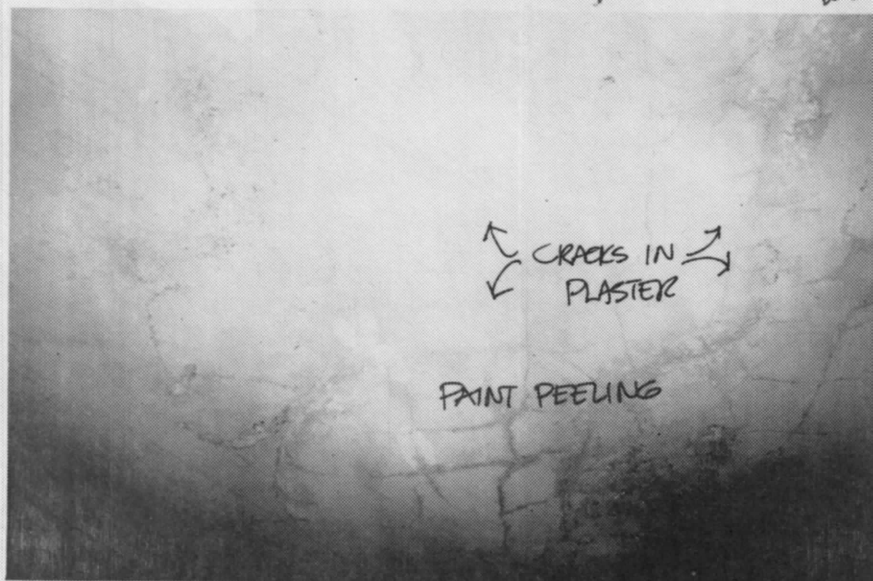
MENS DRESSING RM. CEILING, 2ND FL. / ROOF LEAKS
