The purpose of this report is to document the evolution of the structure, assess existing conditions and features, evaluate alternative treatments, and recommend treatments responding to objectives identified by park management for the rehabilitation of the Armco-Ferro House. The Armco-Ferro House was constructed for the 1933 Century of Progress Exposition. This report will offer alternative treatments for key issues while proposing treatments that will preserve the structure for the use and enjoyment of future generations.

In late 2004 and early 2005 the national lakeshore's Historical Architect, with the assistance of Todd Zeiger of Historic Landmarks Foundation of Indiana (HLFI), completed an assessment of the house in preparation for the completion of this report.

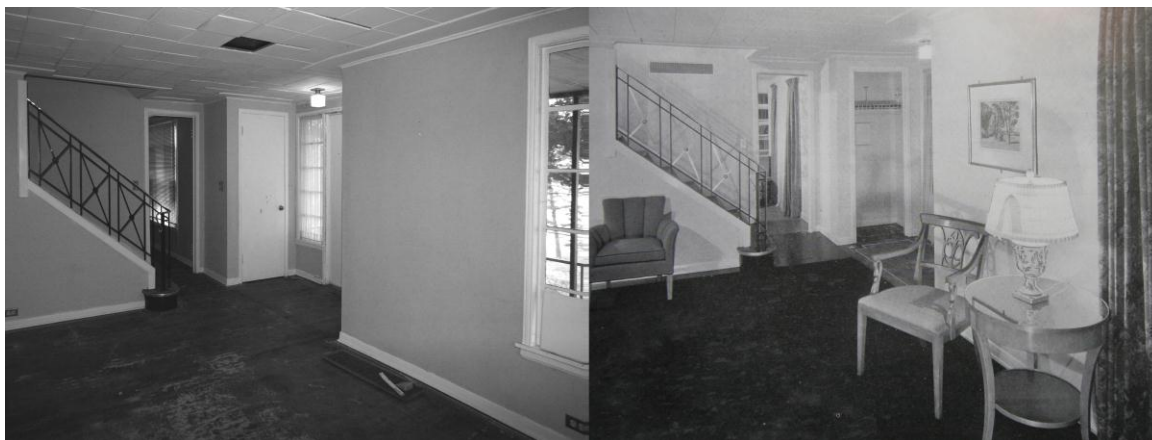
Upon entering the front door your eye focuses on the stair to the second floor, with its original black linoleum with metal nosing, and the original nickel and steel handrail. The entry area itself is defined by the symmetrical closets. The original linoleum, with an inlaid nautical pattern, remains on the floor of both closets.

The walls of the entry and stairwell were originally covered with insulation board finished with two coats of plaster; all of which have survived. The original Celotex ceiling tiles are in place, with the pattern continuing into the living room. The original metal clad front door is in place. Two of the original light fixtures remain; one in the entry and one in the east closet. The space is in fair condition.

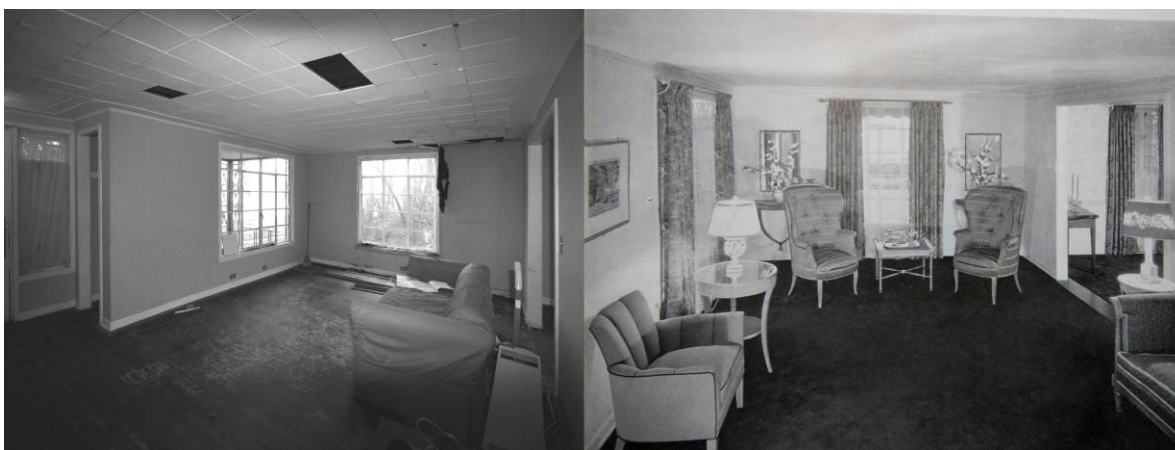
### Living Room

The original wall finish material was insulation board with two coats of plaster. Most of it has survived, with only the east wall having been replaced by the most recent resident. The wall was stripped down to steel, Thermax insulation board was installed and greenboard placed over it, and the wall was plastered. The original Celotex ceiling tiles are in place, with the pattern extending into the entry area, however due to water infiltration many of them are separating from the steel structure above. The original wood subfloor is in place over the steel floor structure, however there has been significant deterioration of both on the east side of the room. Sections of the original black linoleum, with a nautical motif inset, are in place in the entry hall closets.

The deterioration of the wall materials, subfloor, and steel structure, was the result of a series of events. The interior roof drains were disconnected in either late 1933 or early 1934, and roof drainage was rerouted to new scuppers in the parapet walls. The scuppers have not been draining the roof properly for years because of the number of layers of roofing material that has been applied. The roofing material has deteriorated, and water is getting into the parapet walls at the scuppers; primarily at the east wall of the house. Water is running down the interior of the wall through the continuous corrugated panels.<sup>45</sup> The room is in poor condition.

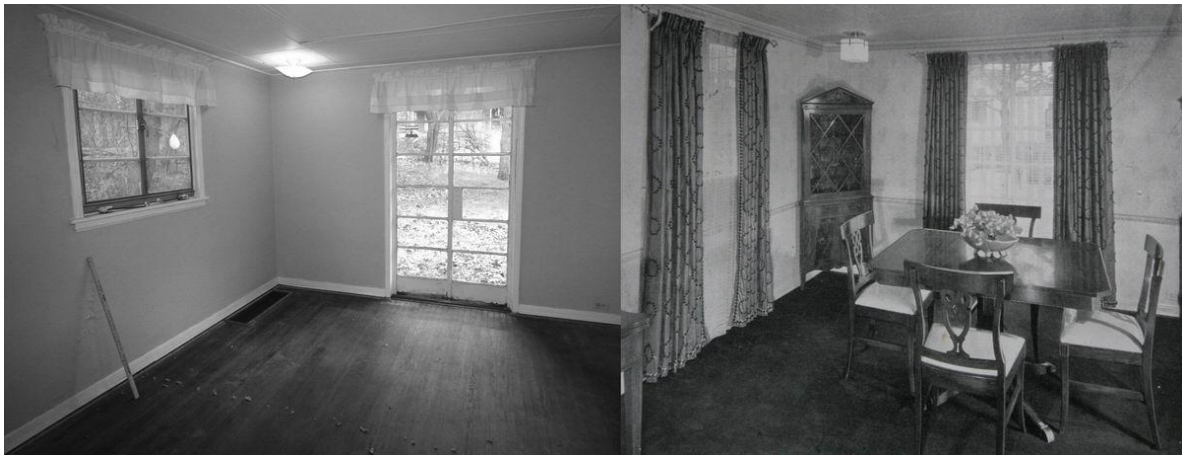
**Dining Room**

The original wall finish material was insulation board with two coats of plaster; all of it is in place. The original patterned Nu-Wood ceiling remains, however there has been some shifting due to water infiltration in the bedroom above. The two light fixtures, located in opposite corners, are not the original, however they are hung in the location of the original fixtures for the 1933 fair season. When the brochure from the 1933 season was found it was determined why the fixtures were located in opposite corners rather than in the center of the room. For the 1933 season this room was not only decorated with the dining table it included a “permanent” card table. The tables were located in opposite corners. The steel framed French doors located on the south wall of the room have been severely damaged. The lower panel of one has been bent out. The room is in fair condition.

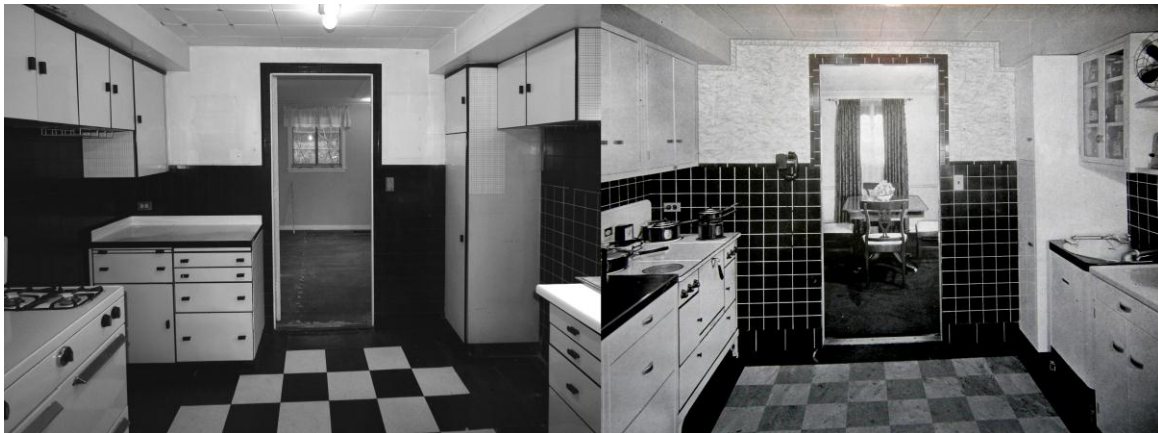
**Kitchen**

The original two-toned ivory cabinets, of which there are photographs, were removed probably in late 1934 or early 1935. The original sink was ivory and the 1934 countertops were covered with black linoleum edged in Monel. The national lakeshore's Historical Architect assumes, from research completed by HABS, that the original cabinets were removed prior to the move across the lake, and sold to help pay for the move. It has also been speculated that the removal of fixtures, from the houses that were barged, was done to lighten the load.

The existing kitchen is very similar to the original in the style of cabinets and layout. The stepped ceiling has not been modified, however some of the Celotex ceiling tiles have separated from the steel structure above due to water infiltration. The original wall finish material was insulation board with two coats of plaster, and for the 1934 fair season a wainscot of Masonite was added. The Masonite was made to look like ceramic or metal tile, and came in sections 2 tiles high x three tiles wide. Both remain, however the tile has numerous layers of paint. The floor tiles for the 1933 fair season were a solid color, and those from the 1934 fair season were squares of linoleum laid in a picture frame pattern. The existing tile is similar in color and pattern to those from 1934. The room is in poor condition.

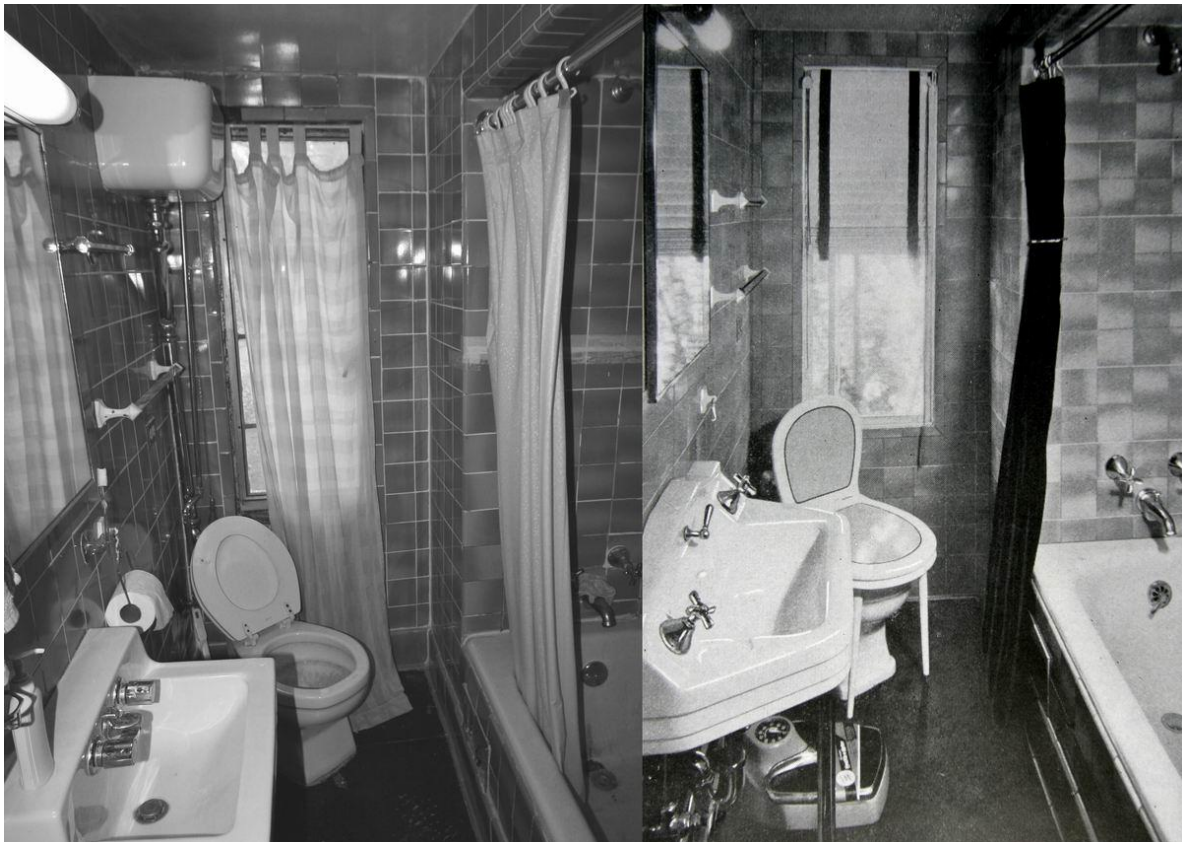
### **Full Bathroom**

The only original fixture remaining is the tub. The porcelain sink appears to be circa 1950’s. The porcelain toilet is a replacement. The pipes and the toilet froze in 1977. The original wall finish materials included insulation board with two coats of plaster and metal tiles. Both are in place, however several tiles are missing. The ceiling was finished with insulation board and two coats of plaster, and the floor with terrazzo; both of which remain. The room is in fair condition.

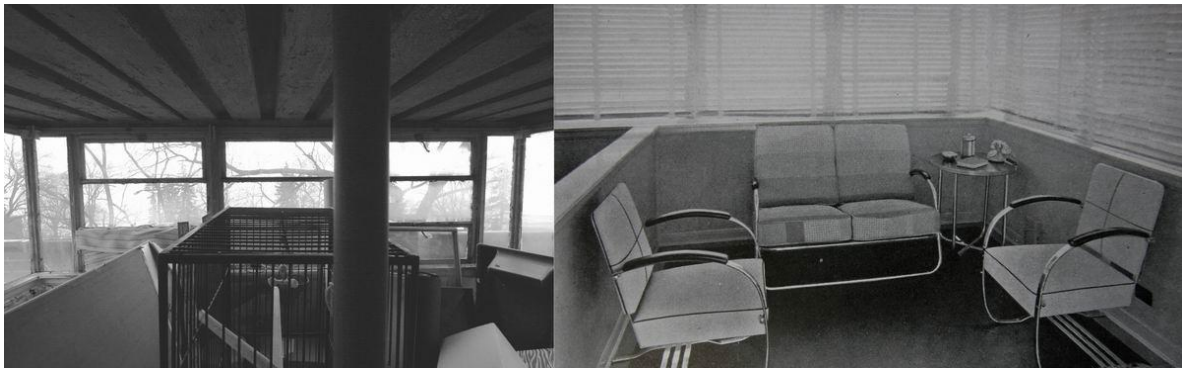
**Third Floor  
Solarium**

The solarium was originally designed to be an open space with easy access to the roof deck. The knee walls, finished with plastered insulation board, are of the same steel construction system used for the walls and floors. The steel frame awning windows were installed above the knee wall to provide ample air circulation. The original steel door with a fixed window provides access to the deck. The ceiling was finished with Celotex tiles, however it has been removed, date unknown. The floor was finished with black linoleum with a triple white stripe inset at the perimeter. It has been removed; date unknown. Documentation has not been located to determine if the floor for the 1933 season was the same as 1934. The existing floor is linoleum. The room is in poor condition.

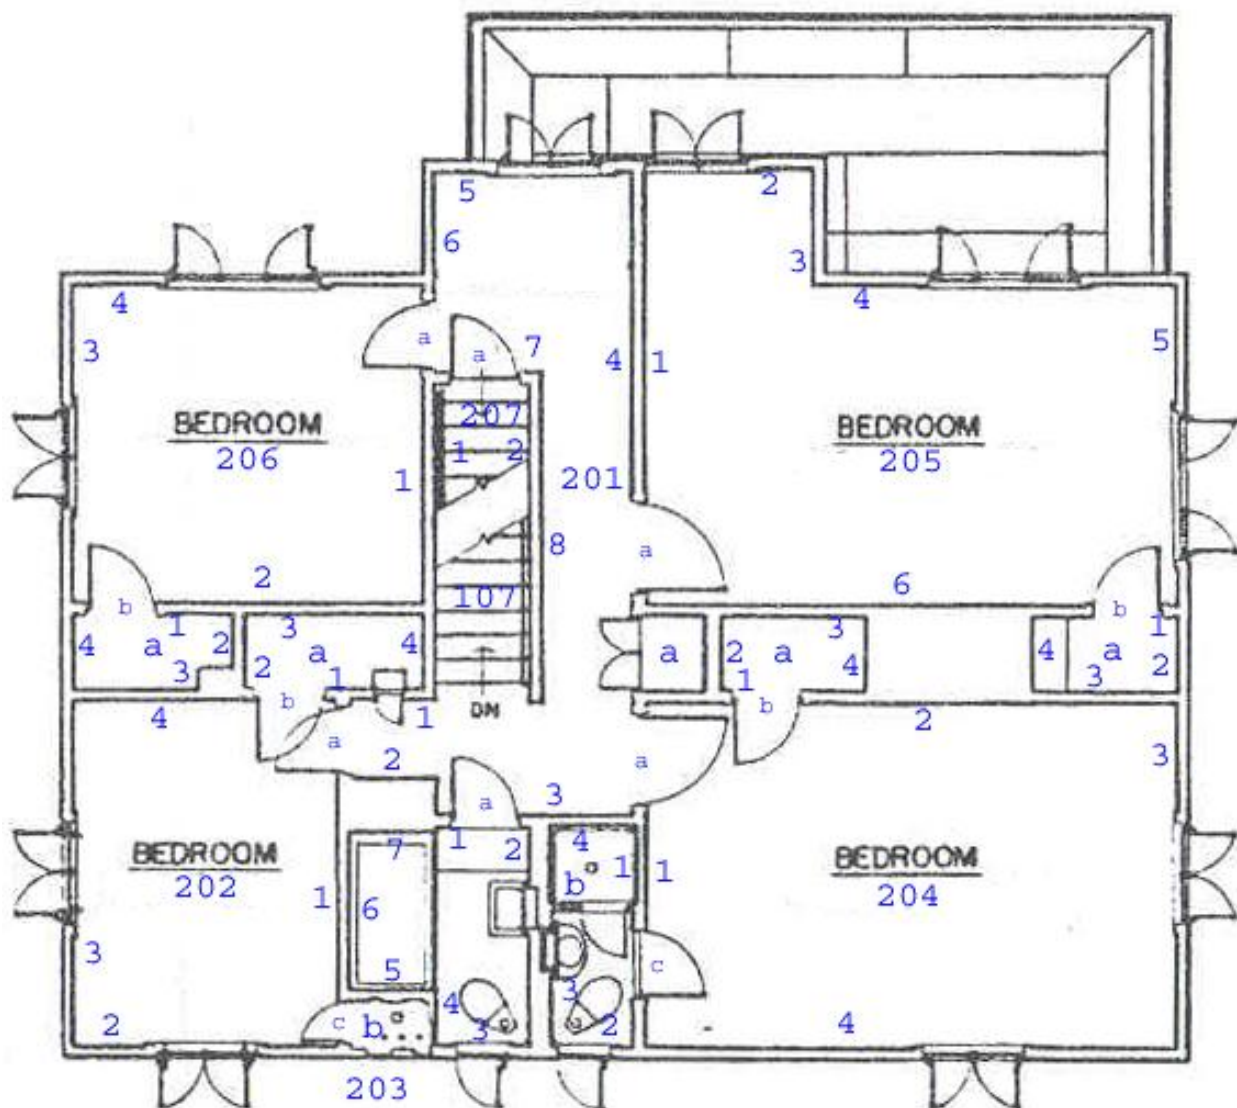
### Second Floor Plan

The wall finish materials have deteriorated due to numerous water leaks, and are in poor condition. The insulation board was attached to the steel structure using horizontal furring strips, and then two coats of plaster were applied. Please see the Wall Finish Schedule for a complete list of materials.
