The purpose of this document is to document the evolution of the structure, assess existing conditions and features, evaluate alternative treatments, and recommend treatments responding to objectives identified by park management for the rehabilitation of the House of Tomorrow. The House of Tomorrow was constructed for the 1933 Century of Progress Exposition. This report will offer alternative treatments for key issues while proposing treatments that will preserve the structure for the use and enjoyment of future generations.

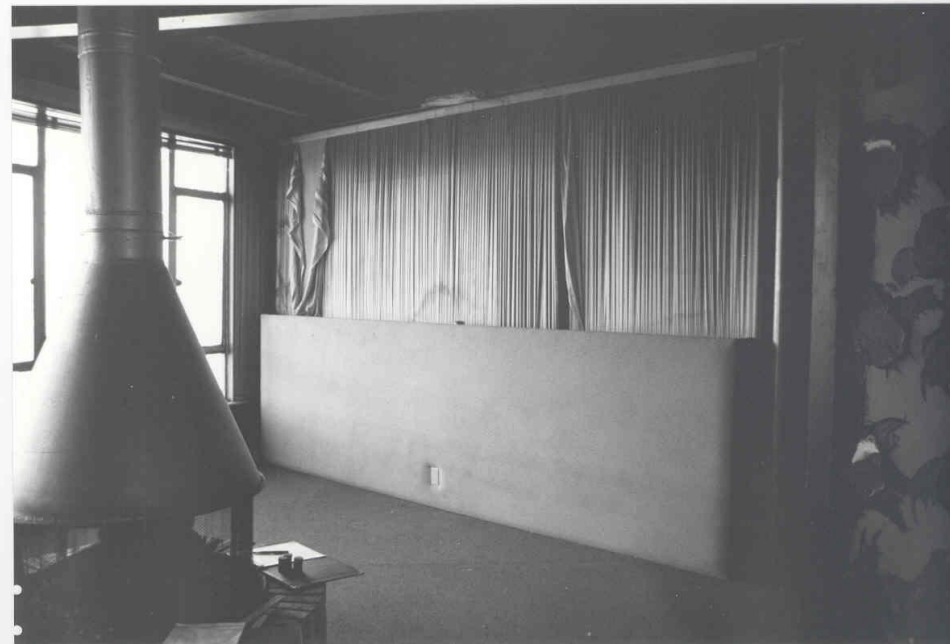
View 2 - Living Room – East Wall – Note the addition of fabrics and the fireplace.

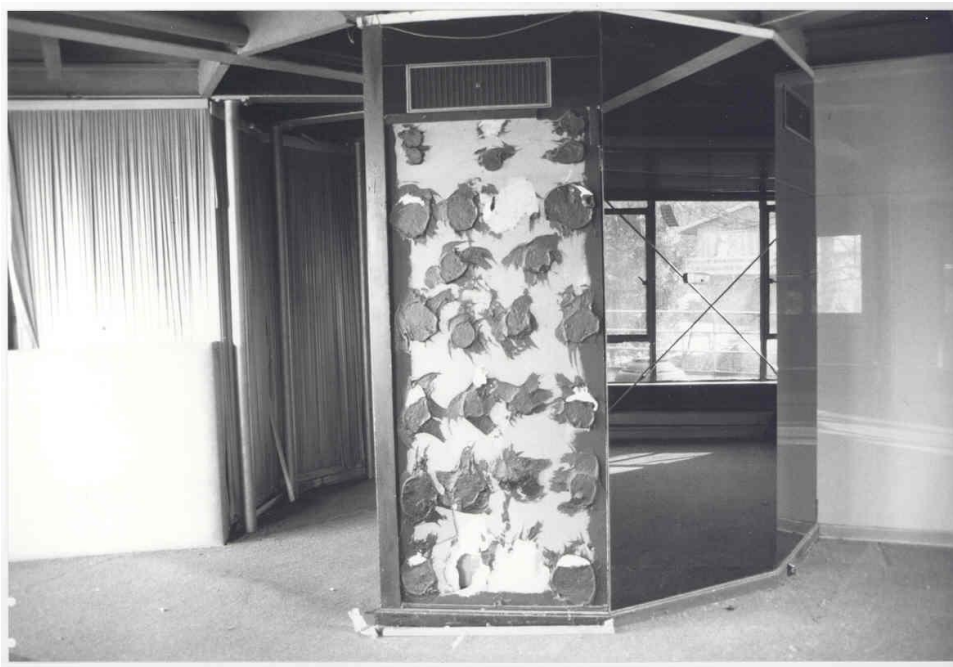
View 4 - Central Core – Note the use of Black and Gray Carrara glass, and the missing glass.

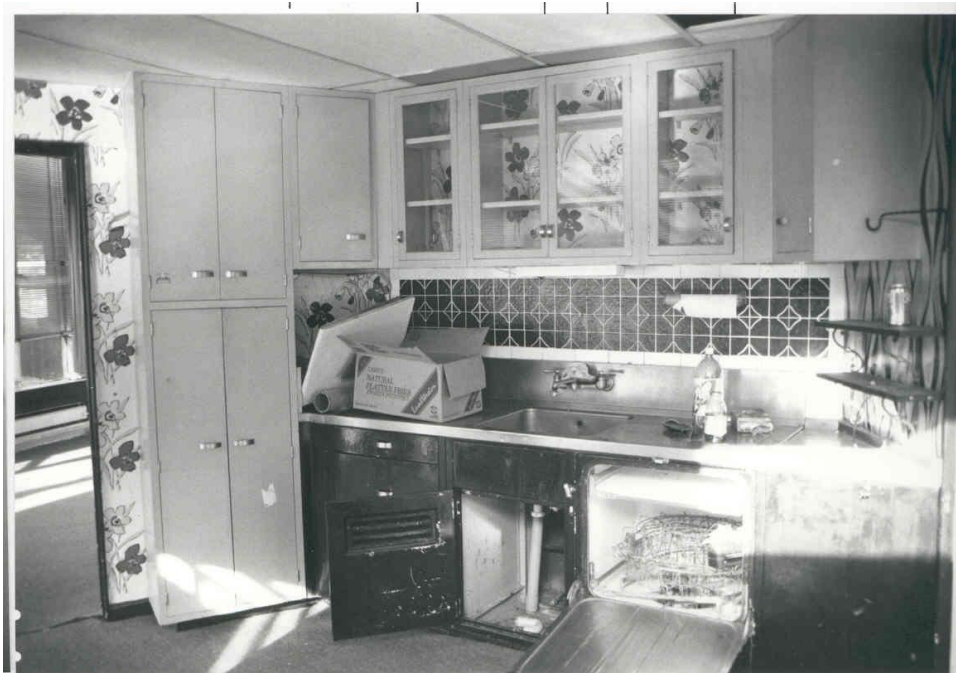
View 9 - Kitchen – North Wall – Note the original dishwasher and cabinets.

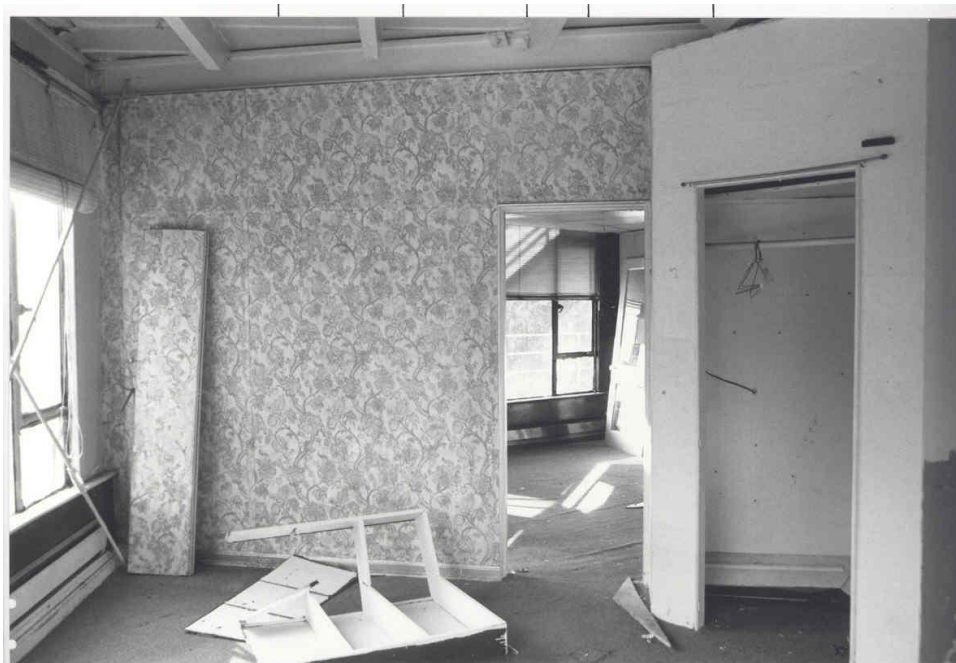
View 15 - Children's Bedroom – West Wall – Note the aluminum painted fabric wall covering.

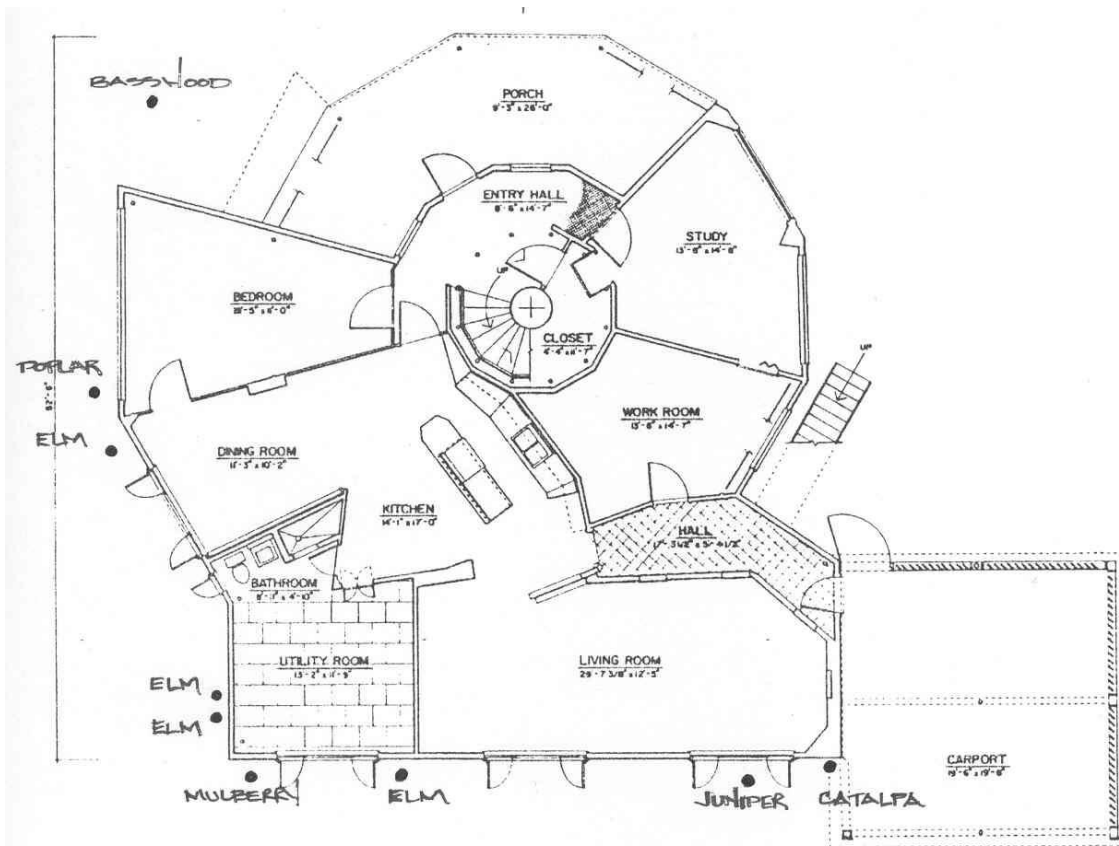
1. The trees that were planted on the north, west, and south sides of the house are affecting the integrity of the structure. They are located too close to the exterior walls causing damage to the siding and roofing. In addition, the root systems are growing under the on-grade slab foundation.

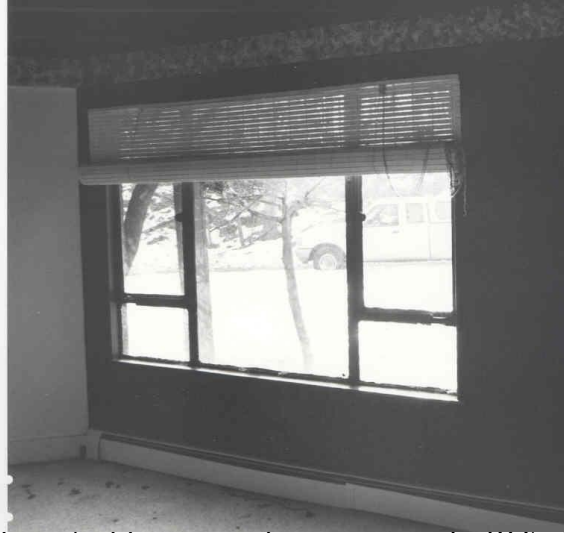
2. The second and third floor steel frame windows, circa early 1935, have severely deteriorated due to a lack of general maintenance, and extensive moisture infiltration. The windows, which are glazed on the interior of the frame, are caked with caulk and paint, and are in poor condition. The wood framing surrounding the windows has deteriorated to the point that there are significant gaps in the framing and holes in the walls. The framing is in poor condition.

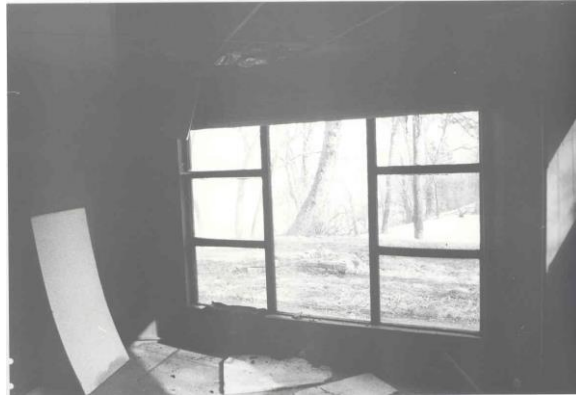
3. The original steel-framed window, a horizontal single-paned rectangular fixed window with two lights, in the study/recreation room was destroyed in 1965 during a storm. It was replaced with a

wood-framed window similar to the three-part steel-framed window used in the living room/hanger. However, the existing window does not have casements; it is completely fixed. See oral history interview, Appendix D, Exhibit D. The window is in poor condition due to a lack of general maintenance, and moisture infiltration.

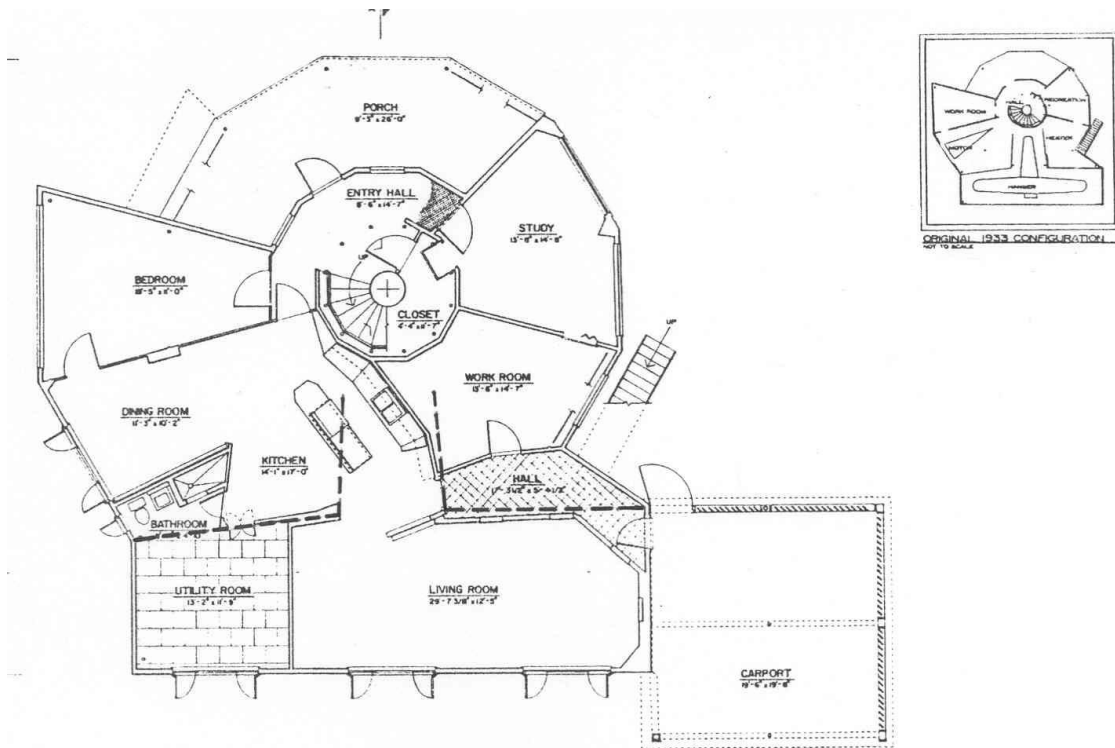
2. There were several original partitions on the first floor that were removed, date unknown.

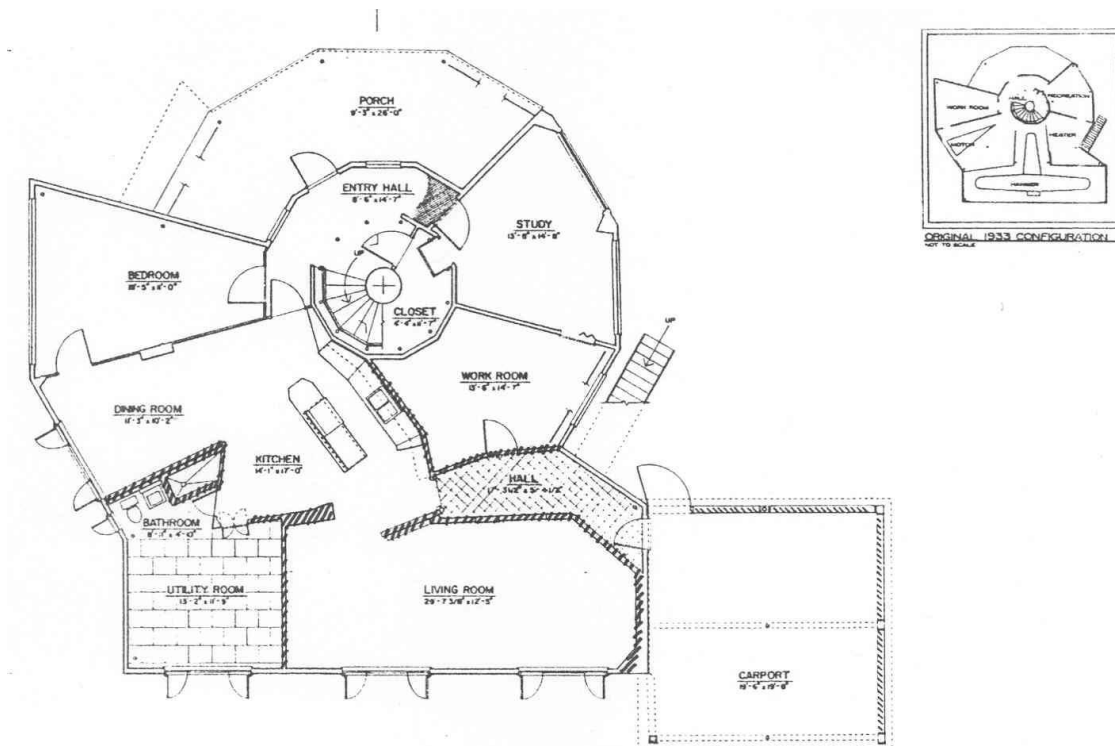
3. There are several partitions that were added on the first floor that were not part of the original design.
