# PATTERSON-MCDERMOTT CABIN

KLONDIKE GOLD RUSH  
NATIONAL HISTORICAL PARK  
SKAGWAY, ALASKA

## HISTORIC STRUCTURE REPORT

2018

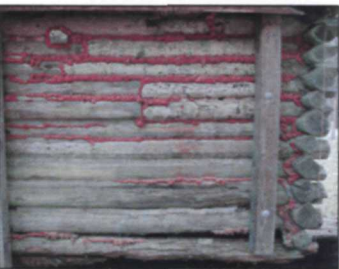
**Figure 31.**

Patterson Cabin, replaced logs on east elevation, photographed by Kathleen Kathleen Wackrow, NPS, April 2016 (NPS, AKRO, Historic Architecture, Patterson Cabin Digital Files).

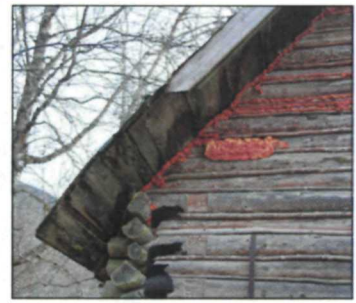
**Figure 87.** Broken vergeboard, north elevation, photographed by Kathleen Wackrow, NPS, April 2016 (NPS, AKRO, Historic Architecture, Patterson Cabin Digital Files).

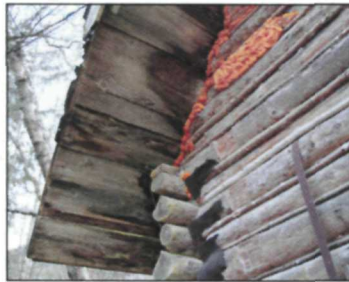
**Figure 88.** Biological growth, north elevation, photographed by Kathleen Wackrow, NPS, April 2016 (NPS, AKRO, Historic Architecture, Patterson Cabin Digital Files).
