Lincoln Home National Historic Site  
Springfield, Illinois

## Historic Structure Report

May 19, 2023

Prepared by: Seven Generations Architecture + Engineering

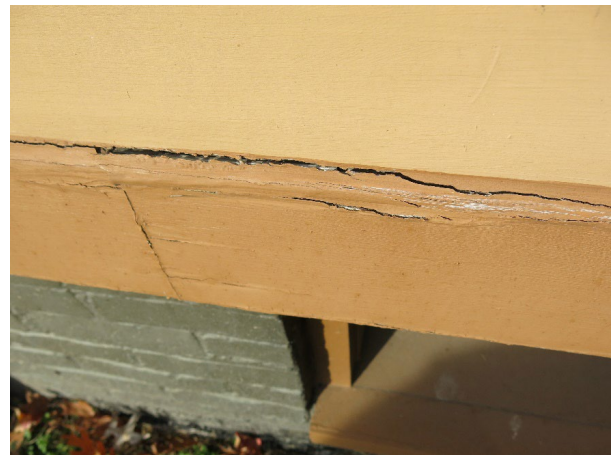
**Figure C.27.** Detail of deterioration at wood water table. Source: RATIO Architects.

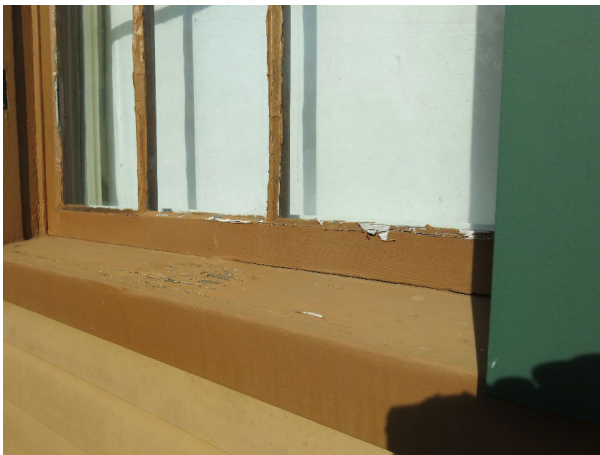
**Figure C.29.** Paint deterioration at sill; typical deterioration of paint and glazing putty at sash. Source: RATIO Architects.

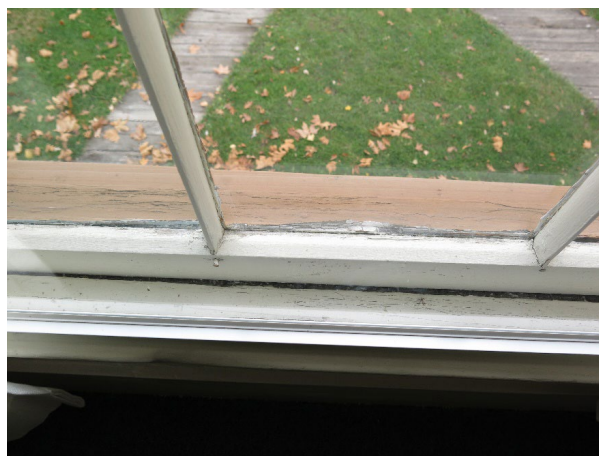
**Figure C.31.** Detail of window of room 204 showing low-profile aluminum interior storm sash. Note deterioration of glazing putty and sill paint at exterior of wood sash. Source: RATIO Architects.

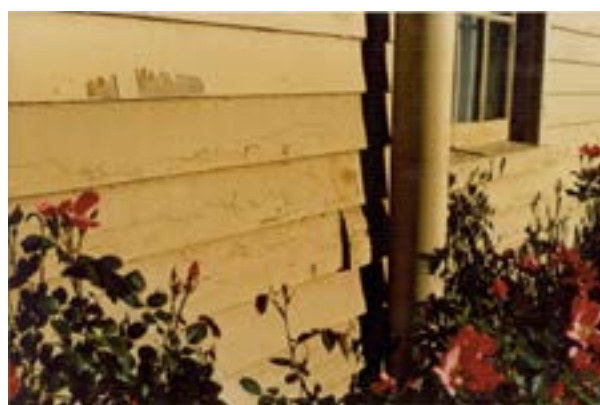
**Figure C.53.** Detail of exterior paint conditions prior to 1976 paint removal and repainting campaign. Source: LIHO Photo ID: B2F10P24.

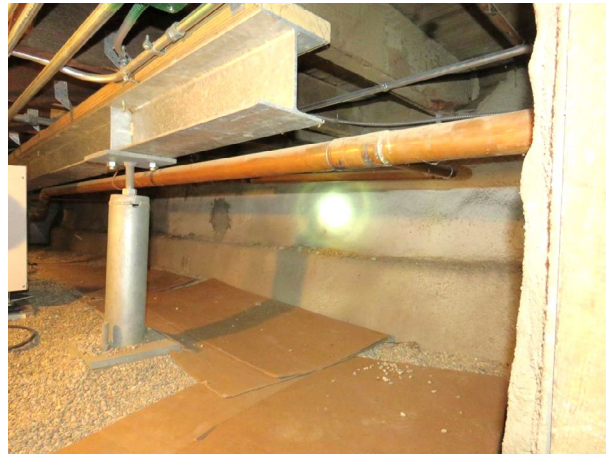
**Figure C.57.** View looking southeast showing the underpinning shelf along the inside of the south exterior foundation. This underpinning was installed to address foundation issues discovered during the 1954-1955. The 1986 Hahn restoration drawings show this shelf as existing. It was retained in combination with additional underpinning. Source: Lawson Elser

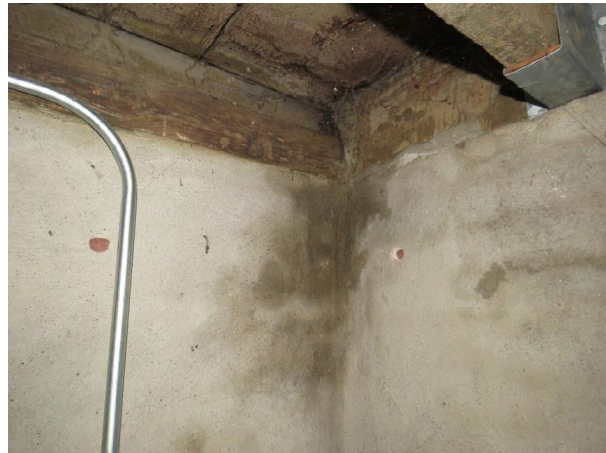
**Figure C.58.** View of the inside of the basement wall at the NW corner showing some dampness in the cement parking. Source: Lawson Elser.

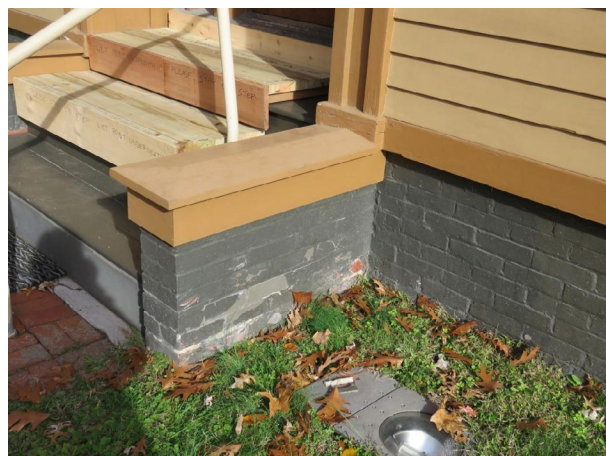
**Figure C.59.** View of the exterior brick wall at the west entry with some peeling paint, spalling, and repointing. Source: Lawson Elser.

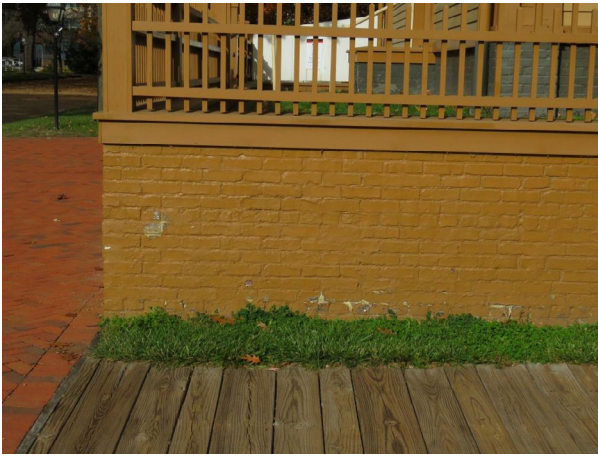
**Figure C.60.** Peeling paint on the exterior brick retaining wall along the on the south side. Source: Lawson Elser.

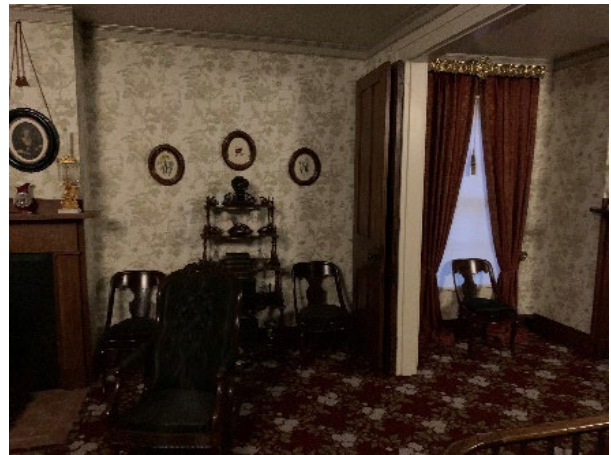
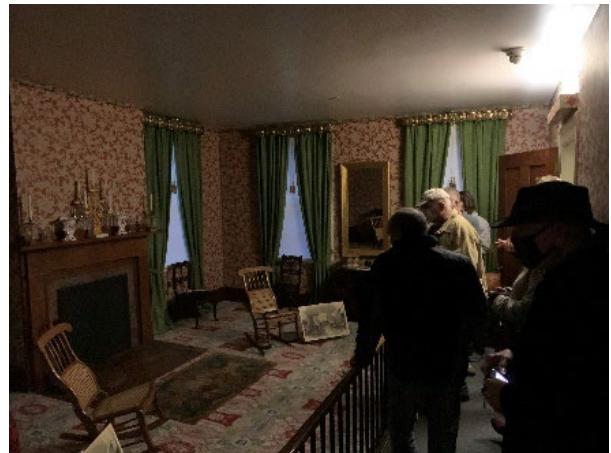
**Figure C.78.** Views of Parlors and Sitting Room during tour, 4:42-4:47 PM, November 17, 2021. The new replacement lamps in the first-floor fixtures are too dim to provide sufficient illumination for late-afternoon tours, impairing the visitor experience. Source: RATIO Architects.

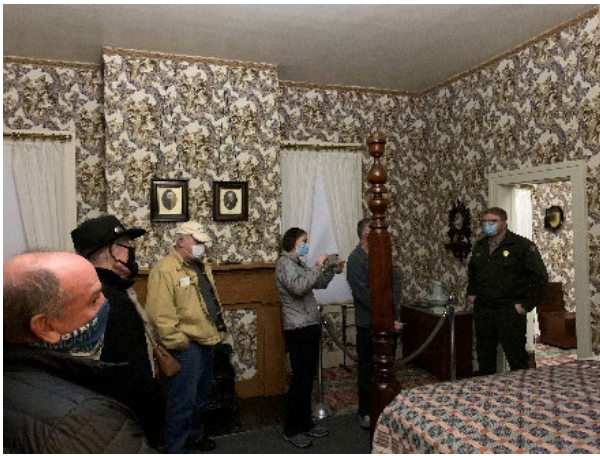
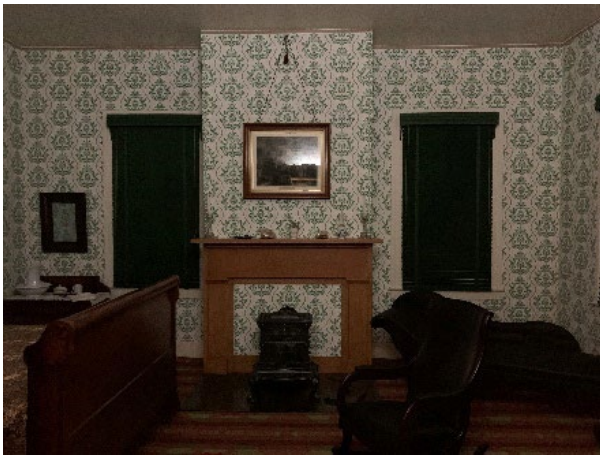
**Figure C.79.** Views of Mr. Lincoln's Bedroom and Guest Bedroom during tour, 4:51 PM, November 17, 2021. The new replacement lamps in the second-floor fixtures appeared to be of sufficient brightness, unlike those at the first floor. Source: RATIO Architects.

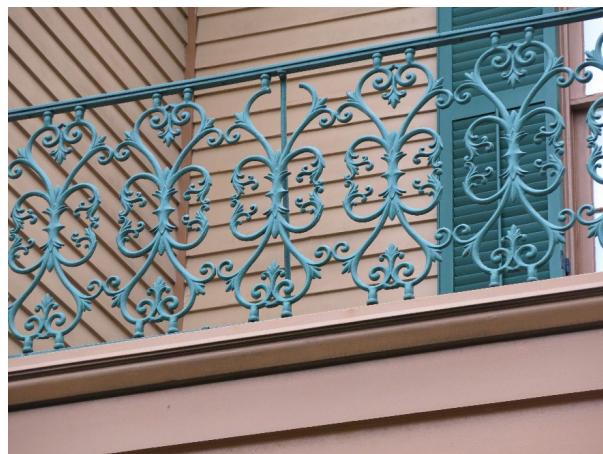
**Figure C.141.** Detail of 1856 cast iron balustrade, November 2021. The damage to the panel at center left occurred before the Whipple photograph was taken in the summer of 1860. Source: RATIO Architects.
