HISTORIC STRUCTURES REPORT  
ARCHITECTURAL DATA, PART I

REHABILITATION AND RESTORATION  
OF THE  
DOGAN HOUSE

MANASSAS NATIONAL BATTLEFIELD PARK  
Virginia

April 1960

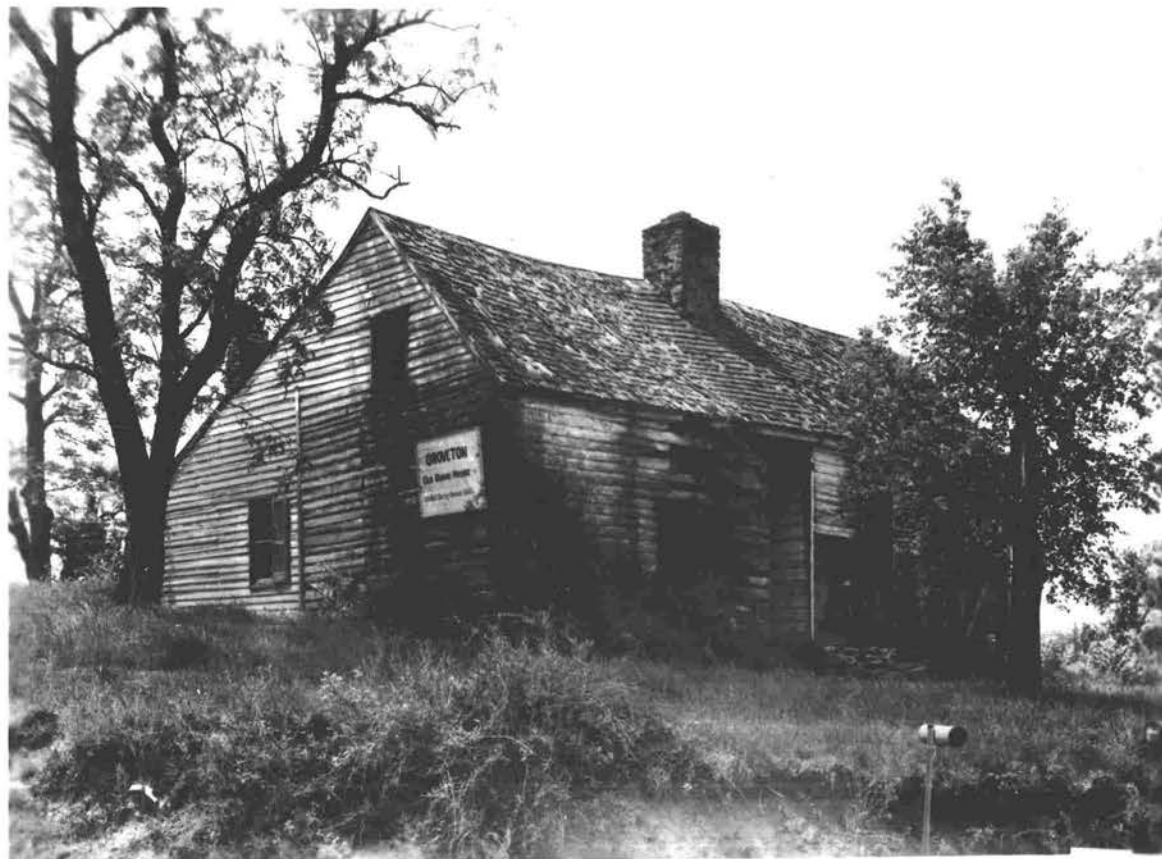
ILLUSTRATION NO. 5      EAST ELEVATION

Early view taken from the east shows the Dogan House prior to stabilization. Tradition says that a cannon ball, fired from a Confederate field piece, crashed through the west wall, skidded across the floor, under the dining table, and out the west wall while the occupants were having breakfast. Notice nine holes in fascia board which former owners say were cut out for bird nests. A section of shelving can be seen in place in the small pantry room located opposite the chimney in center of photograph. House to rear was erected after 1865. Note wood shingle roof.

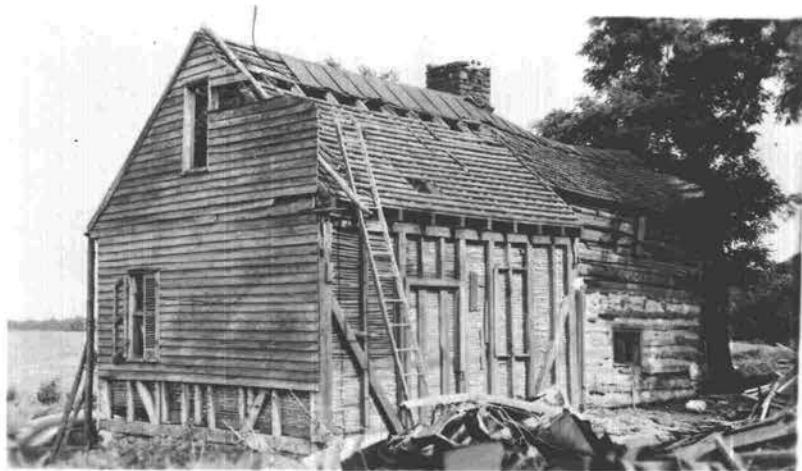
ILLUSTRATION NO. 8     NORTH WEST VIEW

This photograph shows the demolition of later addition to the Jogan House. Work was accomplished in 1948 by Mr. Raymond H. Cross, carpenter, under the supervision of the Prince William County Chamber of Commerce. Note door and window frame covered over by lath and plaster.

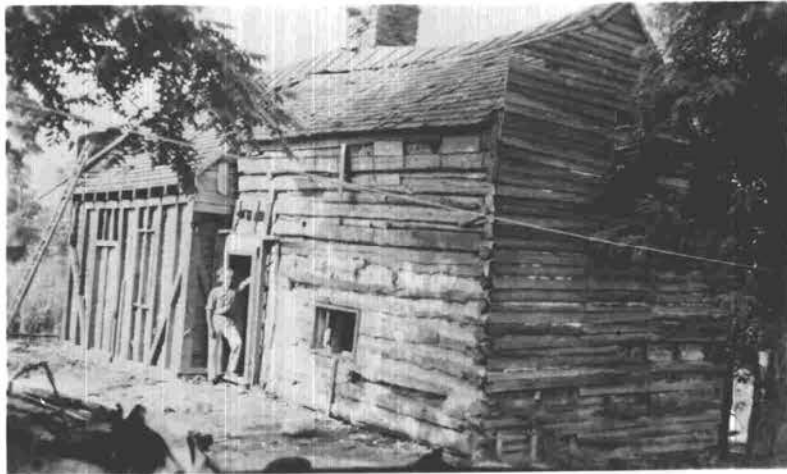
ILLUSTRATION NO. 9    SOUTH WEST VIEW

View of demolition progress. Notice the abundance of original members were still intact on the building, many have since been removed.

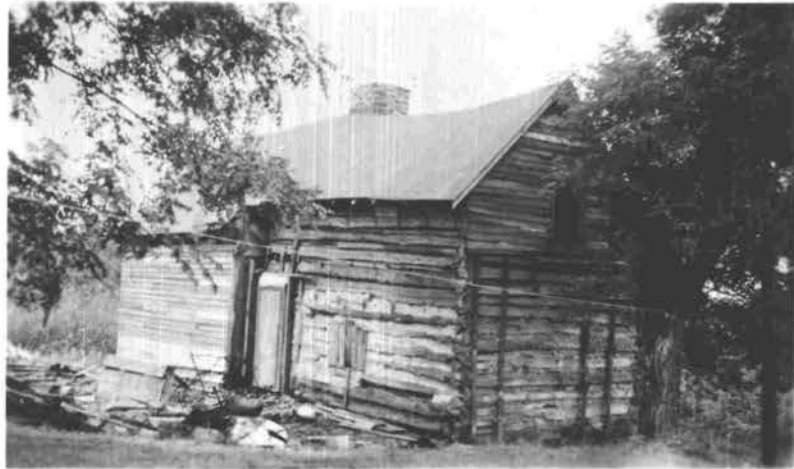
ILLUSTRATION NO. 10 SOUTH WEST VIEW

This photograph shows the complete view of the demolition of the non-historic addition and the subsequent stabilization. A false roof was laid over the original at this time to preserve all the original structure possible. Some weatherboarding was applied, also repair and repointing of the stone foundation and chimney.

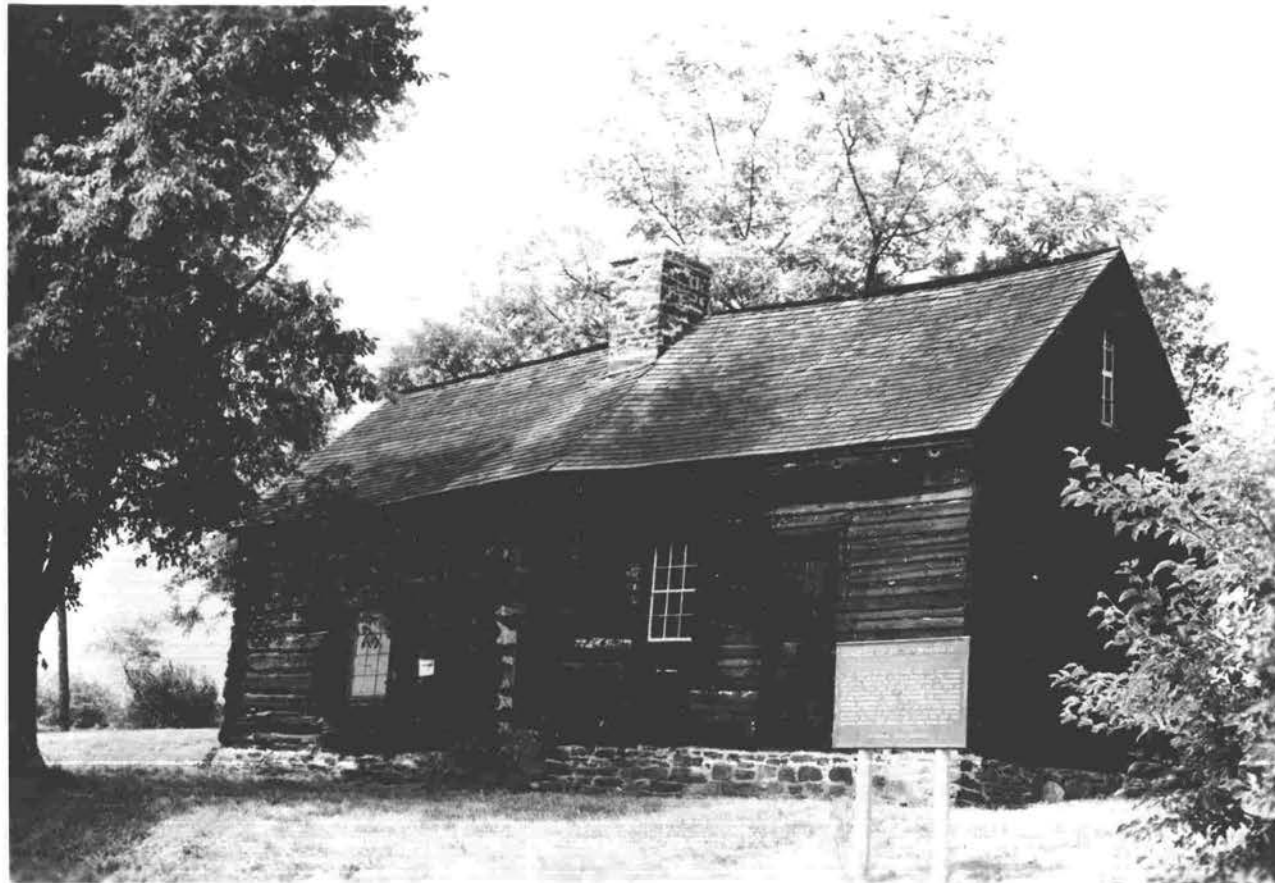
ILLUSTRATION NO. 12      VIEW FROM NORTH EAST

Latest photograph of the Dogan House taken from the Croveton-Sudley Road in 1959. The straight break in roof to the right of the chimney represents the junction of the early log structure and the frame portion.

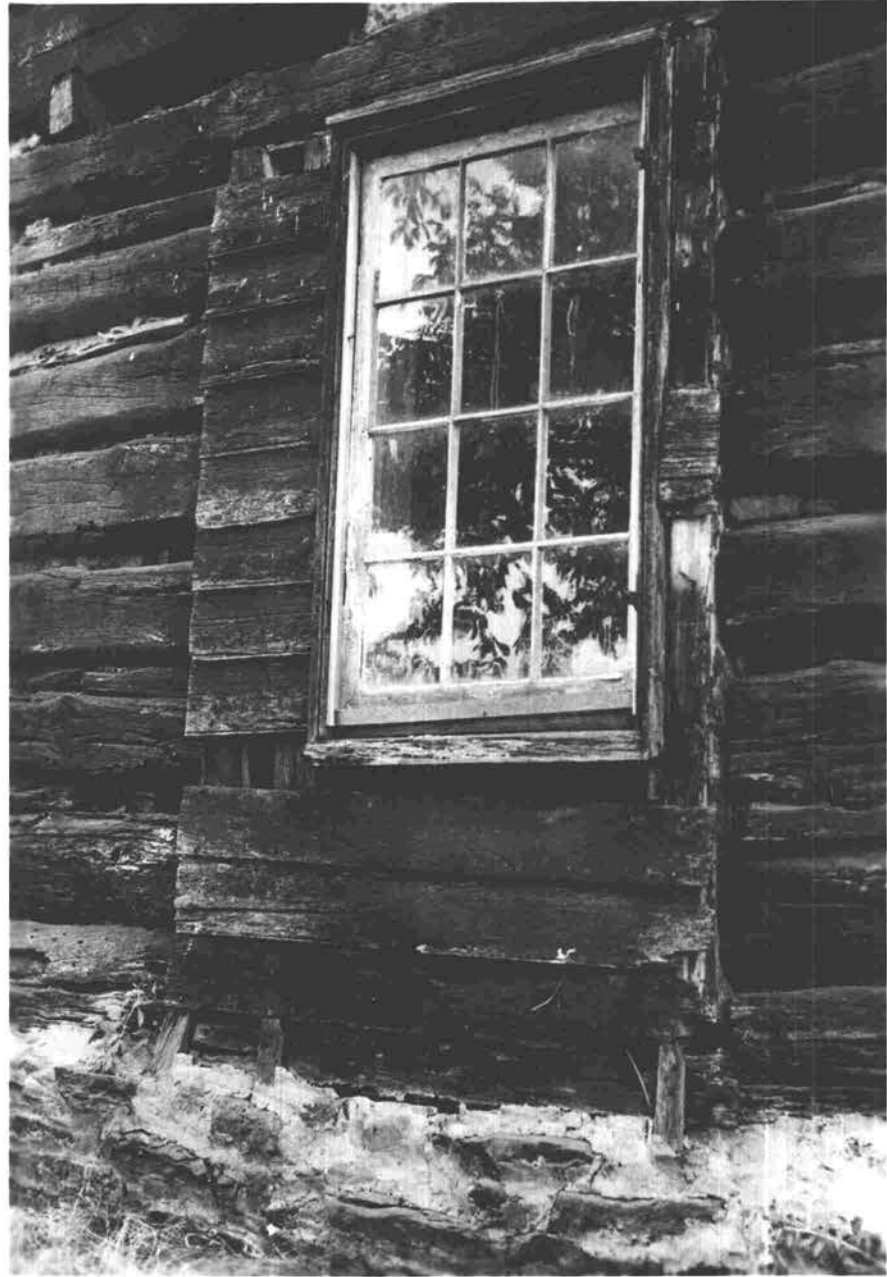
ILLUSTRATION NO. 14 EAST WINDOW, LOG STRUCTURE

This view shows an alteration to an early door opening on the east side of the original log structure. The door frame is still intact and this view shows the logs butting up against the door frame. Later alterations changed the doorway to a window opening as shown.

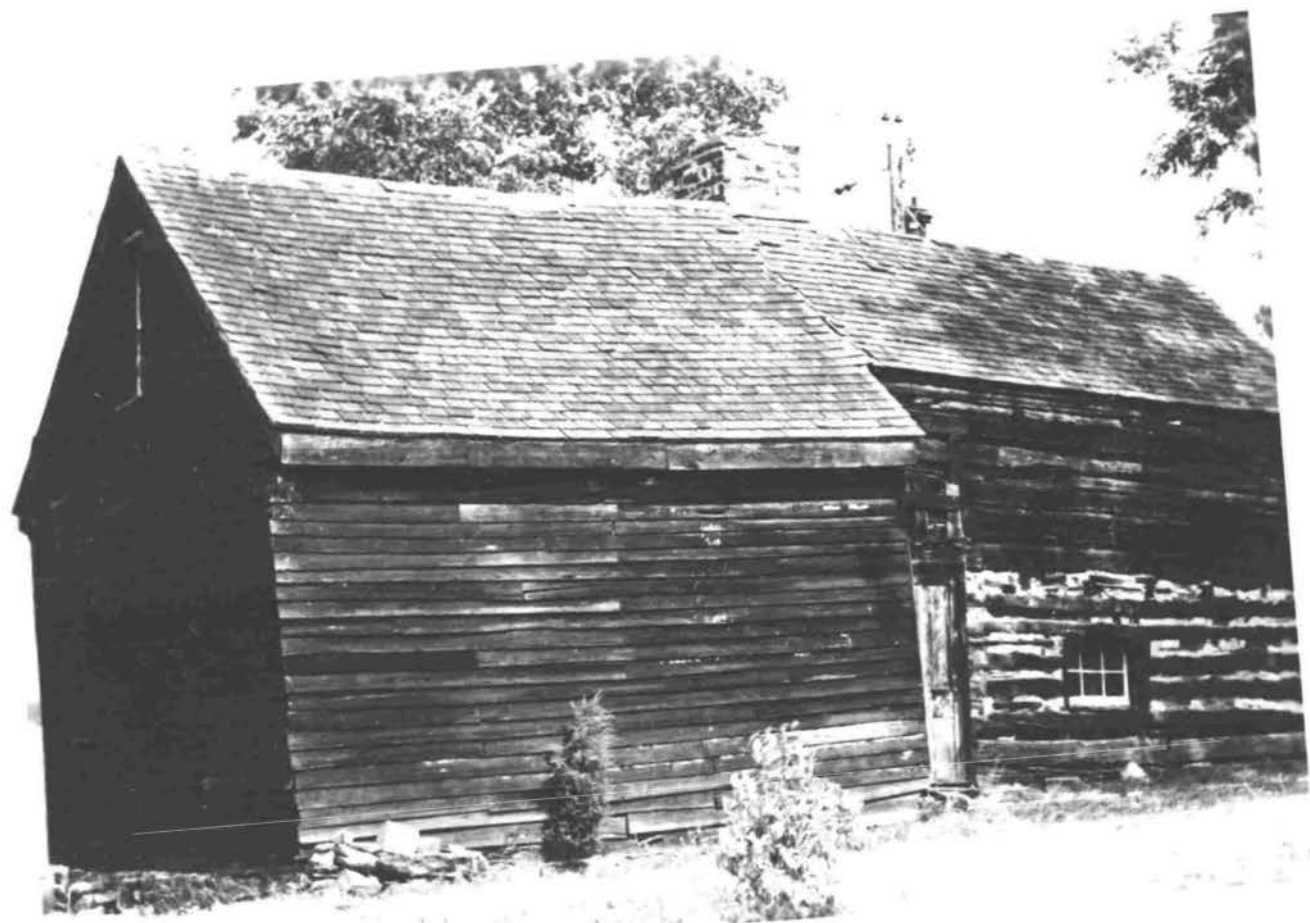
ILLUSTRATION NO. 15      VIEW FROM SOUTH WEST

The log structure seems to have suffered more abuse than its frame counterpart. Due to the deterioration of the lower logs in the south wall, the log building has settled approximately two feet, and as a result, this section of the house has separated from the frame addition. Photo Illustration No. 15 shows the physical break in the roof at the juncture of the two buildings.

Further repairs by the National Park Service in 1950 are visible in this photograph. A new wood shingle roof, removal and replacement of the roof structure over the log structure, removal of the floor board and interior trim was achieved at this time.

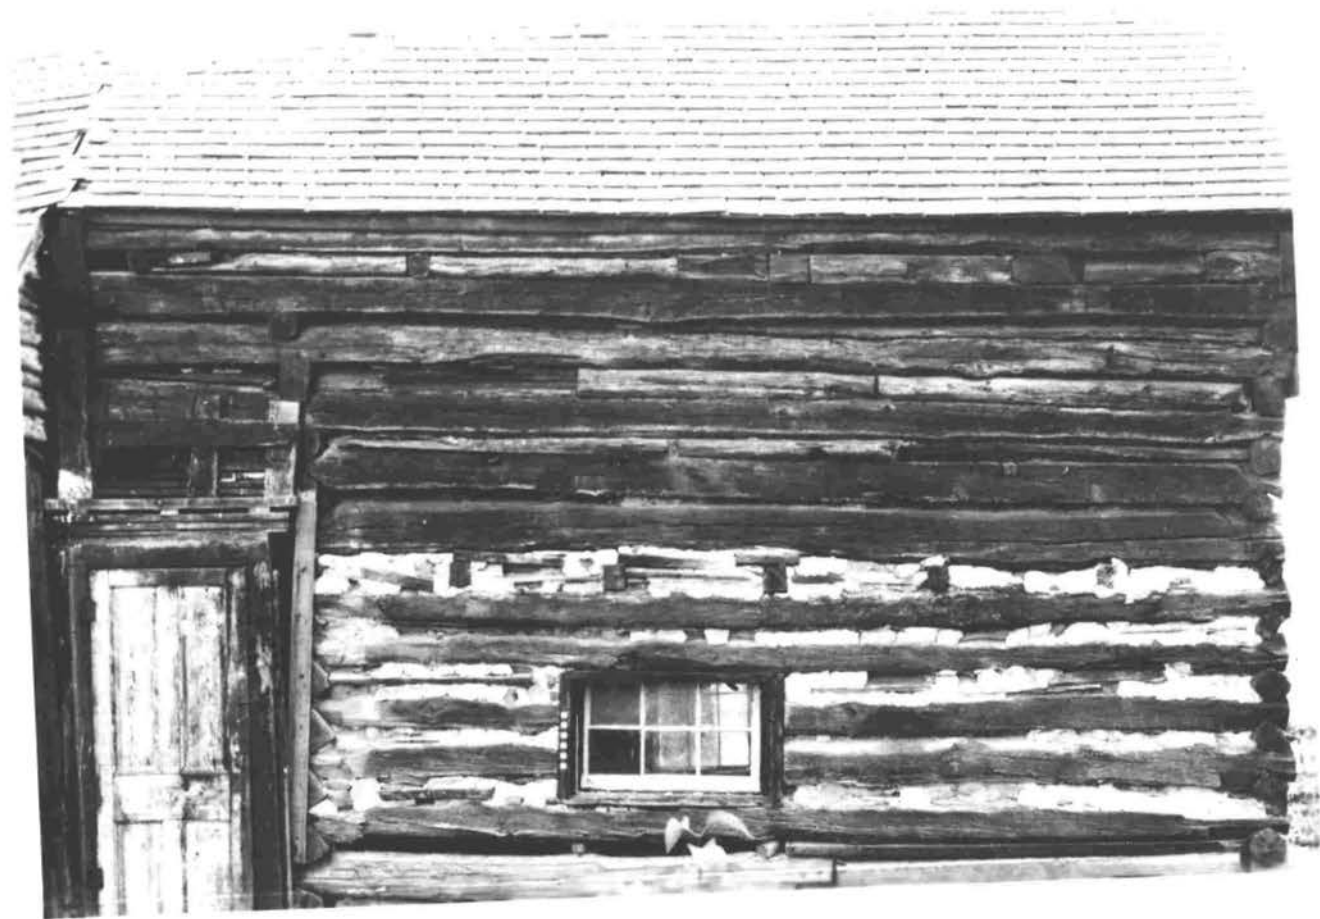
ILLUSTRATION NO. 16      WEST ELEVATION OF THE LOG STRUCTURE

This view shows the gradual settling of the log structure on the right due to deterioration of the logs next to the ground. The spliced log at the lower part of this photograph was replaced in 1950. Notice metal chinking in lower part of building and wooden chinking above 2nd floor joists. Logs above 2nd floor appear to have been added at a different period. Notice difference in end notchings of logs from upper to lower part.

Frame: Straighten and level existing building; replace all rotted members in log structure and frame addition.

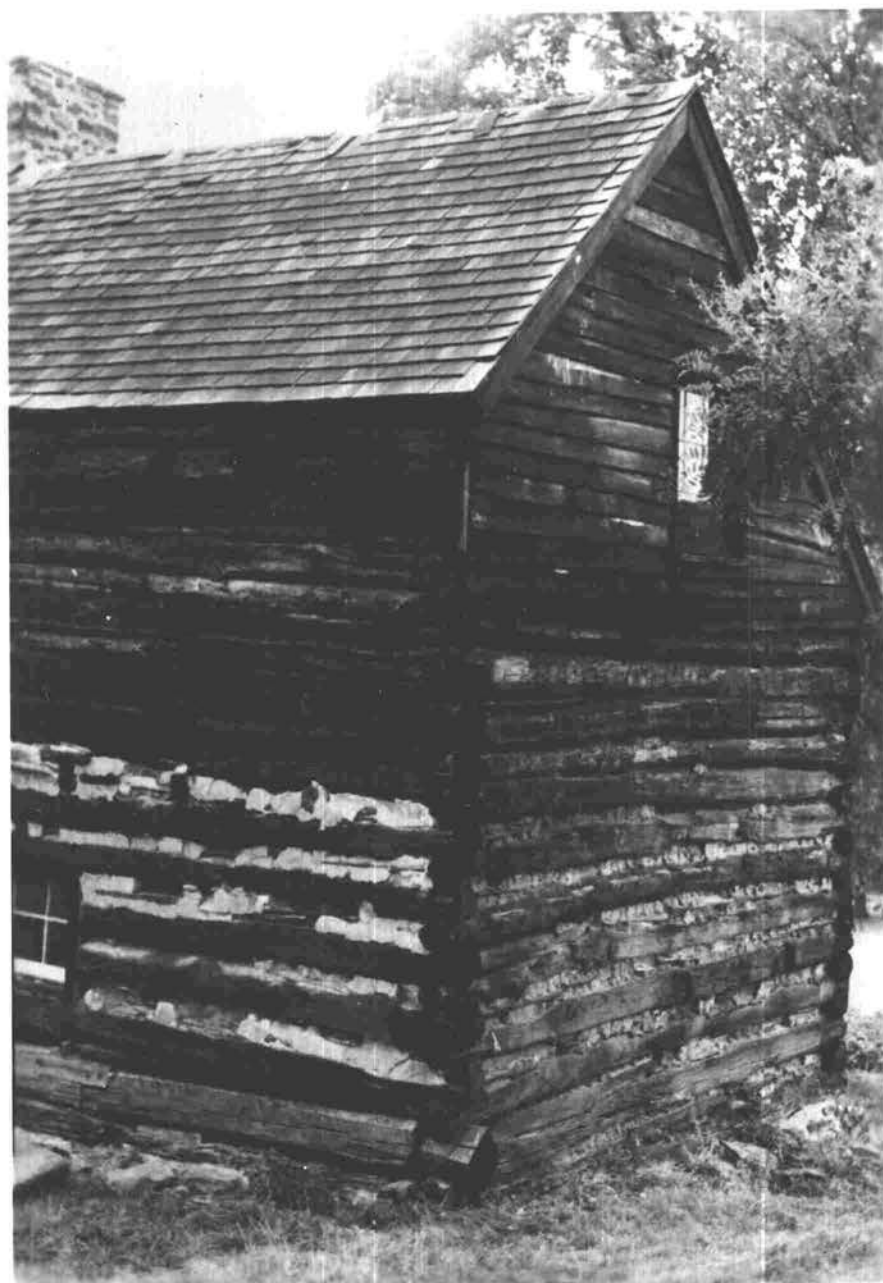
ILLUSTRATION NO. 19    VIEW FROM SOUTH WEST

The rapid deterioration of the basic log structure can be seen clearly in this photograph. The corner nearest the camera has already lost three logs in height. Notice changes in log construction from 1st to 2nd floor.

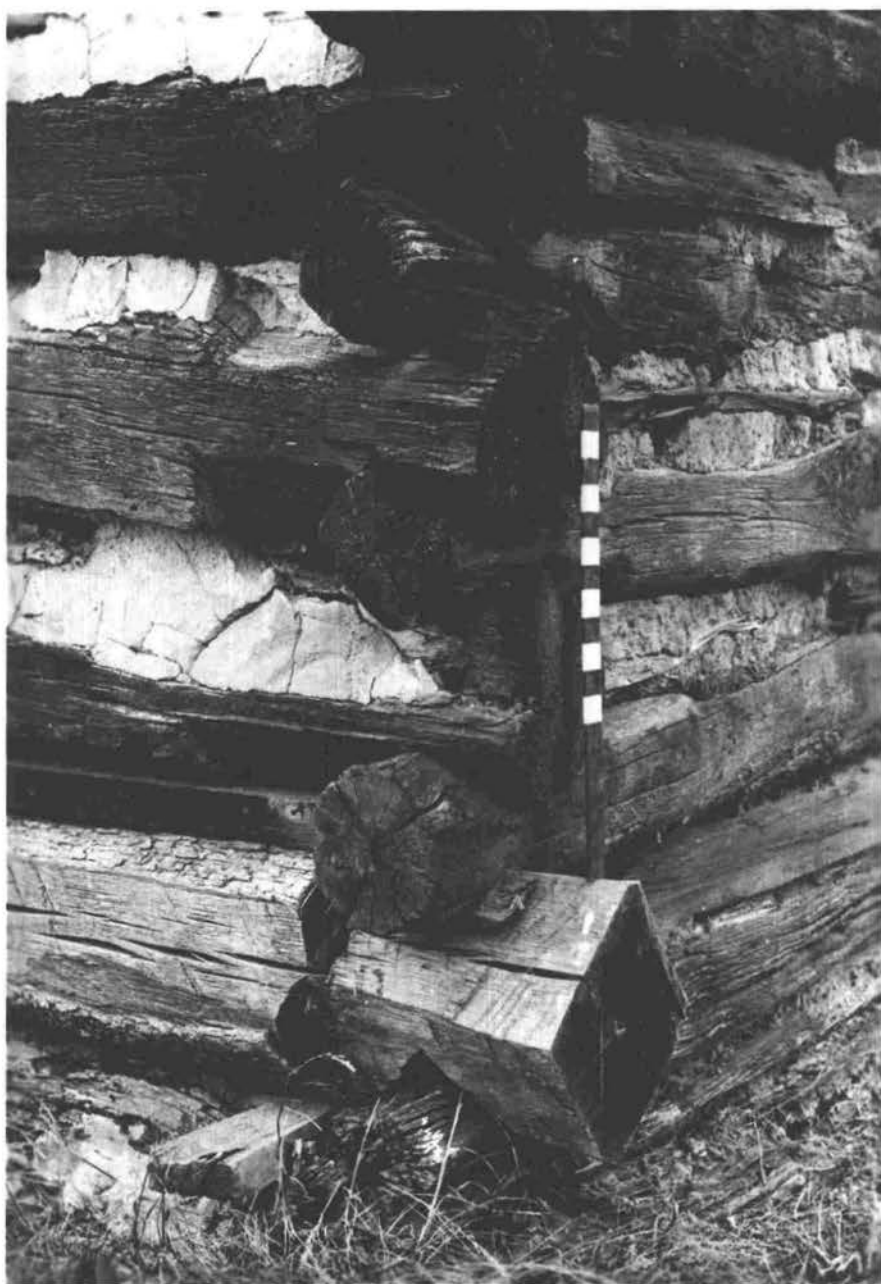
ILLUSTRATION NO. 20     SOUTHEAST CORNER

This photograph shows a more detailed view of the serious deterioration occurring in the lower logs. Log to the lower left is a 1950's replacement.

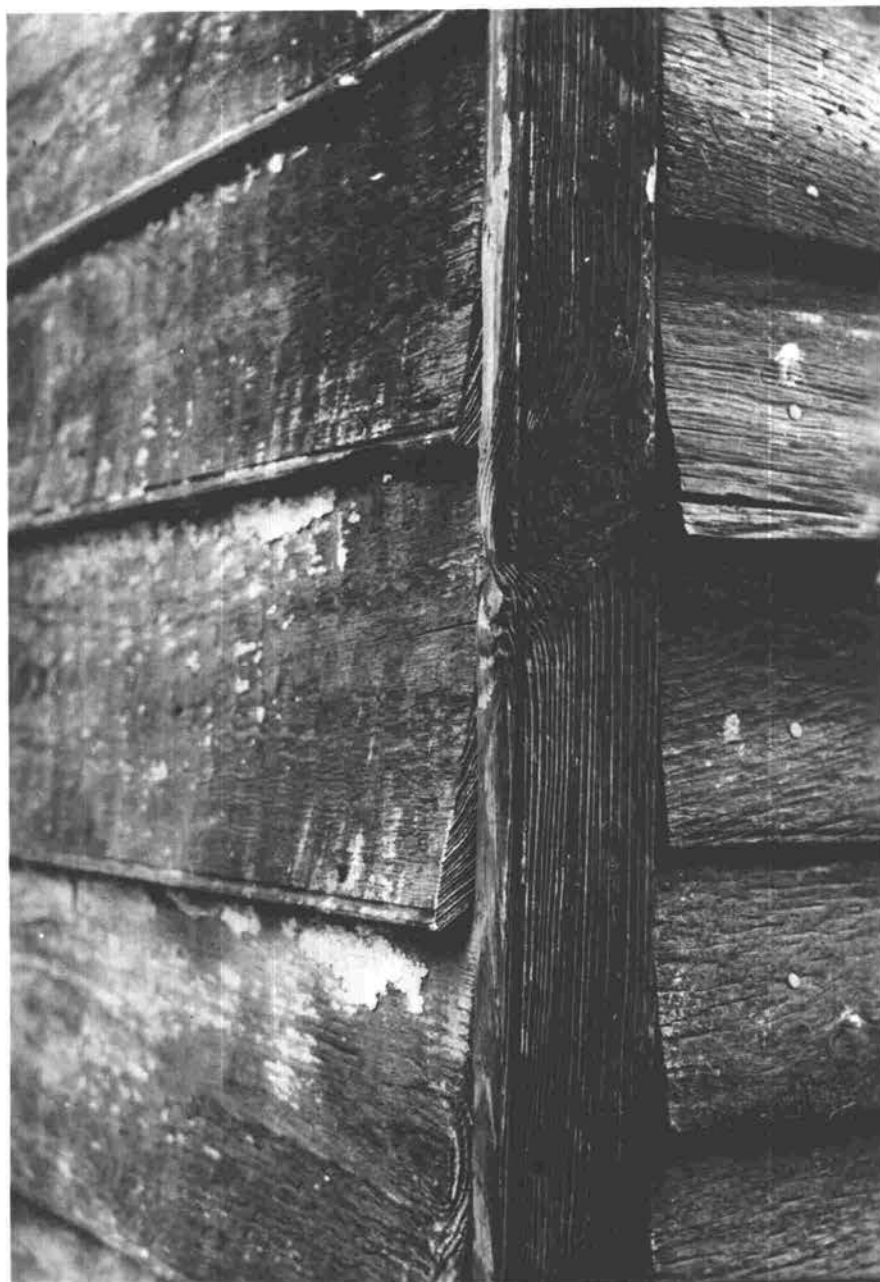
ILLUSTRATION NO. 23      CORNER BOARDS, NORTH EAST CORNER

Possibly the original beaded corner boards  
and several original beaded weatherboards are visible  
dating back to the 1860 period when the frame building was  
moved about 400 yards and connected to the small log cabin  
at the Groveton crossroads.

Weatherboarding: Install new beaded cornerboards and replace all weatherboarding that is not the original beaded type.

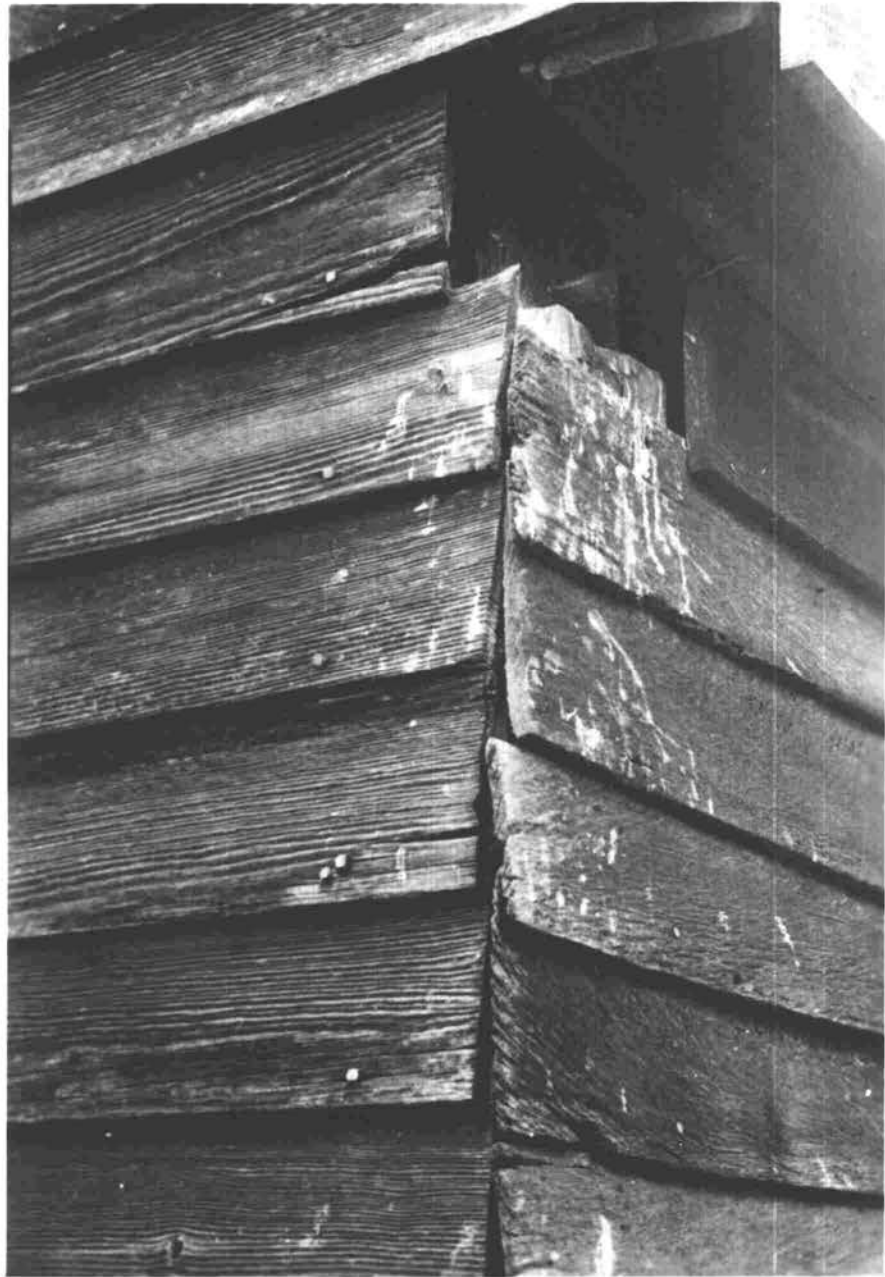
ILLUSTRATION NO. 24 NORTH WEST CORNER

Condition found at north west cornice as  
left in 1948 by Prince William County Chamber of  
Commerce stabilization project.

Cornice: Replace crown moulding, fascia and soffit boards and bed molding. Replace verge boards and trim.

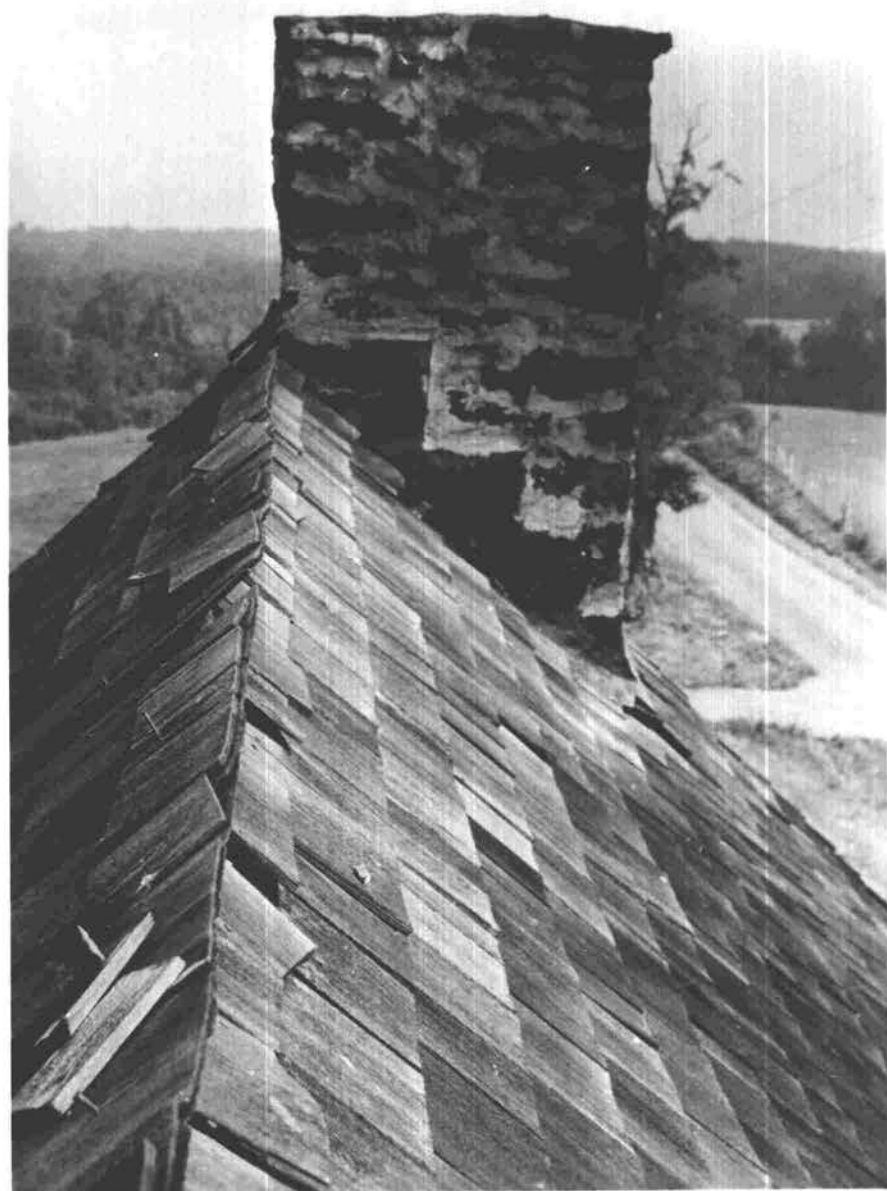
ILLUSTRATION NO. 25 CHIMNEY, LOOKING NORTH

Repairs and repointing of chimney was done in 1948. The wooden shingle roof was laid in 1950 under National Park Service contract work.

Chimney: Rebuild portion above roof line; repair chimney where required.

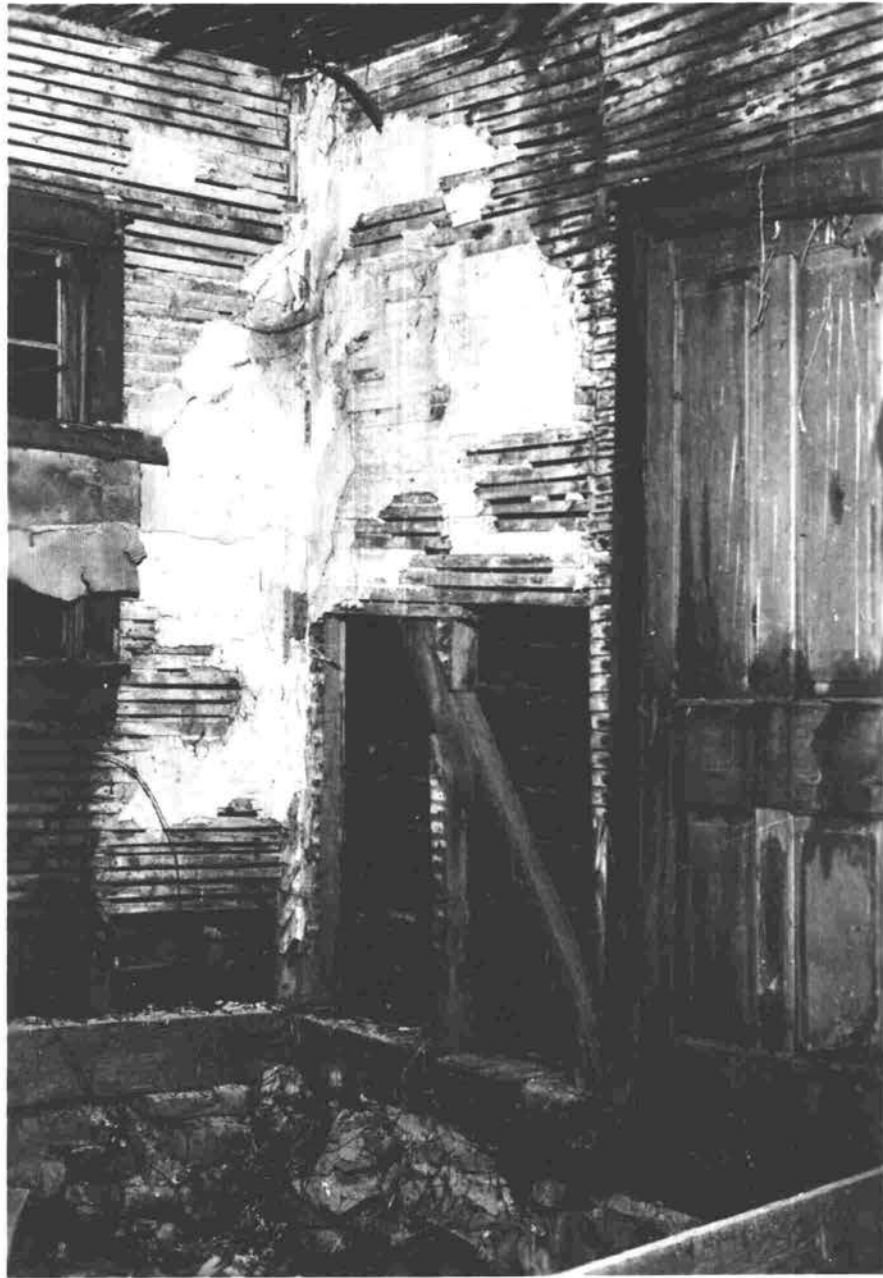
ILLUSTRATION NO. 26     NORTH EAST CORNER, FRAME ADDITION

This photograph shows the interior condition of the Dogan House in 1959. Most of the interior floor and trim was removed and evidently lost by the National Park Service in 1950. Note typical frame construction.

Floors: Replace floor joists and floor boards on the first floor. Repair or replace floor joists and floor boards on

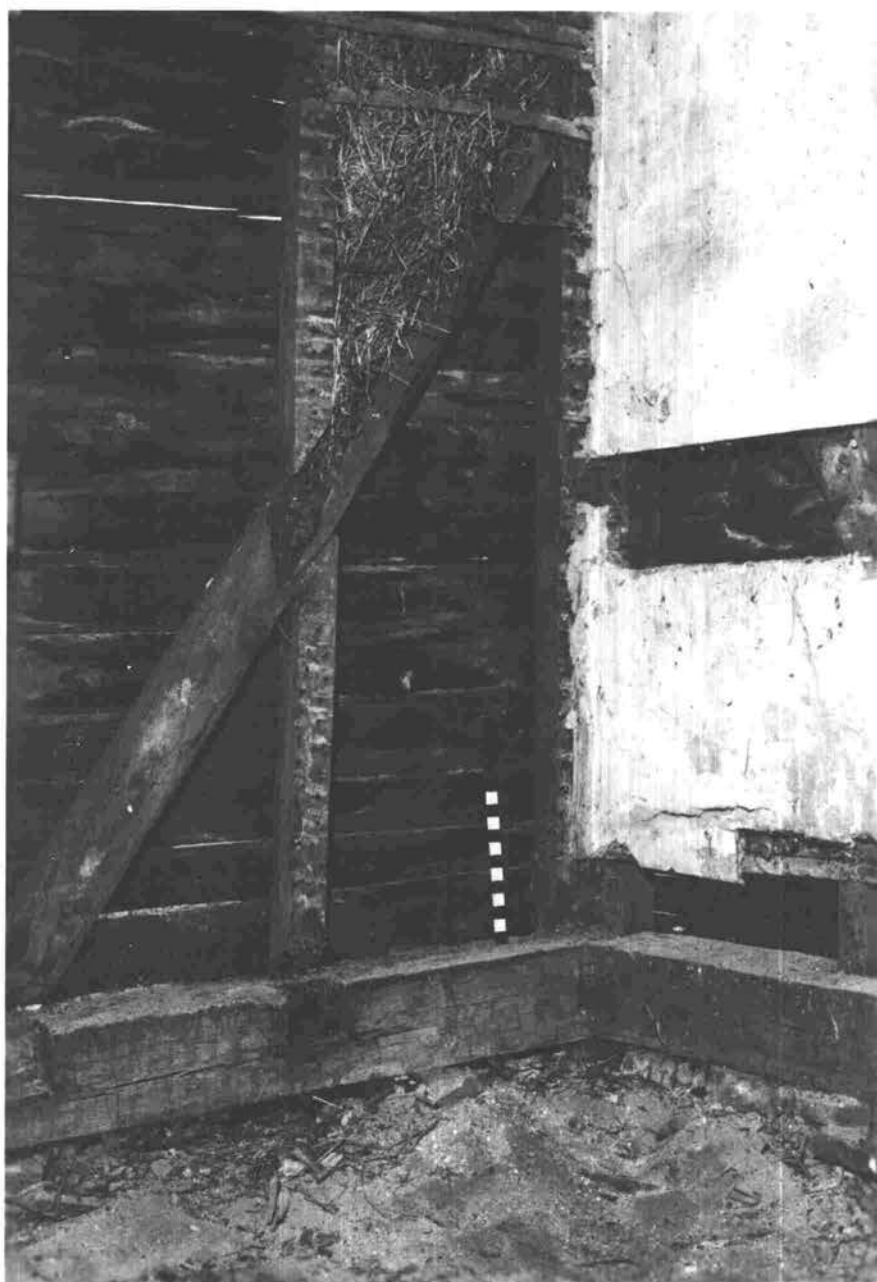
ILLUSTRATION NO. 27    NORTH WEST CORNER, FRAMES ADDITION

Although much of the original split lath and plaster remains on the 1st floor, frame addition, it cannot be saved. The same condition exists for the mortar "chinking" in the log structure. Under any movement of the building the "Chinking" will fall out. Consequently it has been anticipated that all new work will be required.

Some of the original split wood lath and plaster can be seen in this view. Baseboards and chairrails have been removed leaving spaces in the plaster to the right.

Walls: Remove and replace existing lath and plaster on the first floor. Replace chairrail, baseboard and mantel (s).

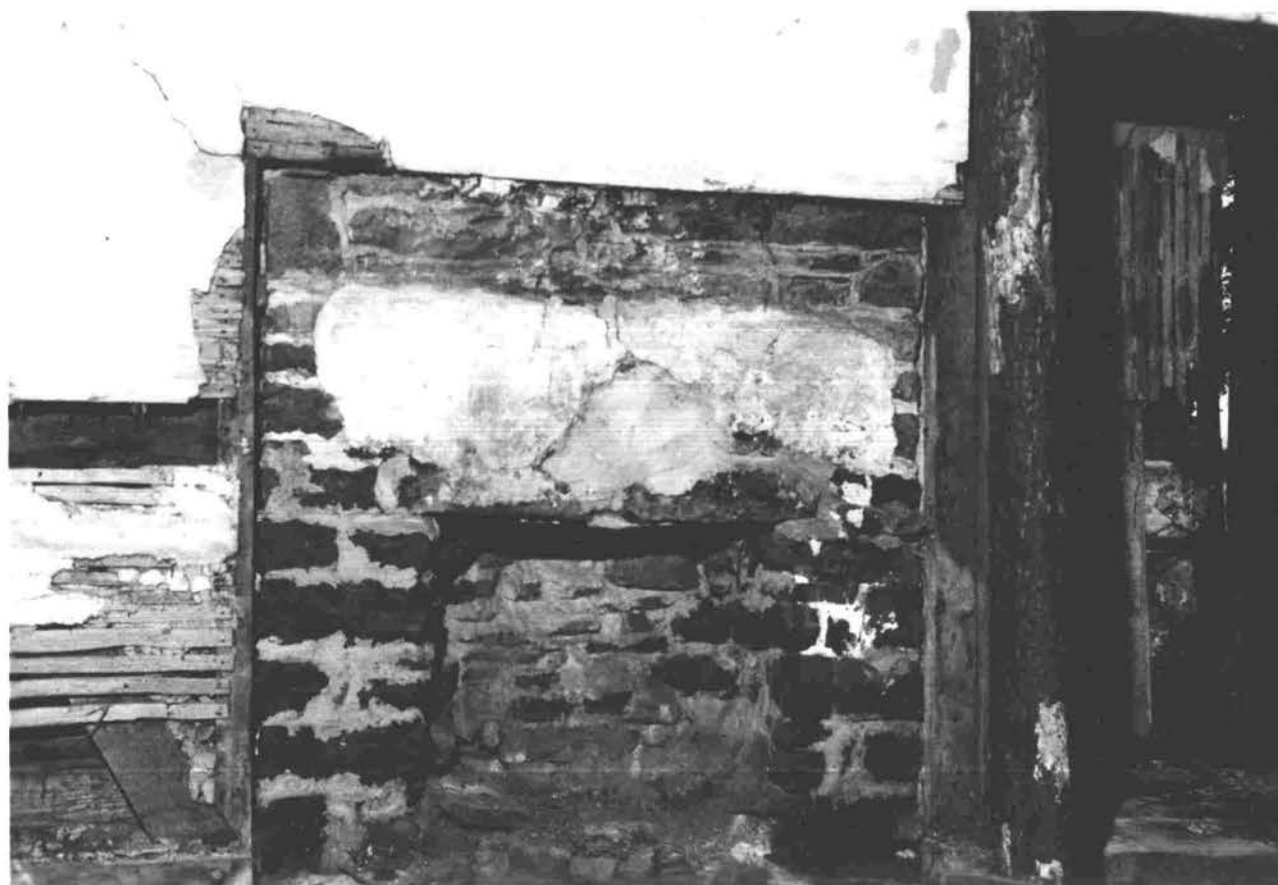
ILLUSTRATION NO. 26 FIREPLACE, FRAME ADDITION

View of living room fireplace located in the frame addition. Mantel and hearth have been removed as well as chairrail, baseboard and floor boards.

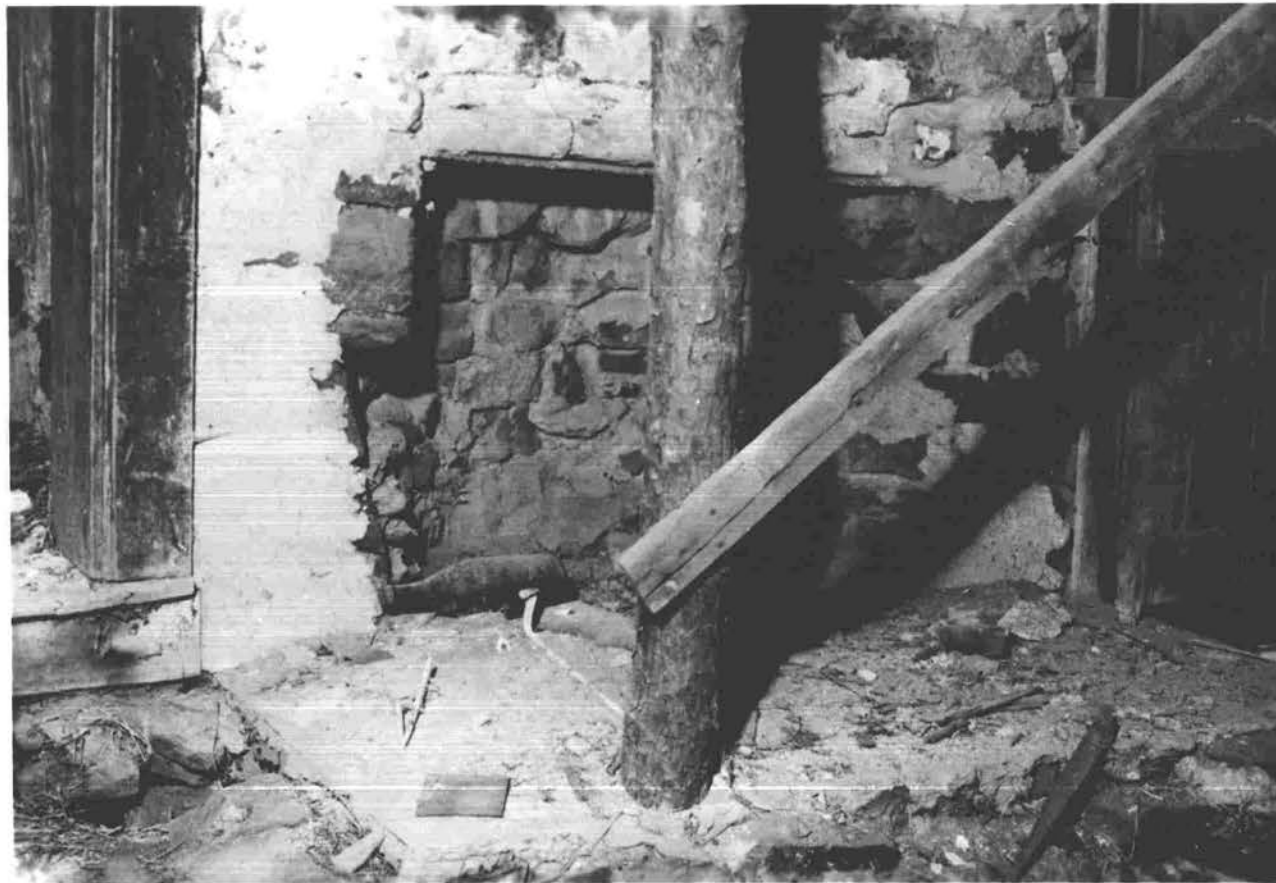
ILLUSTRATION NO. 29      FIREPLACE, LOG STRUCTURE

Conditions as found in 1959 of the fireplace in 1st floor room of the log section of the Dogan House. To the right of the fireplace can be seen the pantry door and the door to the left, the only means of access into the log portion of the house. Floor boards were also removed from this room.

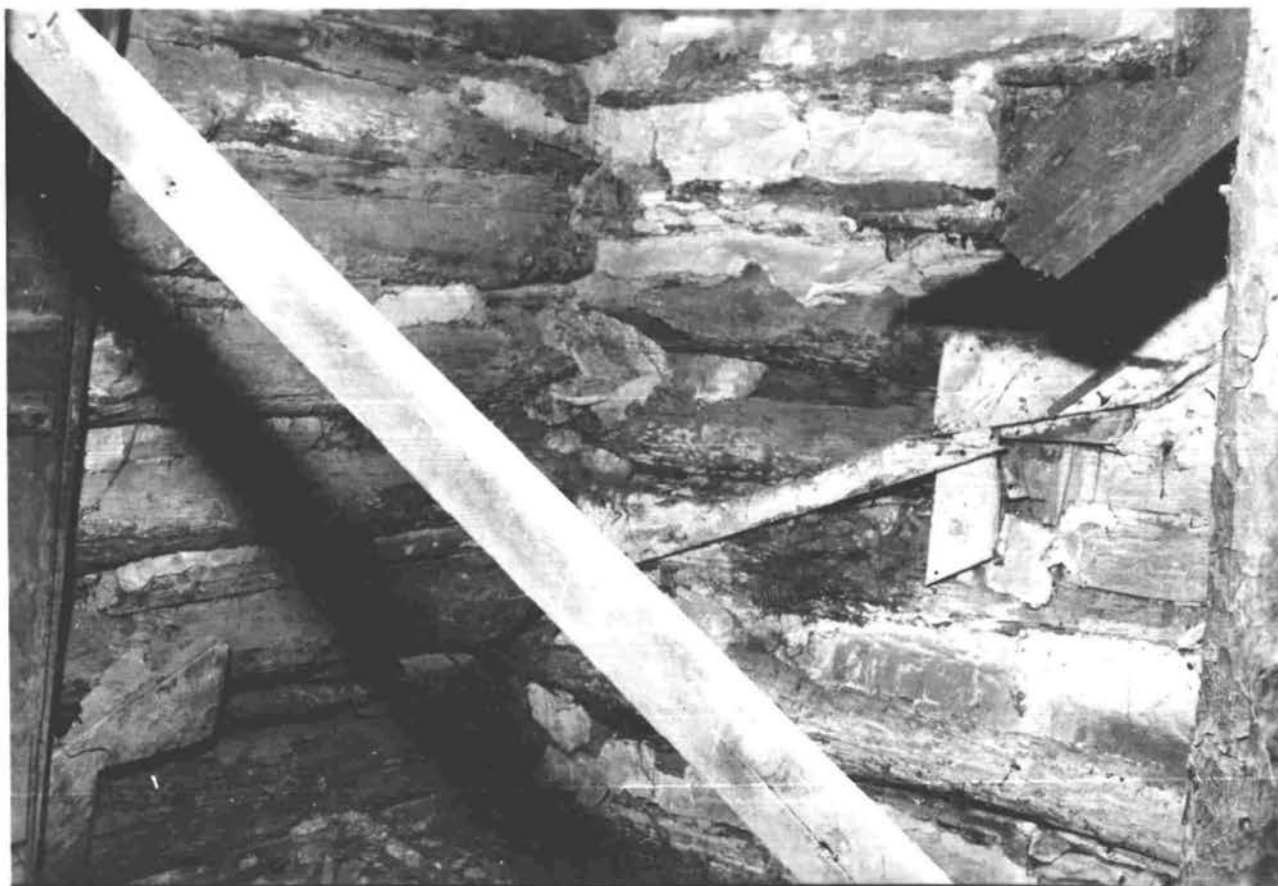
ILLUSTRATION NO. 32      STAIRWAY REMAINS

This view shows the last remnants of the "dog-leg" stairway located in the south-east corner of the log building. The stairway was once enclosed and the board and batten door at the foot of the stairway is visible to the entrance left.

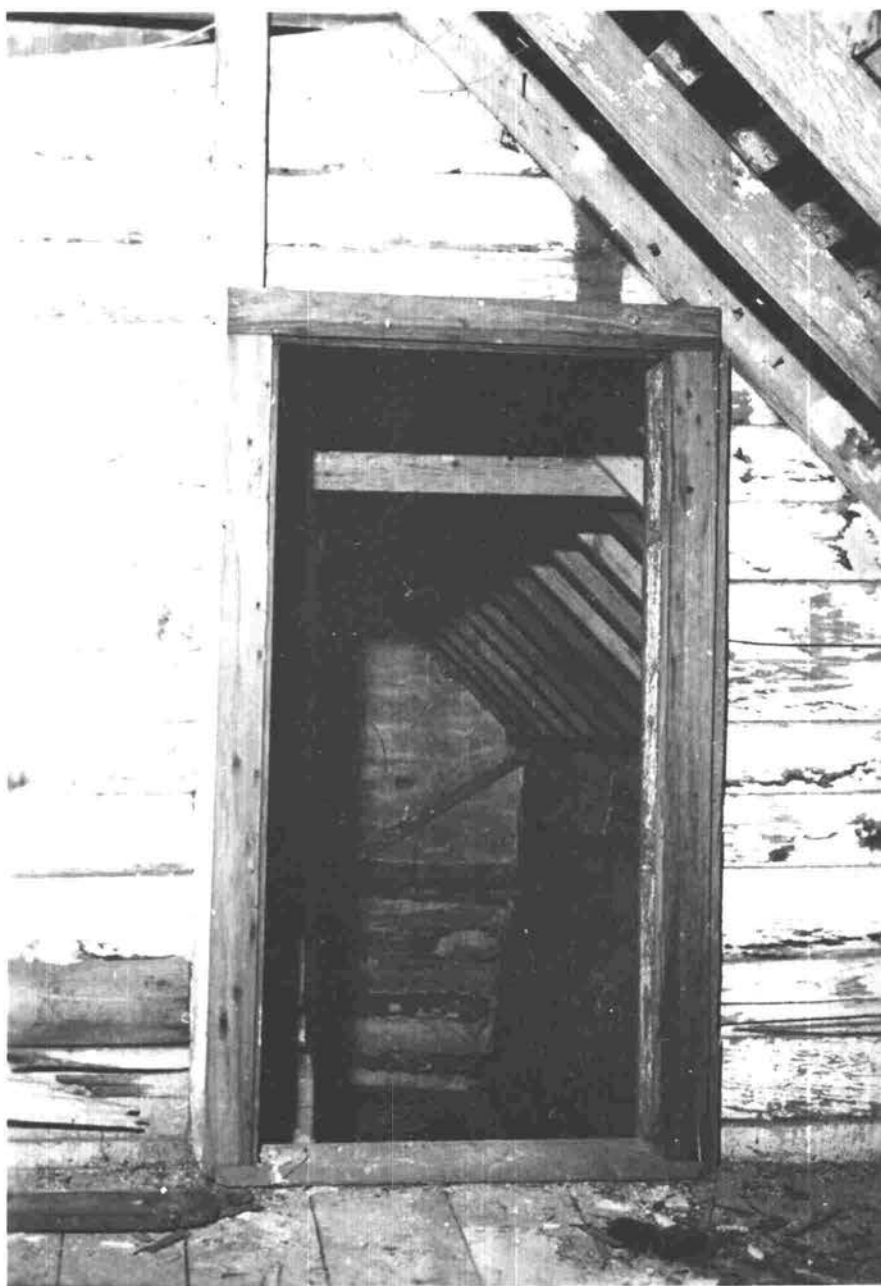
ILLUSTRATION NO. 34      ACCESS DOOR 2nd FLOOR

One studding has been removed to allow a doorway cut between the attic room of the frame addition and the 2nd floor room of the log structure. Looking south into the log structure beyond. Roof sheathing above has been reused. Roof over the log structure was replaced with 2" X 16", 16" on centers.
