## HISTORIC STRUCTURES REPORT

## ARCHITECTURAL DATA, PART II

## REHABILITATION AND RESTORATION

## DOGAN HOUSE

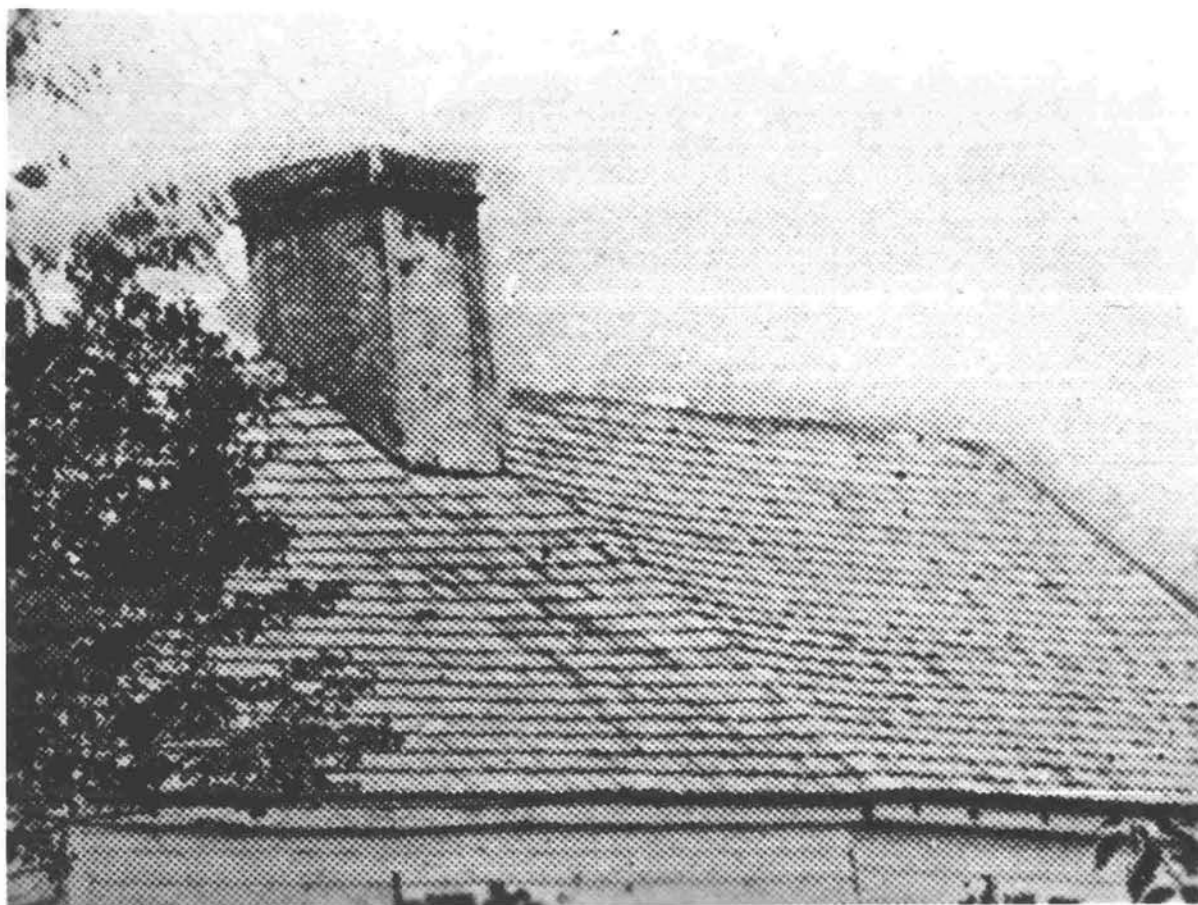
ILLUSTRATION NO. 2

ENLARGEMENT OF EAST ROOF AREA

Enlargement of roof area showing what appears to be  
whitewash on chimney. Shingle roof probably is that of 1860.

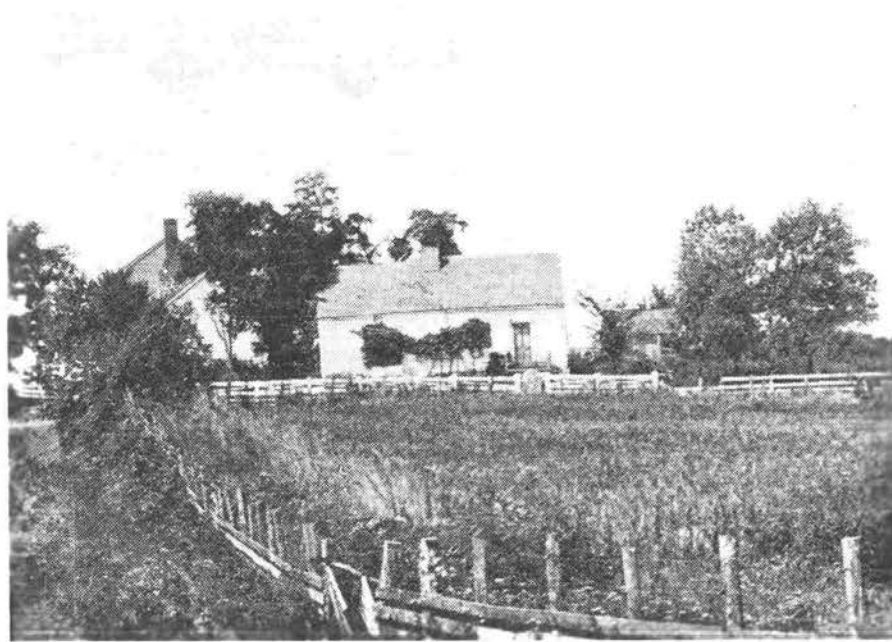
ILLUSTRATION NO. 3

DOGAN HOUSE, VIEW FROM EAST

This view shows the basis for construction of platform on east side of house. A small stoop can be seen in front of door facing road. It is assumed that the porch was reconstructed (1881) in a similar manner to that of 1860. Note chimney appears to have stucco or whitewash.

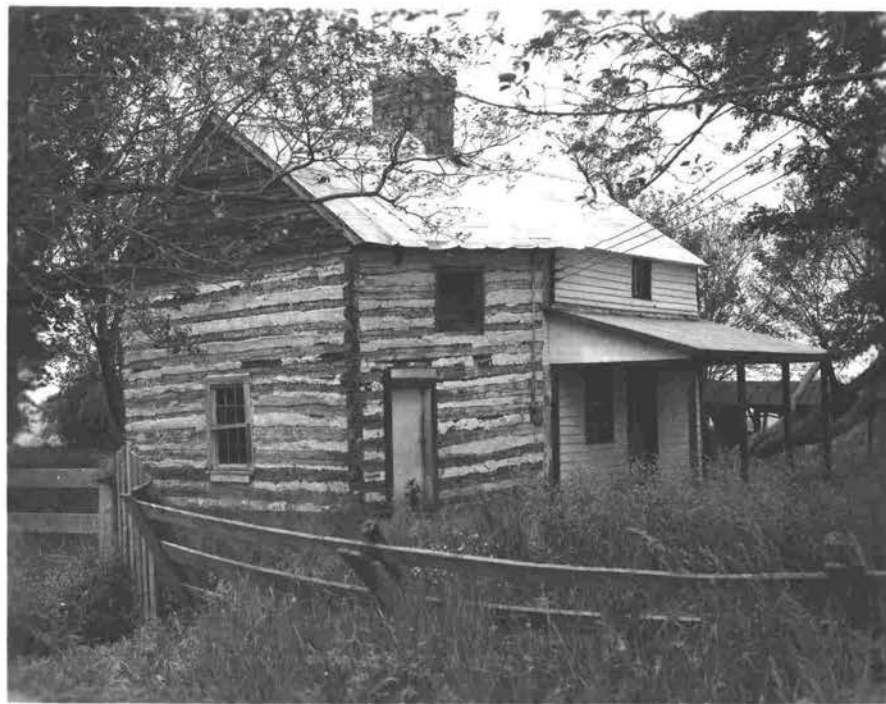
ILLUSTRATION NO. 4

GRIN HOUSE

A part log and frame house very similar to the present Dogan House. In this instance, the log portion was added to the frame structure, unlike the Dogan House where the frame building was moved over and attached to the log cabin. Interior details of both structures are very similar. This building is located about 1/2 mile from Centreville, Va. on Route 28.

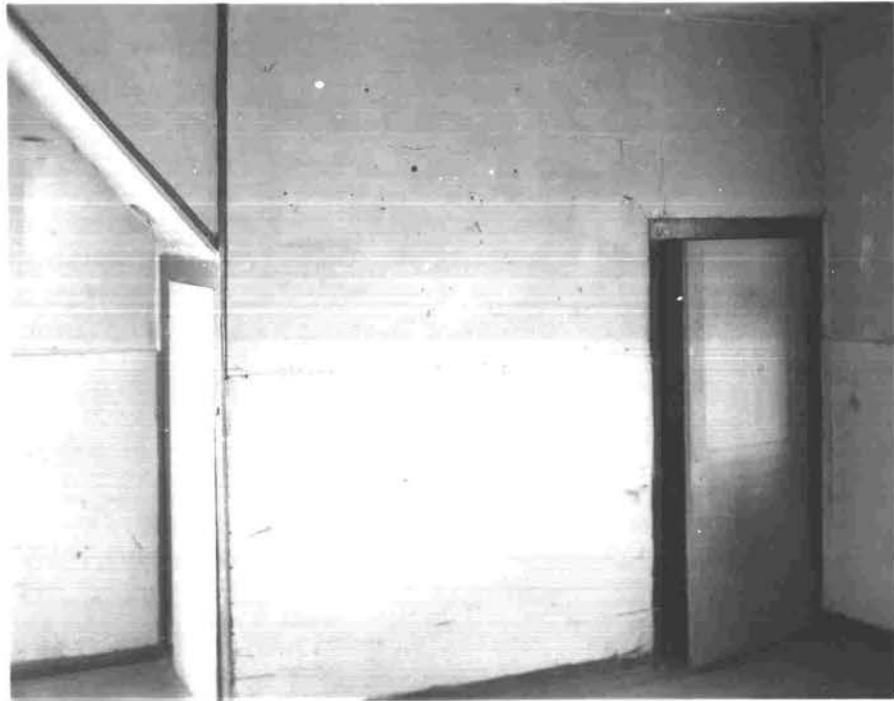
ILLUSTRATION NO. 5

GRIN HOUSE

Interior view of stairway in frame portion of the Grin House. Stairway is almost an identical match for the original one removed from the frame addition of the Dogan House in 1881.

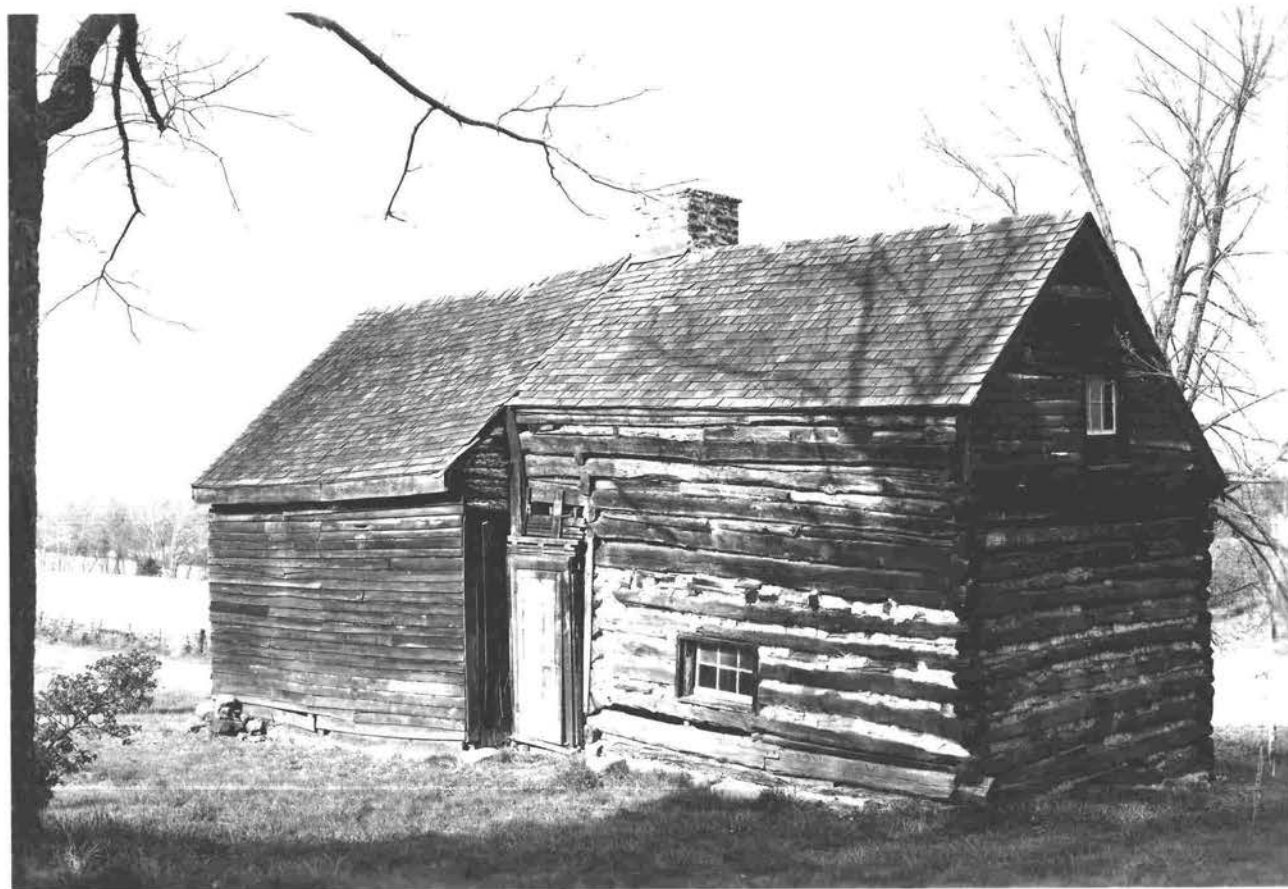
ILLUSTRATION NO. 12

DOGAN HOUSE FROM SOUTH-WEST

This view shows the conditions of the Dogan House just prior to architectural investigation and exploratory excavations.

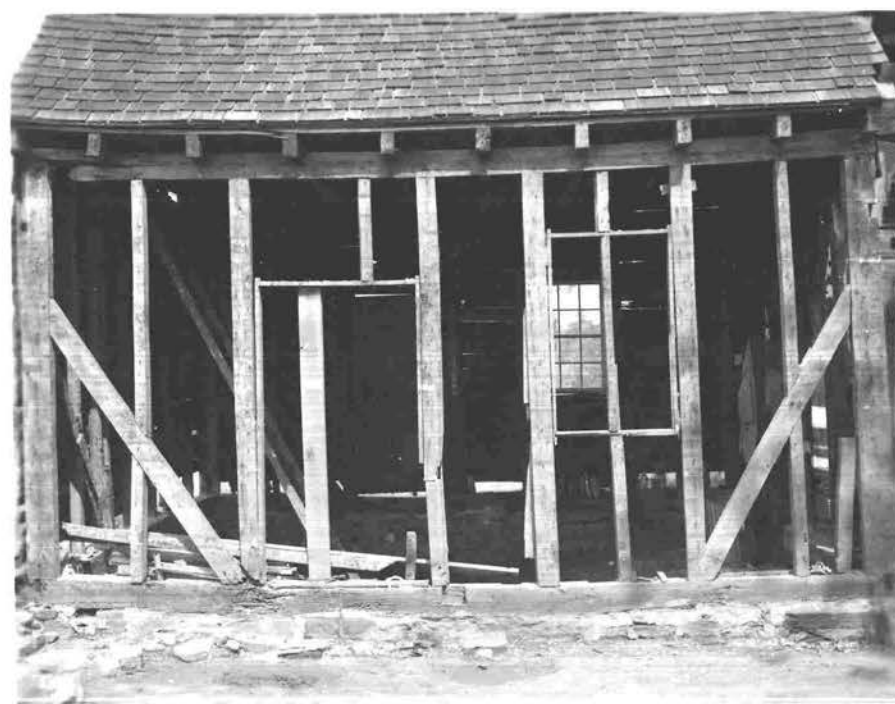
ILLUSTRATION NO. 13

Frame Addition, Degan House

This view shows a window and door frame left intact within the west wall of the frame portion during the remodeling of 1881-82. Openings on east wall have identical spacing. All studs and corner braces are members of the original frame.

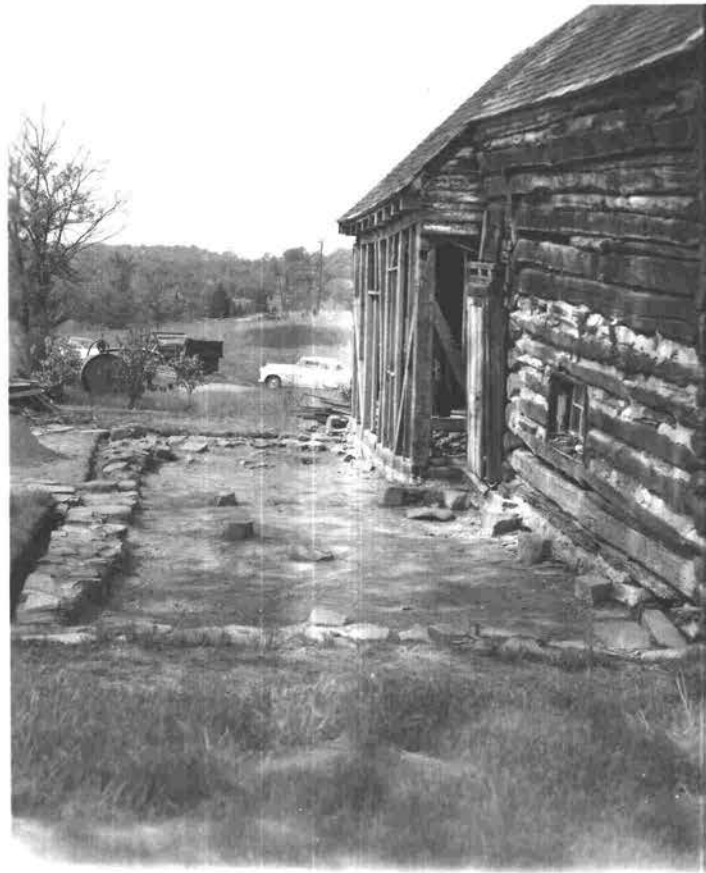
ILLUSTRATION NO. 14

WEST EXCAVATION

Exploratory excavations on the west side of the Dogen House. No evidence of foundations earlier than 1881-1882 one shown in this view was found during exploratory work. Rock used for this foundation was granite rather than the red sandstone used for the 1860 foundation.

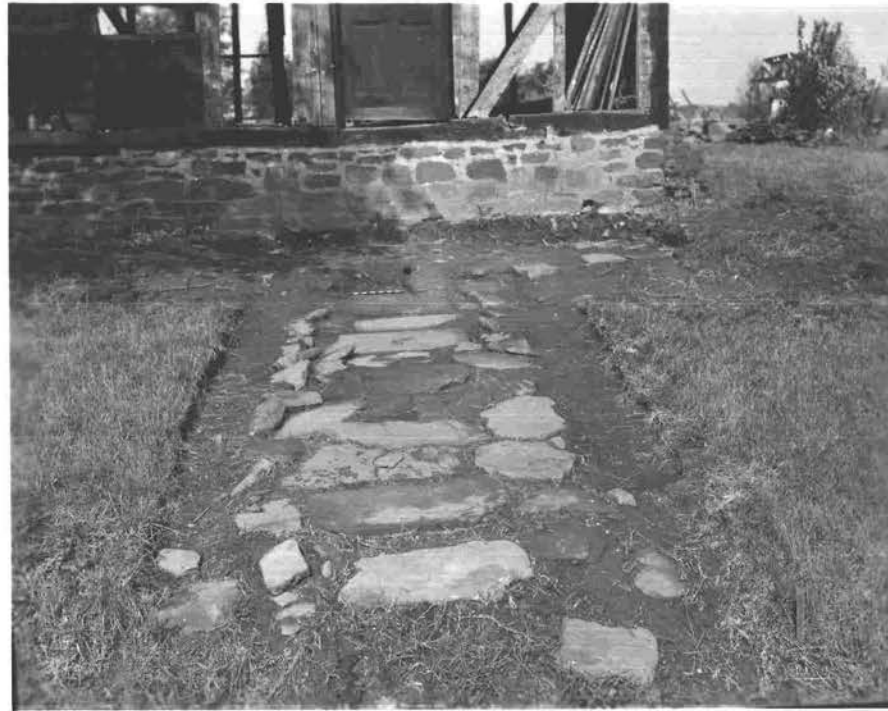
ILLUSTRATION NO. 15

**EAST EXCAVATION**

Remains of an early stone walk was uncovered on the east side of the Dogan House. No porch or step footings could be identified during excavation.

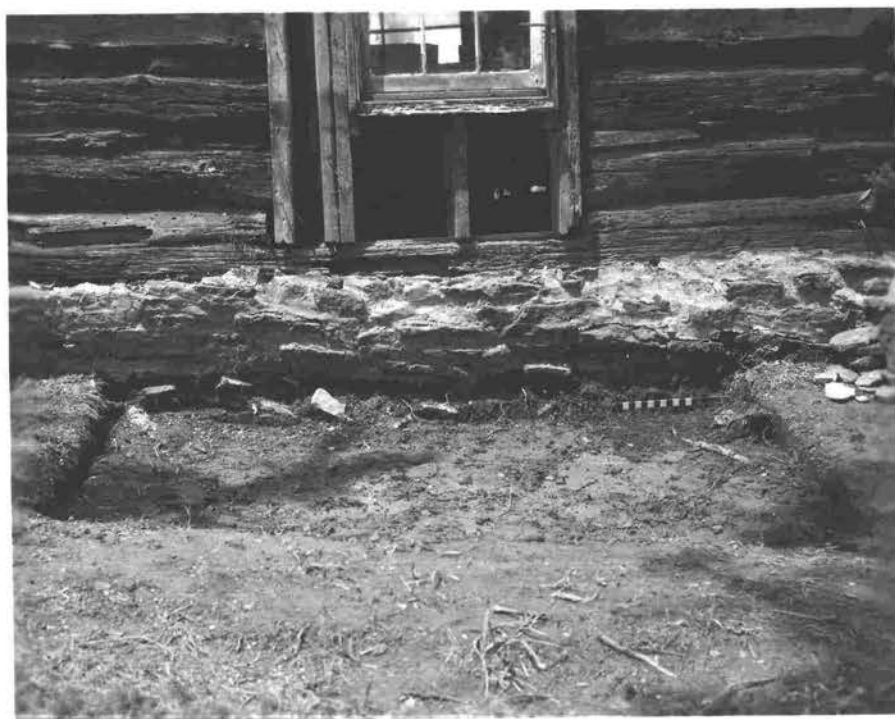
ILLUSTRATION NO. 16

EAST EXCAVATION

This small area east of an original door opening was uncovered in an attempt to locate footings for steps, porches or platforms. A bayonet was uncovered just to right of picture in extended digging.

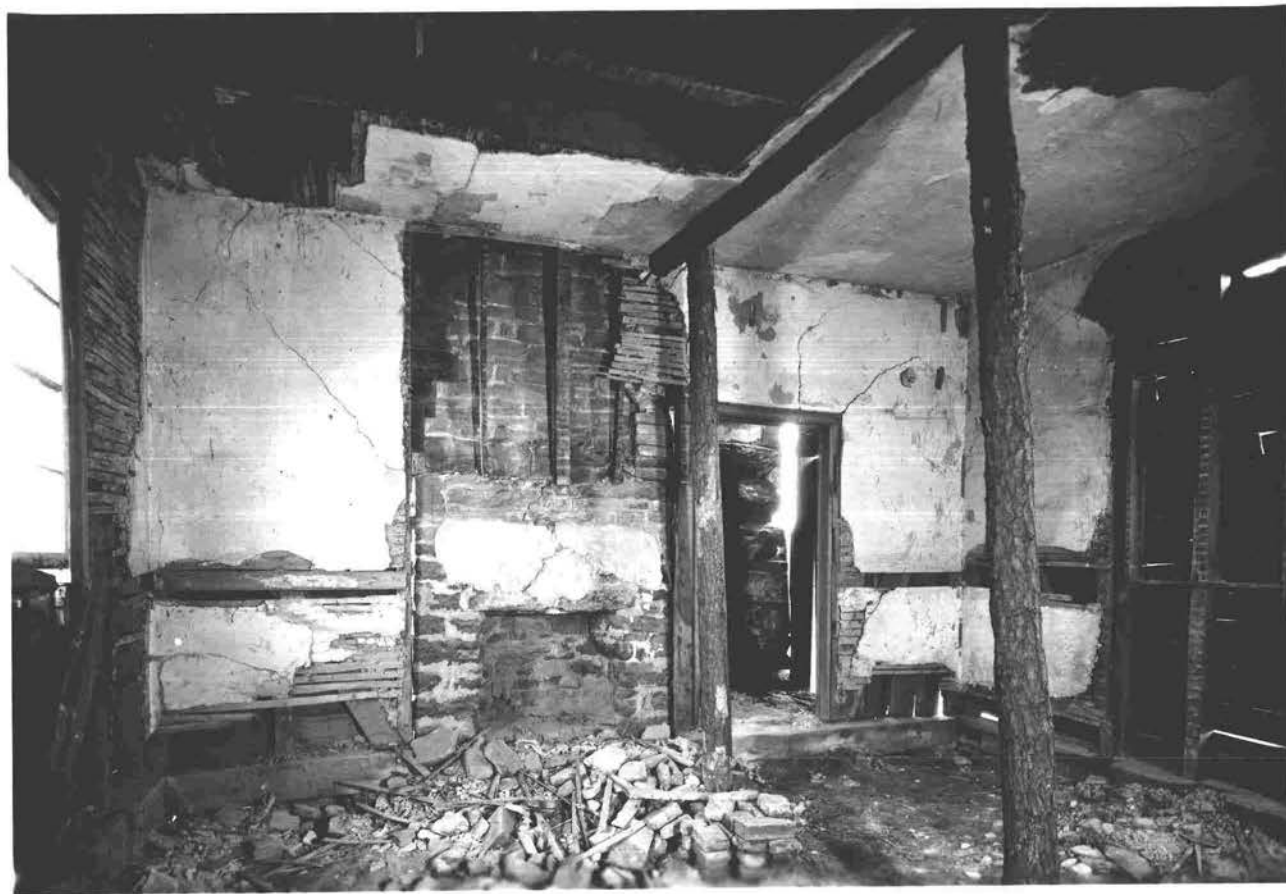
ILLUSTRATION NO. 17

Illustration No. 17 shows the plaster surface remaining on the face of the chimney that outlines the original mantel piece now missing around the fireplace in the frame addition. The width of the mantel can be determined by the measurements between the original piece of chairrail on the left and the door casing on the right.

The height of the mantel can be determined by the outline left by the stucco surface. Since the original mantel is missing, the design for the replacement will be conjectural.

SOUTH WALL, FRAME ADDITION

View of frame addition to the south showing original plaster walls and ceilings and methods used to finish interior surfaces. An original piece of chair rail set back into place can be seen to left. Below is space for a baseboard.

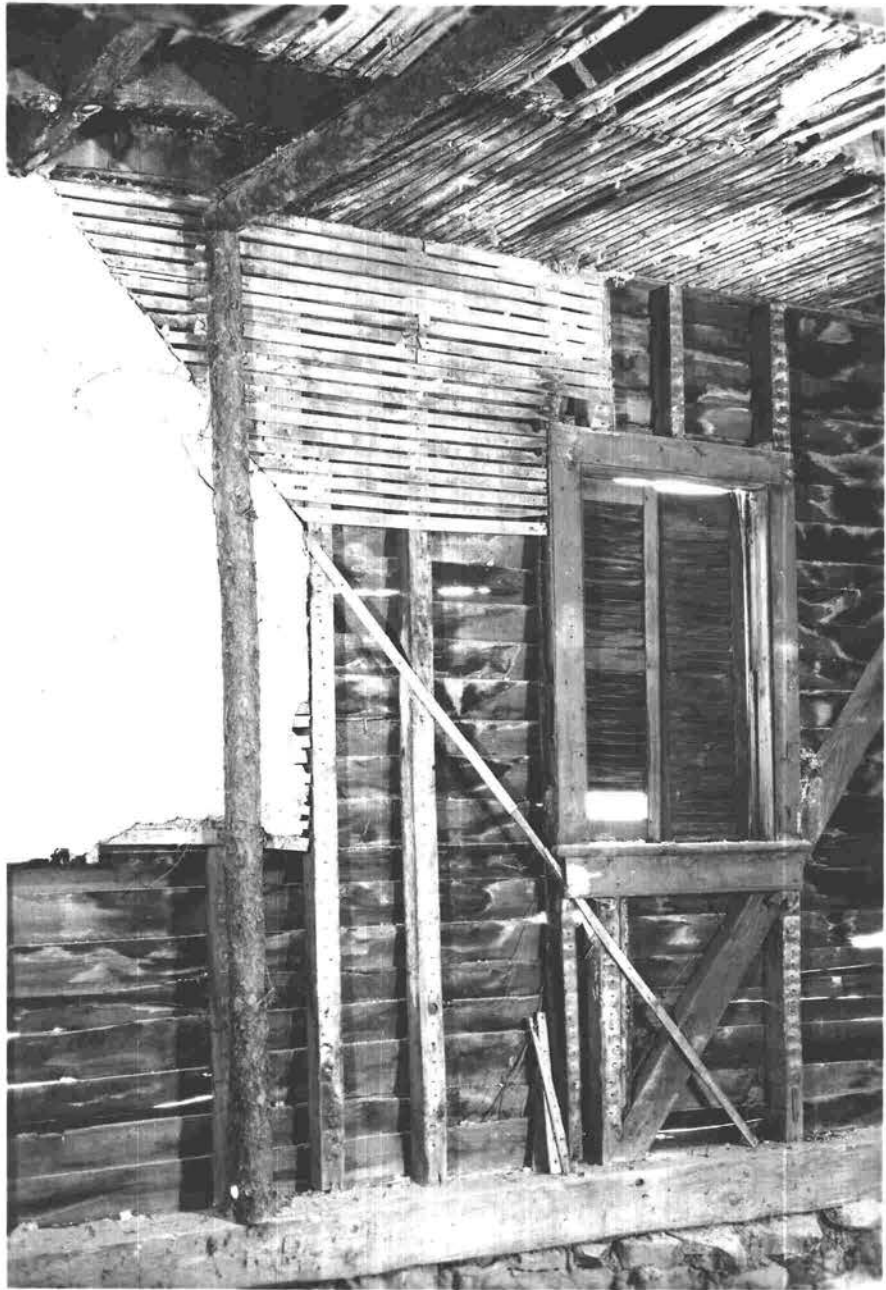
ILLUSTRATION NO. 18

NORTH WALL, FIRST FLOOR

It has been assumed that the use of sawn pine lath occurred during the alterations of 1881-1882 and the use of hand split chestnut-oak lath for the original 1840 structure. This view shows the use of the sawn pine lath nailed over areas where a stairway was removed in 1881-1882. Whitewashed studs were enclosed by stairway. The window is also an 1881 addition. Note original stud cut off to accommodate window frame.

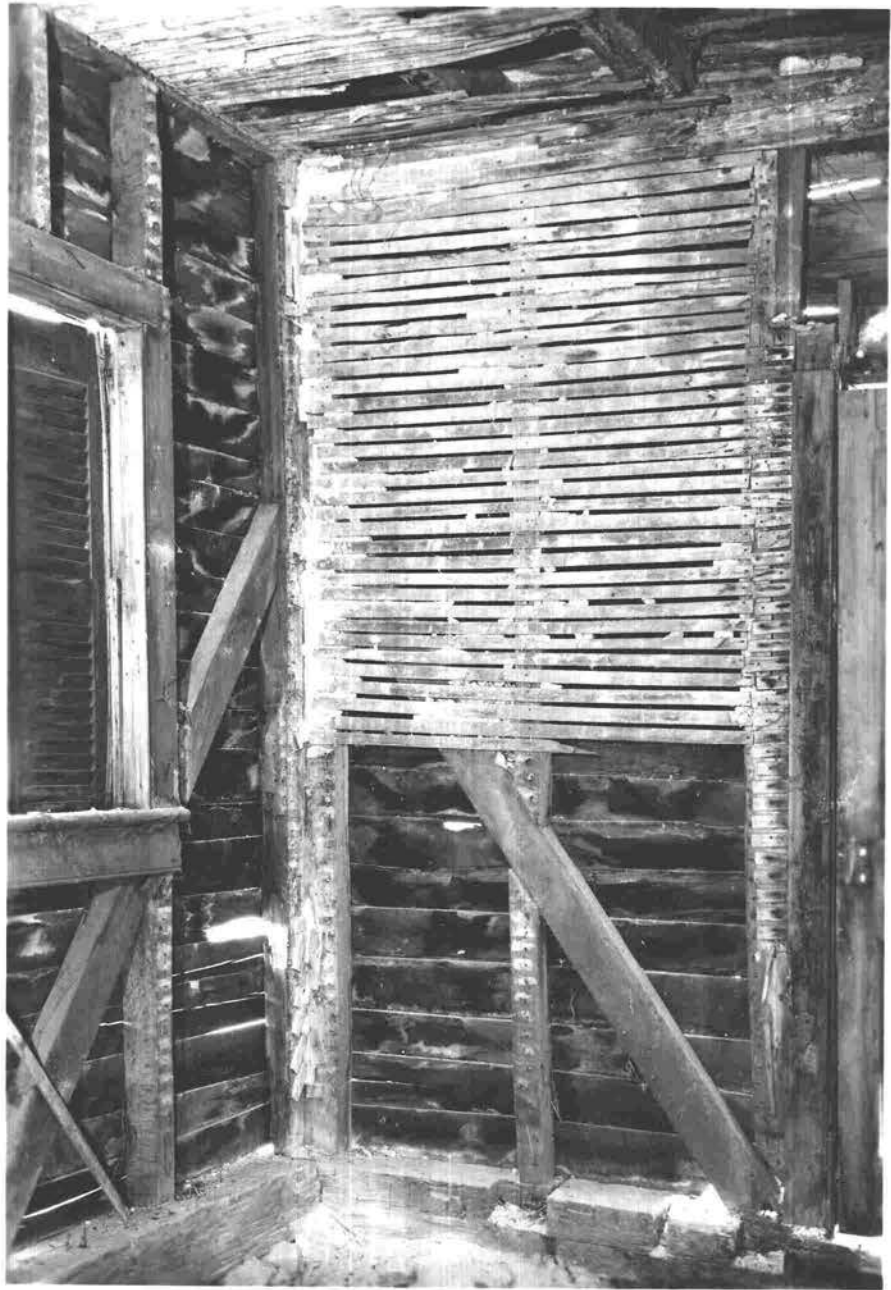
ILLUSTRATION NO. 19

NORTHEAST CORNER, FIRST FLOOR

Other 1881-1882 alterations indicated by the use of sawn pine lath is the change in width of the east door. Original opening matches size of old door frame found in west wall, see Illustration No. 13. When the chimney was removed this area was re-lathed and plastered. One notch for stairway stud can be seen in ceiling joist in upper right of photograph. Compare stairway design with Illustration No. 5.

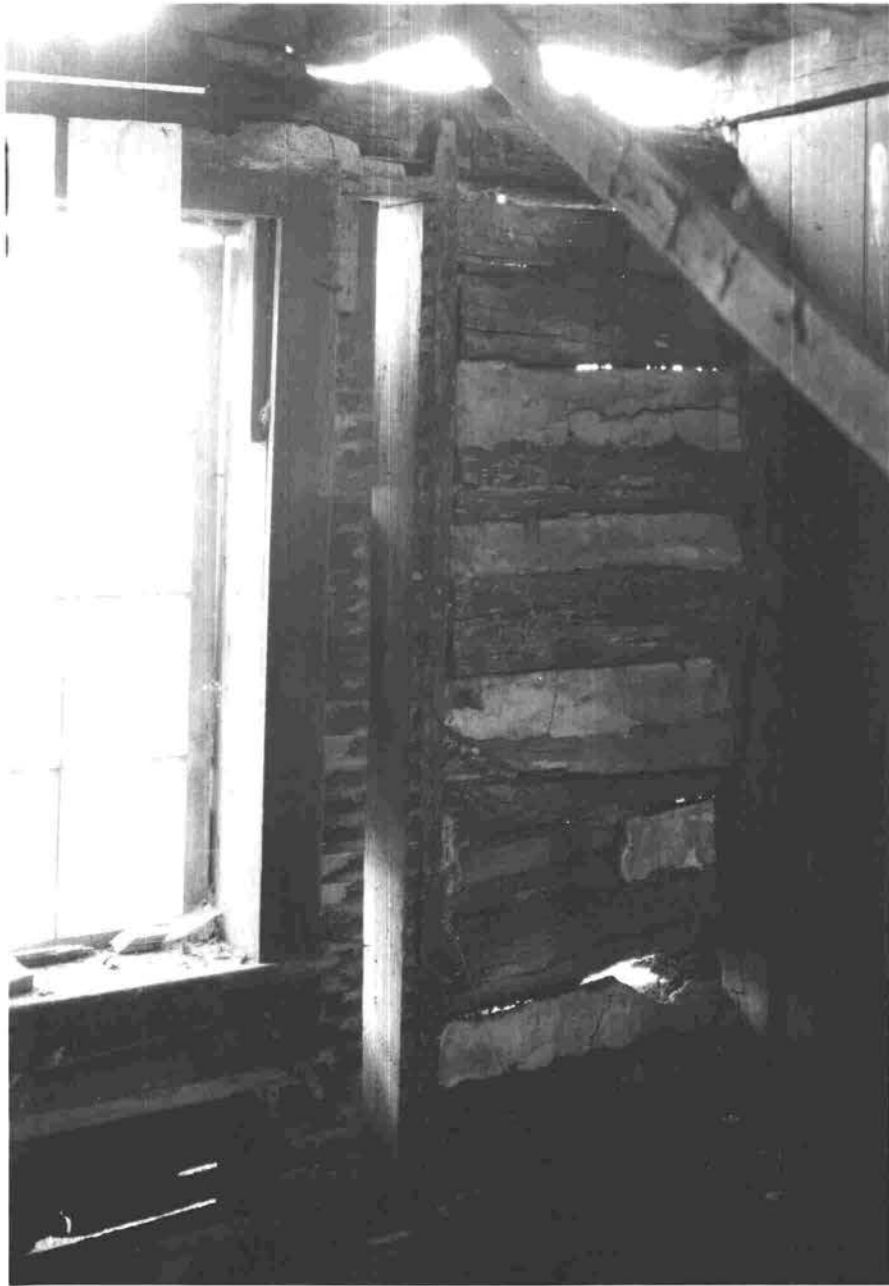
ILLUSTRATION NO. 20.

EAST DOOR FRAME, LOG CABIN

An original door frame enclosed by the 1881-1882 alteration. Sawn lath was used to cover over opening between window and door frame.

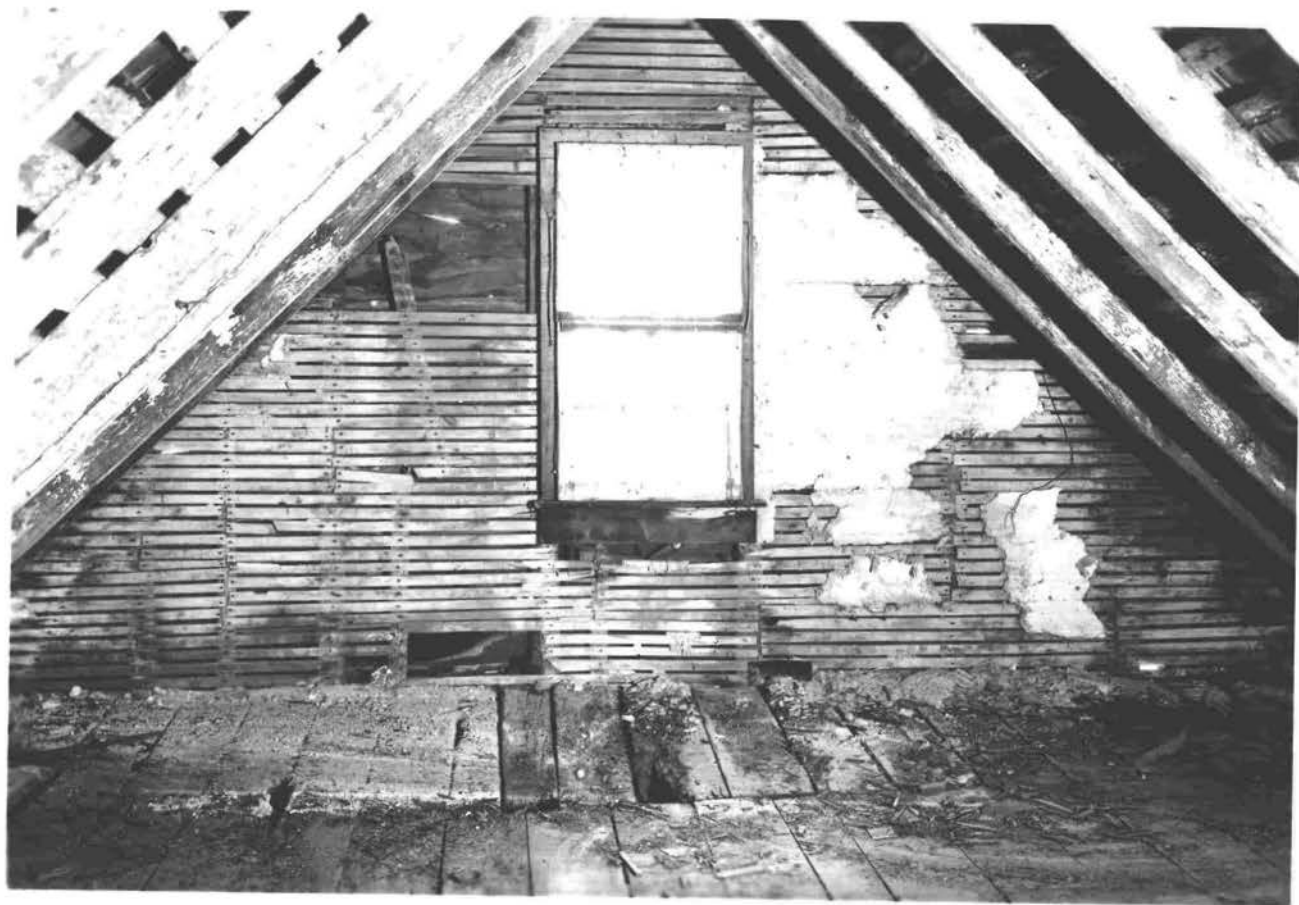
ILLUSTRATION NO. 21

SECOND FLOOR, FRAME ADDITION

Looking north, second floor of frame addition. Wall was covered with sawn lath and plaster indicating that the changes were made in 1881-1882. Remainder of walls and ceiling were whitewashed. Floor boards show where repairs were made when the stairway was removed.

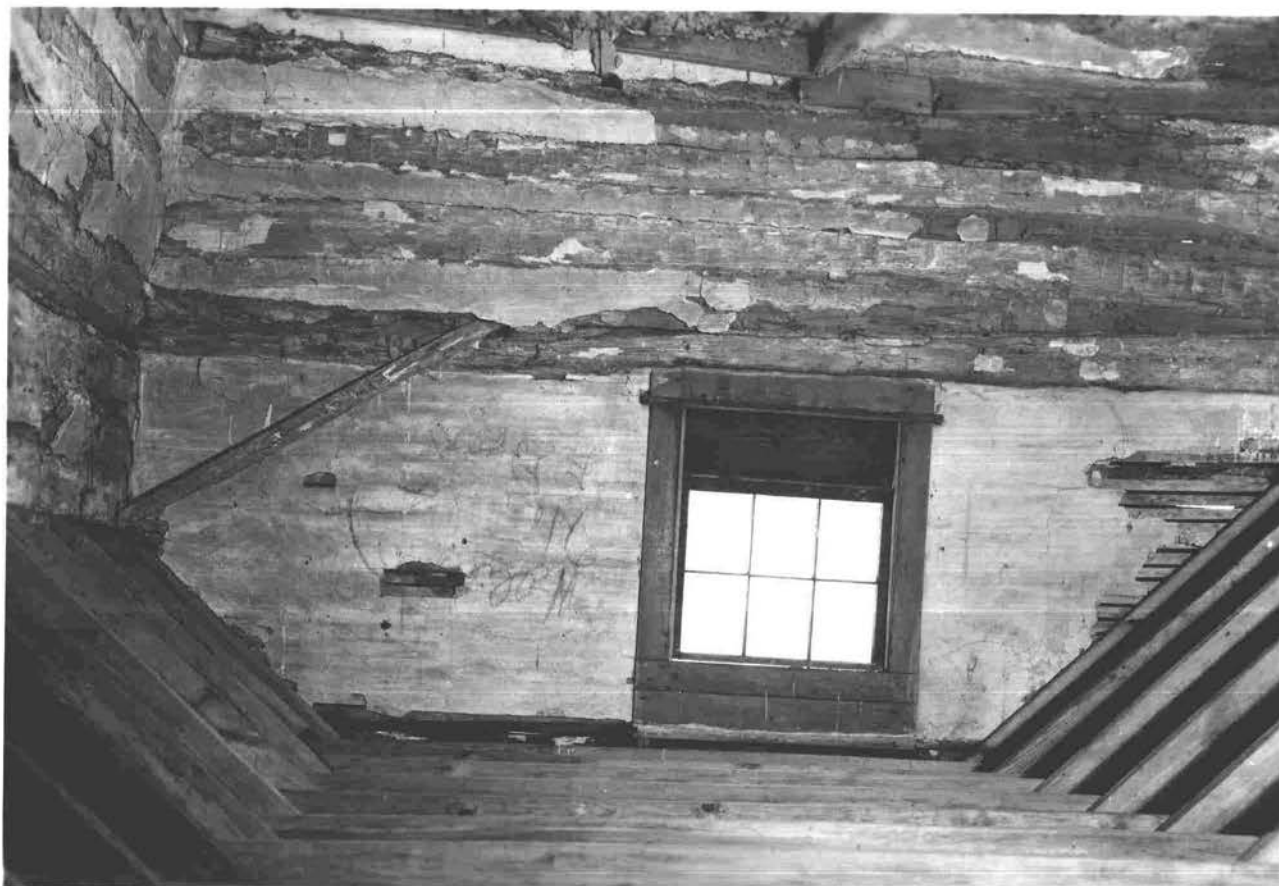
ILLUSTRATION NO. 22

SECOND FLOOR, LOG CABIN

View of the south wall, second floor of the log cabin. Log wall to right was raised to present height in 1860 when frame building was added to the north side of the log cabin. Notice the diagonal brace in the right corner intended to stabilize the logs above the adjoining wall. When the ridge of the roof was raised, it was necessary to build up one of the wall heights to compensate for the log cabin being narrower in width than the frame addition. Window was found to be one added in 1881-1882. Present roof structure was constructed in 1950 by the Washington Home Improvement Company.

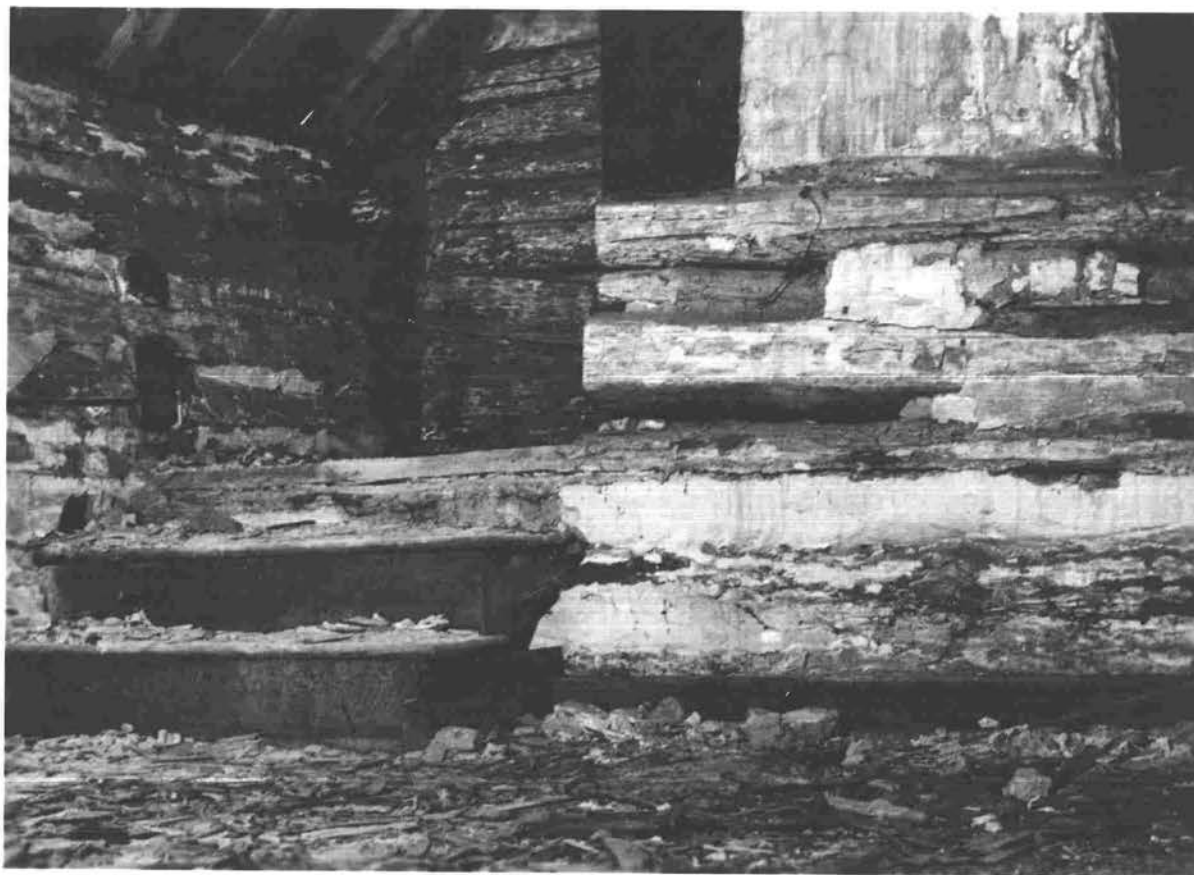
ILLUSTRATION NO. 23

Illustration No. 23 shows this condition with the notch for the diagonal brace visible in the top log of the west wall just under the plate. The original wall line of the log cabin can be distinguished by the whitewash marks left on the weatherboarding of the frame addition. The steps shown in the same photograph are 1881, although the platform beyond over the hall is thought to be in its original location. Illustration No. 22 shows a similar condition existing at the south-west corner of the room. The condition of the north wall must have looked much like the south wall in 1860 when the upper part of the walls in the log cabin were raised.

DETAIL - STEPS, SECOND FLOOR

Log Portion to second floor level, frame (North) portion. Probably installed in 1881.

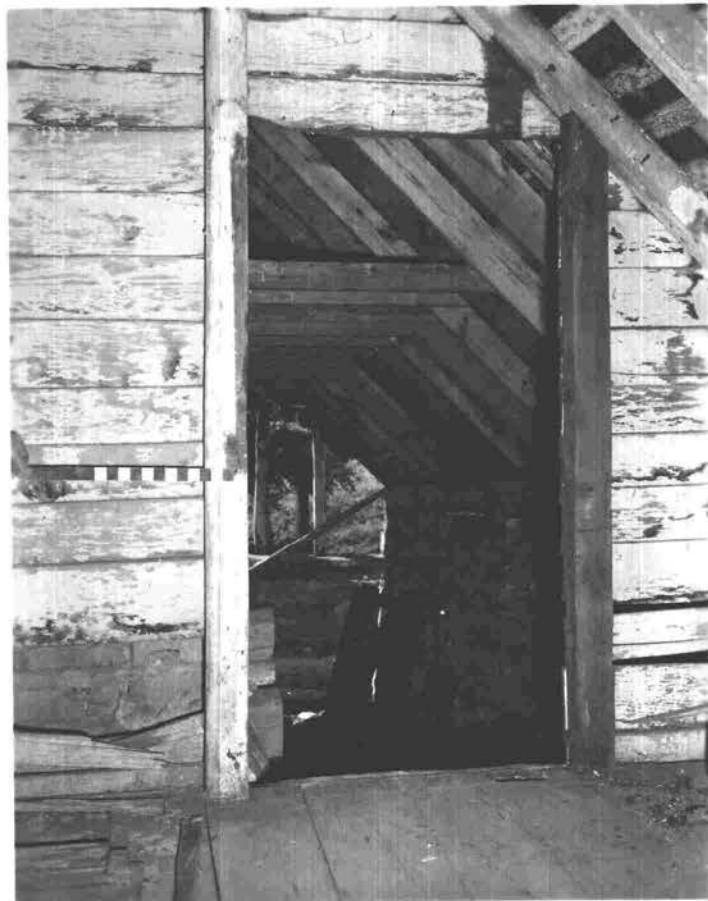
ILLUSTRATION NO. 24

SOUTH WALL SECOND FLOOR

This view shows the changes that occurred in 1881 to the south wall, second floor of the frame addition. A four light window was removed and a doorway cut through for access into the log cabin. Outline of the original window sill and trim can be seen on the stud to the left. To the right, the outline of the stud can be seen on the weatherboarding above and from the original mortice and tenon joint at floor level.
