# Medgar and Myrlie Evers Home National Monument Historic Structure Report - Appendices

## CONDITION ASSESSMENT

### MEDGAR AND MYRLIE EVERS HOME NATIONAL MONUMENT

SEPTEMBER 2021

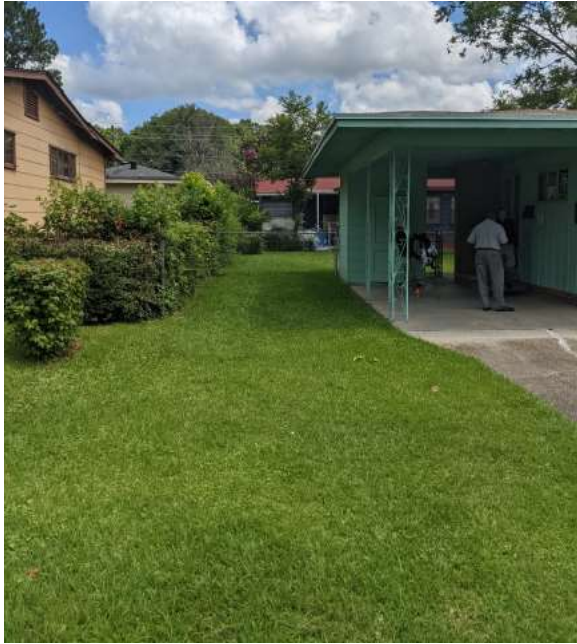
**Lawn:** The existing lawn appears to be healthy. Although weeds are present, the condition is typical of, if not better than, the rest of the neighborhood. See Figure 10.

Figure 10. Lawn Condition.

**Lawn:** general maintenance only. Should drainage and grading improvements be completed, then the yard areas would need repair. (Level 3-S)

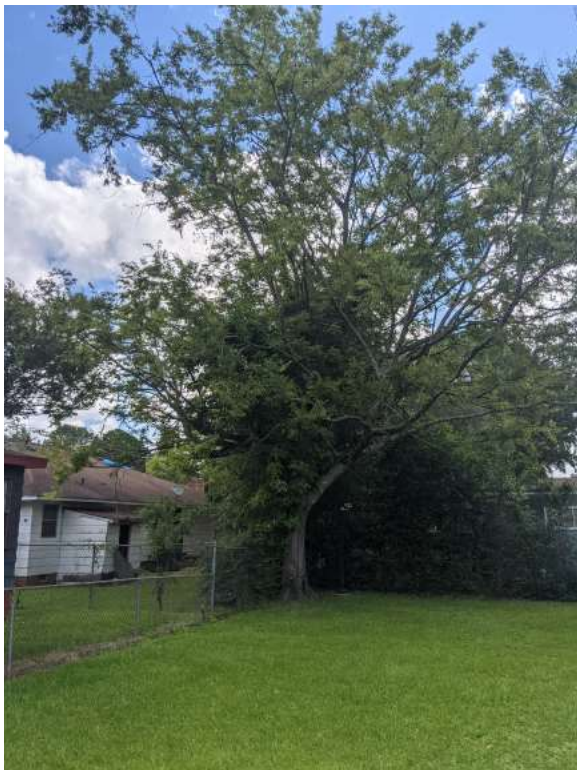
**Trees:** There is only one existing tree on the property and that is a hackberry (*Celtis occidentalis*) located in the northeast corner of the rear yard. See image below. The tree is approximately 36 inches in diameter at breast height (dbh) and is in reasonably stable condition but showing visible signs of decline. The tree canopy extends over multiple properties and is well within reach of several structures, should the tree fall. The age of the tree is unknown, but it is

believed that the tree was present during the period of significance for the property, indicating it may be minimally 65 years in age.

Figure 11. Significant Hackberry tree at rear of property.

**Trees:** Due to the decline of the existing hackberry and the liability concerns of it falling onto the house or adjacent property, it is recommended to be removed. As this tree was present during the period of significance, it is also recommended that a creative reuse of the tree be explored. This might include, an art display, carved bench seats, signage posts, etc. The tree should be cut below ground as far as possible. The excavated area should be compacted with fill material to an elevation roughly 2-3 inches below adjacent grade. Fill remainder of the depth with topsoil. Over time as the stump and roots decay, more fill material will be required. Planting of a replacement tree, possibly of a smaller variety, may be considered for interpretive purposes as well. (Level 1-M)

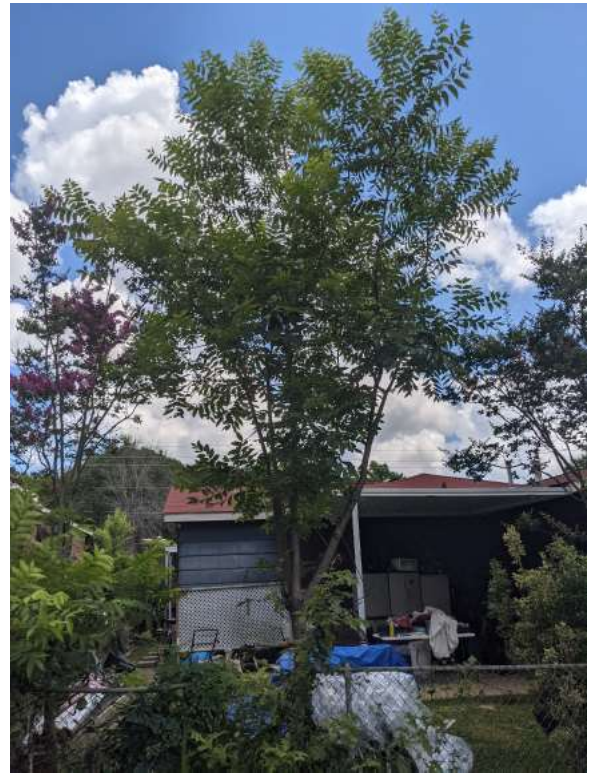
Along the rear property line there are several other trees that are on an adjacent property, and a portion of their canopy extends onto the Medgar and Myrlie Evers property. The species appear to be crape myrtle (*Lagerstroemia indica*) and Tree of Heaven (*Ailanthus altissima*). The trees do not pose any significant risk to the property; however Tree of Heaven can be extremely invasive.

Figure 12. Neighboring trees.

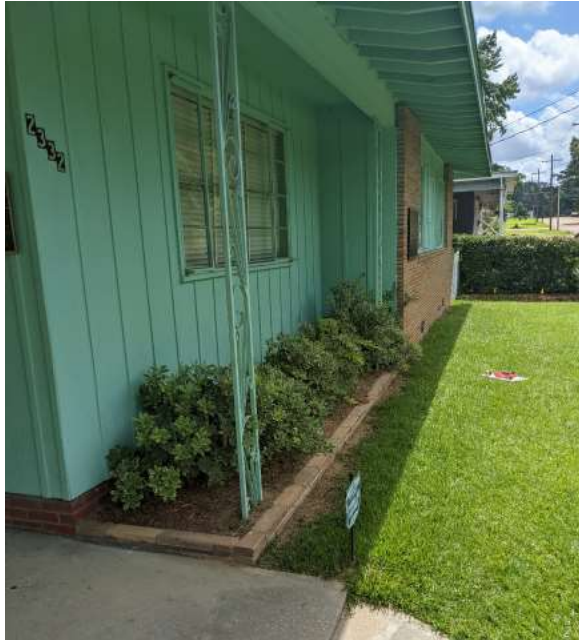
**Raised Planting Bed:** At the front of the house there is a narrow, raised planting bed which contains some foundation plantings. (see image below) The bed is constructed using one wythe of bricks, two courses high. It is understood that during the period of historic significance, there was a raised bed in this location, however the current bed is not original. It was reconstructed as part of the improvements in 2013. The current plants, Japanese pittosporum, are also not original.

Figure 13. Front planting bed.

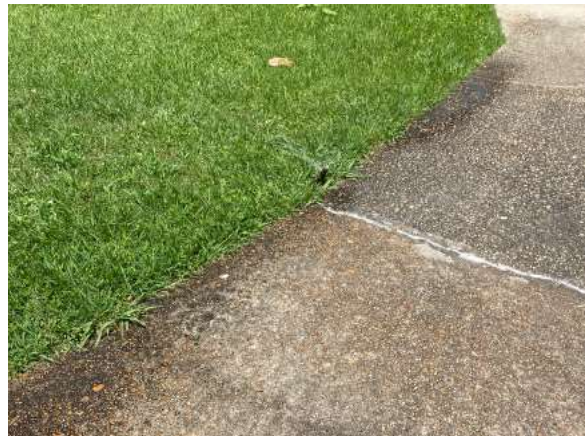
There is an existing irrigation system consisting of mainly pop-up rotary style heads. These are located throughout the front and rear yards, as well as in the front landscape bed. The control panel is located on the east side of the house near the HVAC condenser unit and other utilities. Multiple valves are located within the lawn/landscape next to the house in the backyard. There are a couple of broken sprinkler heads located in the front yard near the driveway. Other than the few damaged sprinkler heads, the system appears to be in working order. (see image below)

Figure 20. Damaged sprinkler head.

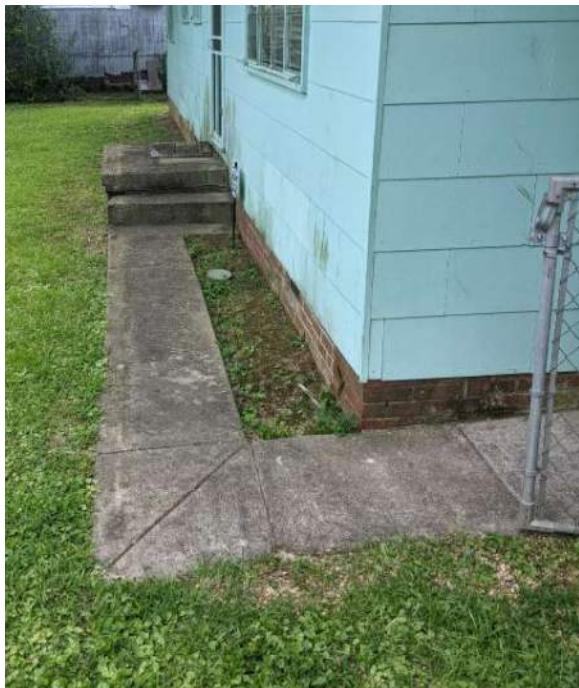
**Sidewalks:** There is an existing concrete sidewalk that connects the concrete pad underneath the carport, to the rear entrance of the house. This is understood to be the original configuration of the sidewalk. The sidewalk ranges from 30" wide to 24" wide. The concrete shows signs of typical wear but is in relatively sound condition. However, it does appear that the sidewalk is sloped to drain toward the house, which could be adding to water issues in the crawl space. Any water that makes its way between the sidewalk and foundation is trapped.

Figure 21. Existing rear sidewalk.

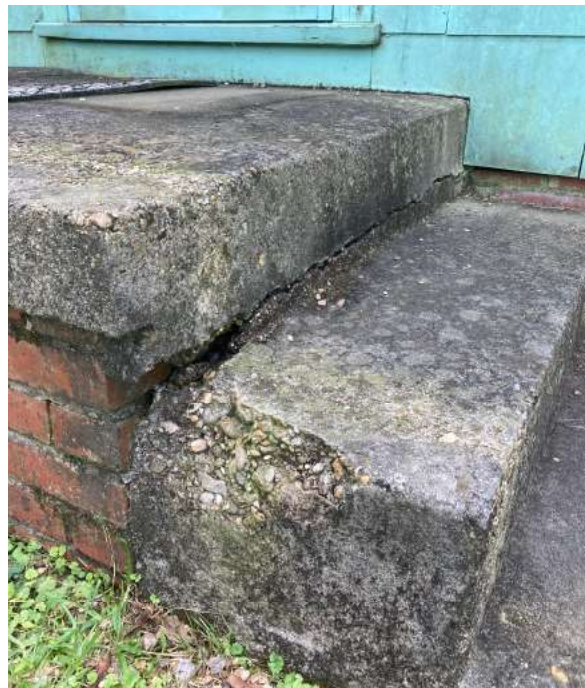
**Stairs:** The stairs at the rear entrance are concrete, sitting on red brick foundation and are discolored and worn. There are significant chips in the concrete and a major crack underneath the concrete landing/stoop. Dirt and biological growth can be seen on the concrete, bricks and mortar. The stairs in the carport are a similar concrete and brick configuration; the concrete shows an expected level of wear but is well intact. Some staining from a cleaner or mortar can be seen on the brick.

Figure 23. Spalling and crack at rear stair.

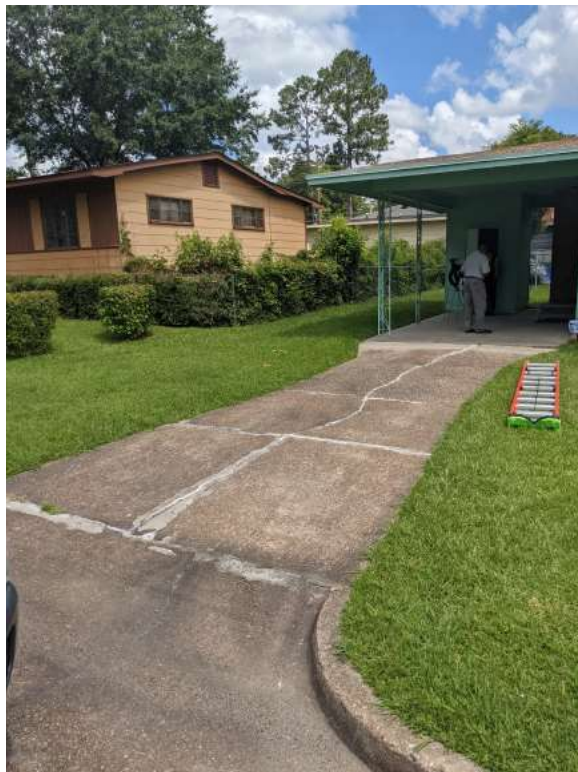
**Driveway:** The condition of the driveway is greatly deteriorated. Significant cracks have been present for some time, anecdotal evidence suggests a nearby oak that has since been removed, caused the cracking. It has been described that a film crew in the mid to late 1990's removed the oak, lifted and reset the concrete driveway. It appears that old and recent patch work has been completed to try to seal the cracks. The material used to seal the cracks is of a contrasting color to the concrete which only highlights the cracks and makes them more visible. This fill material is also starting to fail as the cracks get wider and the driveway continues to degrade. The 3 main panels of the driveway are in the worst condition and will continue to deteriorate. The concrete driveway apron and curb cut, and carport concrete are in sound condition.

Figure 25. Driveway

**Driveway:** There are several, large cracks in the three main slabs of the exposed aggregate concrete driveway. It is evident that repairs have been attempted in the past, but the joint filler will

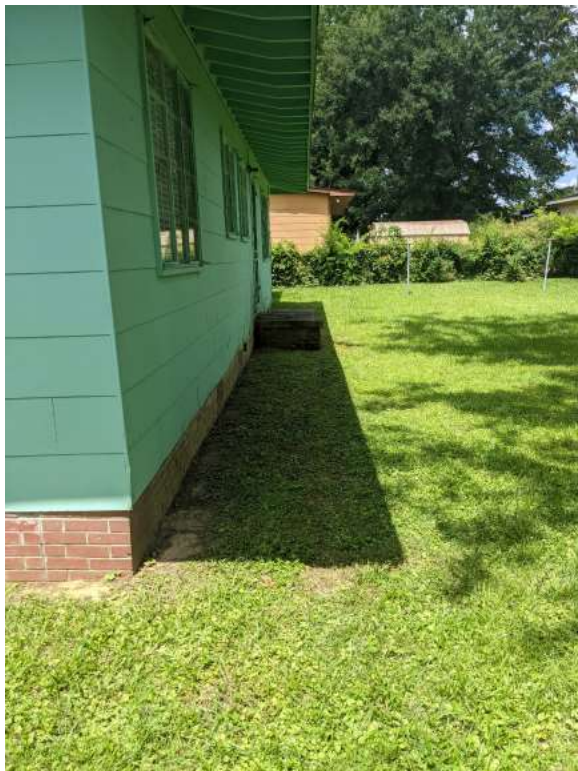
Figure 28. Drip edge erosion from roof.

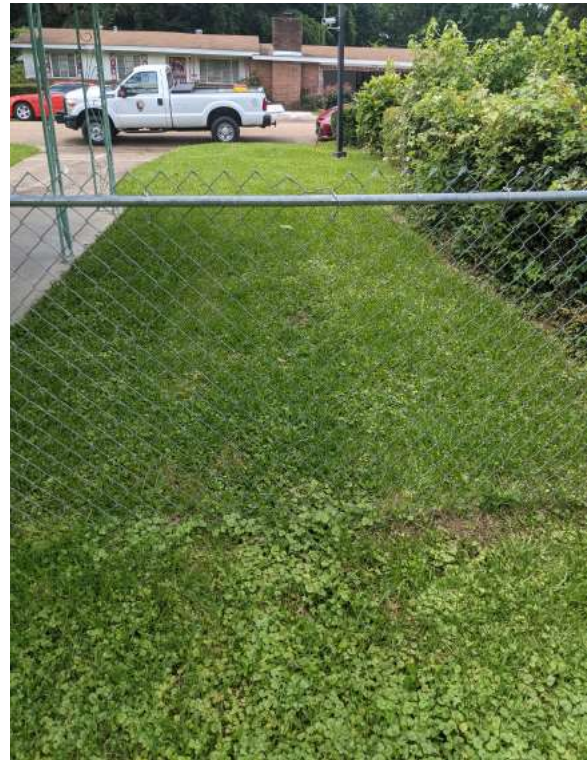
sink holes on the property. See the site plan in Appendix A for locations. One is located beside the carport building, underneath the chain-link fence. This sinkhole was caused by the decay of an old tree and the accompanying roots. The ground has now settled and created a significant depression. The area expands significantly on both sides of the fence and varies in depth from a few inches to over a foot. It is hidden by grass and is a safety concern.

Figure 29. Sink hole where tree has been removed.

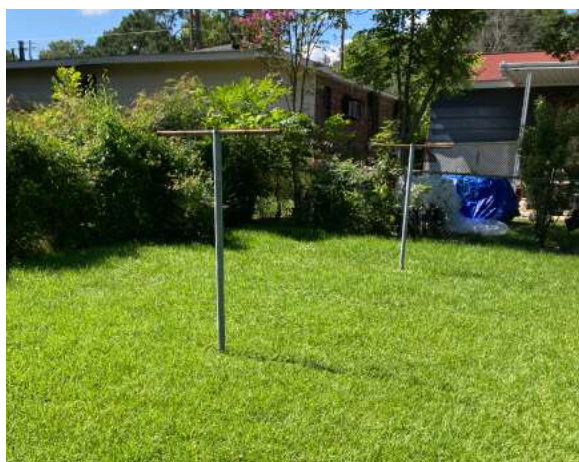
**Clothesline poles:** Two clothesline poles are located in the rear yard. These are believed to be in their historic location. The concrete footing for one of the poles is heaving out of the ground and could become a hazard.

Figure 30. Clothesline Poles

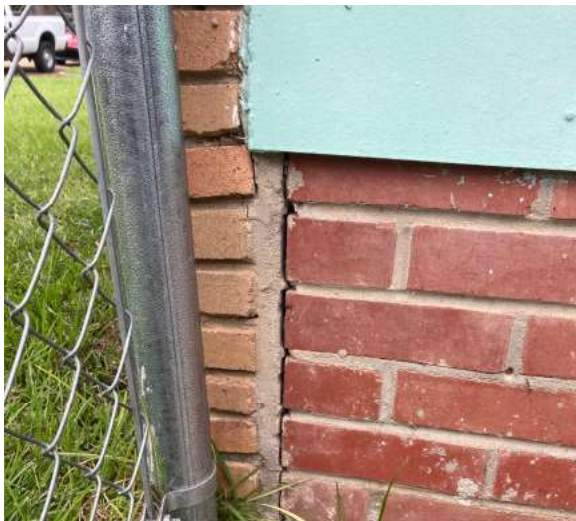
Conditions of joints between dissimilar materials around the structure are a common point of weakness, where joint compound has deteriorated, or materials have separated.

Figure 35. Joint conditions between multiple materials.

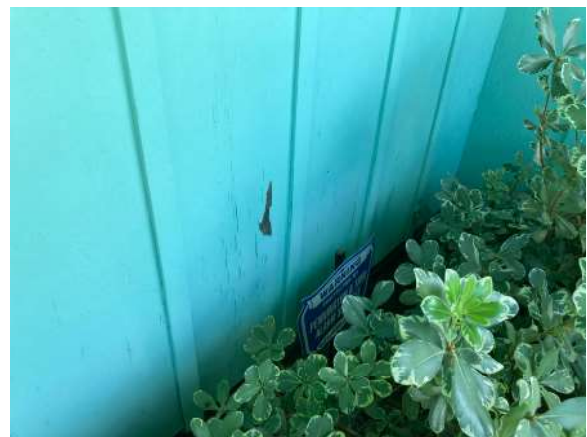
Paint on wood and other siding elements is beginning to show signs of thinning in small areas. The area of most deterioration is at the front, within the planter where humidity is trapped behind the plants and the paint can be seen peeling on the board and batten siding. On the rear elevation, lower lap siding panels and bricks are discolored with dirt.

Figure 37. Paint peeling at planter.

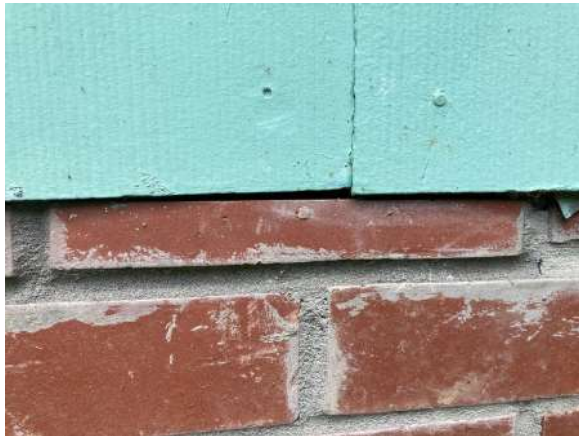
There does not appear to be continuous flashing at the transition from siding to the brick foundation wall. Some panels do not extend over the brick, which appears to have been cut. Paint from the siding and smeared mortar are also present on the face of the brick foundation.

Figure 39. Transition from siding to brick.

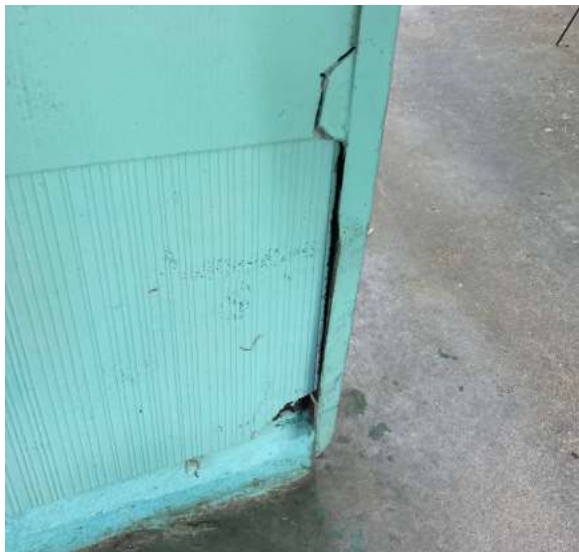
Figure 40. Broken panels and bent corner trim.

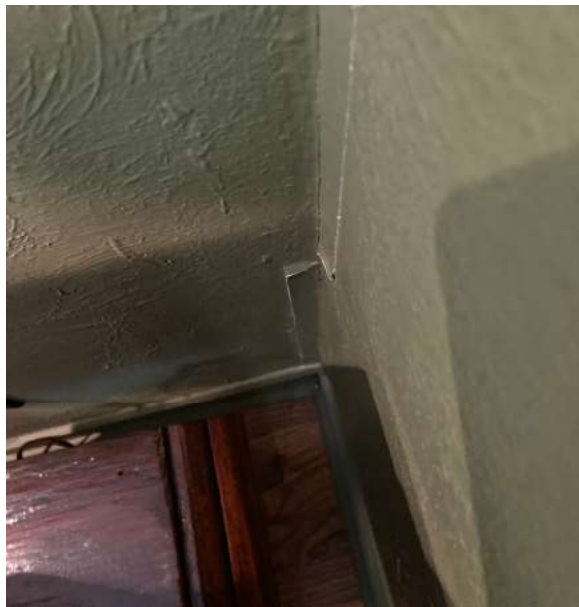
Figure 43. Torn and detaching corner bead in room 106.

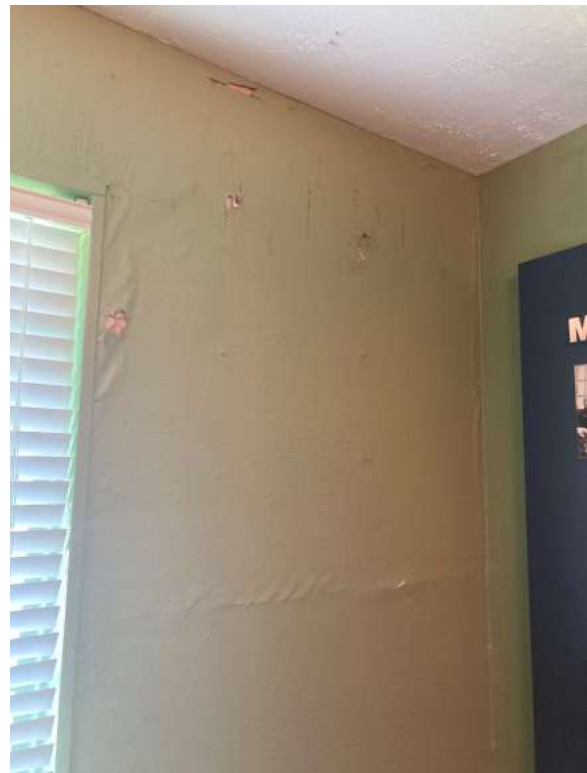
The south, exterior wall and ceiling of Bedroom 3, room 107 show signs of water intrusion in the form of peeling texture and paint. Materials were dry at the time of the condition assessment, and it has been reported that there has not been an active leak. Also on the south wall, there are visible attachment points telescoping through the finishes as well as an obvious horizontal joint or edge of material.

Noted in the environmental report, included in Appendix B, there is a notable presence of mold in the house. The structural report, included in Appendix D, identifies significant water entering the crawl space and is likely the primary source of moisture feeding the mold. Mold was not visibly identified on interior materials; it is possible there is mold within the walls from previous leaks that is not visible at this time.

Figure 44. Visible moisture damage at exterior wall of room 107.

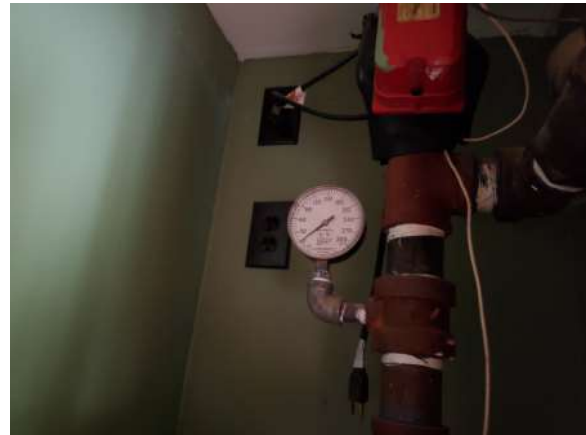
The sprinkler system was noted as not in use due to the inline pressure gauge reading of 0 psi.

Figure 48. Pressure gauge indicating 0 psi.

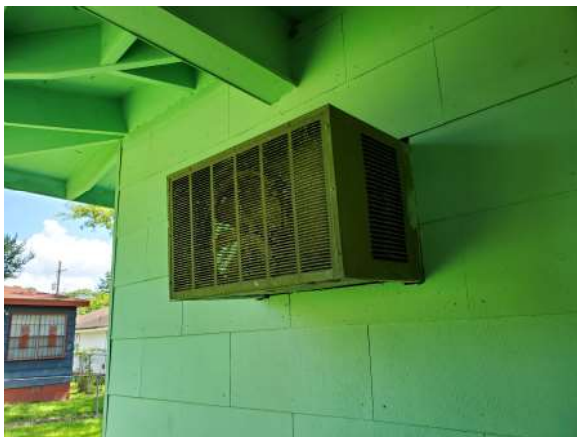
A Whirlpool through wall air conditioning unit installed in 1963 in the dining room is not operable and kept for historical reasons.

Figure 51. Historic Whirlpool wall unit, not in use.

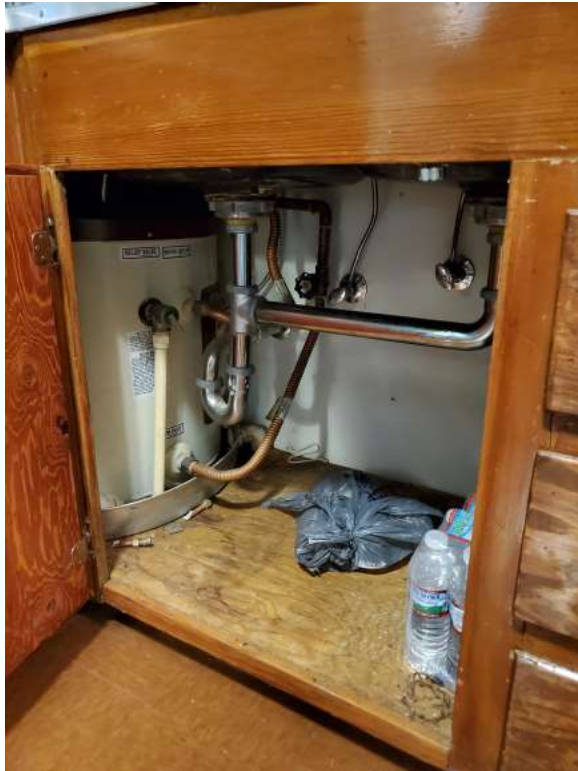
The water heater in the kitchen is not functioning and is showing signs of rust.

Figure 52. Water heater below kitchen sink.

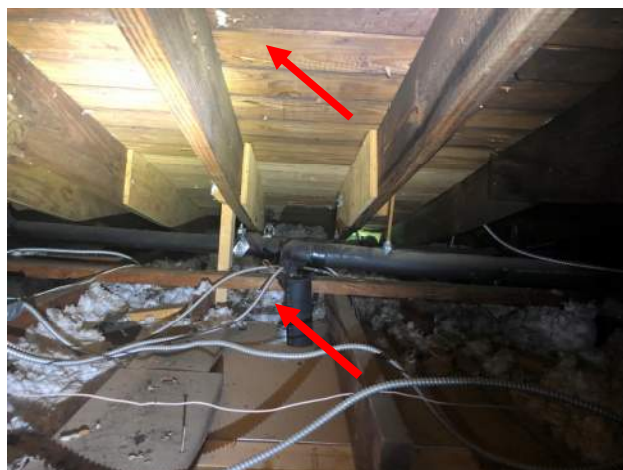
**Photo 4** – Repair of rafters and roof sheathing.

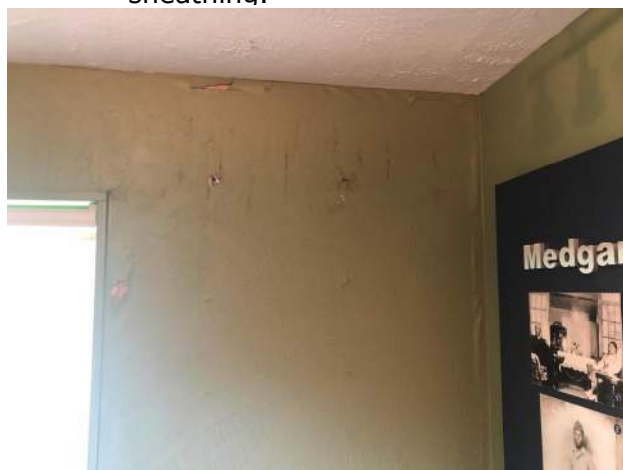
**Photo 5** – Water damage of south wall of front bedroom.

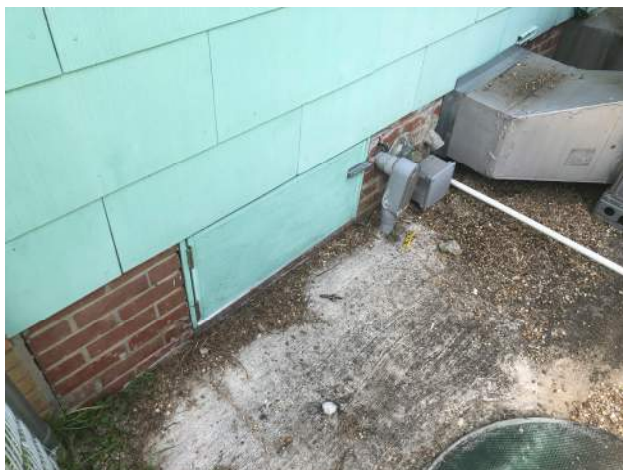
**Photo 9** – Typical foundation wall, face brick and access to crawlspace on east side.

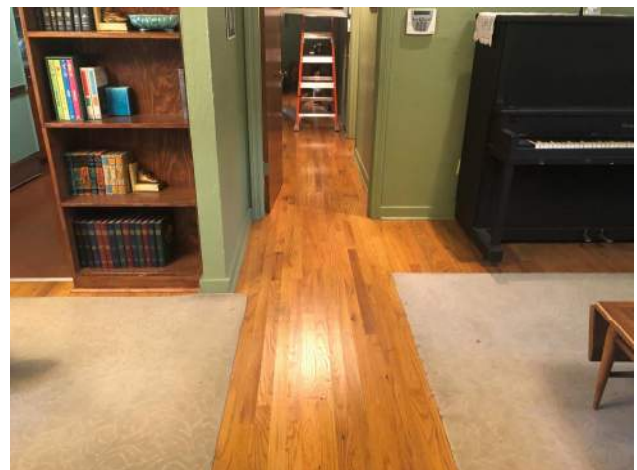
**Photo 12** – Cupping of hardwood floors.

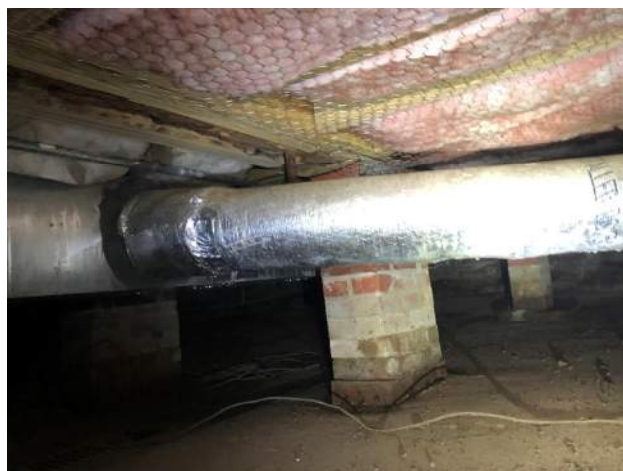
**Photo 16** – Moisture at base of pier.

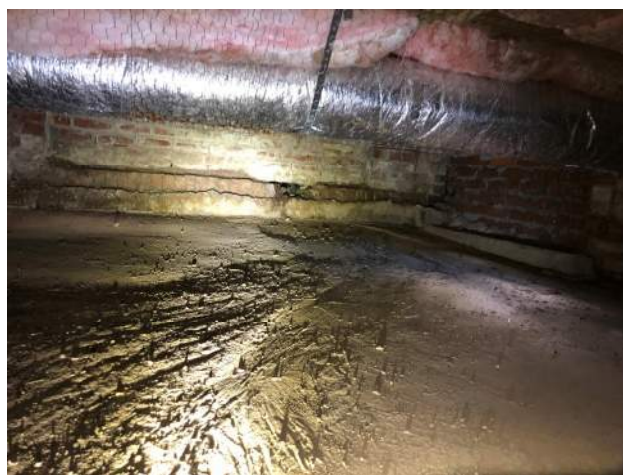
**Photo 17** – Erosion of silt from moving water, leaking through west wall.

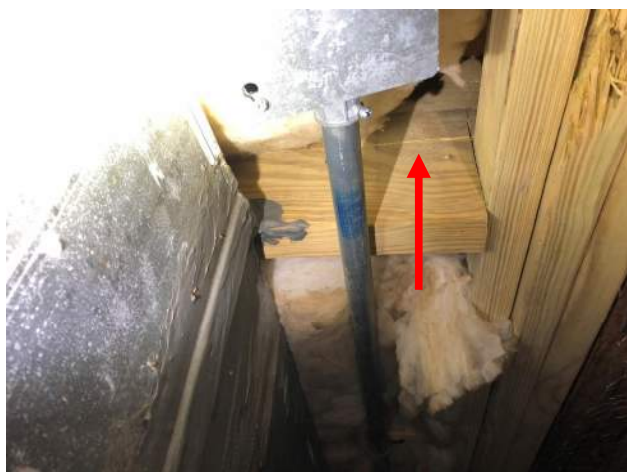
**Photo 15** – Split in joist at notch at center beam.

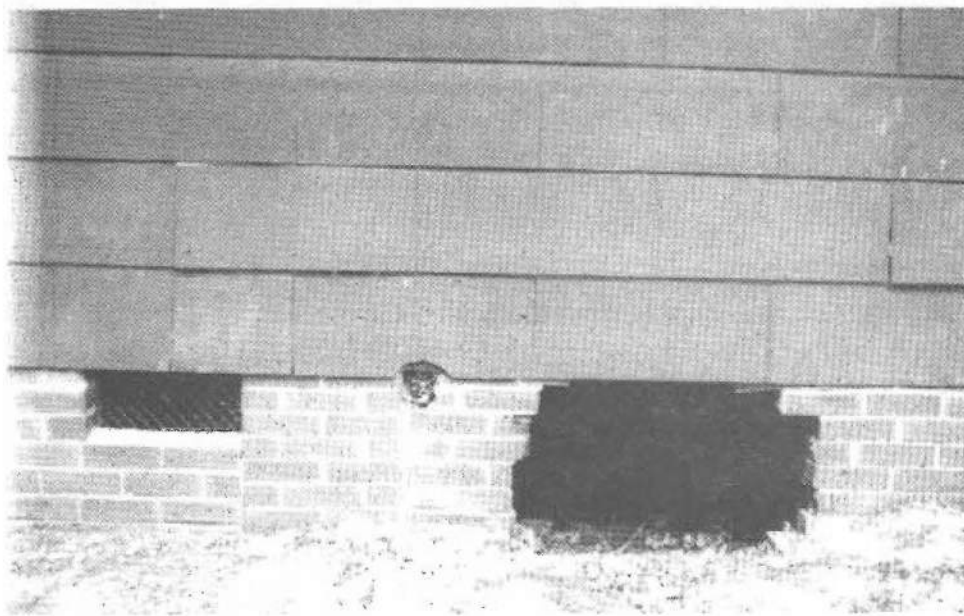
East elevation: The crawlspace access is also slightly damaged and requires patching.

Figure 8. Hole in the brick curtain wall next to the rear stoop. The original siding found on the north, west and east elevations is asbestos.

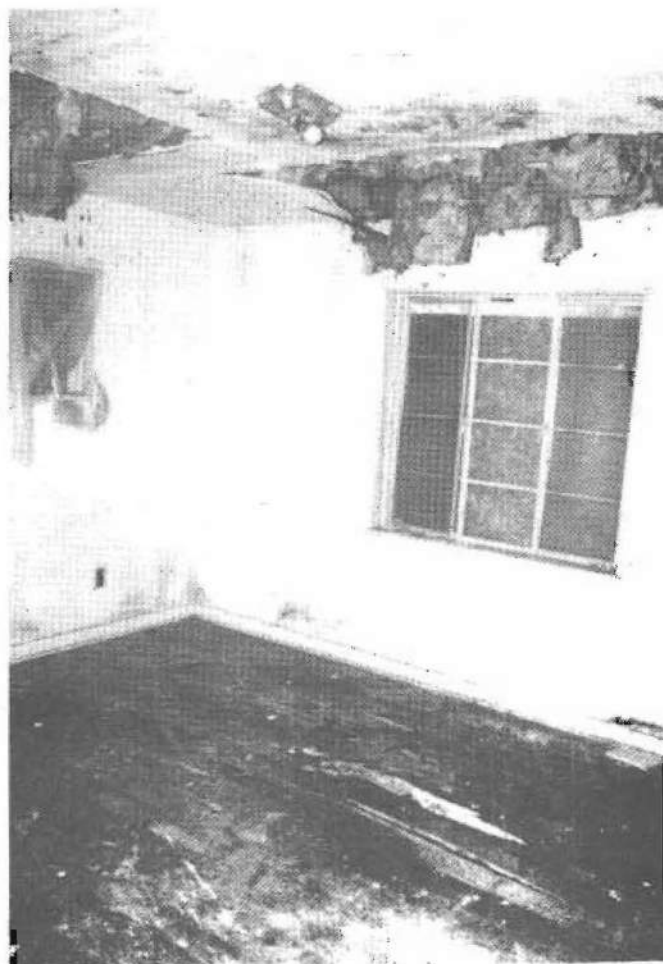
**Figure 28.** The fallen and deteriorated ceiling allows a view of the attic space above Bedroom 2 in this 1994 photograph. Areas of patched roof decking visible in the photograph have halted the leaks that caused the water damage.
