## **MESA VERDE NATIONAL PARK**

Far View / Weatherill  
"Three-Way"  
"Four-Way"

**Traffic Safety Study**

**April 4, 1996**

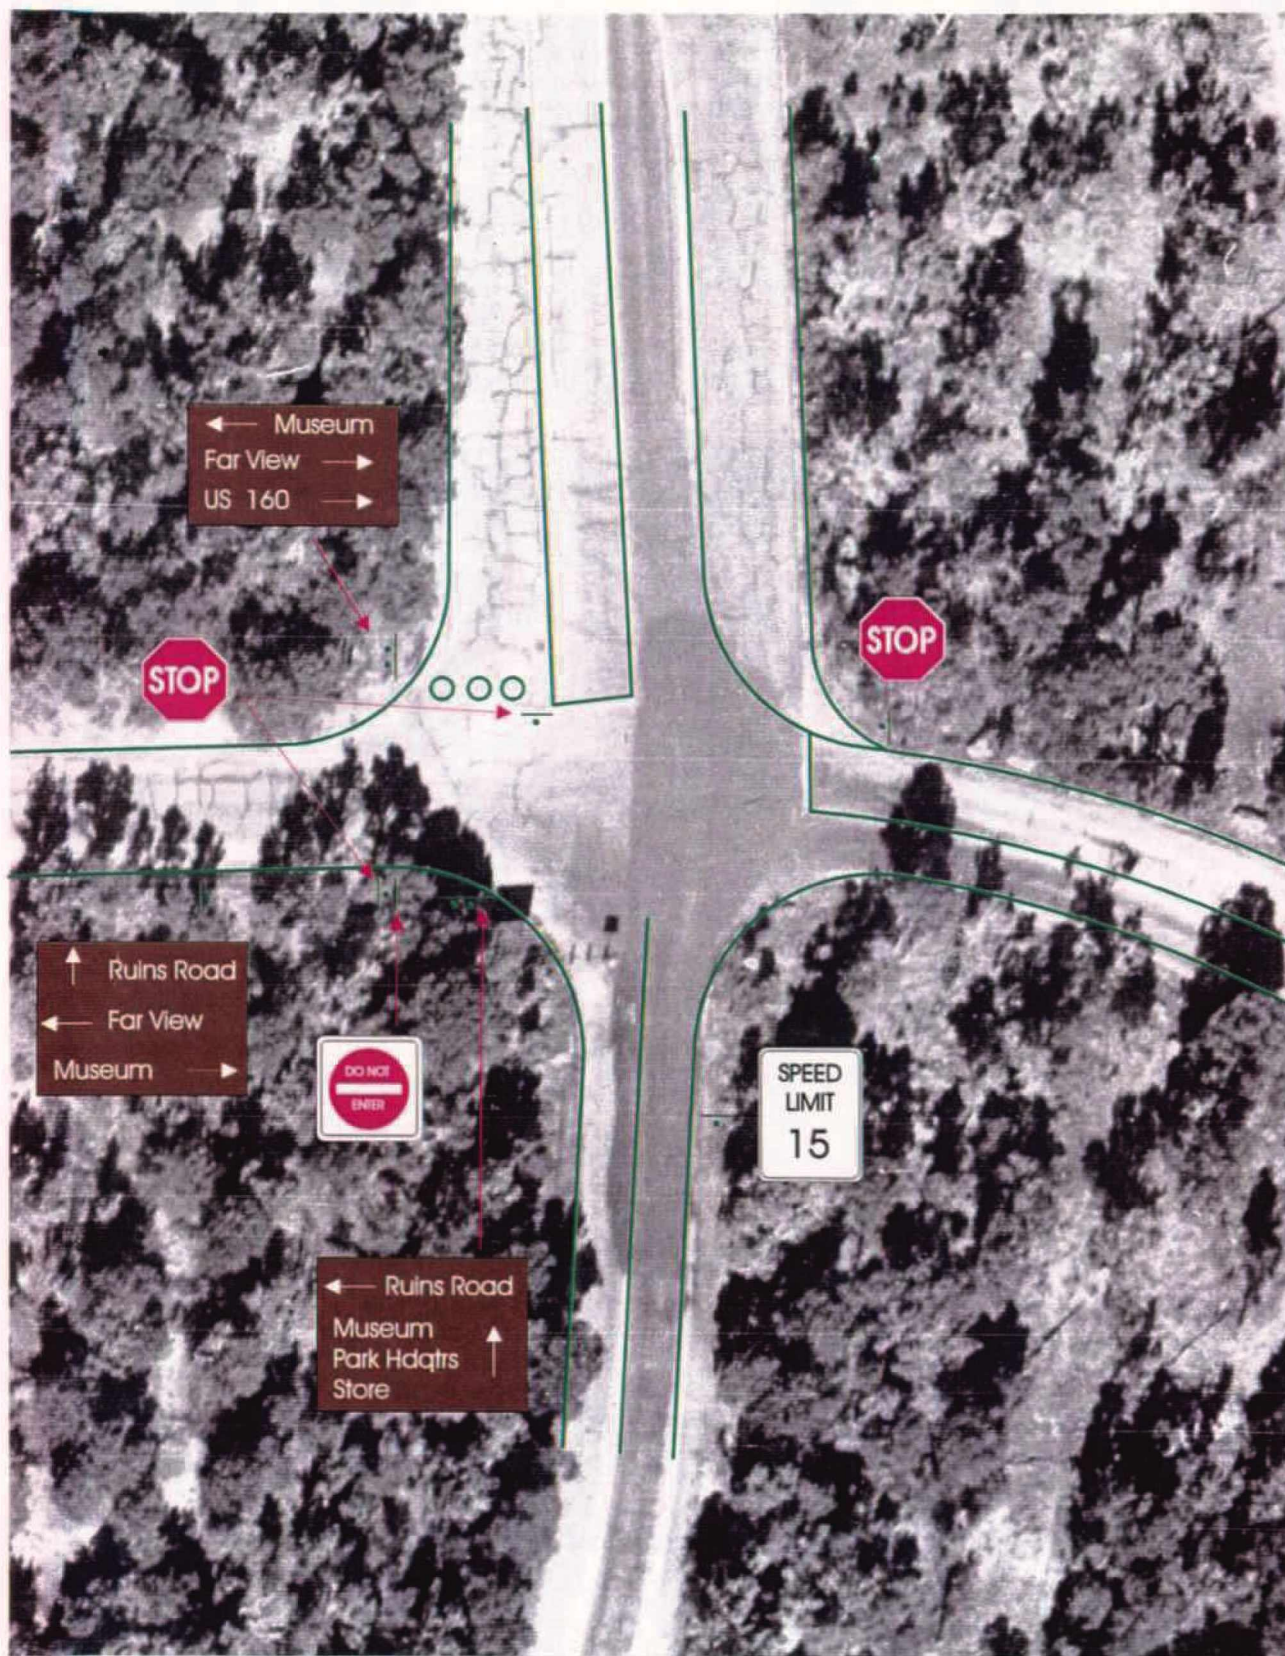
This is the intersection between the Ruins Road and the road to the museum as shown in Figure 2. North of the intersection, Chapin Mesa Road is a two-lane, two-way park roadway. East of the intersection, Ruins Road is also a two-lane, two-way roadway. The south and west legs of the intersection are endpoints of a one-way roadway traveling clockwise through the park headquarters and the museum area. At the intersection, vehicles proceed southbound to the museum. The west approach is marked with a "Do Not Enter" sign. It is apparent from the intersection geometrics that the loop was one-way in the opposite direction at one point. There are traffic barrels in the now vacant southbound right turn lane blocking this movement.

Park Staff raised the concern that this intersection is operating poorly and is confusing to motorists. They confirmed that the museum loop roadway was operating in a counterclockwise direction at one time. However, in order to provide the visitor with the opportunity to pass the restaurant and the museum prior to encountering the majority of the parking areas, the direction of the one-way roadway was reversed. According to the Park Staff, the speed of traffic seems to be higher now with the clockwise circulation. They also advised that there is no significant accident problem at the intersection. Some delay does exist at the intersection where at peak times there may be a queue of 6 or 7 cars trying to get through the intersection. The Park Staff did not express strong feelings about whether the flow of the one-way road should be in a clockwise or counterclockwise direction. They also advised that motorists sometimes leave the parking areas and drive the wrong way on the one-way roadway.

A field visit was conducted at the intersection to collect data and watch the operations. The following visual items were noticed.

- 1) The stop line for the eastbound approach is located too far back from the intersection.
- 2) Southbound vehicles do not have any advanced warning that southbound right turns are prohibited.
- 3) There is only one "Do Not Enter" sign for the west leg of the intersection.

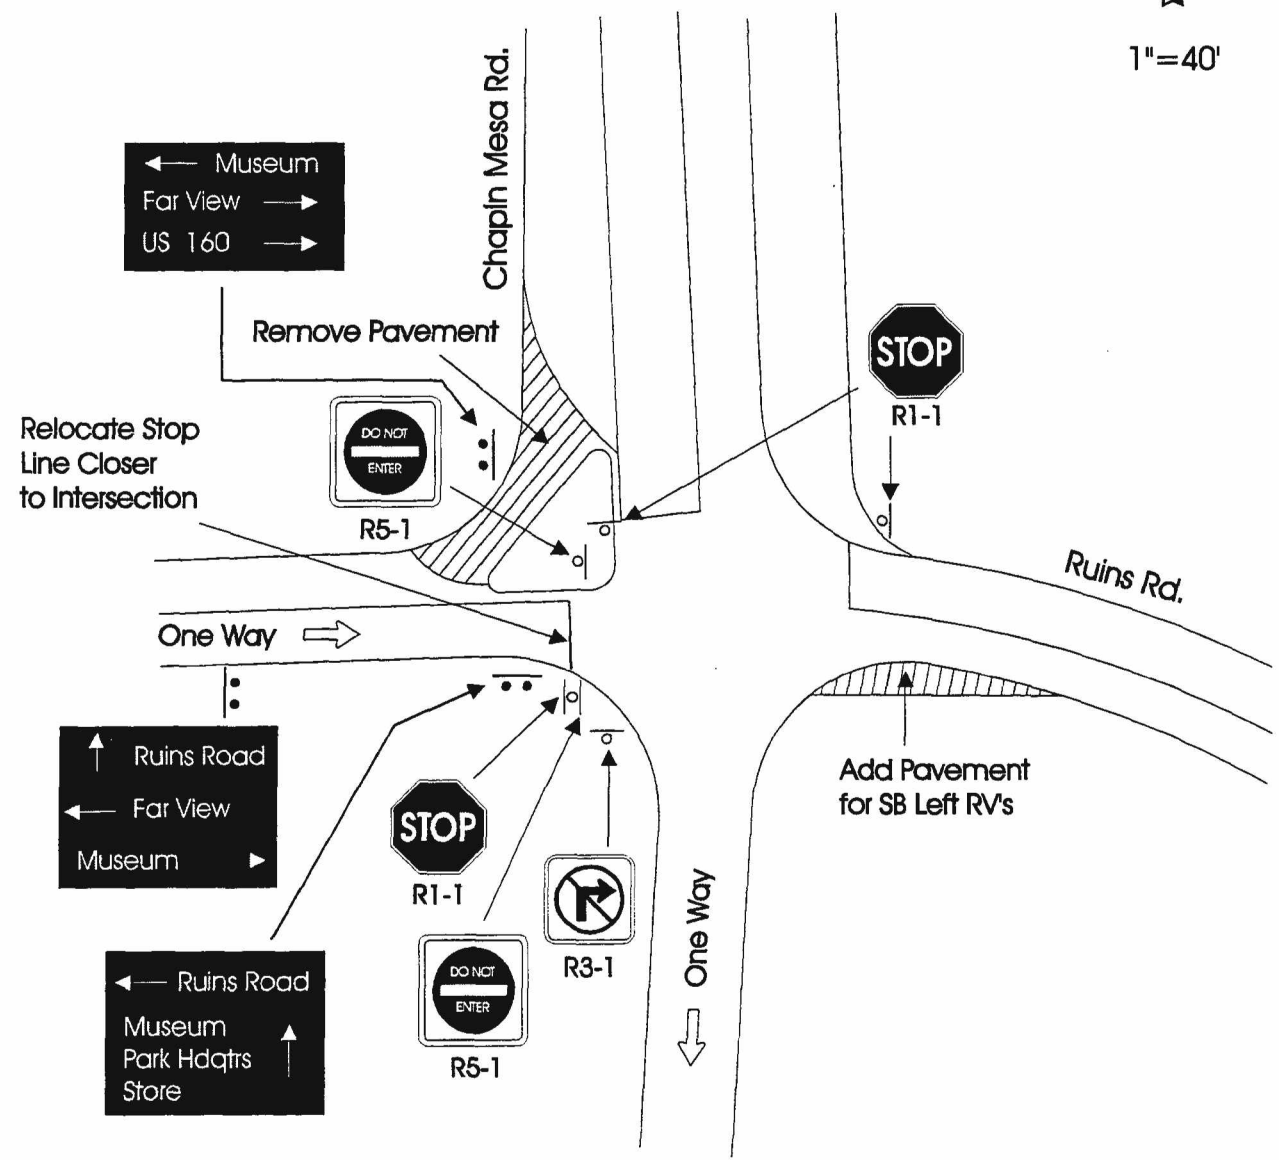
This solution leaves the flow as it currently is, and improves the operation of the intersection. The approximate cost for this solution is \$10,000. Figure 3 shows the modifications that should be made to the intersection if it were to remain as a counterclockwise operation.

- 1) A southbound "No Right Turn" sign (R3-1) should be added to provide clear indication to southbound vehicles that a right turn movement is prohibited.

- 2) The westbound stop line should be relocated closer to the intersection. However, it should not be placed in such a manner that recreational vehicles cannot make their turning movements.
- 3) Another "Do Not Enter" sign (R5-1) should be added to the north side of the west approach. Westbound traffic may not see the existing R5-1 sign on the south side of the roadway until they are at the stop line.

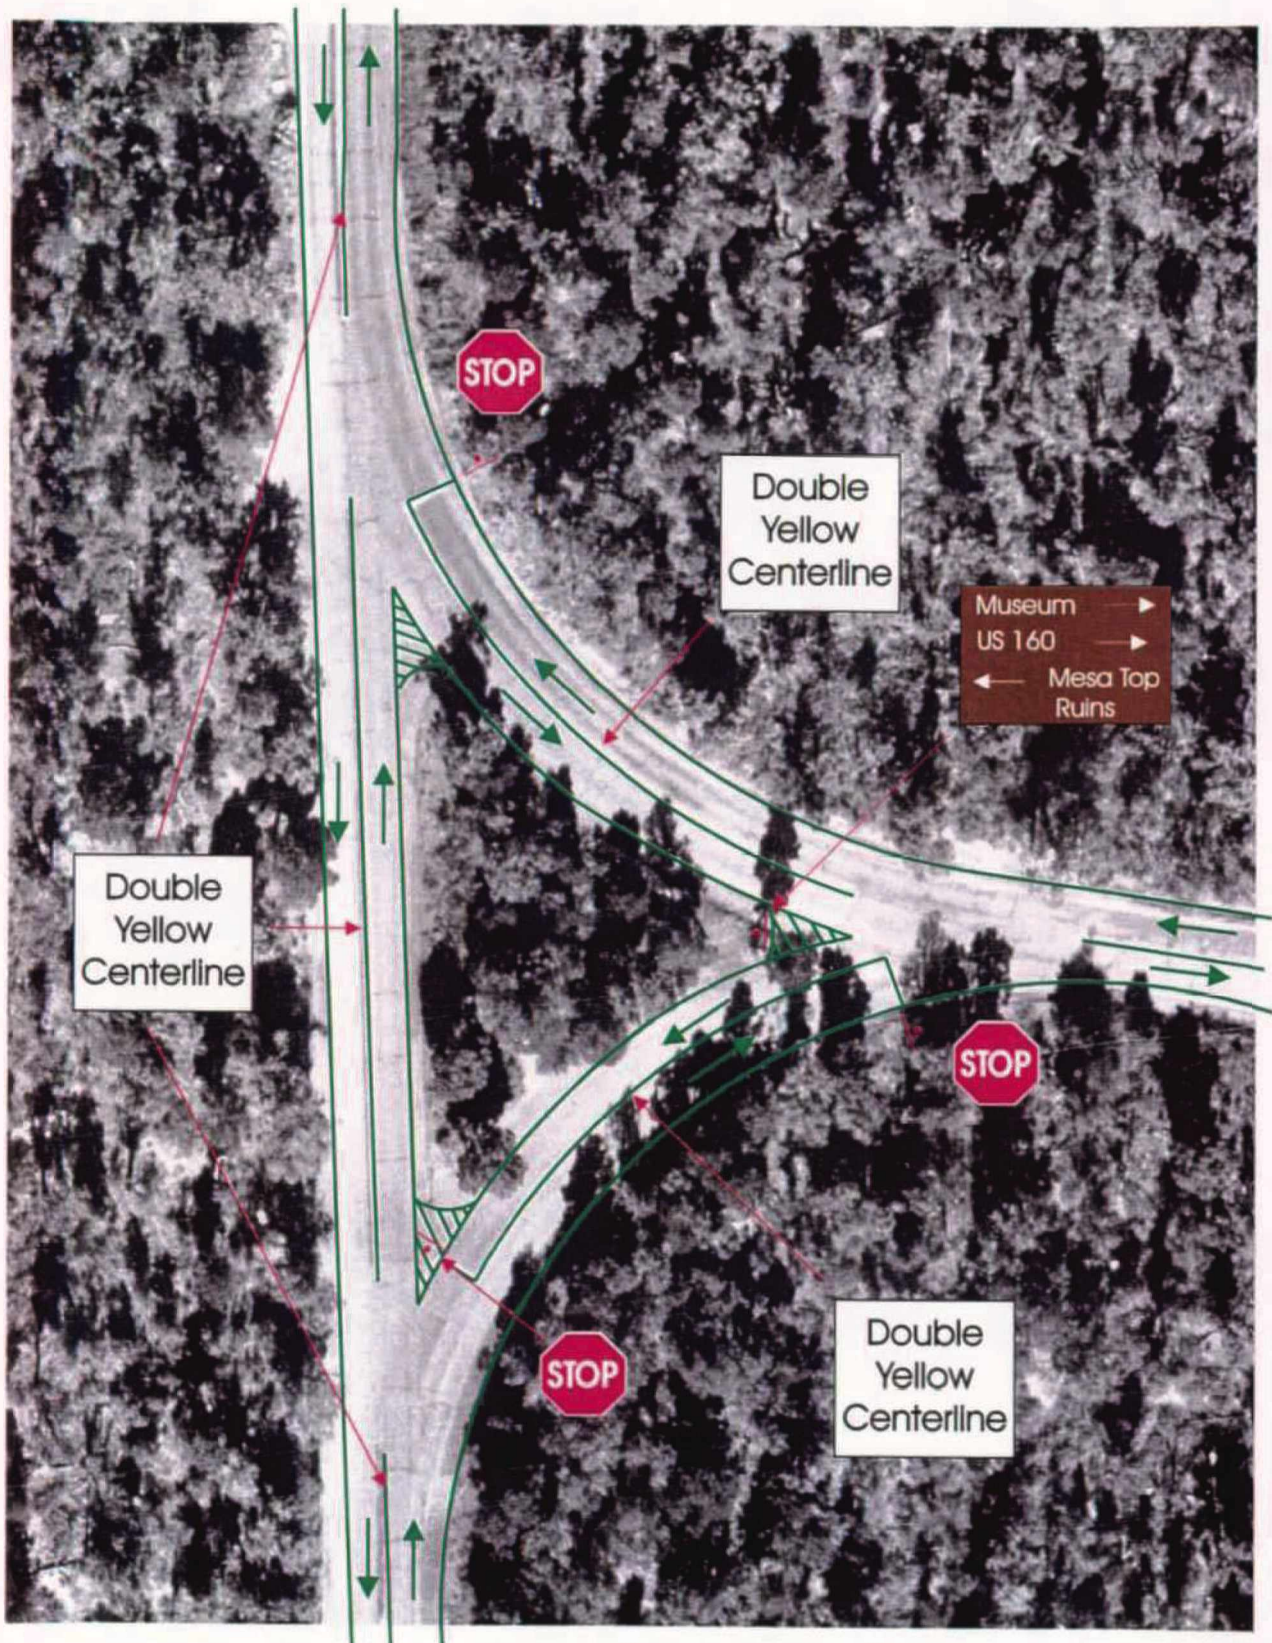
This is the intersection of the Ruins Road with the road to Cliff Palace. The roadway is nearly a tee intersection with Ruins Road running north/south and Cliff Palace Loop Road being the stem of the tee to the east. However, the westbound right is a wye, and the northbound right is a wye, creating a large island in the middle of the intersection as shown in Figure 7. All three legs of the wye are two-way.

Discussions with the park staff revealed that this intersection causes confusion for visitors. For example, the angled stop signs are visible from two directions and, are confusing to some motorists. The two-way roads on each side of the island create many conflicting movements. The Park Staff felt that modifications to the alignment of the roadway may require an archaeological survey, although if all reconstruction occurred within the existing triangle, it may not be necessary. They will research this issue. The potential of a roundabout was discussed, and the park staff felt that this is not a good solution due to driver confusion. The right of way required for a roundabout encroaches on sensitive lands.

- 1) It was noticed that some drivers turn at the inappropriate, but legal location. For example, drivers proceeding southbound along Ruins Road who want to turn to Cliff Palace Road may easily do so at the north intersection. However, some are performing this movement at the south intersection. The angle at the south intersection is much greater.
- 2) The predominant movement was noticed to be to and from Cliff Palace. This was verified by traffic volumes which showed that the major movement is between the north and east approaches to the intersection.

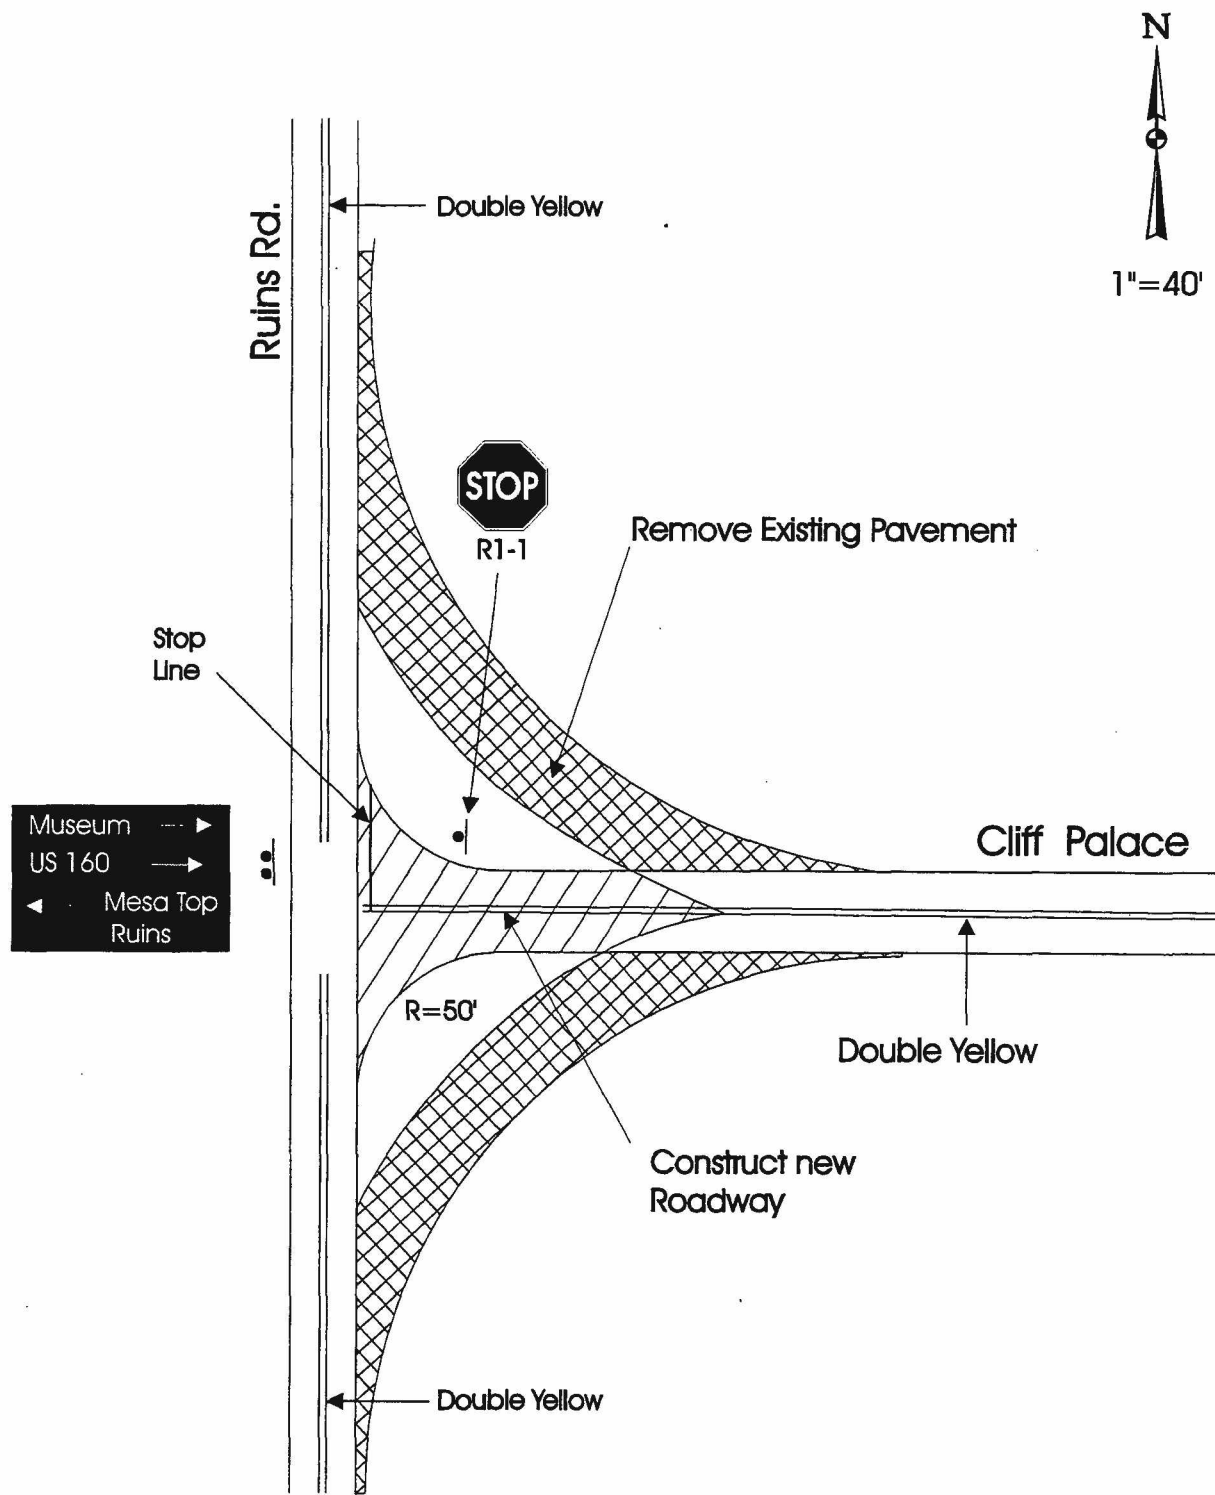
The recommended solution is to create a simple tee intersection. Ruins Road would be the top of the tee, and Cliff Palace Road would be the stem. The advantages of this configuration are that there is no sight distance problems for westbound traffic. However, substantial geometric changes need to occur. This will require paving through the island. This solution also provides the least amount of confusion for motorists, as drivers are familiar with tee intersections. The approximate cost of this solution is \$22,000.

The recommended geometric, signing and striping changes are shown in Figure 10.

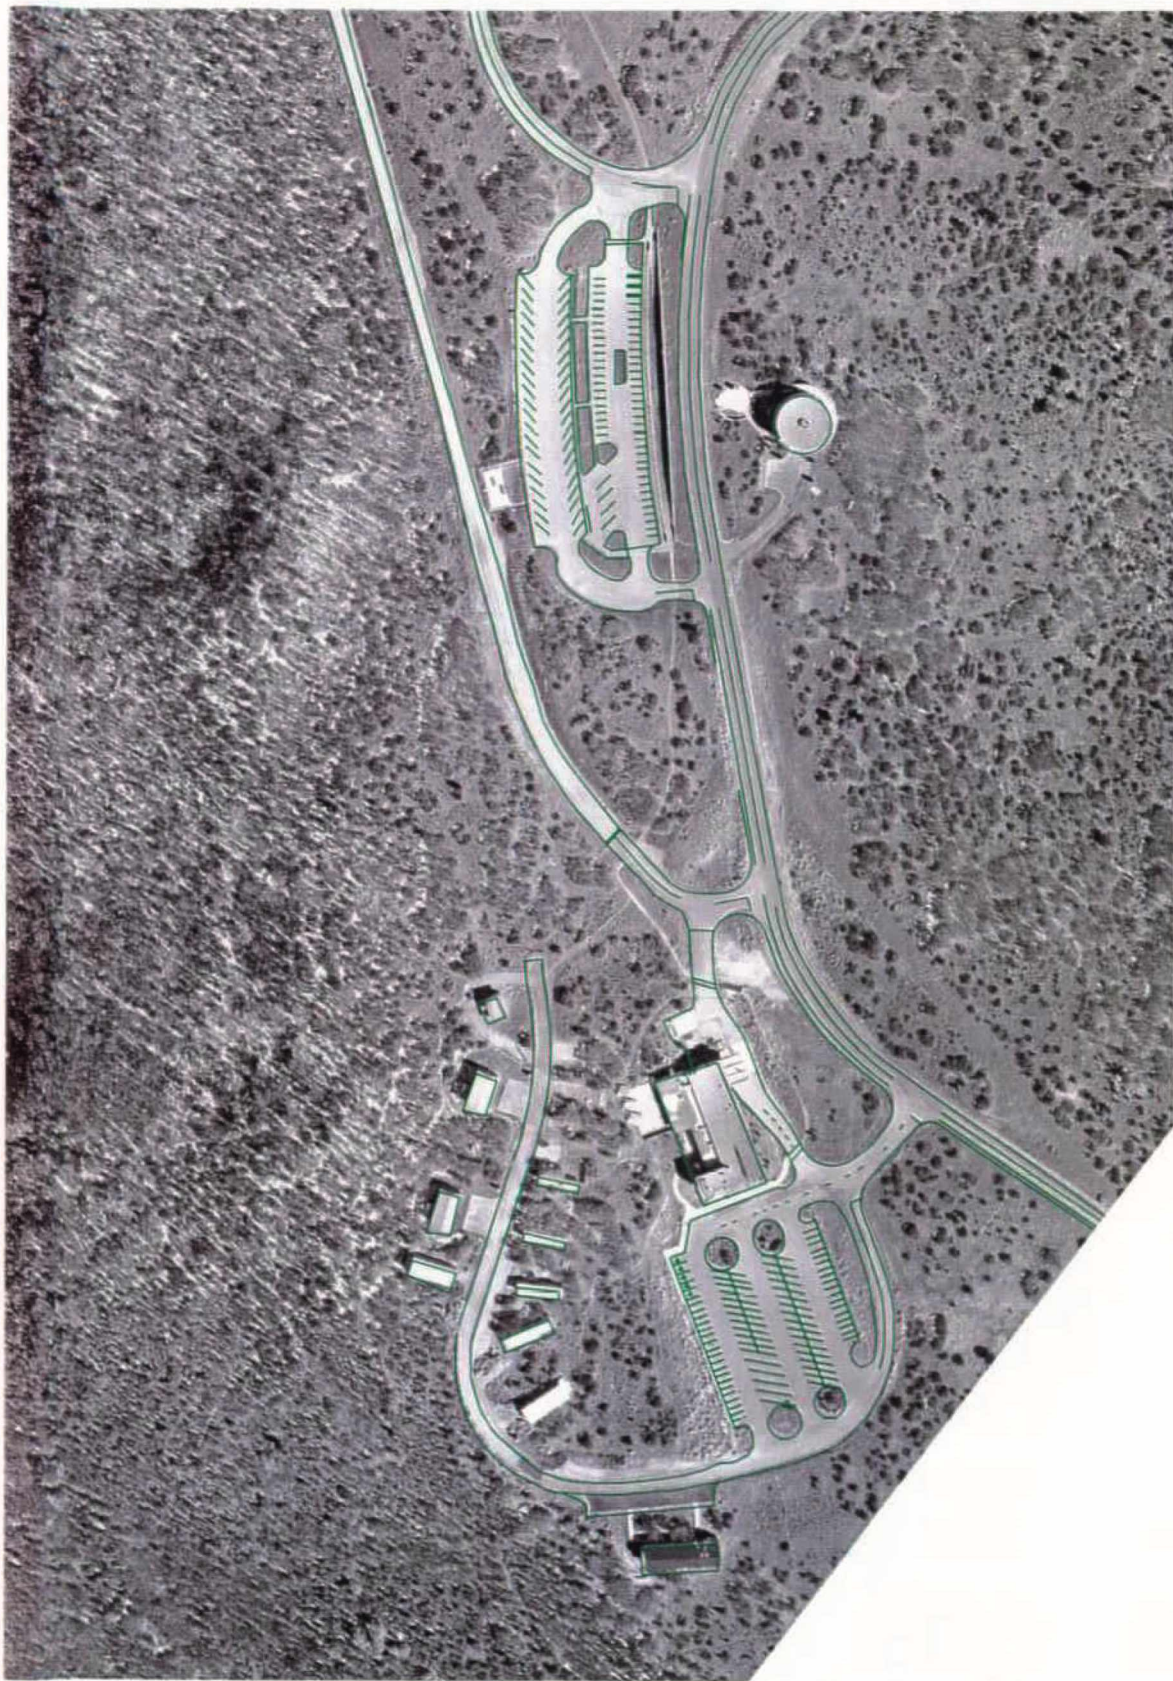
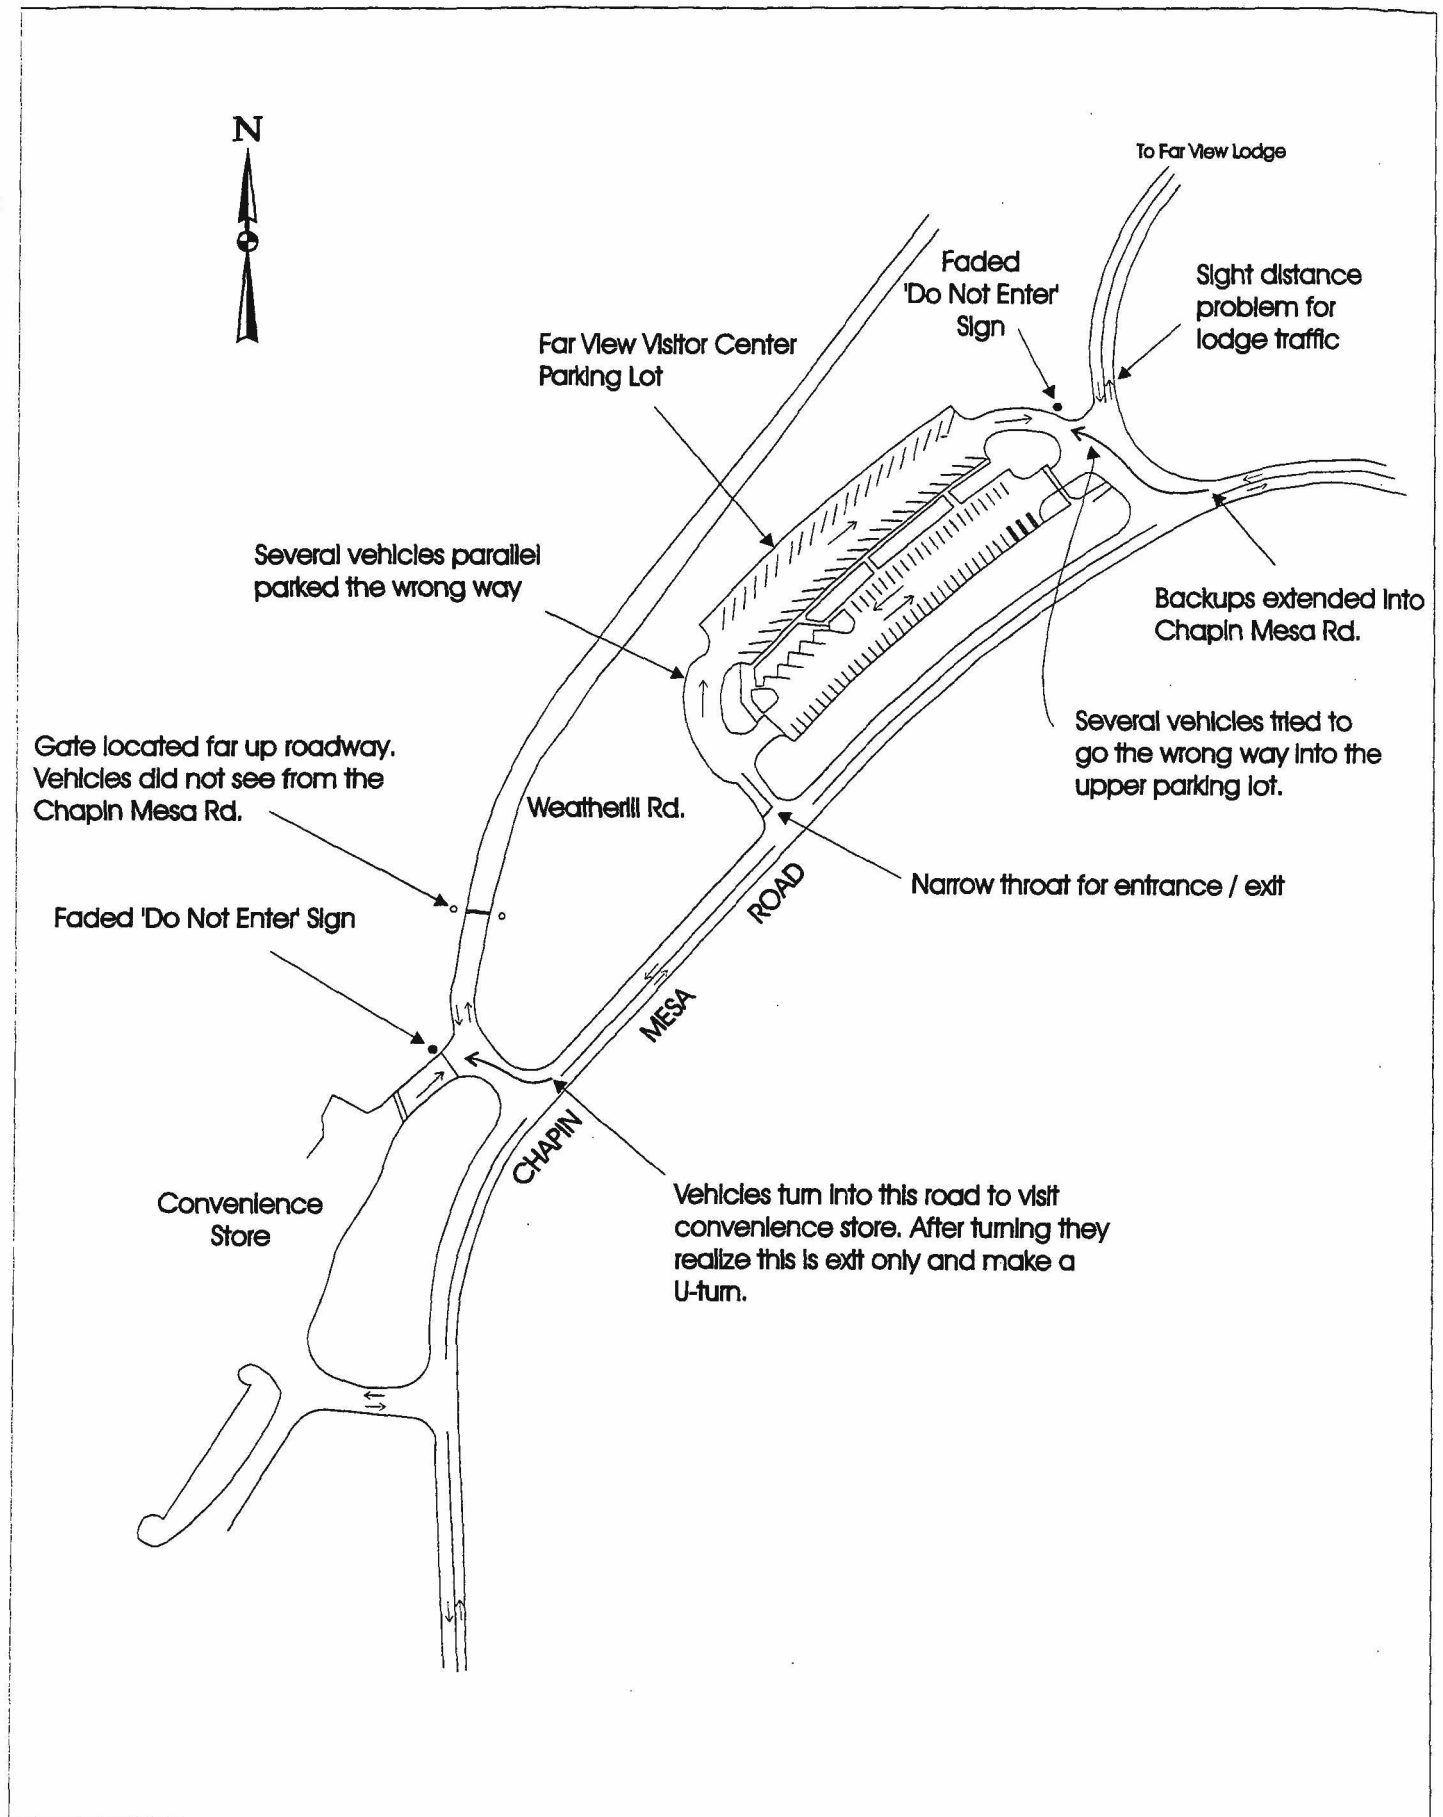
Field observations were conducted in the area to determine points of conflict and confusion. The following observations were noticed during the field review (see Figure 12).

- 1) The north entrance road to Far View Visitor Center parking and the lodge has a sign for southbound traffic that says "Visitor Center Information." This sign is unclear since the parking lot is on the right and the visitor center is on the left.

- 2) There is a T-intersection warning sign for the north intersection. This sign may not be the best sign for this location. The sign does not appear to be in good shape.

- 3) There is a "Do Not Enter" sign at the north intersection which forbids traffic on the upper portion of the parking lot. This sign is extremely faded.

- 4) There is a crosswalk at the north intersection that does not extend fully across the roadway.
- 5) The sign "Lodge and Rooms" at the north intersection is not very visible.

- 6) General confusion was noted at the north intersection. Visitors could not distinguish the "Do Not Enter" sign until they had already partially pulled into the roadway to the upper parking lot. At times, visitors making a southbound right at the north intersection queued along Chapin Mesa Road causing through traffic to stop.

- 7) Drivers coming from the lodge and stopping at the stop sign just west of the upper parking lot cannot see drivers on Chapin Mesa Road.
- 8) There was a path worn into the ground at the south end of the parking lot showing that some pedestrians are not using the tunnel to the Visitor Center.

- 9) The south driveway to the Far View Visitor Center parking lot has a narrow throat.

- 10) Several non-RV vehicles were noted parking in the RV spaces.
- 11) The stop line at the south driveway is located too far back of the intersection and, at its present location, shrubbery impairs sight distance to the south.
- 12) Several visitors were observed turning into the Weatherill Road attempting to go to the service station. The signing at this location is unclear. The service station is accessed from the south. Those vehicles that attempt to use the north roadway must turn around in a very narrow roadway.
- 13) The gate at Weatherill Road is located a sufficient distance from Chapin Mesa Road so that it cannot be seen from Chapin Mesa Road. If the gate is closed, drivers may not know this until they turn onto Weatherill Road. At that point, they must make a U-turn in the roadway.

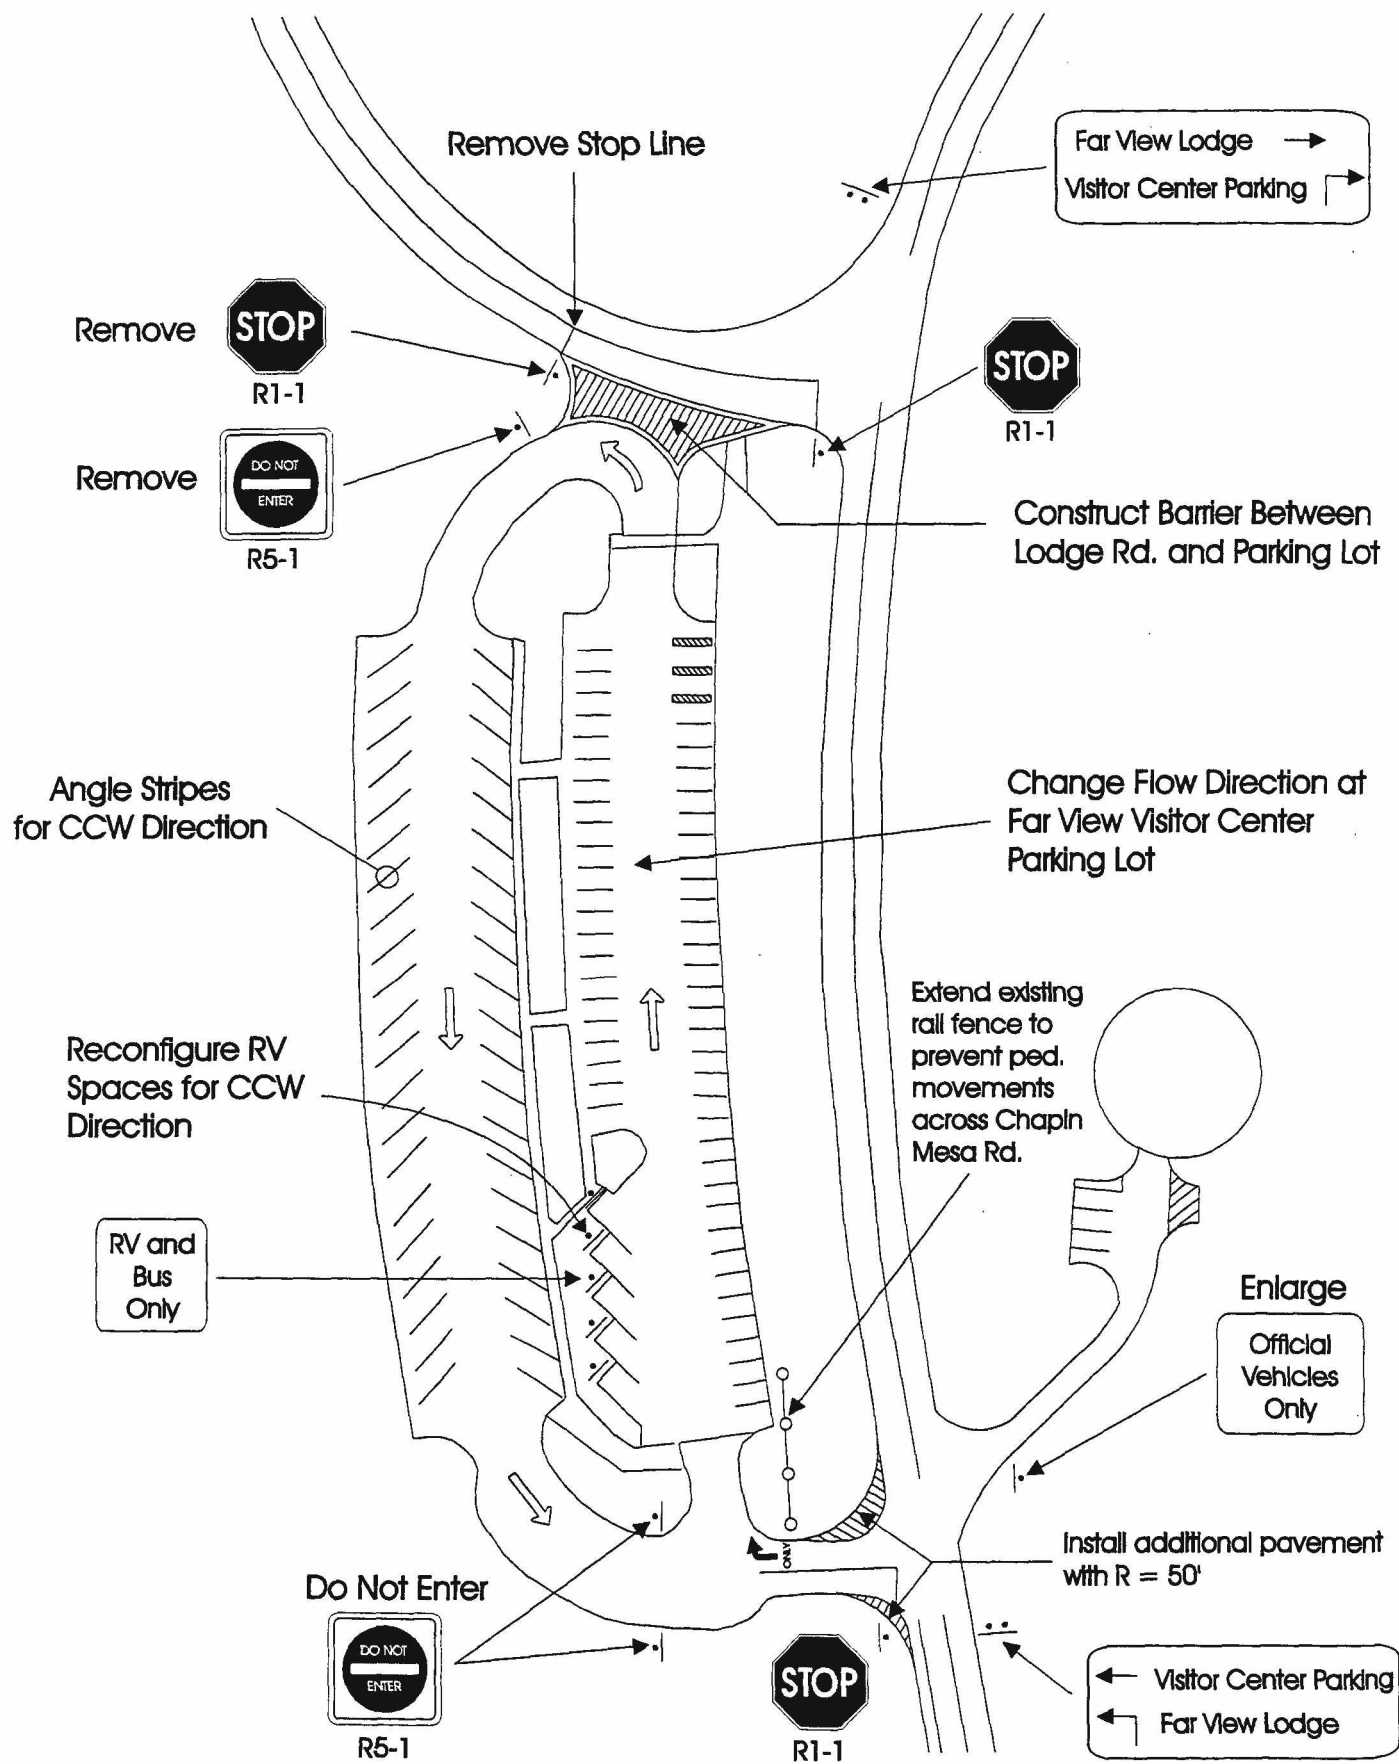
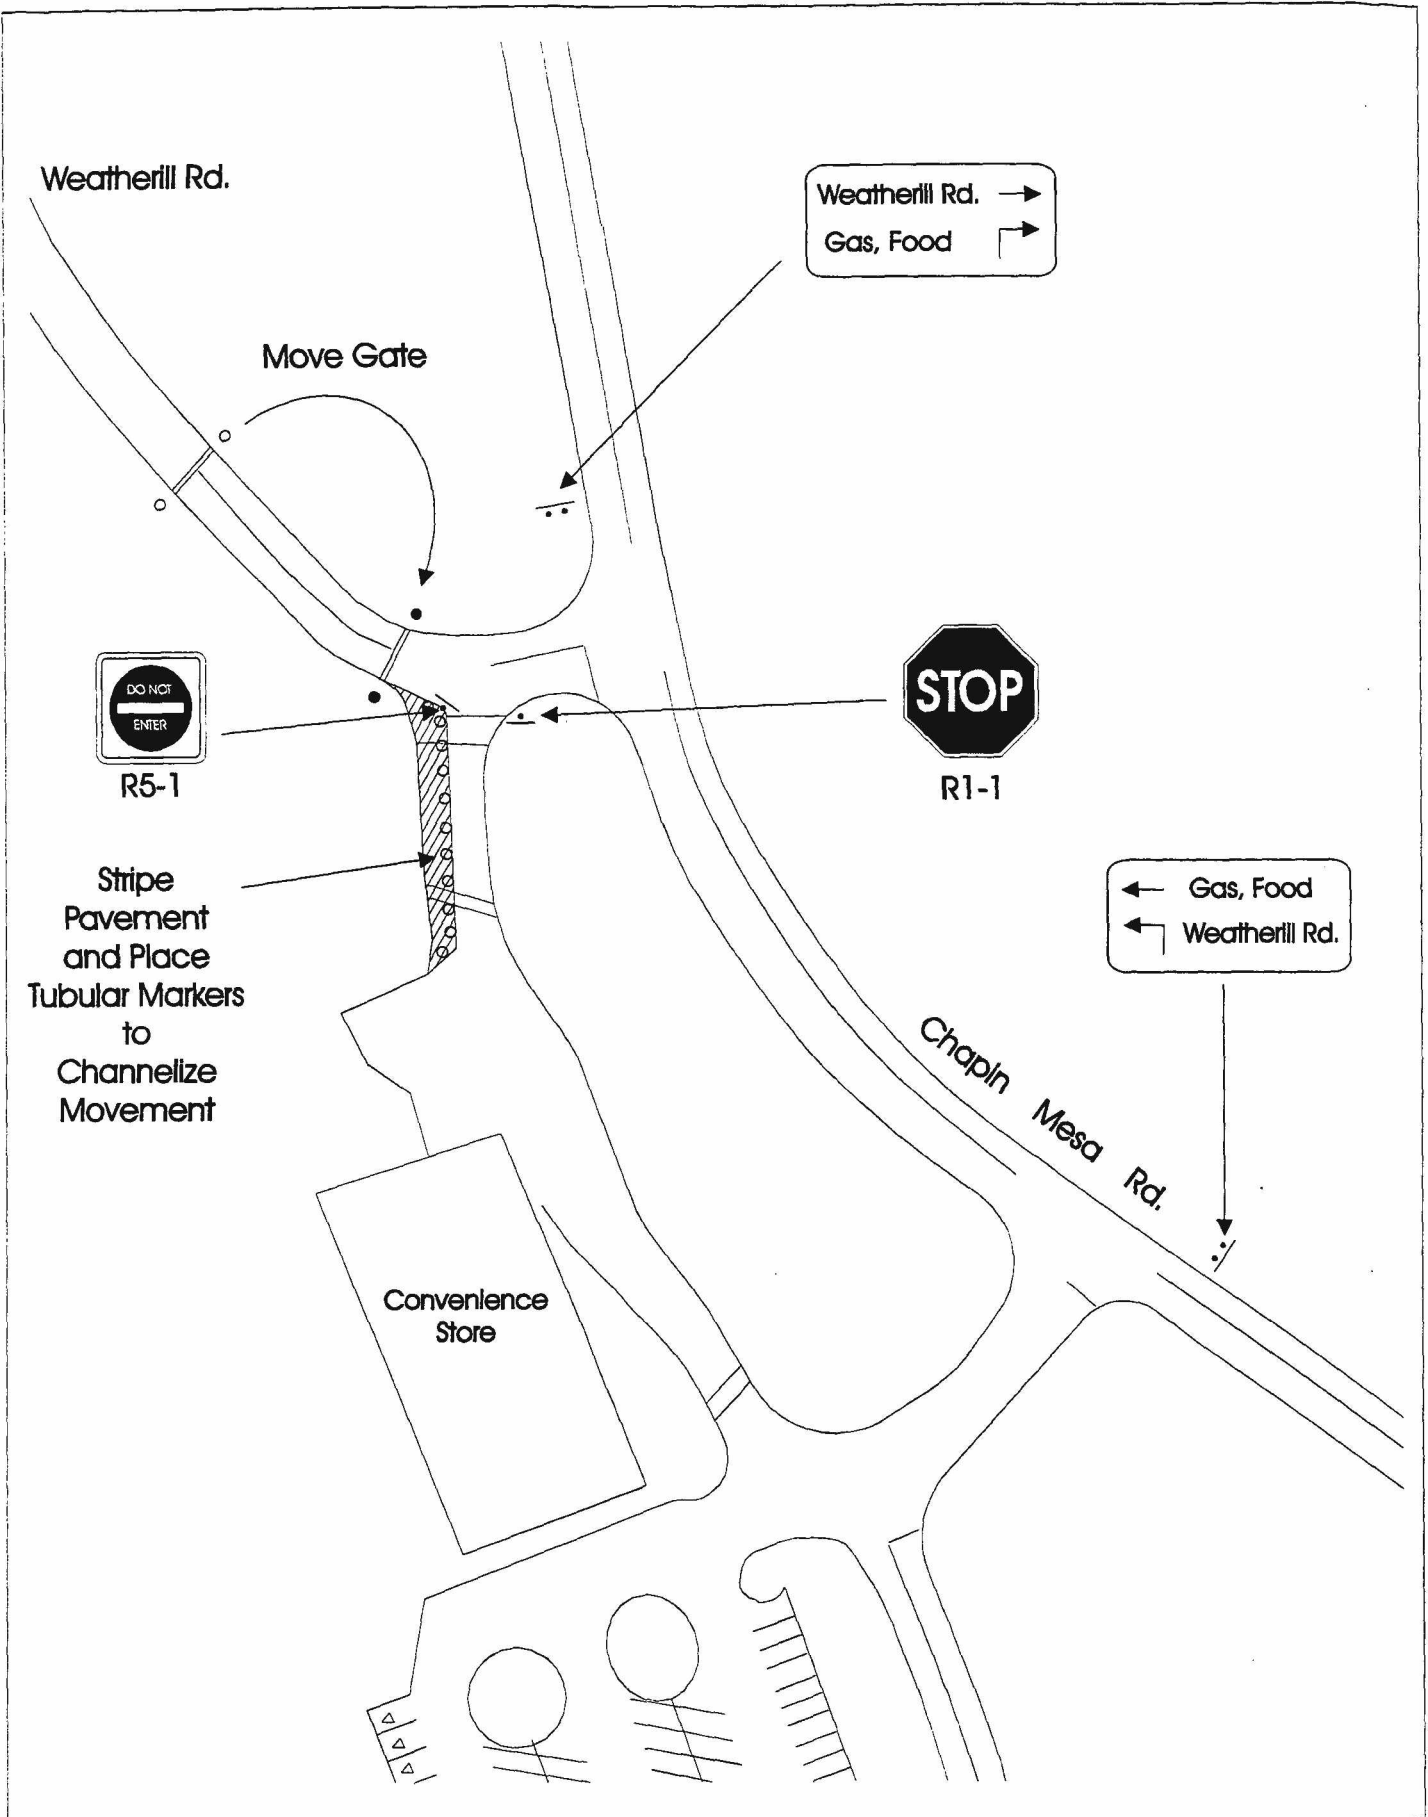
The recommended solutions are shown in Figures 13 and 14. The approximate cost for these improvements is \$30,000.

- 1) The north entrance should be reconfigured to only allow access to the Far View Lodge. A sign needs to be installed north of this intersection showing Far View Lodge as the immediate right, and the Visitor Center parking lot at the following right.
- 2) The parking lot access should be provided solely by the south entrance. This would be a two-way entrance, and should be widened. The direction of flow for the parking lot should be changed from clockwise to counterclockwise. This would reduce the number of conflicting movements at the south intersection. The angled RV parking would need to be reconfigured and signed.
- 3) The exit from the gas station to Weatherill should be channelized more so that it does not appear to be an entrance.
- 4) Another directional sign should be placed north of Weatherill Road showing directions to Weatherill Mesa Road and the concession facilities.

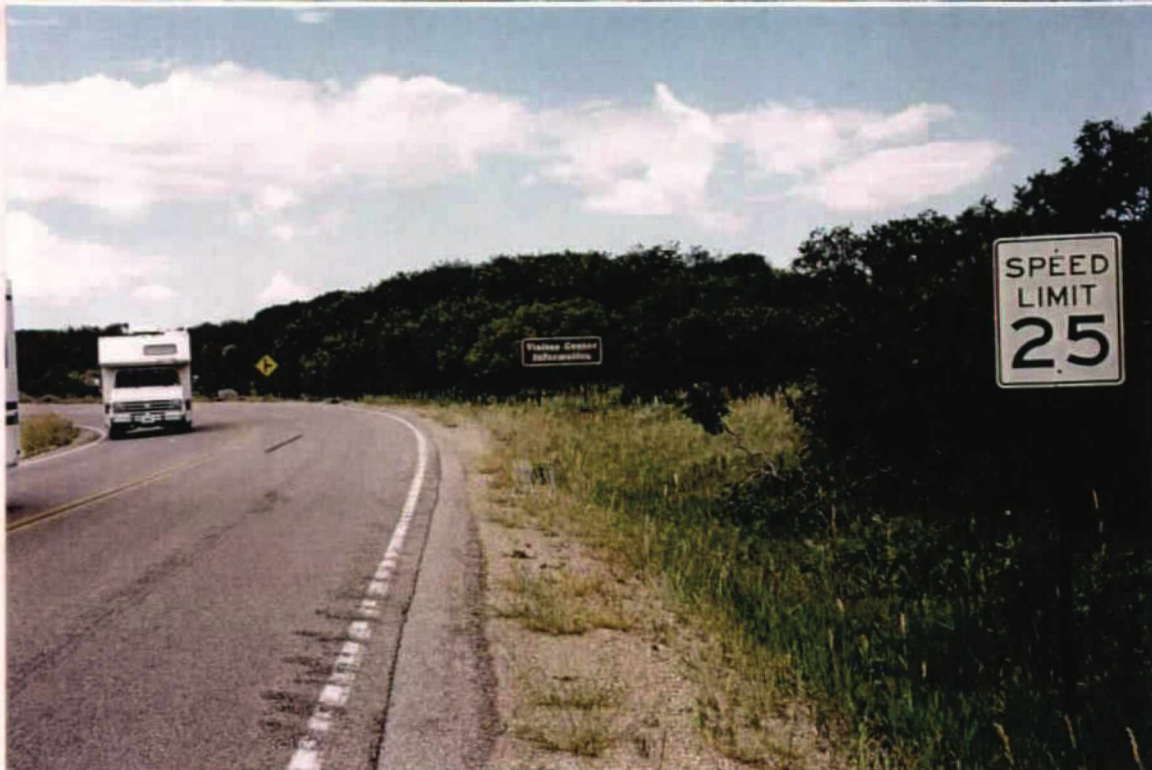
*Photograph #1* - southbound at the entrance road at Mesa Verde approaching the Farview Visitor Center. The sign "Visitor Center Information" is on the right and perhaps should say next right or have a right arrow rather than just having the sign since the visitor center is on the left and the parking lot is on the right. There may be a better sign than the T-intersection warning sign that shows the variety of driveways or it may be that the sign is not necessary. If the sign is necessary, it should be replaced. It does not appear to be in very good shape and is probably not reflective.

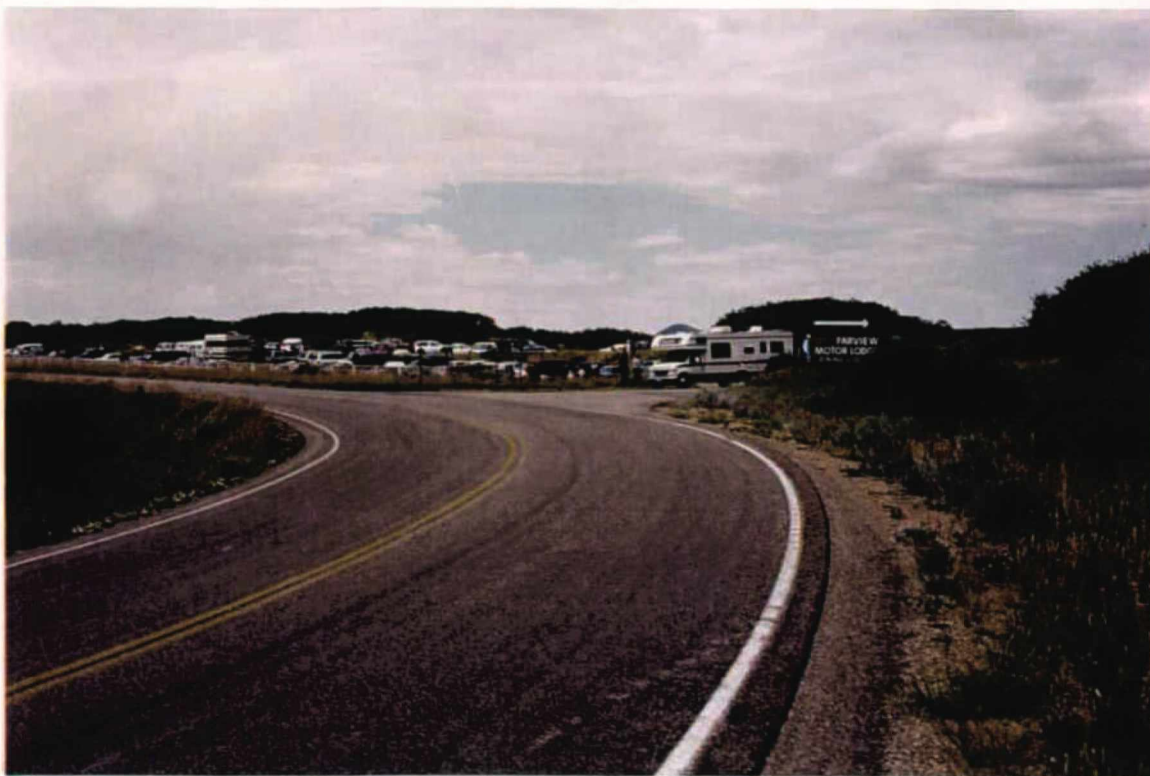
*Photograph #2* - shows the driveway entrance and the road that is also the lodge entrance. Again, the visitor center parking perhaps would be more clear if there were an arrow to the right.

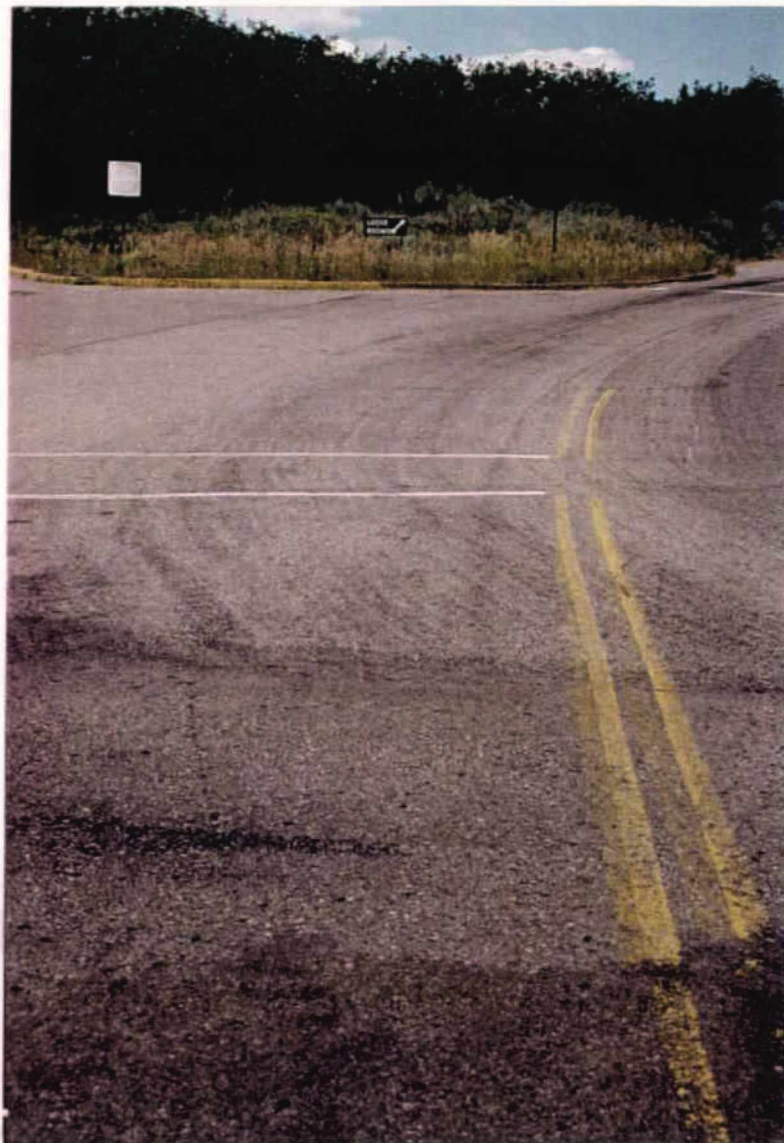
*Photograph #3* - is looking in a westerly direction at the lodge driveway. The "Do Not Enter" sign on the left is in extremely poor shape. The sign "lodge and rooms" perhaps could be made more clear. Note: the crosswalk in the foreground does not continue completely across the road.
