## **MESA VERDE NATIONAL PARK**

Far View / Weatherill  
"Three-Way"  
"Four-Way"

**Traffic Safety Study**

**April 4, 1996**

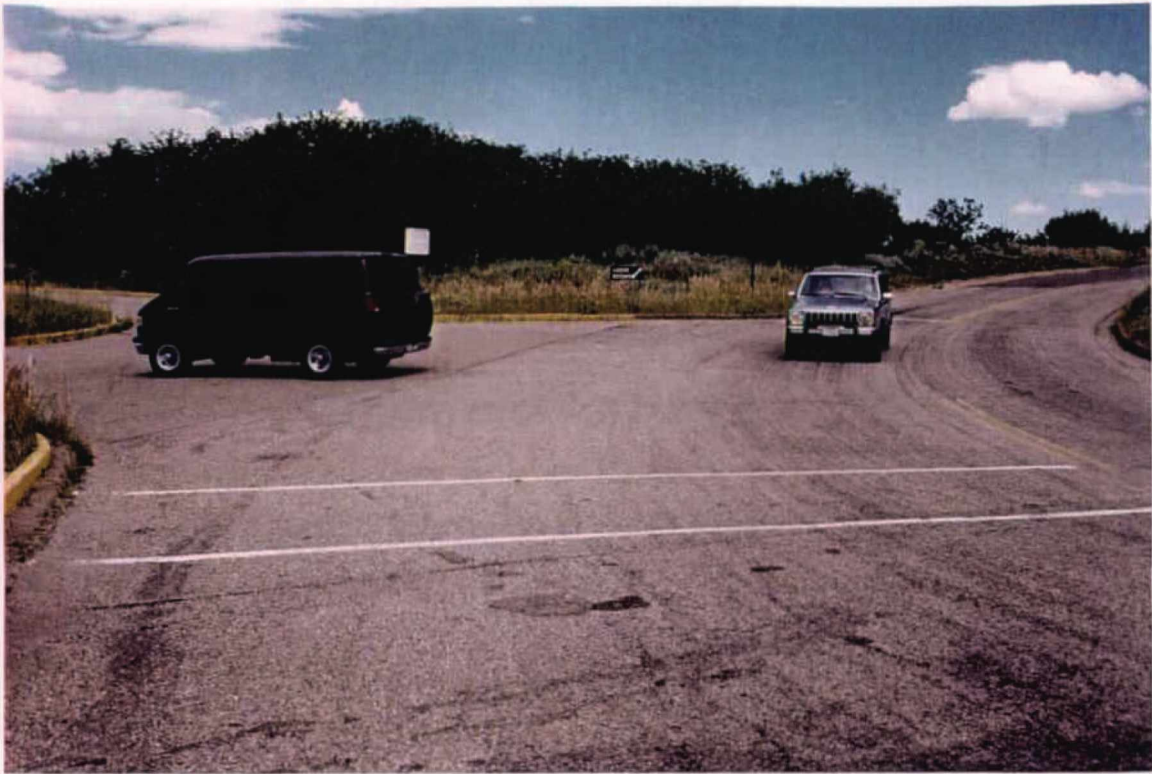
*Photograph #4* - shows the similar condition.

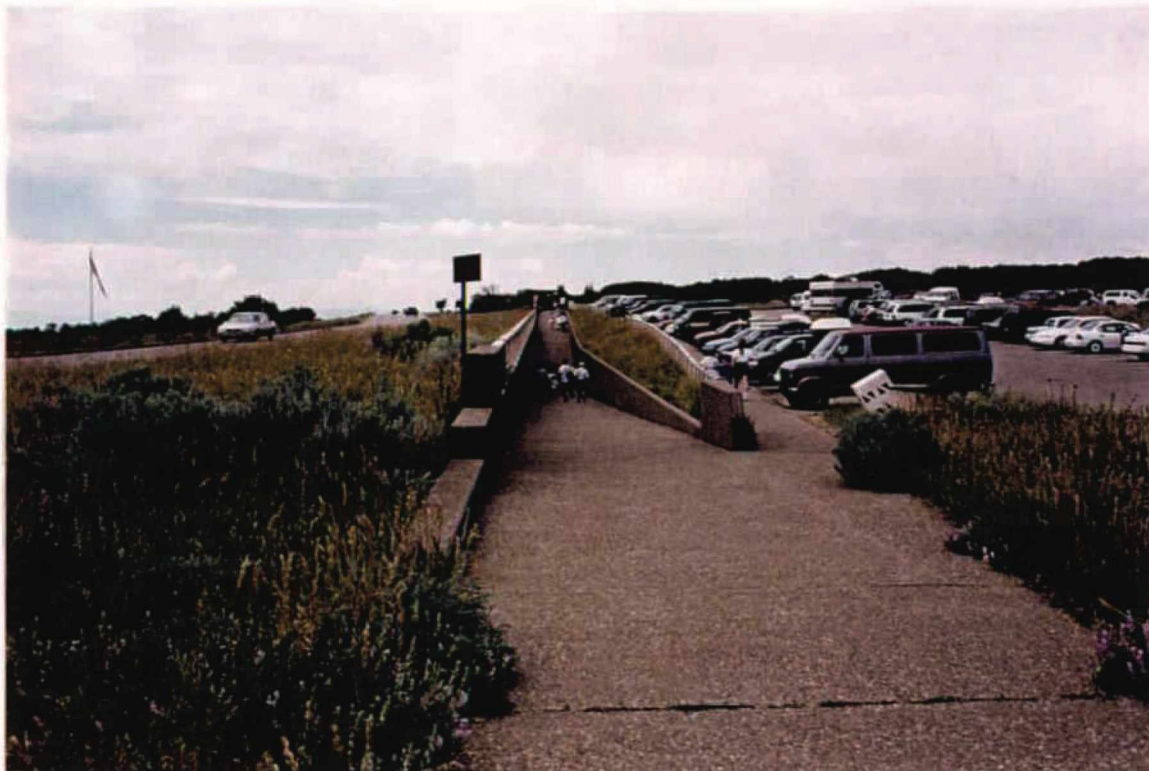
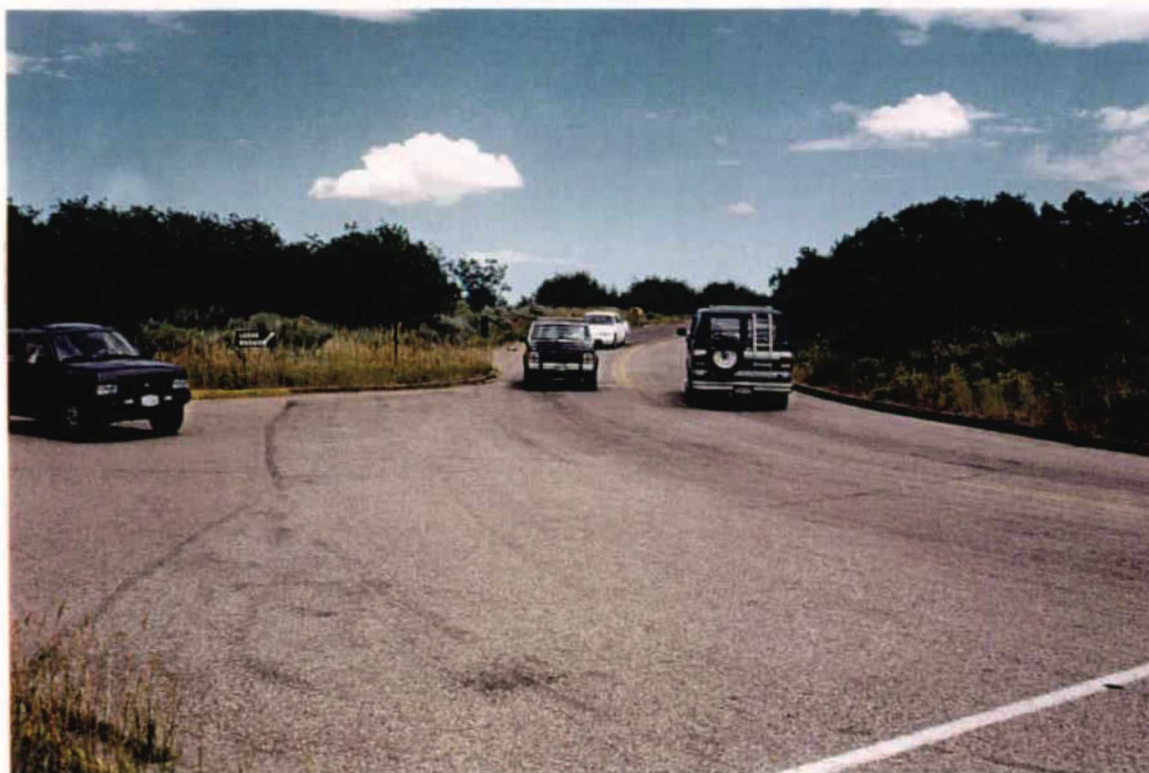
Photograph #5 - shows the ramp to the tunnel which goes under the road to the visitor center which seems to work quite well. Where the lodge road and the parking lot come together there seems to be some confusion because of the different directions people are going. A lot of movements are happening right in that area which is shown in *Photograph #6*.

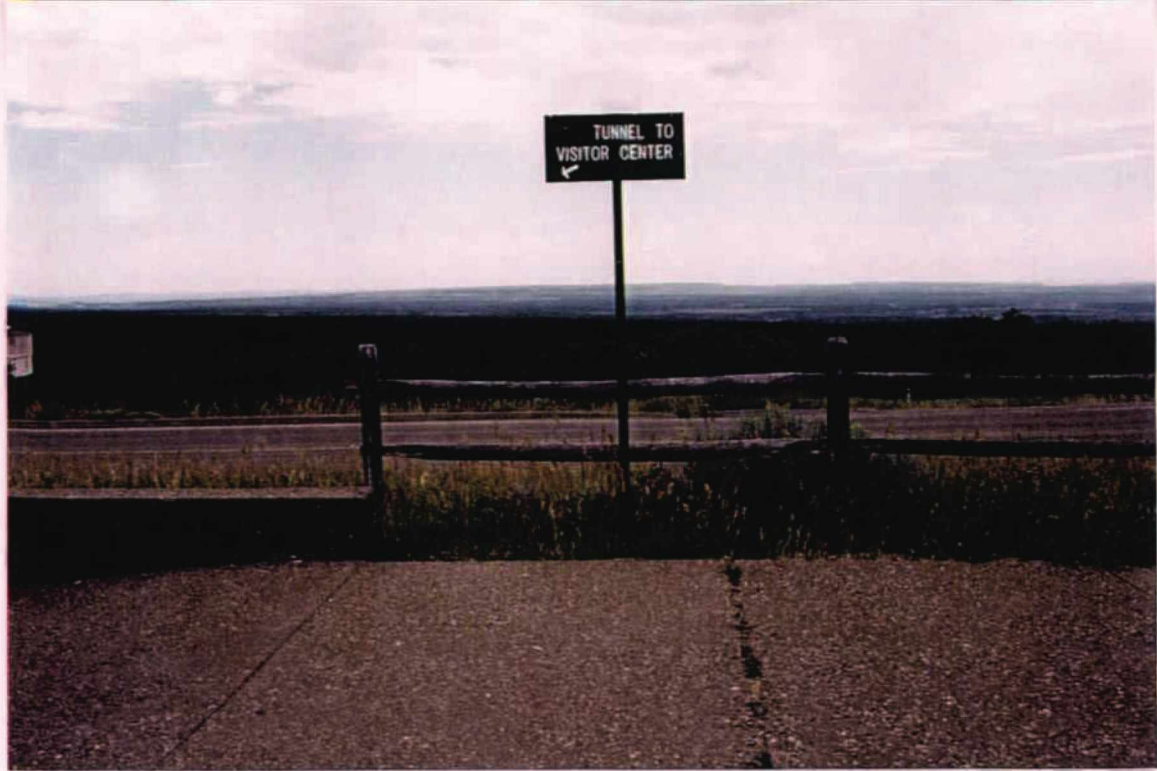
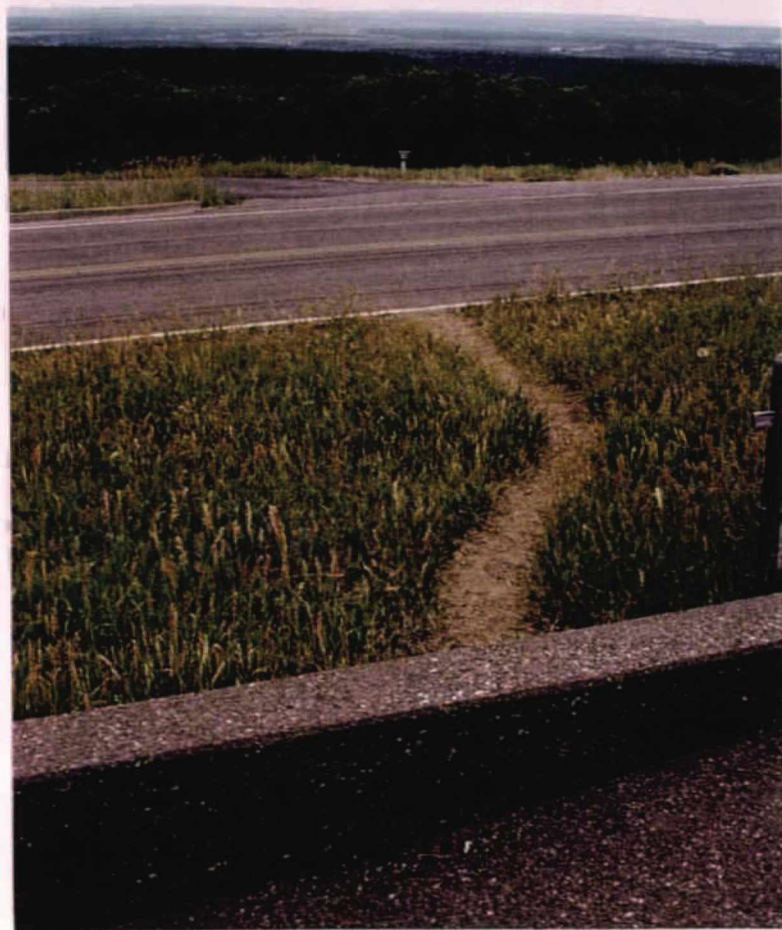
*Photograph #7 and #8 - are at the south end of the parking lot at Farview showing the path that apparently some people, rather than taking the tunnel, are using to go across the road to the driveway for park service employees - very small parking lot down there. It may be that an additional taller barrier through there would help to discourage that.*

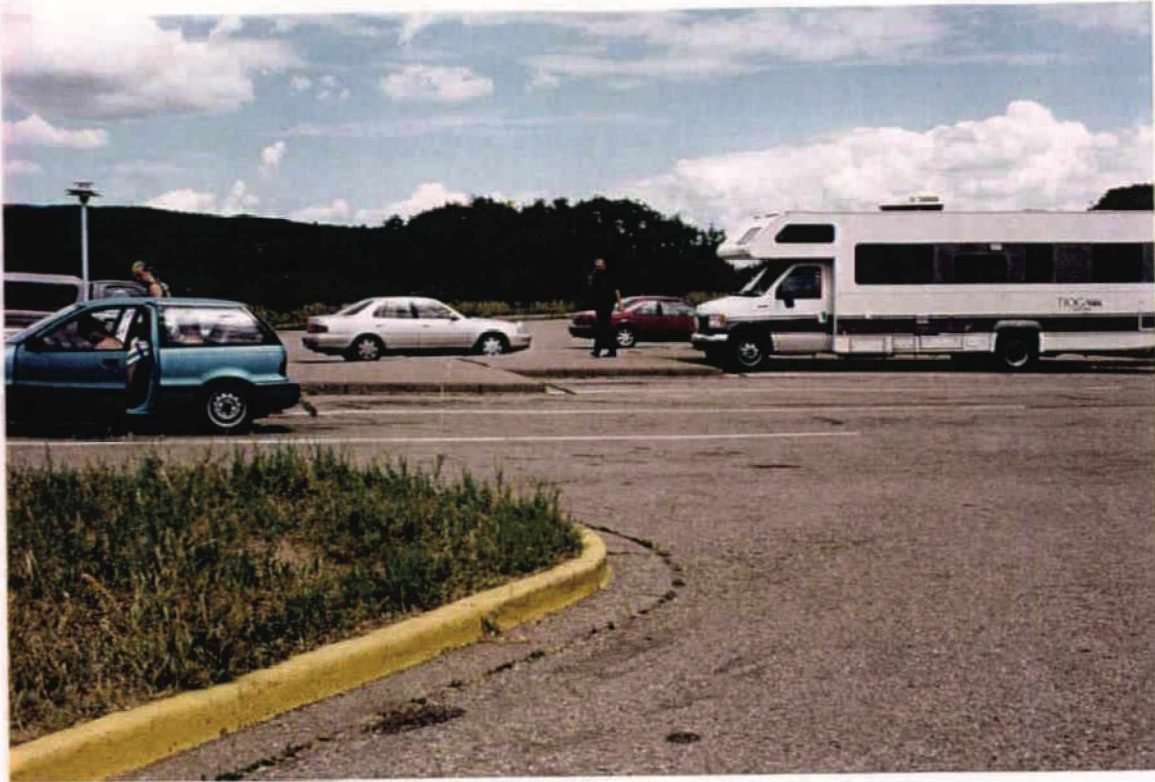
*Photograph #9* - is looking in a northwesterly direction at the parking lot. One idea, is to make the north driveway to the lodge only and the only entrance to the parking lot from the south. We would want to make the circulation of the parking lot in a counterclockwise direction which would be reversing the angle for the RV parking of the area shown in *Photograph #9*. Also, there should be signs that show that area of parking is reserved for oversized vehicles. Reversing the parking lot would mean changing the stripes on the west side of it. This will probably necessitate having a slurry seal of the entire lot and restripe the lot.

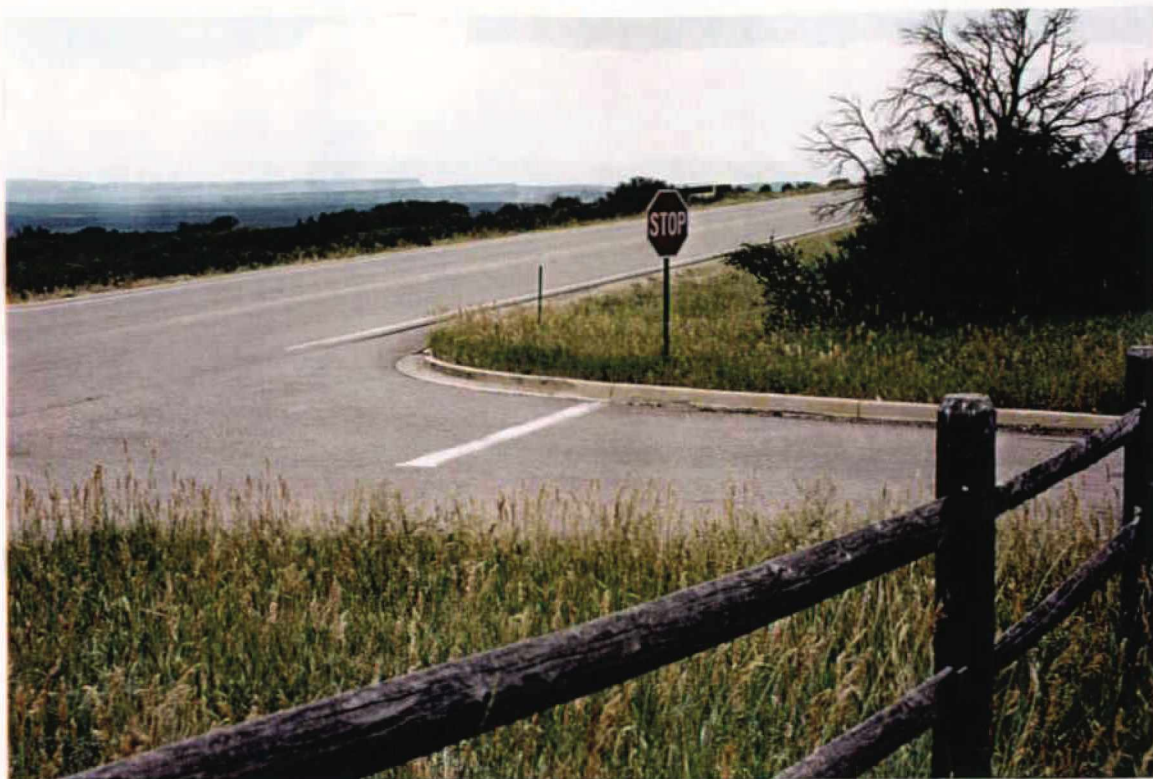
*Photograph #10* - is the south driveway at the Farview Visitor Center parking lot. The stop line may need to be extended farther out. Most of the vehicles that were observed were pulling beyond that to be able to see back to the south. It appears this intersection throat should be widened, if this is the only location for entrance into the parking lot.

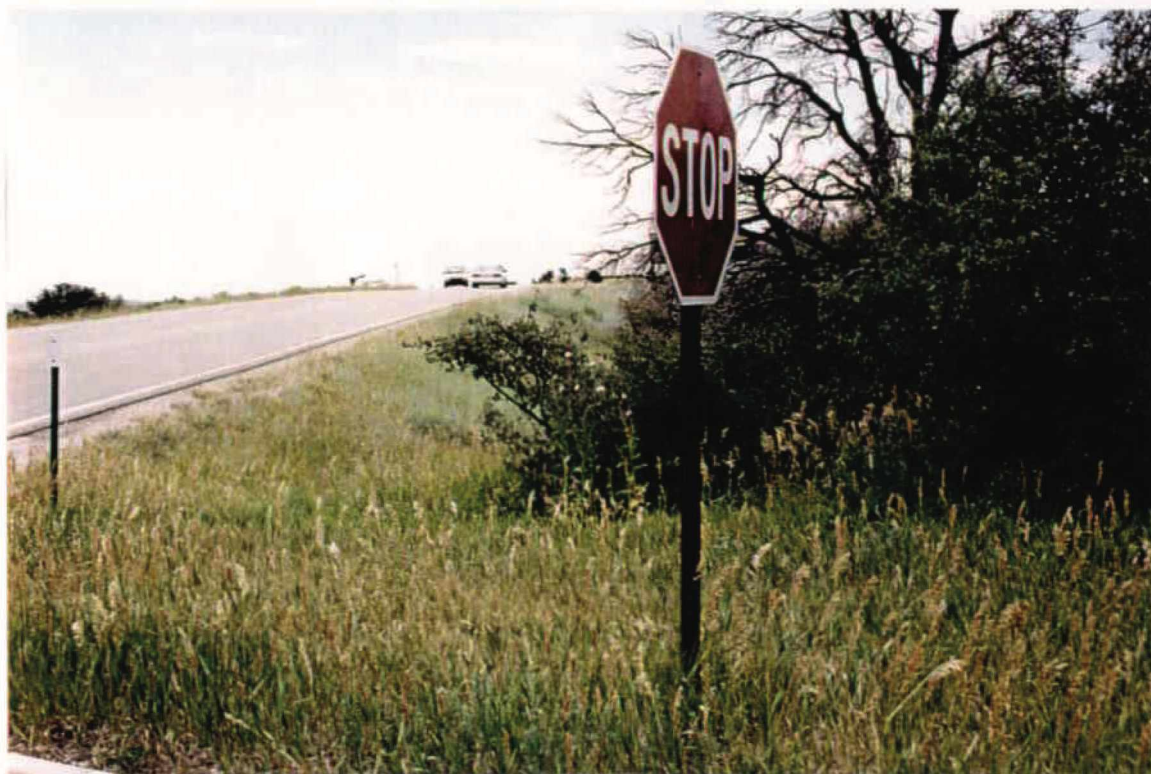
*Photograph #11* - is looking in a southerly direction from the stop line. Shrubbery on the southwest corner of the driveway intersection should be trimmed to improve sight distance.

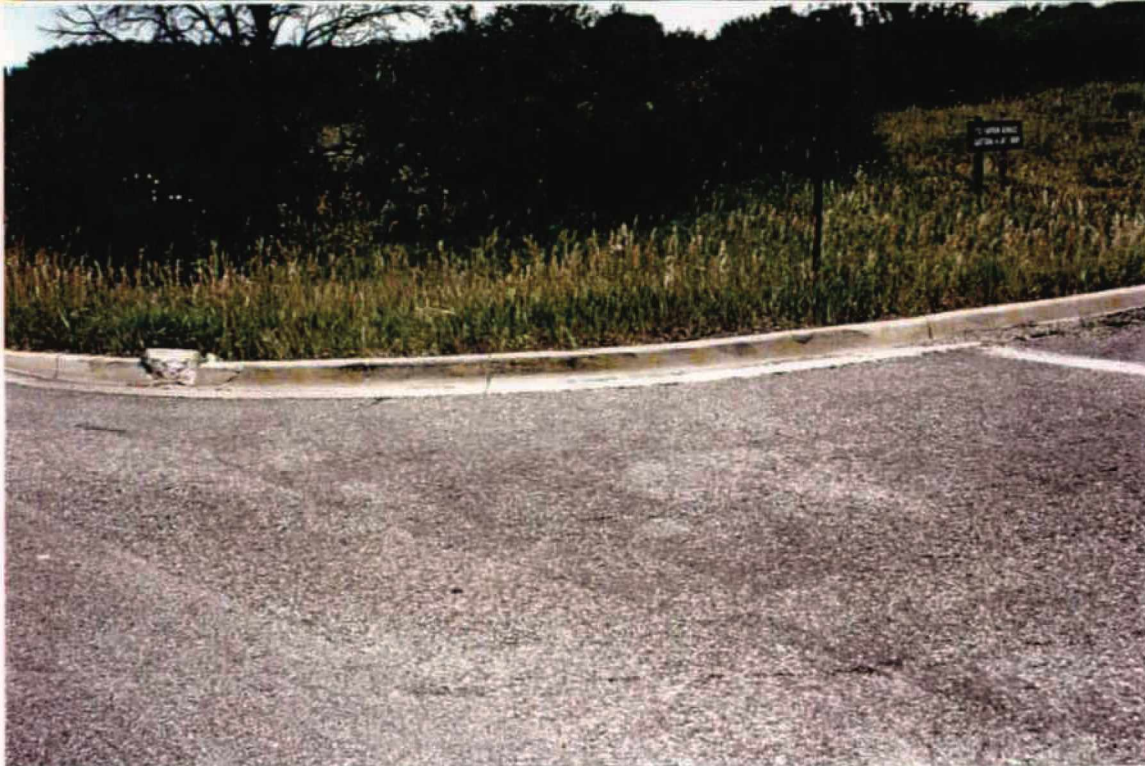
*Photograph #12* - shows the curb for the exit from this driveway. It appears that right turning traffic out has broken the curb as evidenced by the black marks in the broken curb. Again, widening this throat and improving the radius would be desirable if this is the only entrance and exit.

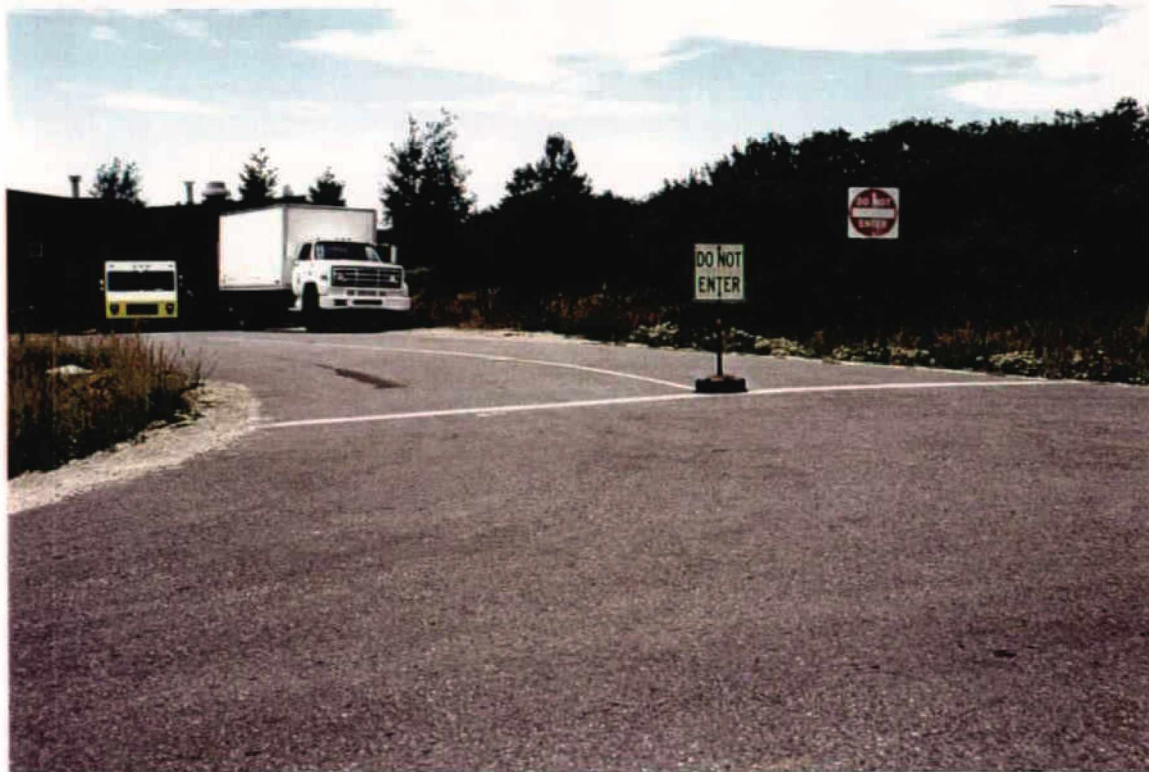
*Photograph #13* - is the "Do Not Enter" on the north side of the service station. We observed vehicles wanting to go to the gas station making a right turn from the main roadway and then realizing that they could not turn left into the gas station. We need to find out why the gas station driveway is one way.

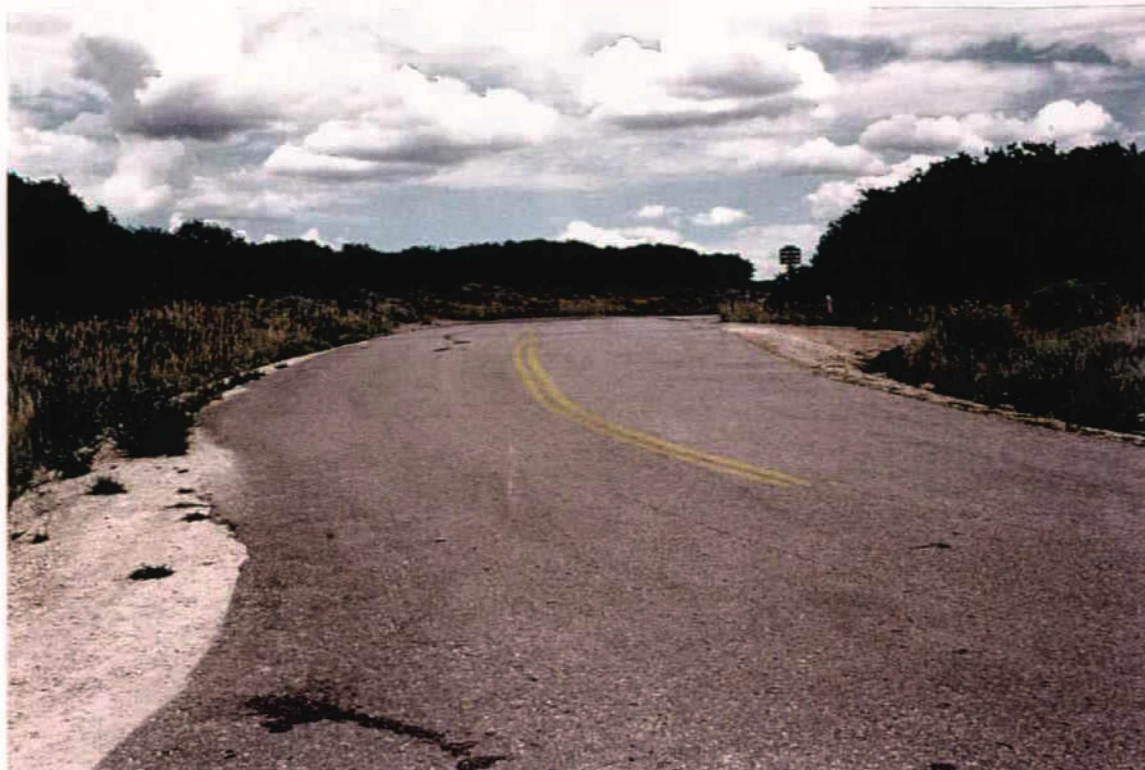
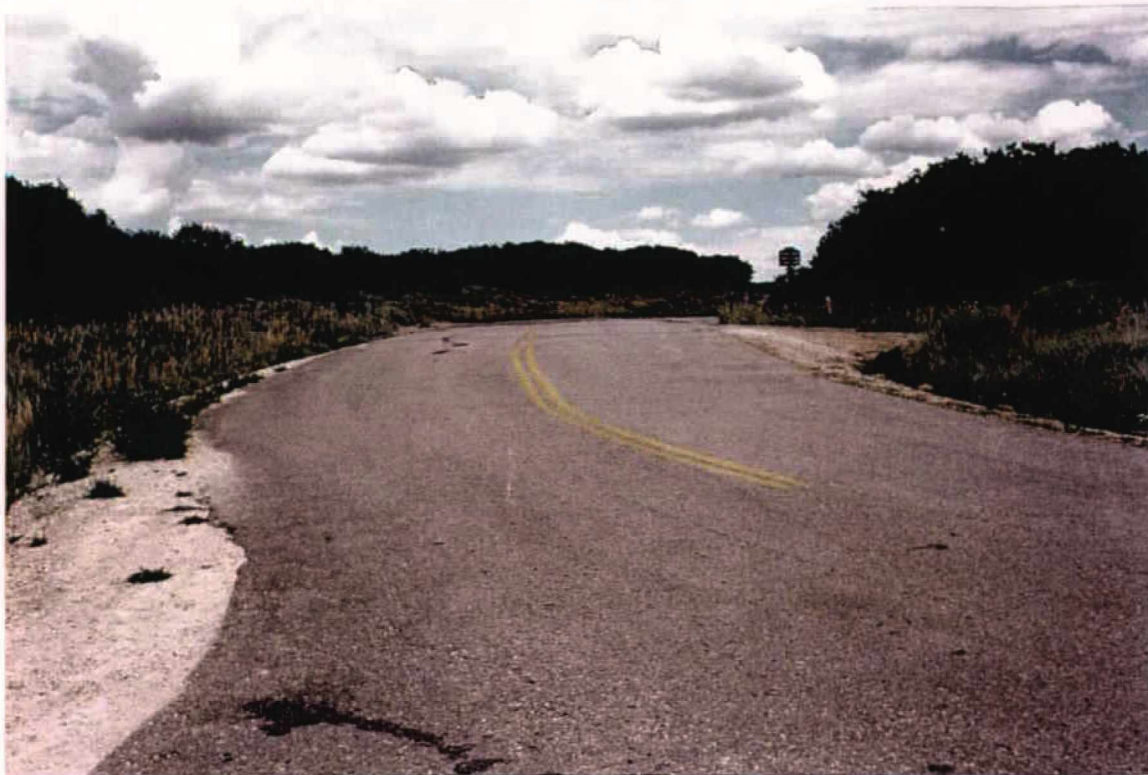
*Photograph #14* - shows the gate. You can see on the right where people turn around either when the gate is closed or perhaps when they have already made a right turn or have entered from the main road and then realize they can't turn into the gas station.

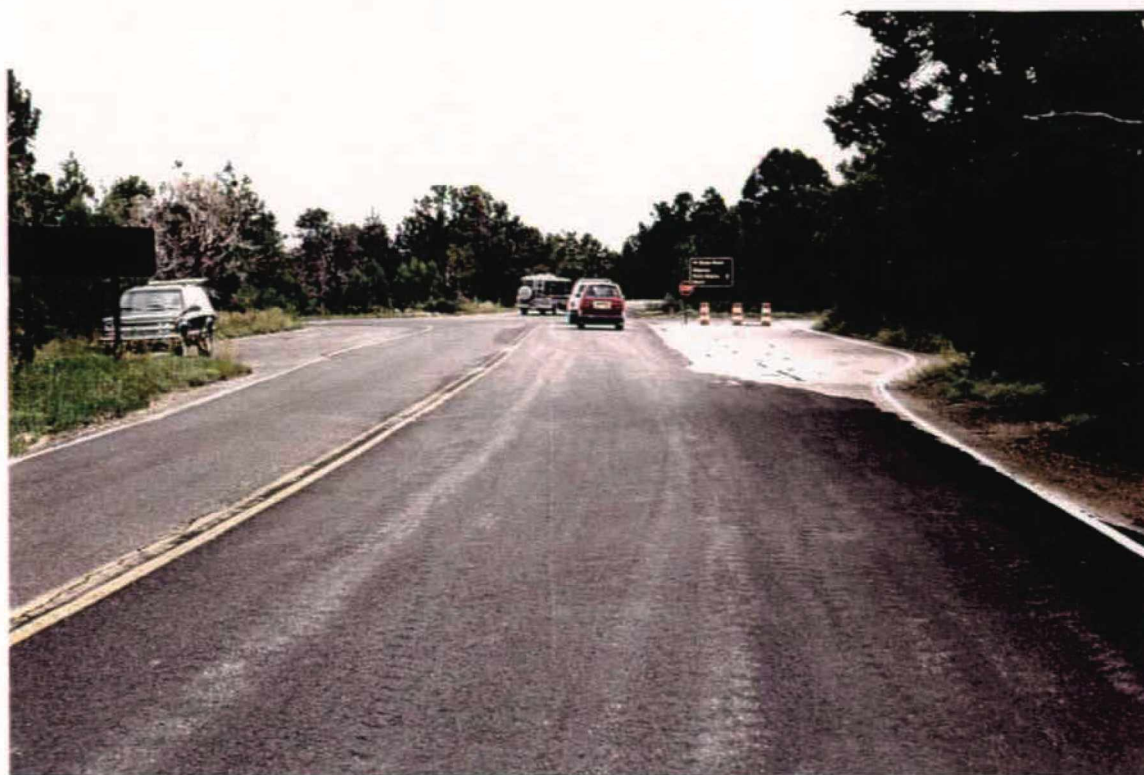
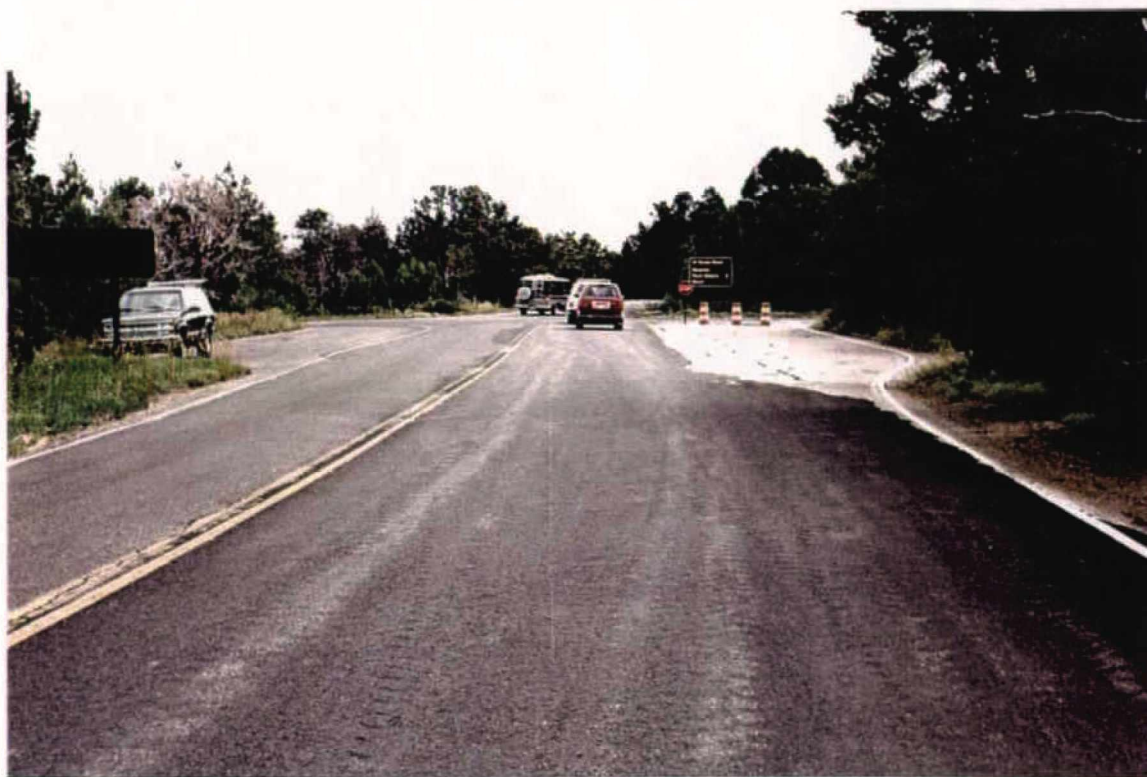
*Photograph #15* - is looking south at the 4-way intersection. It also shows a van who made a mistake and is backing up.
