## United States Department of the Interior

NATIONAL PARK SERVICE  
Manzanar National Historic Site  
P.O. Box 426 5001 Highway 395  
Independence, California 93526

To: Superintendent, Minidoka National Historic Site  
From: Archeologist, Manzanar National Historic Site  
Subject: Trip Report, Robeson Property Survey, Jerome County, Idaho, October 29-31, 2009  
(Project Number MIIN 2009 B).

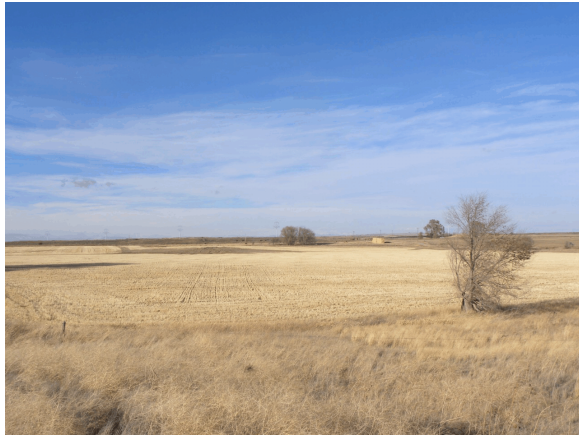
Figure 1. Overview of Robeson Property, view to north.

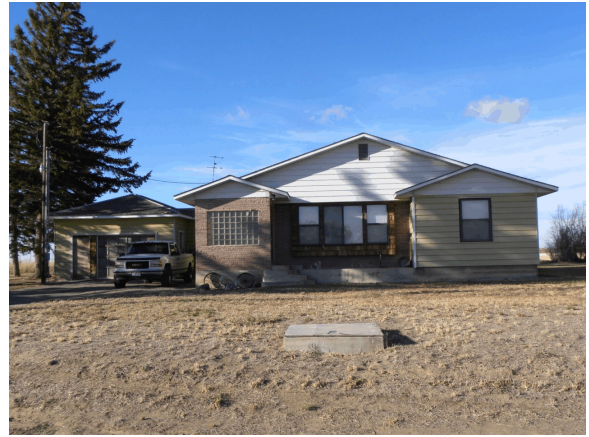
| Fea. No. | Field No. | Component | | Description | Notes |
|---|---|---|---|---|---|
| 1.1 | 59 | | X | farm house with attached garage | 1450 sq ft building with 480 sq ft garage connected by 125 sq ft enclosed breezeway; interior not accessible |
| 1.4 | 63 | | X | well box | subterranean concrete box 45 x 46 inches, 7 ft deep, top opening is 26x 26½ inches |

Figure 2. Farm residence, Robeson Property Feature 1.1; well box (Feature 1.4) in foreground.

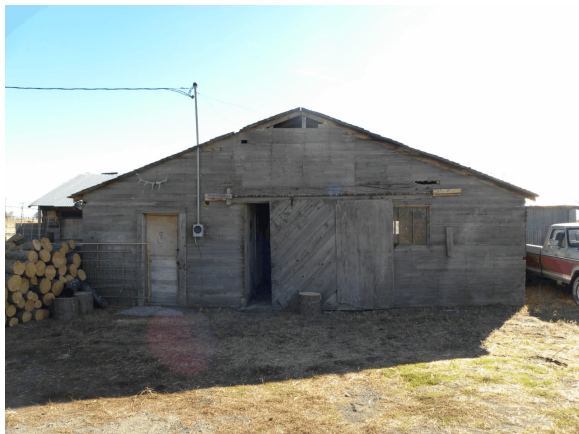
| Fea. No. | Field No. | Component | | Description | Notes |
|---|---|---|---|---|---|
| 1.2 | 60 | | X | barn | 1745 sq ft building |

Figure 3. Barn, Robeson Property Feature 1.2.

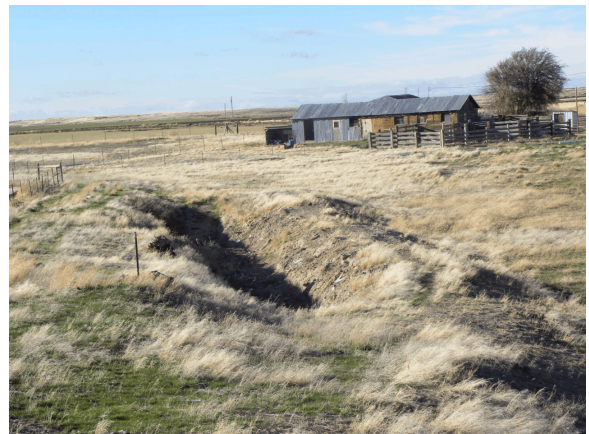
| Fea. No. | Field No. | Component | | Description | Notes |
|---|---|---|---|---|---|
| 1.7 | 48 | | X | trash pit | trench 25 x 160 ft, up to 6 ft deep, burned domestic trash includes aluminum cans, porcelain doll parts, auto parts |

Figure 4. Trash pit, Robeson Property Feature 1.7.

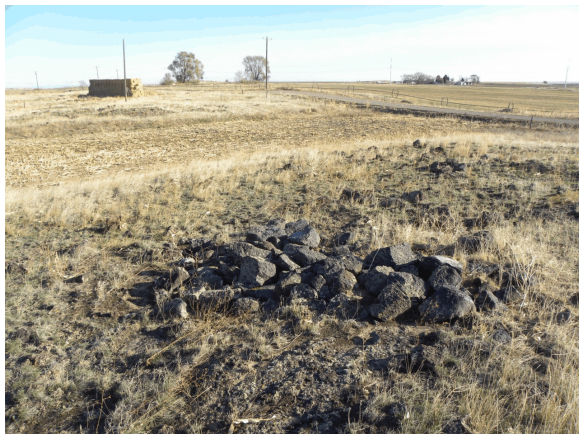
| Fea. No. | Field No. | Component | | Description | Notes |
|---|---|---|---|---|---|
| 10.7 | 4-7 | | X | rock pile | 6 x 12 ft, large rocks |

Figure 5. Rock pile, Robeson Property Feature 10.7.

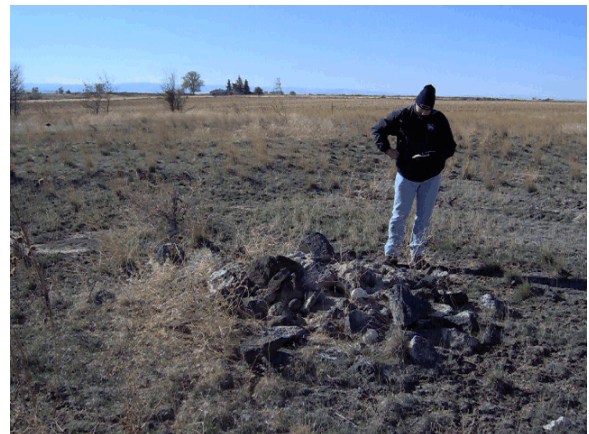
| Fea. No. | Field No. | Component | | Description | Notes |
|---|---|---|---|---|---|
| 21 | 9 | | X | rock pile | 8 x 8 ft |

Figure 6. Rock pile, Robeson Property Feature 21.

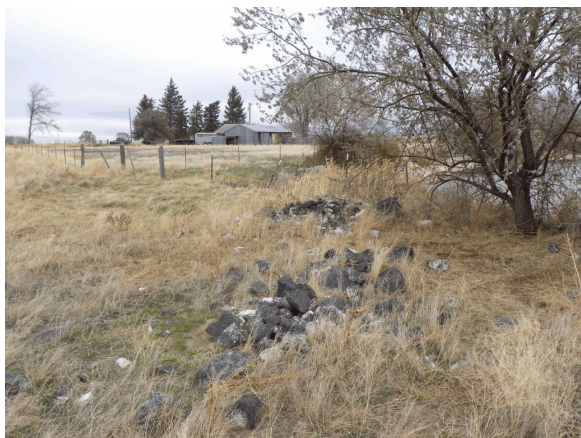
| Fea. No. | Field No. | Component | | Description | Notes |
|---|---|---|---|---|---|
| 14.1 | 33-1 | | X | rock pile | 10 x 18 ft |

Figure 7. Rock pile, Robeson Property Feature 14.1.

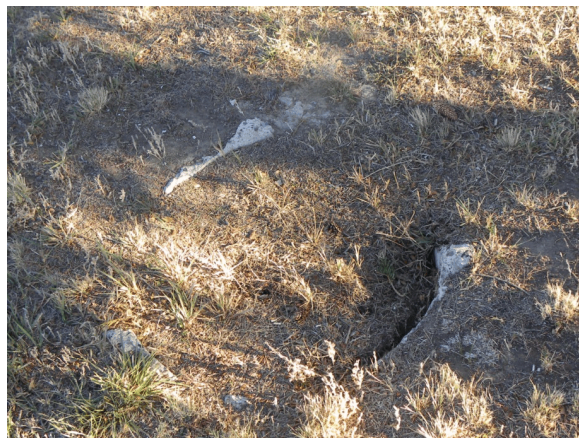
| Fea. No. | Field No. | Component | | Description | Notes |
|---|---|---|---|---|---|
| 1.14 | 52 | X | | in situ manhole remnants | concrete oval, approx 31 x 32 inches, broken top edge |

Figure 8. In situ relocation center manhole, Robeson Property Feature 1.14.

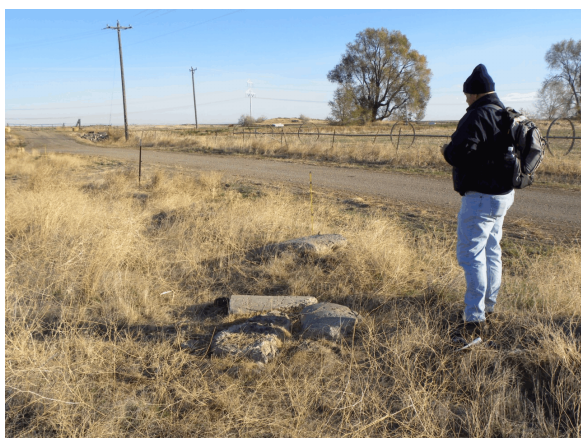
| Fea. No. | Field No. | Component | | Description | Notes |
|---|---|---|---|---|---|
| 6 | 1 | X | | concrete manhole debris | four large concrete slabs, 20 x 21", 18 x 35", 22 x 32", 32 x 36" |

Figure 9. Manhole debris, Robeson Property Feature 6.

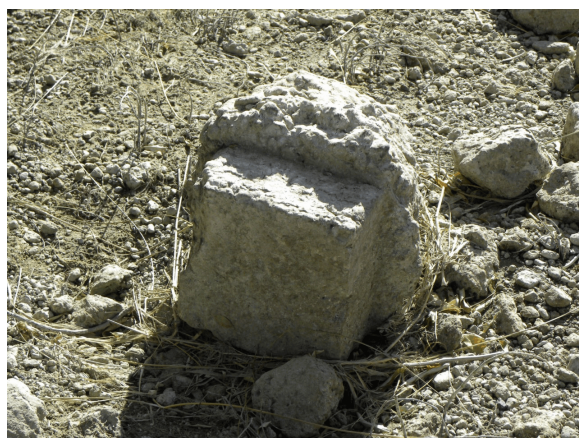
| Fea. No. | Field No. | Component | | Description | Notes |
|---|---|---|---|---|---|
| 44 | 39 | X | | footing in ditch | 8 x 8 x 3 $\frac{1}{2}$ inches |

Figure 10. Small concrete footer, Robeson Property Feature 44.

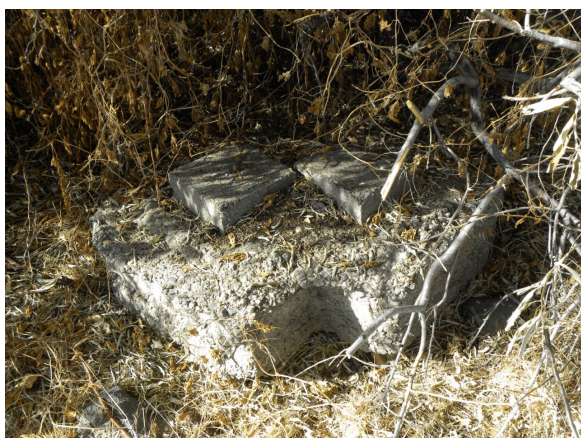
| Fea. No. | Field No. | Component | | Description | Notes |
|---|---|---|---|---|---|
| 3.3 | 41 | X | | large concrete footer | double footing, each is 9⅞ x 9⅞ x 3½ inches, 12-13 inches thick, outside survey area |

Figure 11. Large concrete footer, Robeson Property Feature 3.3.

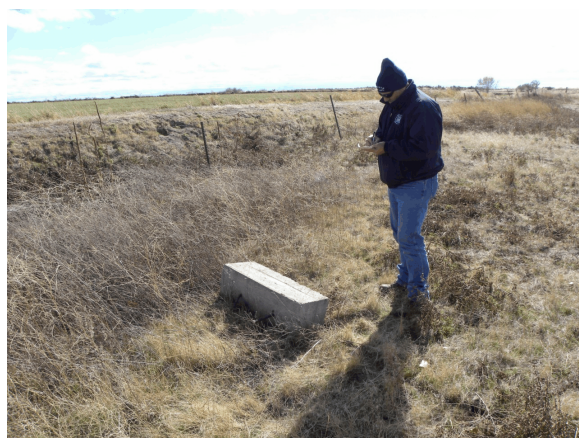
| Fea. No. | Field No. | Component | | Description | Notes |
|---|---|---|---|---|---|
| 3.4 | 43 | X | | concrete footer/pier | 12 x12 x 32 inches, extruding 2 inch long rebar on one side and bolts on the other (¾ inch with nuts, 8 inches long) |

Figure 12. Large concrete footer, Robeson Property Feature 3.4.

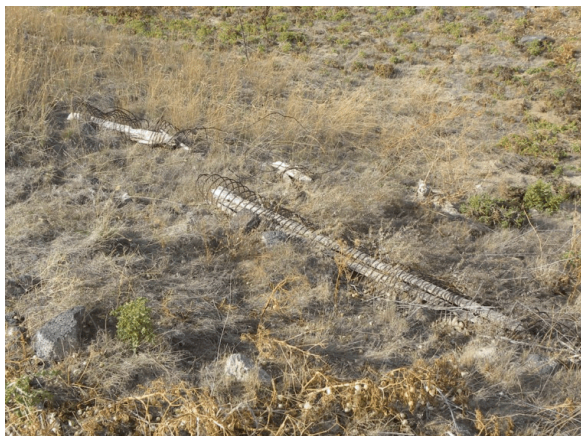
| Fea. No. | Field No. | Component | | Description | Notes |
|---|---|---|---|---|---|
| 25 | 25 | X | | wood pipe | two sections of wood pipe with wire bundling, 7 ft long, approx 9 inch diameter |

Figure 13. Wood pipe, Robeson Property Feature 25.

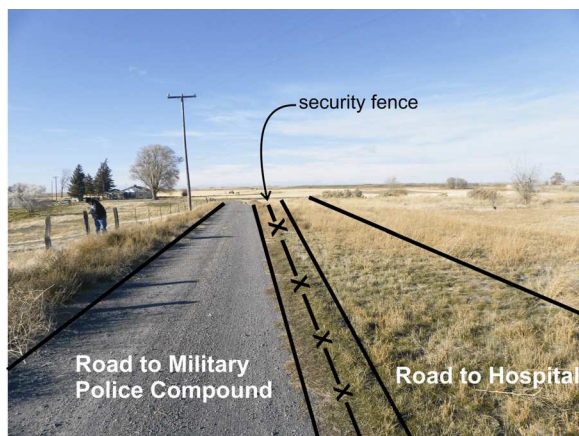
Resources that potentially date to both the farm and relocation center include roads, fences, vegetation, and debris. Two currently used roads match relocation center road alignments. The dirt road along the northern edge of the survey area corresponds to 'B' Street of the relocation center. The road leading to the Robeson farm residence and barn corresponds to the road that led to the military police compound. Both roads are likely modified from their historic appearance. For example, when the relocation center was constructed, according to the WRA blueprints, the road to the military police compound lay just west of the security fence. Another road, to the hospital and residential areas, ran parallel, on the inside of the security fence (Figure 14). Now, there is a fence on the opposite side of the military police compound road, along the west side of the road to the farm residence. This fence may incorporate recycled materials from the original security fence, and may have been moved after the center closed, or even possibly during the relocation center use. Although the road to the hospital is overgrown with grasses and is no longer used, its grade is still discernible.

Figure 14. Road to farm residence showing historic road and fence locations.

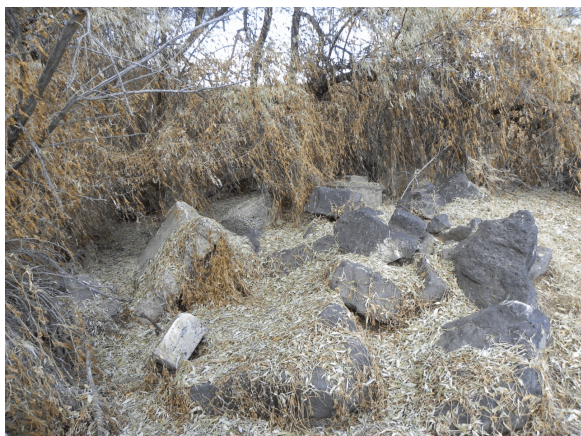
| Fea. No. | Field No. | Component | | Description | Notes |
|---|---|---|---|---|---|
| 3.1 | 44 | X | X | concrete dump, rock piles | at least 16 footers and piers, numerous concrete slab and other concrete fragments, large rocks, overgrown by trees, outside survey area, footings measure 12 x 7½ x 32 inches, 10 x 10 x 3½ inches (n =8), 12 x 5½ x 32 inches, and 12 x 3½ x 32 |

Figure 15. Large footers and rocks, Robeson Property Feature 3.1.

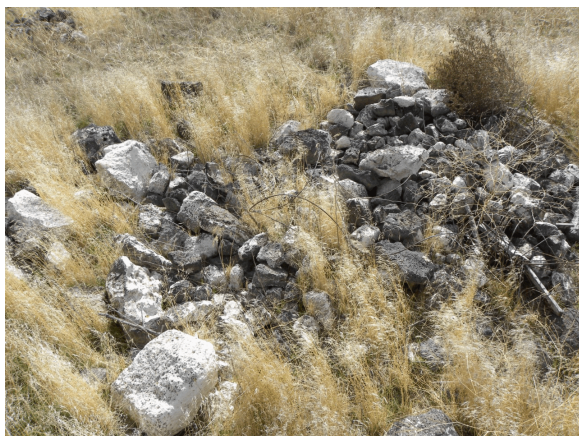
| Fea. No. | Field No. | Component | | Description | Notes |
|---|---|---|---|---|---|
| 3.6 | 45 | X | | footings, wood pipe, concrete pipe | three footings (10 x 10 x 3½"), wood pipe remnants, concrete pipe piece (20" long, 8" ID), rocks |

Figure 16. Rocks and concrete debris, Robeson Property Feature 3.6.

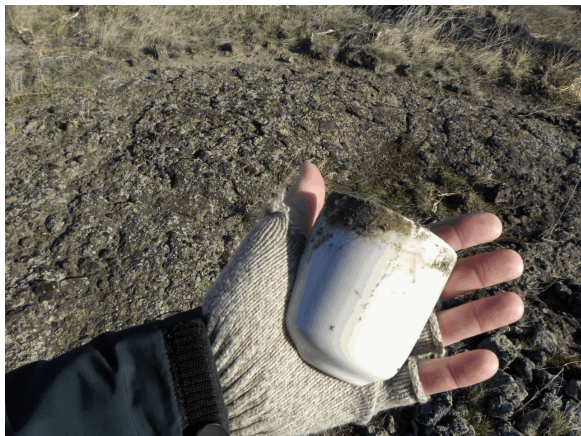
| Fea. No. | Field No. | Component | | Description | Notes |
|---|---|---|---|---|---|
| 10.6 | 4-6 | X | X | rock pile with artifacts | 5 x 11 ft, brick fragment, coffee cup fragment |

Figure 17. Coffee cup fragment, Robeson Property Feature 10.6.

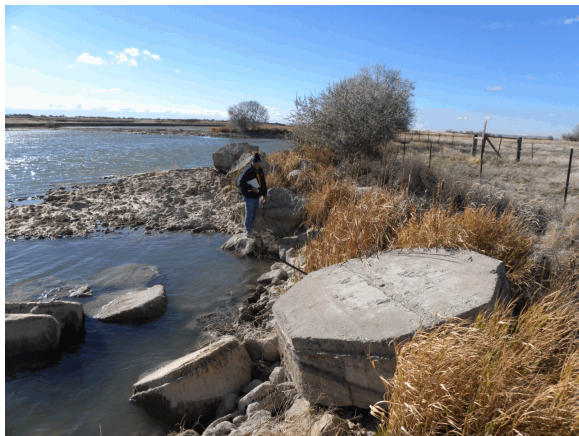
Other resources that potentially date to both the farm and relocation center include six areas with rock piles and concrete remnants or footers (Figures 15 and 16), a rock pile with brick fragments, a rock pile with a brick fragment and a coffee cup fragment (Figure 17), a fallen fence post, a ball of wire fencing, and a rock with hole drilled through it. Two areas (Features 3 and 15) contain unusually large footers and other concrete pieces. The large footings at Feature 3 are likely from the hospital, which was located close by, to the northeast. At other relocation centers, hospital footings tend to be larger than those used for other buildings (Burton et al. 2002:85). According to some of the WRA blueprints, the area around Feature 3 (Map 10) may have been inundated by the North Side Canal during the relocation center use. The large concrete debris at Feature 15, which includes large hexagonal pieces evidently used to reinforce the canal bank (Figure 18), may be from the sewage treatment plant.

| Fea. No. | Field No. | Component | | Description | Notes |
|---|---|---|---|---|---|
| 15 | 57 (46) | X | X | concrete and rock piles with artifacts | approx 100 ft long area along canal bank and within canal, concrete chunks up to 5 x 7 ft, wood pipe fragments, wood pipe (8½" dia), 4 footings/piers, two footings, three small hexagonal shaped fragments in canal, 7 ft dia hexagonal shaped fragment with 1½ inch hole in the center, concrete pipe (24" ID), 2 concrete pipe (22" ID), 4 concrete pipe (12" ID), 2 rocks with drilled holes (2½ inch diameter), loose wire and cable |

Figure 18. Large concrete debris, Robeson Property Feature 15.
