## **HISTORIC STRUCTURE REPORT**

### **GOWING-CLARK HOUSE (Daniel Taylor House)**

**Minuteman National Historical Park  
Concord, Massachusetts**

**February 2000**

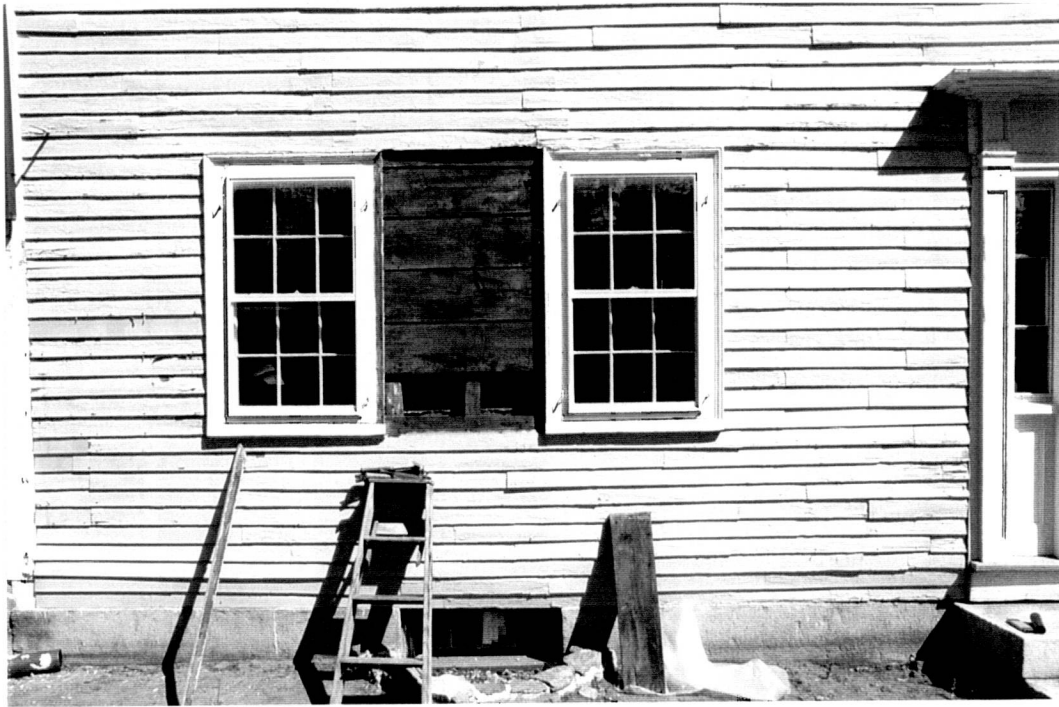
When clapboards were removed from the south façade of the main house in June 1999, it was observed that the composition of the walls behind the sheathing boards differed on the west and the east ends. On the west end, the sheathing was nailed to studs, which in turn could be seen to have been used as a nailers for the horizontal lath and plaster applied on the interior wall (**figs. 12 & 13**). On the east end, a layer of vertical accordion lath and plaster was visible through the gaps in the sheathing boards applied to the *exterior* side of the wall studs, possibly for use as a wind break. This feature was not present on the west end of the wall. Comparison of the nails from the two ends of the wall could help determine if they were built at the same or different times. However, no nails were removed from the sheathing or from the window casing on the east end of the wall (as they were from the west end) because of concerns that evidence on the lath and plaster the “wind break” would be disturbed. Thus it is not known why the two sides of the wall were have different construction.

**Figure 12.** Gowing-Clark House – South Façade, West End (1999).

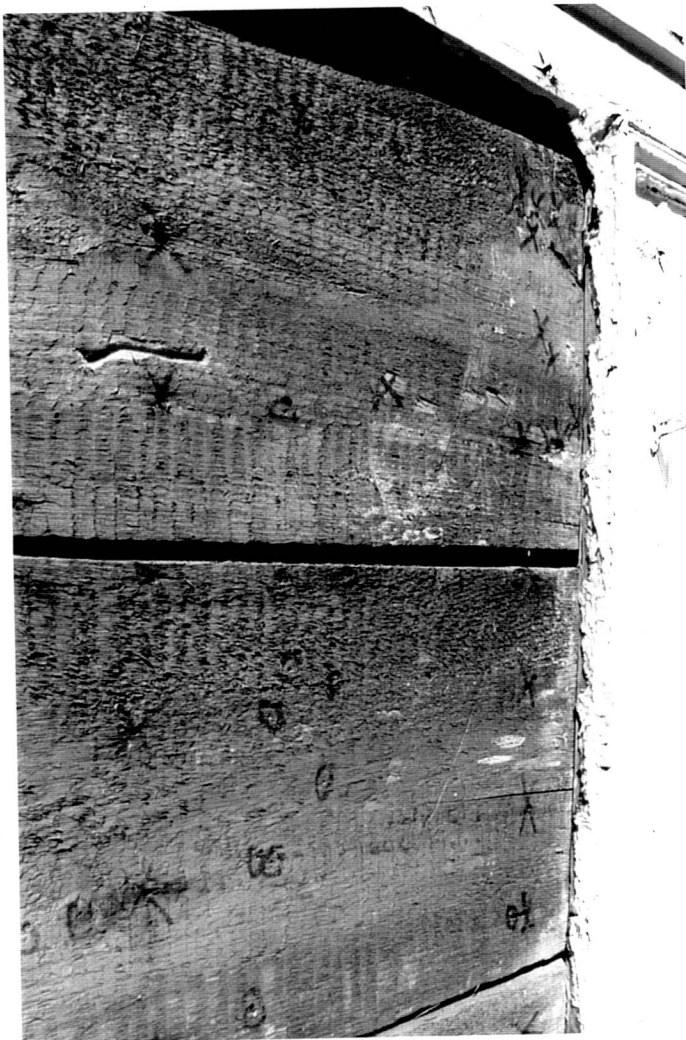
When clapboards were removed from selected areas of investigation, it was apparent that they were the only episode of cladding attached to sheathing boards which were original to the house's construction. Close examination of the cut nails attaching the clapboards to the sheathing revealed that they have the physical characteristics of machine-cut nails that were manufactured only between circa 1815 and circa 1835.<sup>51</sup> The circa 1815-1835 nails were found in original wall sheathing and clapboards on the south façade of the main house and on the east wall of the ell, in original window casing on the main house south façade, in the subflooring and main staircase framing in the main house, and on interior wall sheathing boards in the second-floor ell storage area. Thus, the nail evidence dates the construction of both the main house and the ell to between circa 1815 and circa 1835.

**Figure 13.** Gowing-Clark House – South Façade, West End, Detail Showing Original Mill-Sawn Sheathing (1999).

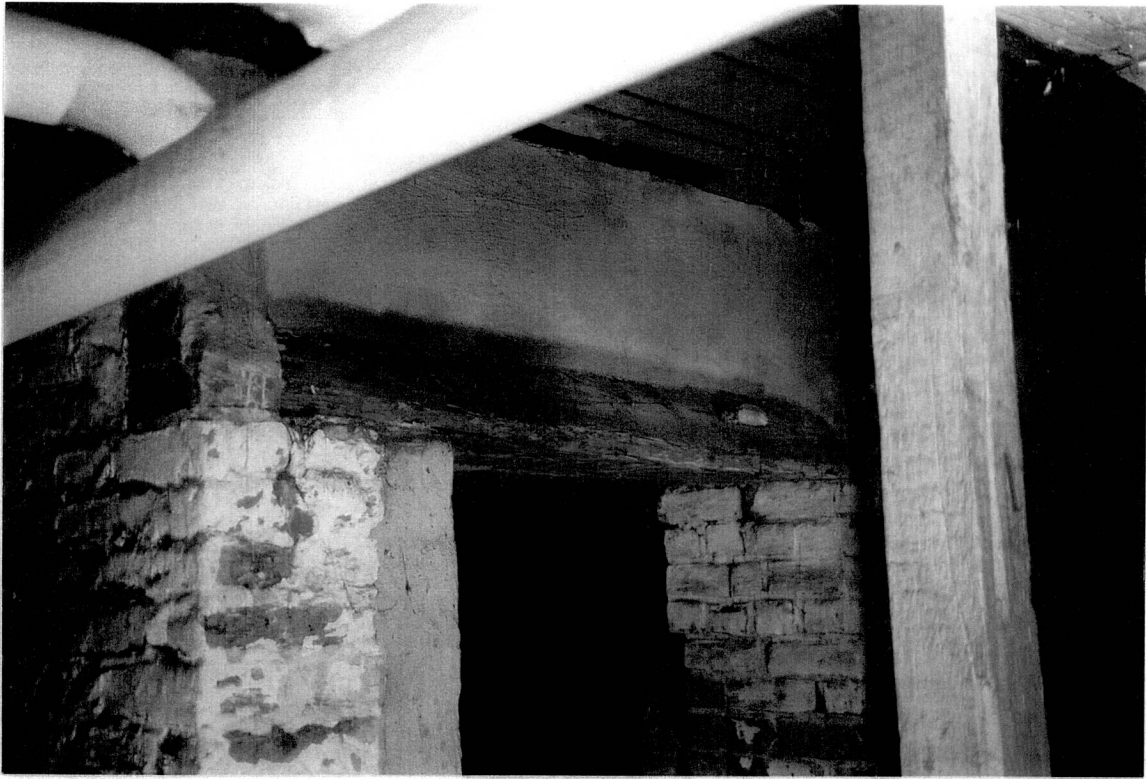
- In the ell cellar, the north/south girt that marks where the ell begins to extend east of the east wall of the main house is a massive beam measuring at least 1 foot in cross section (**fig. 18**). This beam was original to the construction to ell-cellar area, but is considerably oversized for its use and also has empty pockets. In addition, although the girt is extremely deteriorated a portion of a bead has survived on one edge. The size of the girt plus the presence of a decorative bead indicates that this girt was once a major carrying beam, probably a summer, from an earlier house that had been exposed and decorated.

**Figure 18.** Gowing-Clark House – Ell Cellar, Reused Timber as North/South Girt (2000).

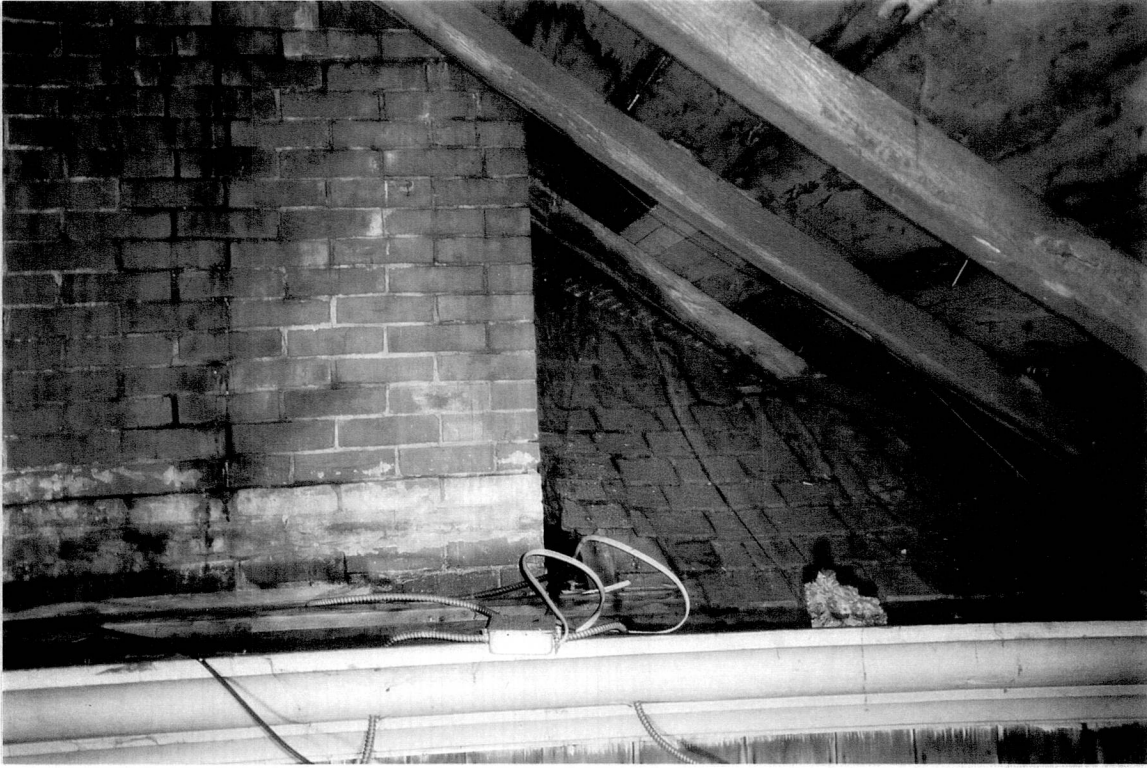
**Figure 19.** Gowling-Clark House – Ell Attic Looking South, Formerly-Exposed Original Roofing on North Slope of Main-House Roof (2000).

- When the “new” roof was built it covered the east end of the main house's north wall, preserving a section of the north roof slope and north wall shingles. The roof shingles are original to the circa-1830 construction of the house -- they are attached using circa 1815-1835 cut nails and display several years of weathering. The wall shingles are replacement shingles -- they are circular-sawn and attached using modern cut nails and show minor weathering. “Modern” cut nails<sup>53</sup> were manufactured beginning around 1835, and circular-sawn shingles were commonly available after the 1840s. Thus, either Gowing or Clark could have replaced the wall shingles before the ell roof was raised.

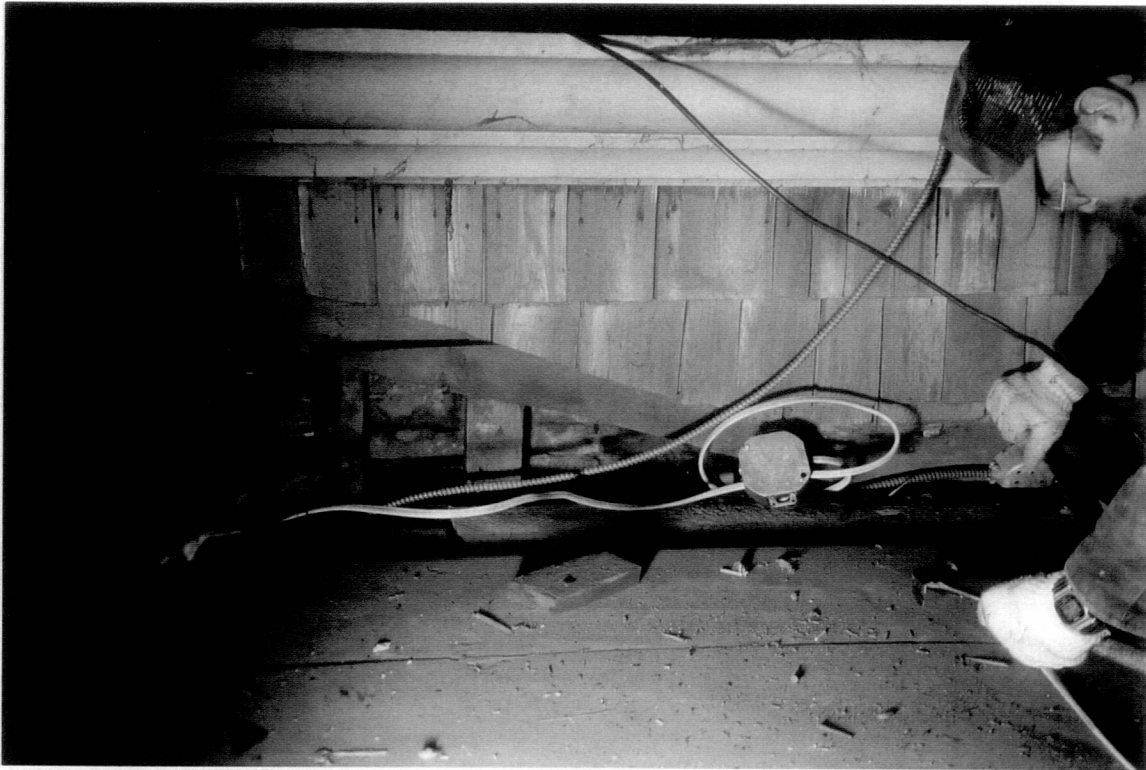
There is ample evidence that the original ell had a saltbox roof that was later replaced with the existing gable roof. The original roof had a short east slope that rose from at the existing east-wall plate (see *Ell – Construction*, above) to a ridge located near the level of the main house's north-wall cornice. The long east roof slope of the ell descended from this ridge to a west-wall girt (or plate) located approximately 2 feet above the second-floor floor level (**figs. 20-22**).

**Figure 23.** Gowling-Clark House – Ell Attic Looking South, Formerly-Exposed Area of Main House North Wall Showing Original Slope of Ell West Roof (2000).

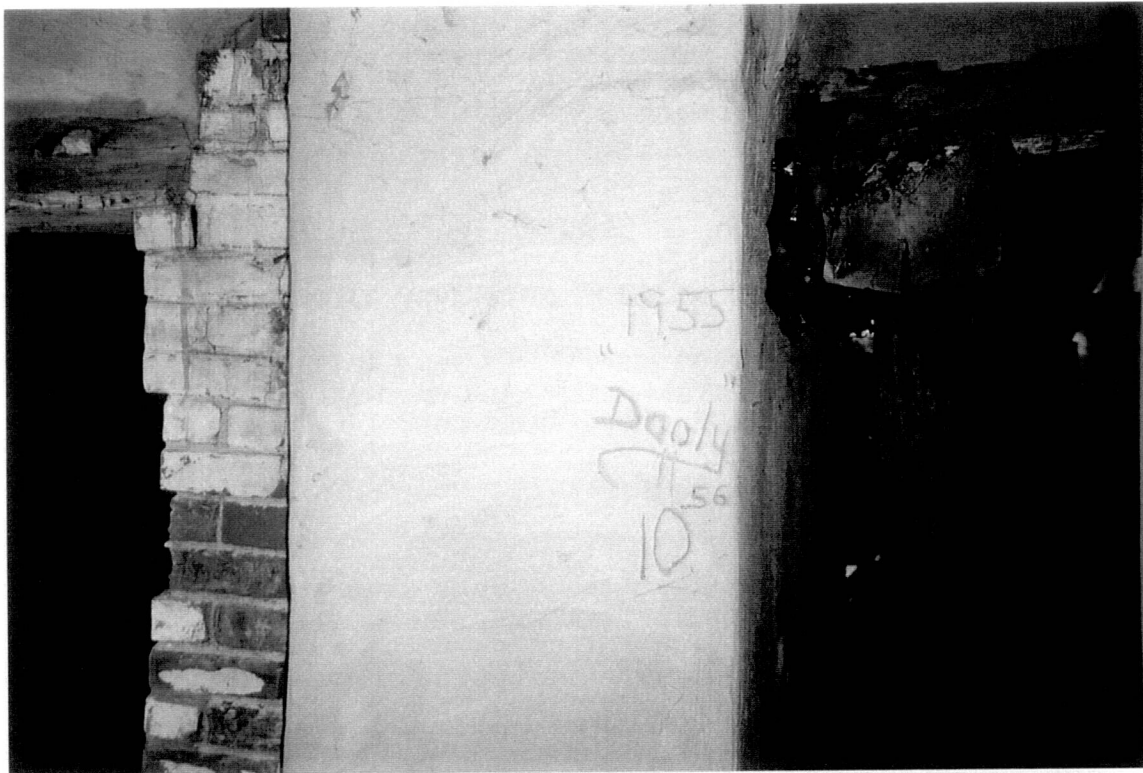
However, close examination of the brick used to construct the piers for both bases revealed that they are the same type of brick, and analysis of mortar samples taken from piers of both bases indicated that the mortar taken from the west base has the same characteristics as that taken from the east base. These mortars also share the same characteristics as the mortar taken from both the stone and the brick on the original foundation walls. In addition, it was determined that the granite lintels supporting the west chimney were not original - the lintels do not fit well into the pockets in the brick piers and have been shimmed with several small pieces of stone. The original lintels were probably also timbers, which had deteriorated in the damp atmosphere of the cellar and had been replaced with granite. It therefore appears that the L-shaped cellar and the chimney bases were all built during the same building campaign.

**Figure 30.** Gowing-Clark House – Ell Cellar, North Side of Center Chimney-Base Pier (2000).

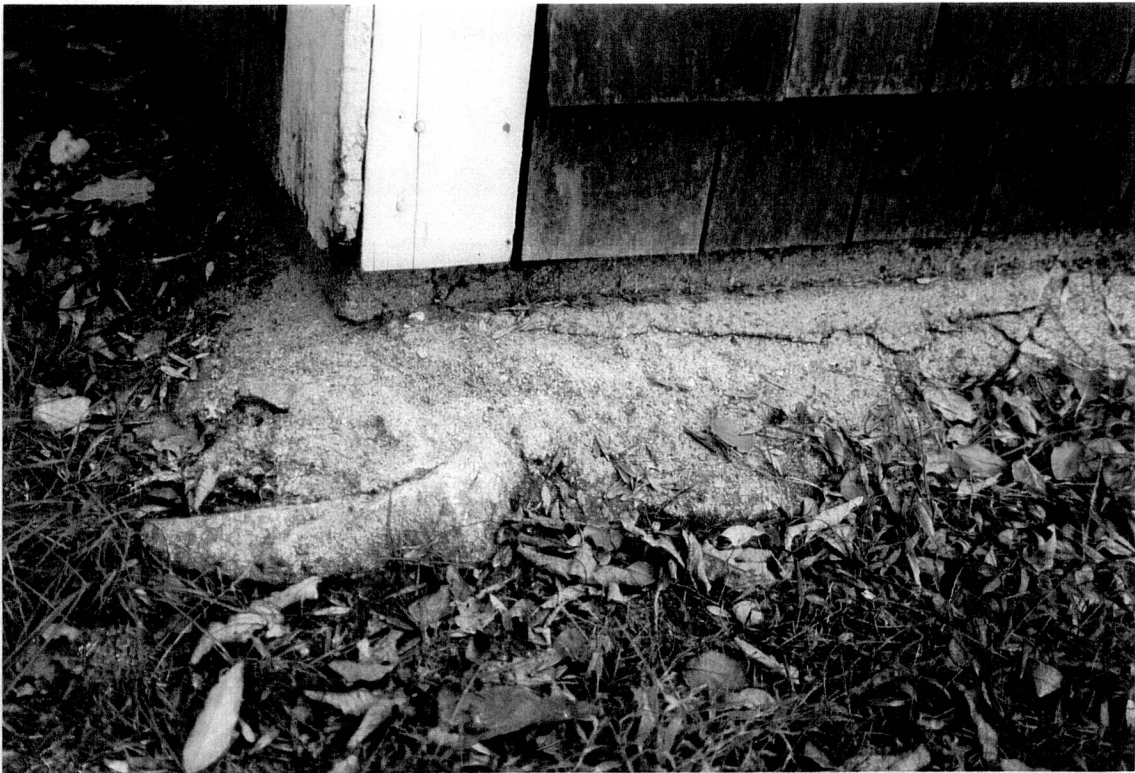
**Figure 40.** Gowling-Clark House – Ell, Northwest Corner, Foundation(1999).
