HISTORIC STRUCTURES REPORT

BUILDING NUMBER LIN-3

THE JOSIAH NELSON HOUSE

Minute Man National Historical Park Project

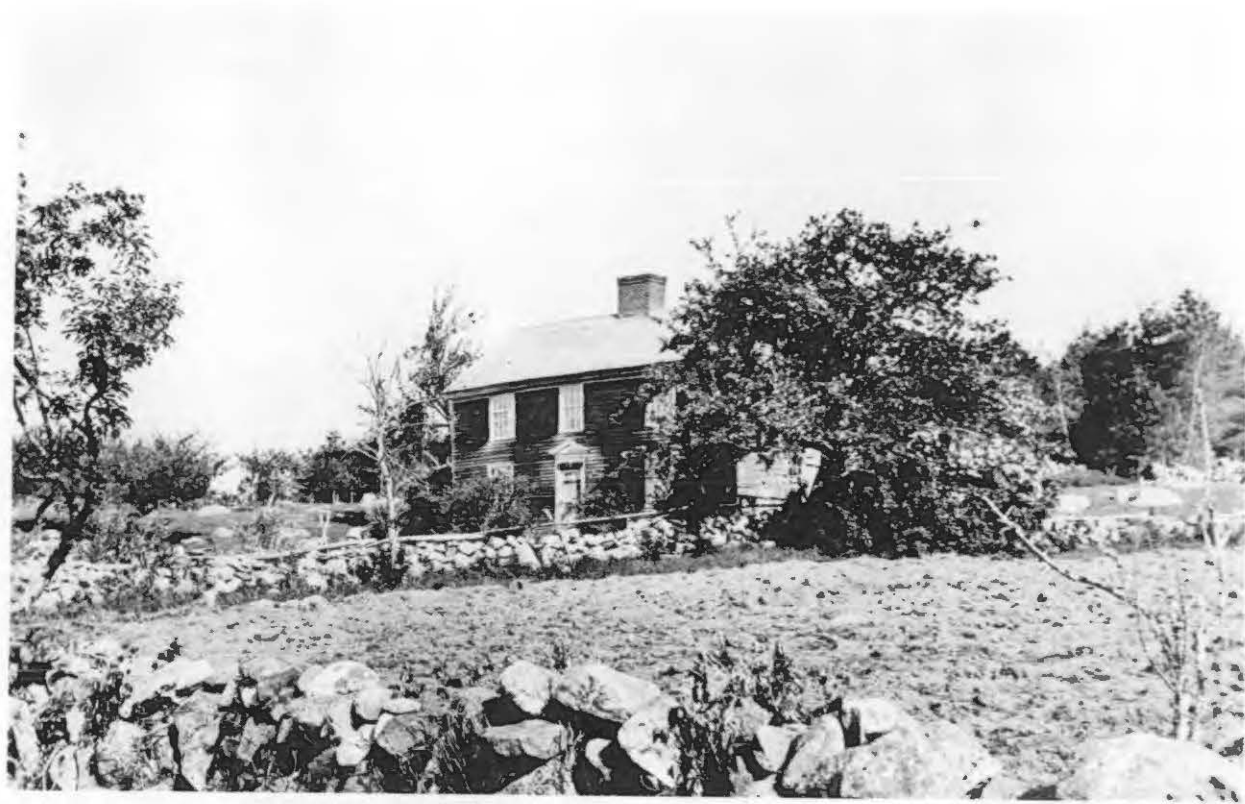
ILLUSTRATION NO. 1

The equal gable roof was covered with wood shingles; twenty-nine courses of which are visible on the front slope. The edge of the roof was finished in a moulded wood cornice which does not appear to return against the gable ends of the house. There is no gutter or downspout visible in any of the photographs (see Illustration Nos. 1 & 2).

The south and east walls had wood clapboards; forty-two courses of clapboards are visible on the south elevation. (See Illustration Nos. 1 & 2). The outline of what may have been a vertical wood corner board is visible at the west end of the house. The house was set close to grade and had a wood baseboard below the bottom course of clapboards.

View from southeast, prior to 1908.

Note: First floor east gable window visible behind tree, character of stone wall construction. Photo copies from photograph in possession of Mr. and Mrs. W. Newton Nelson, Lincoln, Massachusetts.

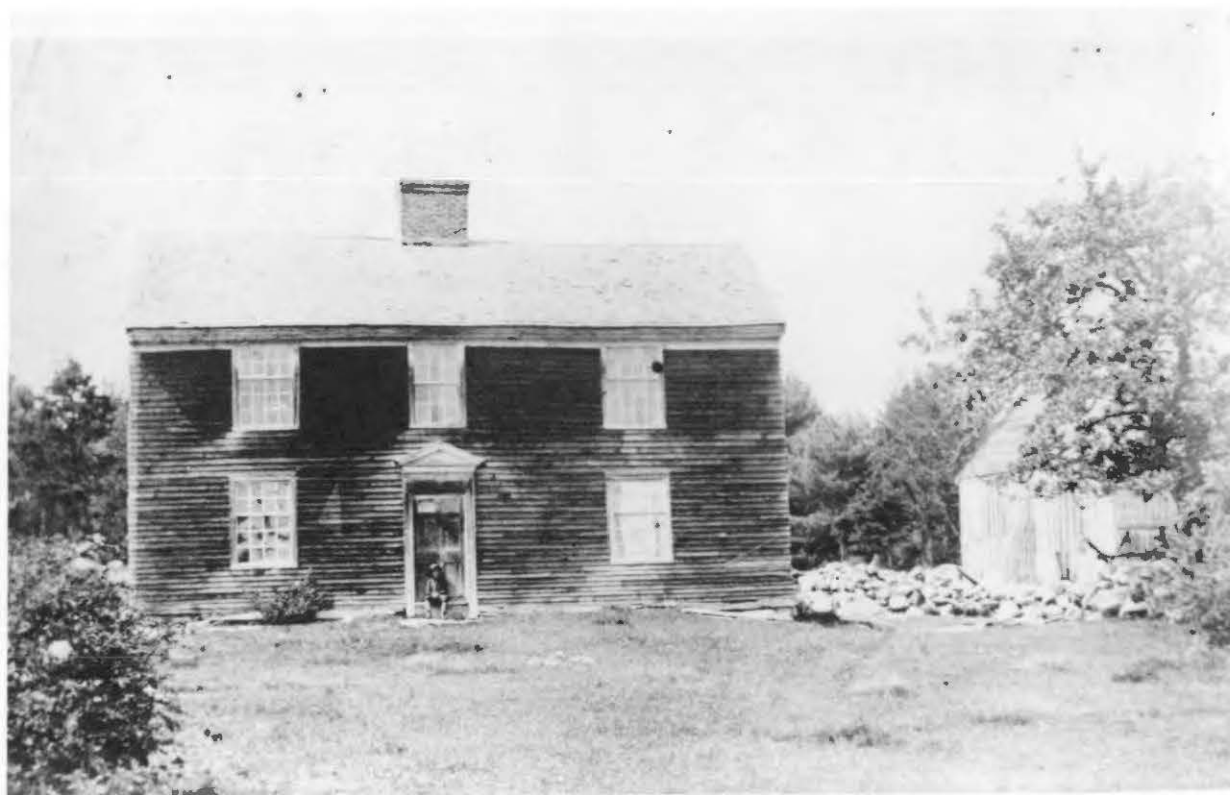
ILLUSTRATION NO. 2

glass at the time the photograph was taken. The door was flanked by a projecting frame and a pedimented head, which has moulded trim. The door sill consisted of a wood threshold above one granite step (see Illustration No. 2). The granite step shown in the photograph remains at the site.

View from south, prior to 1908.

Note: corbeled brick chimney cap, shingle roof covering, lack of corner boards, moulded window head cornice, pedimented head of main entry, west end of barn visible at right side of picture.

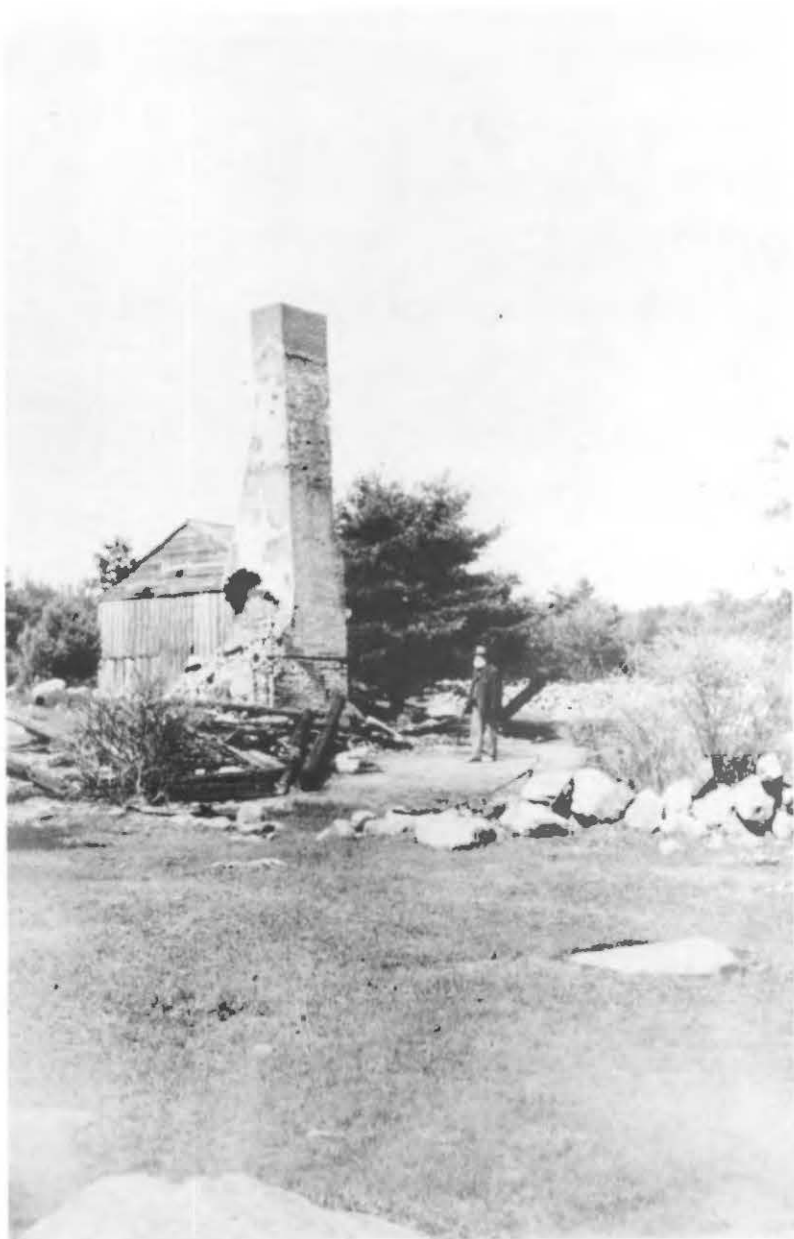
ILLUSTRATION NO. 3

From the large number and size of the charred timbers remaining at the site following the fire (see Illustration No. 3) and the local construction practices, it would seem likely that the house was framed with hewn, mortise and tenon wood framing members.

If the chimney construction followed the general local pattern, it is likely that the central brick chimney consisted of four fireplaces, an oven and a meat chamber. The corner of the corbeled brick hearth for the second floor east room is visible in one of the photographs, (see Illustration No. 3).

Evidence visible in the photograph taken following the burning of the house clearly shows the location of at least one set of stairs that would have been found within the house. The outline of a stair carriage is visible on the front face of the chimney, showing both the risers and the treads. It is likely a triple run wood stair was situated in the space between the front door and the central brick chimney (see Illustration No. 3).

The west surface of the brick chimney appears to have a plaster finish at the second floor level (see Illustration No. 3). Mr. Nelson recalls one of the rooms having wood paneling on the fireplace wall.

View from southwest, taken after fire  
of 1908.

Note: projecting drip courses on front and rear  
face of chimney, corbeled brick hearth on east  
face of chimney, outline of stair carriage on  
south face of chimney, charred framing timbers  
around site, west end of barn visible behind  
chimney. Photo copied from photograph in possession  
of Mr. and Mrs. W. Newton Nelson, Lincoln, Mass.

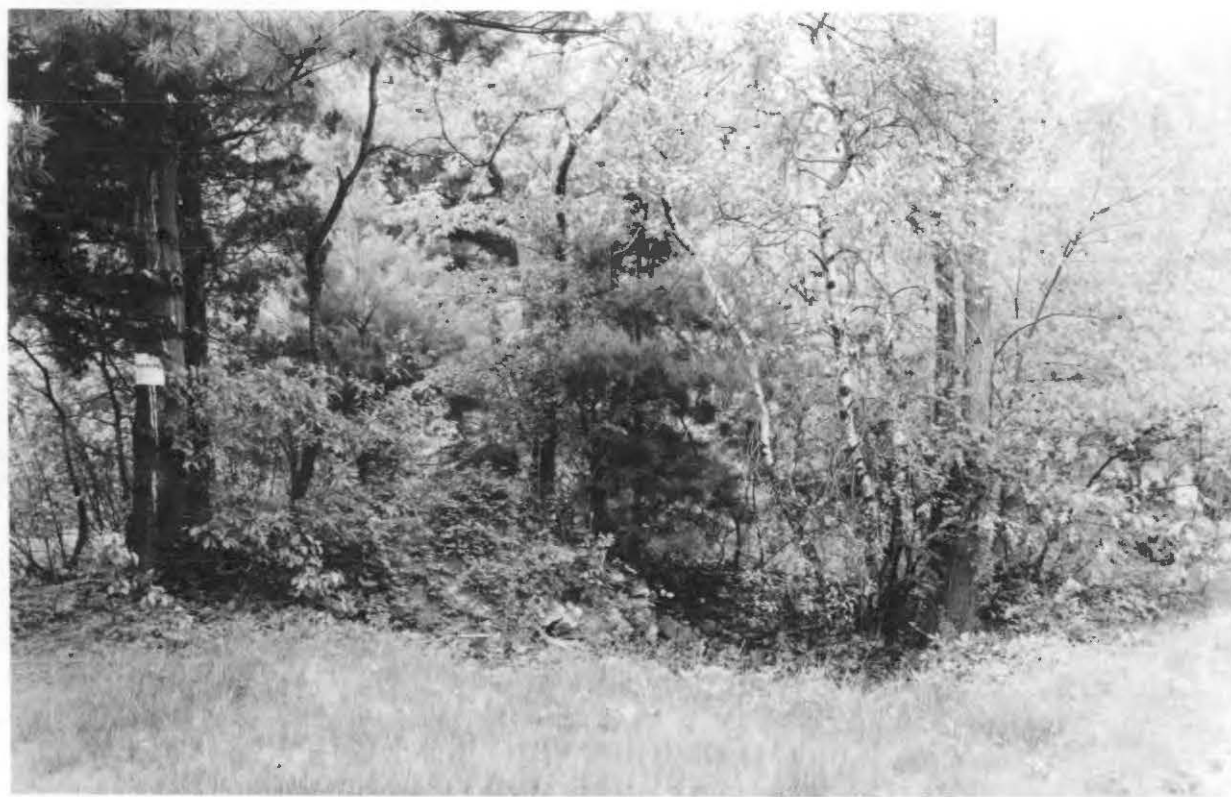
ILLUSTRATION NO. 4

The partially visible cellar remains and a mound of crumbled brick covered with soil and leaves are all that are left of the house (See Illustration No. 4). Sections of stone walls enclosing the property are also in evidence. The existing landscape has no known historical significance.

House site, view from south, 1962.

Note: mound to left of picture is chimney base remains, depression to left is east portion of cellar remains, picture taken prior to clearing of vegetation cover.

Following the completion and approval of both the Architectural and Historical Data Sections, Part I Reports, it is recommended that an archeological investigation be conducted at the house site to determine the extent of the foundations and to expose the central brick chimney remains. Following this investigation, it is recommended that the cellar foundation walls be stabilized for future interpretive use.
