**HISTORIC STRUCTURES REPORT**

**BUILDING NUMBER LEX-3**

**THE JACOB WHITTEMORE HOUSE**

**Prepared by  
Russell V. Keune  
Architect  
January, 1963**

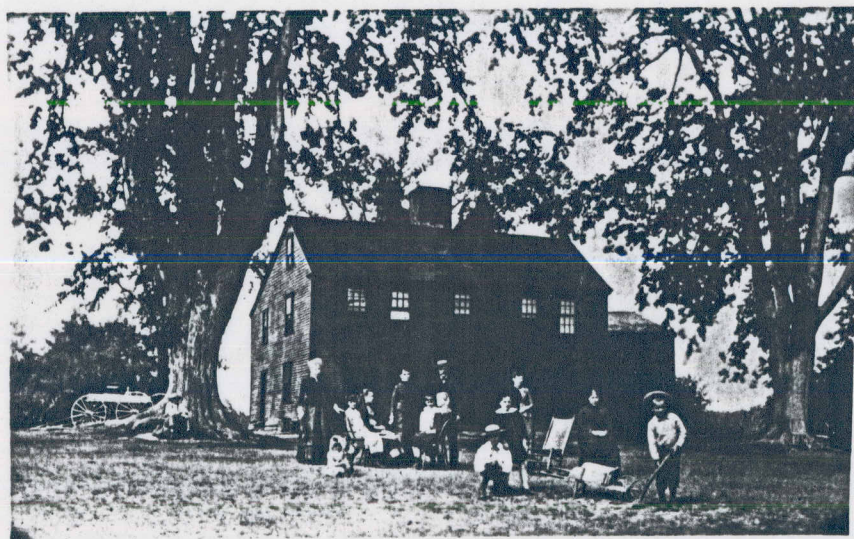
Note: Condition of northwest facade prior to any side  
additions, all on southwest facade, corbelled brick  
chimney cap, symmetrically placed elm trees.
