# **JOHN NELSON HOUSE**

**Minuteman National Historical Park**

## **INTERIOR PAINT STUDY**

### **First and Second Stories**

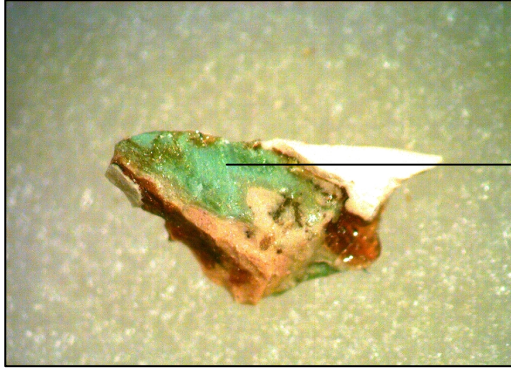
Paint Sample MIMA 1-111-A P240,  
Room 104, Door D 1/104, panel. First  
finish, blue-green clearly visible.

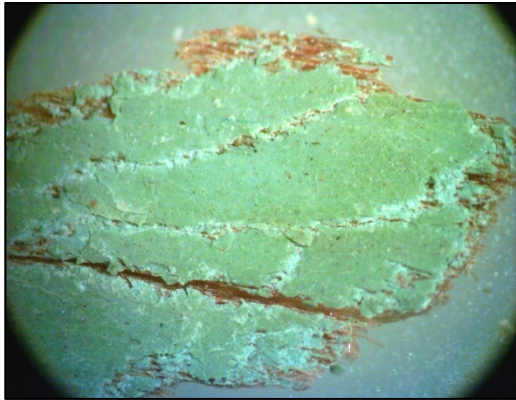
Paint sample, MIMA 1-111-A P161,  
Room 101, Door D 1/103, panel. First  
finish blue-green with thin yellow glaze  
or varnish.

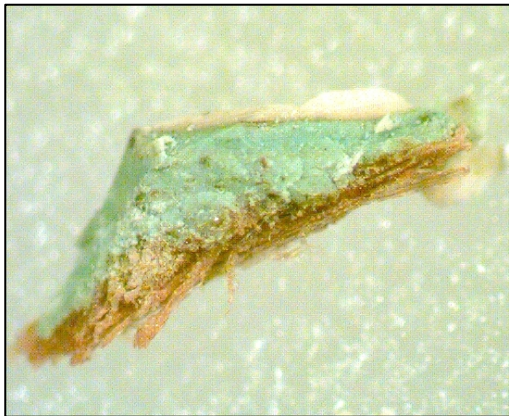
Paint sample, MIMA 1-111-A P211,  
Room 103, Door D1/103 surround.  
First finish bluegreen.

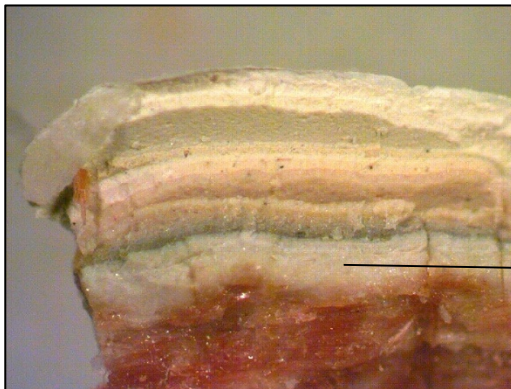
Paint sample, MIMA 1-111-A P189,  
Room 102, W104, interior shutters.  
First finish, cream.

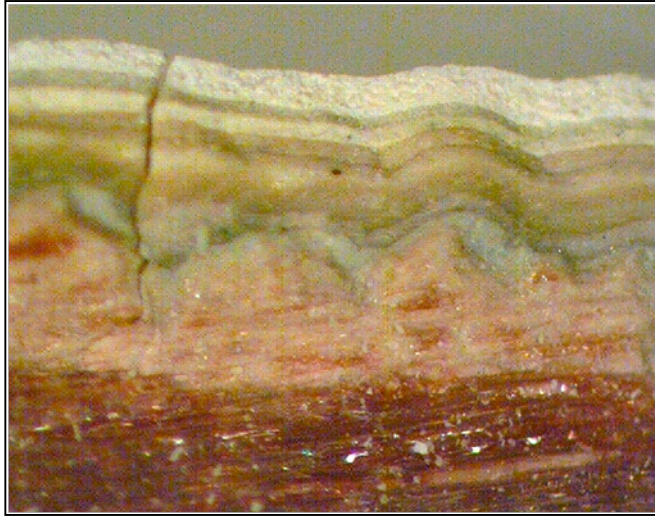
Paint sample, MIMA 1-111-A  
P341, Room 201, D 1/201,  
doorway casing. First finish,  
cream, clearly visible.

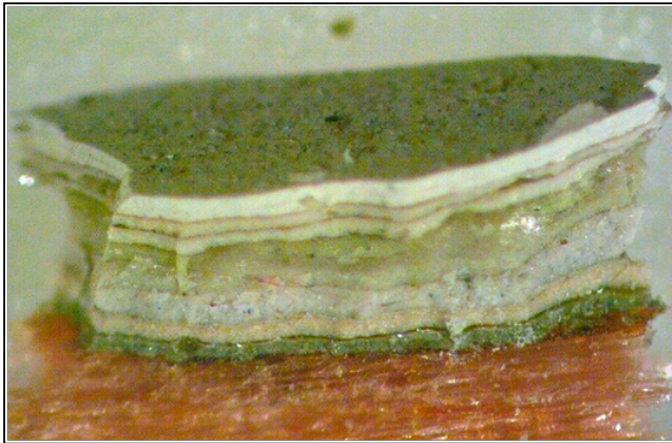
Paint sample, MIMA 1-111-A  
P353, Room 201, baseboard,  
at east wall. First finish,  
blue-green with glaze coat,  
clearly visible.

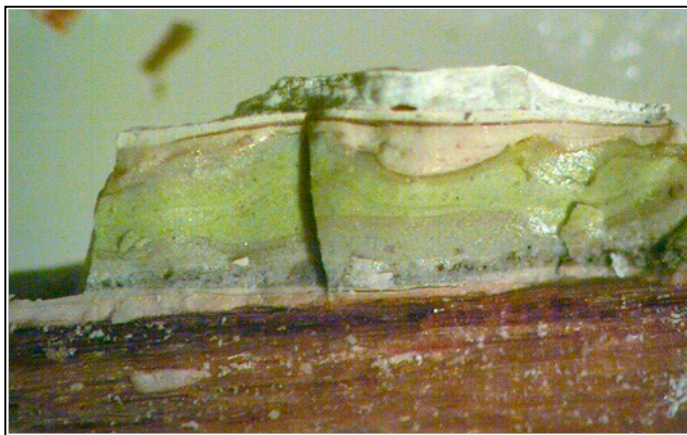
Paint sample, MIMA 1-  
111 A P349. Room  
201, D 1/204, door  
panel, hallway side.  
First cream finish  
visible.

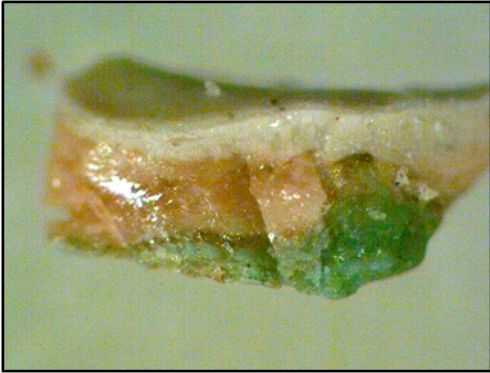
Paint sample, MIMA 1-111-A P358, Room 202, D 2/202, doorway casing. First finish, blue-green, clearly visible.

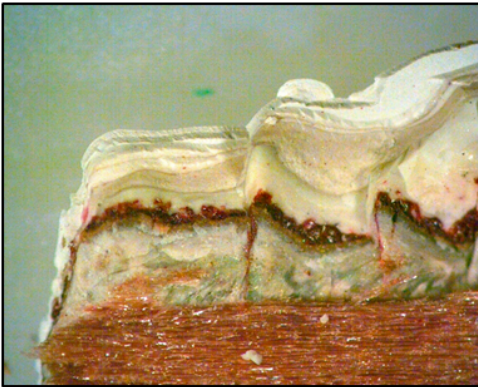
Paint sample, MIMA 1-111-A P364. Room 202, window W204, lower sash. First finish, blue-green, is visible. Note deep red finish applied several finishes later (date unknown).

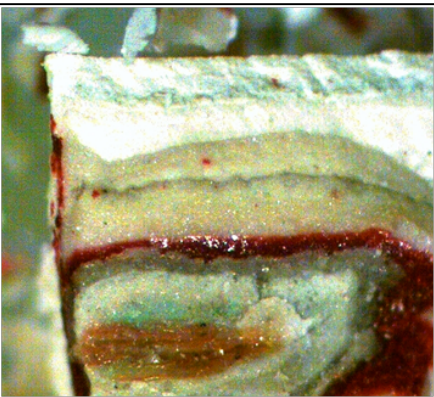
Paint sample, MIMA 1-111-A P402. Room 202, window W209, lower sash. First finish, blue-green, is visible. Note deep red finish applied several finishes later (date unknown).

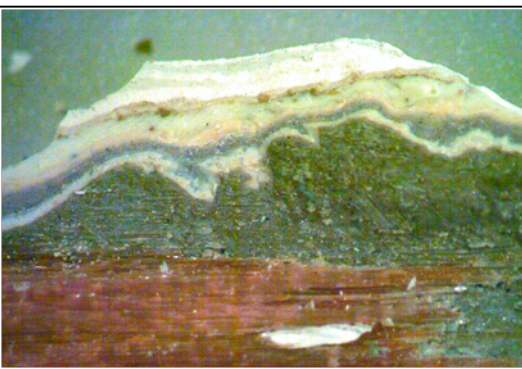
Paint sample, MIMA 1-111-A P371. Room 202, Baseboard, west wall, north jog of fireplace box. First finish, blue-green, is visible.

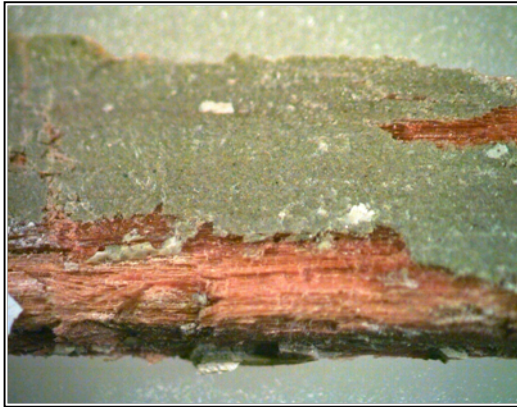
Paint Sample MIMA 1-111-A P410, Room 204, baseboard, south wall. Original surface of blue-green paint much faded and with all top layers fallen away from first finish.

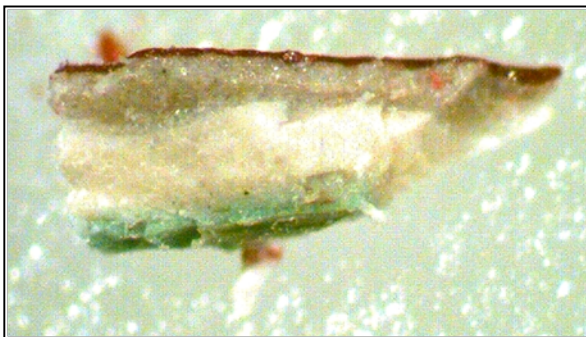
Paint sample MIMA 1-111-A P405, Room 204, window sash, W 211. Original blue-green finish clear. Note deep red finish on top. Newer paint layers fallen away.

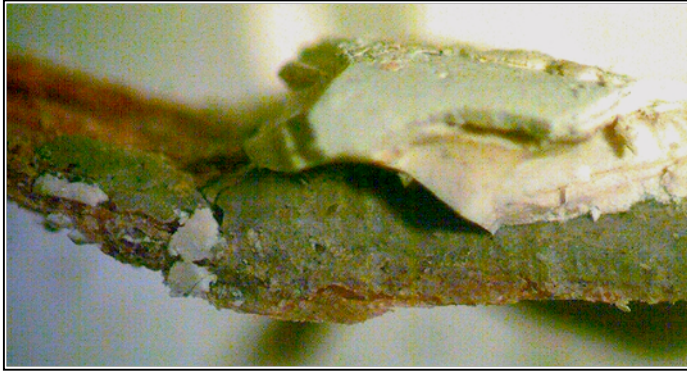
Paint sample MIMA 1-111-A P440, Room 206, D2/206, door. Original gray-green visible on wood substrate.

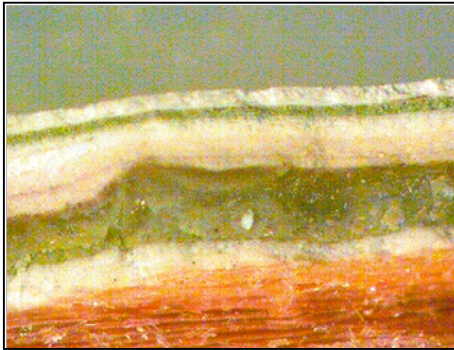
Paint sample, MIMA 1-111-A P448, Room 207, D1/207, door panel, Room 207 side. Original cream-white finish visible on wood substrate.

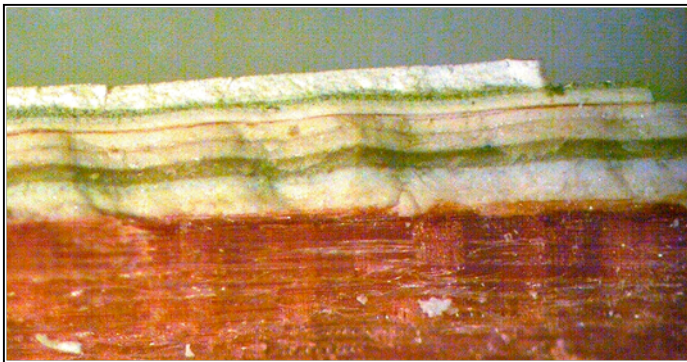
Paint sample MIMA 1-111-A P454 Room 207, D1/208, door panel, Room 207 side. Paint history matches D1/207 shown above.

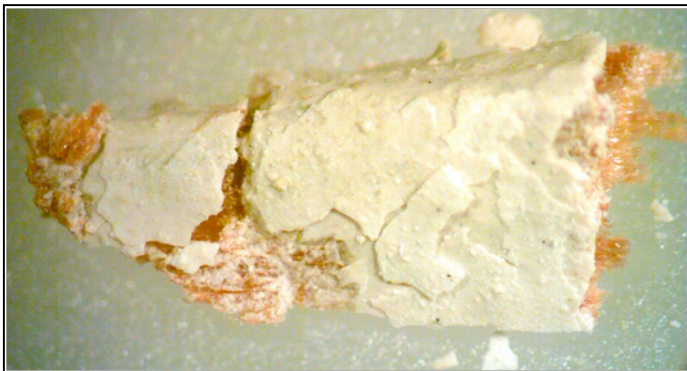
Paint sample MIMA 1-111-A P468, Room 208, D 2/208, door casing in closet. Cream- white finish present with no further paint history evident.

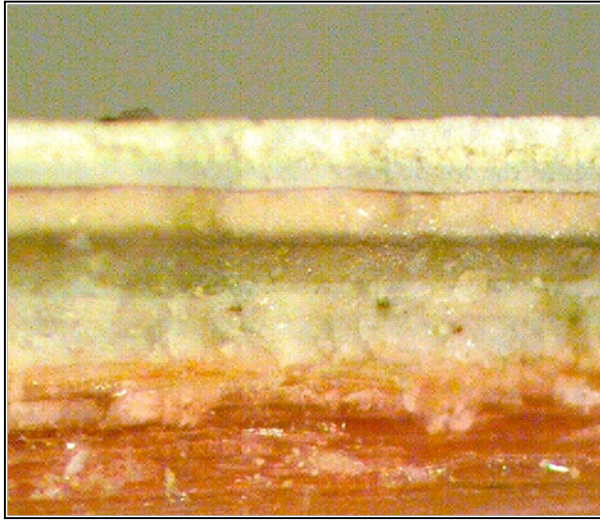
Paint sample MIMA 1-111-A P469, Room 208, baseboard. Original cream-white finish visible on substrate. Cream-white finish is consistent throughout Room 208 and matches trim in Room 207 as well.
