COMPLETION REPORT  
REPAIRS TO THE JOHN NELSON BARN  
Minute Man National Historical Park  
Concord, Massachusetts

January 1979

COMPLETION REPORT  
Repairs to the John Nelson Barn  
North Great Road, Lincoln, Massachusetts  
Minute Man National Historical Park

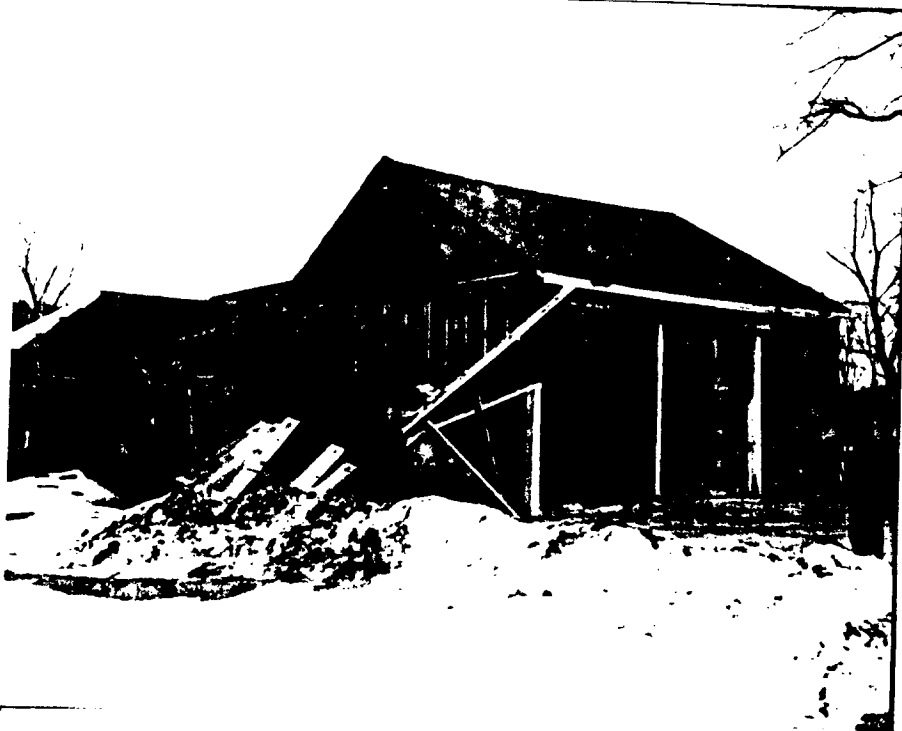
PHOTO ILLUSTRATION NO. 1

PREFACE: A partial rehabilitation of the John Nelson Barn was precipitated by the collapse of the ca. 1870 lean-to. Its general deterioration over the years accompanied by the heavy snowfall in January and February of 1978 resulted in its final failure.

The John Nelson Barn showing the collapsed lean-to on the west side after the winter of 1977-78. The lean-to appears to have been built about 1875 while the west wing was added about 1915. View looking northeast.

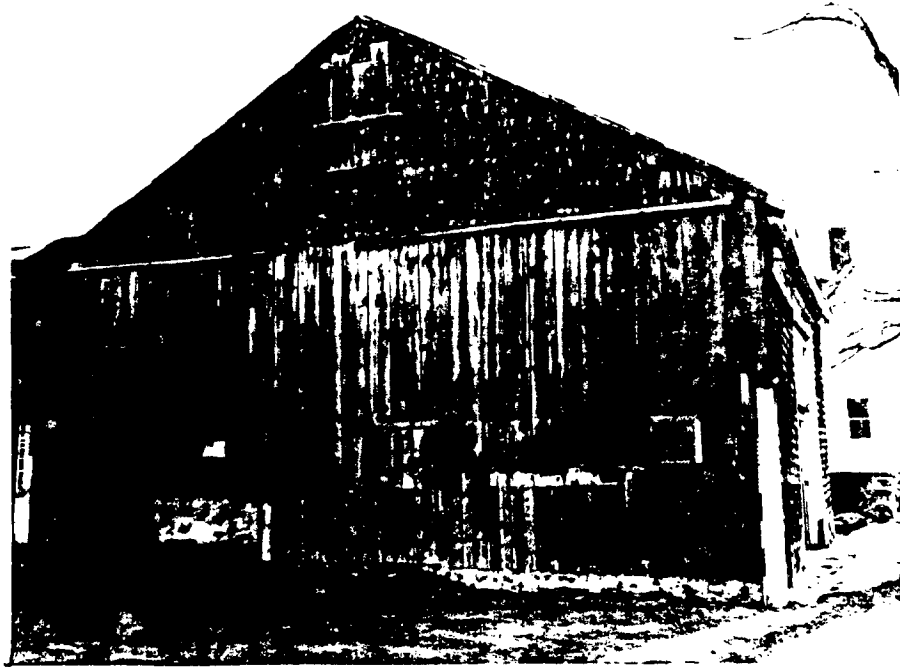
PHOTO ILLUSTRATION NO. 2

By April 13th, the lean-to site had been cleared by Park maintenance and work started on repairs to the west end wall (as seen in Photo Illustration No. 2). Two new window frames were required; one to replace the deteriorated frame found in the west gable end and one new frame installed in an opening directly below as determined by the architectural evidence found on the wall boards. Photographs and measurements were taken to record the evidence of the former window opening. A new window frame was installed in the east gable end where no frame previously existed. A modern six-over-six double hung sash was purchased and installed in the frame as a temporary measure until further research and restoration work is carried out.

After the west wing was removed, the west walls and roof were repaired using modern framing lumber, plywood sheathing, and asphalt roofing paper. White cedar shingles were nailed over the old barn boards of ca. 1830 in order to preserve them. Originally they were exposed on the west wall until the lean-to was built in ca. 1870. Actually, the lower portion of the west wall had been severely repaired and was in poor condition, as seen in Photo Illustration No. 2.

The west gable wall of the John Nelson Barn after the lean-to had been removed by N.P.S. workmen. This view shows the barn after one bay was added across the north end and the roof raised. The vertical tongue and groove boarding was added at the same time, nailed with machine cut nails. This change probably occurred about 1830. When the lean-to was added the wall boards above the roof line were shingled as shown in this view.

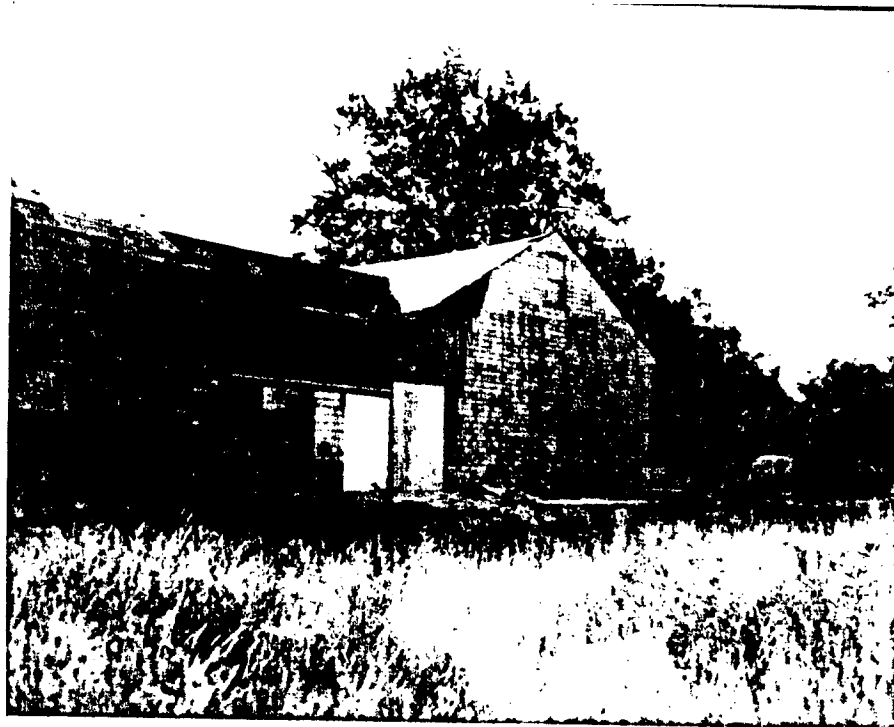
PHOTO ILLUSTRATION NO. 4

The west side of the John Nelson Barn after the removal of the ca. 1875 lean-to and ca. 1915 wing by N.P.S. workmen. The concrete floor and stone foundation walls under the wing remain to be removed. Shingling of the west wall is underway. A new window frame was built for the gable end opening and the center lower opening. Lower right window frame was an old opening found in place.

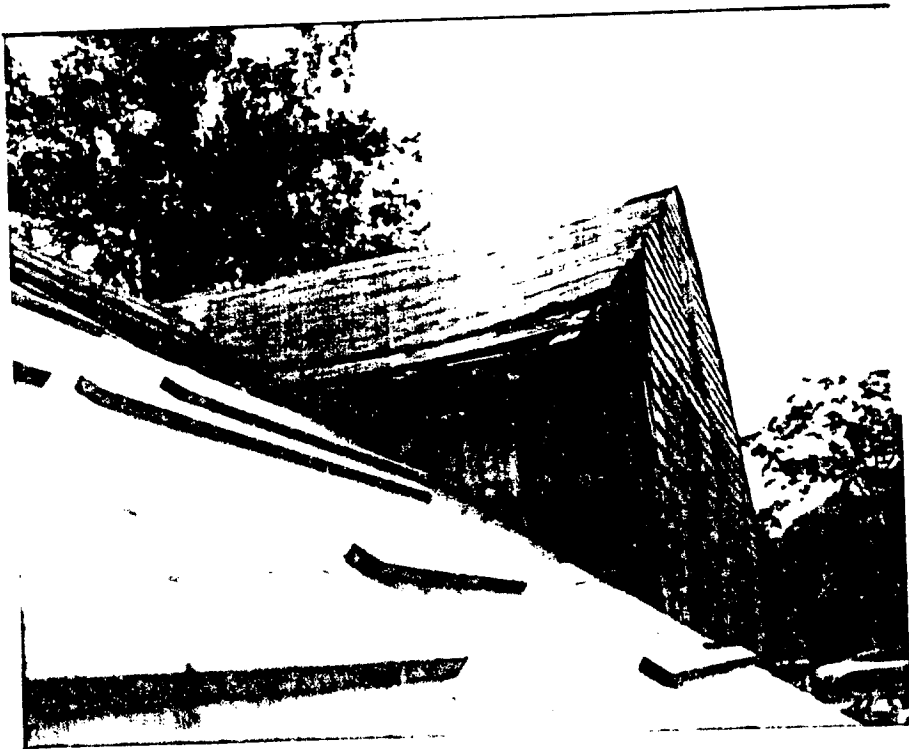
PHOTO ILLUSTRATION NO. 5

An overhanging beam located at the west end of the north cornice was found severely rotted and had to be replaced. It was approximately an 8" x 8" x 12' hand-hewn oak timber morticed and tenoned between two beams supporting principal rafters. All of the prin-

A rotted beam was uncovered at the west end of the north roof overhang after the ca. 1830 fascia board was removed. This piece was beyond saving and had to be removed and replaced. The rafters along the north roof slope had to be shored with additional struts on the inside to strengthen the roof structure.

cial rafters along the north roof slope were strengthened from the mid-purlin point to the north plate with 2" x 10"s nailed to both sides then braced with interior struts.

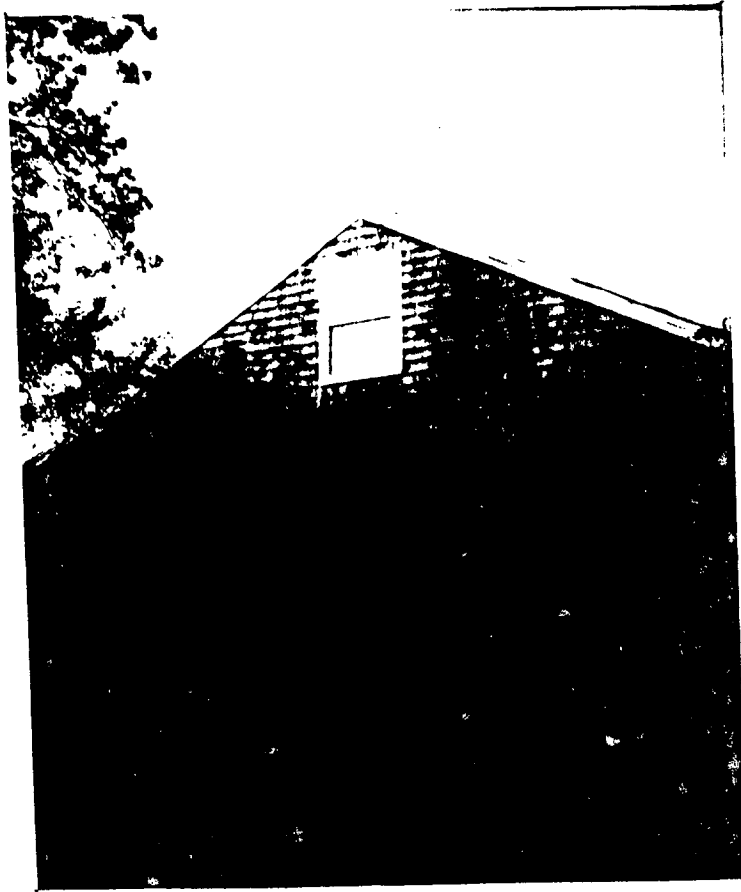
PHOTO ILLUSTRATION NO. 6

A new window frame was made for the east gable end of the John Nelson Barn. The sash is a modern replacement used temporarily until further work is done on the Barn.

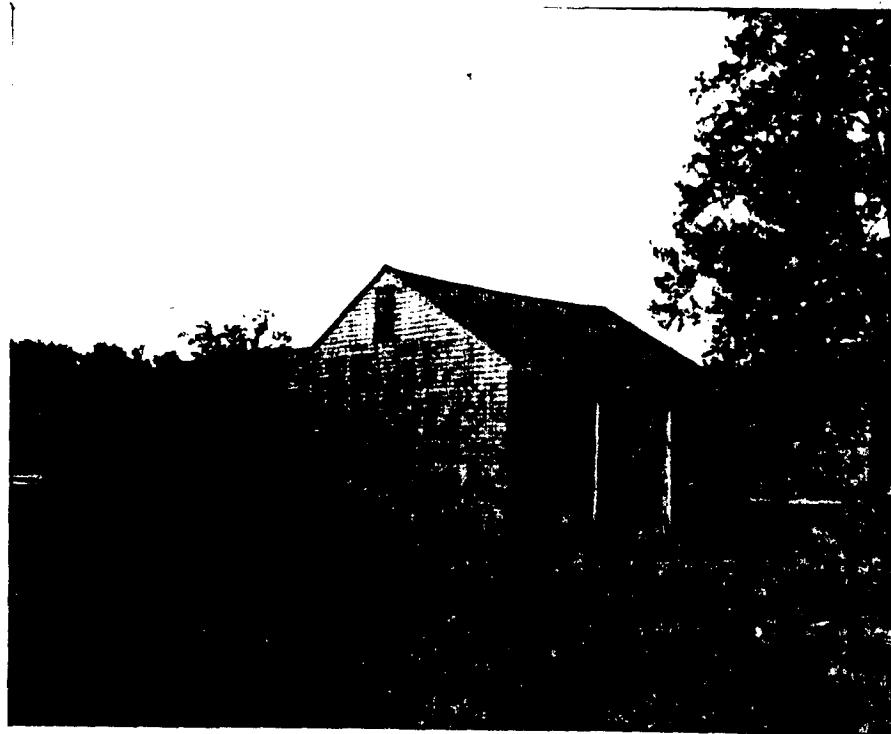
PHOTO ILLUSTRATION NO. 8

New fascia and soffit boards were installed along the south eave overhang to replace the original ones which had rotted beyond repair. These pieces were left unpainted.

View of the completed rehabilitation work on the west side of the John Nelson Barn. New fascia and soffit boards were installed along the south eaves to replace rotted members. All work was done by day labor using the workmen from the Minute Man National Historical Park.

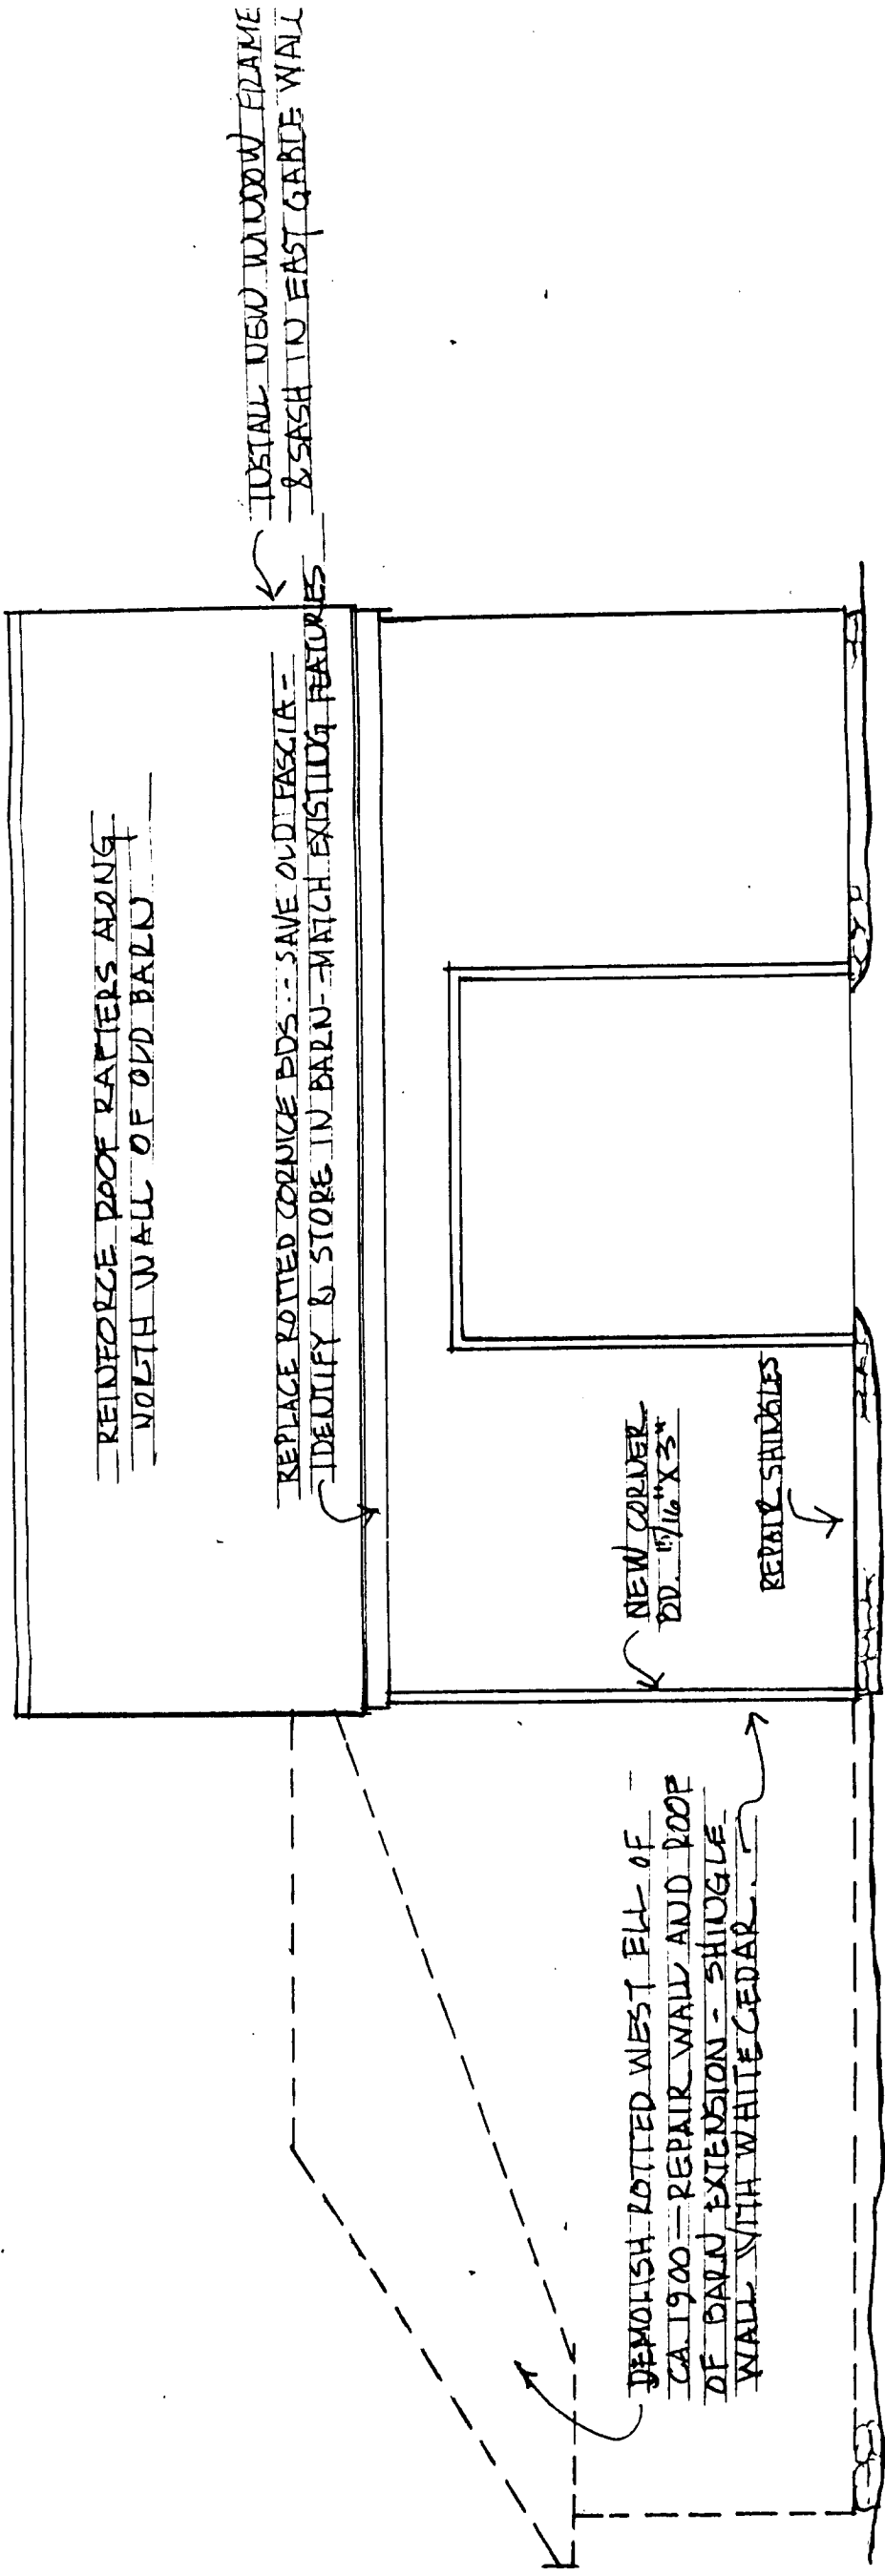
REPAIRS TO WEST WALL OF THE JOHN NELSON BARN  
NORTH GREAT ROAD, LINCOLN, MASS. MINUTE MAN NAT. HIST. PARK

WEST ELL  
(TO BE DEMOLISHED)
