COMPLETION REPORT  
RESTORATION OF THE HARTWELL TAVERN  
Minute Man National Historical Park  
Concord, Massachusetts

May 1983

National Park Service - North Atlantic Region  
North Atlantic Historic Preservation Center

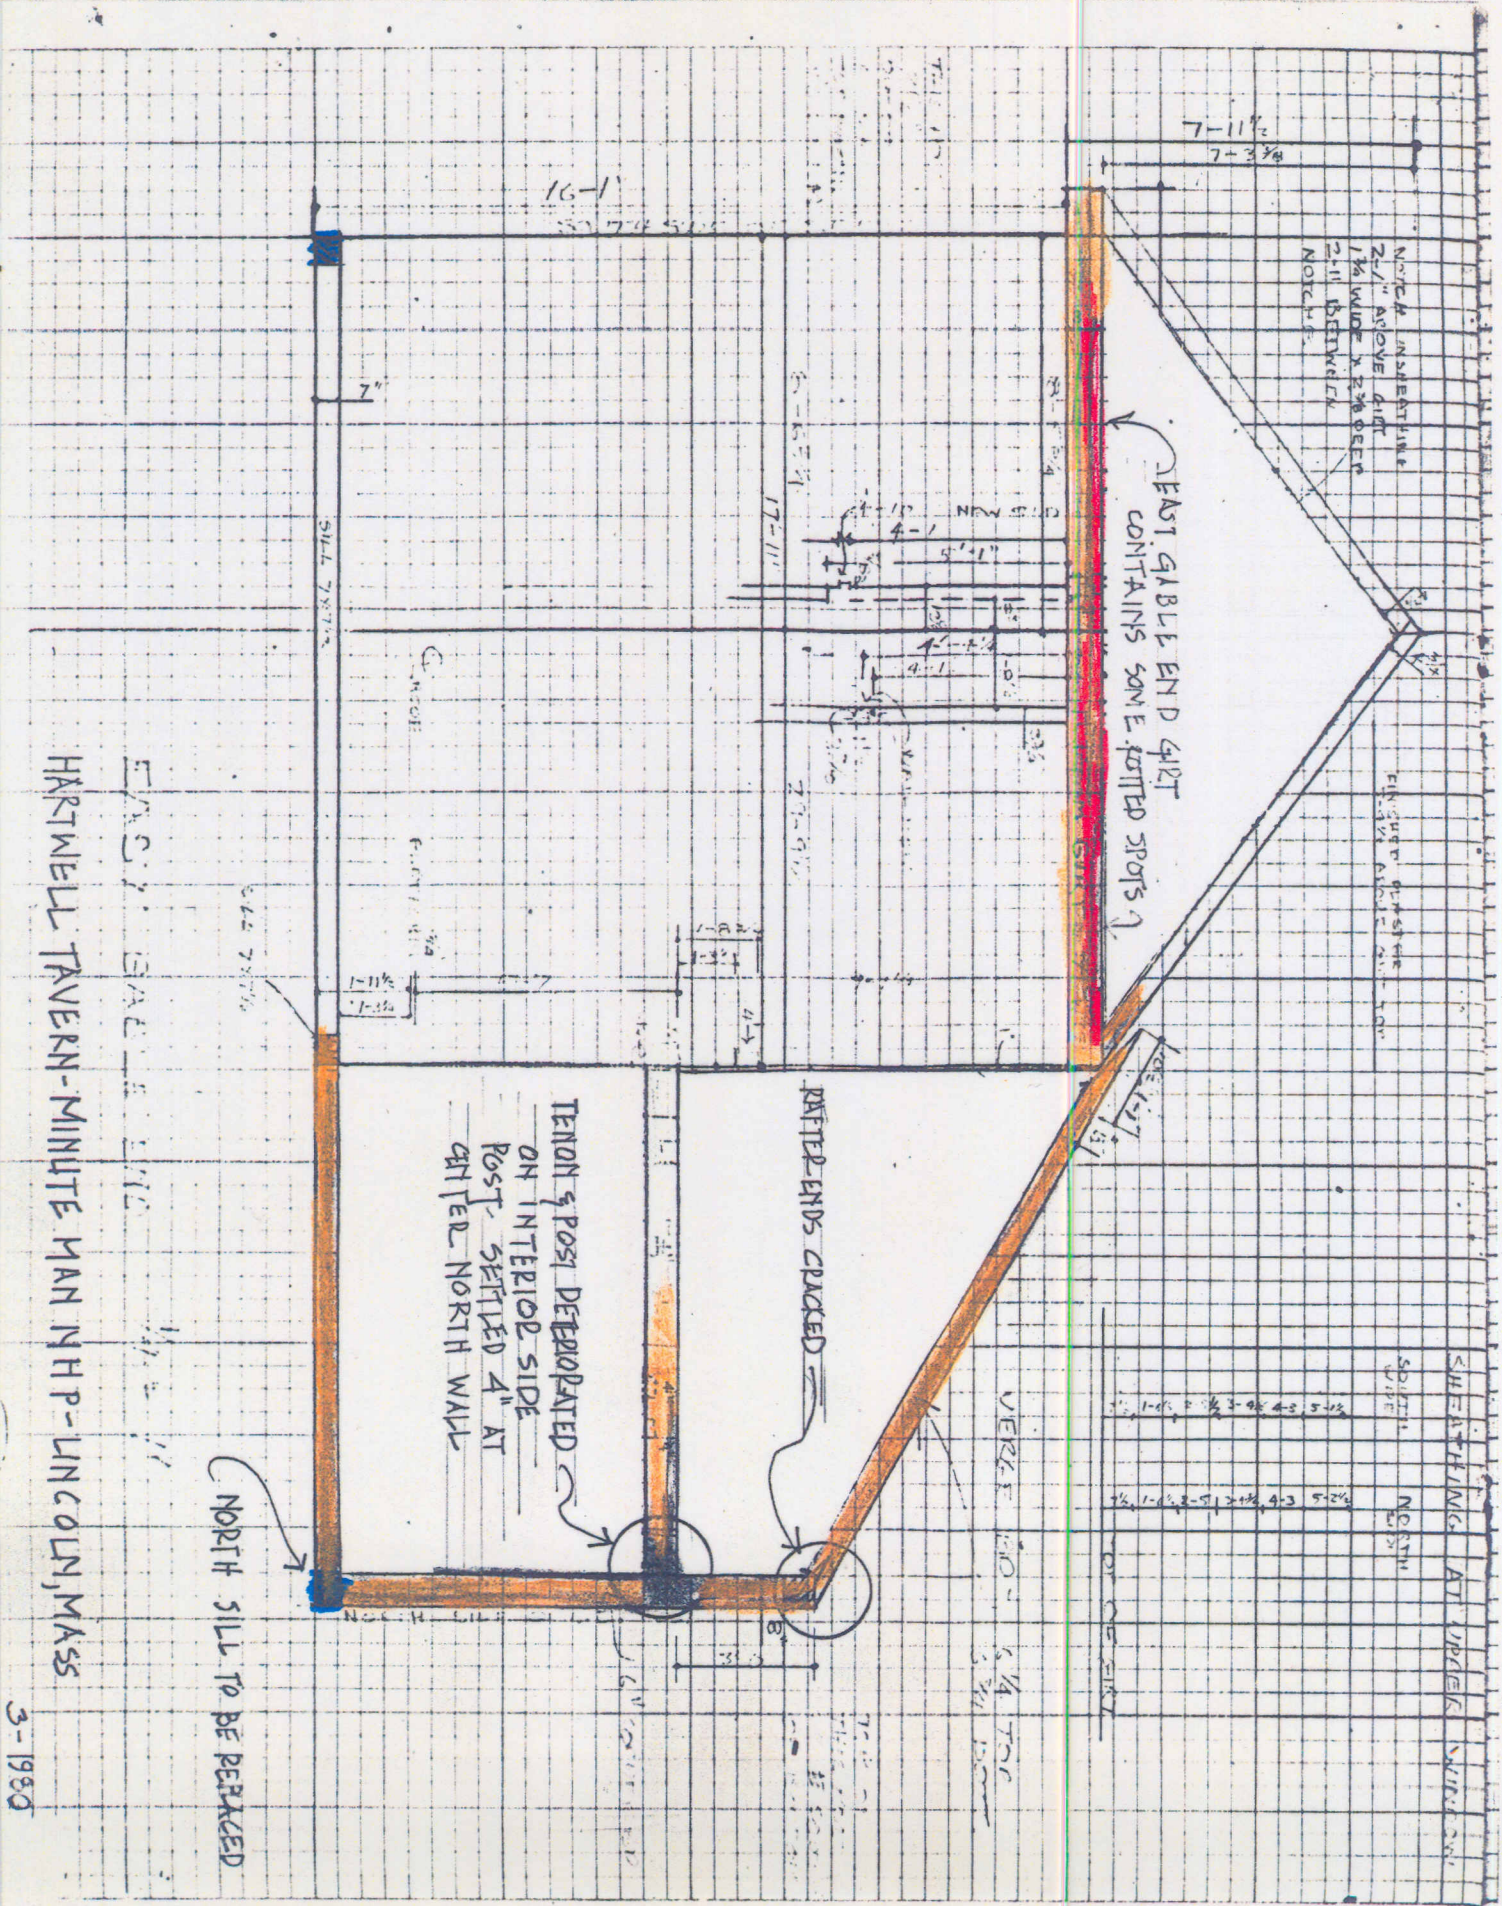
NORTH WALL OF KITCHEN LEAN-TO  
 EXTERIOR VIEW  
 HARTWELL TAVERN  
 MINUTE MAN NHP LINCOLN, MASS.

PARTIAL ENDS CRACKED

NORTH SILL TO BE REPLACED

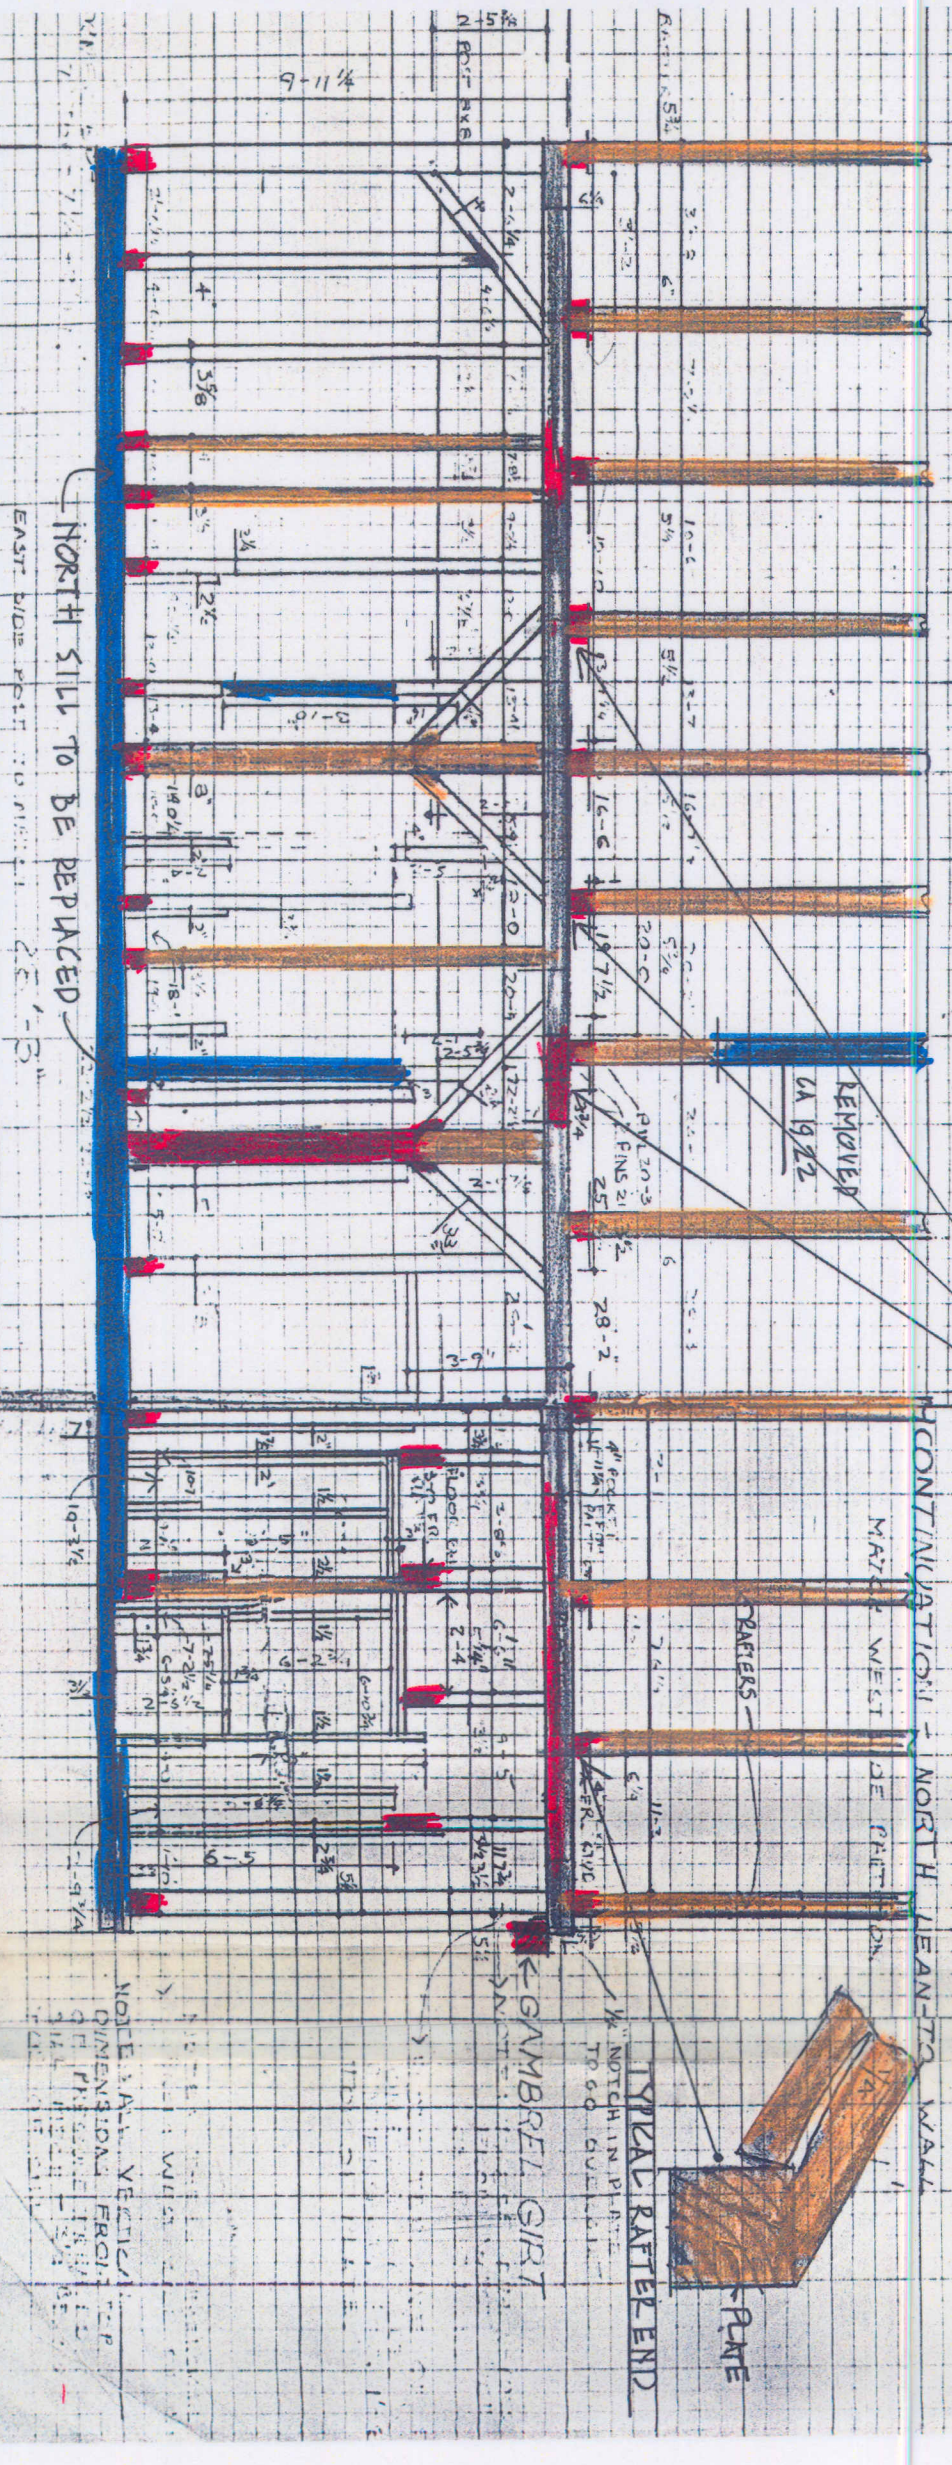
NORTH SILL TO BE REPLACED

EAST SIDE POST TO REMAIN 25'-5"

ALL RAFTER ENDS AT PLATE RAFTERS SOUND BUT CRACKED BY SINKS  
 -SPLICE IN PLATE RAFTERS DUE TO SETTLEMENT

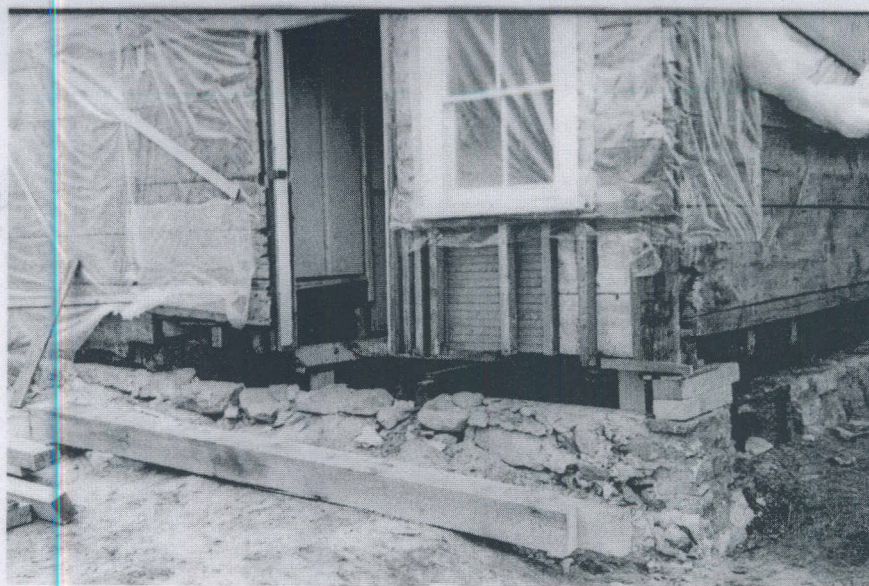
Kitchen lean-to, east wall. A modern sill has been removed and the above oak (pressure treated) sill cut and fitted to take its place.

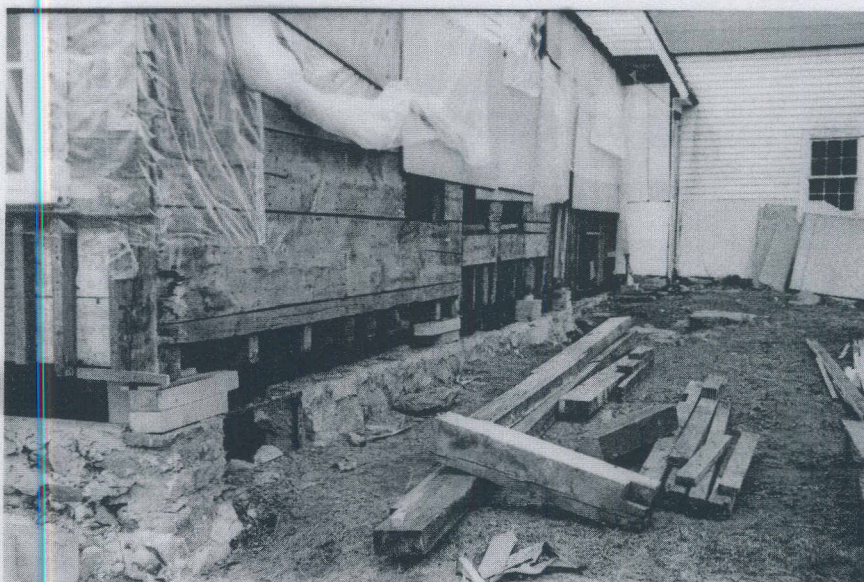
Kitchen lean-to, north wall. Ca. 1900's foundation sills have been removed and will be replaced with pressure-treated oak sills equal in size to the original ones.

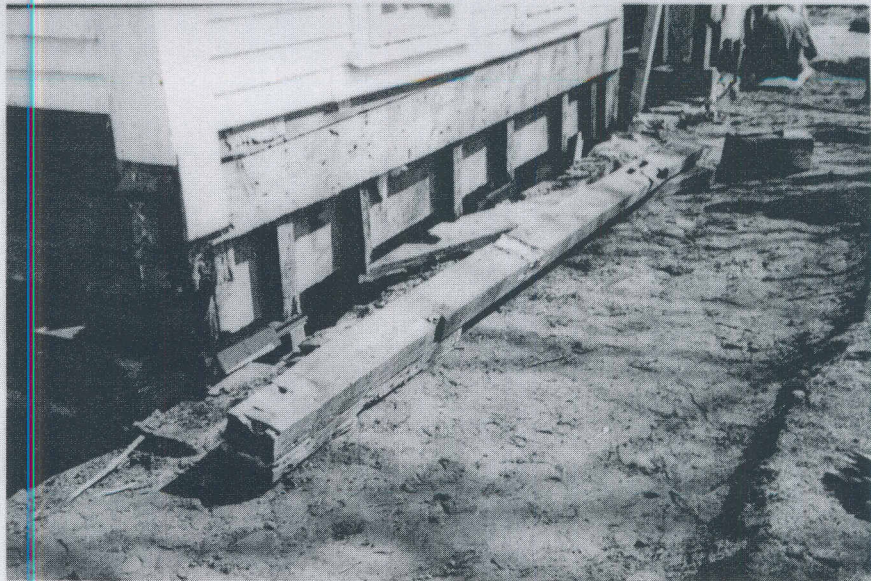
Southwest corner of the Hartwell Tavern showing the removal of an early 20th-century foundation sill along the south wall of the 1733 house. It was eventually replaced with a pressure-treated oak sill having dimensions to match the original sill.

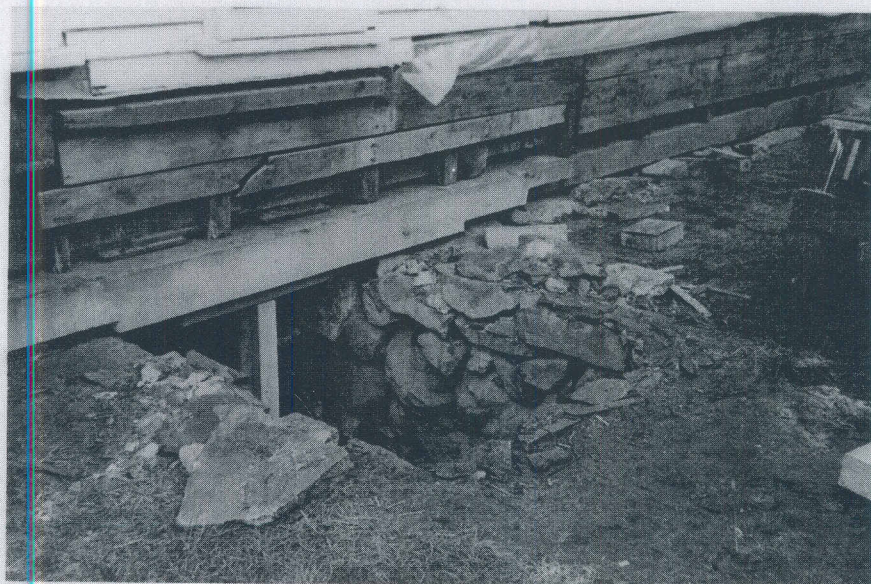
Sill splice installed above the cellar bulkhead on the west wall of the c. 1783 gambrel addition. The stone steps to the cellar were eventually relaid and a new wooden bulkhead constructed.

The stone underpinning of the shed addition was found unstable and required relaying. Four lower steps in the cellar bulkhead were either dislodged or missing before restoration work began; these were replaced.

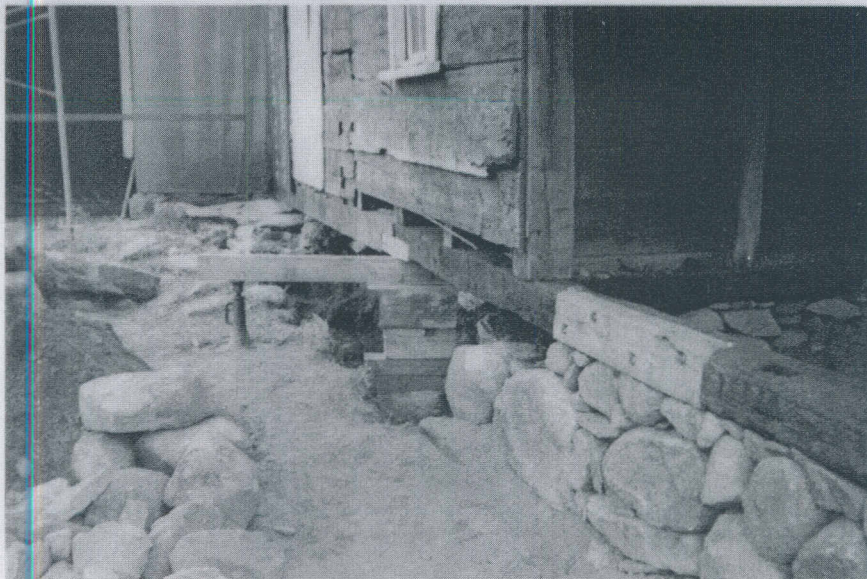
New splice in end of foundation sill at the northeast corner of the shed addition. Stone underpinning was relaid along the east wall of the shed at the same time.

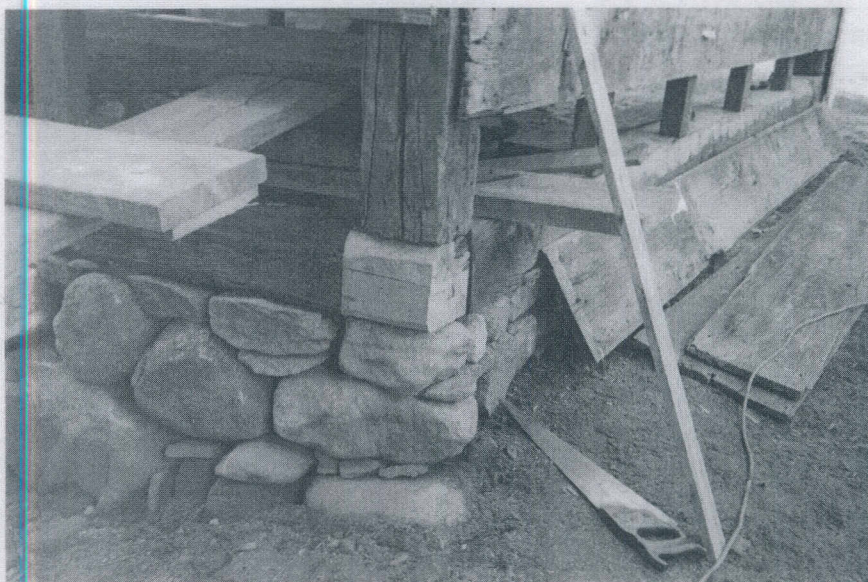
East wall of the shed addition showing splices made to the original foundation sill and masons work in relaying the stone underpinning.

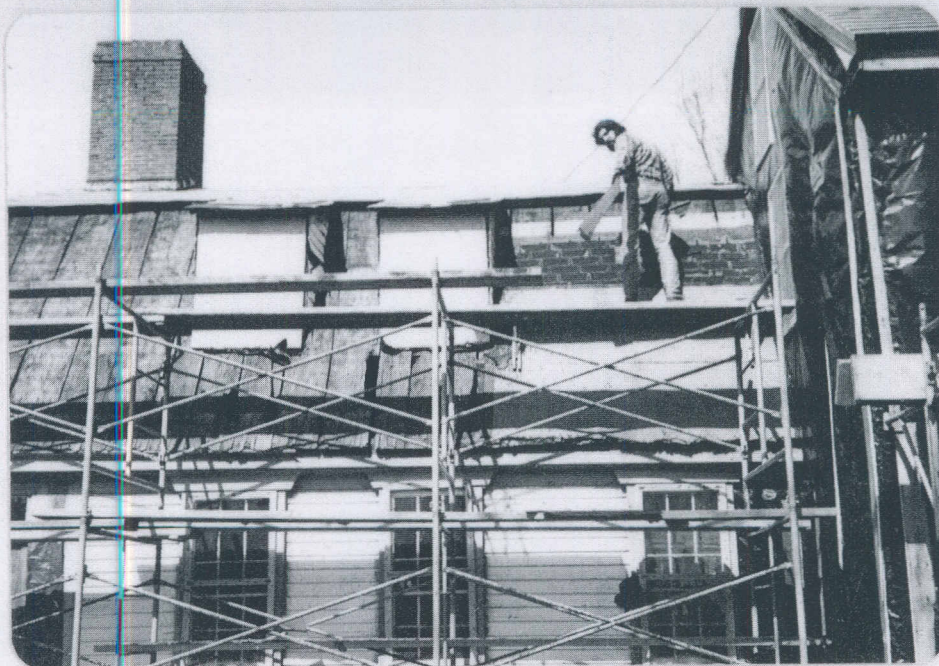
Donald McKeever shown stripping asphalt roofing from south roof of the c. 1783 gambrel addition. The two dormer window openings and three first floor window openings retain their original window frames.

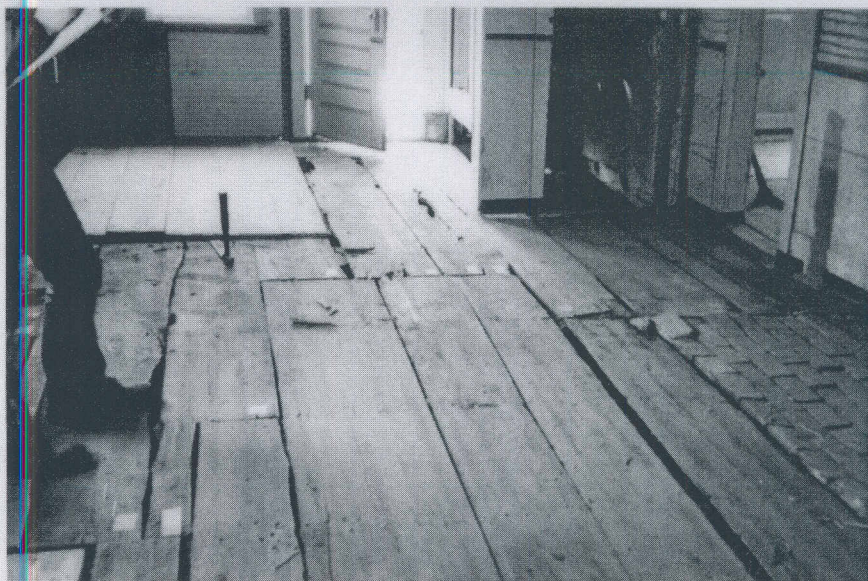
Original floor boards in the Kitchen lean-to. The six finish floor boards seen in the upper left hand corner are original to a small room once located here. The remaining boards are from the original sub-floor of ca. 1830. Kitchen hearth dates from c. 1830 and was taken up and relaid in 1981.

Excluding the floor boards found in the west and northeast rooms of the kitchen lean-to, which are original to c1830, the flooring relaid on the first floor in the kitchen, East and West Parlors and hallway are replacements boards. Boards used on the kitchen floor were those removed from the "Vose" House in Concord, Mass., when it was demolished in 1967. The "Vose" House also supplied the oak floor joists and pine sub-flooring used in the East Parlor. New floor boards were laid in the East and West Parlors and hallway on the first floor. These boards were sawn from white pine, eighteen feet long, and fourteen to eighteen inches wide at the W.C. Cows, Inc., sawmill located at North Amherst, Massachusetts. Each board was tapered from end to end, hand-planed, and nailed with T-headed, hand-wrought nails, then left unpainted (as were most colonial floors). On the second floor of the Tavern, paint was removed from the original floor boards in the hallway and in the East and West Chambers. Paint was also removed from the floor boards of the jut-by in the gambrel. The west half of the floor in the attic was insulated with one and one-half inches of polyurethane panels then covered with plywood to permit walking in this area. All floor joists on the first floor throughout the building were reinforced by "sistering" new Douglas fir joists of comparable size alongside the old ones. Reinforcing of the ceiling joists in the lean-to kitchen was also accomplished before a new lath and plaster ceiling was installed.

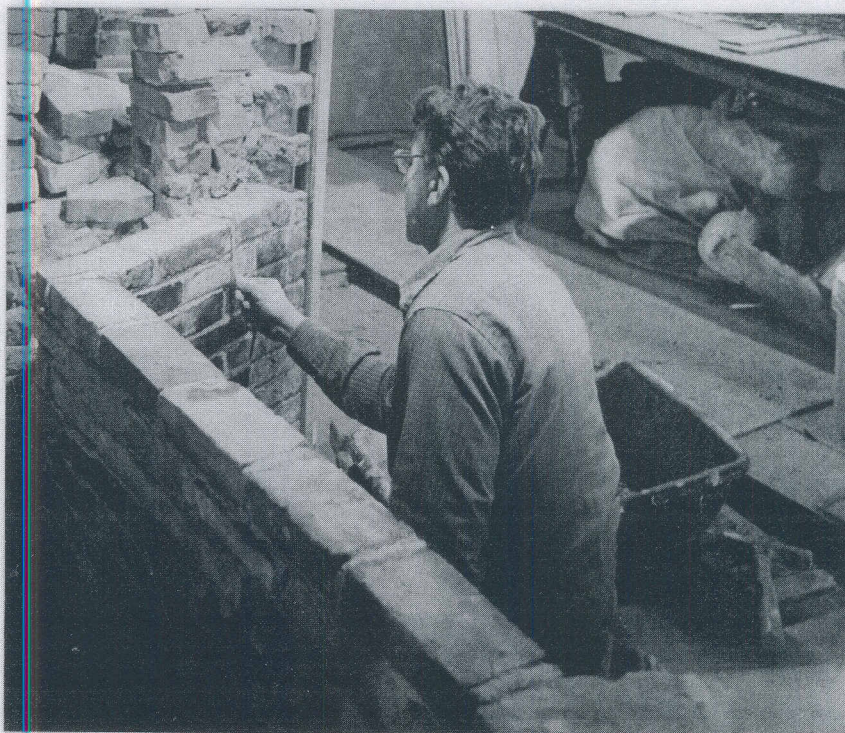
R. Boucher shown rebuilding the fireback and jambs for the fireplace in the Kitchen of the lean-to.

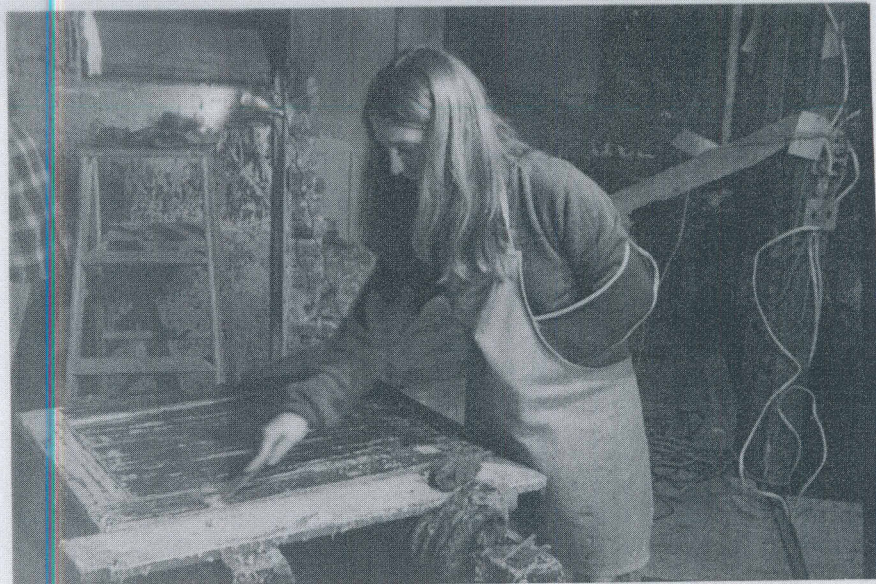
Kathy Thompson removing paint from a cupboard door in the West Parlor. In order to give the public the effect of an unpainted tavern room in 1775, paint was removed from later additions to the West Parlor, such as this cupboard door added in ca. 1830.

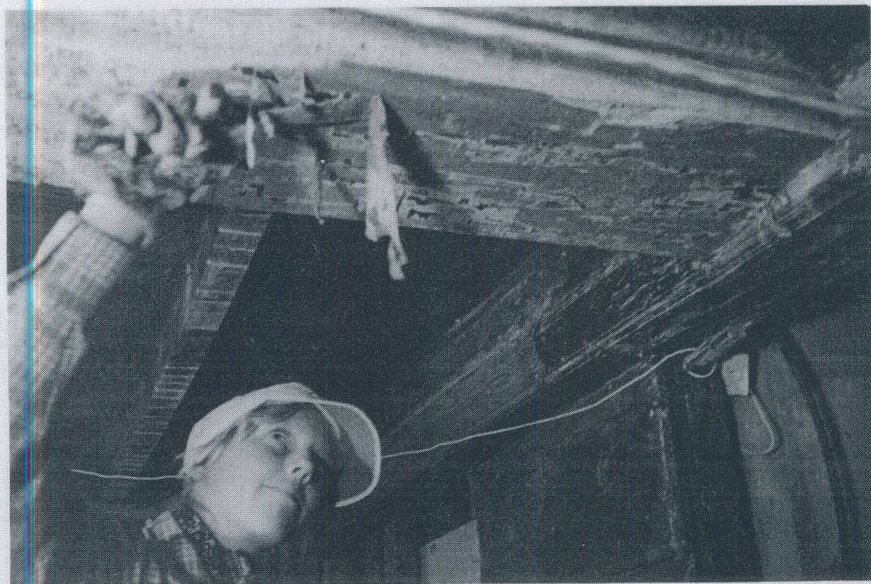
Carol Berry removing paint from the summer beam in the West Parlor. Paint dates after c. 1783 but more likely after 1830.

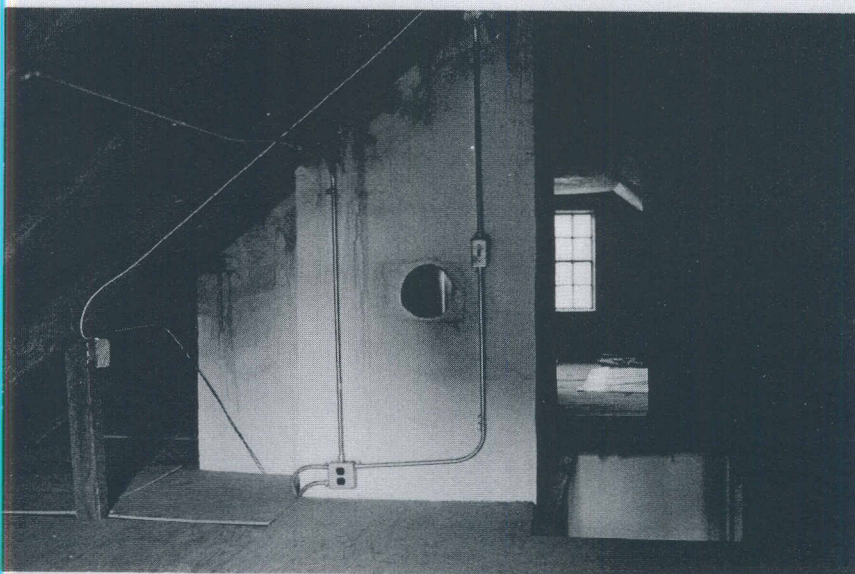
The central chimney in the 1733 house was reconstructed above the attic floor in 1982. Opening in chimney flue is for ventilation of the attic.

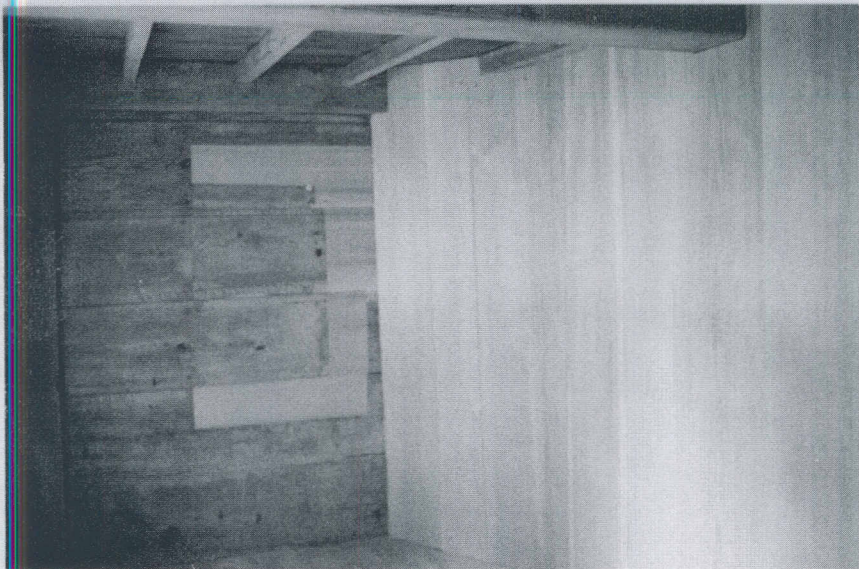
West Chamber of 1733 house thought to be divided into two rooms in c. 1757. View of south room, looking west at repaired wainscoting.

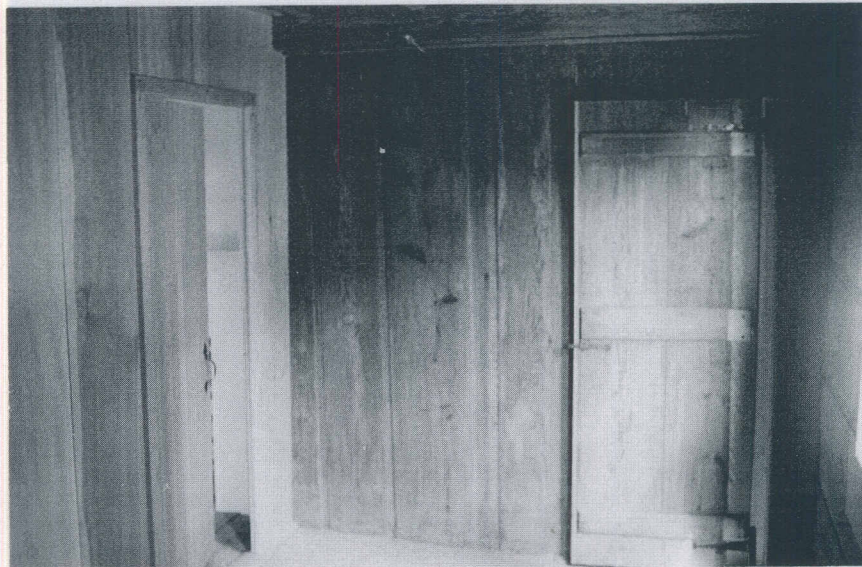
South room of West Chamber, looking east. Board and batten door to hallway was returned to its original location and restored to its original width.

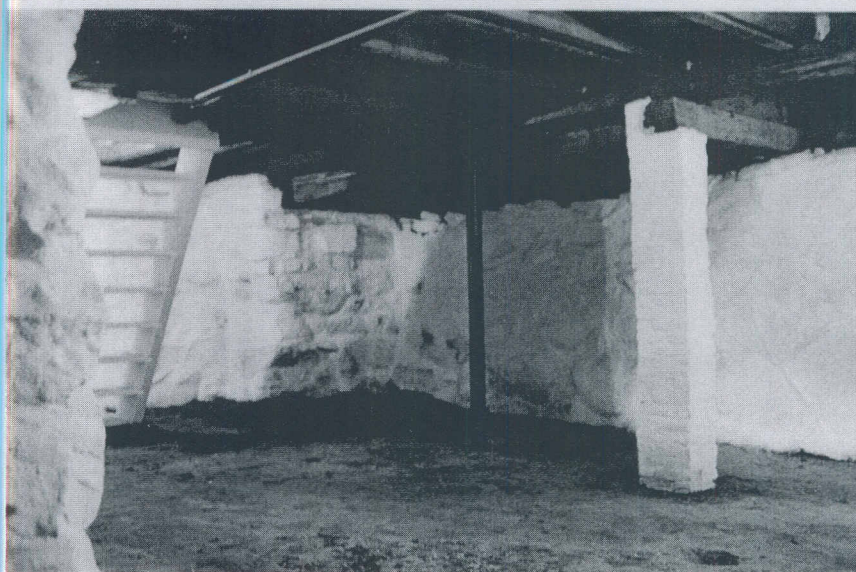
Cellar area under gambrel addition of c. 1783 after rehabilitation work was completed. Cross beam held by brick pier is a replacement.

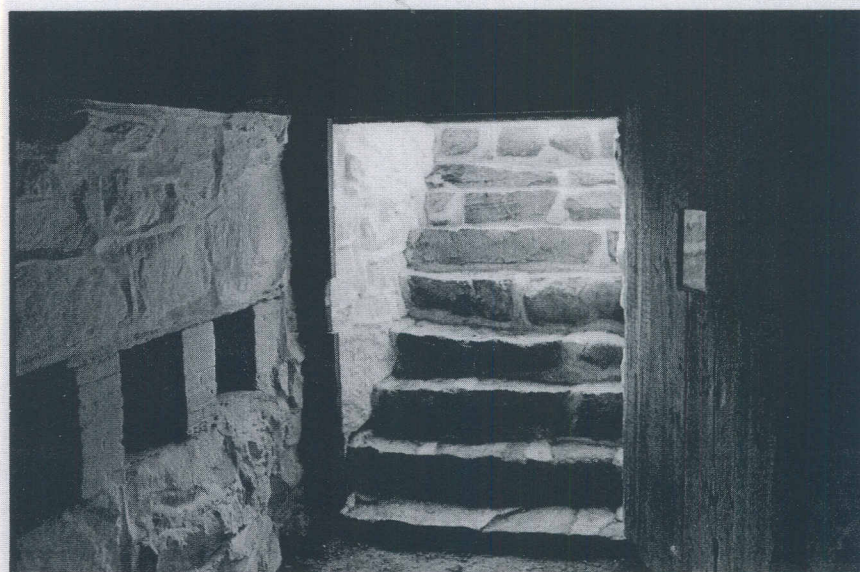
Cellar bulkhead at west wall of gambrel addition. Lower four steps were relaid. Door dating from early 1900's was left intact.
