National Park Service  
Cultural Landscapes Inventory  
2004

Camp Muir  
Mount Rainier National Park

**CULTURAL LANDSCAPES INVENTORY (CLI) PROGRAM**  
*2010 Condition Assessment Update for:*

**Camp Muir**  
**Mount Rainier National Park**

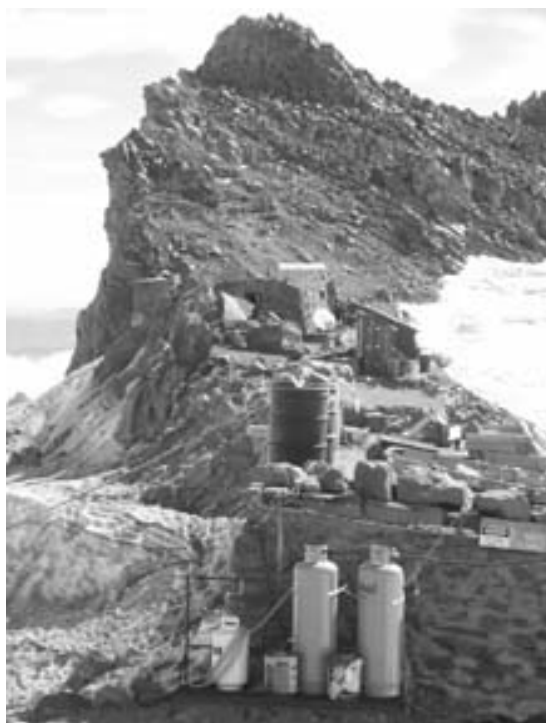
Degradation, a combination of natural and human caused erosion, has reduced the elevation of the ridge significantly. A topographic survey completed in September 2000 indicated that the elevation of the area from the entrance door of the Guide Shelter had dropped roughly 15 feet since 1919. In a historic photo from 1919, the topography appears level at the entrance door to the Guide Shelter, but at present it is necessary to climb an extensive buildup of stone steps to reach the entrance door. Most of the surface substrate loss occurred after the 1970s, as can be seen by comparing a photograph dated 1970–1973 to a photograph of the current existing condition. The construction of the helipad in 1984 and the dramatic increase in the popularity of climbing in the 1970s have exacerbated the loss of surface substrate since the 1970s. This extensive loss of surface substrate is not typical throughout the site. The relatively level area between the helipad and the Public Shelter retains integrity, as does the level terrace south of the Public Shelter. These two areas are the only contributing landscape features of topography, i.e. the only topography that has remained relatively unchanged since the period of significance.

*Contemporary photograph of the narrow ridge on which Camp Muir is sited. NPS Photo*

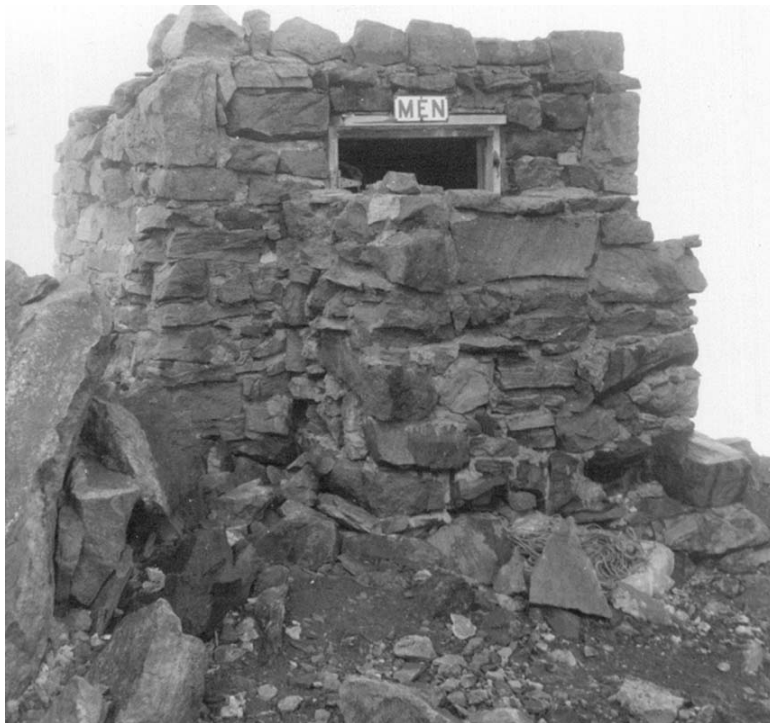
*Historic photograph of the men's pit toilet, 1962. Converted for use as a storage shed in 1973. Note the stone masonry parapet wall in front of the door, which was removed in 1973. MORA Archive (muir8)*

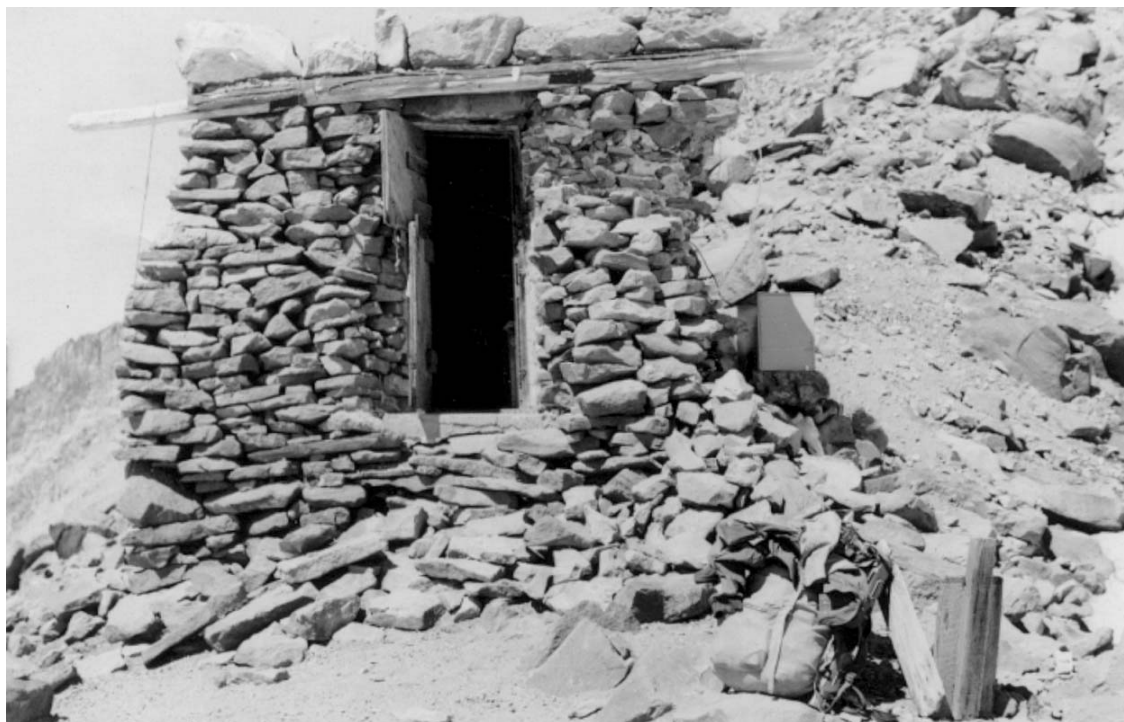
*Historic photograph of the Guide Shelter, 1962. Note the dry-laid masonry walls. MORA Archive (muir1)*

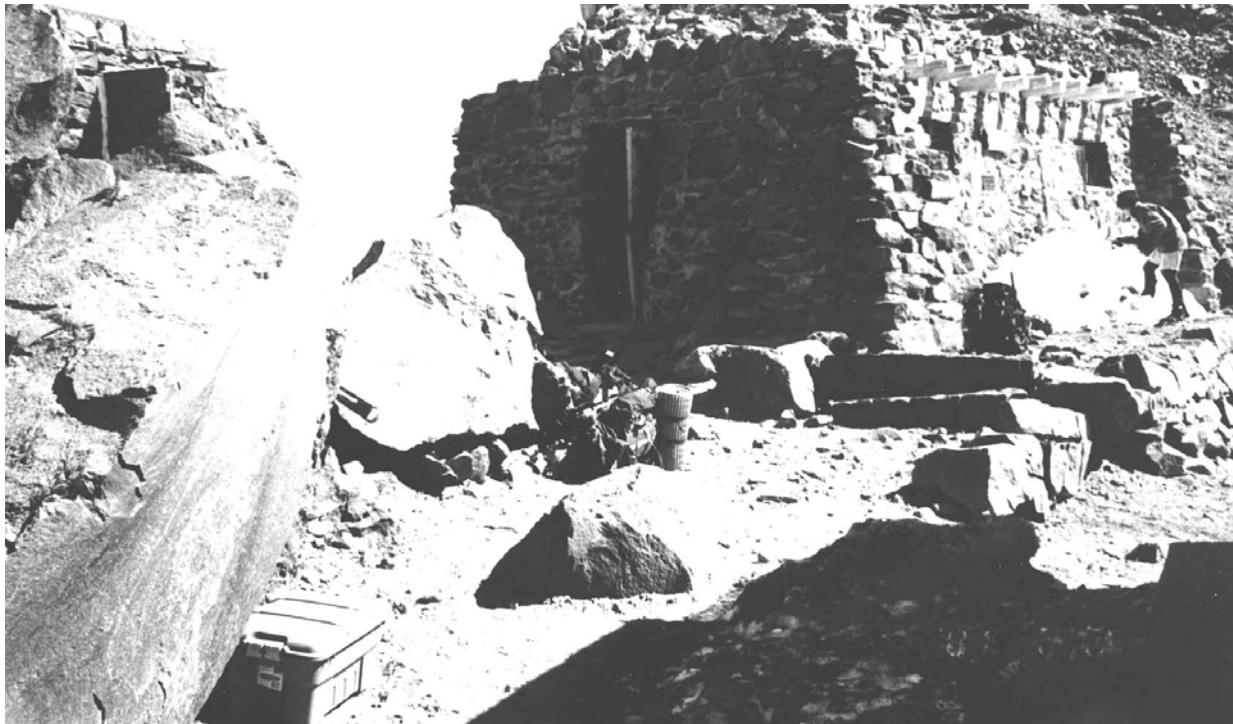
The Public Shelter shows evidence of exposure to the harsh elements. Tarpaper on the ceiling is torn causing the roof to leak. The window framing has dry rot. Ventilation inside is poor. The walls need to be re-mortared as cracks are present on interior walls. The waterproof coating is peeling. Exposed roof joists are dry and weathered. Stone has been lost from southeast wing wall.

*Contemporary photograph of the Public Shelter, 2001. Note the rock outcropping and the loss of finials from the tops of the wing walls. NPS Photo*

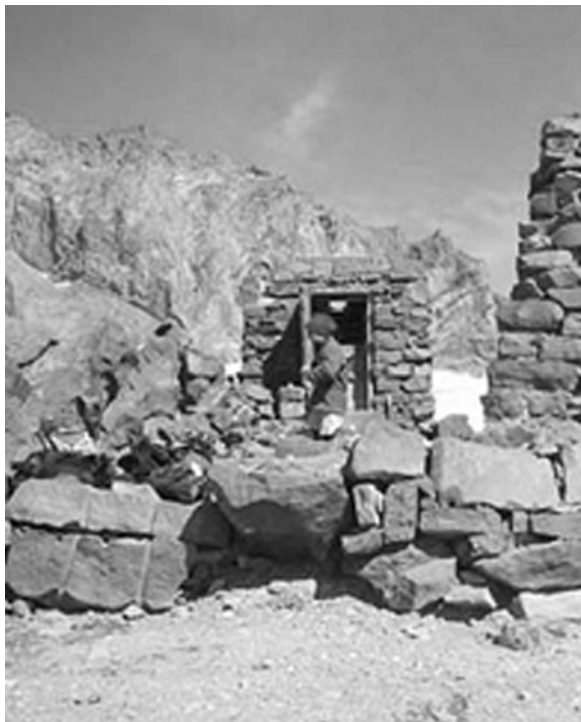
Originally constructed around 1936 as a men's pit toilet, the NPS storage building has undergone changes to be converted to a storage facility. The stone masonry parapet wall was removed in 1973. A solar panel roof was added. Waterproofing has been applied to roof exterior. The historic hole in the comfort station has been sealed up. However, the original wood plank floor remains inside. Built on tuff rock, the foundation of the structure is threatened by wind erosion at the corners. The foundation of the north side has been reinforced with poured concrete, though it is not anchored. The doorframe has dry rot.

*Contemporary photograph of the storage shed (former men's pit toilet), 2001. NPS Photo*

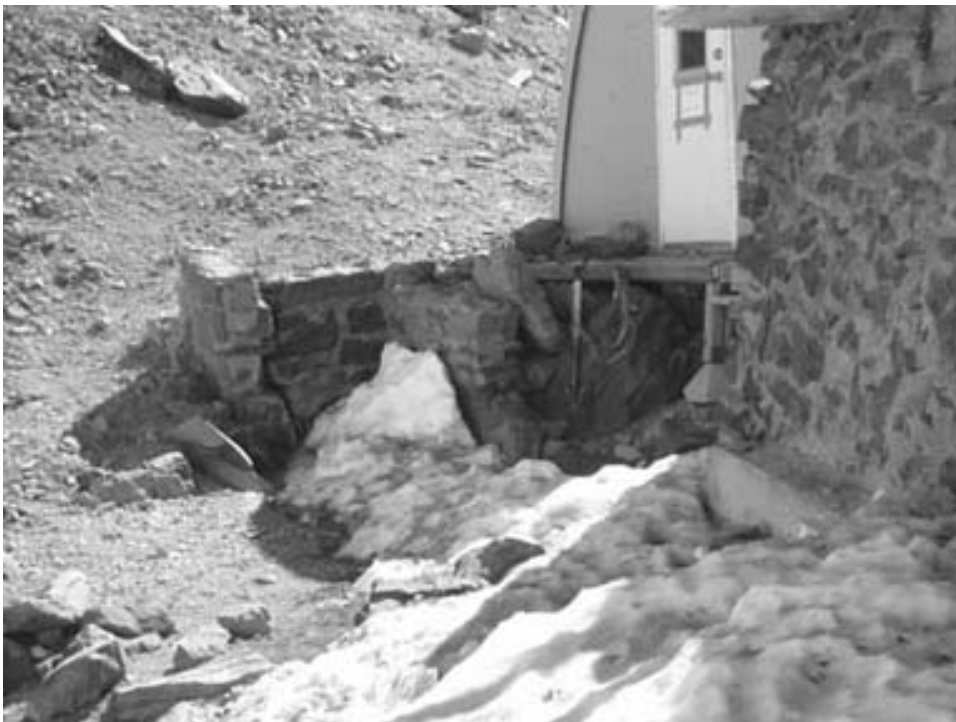
The ruins of the women's pit toilet, which was constructed in 1935–1936, consist of three mortared walls approximately 3 feet high. Erosion has taken a toll on the ruin. A photo from the early 1970s, shows the building in its entirety. It was dismantled in 1973. This ruin is a contributing archeological site dating from the period of significance.

*Contemporary photograph of the ruins of the women's pit toilet, 2001. Also note the rear wall of the Public Shelter showing mortar applied to the stone after the period of significance, and the Weatherport behind. NPS Photo*
