# National Park Service Cultural Landscapes Inventory 2004

Ricksecker Point Mount Rainier National Park

# CULTURAL LANDSCAPES INVENTORY (CLI) PROGRAM 2010 Condition Assessment Update for:

CONDITION ASSESSMENT: FAIR

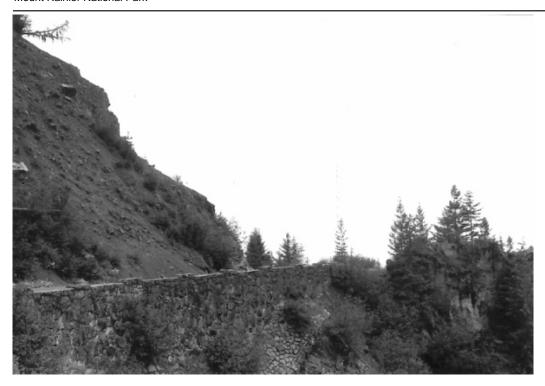
The guardwall retains integrity as a historic structure of the designed landscape, though its condition varies with location along the length. At the Nisqually Valley overlook parking area, a nine-foot long section of guardwall has collapsed, and at various points along the one-third of a mile long guardwall, destabilization is occurring.

Contemporary photograph of the retaining wall and integrated guardwall along the edge of the road at Ricksecker Point. Note the crenellations in the top of the guardwall. (CCSO, 1994.)

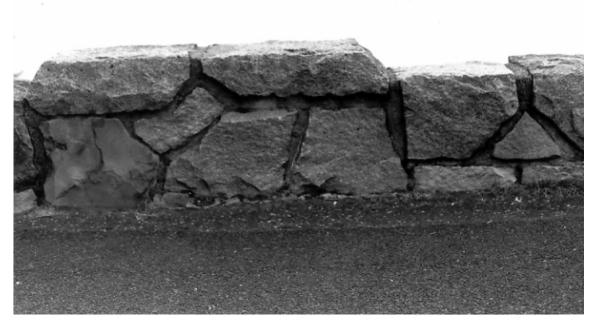
Contemporary photograph showing a detail of the stone masonry guardwall at Ricksecker Point. Note the crenellation in the top of the wall, and the recessed mortar joints, both standard details throughout the 1930s. (CCSO, 1994.)

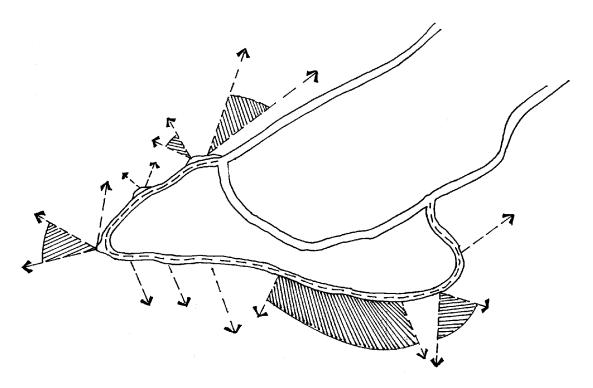
Diagram showing contemporary panoramic views from the road around Ricksecker Point. Note the reduction in views to the south and southeast (towards the Paradise Valley), due to the re-growth of native vegetation. (CCSO, 1994.)
