HISTORIC STRUCTURES REPORT  
ARCHITECTURAL DATA SECTION PART II

THE WICK HOUSE

Morristown National Historical Park  
Jockey Hollow, Morristown, N. J.

June, 1959

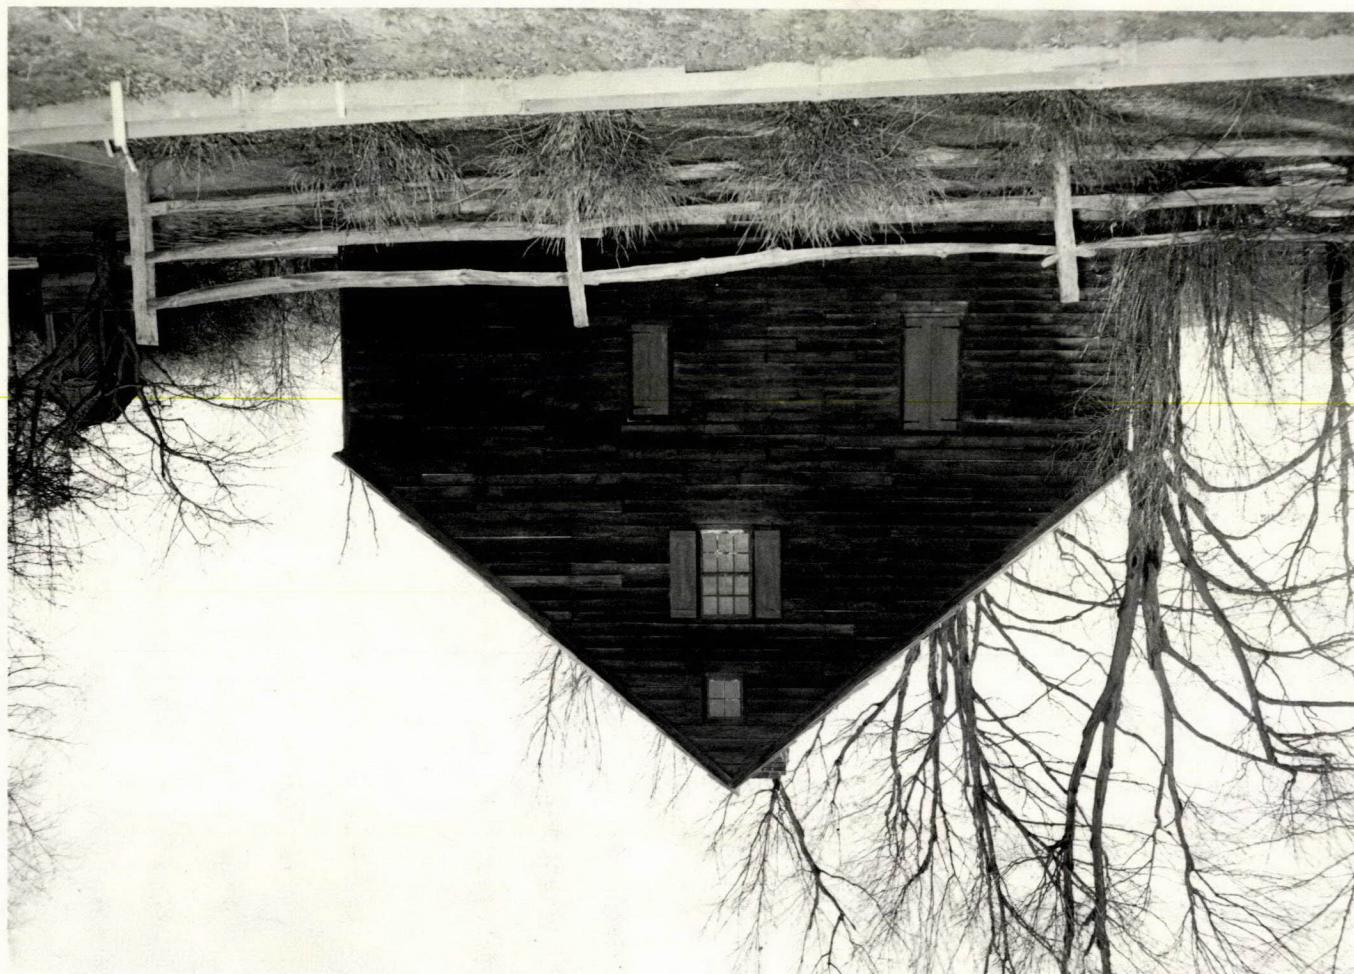
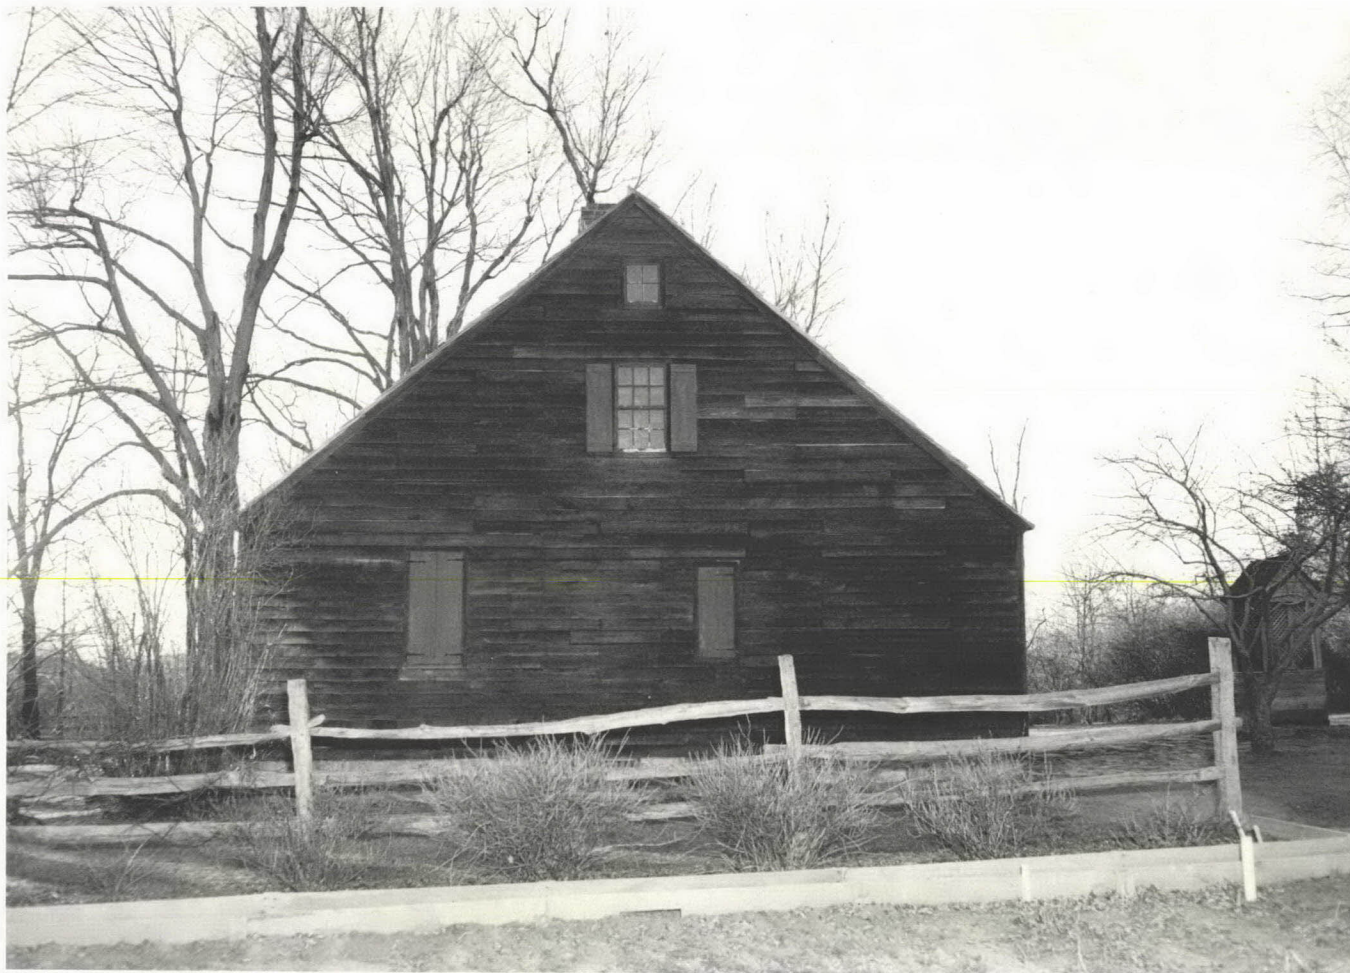
3. Exterior: The large shingles on the roof are in good condition and excepting for a shingle here and there do not need replacement at this time. The clapboards on the north and west walls and the shingle on the south wall also do not need attention. The siding on the east end wall, however, is in need of repair and should be entirely replaced. This wall, in spite of continual patching, is in poor condition. This is partly due to the fact that it is subjected to a frequent quick drying process by the morning sun and partly due to the fact that the new oak clapboards used in the patching were not sufficiently weathered and have shrunk and opened up at the lapped joints. The condition of this wall is shown in the accompanying photograph.

The present oak siding should be removed from the entire east wall and replaced with new heart oak siding of the same width but of sufficient length to reduce the number of end joints to a minimum. It is imperative that the new wood siding be sufficiently weathered or kiln-dried so as not to shrink or curl and split when drying. The building paper in back of the siding boards should be removed and not replaced as this moisture barrier tends to hold the dampness on the back face of the boards while the exterior face is dried out. This aggravates the damaging effects of the drying process. These

boards should be dipped for 3 minutes in a 5% penta solution stain to match the existing siding on the other faces of the house before erection. Any studs on this wall which show signs of rot should be replaced and all should be painted with creosote or penta chlorophenol.
