HISTORIC STRUCTURES REPORT-PART I

WICK HOUSE

MORRISTOWN NATIONAL HISTORICAL PARK

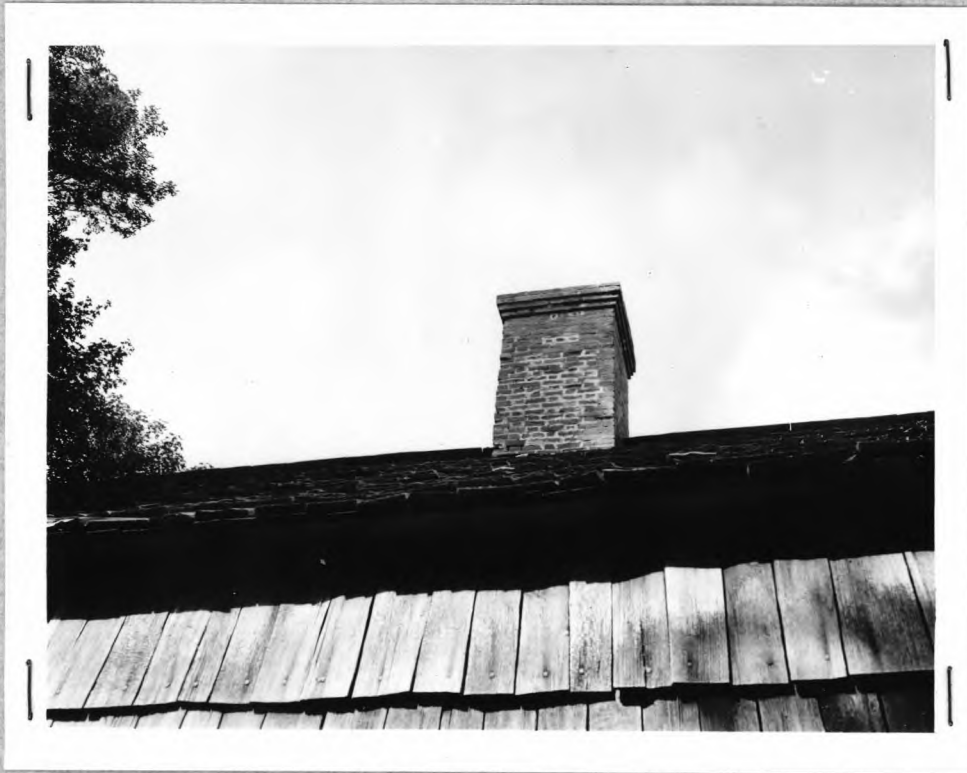
chimney, replacement or extensive repair of the east wall, repair of the roof, and repair of the doors, shutters and windows. In addition, some of the flooring is extremely worn and should be replaced. A thorough architectural investigation should be made to determine the extent of rehabilitation necessary.

1. Exterior view of chimney, showing the deterioration of brickwork.

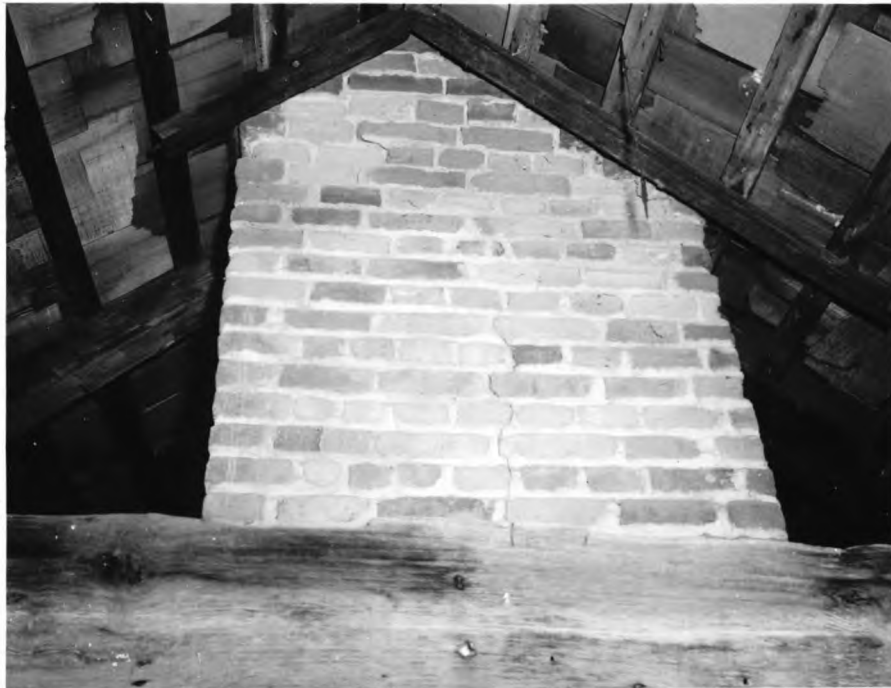
2. Chimney in attic, showing crack in brickwork.

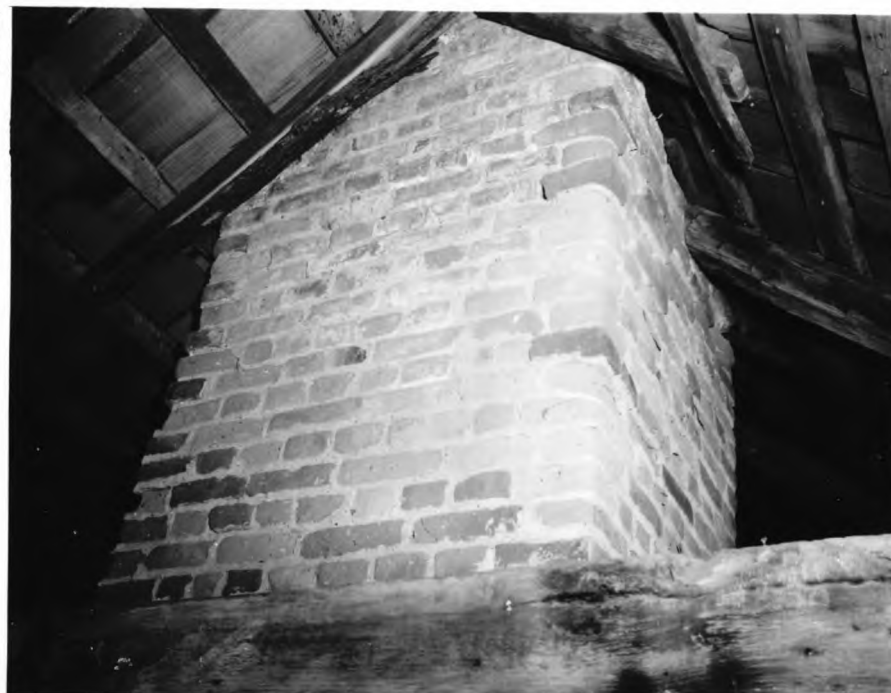
3. Chimney in attic, showing missing brick.

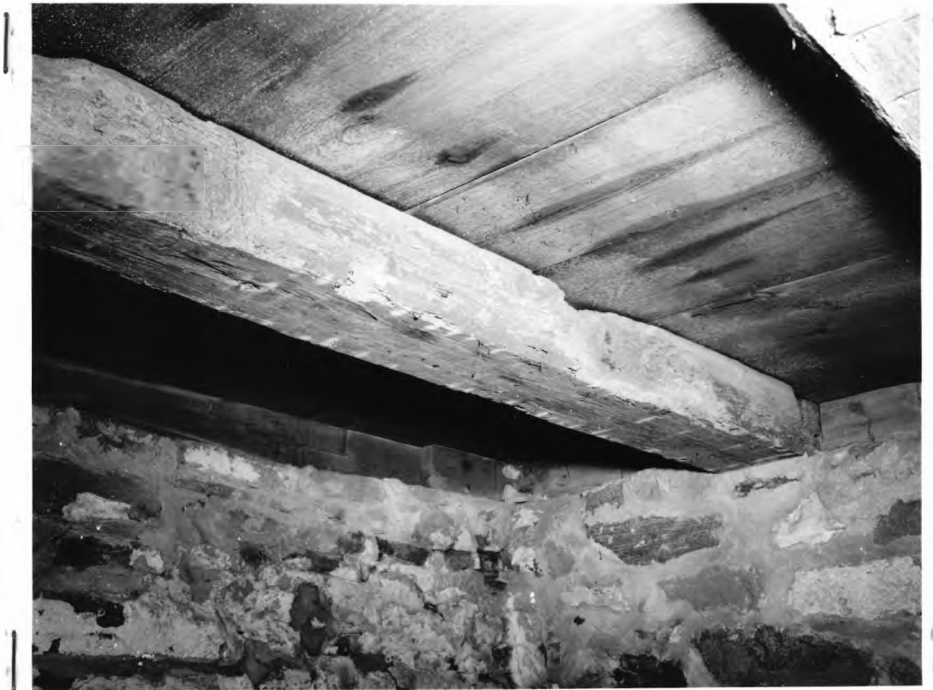
4. Condition of floor joists in cellar.

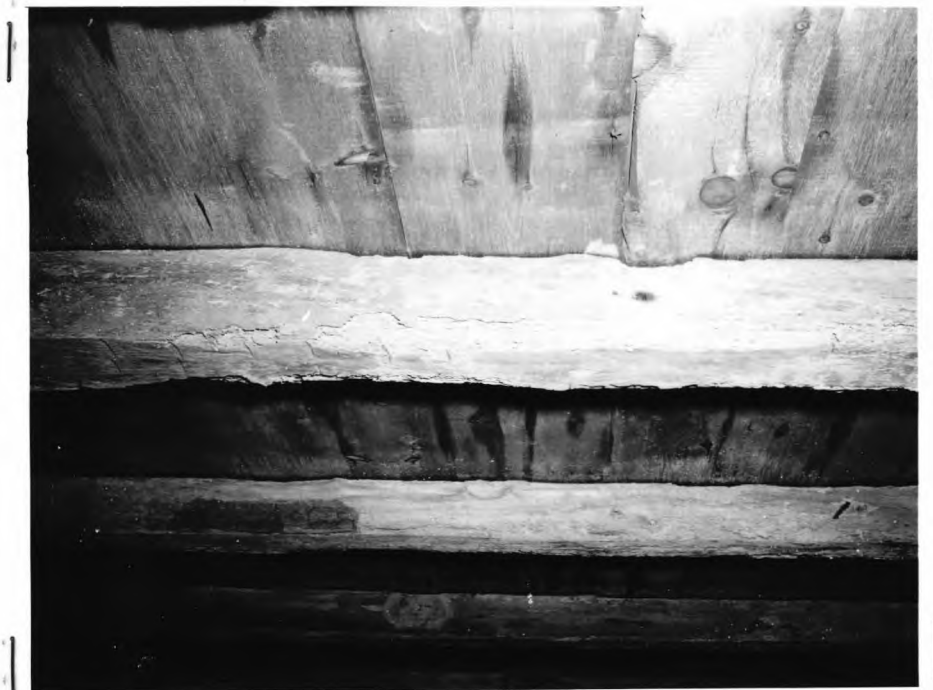
5. Another view of floor joists.

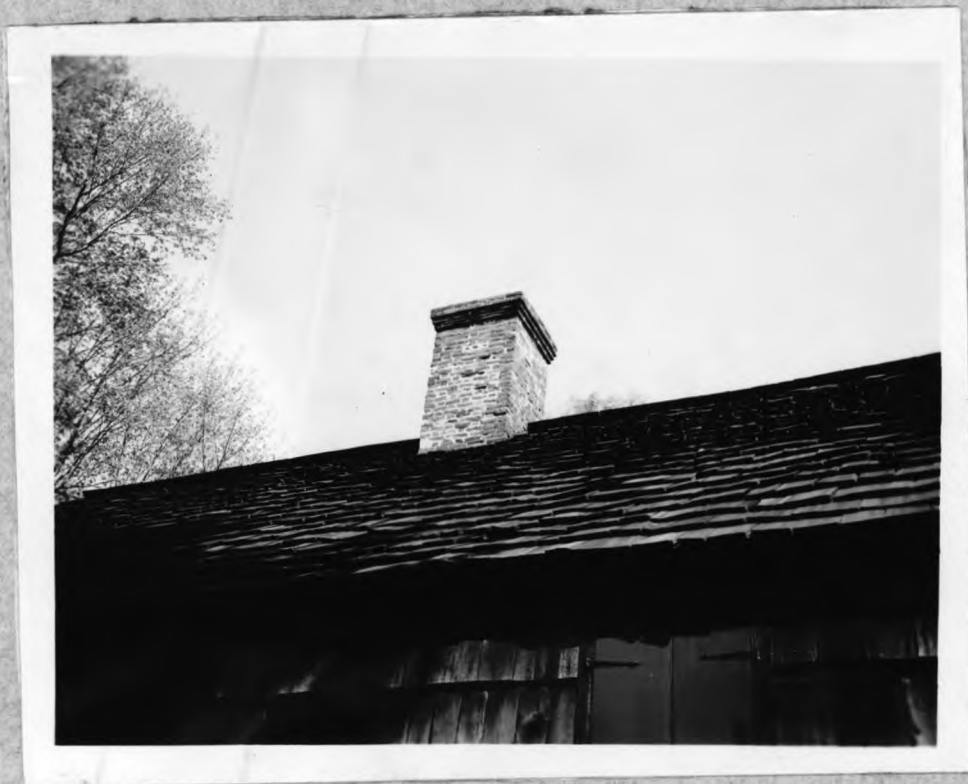
1. North and west sides of the chimney, showing the poor condition of the brick work.

REPAIR OF THE CHIMNEY - Purchase Order 29-82 provided for the furnishing of "materials, labor and equipment to remove soft brick chimney to firm brick below roof and rebuild, with pink Cherry Valley common brick . . . , to the exact size, shape and height of existing chimney. . . . New chimney to be adequately flushed at roof line." As far as is known, the chimney was wholly rebuilt and all the old bricks were replaced by new ones. The cost of this project was \$500. See photographs 1 - 5.

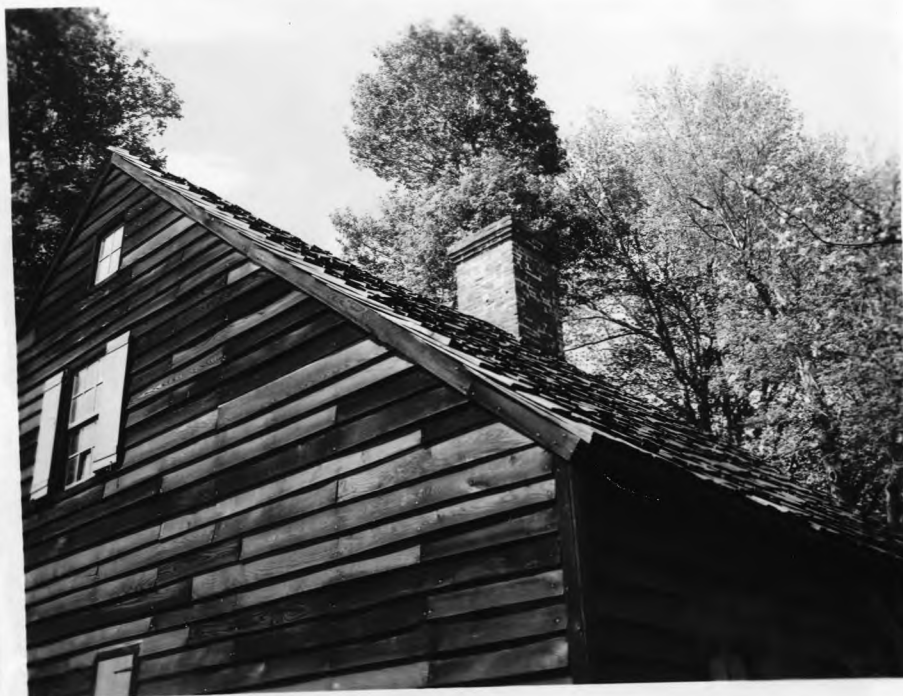
2. North and east sides of the chimney, showing the poor condition of the brick work.

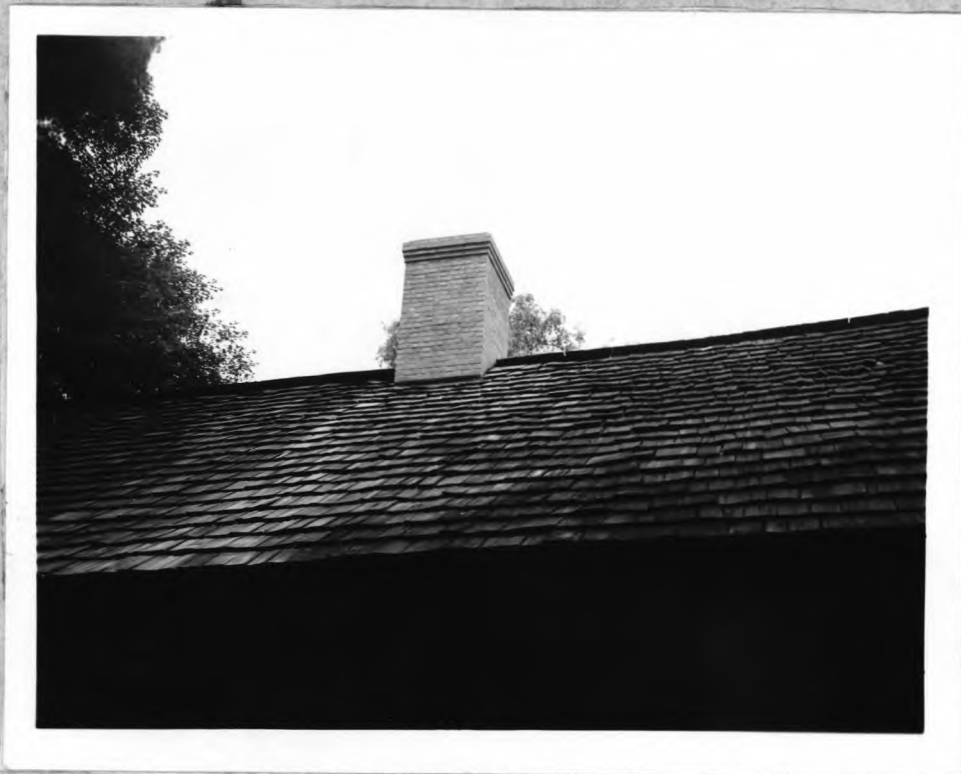
3. North and west sides of the repaired chimney.

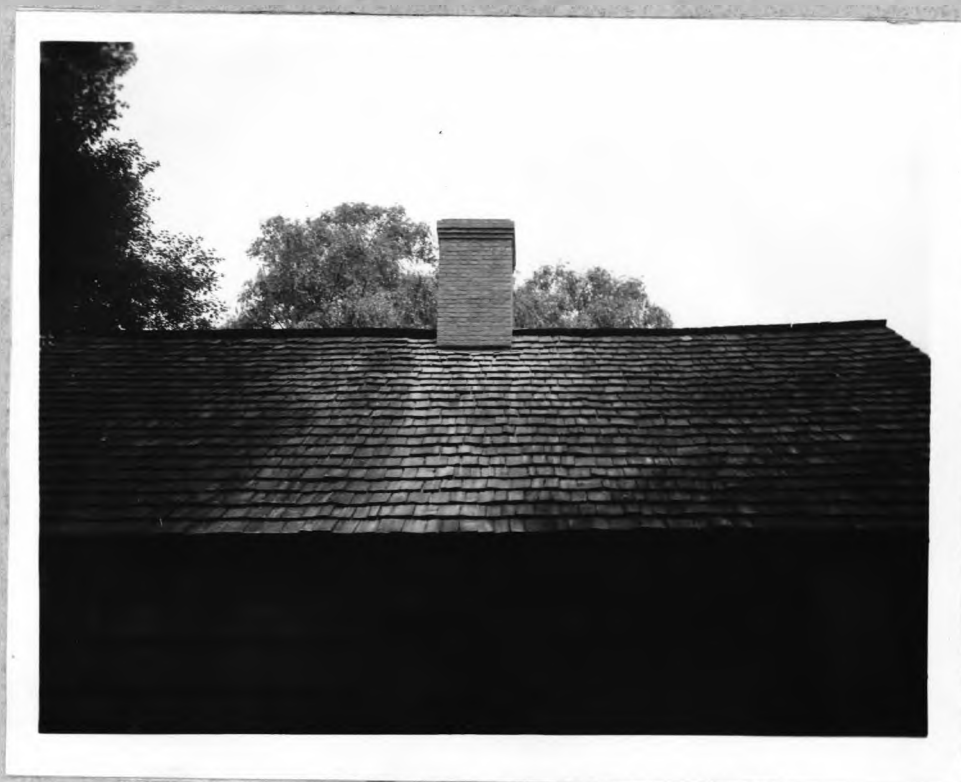
4. North side of the repaired chimney.

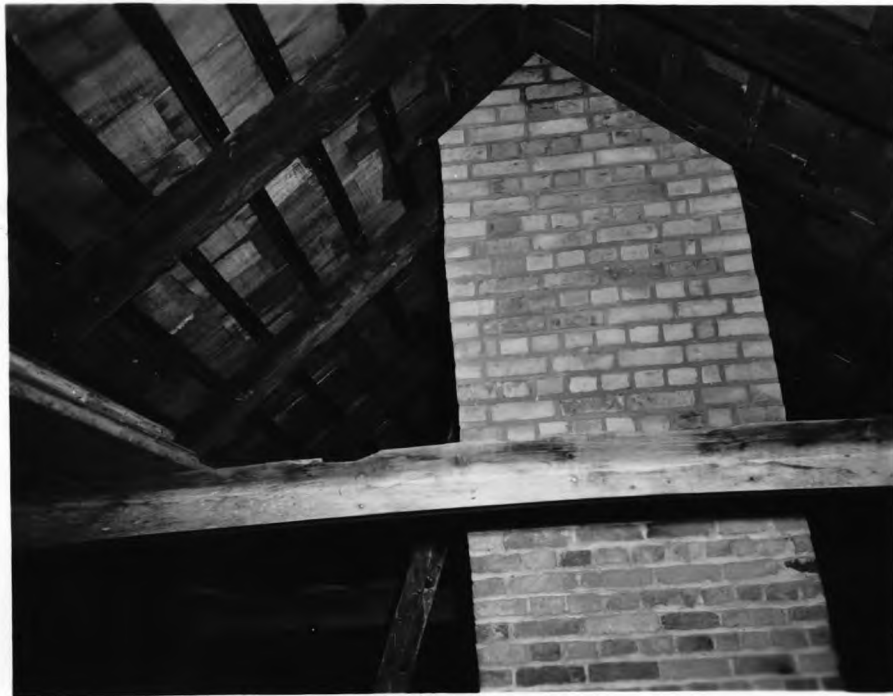
5. Repair of the chimney below the roof.

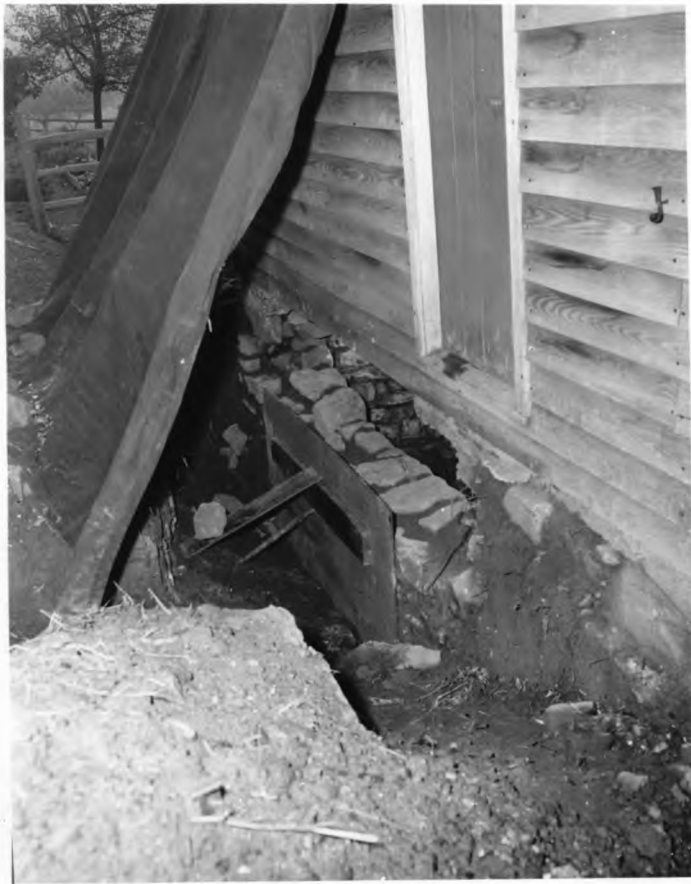
6. The reconstruction of the north basement wall.

REPAIR OF THE FIREPLACE AND NORTH BASEMENT WALL - Purchase Order 29-29 called for the "repair [of the] fireplace as directed" and the reconstruction of the north basement wall using lime-cement and rock. Some brick was replaced in the fireplace, plus some repointing. The north basement wall was rebuilt, using the old stones, and an open type drain was laid outside of the wall, just below the level of the cellar floor. A brick apron, two bricks in width was placed parallel to the top of the wall in order to carry away surface drainage. See photographs 6 - 8.

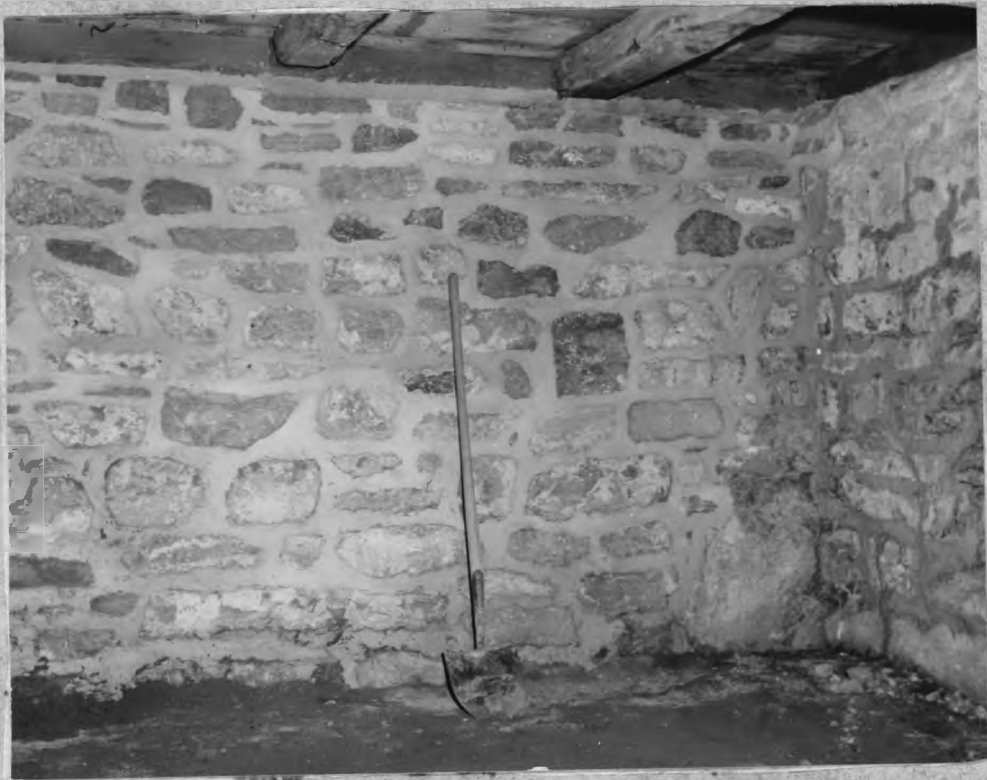
7. The rebuilt cellar wall.

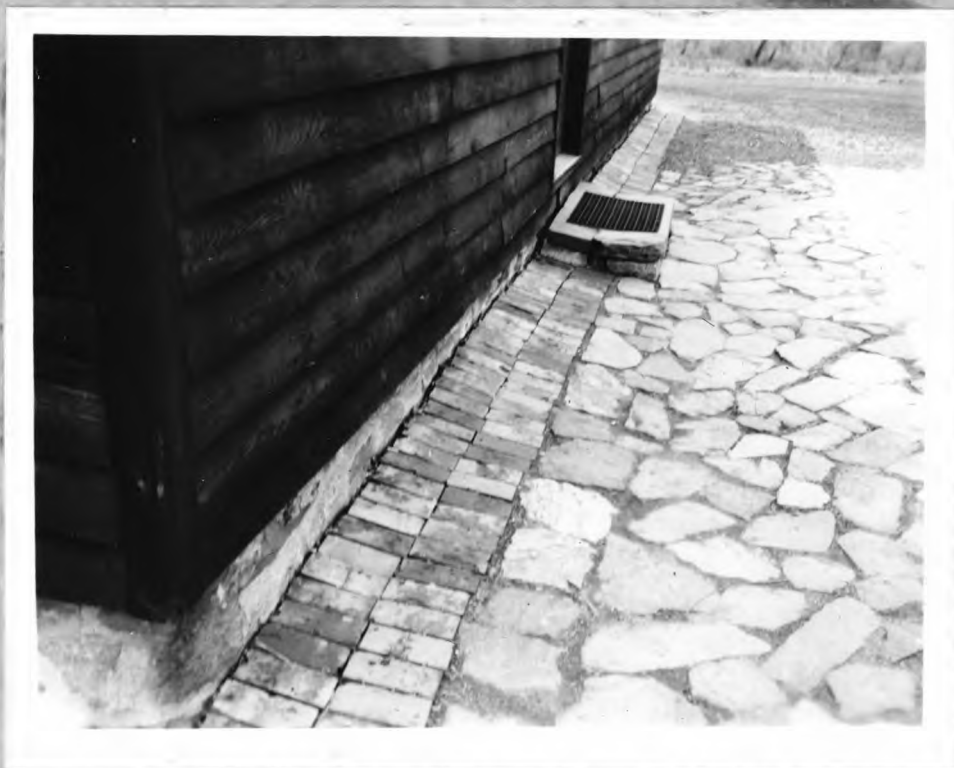
8. Brick apron.

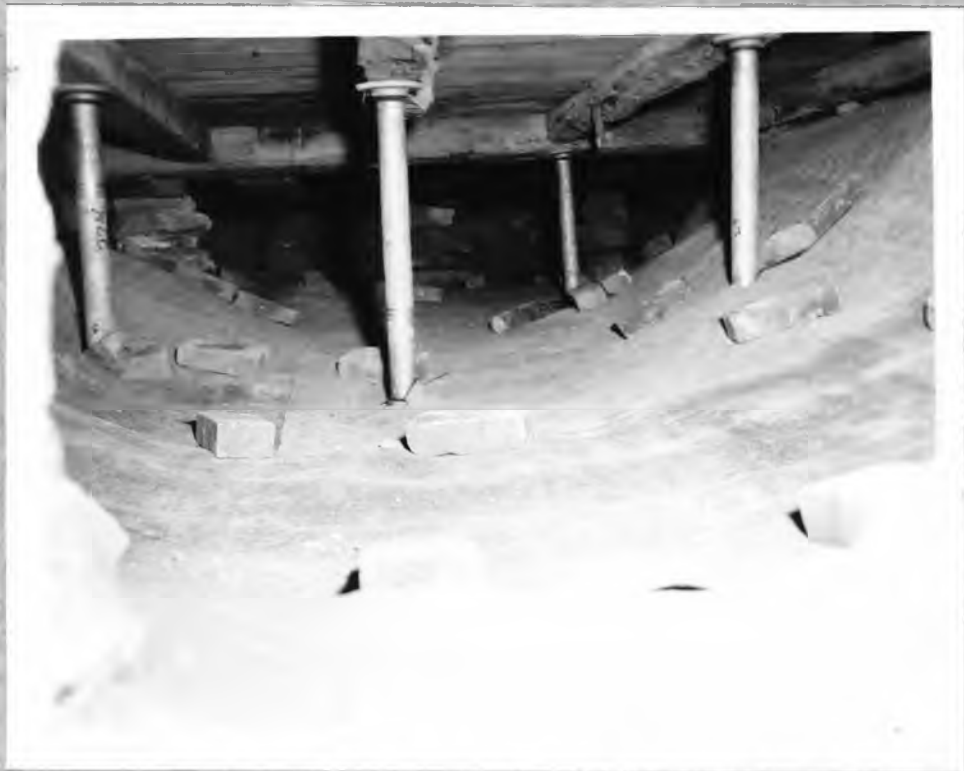
9. The deepened crawl space.

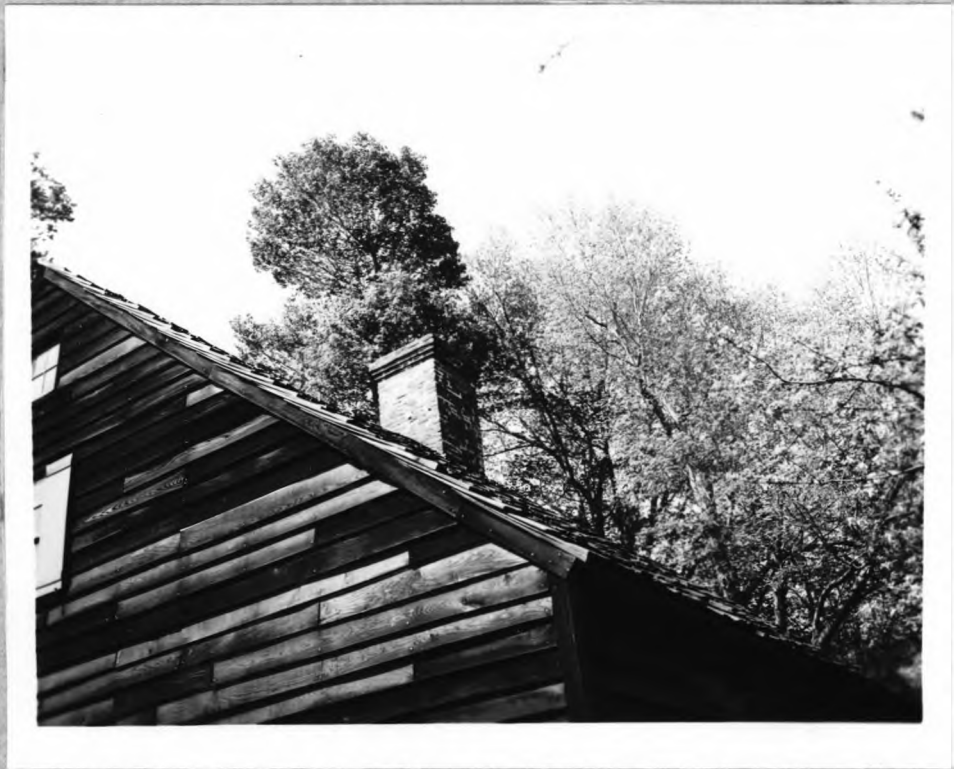
10. The warped siding of the east wall of the Wick House.

REPAIR OF THE SIDING OF THE EAST WALL - White oak lumber for the siding of the east wall was purchased but subsequently it was decided to retain the present siding and hold the new lumber for future use. A coat of boiled linseed oil, with 5% pentochlorophenol added, was not only applied to the east wall, but to the complete exterior of the Wick House. This work was provided for by Purchase Orders 29-49 and 29-86 and cost a total of \$2,540.39. See photographs 10 and 11.

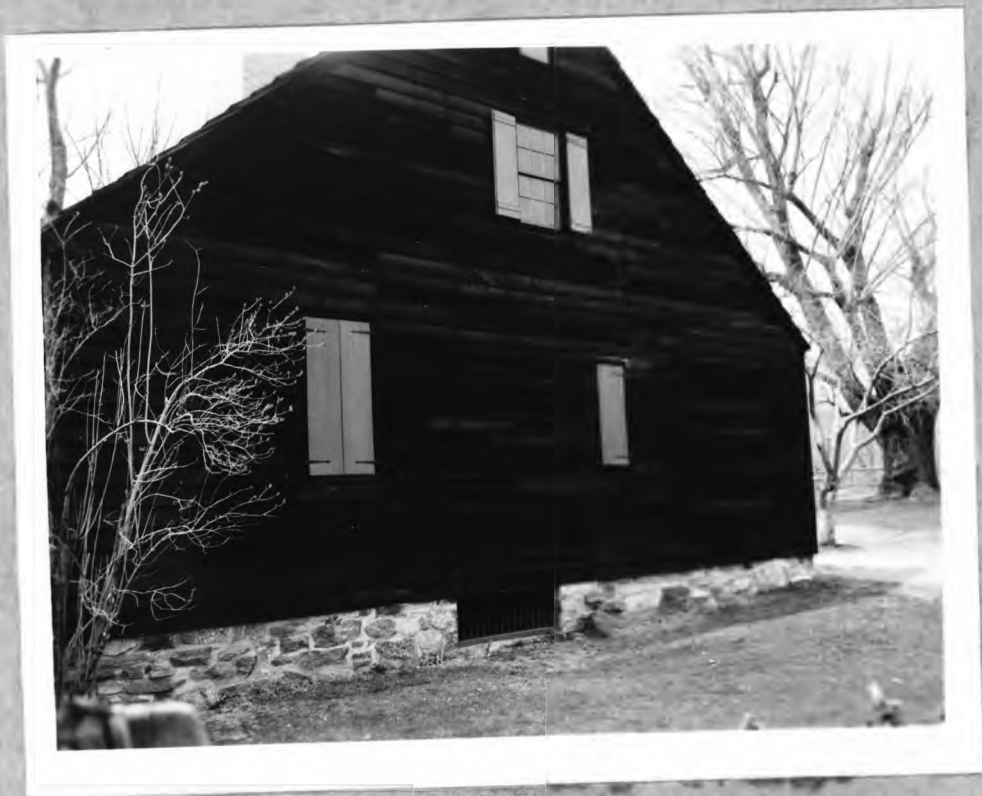
11. The east end after oiling.
