# DISTRICT OF COLUMBIA WAR MEMORIAL

Historic Structure Report  
& Cultural Landscape Assessment

National Mall & Memorial Parks  
PMIS NO. 43699

May 2006

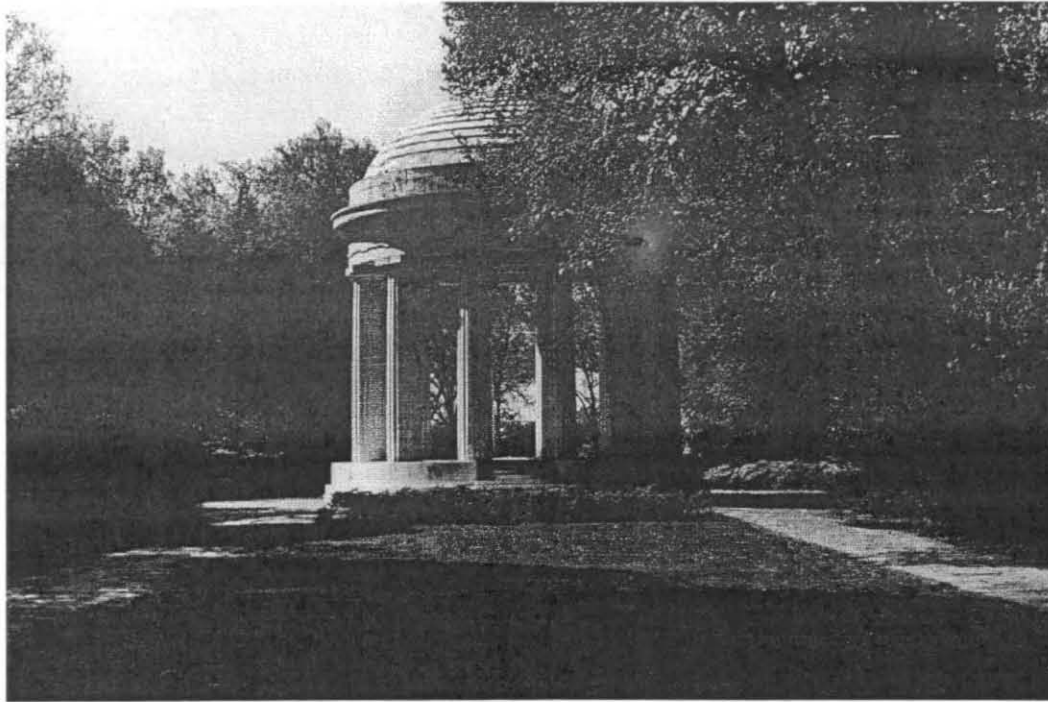
EXISTING CONDITIONS  
@ CORNICE

Figure 24. "Existing Conditions @ Cornice," included in September 28, 1984 report by Tom Fields. [District of Columbia War Memorial File, National Capital Parks-Central, courtesy of Tony Donald.]

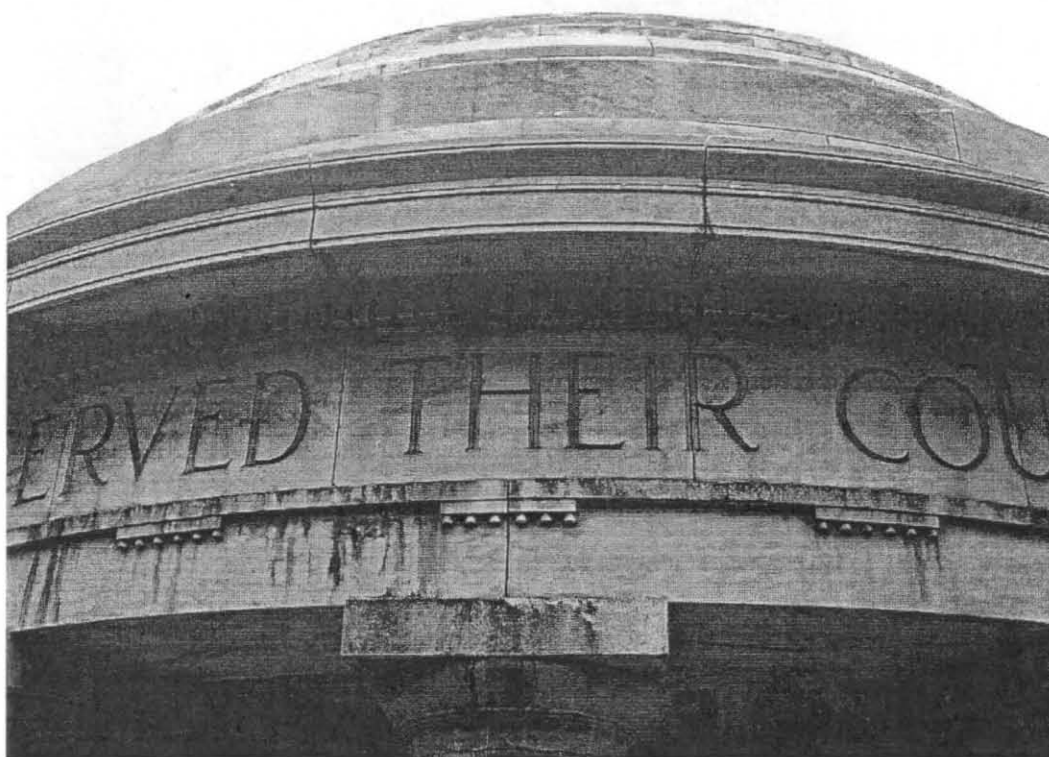
*The Memorial entablature. Note the open mortar joints in the marble construction. [JGWA, 2005]*

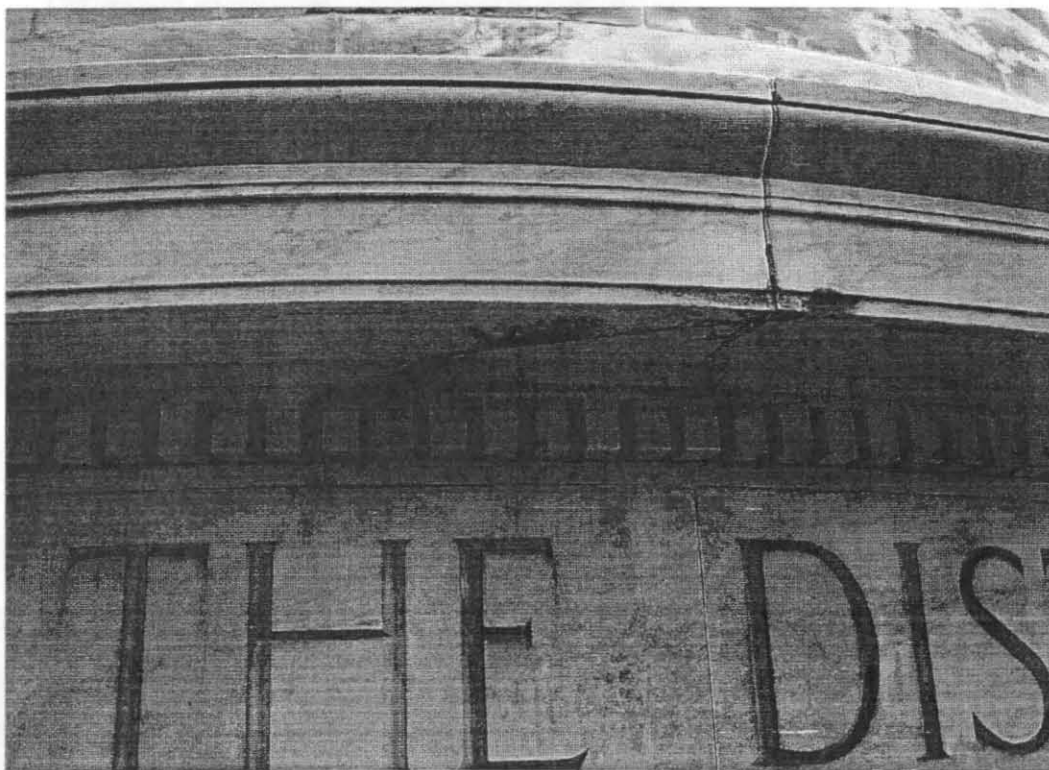
*Detail of the cornice. Several of the cornice stones are cracked. [JGWA, 2005]*

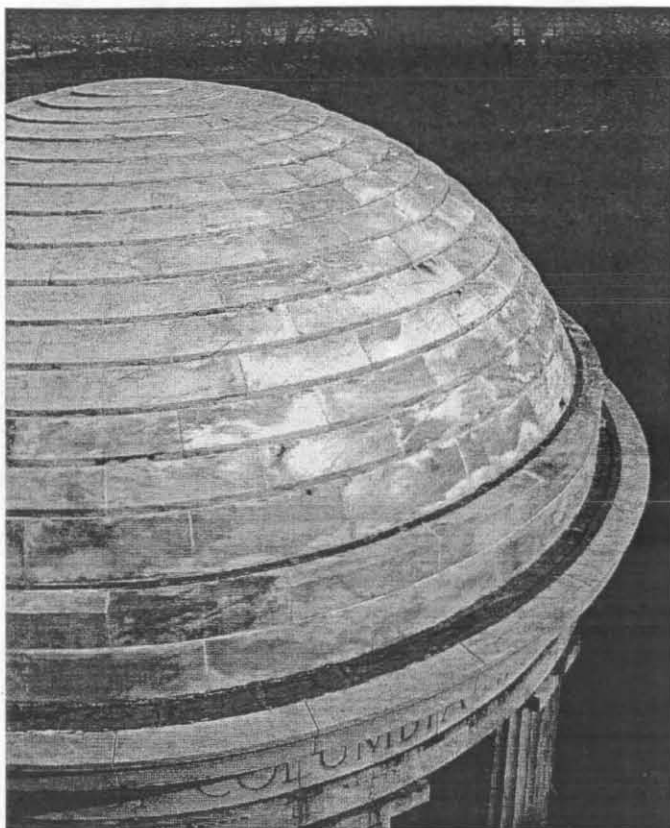
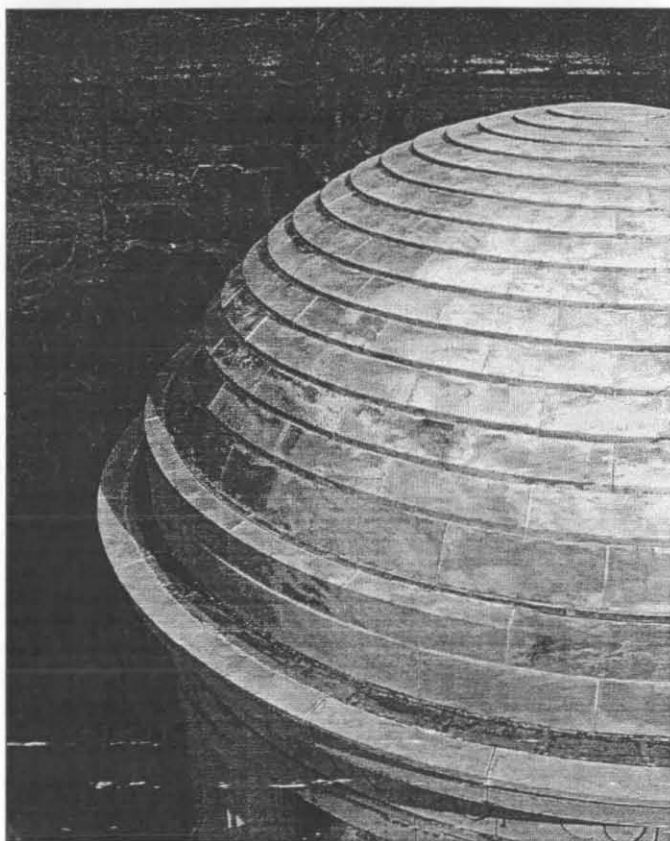
*Views of the dome from the south, looking northeast (upper photo) and northwest (lower photo). Note the shallow gutter construction in the protruding cornice. [JGWA, 2005]*

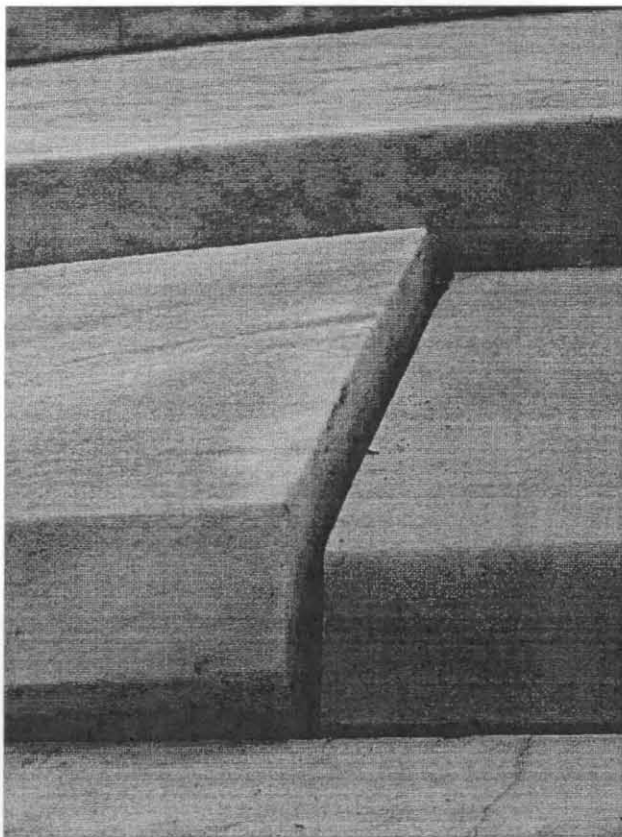
*Detail of a displaced marble roofing tile. Water infiltration and freeze-thaw cycling may be contributing to the displacement of the marble.  
[JGWA, 2005]*

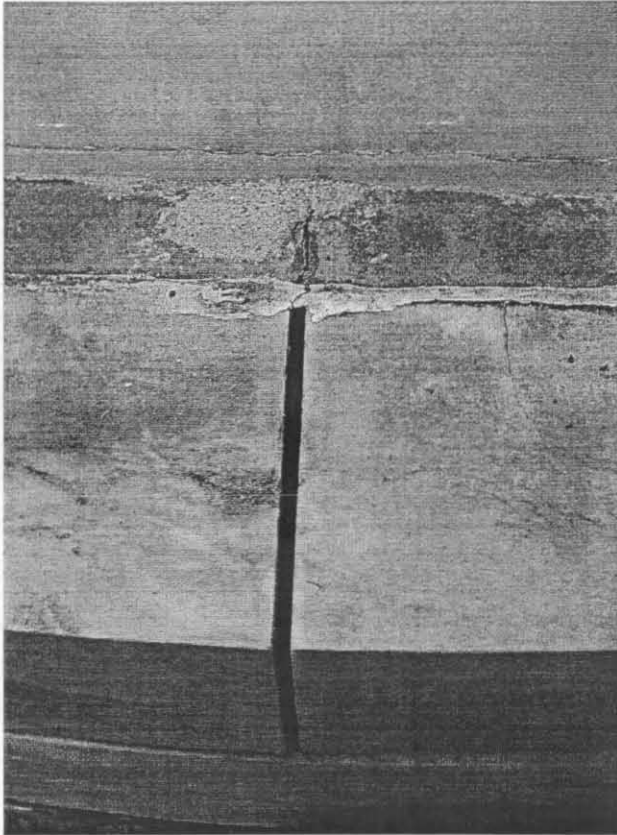
*The original lead flashing on the marble capstones of the drum has been torn by the displacement of the stones. The movement of the stones appears to be the result of water infiltration at the open joints in the masonry and subsequent freeze-thaw cracking. [JGWA, 2005]*

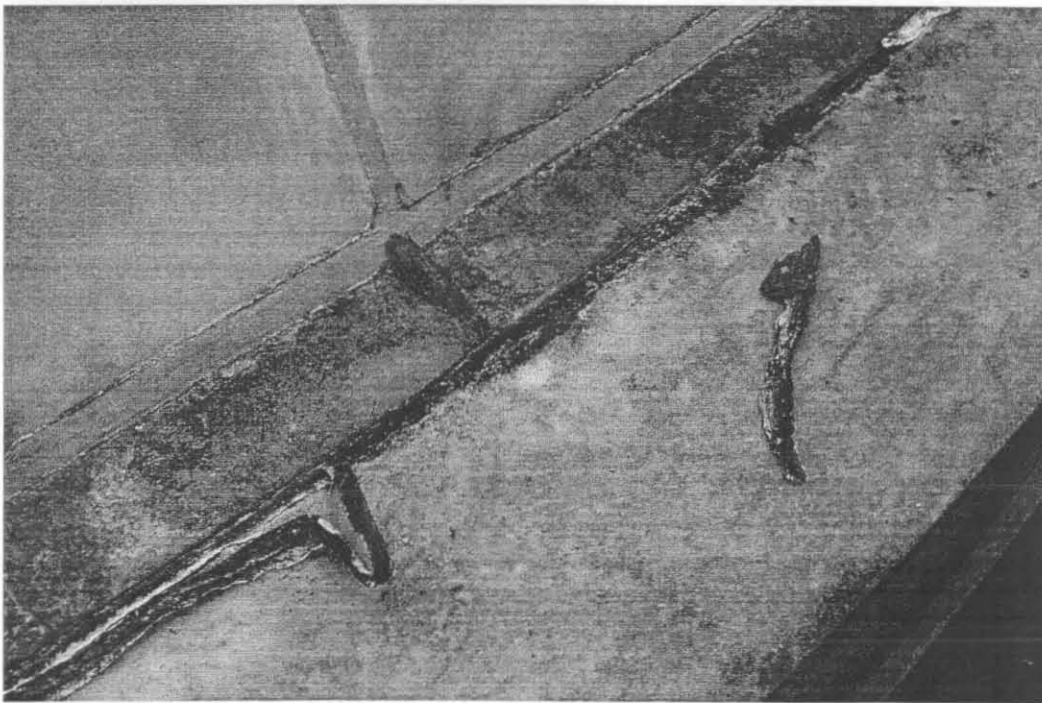
*The original lead flashing on the capstones of the drum was wedged into a reglet cut in the stone. Lead wool was used to retain the flashing in the reglet; the reglet has subsequently been filled with sealant in a misguided attempt to repair the flashing. [JGWA, 2005]*

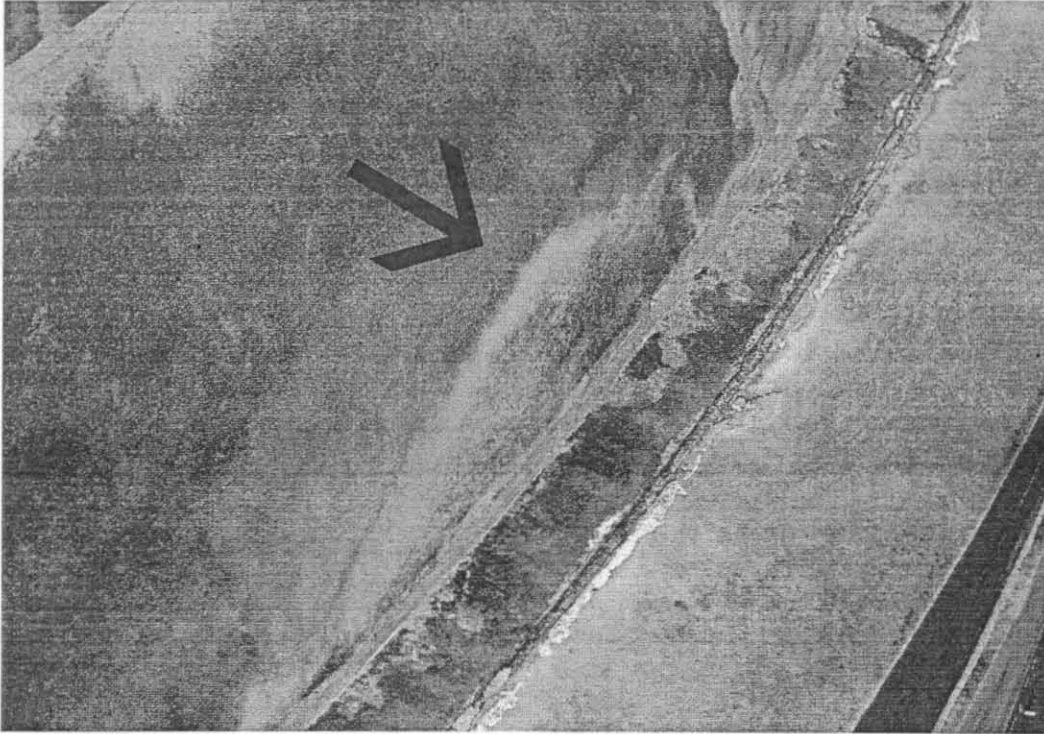
*The bright orange and yellow discoloration visible on the outer marble dome appears to be a biological growth below the surface of the marble. [JGWA, 2005]*

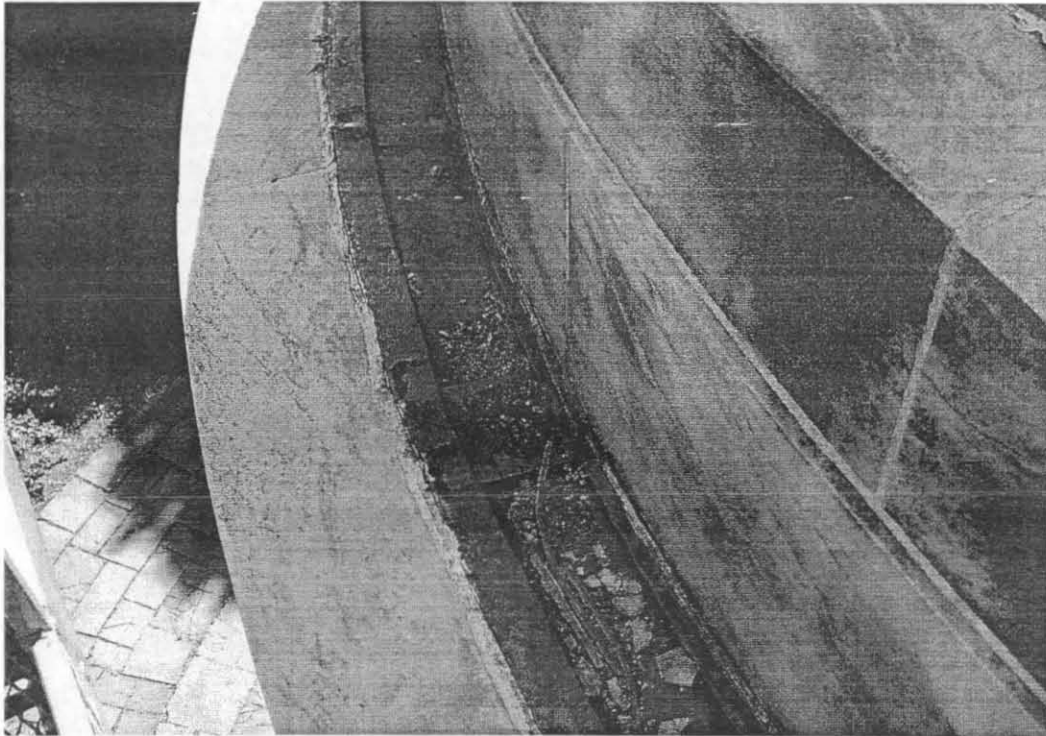
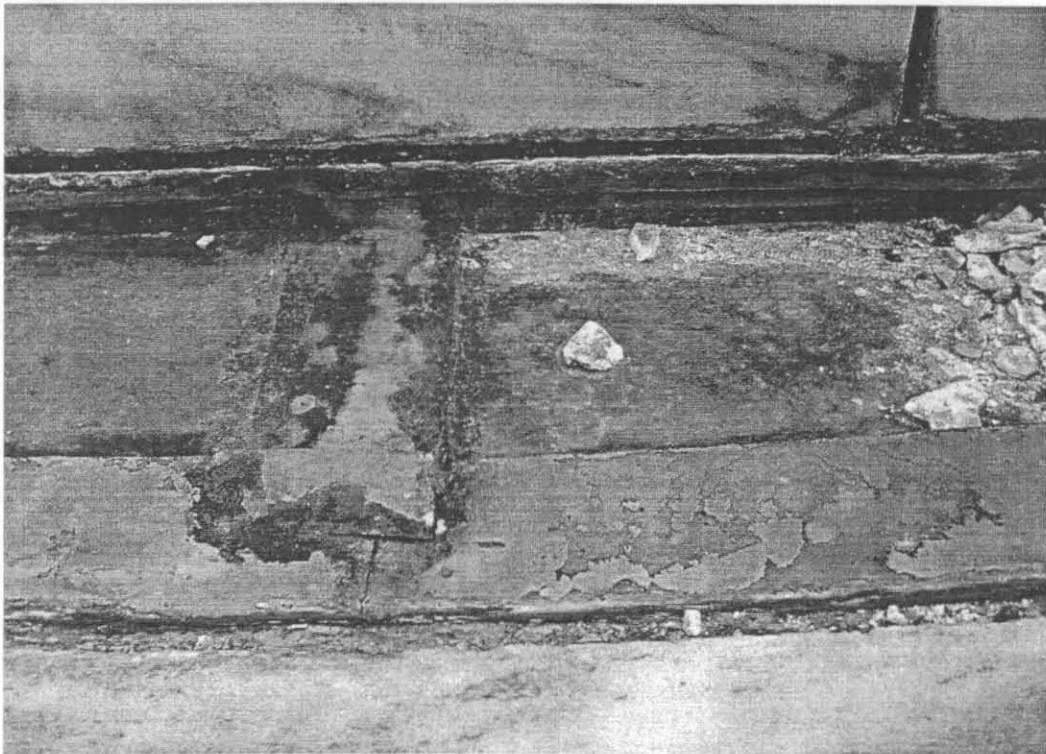
- The pitch of the gutter is insufficient for proper drainage to the four downspout outlets. Cross seams in the copper gutter are pronounced, preventing proper drainage.

*The shallow gutter in the projecting cornice is lined with lead-coated copper (which replaced the original lead flashing). The metal has oxidized and eroded, exposing the intermediate layer of tin. Insufficient pitch, pronounced cross seams, and pieces of deteriorated mortar prevent proper drainage. [JGWA, 2005]*

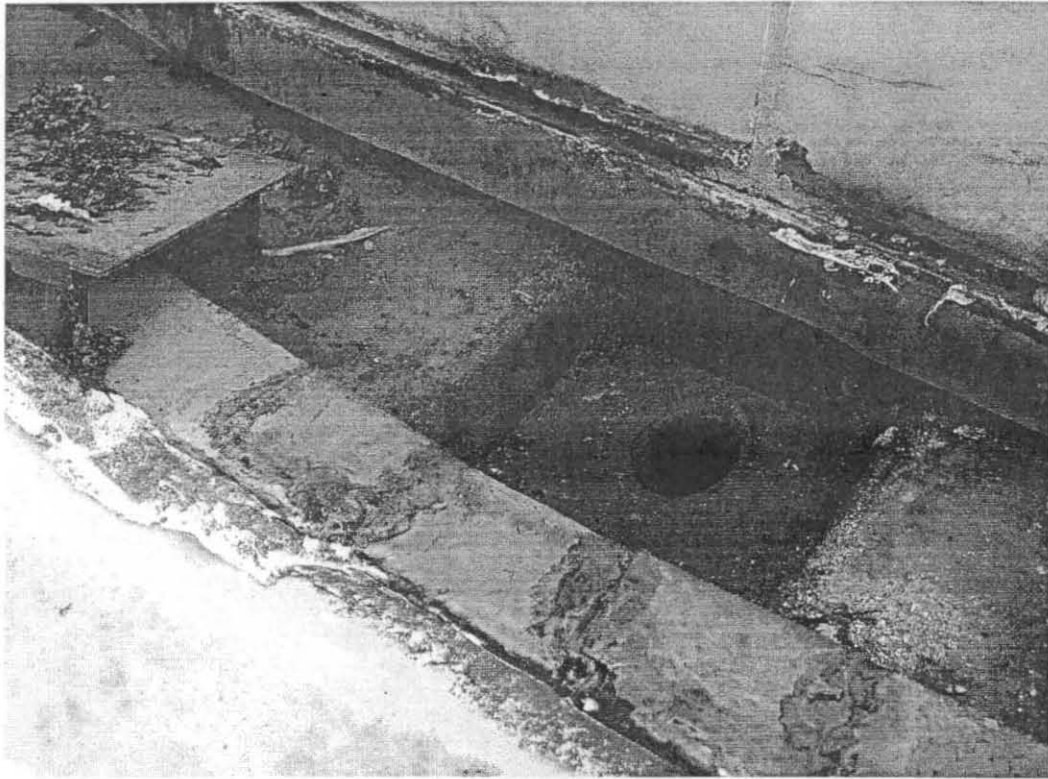
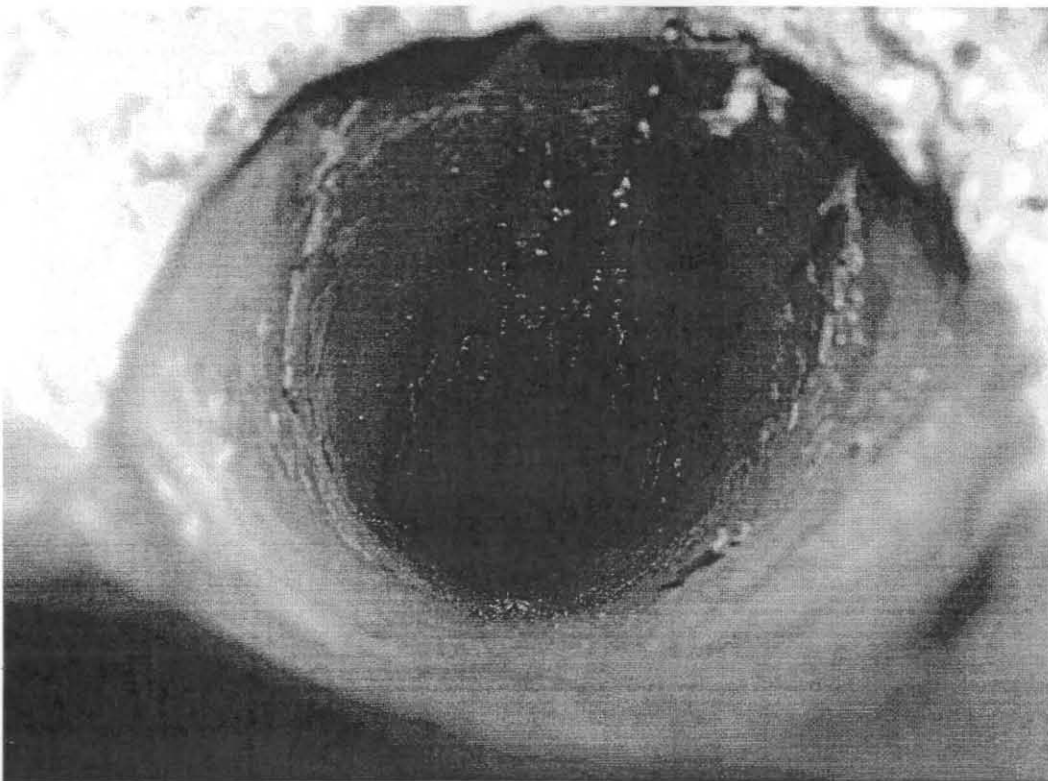
*The downspout outlets from the cornice gutter form a "Y" juncture with the condensate drainage outlets in the attic, draining into internal downspouts routed through four of the columns. [JGWA,*

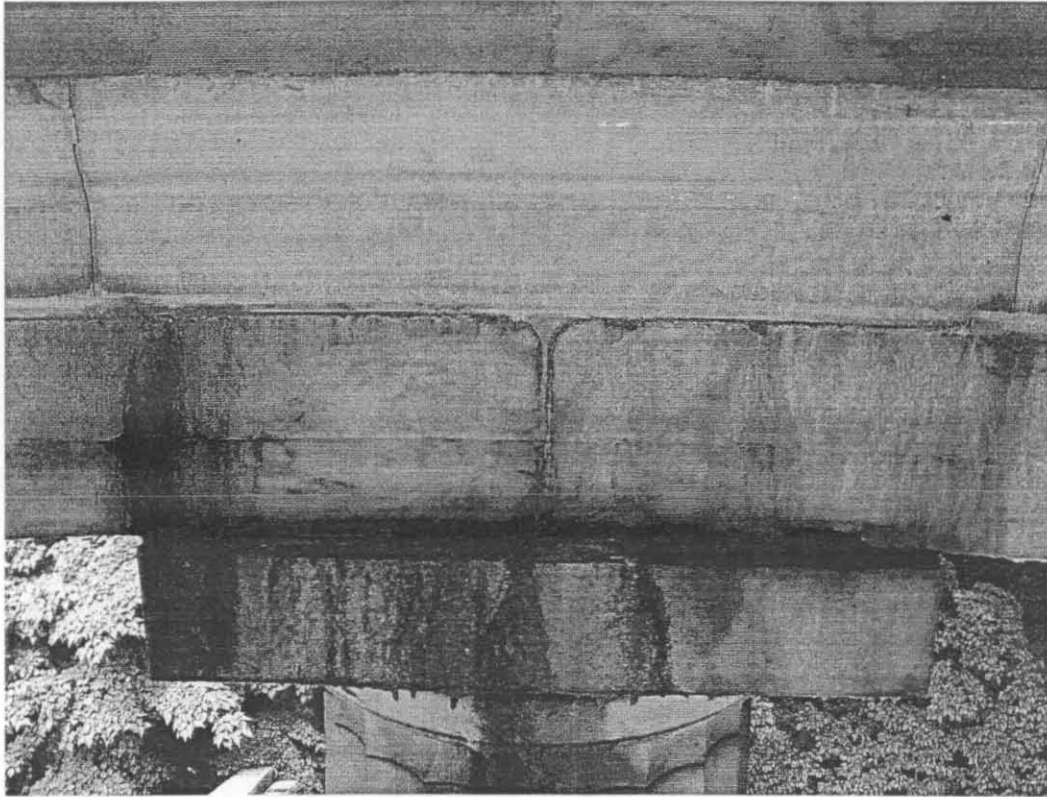
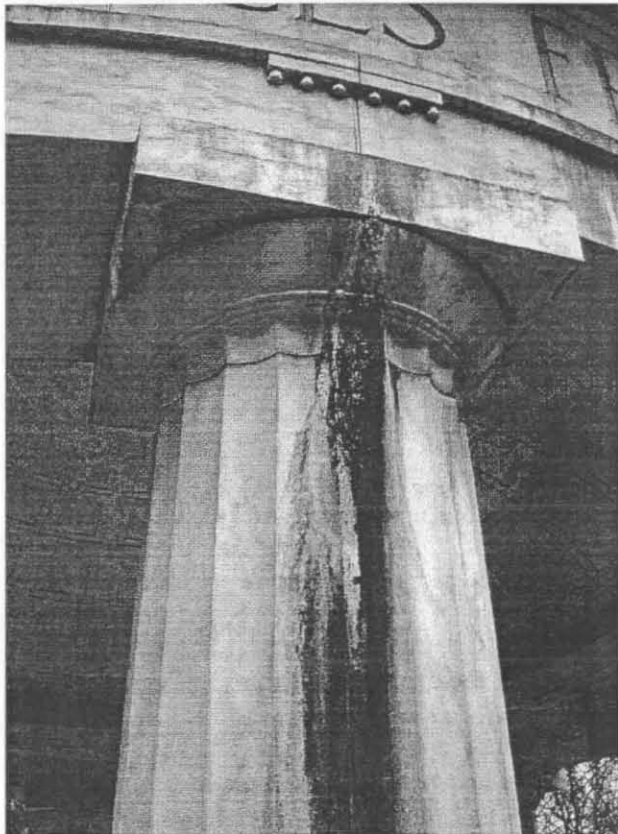
*Most of the column capitals are heavily encrusted with calcium carbonate resulting from the percolation of water through the masonry construction. The staining on the capitals and columns is partially attributable to the dry deposition of sulfur contaminants and the formation of gypsum. [JGWA, 2005]*

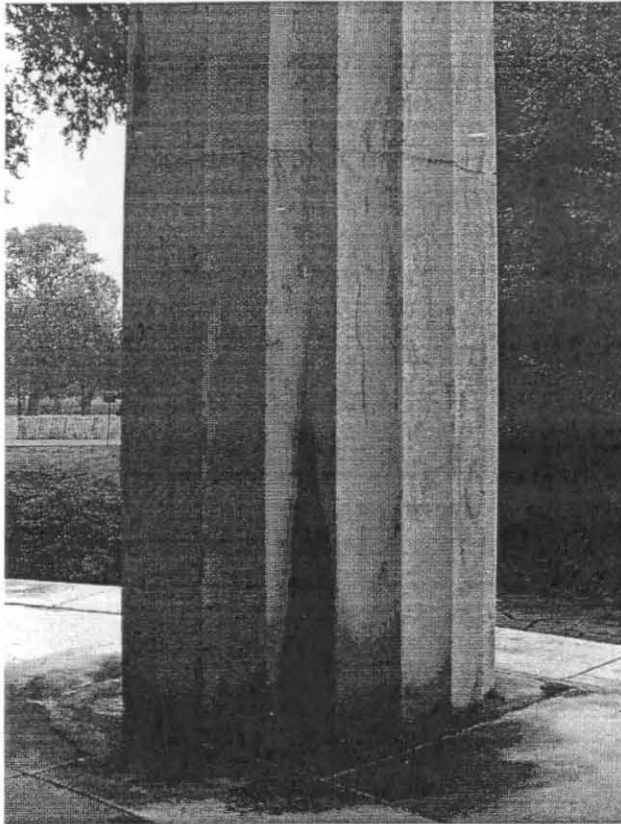
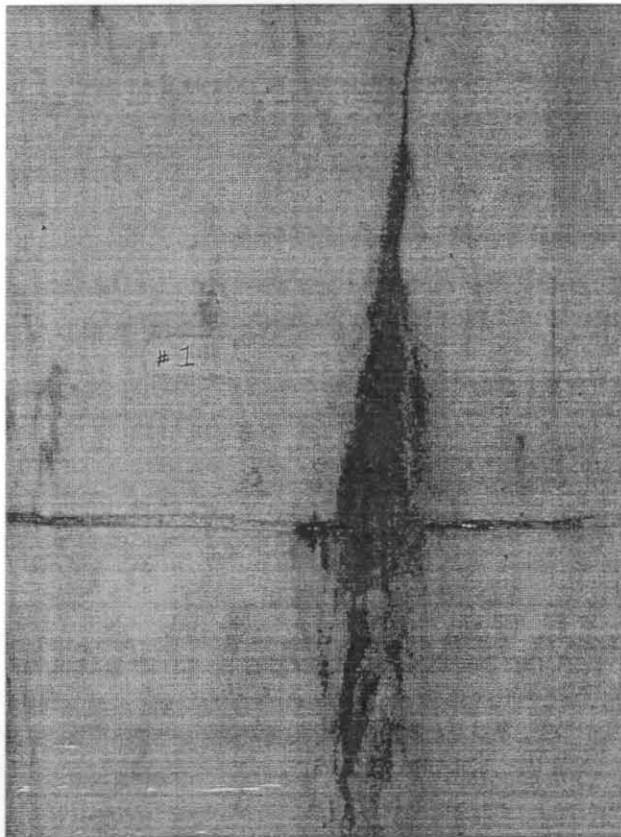
*The vertical staining on column 1 (lower photograph) and on column 4 (upper photograph) is indicative of the staining that has occurred on the four columns with failed internal downspouts. The stains originate at fissures and imperfections in the marble where the storm water drainage has escaped. [JGWA, 2005]*

Field observations on July 15, 2005, revealed that the downspouts in Columns 1, 4, 7, and 10 have apparently failed. Original specifications indicate that these downspouts were of cast-iron construction. Water was found leaking from the horizontal base joints at each of these columns. This appears to be a chronic problem because the constant presence of water on the marble paving at the base of these columns is supporting the growth of algae.

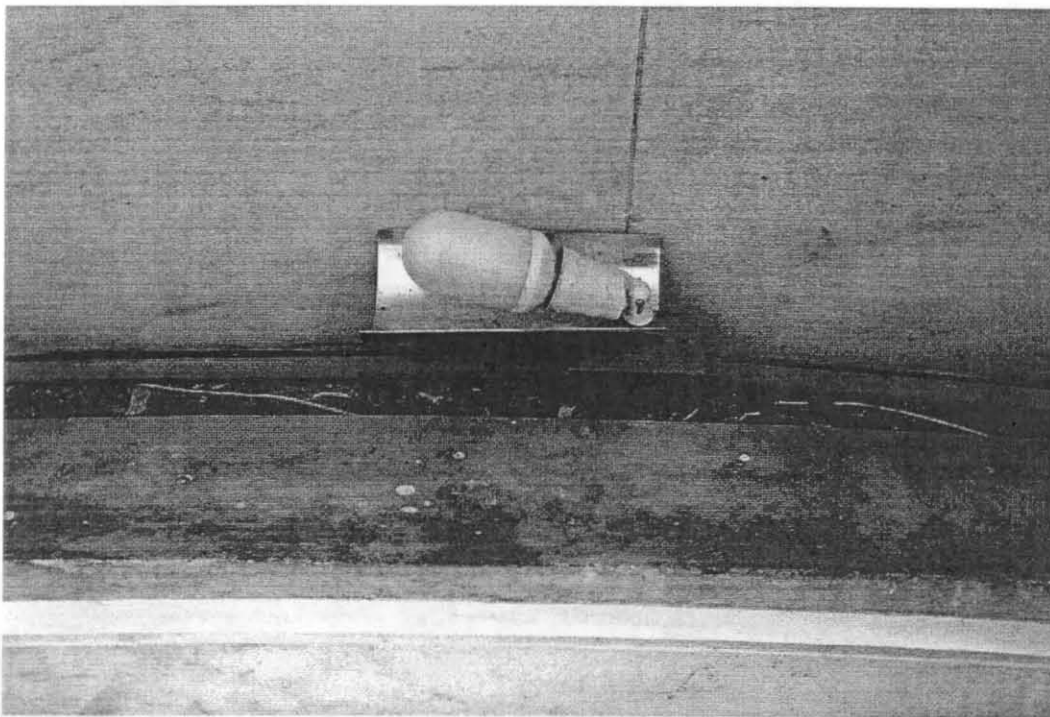
*Modern fluorescent lighting has replaced the original incandescent cove lighting at the base of the lower dome. The quality of the fluorescent lighting detracts from the historic character of the Memorial. [JGWA, 2005]*

Alternate: Install sheet metal flashings and drip edges over the capstones at the base of the outer dome, and over the built-in gutter.
5. Replace the electrical panel box and circuit wiring that services the memorial.
6. Replace the cove lighting beneath the lower dome.

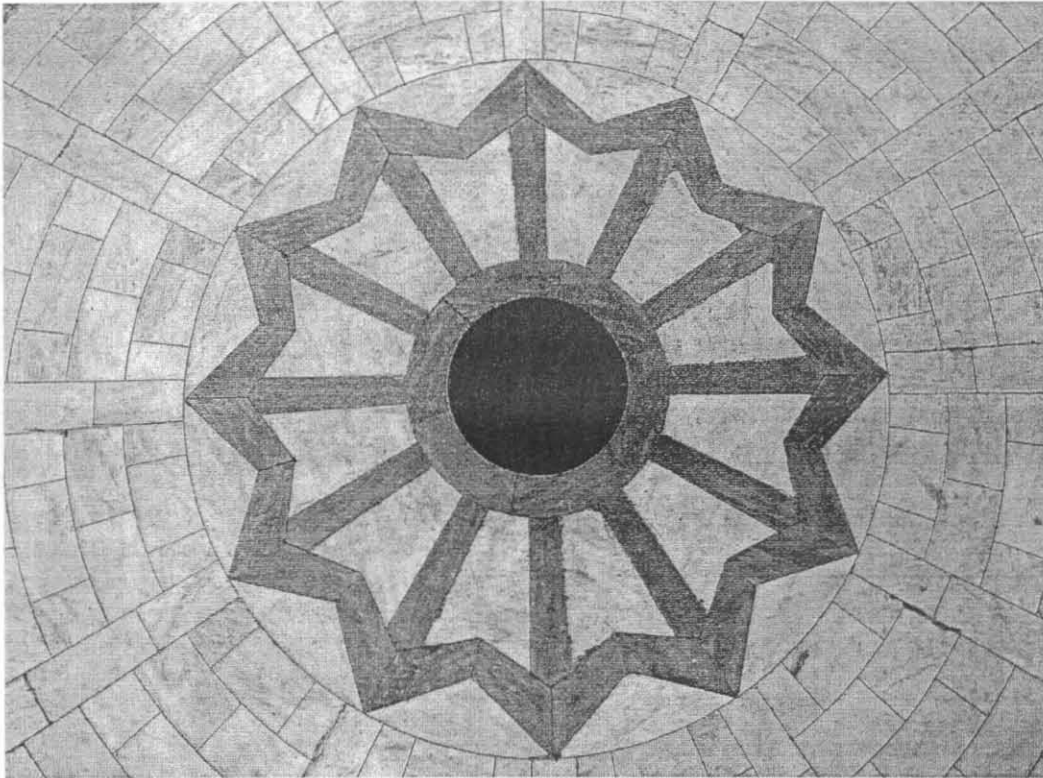
*The floor of the Memorial. The original decorative access cover to the vault at the center of the marble floor was stolen in 1970, and has been replaced by a steel cover. [JGWA, 2005]*

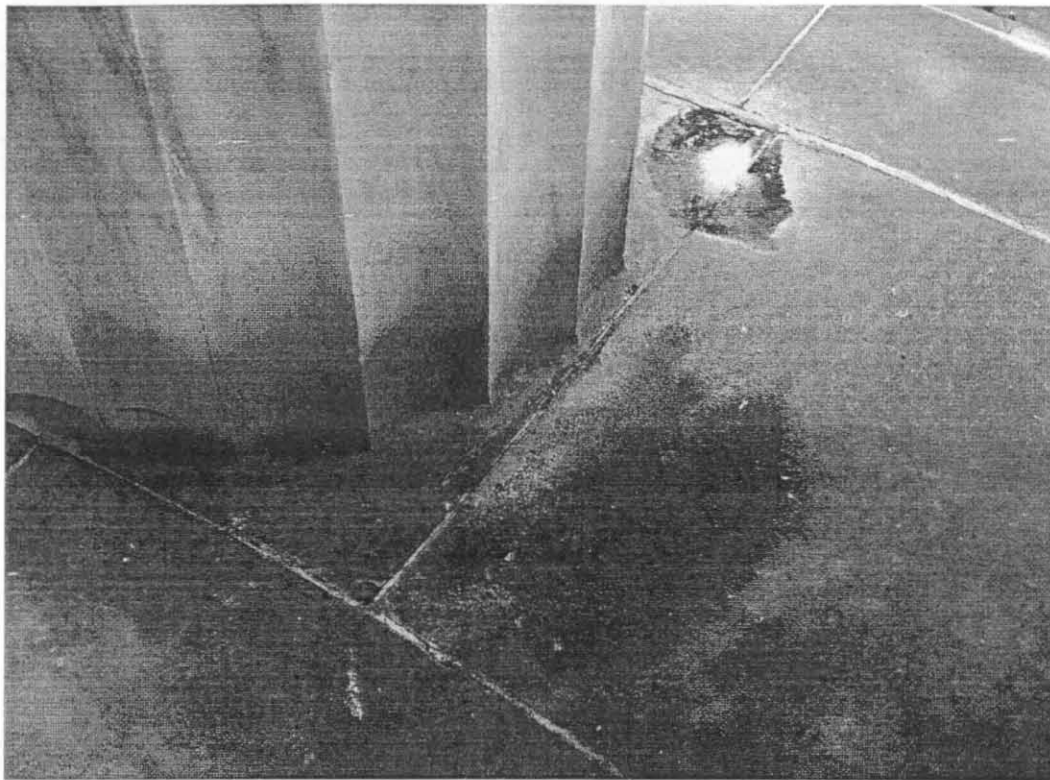
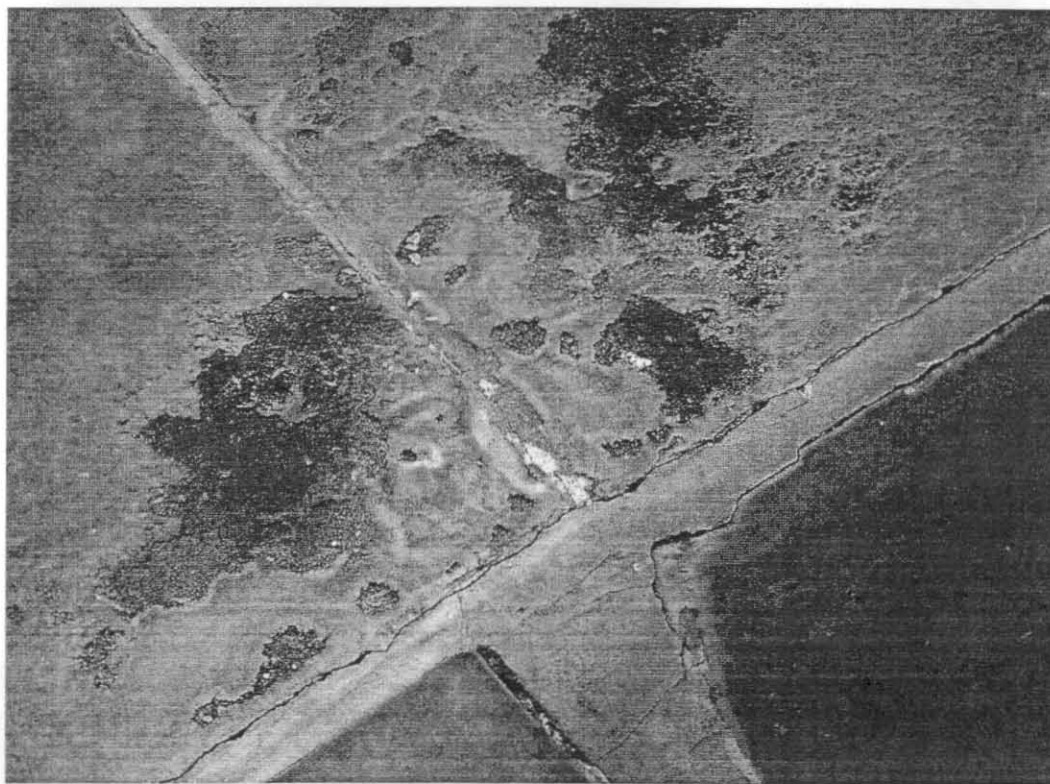
*Between the bases of the columns, the marble floor is darkly stained. Areas of encrustation are pronounced in these locations. [JGWA, 2005]*

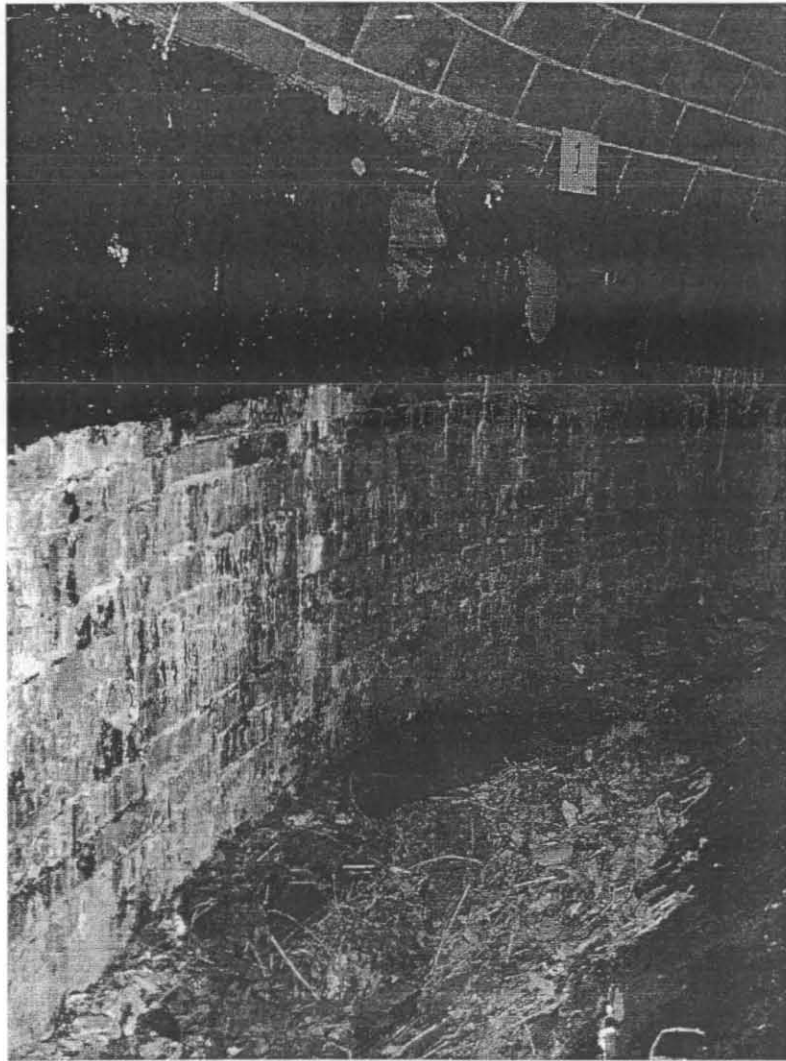
*A significant buildup of debris has occurred in the attic space adjacent to an air vent at the base of the upper dome. The waterproof coating on the drum of the dome appears to have delaminated as the result of water infiltration and freeze-thaw cycling. Efflorescence is visible on the brick drum. [JGWA, 2005]*

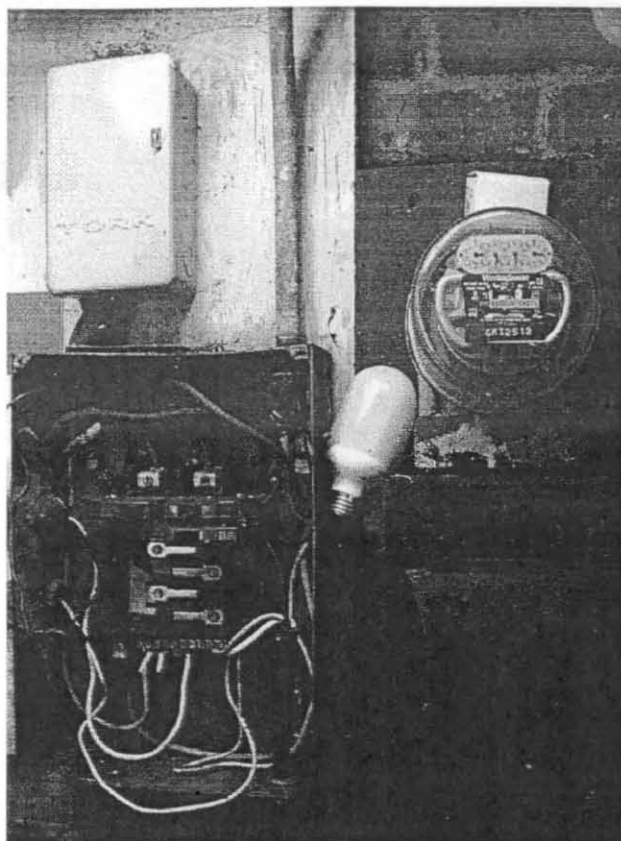
*An open electrical junction box and a panel box with exposed conductors are located in the electrical vault beneath the Memorial. These are significant electrical shock hazards. [JGWA, 2005]*

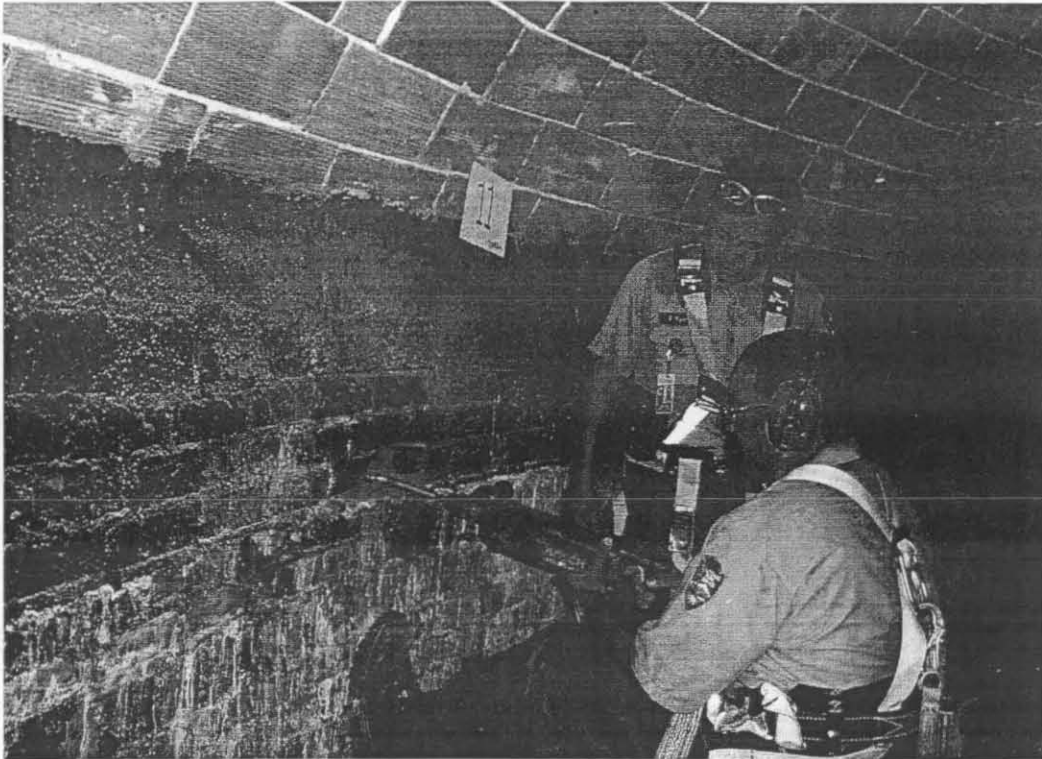
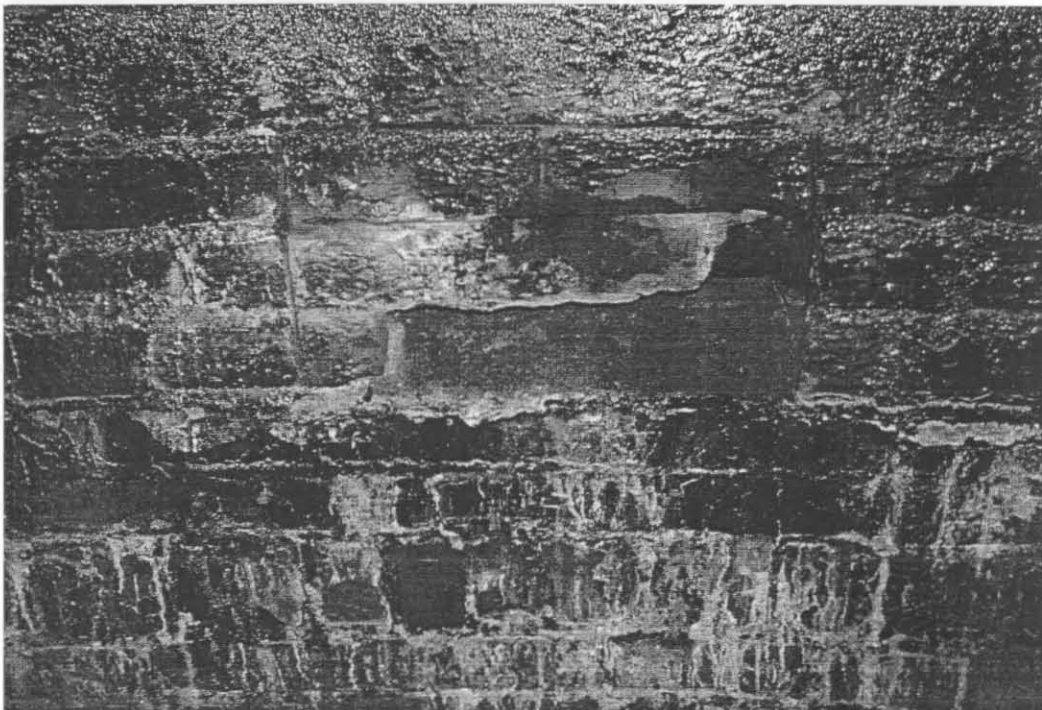
*Probe A investigated the condition of the steel angle tension ring at the base of the upper dome. Binh Nguyen and Ray Wooden of the National Park Service removed brick and mortar from the drum construction supporting the dome. The probe was located between columns 10 and 11. [JGWA, 2005]*

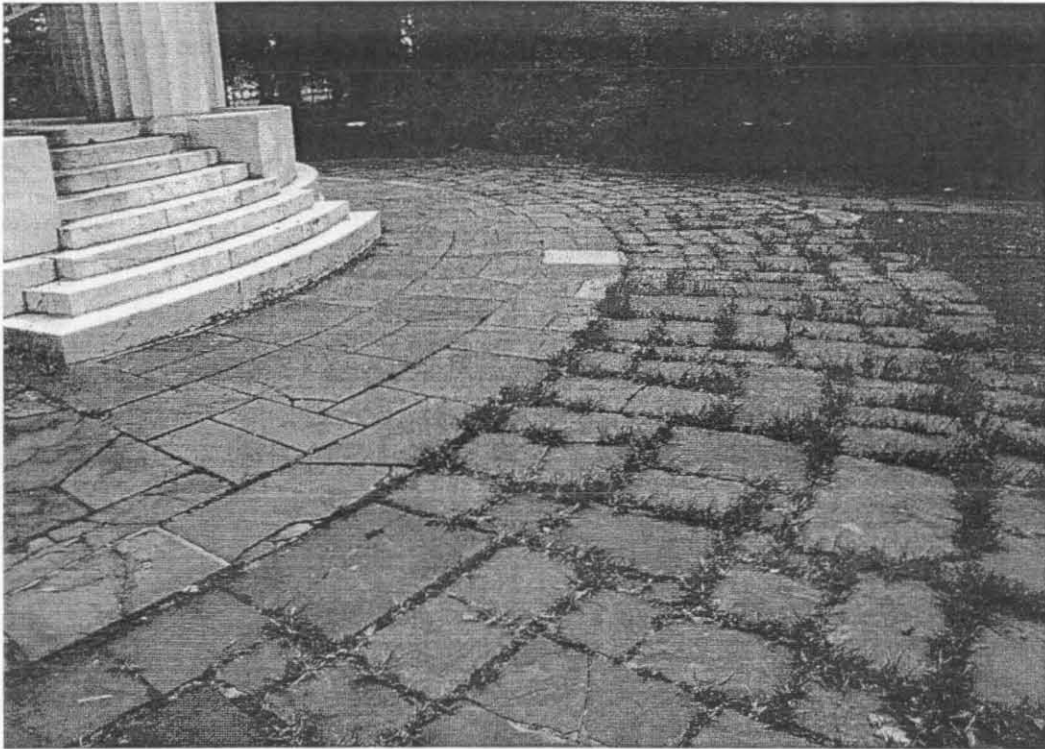
*The outer walk with gravel base has weed infiltration, while the inner walk on concrete does not. [EDC, 2005]*

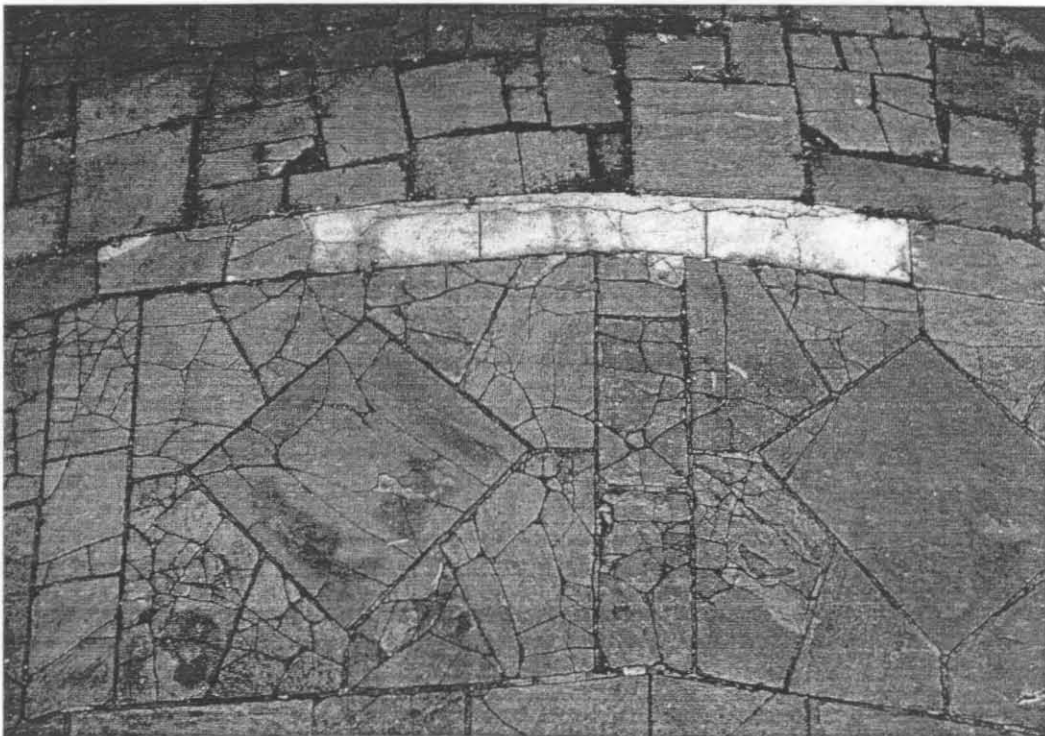
*The inner walk has an ornate pattern, while the outer walk is paved with random-cut flagstones.. Note the broken stones due to vehicular traffic. [EDC, 2005]*

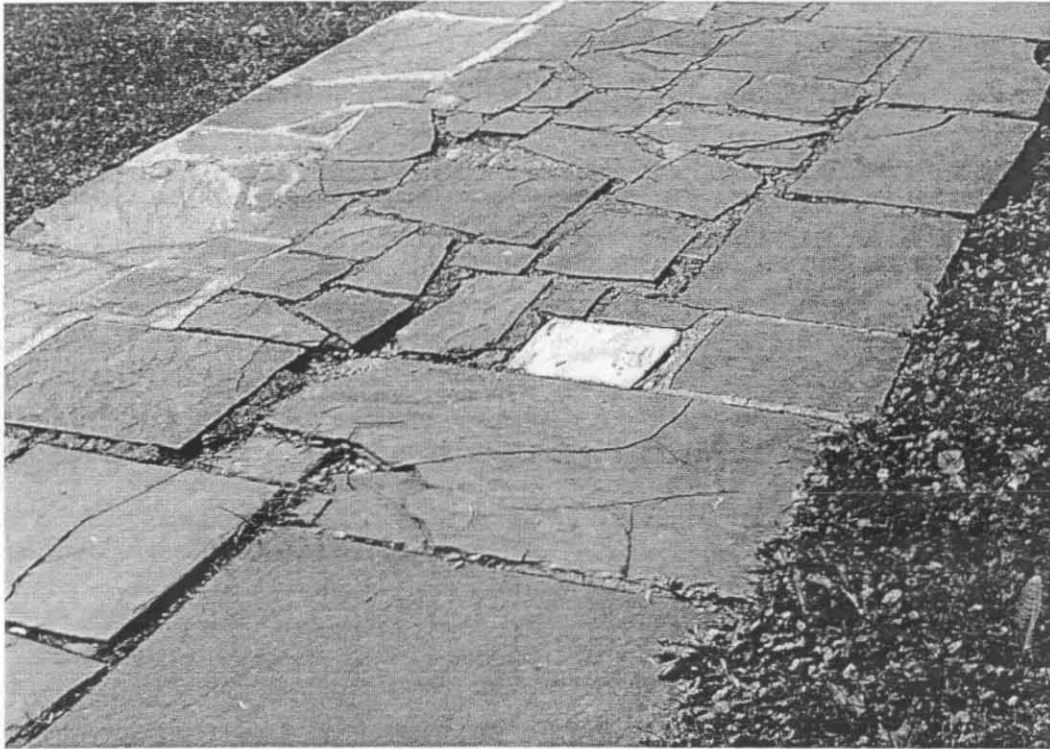
*Concrete has been used to fill in missing flagstones. [EDC, 2005]*

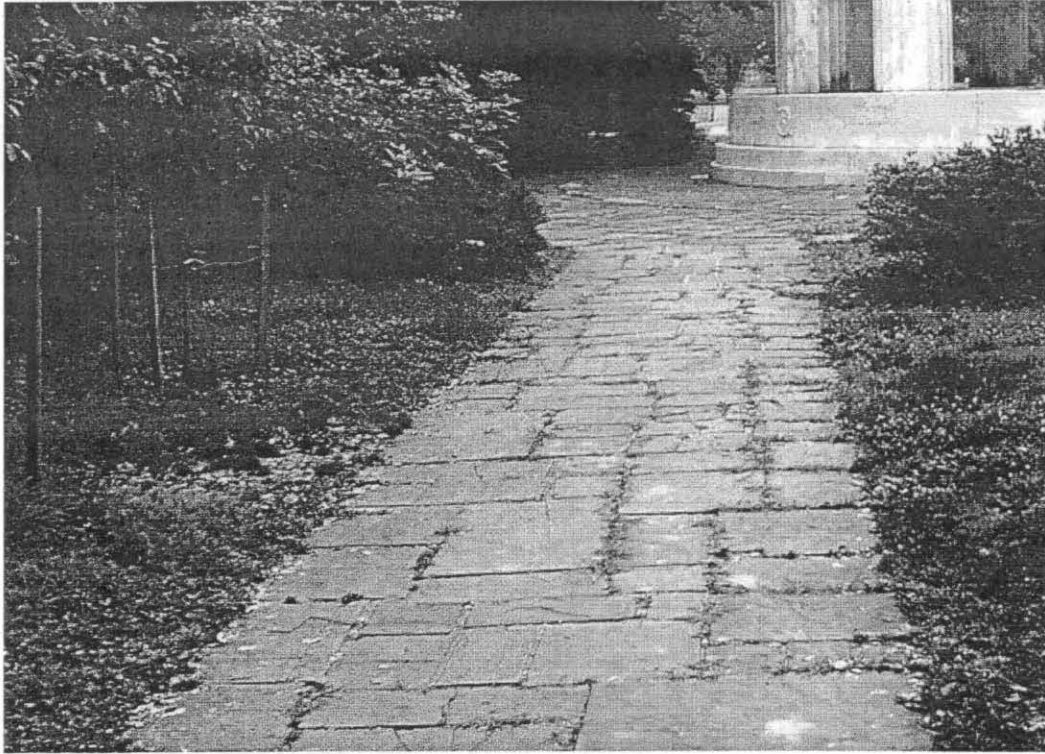
*Weed infiltration along the flagstone walks. [EDC, 2005]*

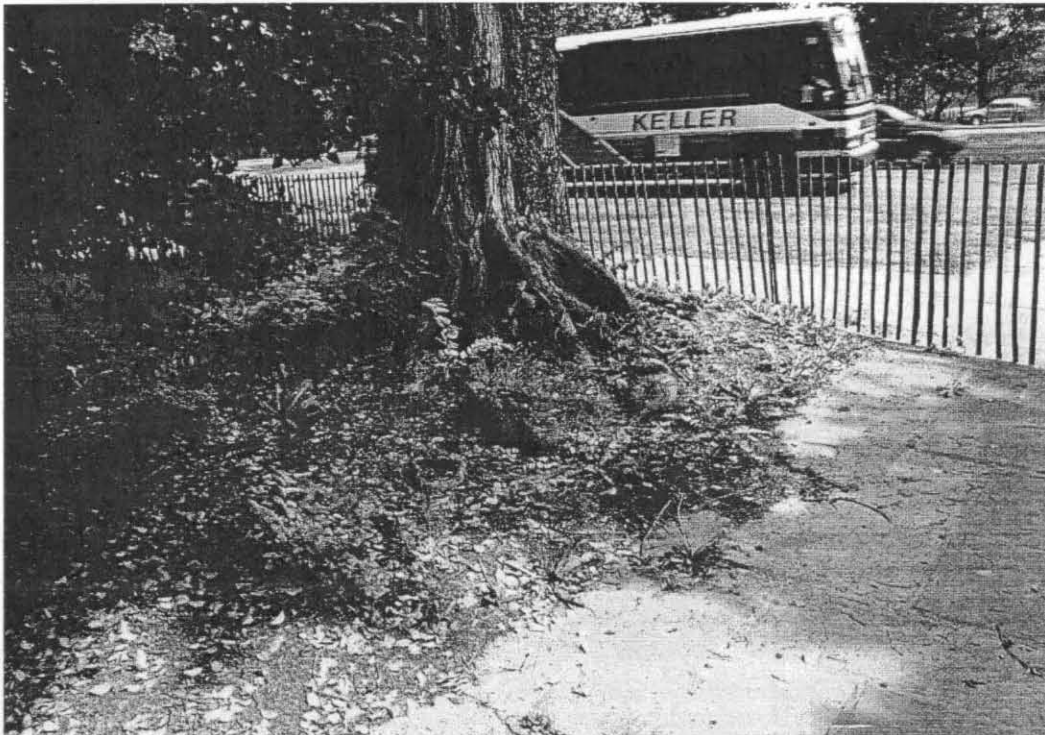
*The roots of this large elm tree are starting to damage the flagstone walk. [EDC, 2005]*
