# DISTRICT OF COLUMBIA WAR MEMORIAL

Historic Structure Report  
& Cultural Landscape Assessment

National Mall & Memorial Parks  
PMIS NO. 43699

May 2006

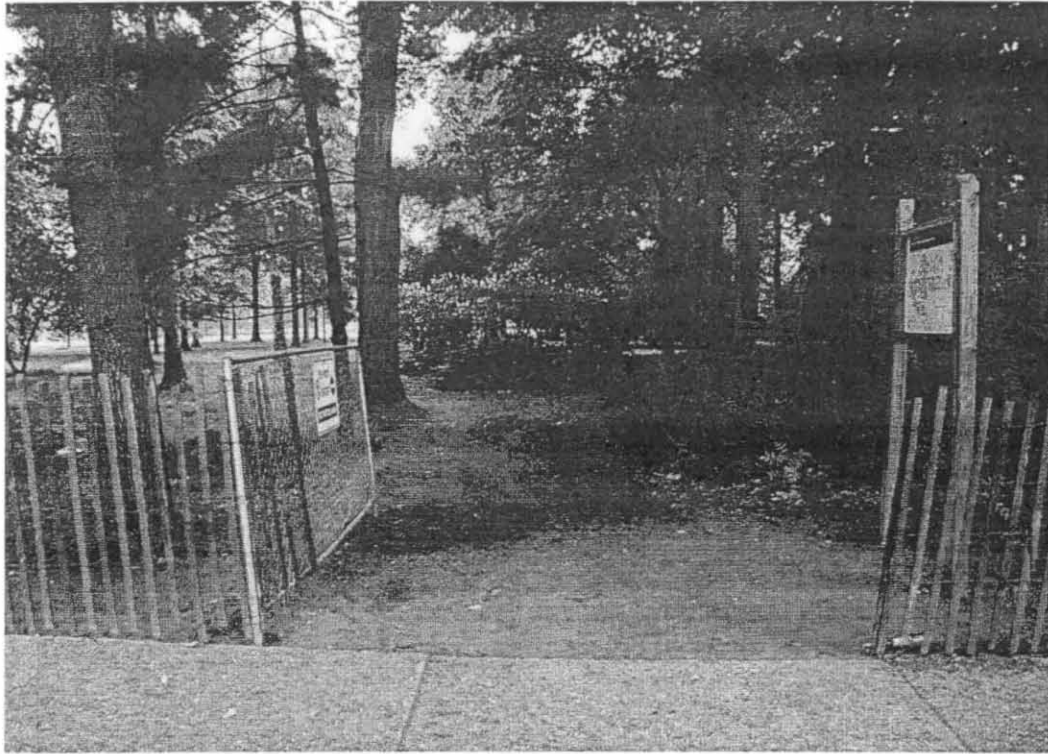
*A major wear trail begins at the crosswalk along Independence Avenue and north of West Basin Drive. [EDC, 2005]*

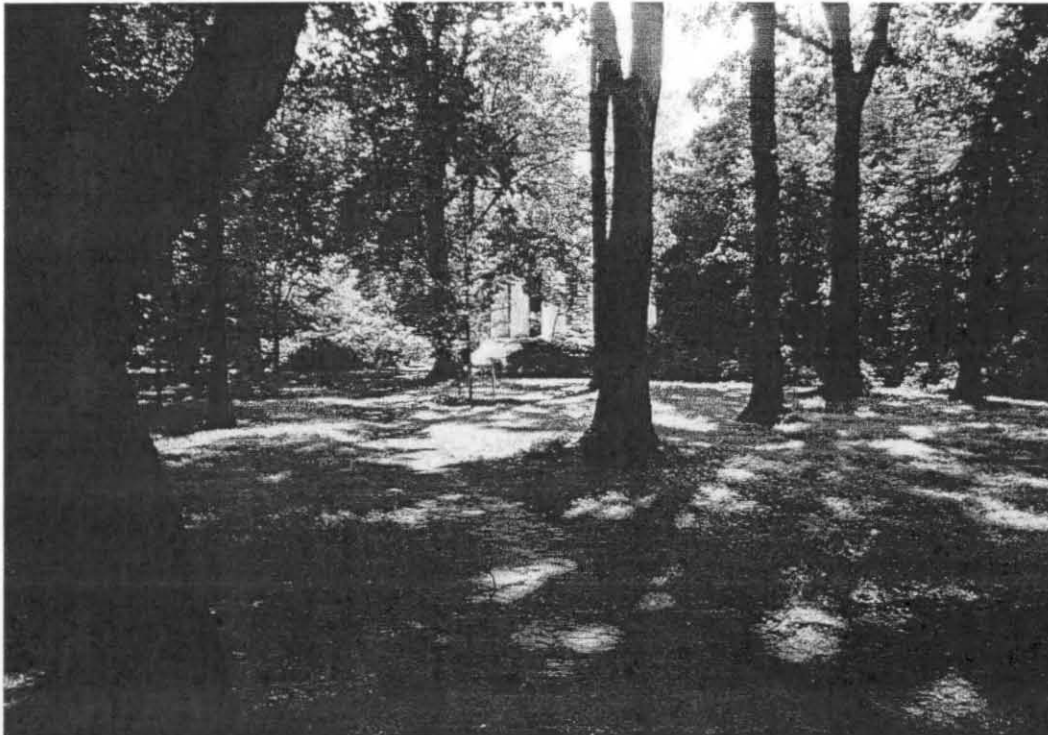
*Wear trail between the Memorial and the public restrooms. [EDC, 2005]*

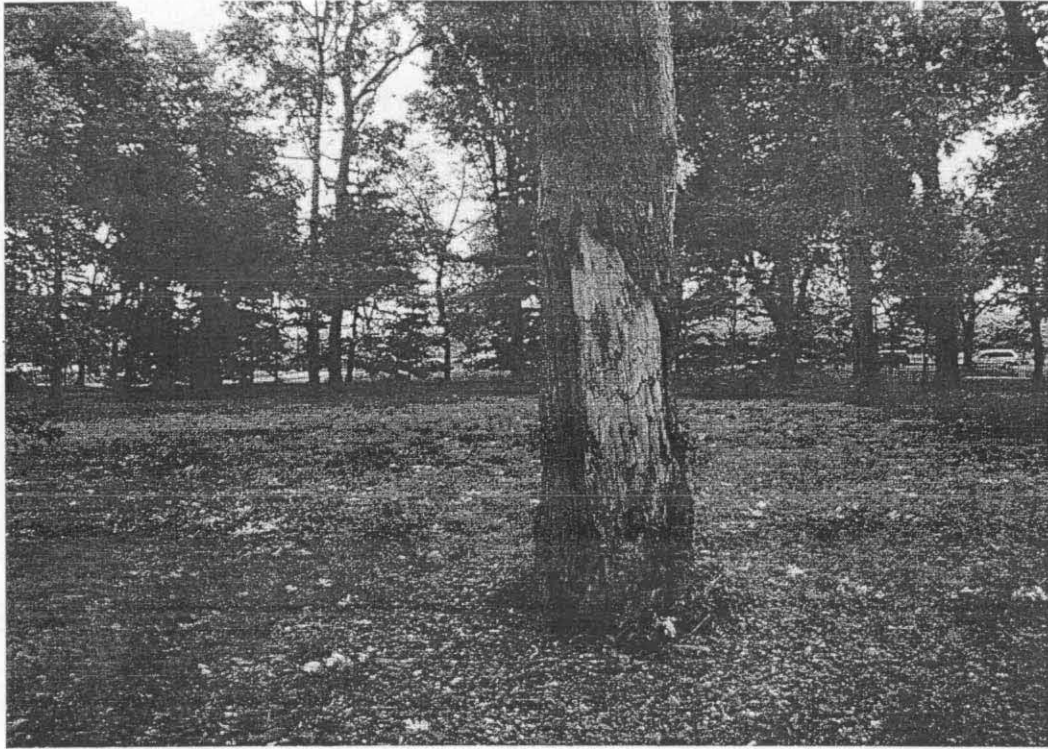
*Mechanical damage to some trees does exist. [EDC, 2005]*

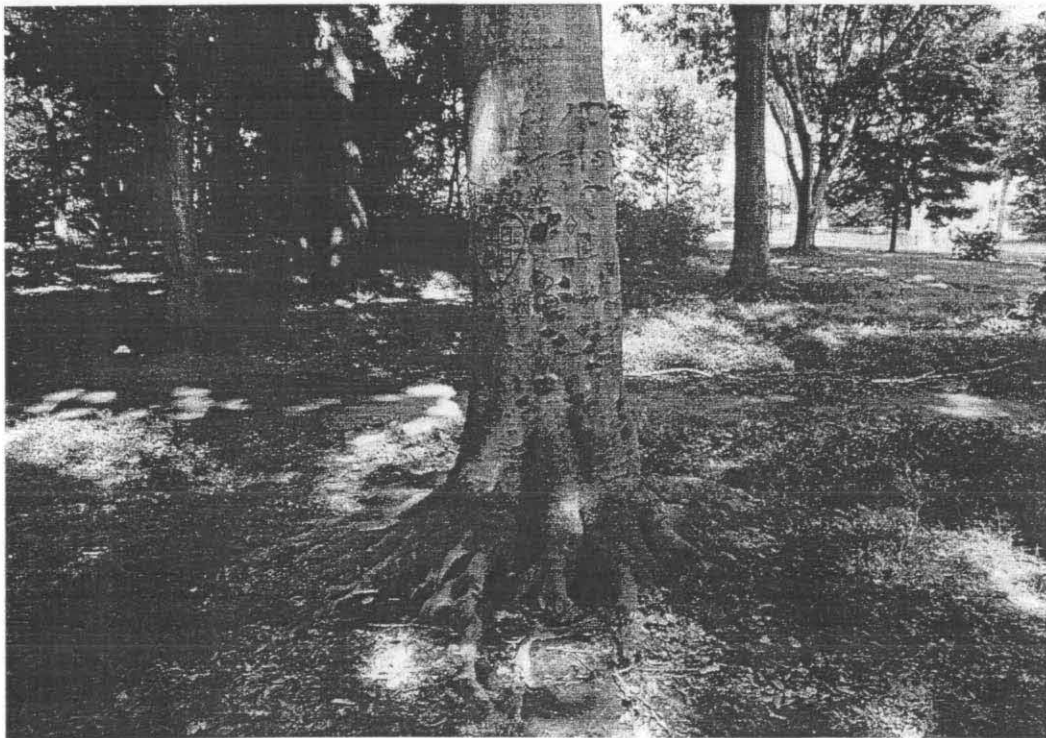
*Vandals have carved graffiti into the beech trees. [EDC, 2005]*

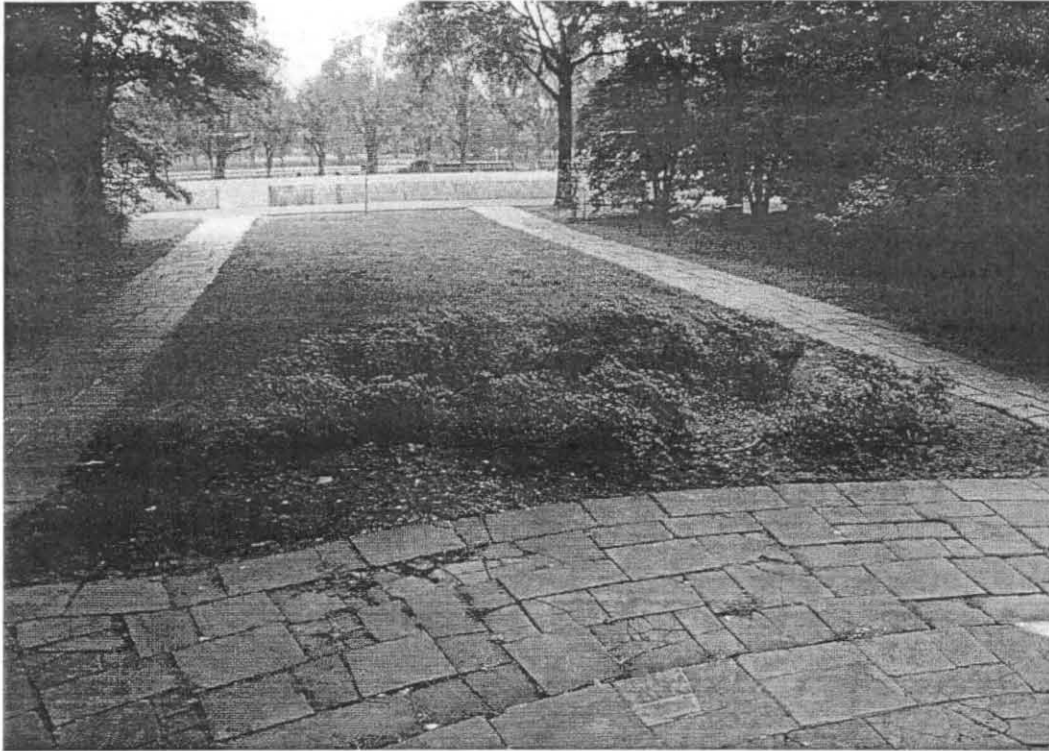
*Azaleas located north of the Memorial are in poor condition. [EDC, 2005]*

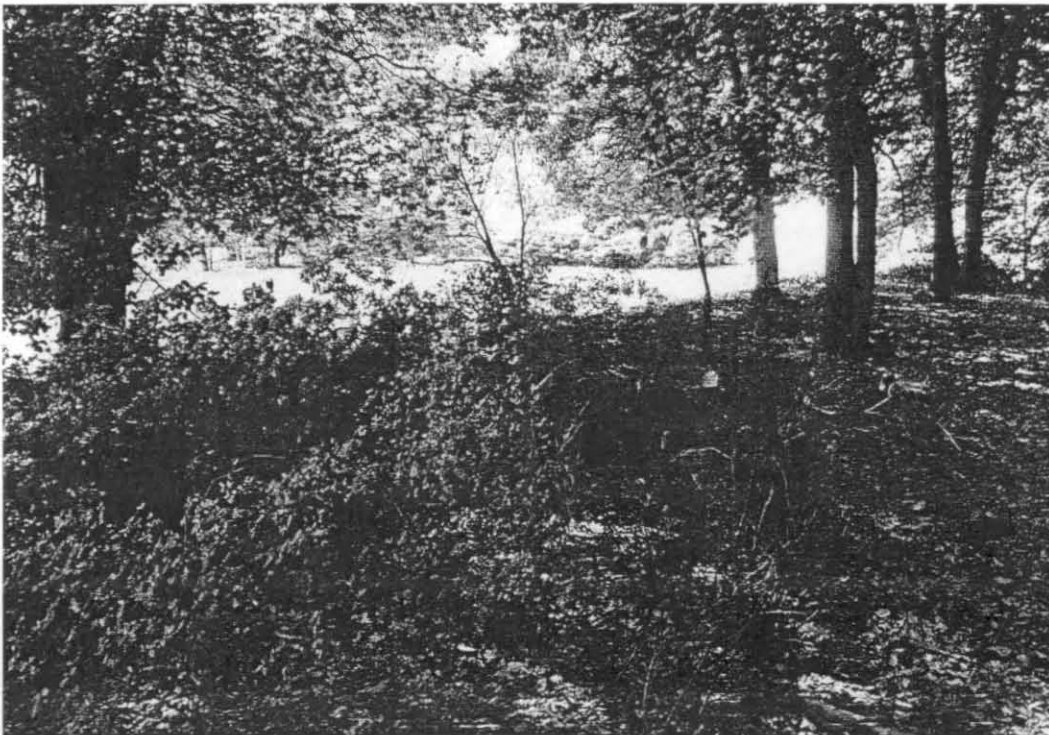
*The azaleas are shaded by the trees above and are in poor to fair condition. [EDC, 2005]*

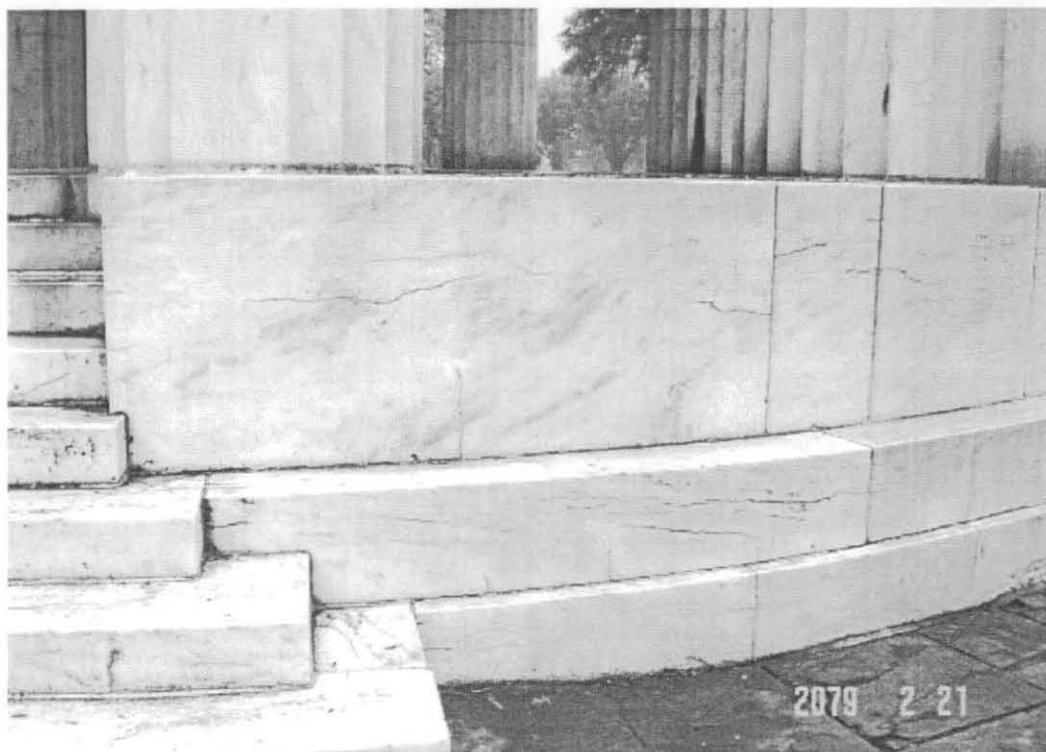
*Dark-colored biological growth is present on marble in shaded areas. The blocks exhibit surface cracking. [MSSC, 2005]*

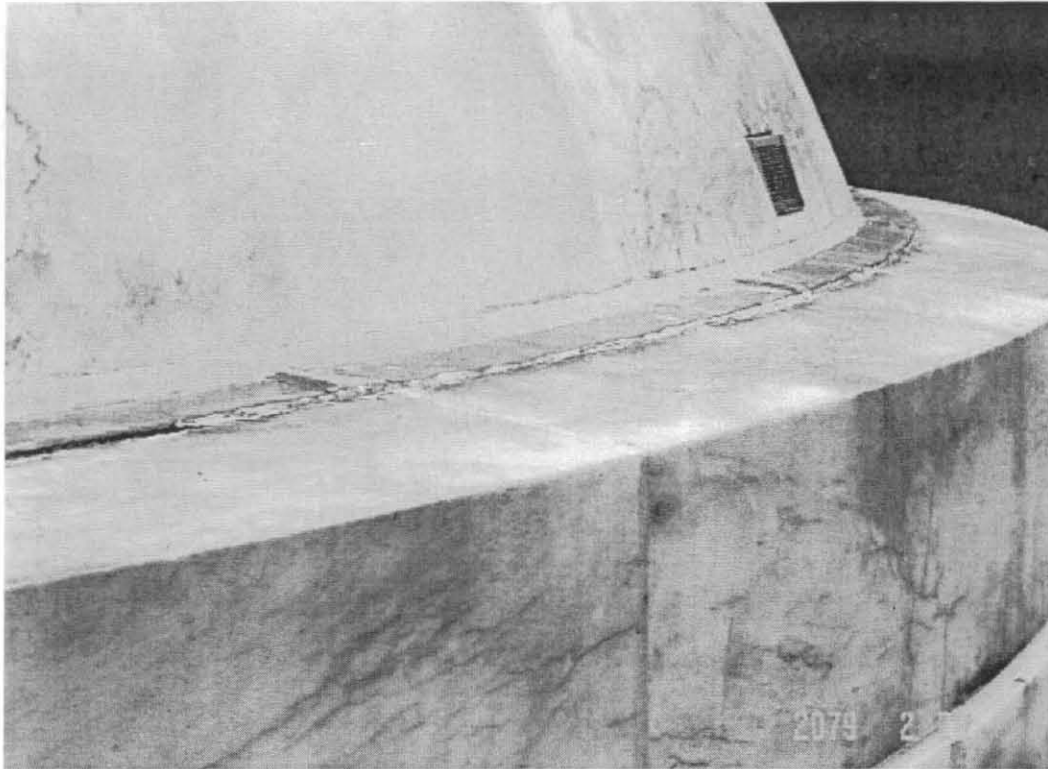
*The bright orange stains on several locations on the dome exterior are below the marble surface. [MSSC, 2005]*

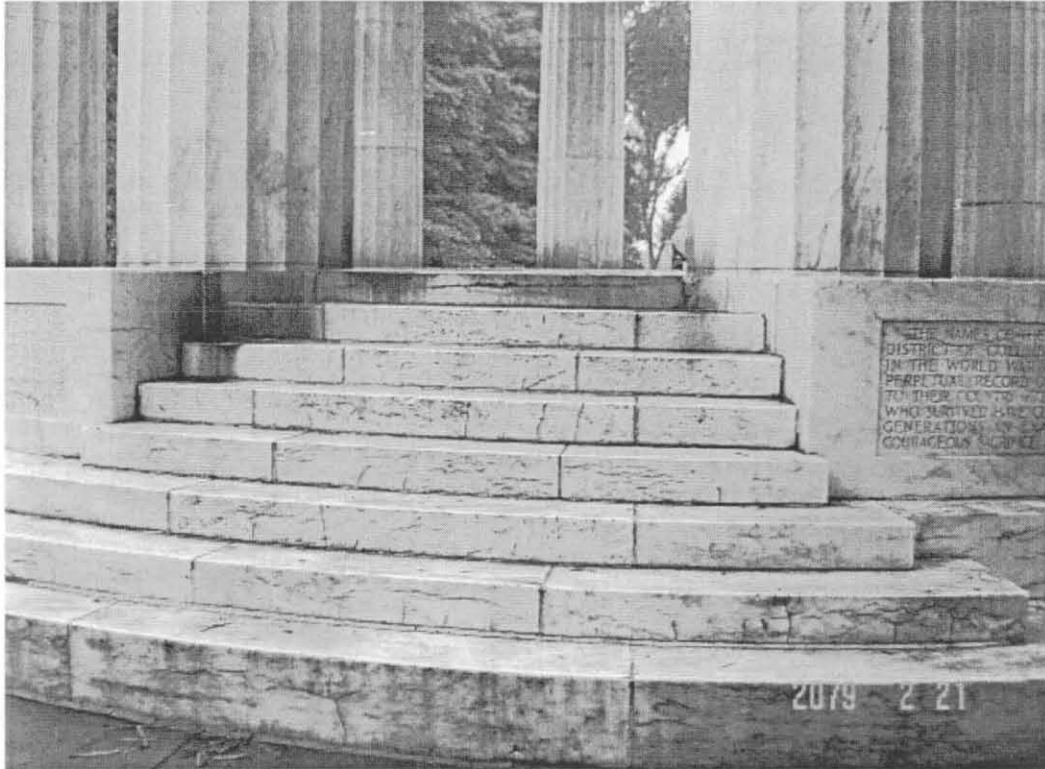
*In the marble base and stairs, the cracks are predominantly horizontal. [MSSC, 2005]*

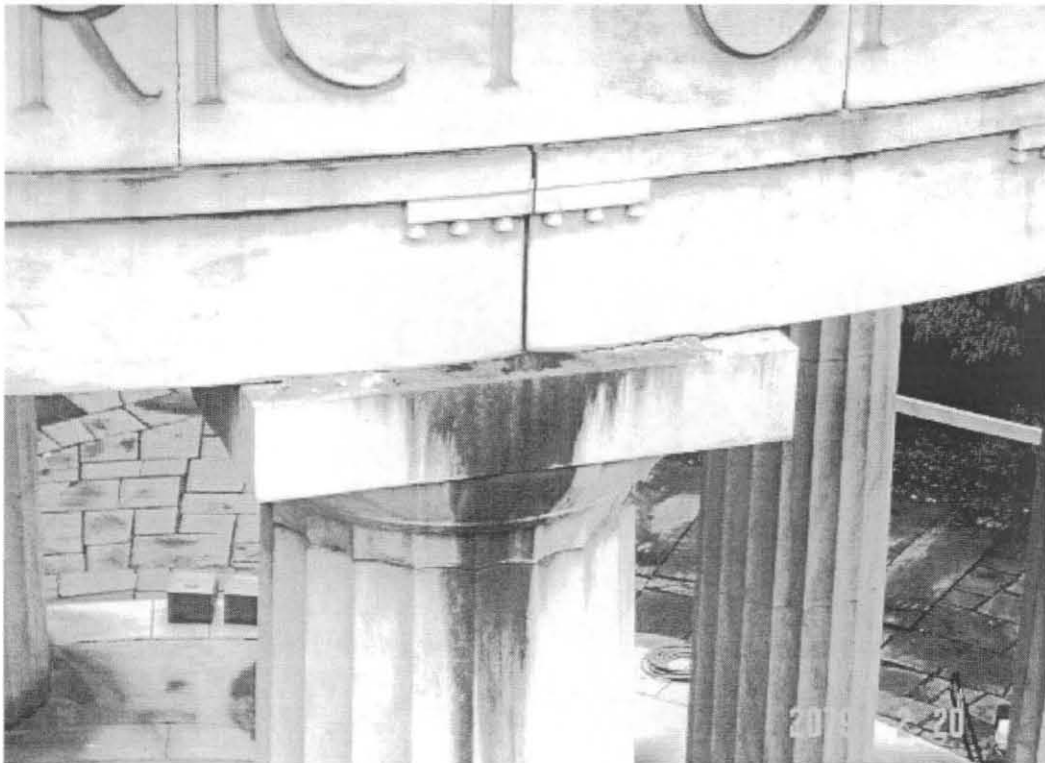
*An open head joint above a column. [MSSC, 2005]*

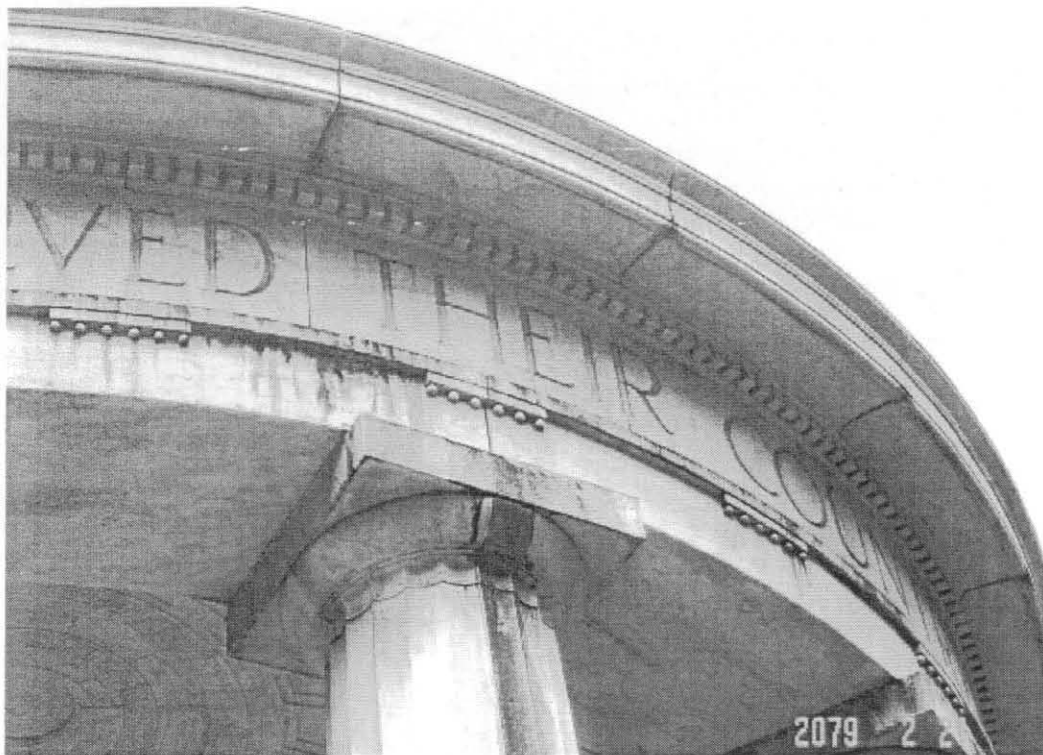
*Mortar is missing and deteriorated in many locations on the entablature. [MSSC, 2005]*

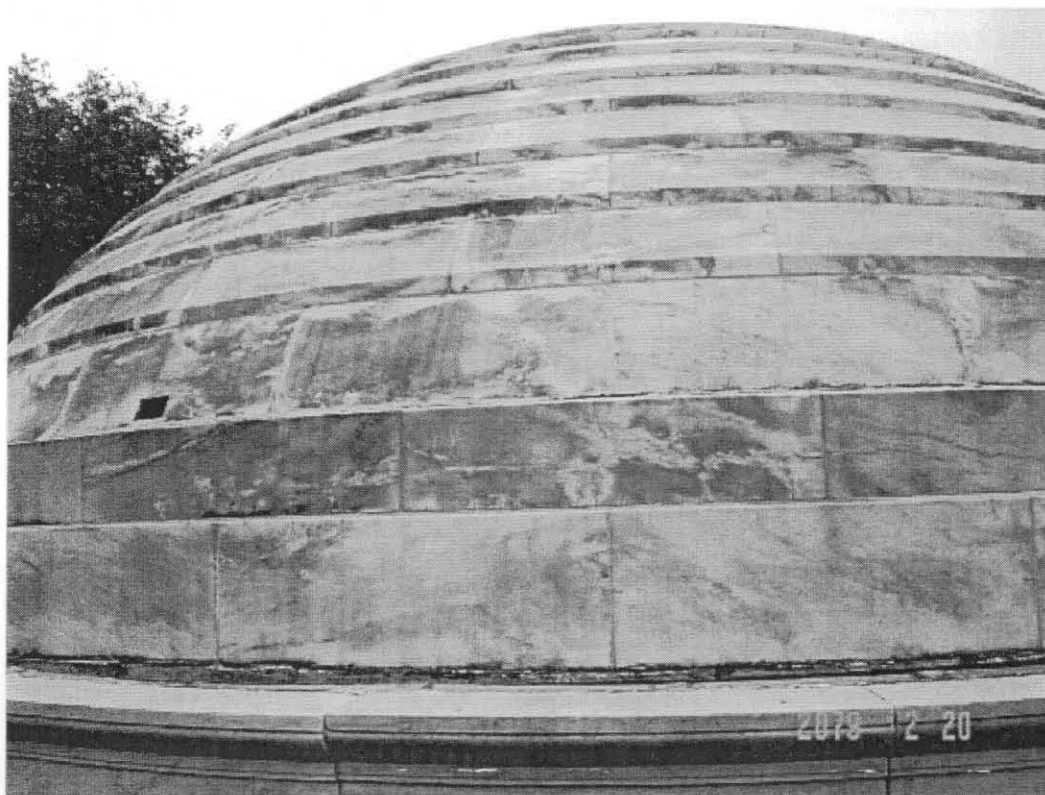
*The marble of the dome exhibits dark mottling. [MSSC, 2005]*

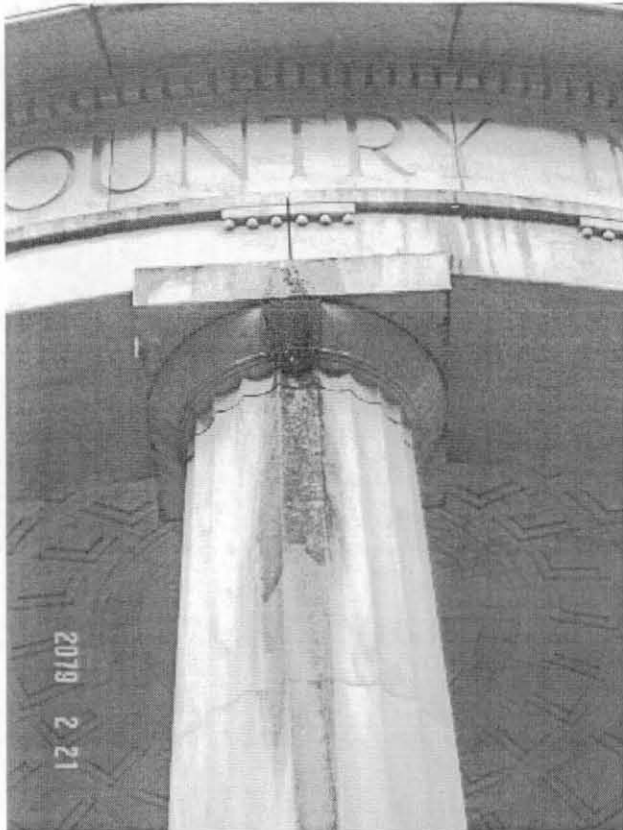
*Vertical staining on exterior of entablature and column. [MSSC, 2005]*

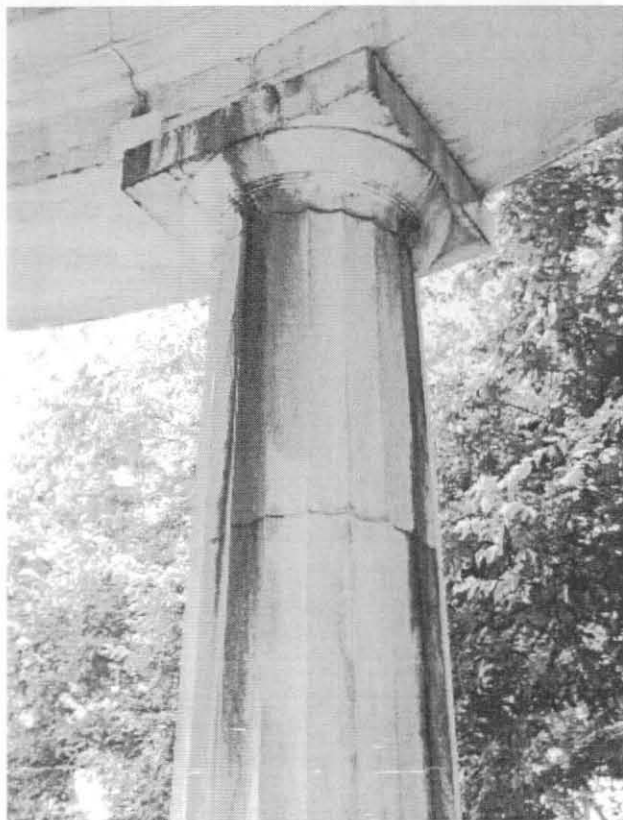
*Vertical staining on interior of column. [MSSC, 2005]*

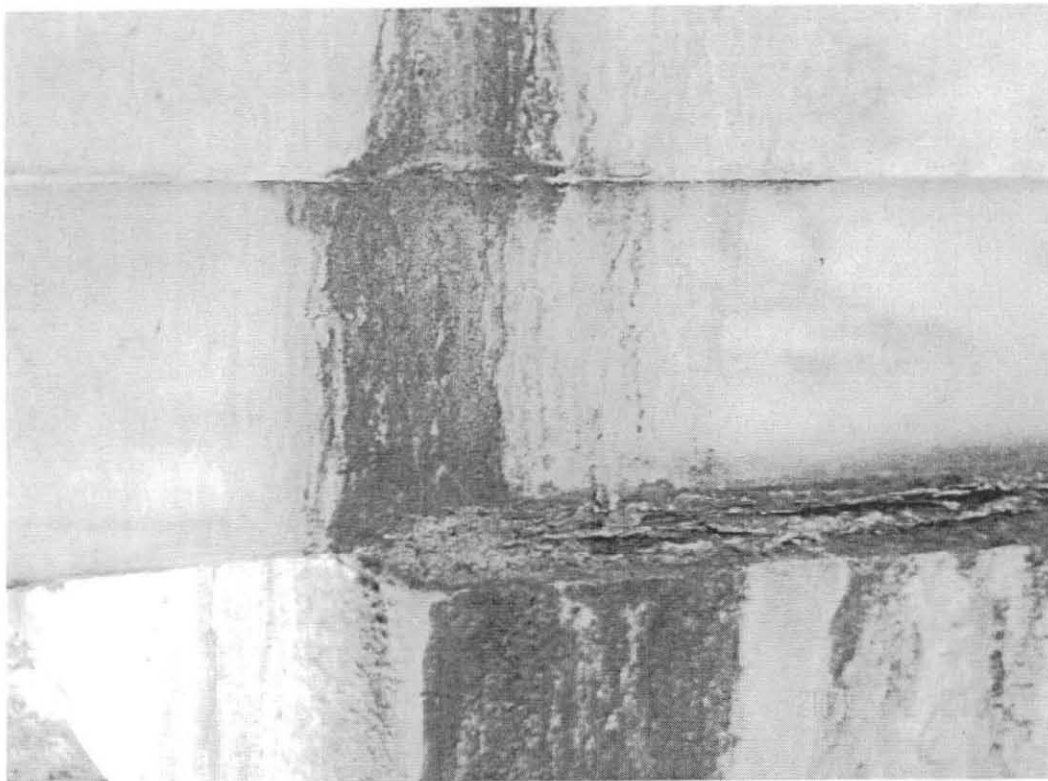
*Deposit of staining material on interior of entablature and column capital. [MSSC, 2005]*

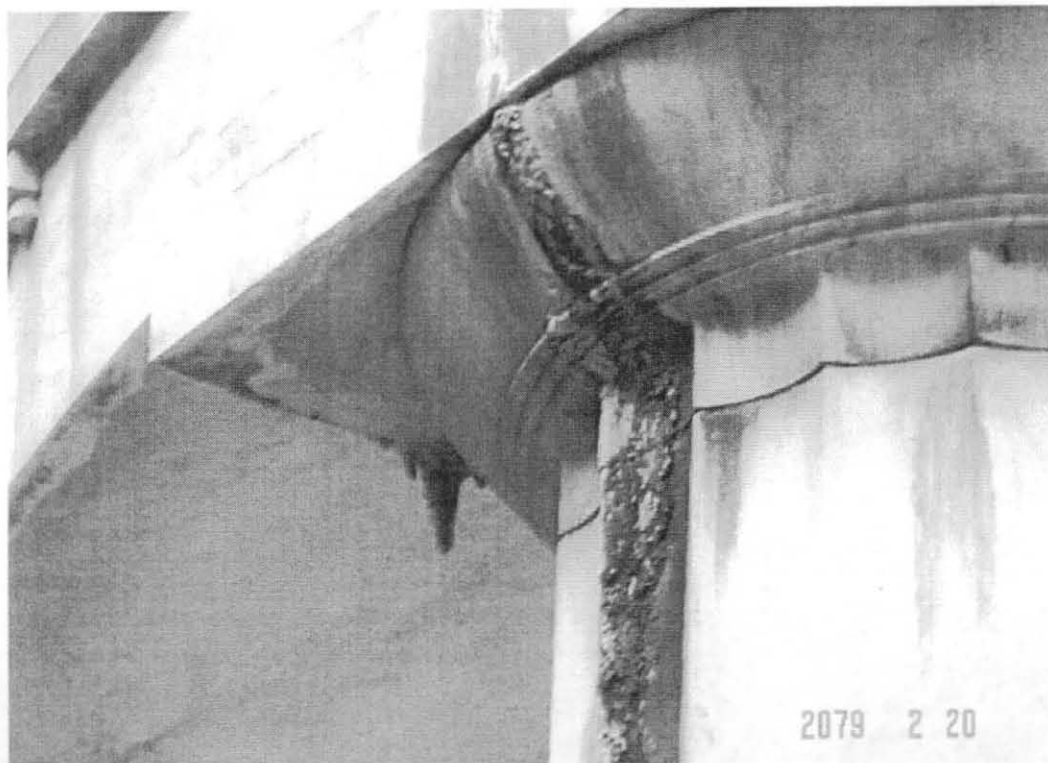
*Stalactite on base of entablature. [MSSC, 2005]*

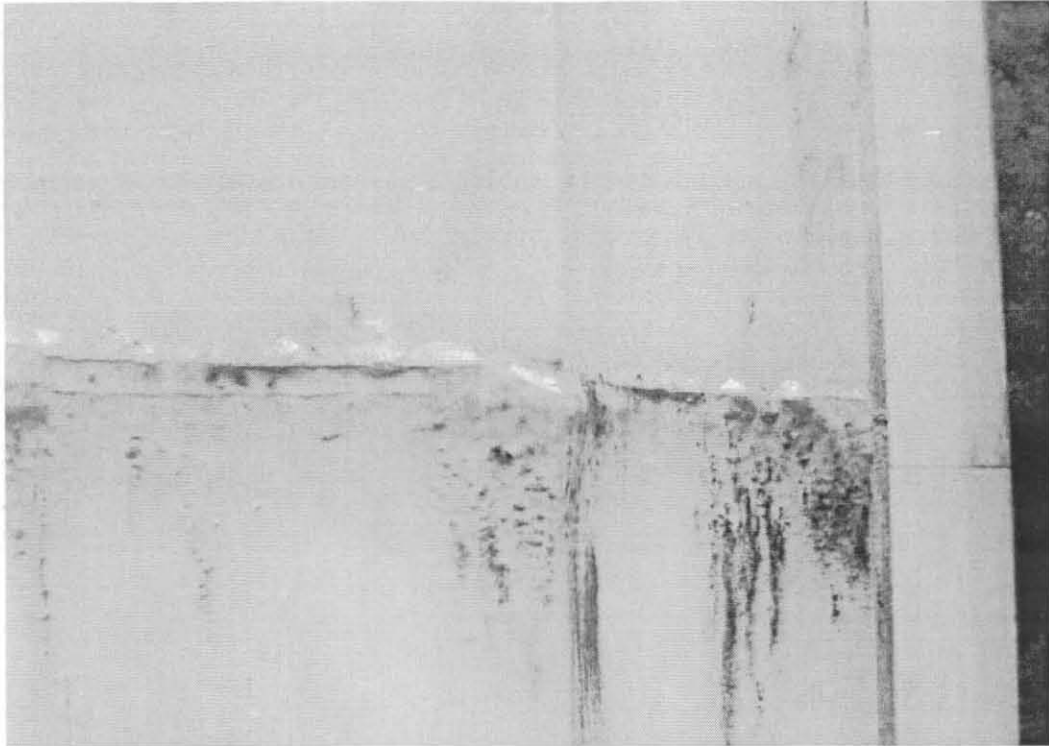
*Staining material at column horizontal joint. [MSSC, 2005]*

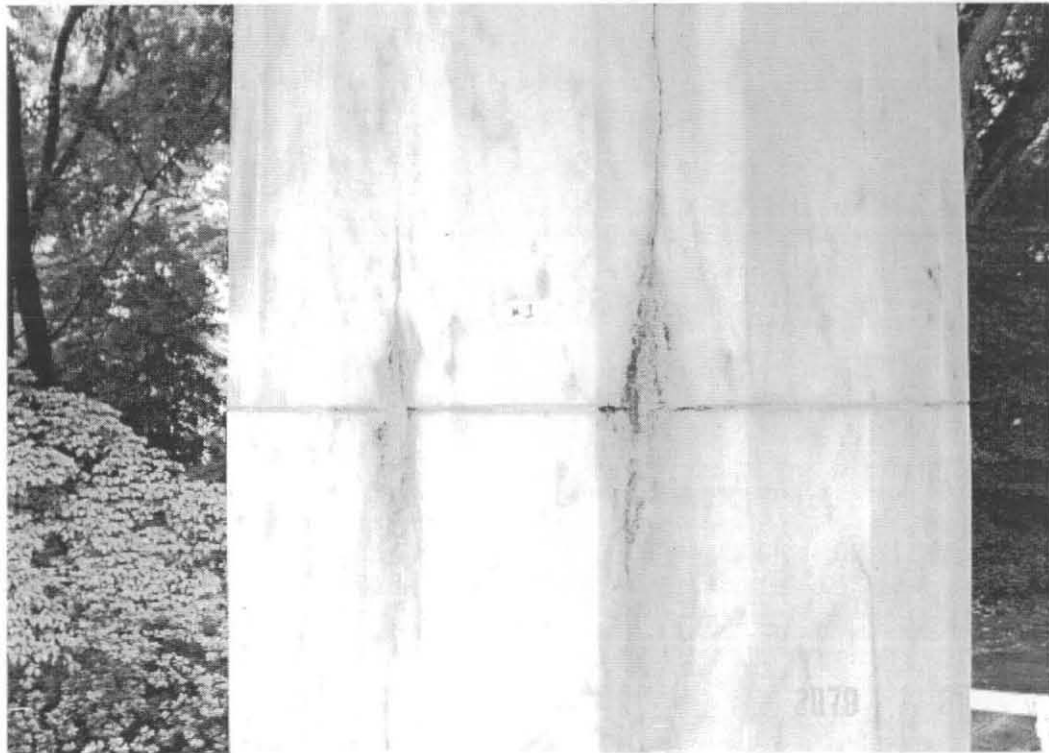
*Staining material at vertical crack in column. [MSSC, 2005]*

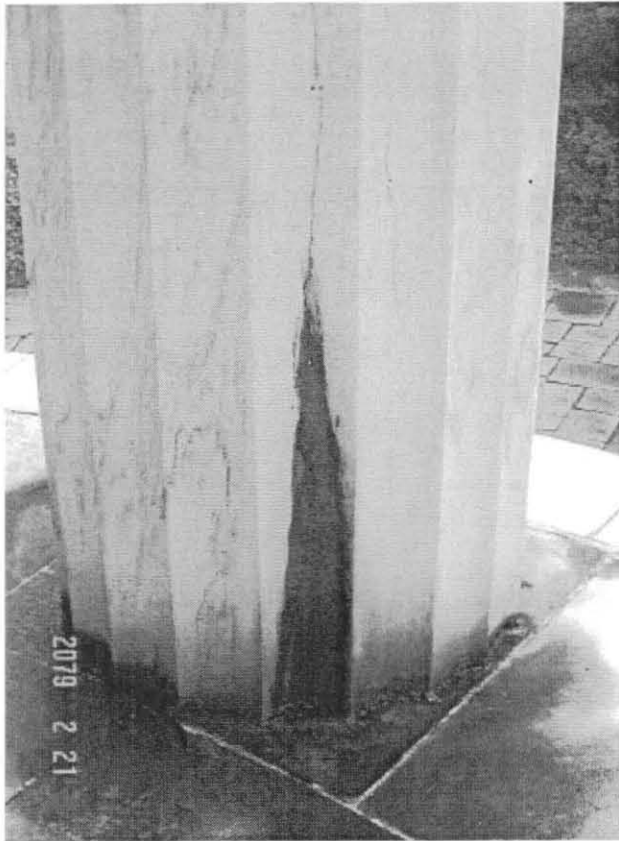
*Severe dark-colored vertical stain at the base of column 4. [MSSC, 2005]*

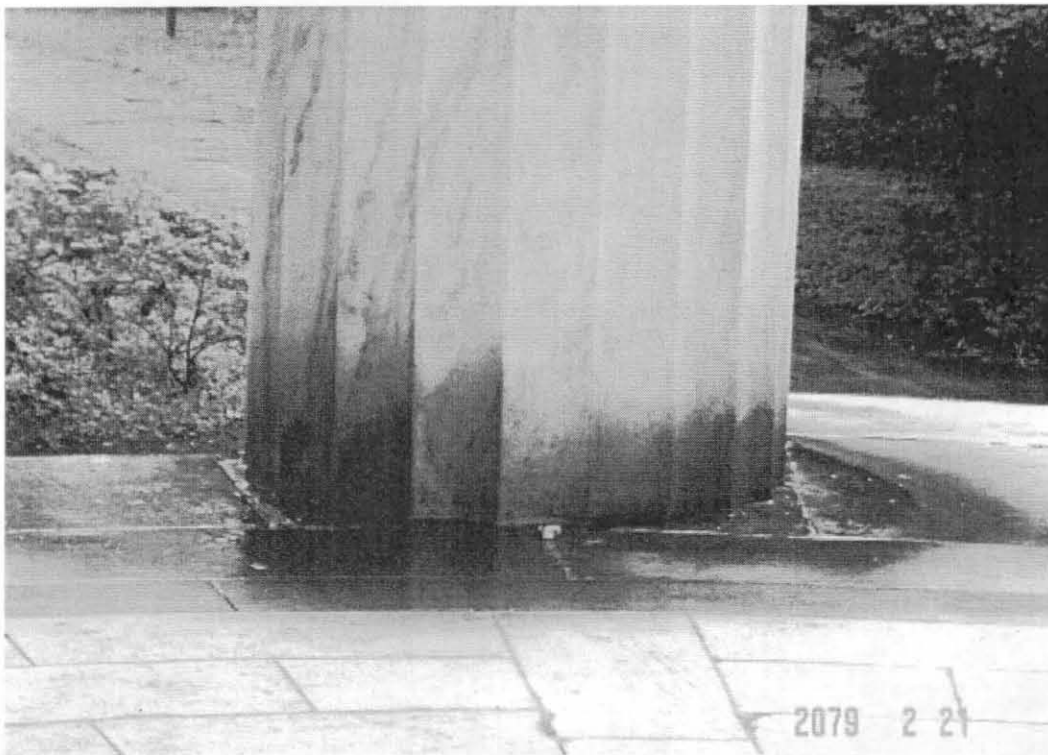
*Dark-colored soiling at base of column. [MSSC, 2005]*
