**WILLIAM JOHNSON HOUSE  
NATCHEZ NATIONAL HISTORICAL PARK**

**NATCHEZ, MISSISSIPPI**

**HISTORIC STRUCTURE REPORT**

ANN BEHA ASSOCIATES

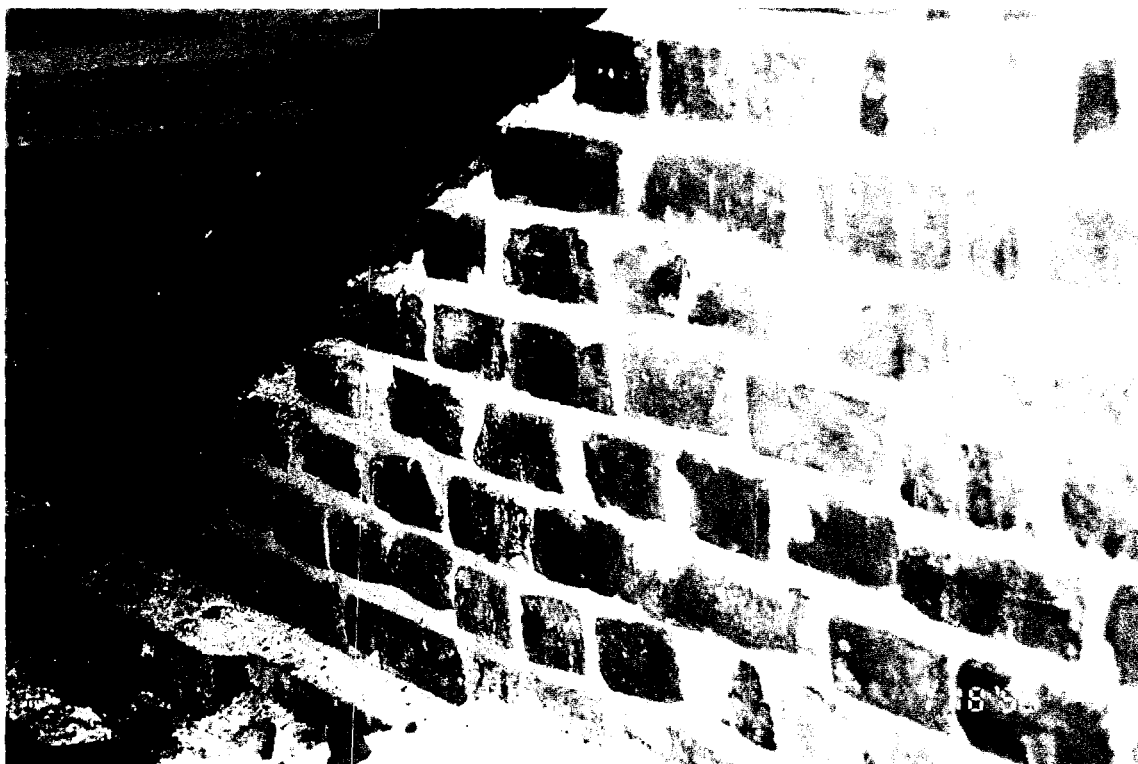
23-A Main House - Deteriorated mortar on east wall in attic.

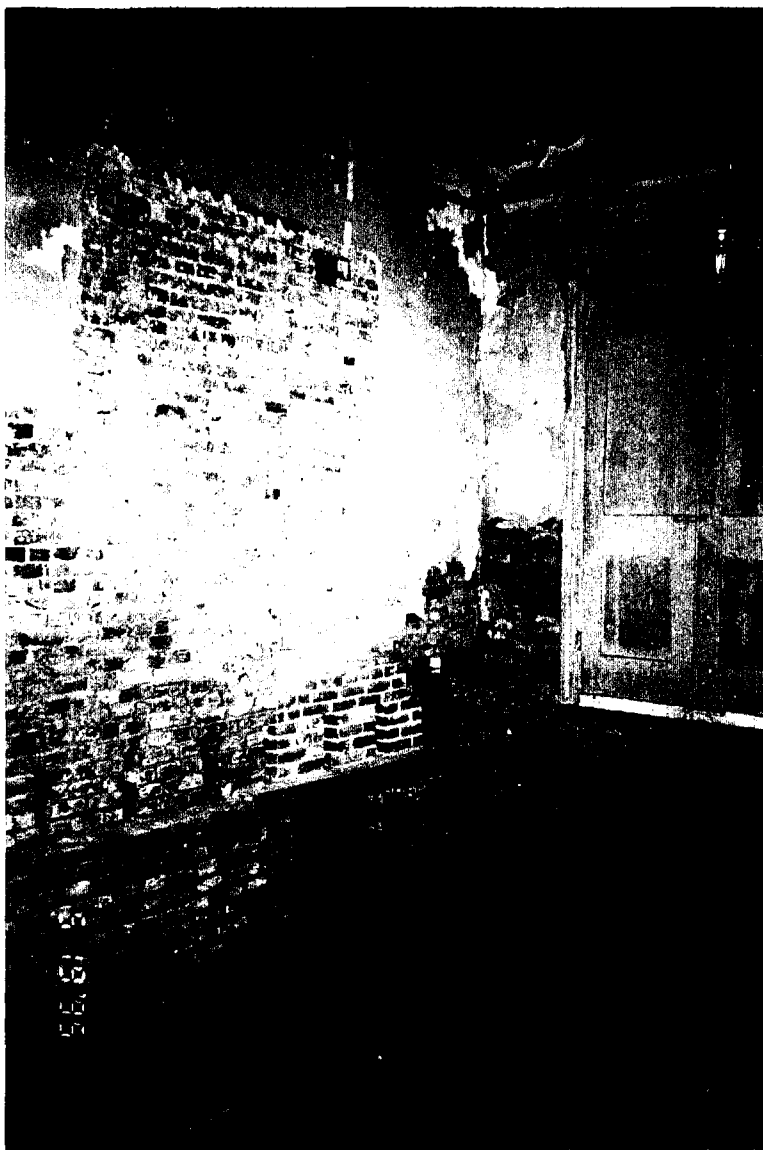
32-A Main House - Missing floor joists and floor from first floor. Missing plaster from walls.

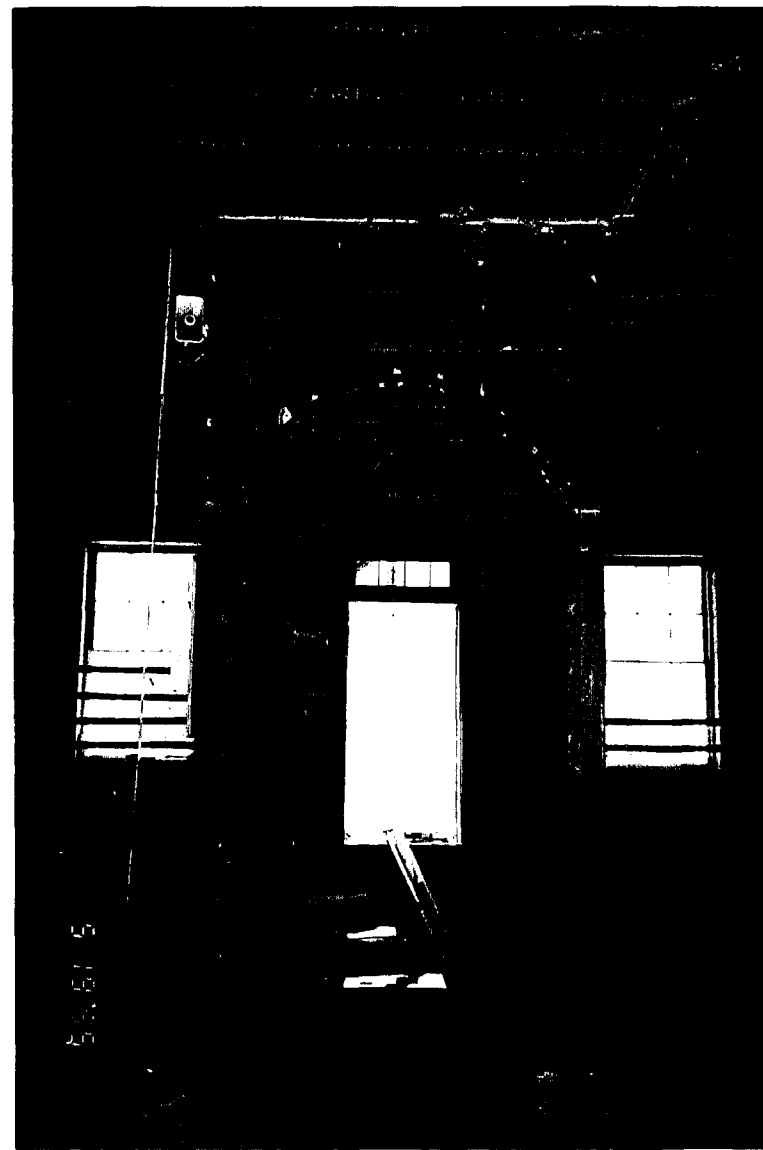
33-A Main House - Missing lath and plaster from ceiling of first floor. View of underside of second-floor framing and the top of the columns supporting the second-floor partition wall (above).

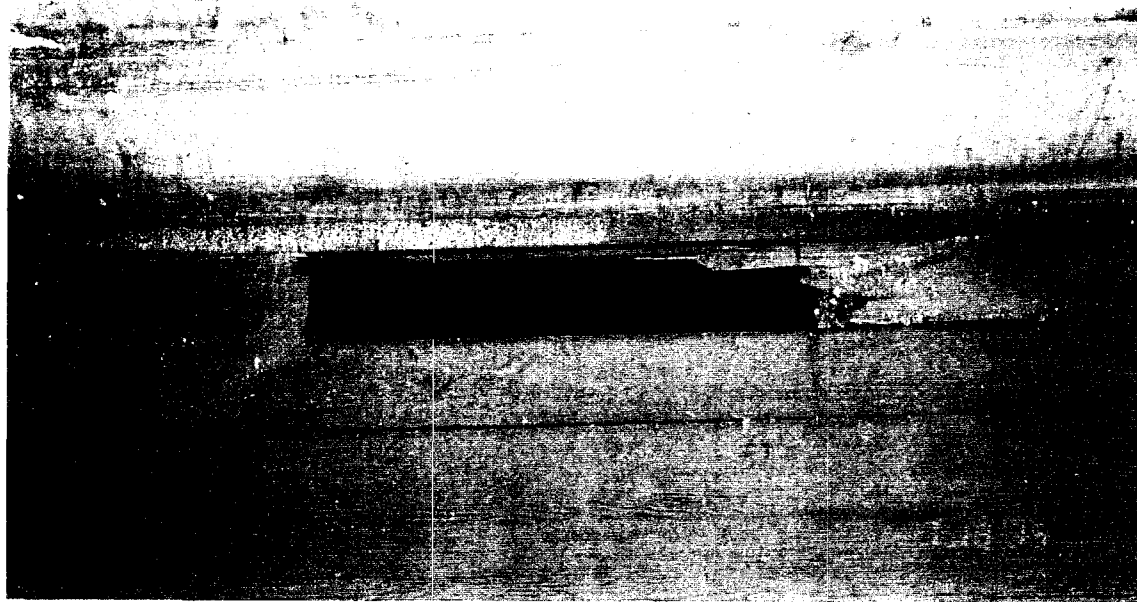
34-A Main House - Holes in second-floor flooring.

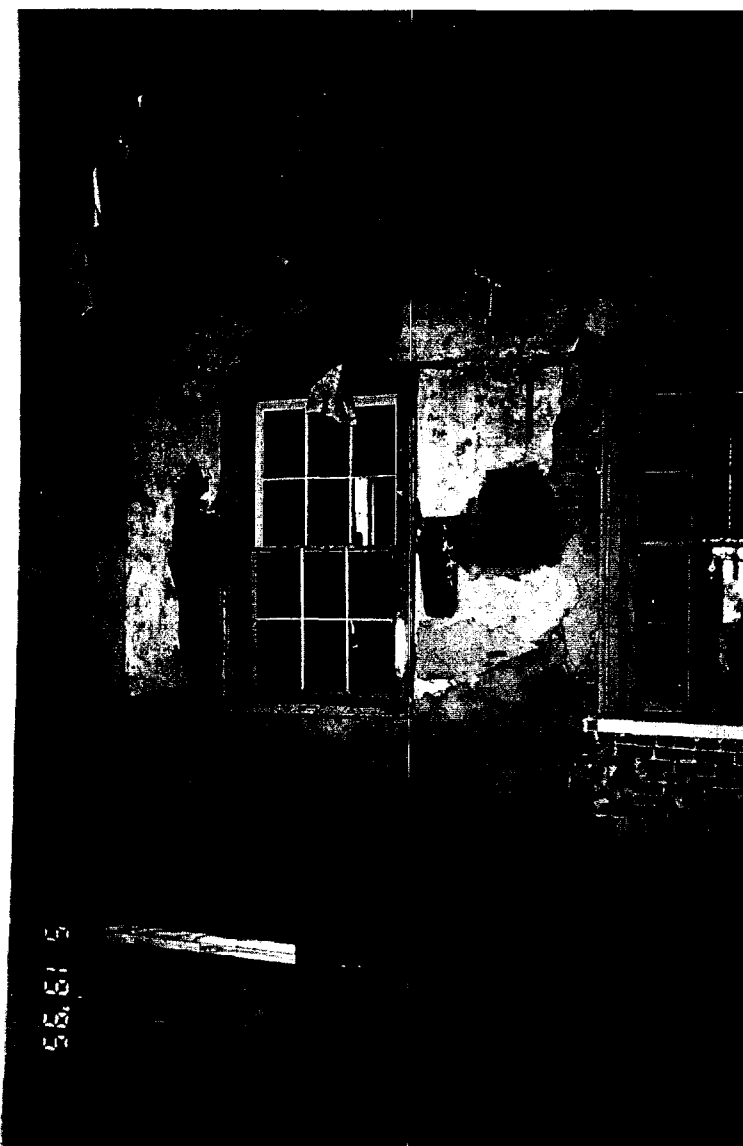
35-A Main House - Missing plaster from second-floor walls and ceiling.

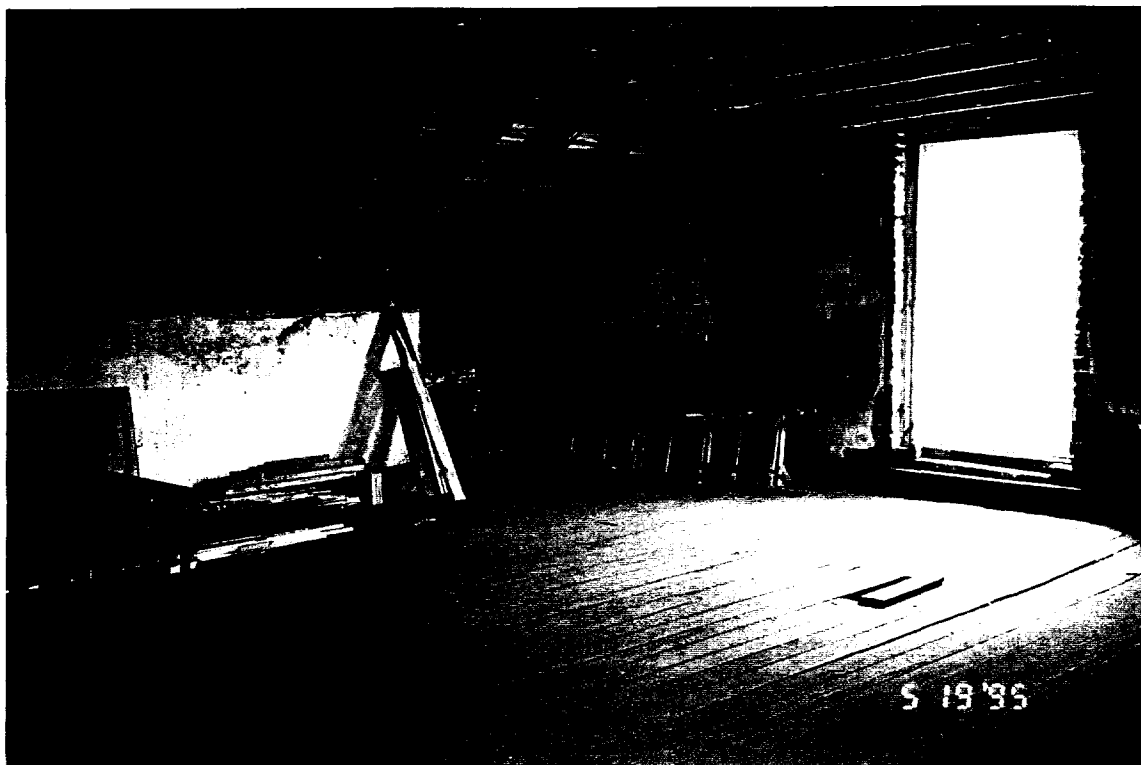
40-A Main House - Missing third-floor plaster.

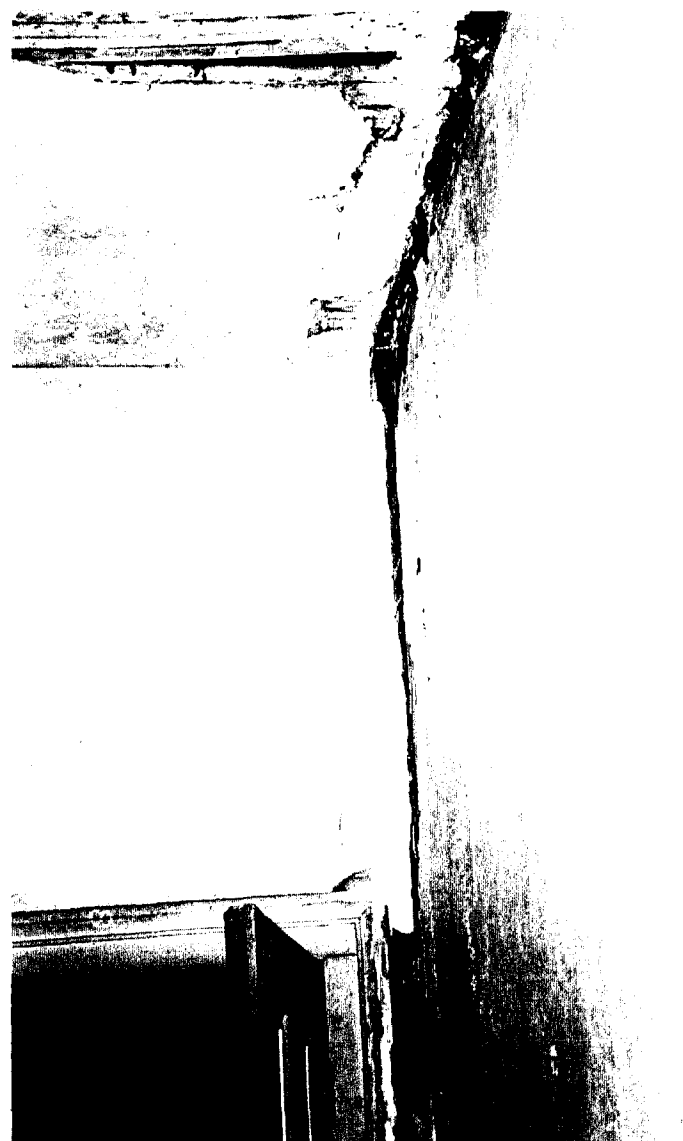
45-S Main House - Crack between second-floor east/west partitions and the "party" wall.

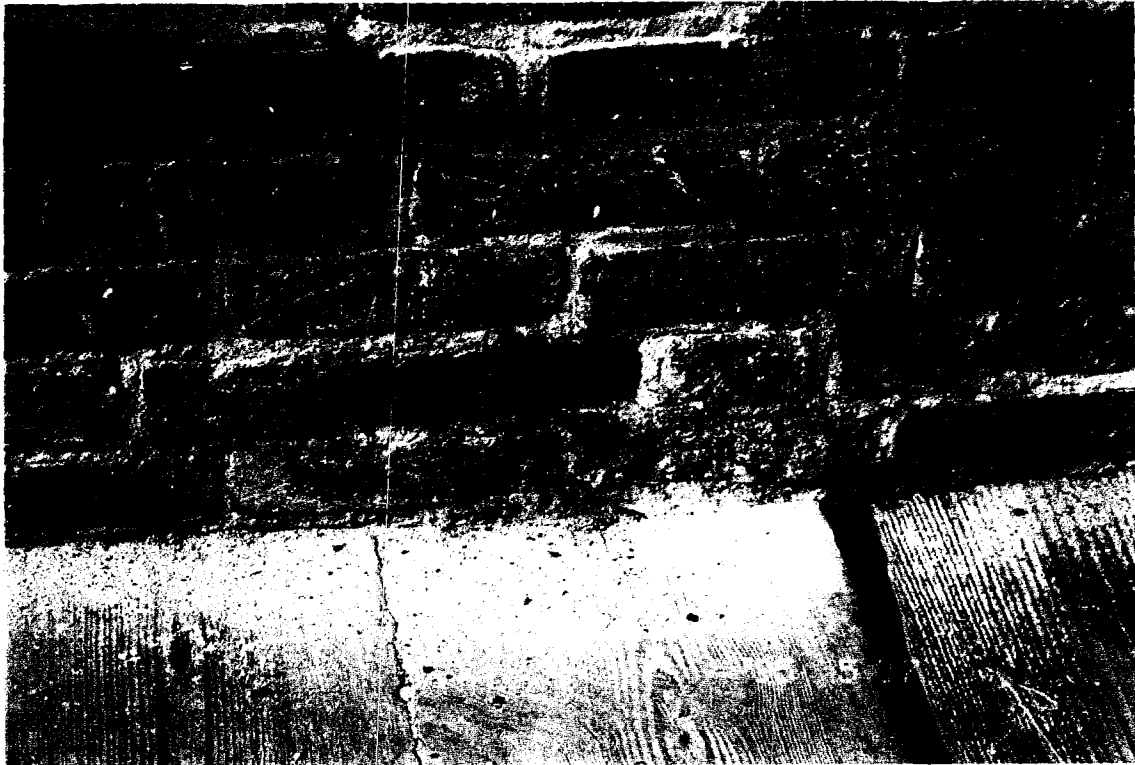
50-S Main House - Detail view of south wall showing spalled brick.

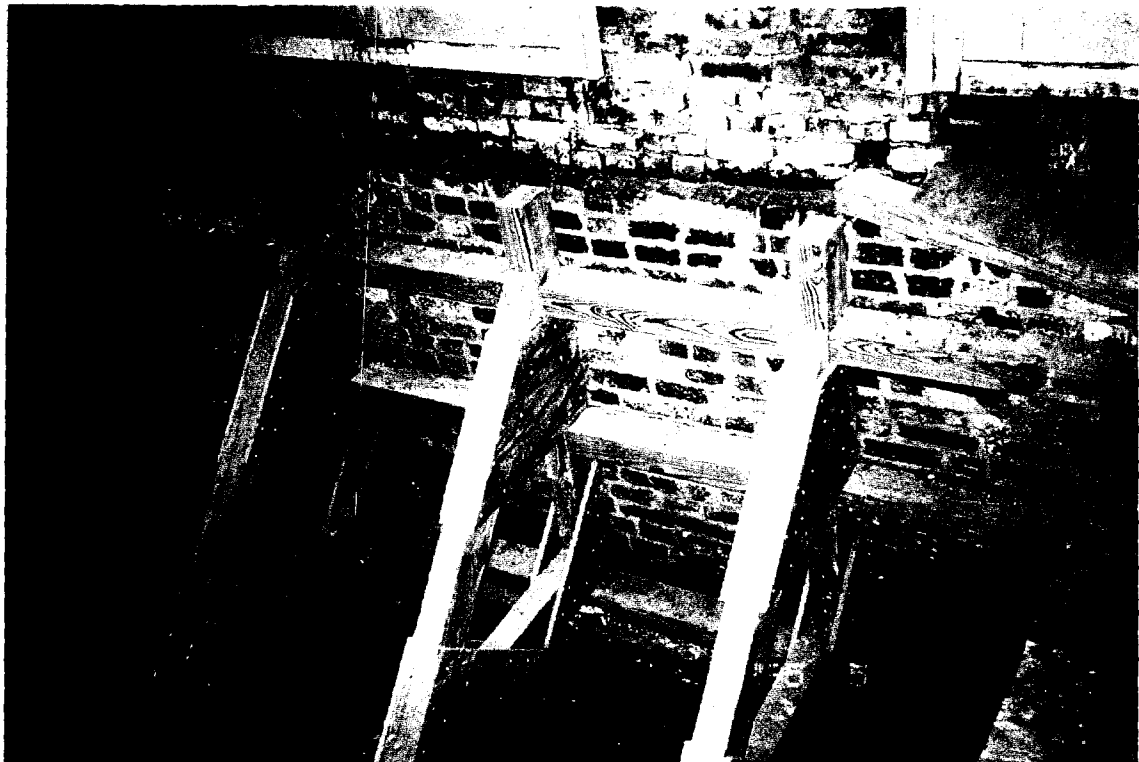
51-S Main House - View of north end of basement, showing diagonal bracing installed by National Park Service.

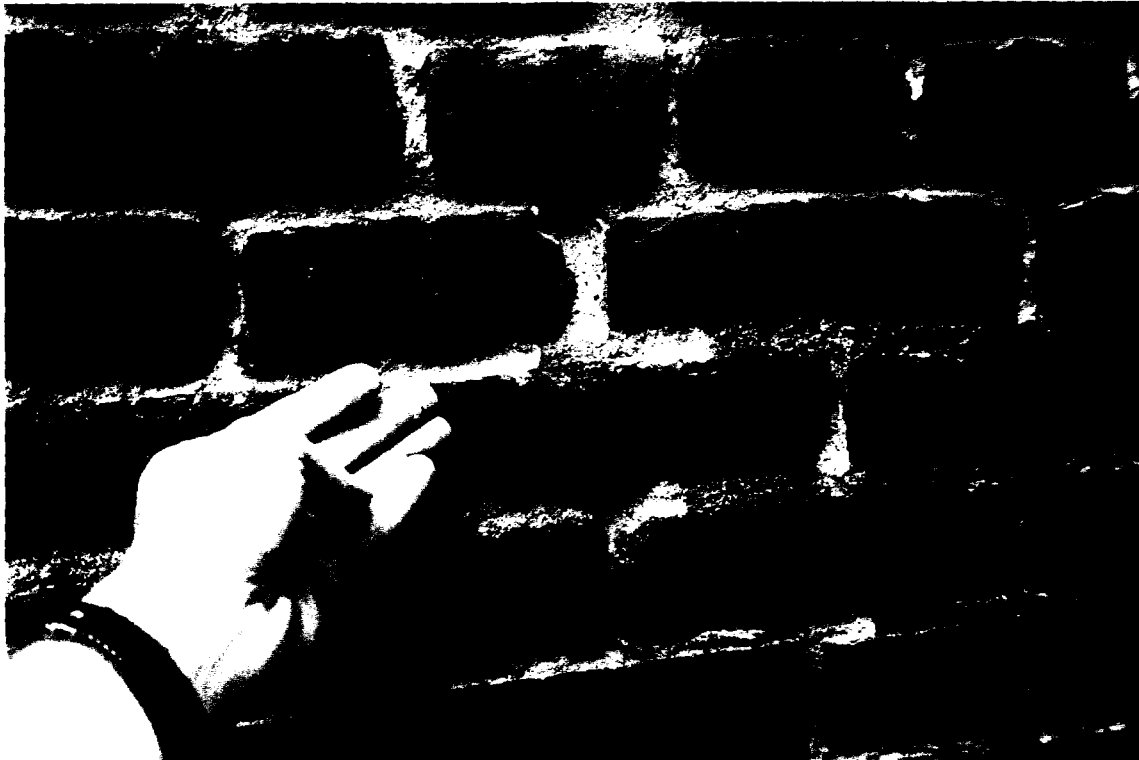
53-S Dependency - Area of spalling mortar on south elevation.

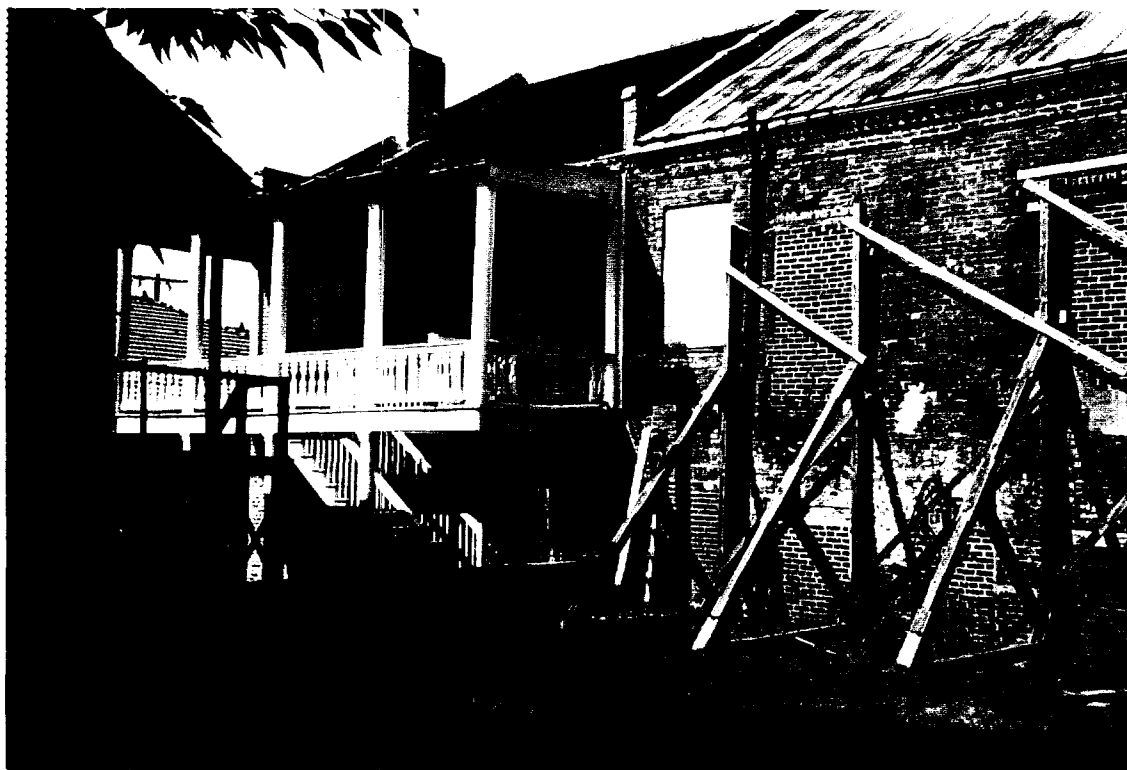
54-S Main House - South elevation of the William Johnson House and McCallum House. Note missing wood column on right side of porch.

The structure does not meet current code requirements for stress levels and the anticipated deflections of floors and the roof. The second- and attic-floor joists and the roof rafters are not capable of supporting the code required minimum live loads and, under such loads, would deflect considerably. RSA therefore has recommended a series of interventions be made, including doubling up framing members and creating a new line of support under the second-floor joists, in order to support the proposed uses. It is also recommended that the connections between the walls and the floor joists of the building be reinforced with new anchors between these elements of the structure. There is rot in the wood members supporting two sections of the exterior walkway; these members should be replaced immediately. The missing porch column on the first-floor level of the south porch should also be replaced immediately.

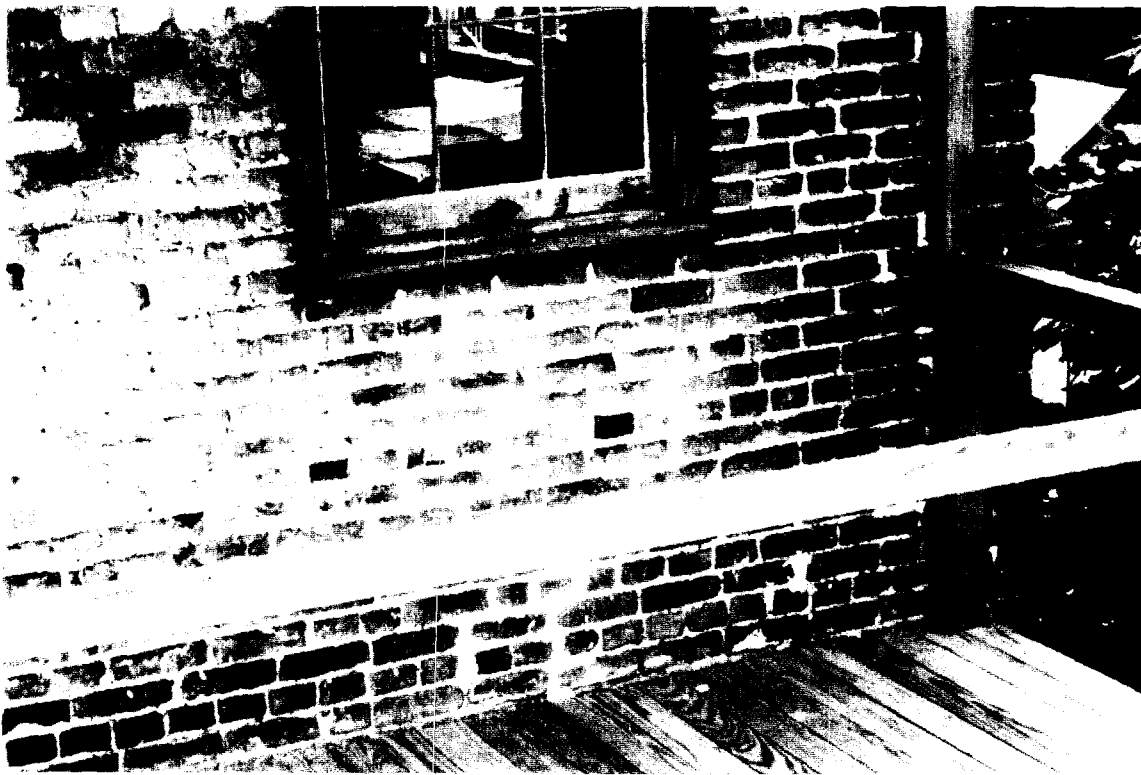
64-A Dependency - Poor match of mortar on north facade.

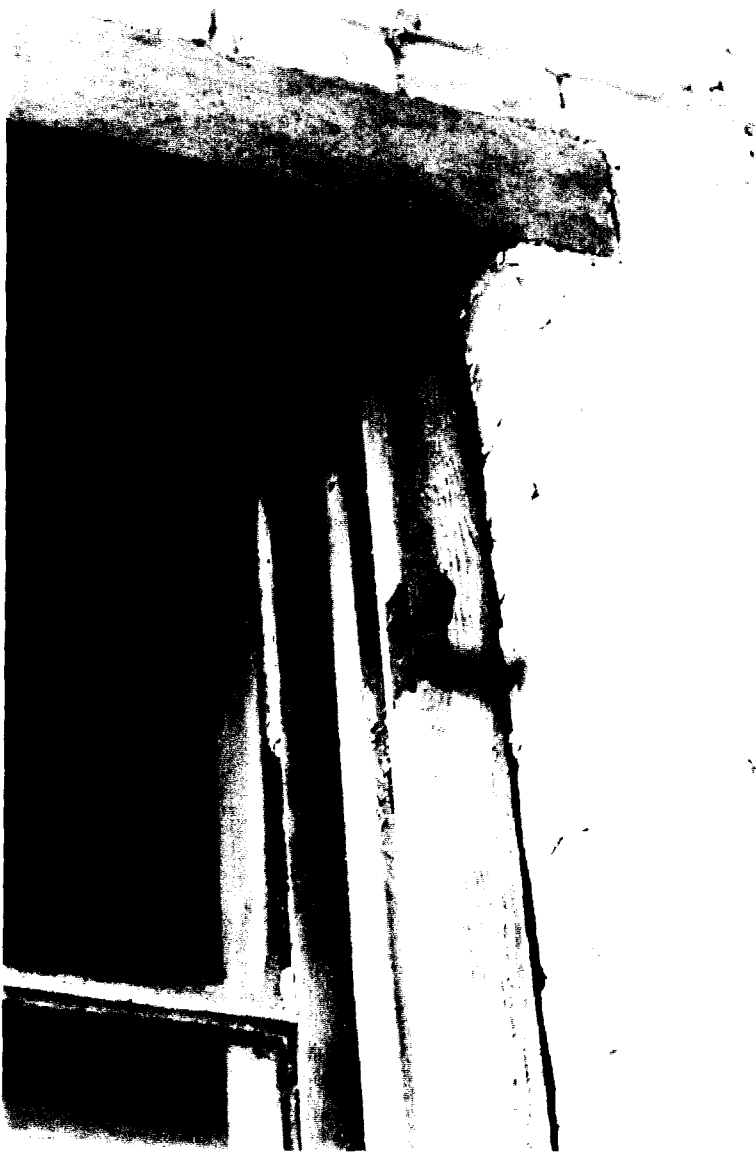
66-A Dependency - Caulk gaps at window frames on north facade.

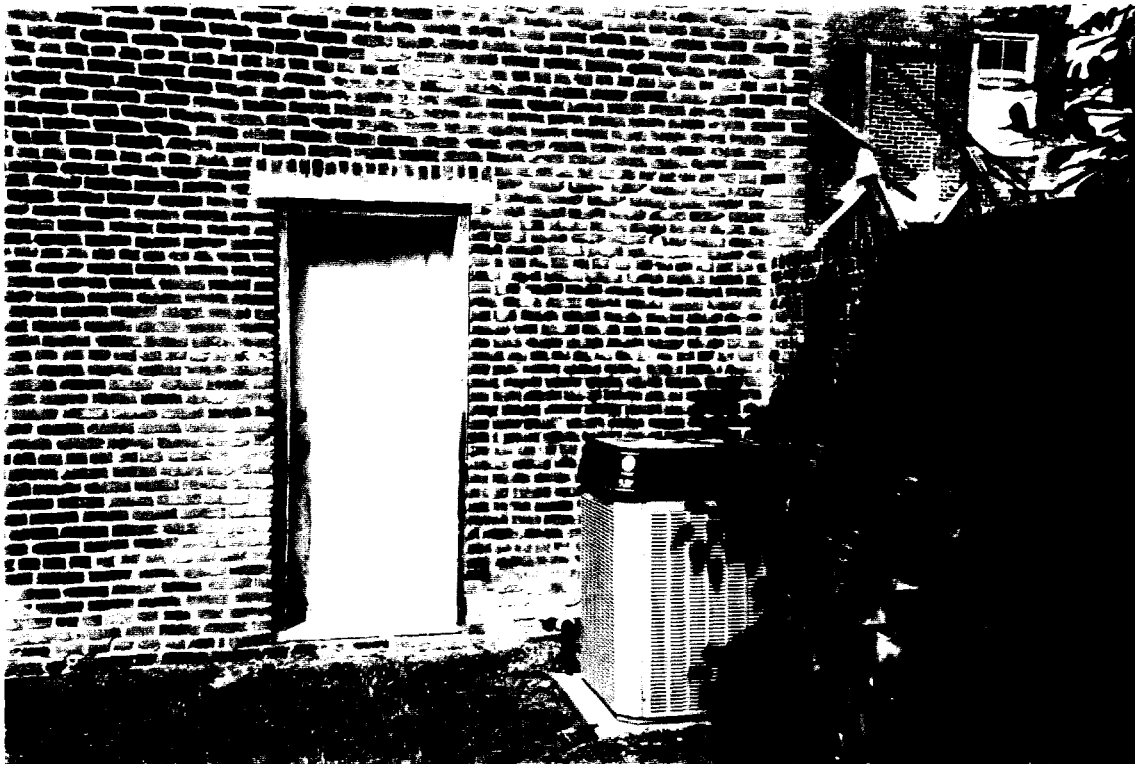
70-S Dependency - Deterioration of brick and mortar on south elevation.

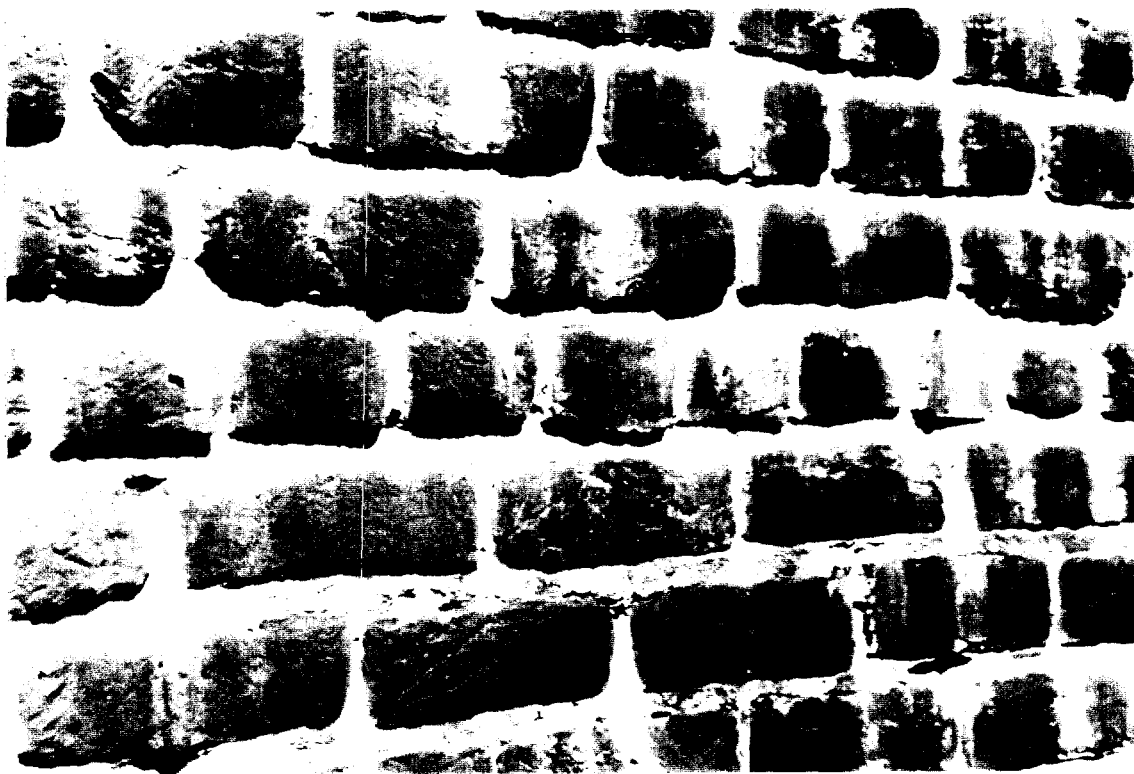
71-S Dependency - Close-up of deterioration of brick on the south elevation.

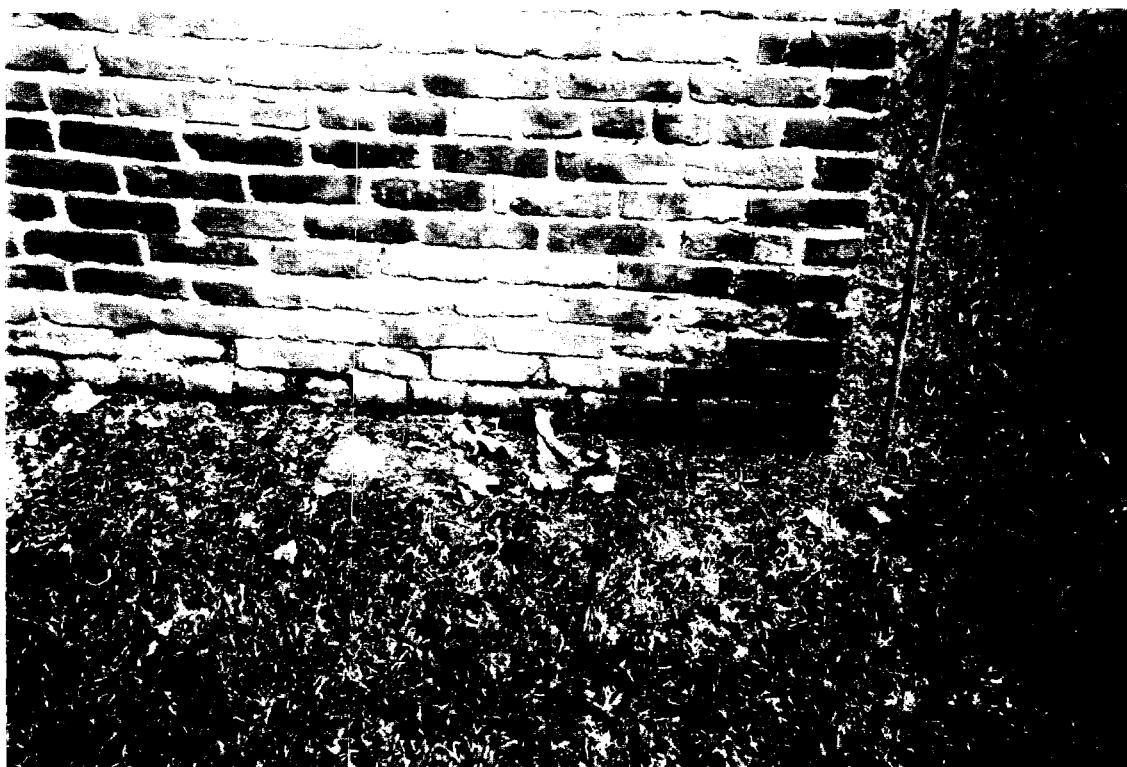
72-S Dependency - View of the rising damp damage to the brick and mortar at the southwest corner.
