John Gordon House  
Natchez Trace Parkway  
**Historic Structure Report**

# Historic Structure Report

April 2012

LCS#: NATR 00020

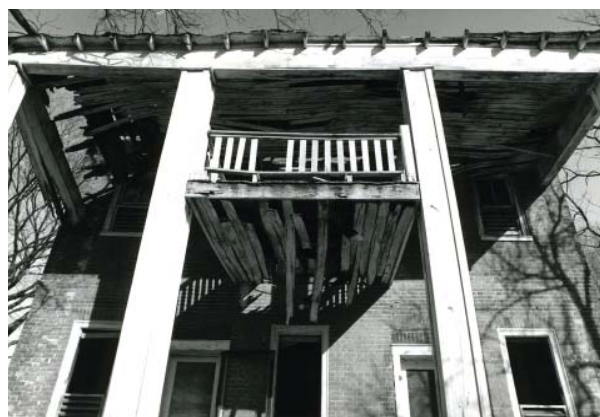
**Figure 63.** 1977 NPS photograph showing deteriorated condition of the porch. (NATR collection)

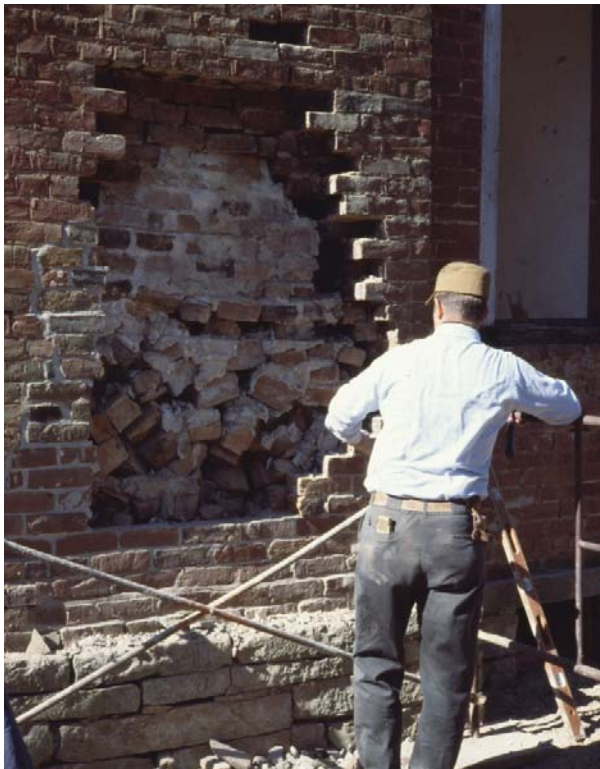
**Figure 70.** Brick repair of east chimney, 11/1977. (color transparency, NATR collection)

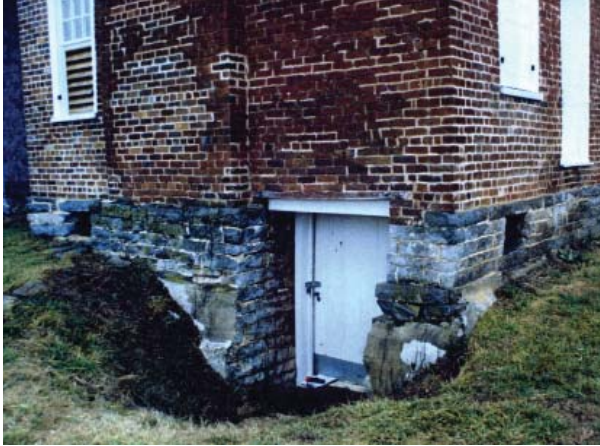
**Figure 74.** 1991 view showing inappropriate repointing and steep grade near basement entrance. (HSAR 1992)

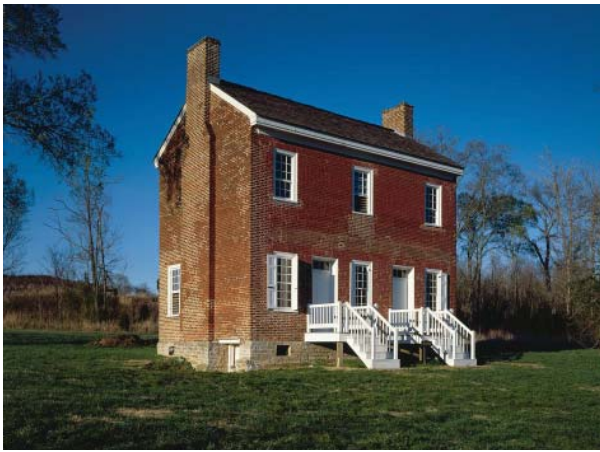
**Figure 80.** South elevation showing poor repointing, ghostmarks of earlier porches and second-floor center doorway, and stairs constructed in 1995. (color transparency, 1998, HAER Survey #MS-15)

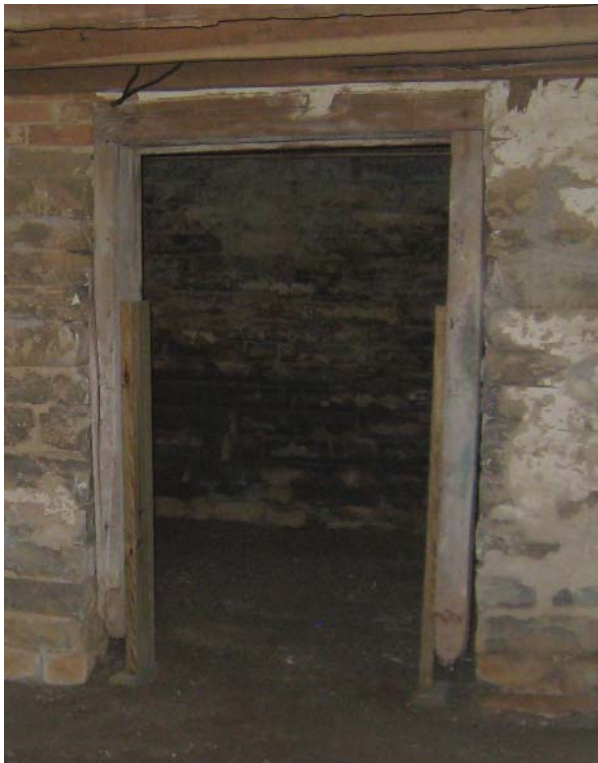
**Figure 82.** Interior basement door showing sistered pieces, 2010.

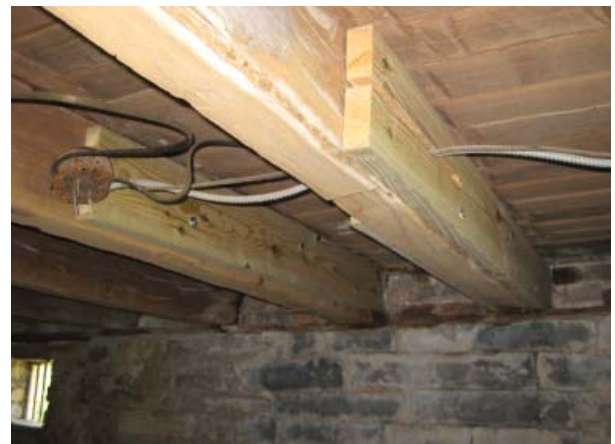
Figure 98. Sistered joists on south wall of Room 001.

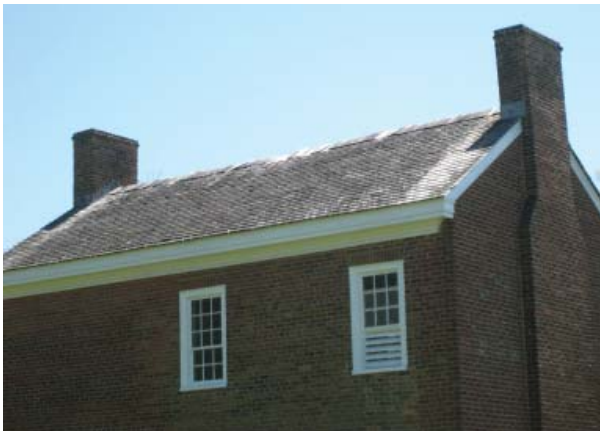
The existing random-width, split-wood shingle roof was installed by NPS crews in 1993. The roof ridge features a roof comb detail. Roofing shingles along roof ridge are failing.

**Figure 105.** Split shingle roofing.

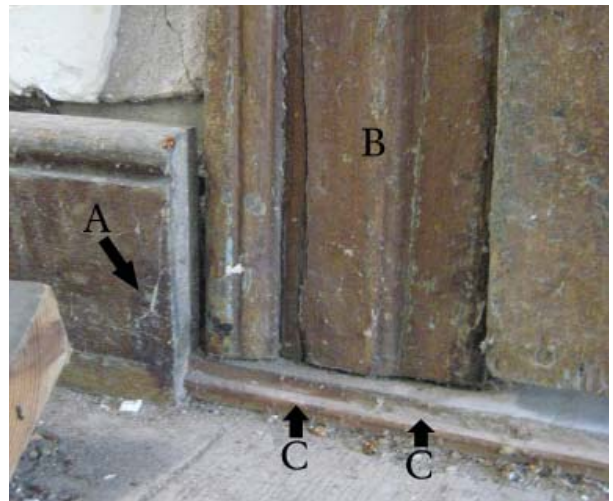
**Figure 151.** Charred edges of baseboard (A) adjacent to undamaged mantel (B) atop remnants of an added flooring (C) now removed.
