# Ridgeland Information Cabin Historic Structure Report

May 2021

## Historic Structure Report

Mills + Schnoering Architects, LLC   Princeton, New Jersey

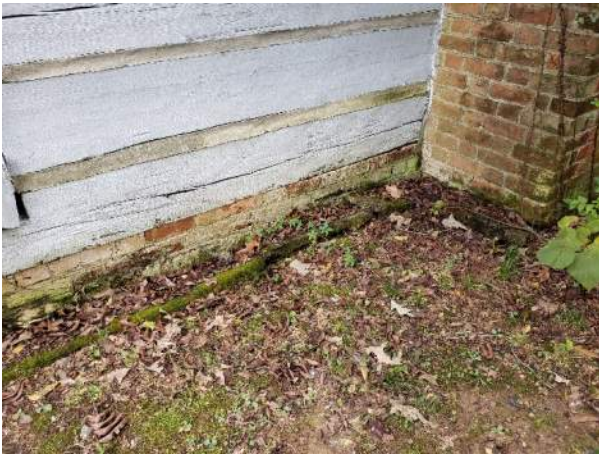
The existing drainage structures on either side of the cabin are composed of discrete concrete splash blocks that have broken down over time and are no longer serviceable. Water pools up against the structure and there is not a positive path that prevents soil scouring and deposition. Regrading the slope away from the cabin in all directions is recommended to alleviate drainage and soil issues. The concrete splash blocks are not original and may be eliminated. The use of a french drain can be evaluated in future grading and drainage plans.

**Figure 98.** Existing conditions with soil grading at the foundation.

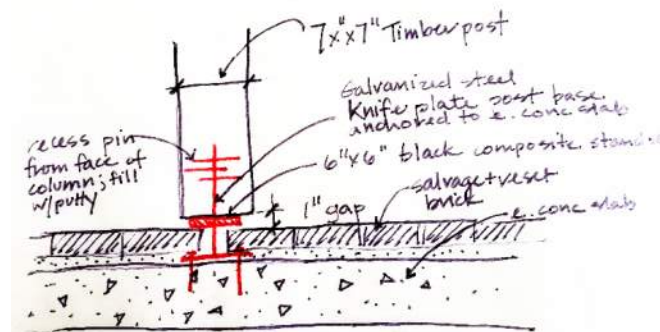
**Figure 99.** Custom concealed post base sketch detail to illustrate concept for raising the post base above the existing brick pavers while minimizing visual change. Actual design to be determined as part of future design phase. (Not to scale)

Temporarily shore existing roof framing as required during installation of the new columns. The base of the columns should also be slightly elevated with a galvanized steel post base or composite post base to prevent further decay. A custom post base may be required for a concealed installation.

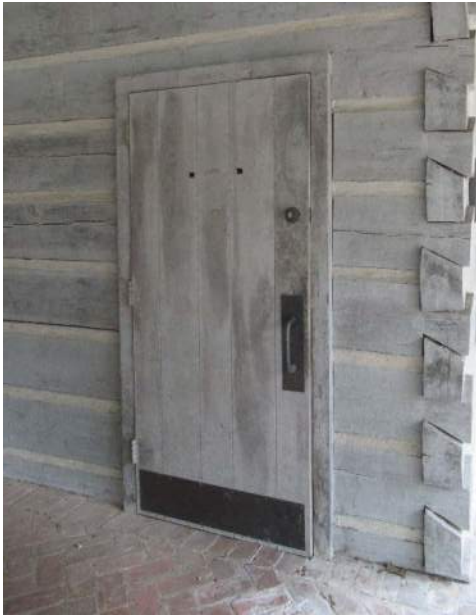
**Figure 100.** Consider replacement of veneered hollow core doors with solid wood batten doors with iron strap hinges and pulls.

**Doors.** Several of the original doors have been replaced with new doors to simulate the appearance of the board and batten doors. Consider replacing simulated doors with new wood board and batten constructed doors to match the original.

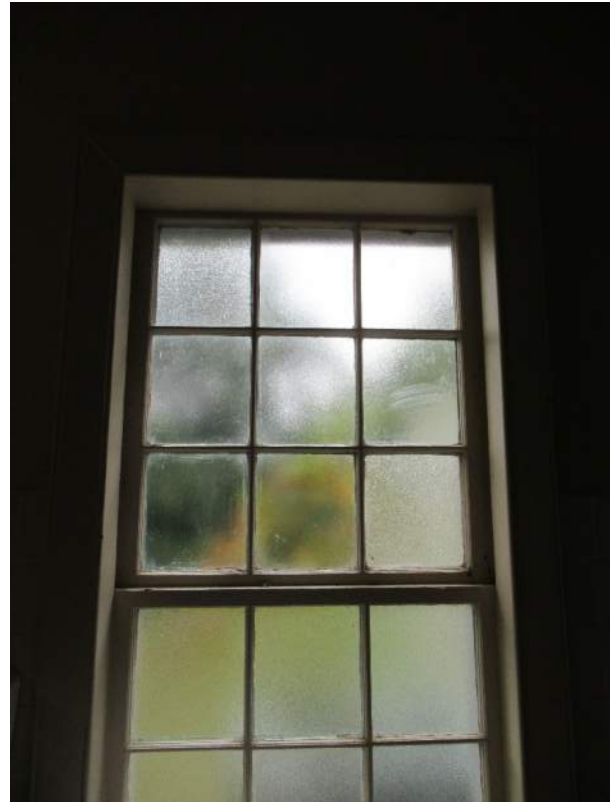
**Figure 101.** Mismatched obscure glazing from Accessible Family Restroom. The glazing should be replaced to maintain a consistent appearance of the original glazing.

restrooms of various periods. The original glass should be preserved. If replacement glazing is required, the glazing should match the original whether clear or obscure.

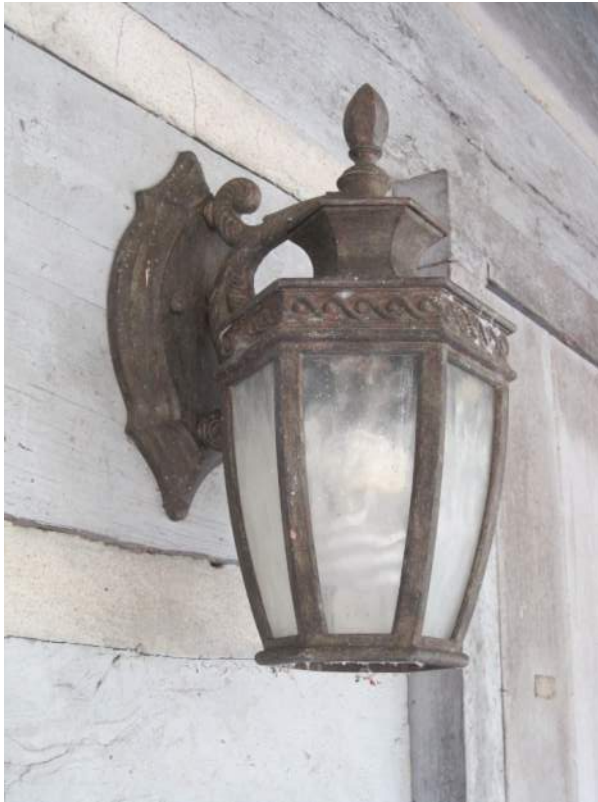
**Figure 102** The existing exterior light fixtures should be replaced with reproduction fixtures which better enforce the historic character of the cabin.

**Exterior Lighting.** The exterior wall mounted light fixtures have been replaced with modern fixtures (Figure 102) that are not in keeping with the original wall sconce seen in the photograph from the dedication in 1951 (Figure 103). These wall mounted lanterns had arched tops likely constructed of copper with an interior reflector and hurricane glass simulating a kerosene lantern (Figure 104). Some modification to the original would be appropriate as shown in the following examples (Figure 105). The fixtures would require mounting heights that comply with ADA -ABAAS or be designed so as not to project from the wall more than 4”.

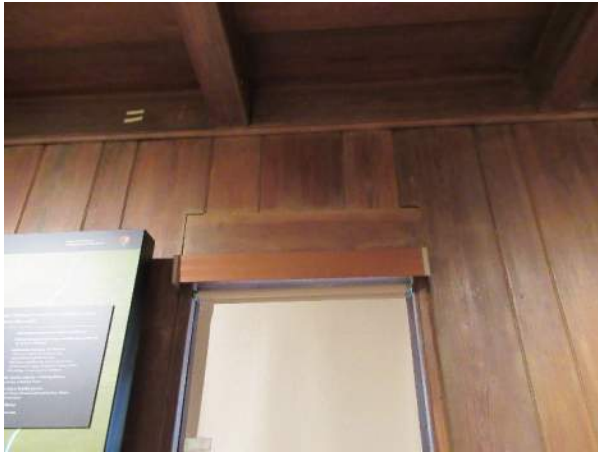
**Figure 107.** Valance for window treatment should be eliminated.

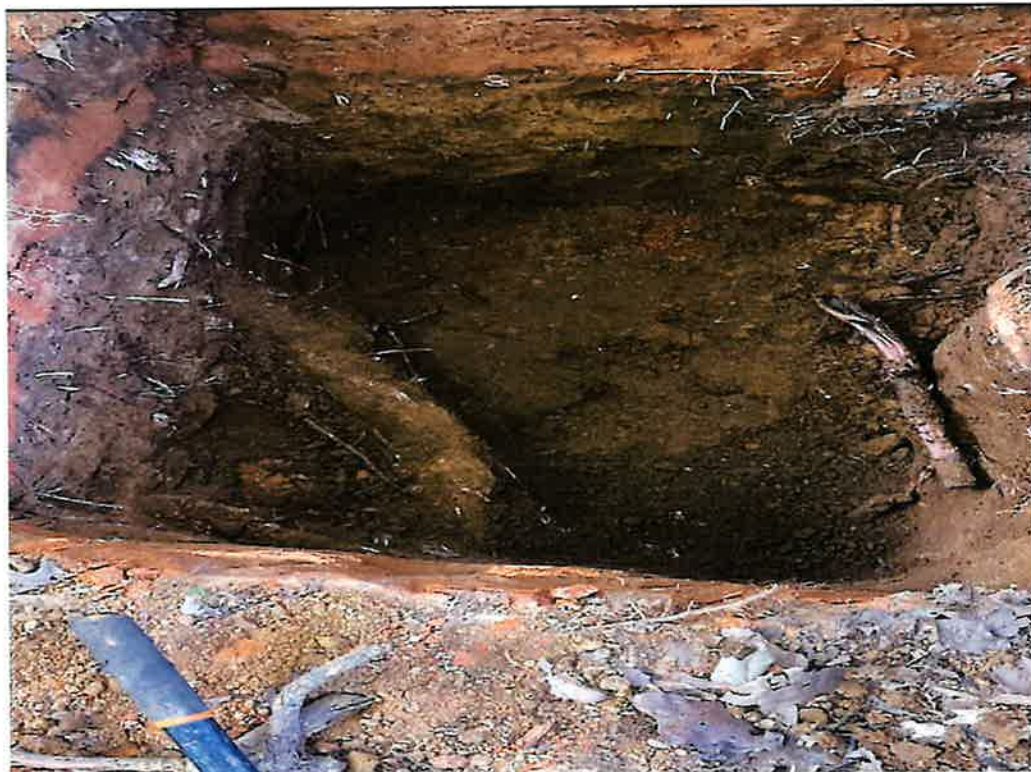
**Photograph No. 2** – A significant number of roots and rootlets were observed in TP#1.

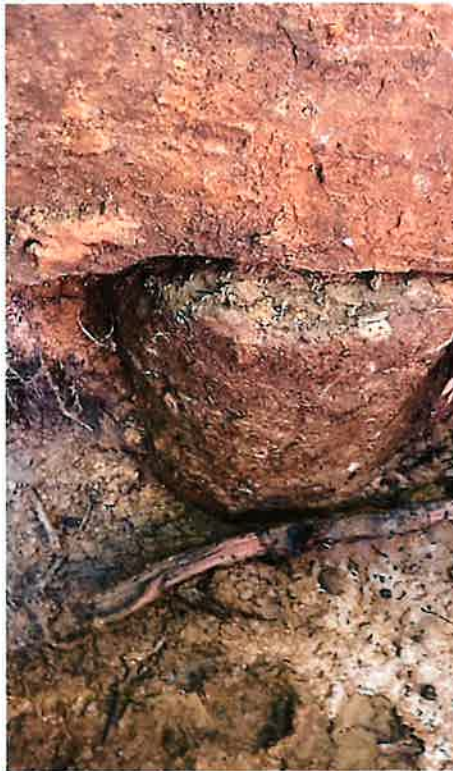
**Photograph No. 3** – Exposed pile appears to be in good condition.

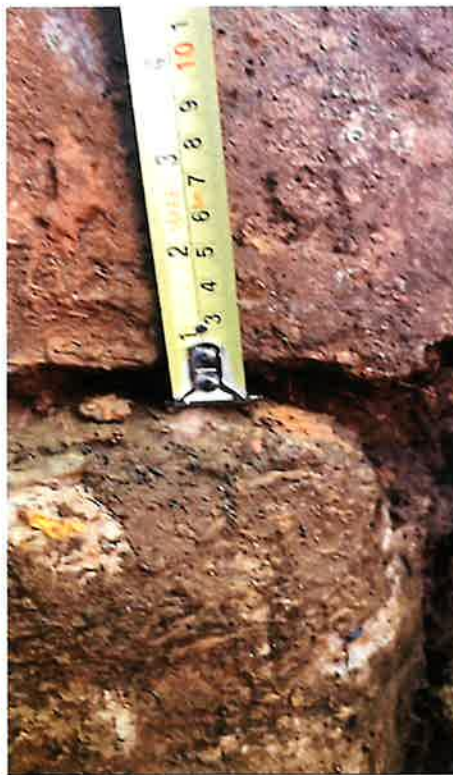
**Photograph No. 4** – Top of pile was not in contact with grade beam near edge of exposed grade beam.

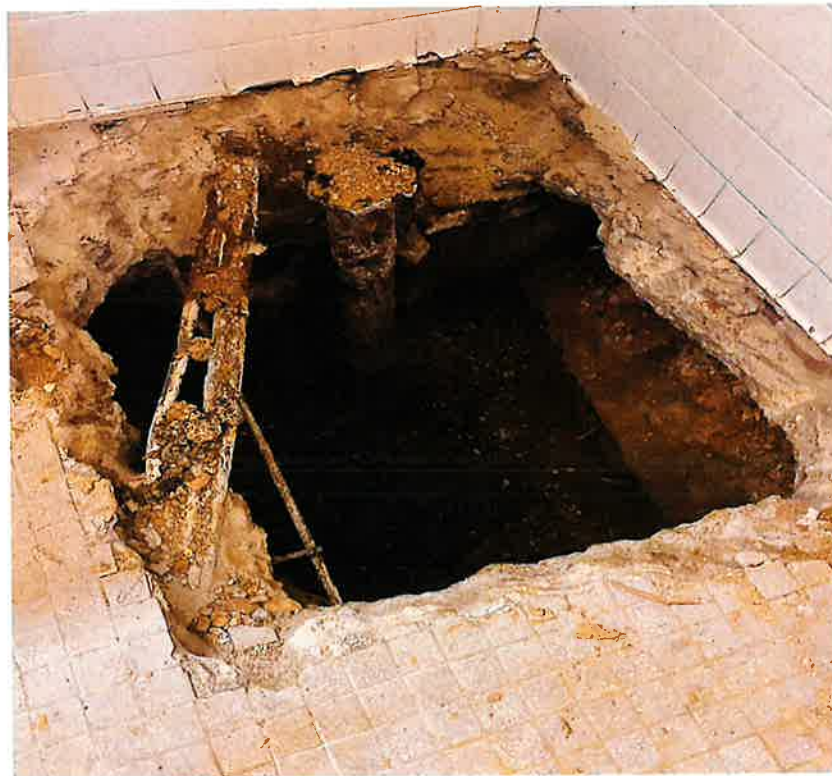
**Photograph No. 8** – TP#2 inside of the women's bathroom. A significant number of rootlets were observed in TP#2.

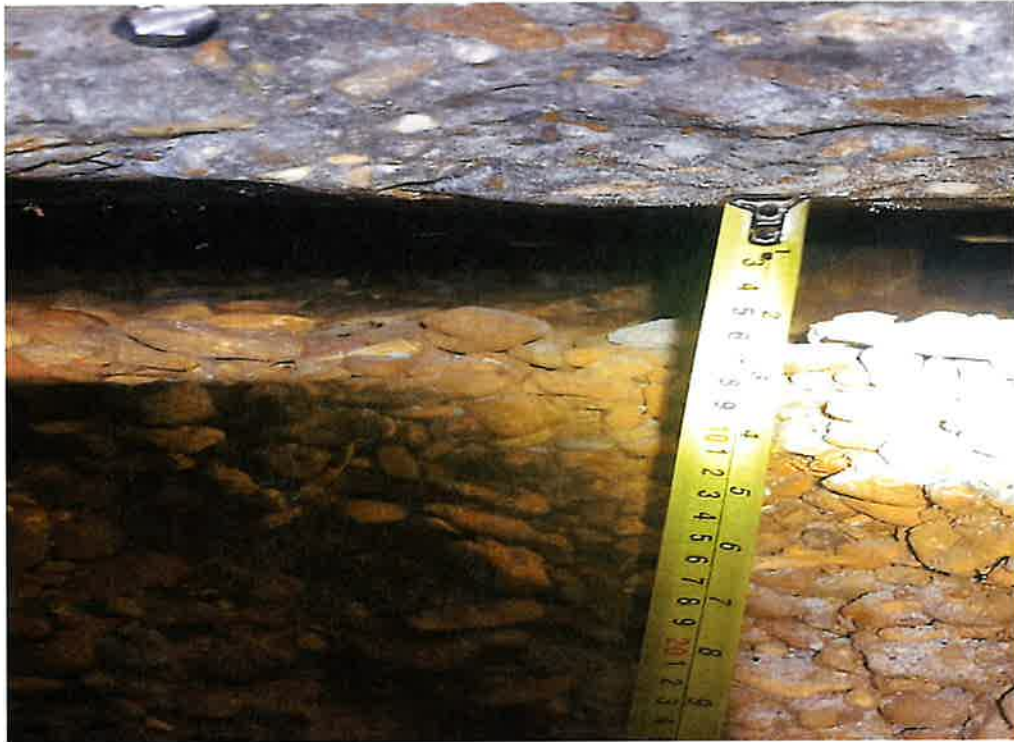
**Photograph No. 9** - A void was observed below the concrete slab.

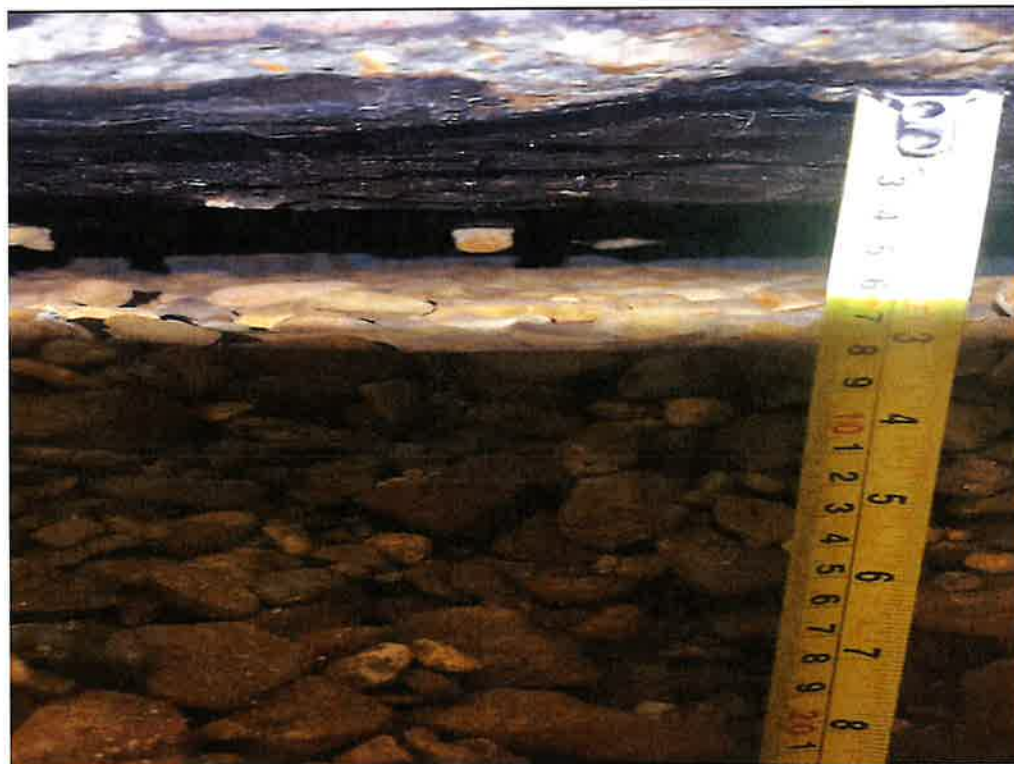
**Photograph No. 10** - A void was observed below the concrete slab.

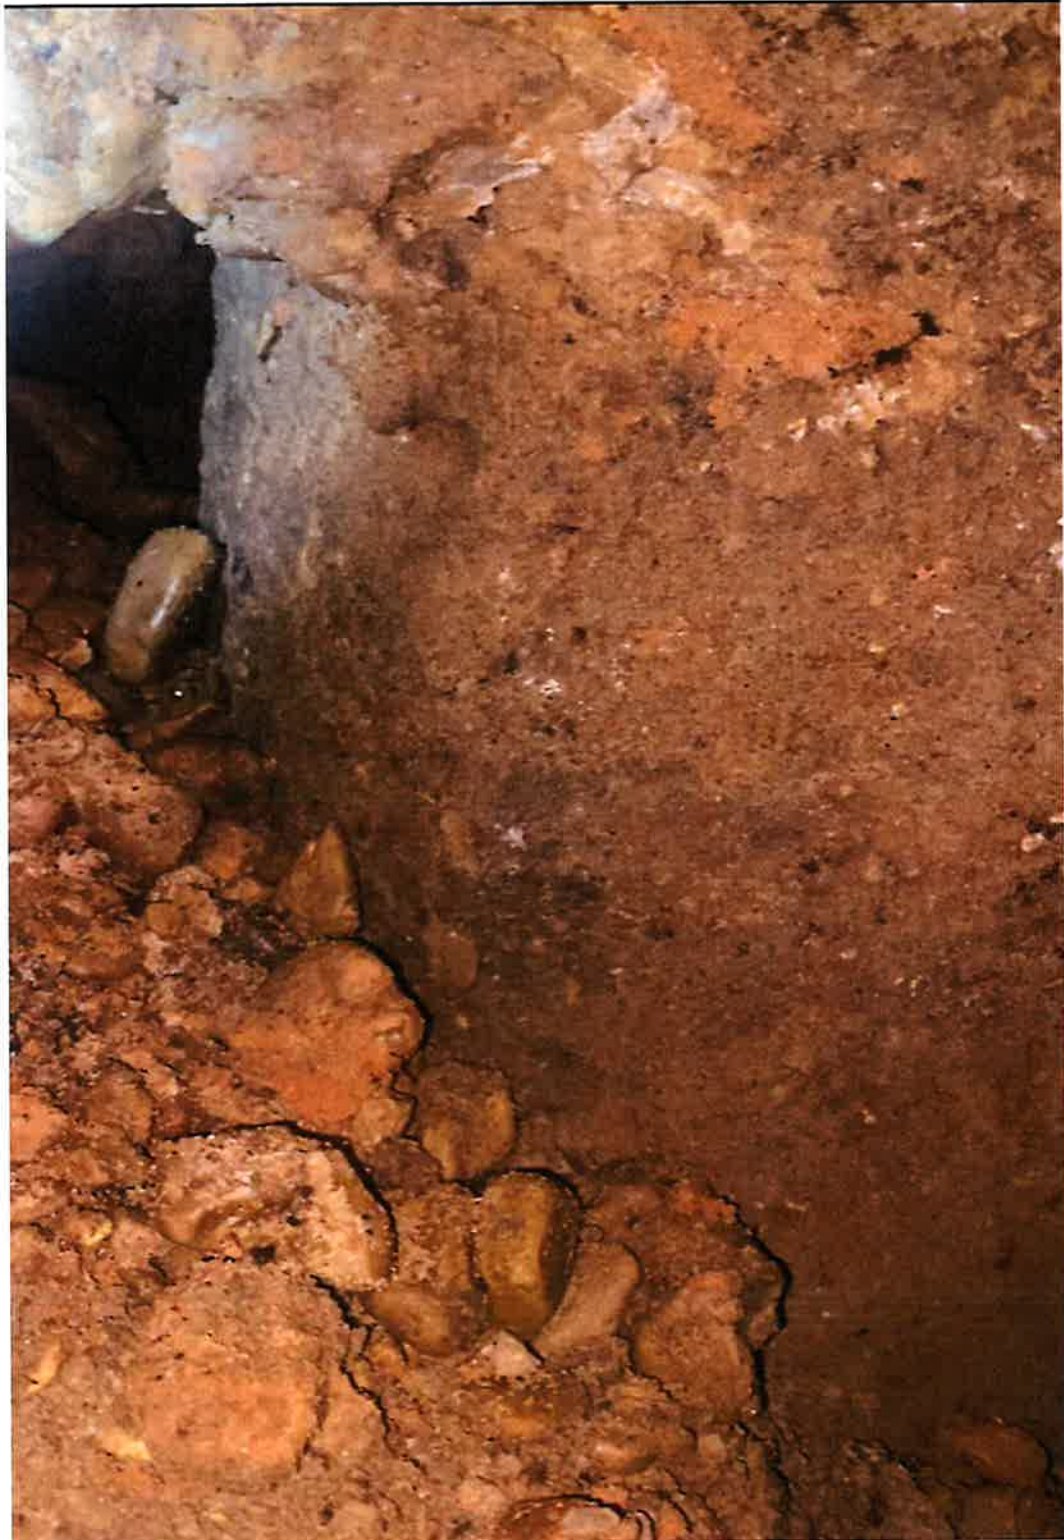
Photograph No.11- Exposed pile appears to be in good condition.
