# Burdick House

NEW PHILADELPHIA NATIONAL HISTORIC SITE  
BARRY, ILLINOIS  
PMIS 343880

## Condition Assessment and Treatment Report

JUNE 2026

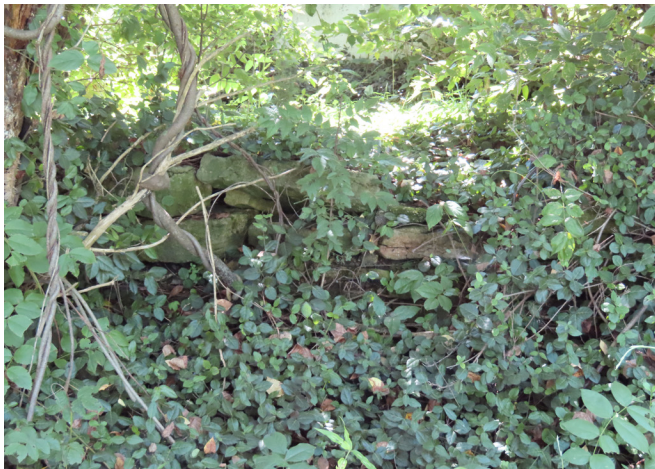
Figure 14. Stone wall at southeast corner of house covered by vegetation. (source:RRJ, 2025)

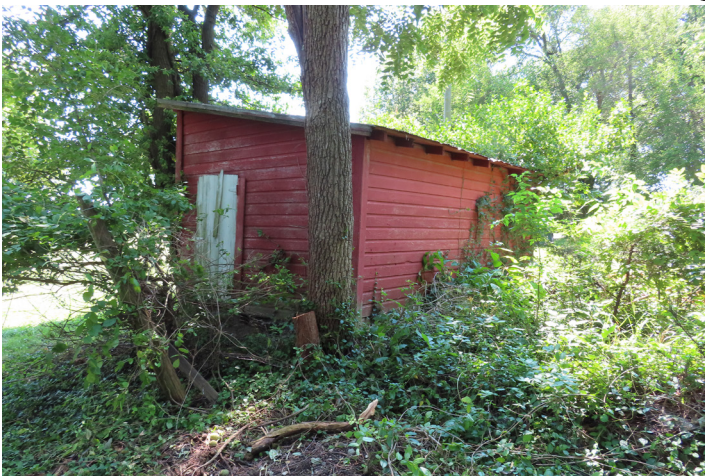
The shed was in fair condition. The exterior paint was weathered and peeling. Both doors were difficult to open. Overgrowth from several trees, bushes and vining plants have inundated the shed. Several cracks were noted in the concrete foundation.

Figure 20. South and east walls of shed.

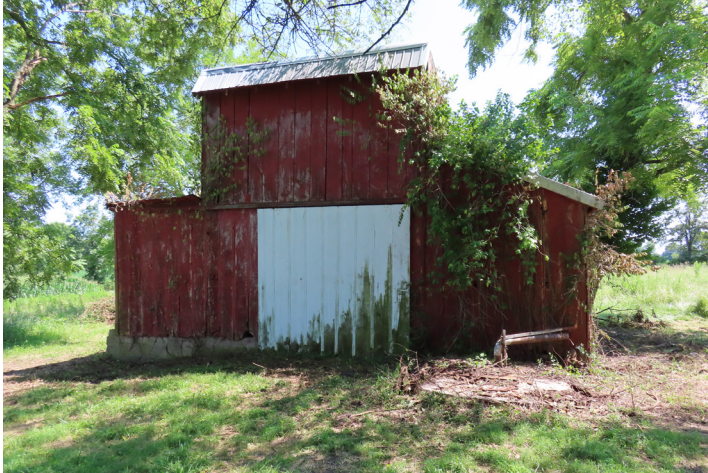
In general, the barn was in fair to poor condition. The exterior paint was severely weathered throughout, exposing the cladding and allowing weathering of the wood. Some rot and loss of wood was noted at the bottom of the wood cladding in isolated locations. These areas allow for pest infiltration. Biological soiling was noted on the north wall barn door. The interior of the barn was empty and was in good condition. The barn roof line was heavily altered during a 2000s repair project. The original gambrel roof was removed and the roof structure was reconfigured to its current irregular shape.

Figure 22. North wall of barn.(source:RRJ, 2025)

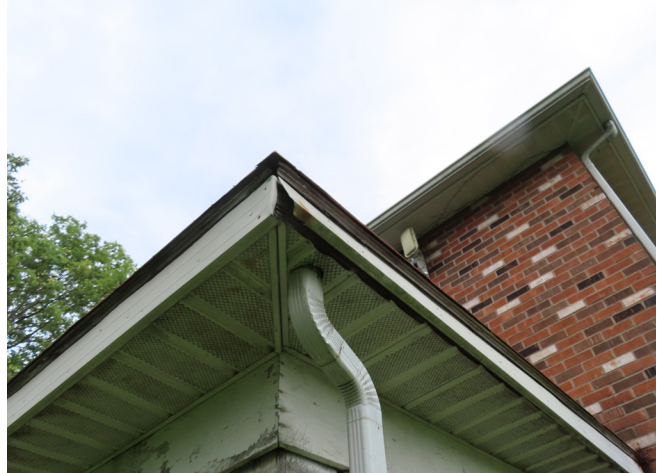
The roof is in good condition. The drainage system is in fair to poor condition. Wood rot was noted on the main porch beam due to improper drainage of the gutter in that area. Vegetation around the perimeter of the house was impeding the flow of water from the downspouts away from the foundation.

Figure 25. Downspouts at main roof and front porch roof of the house. (source: RRJ, 2025)

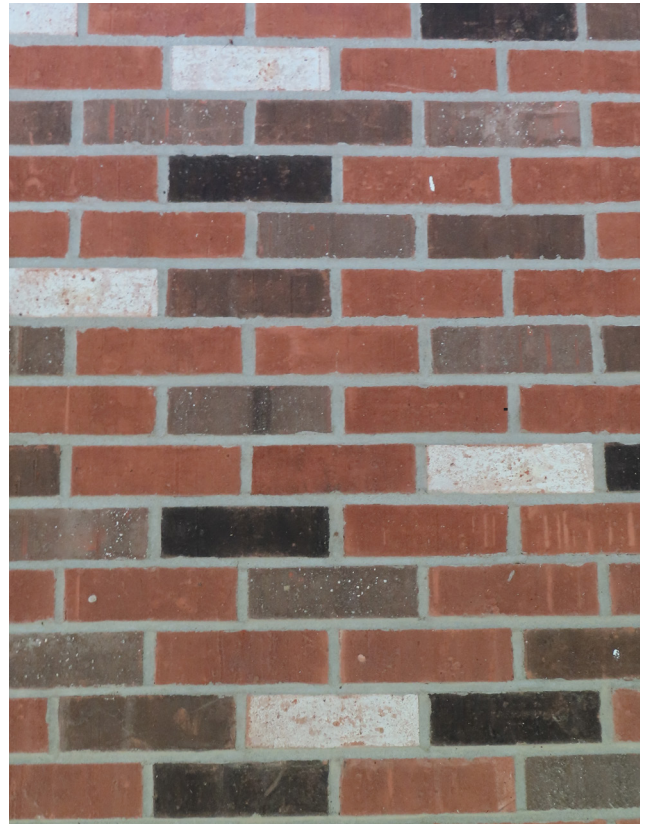
Overall, the brick veneer is in fair to poor condition. Sections of the brick veneer paneling were missing at isolated locations, primarily at the east wall and above the porch at the west wall. The brick veneer was beginning to buckle at the mid-height of the south wall, and some cracking was noted at other isolated locations.

Figure 28. Multi-colored thin brick veneer panel. (source: RRJ, 2025)

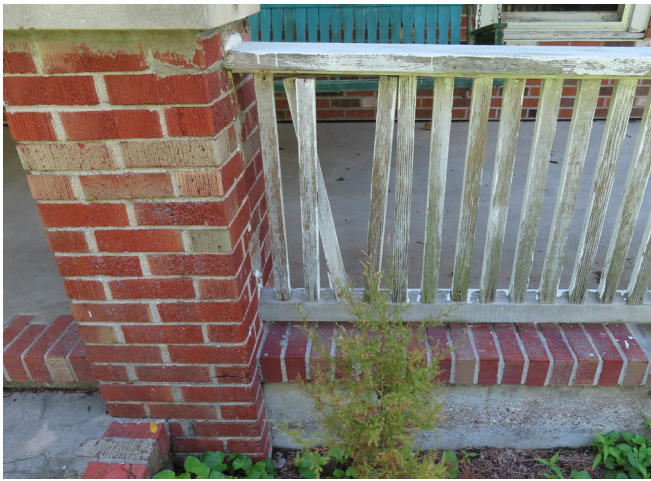
missing all together. The paint throughout all wood elements, including the soffit, porch columns and railings was weathered and peeling. Biological soiling was noted on the porch railings. Two areas of severe wood rot were identified within the main porch beam. This is likely due to improper drainage of the gutter above. A large pest hole was present in the northwest porch column, and squirrels may be living inside the column post. Some wooden trim was missing from the southwest porch column. A bee colony has established itself within the south side of the porch soffit. The porch's concrete foundation is in good condition with only minor deterioration noted at the southeast corner (Figure 29 through Figure 32)

Figure 29. Porch railing with weathered paint and broken rails.. (source: RRJ, 2025)

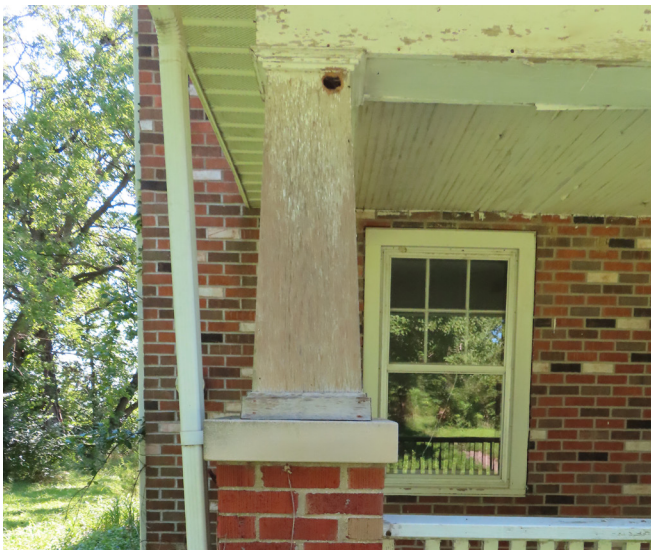
Figure 30. Northwest porch column with weathered paint and large pest hole at top.

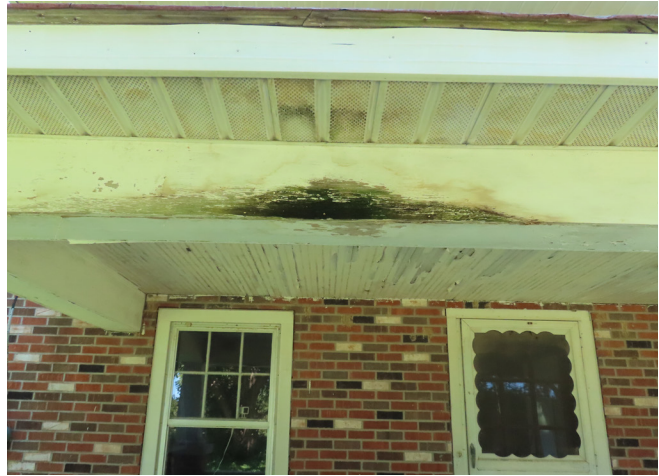
Figure 31. Large area of wood rot of the wood trim around the main porch beam. (source: RRJ, 2025)

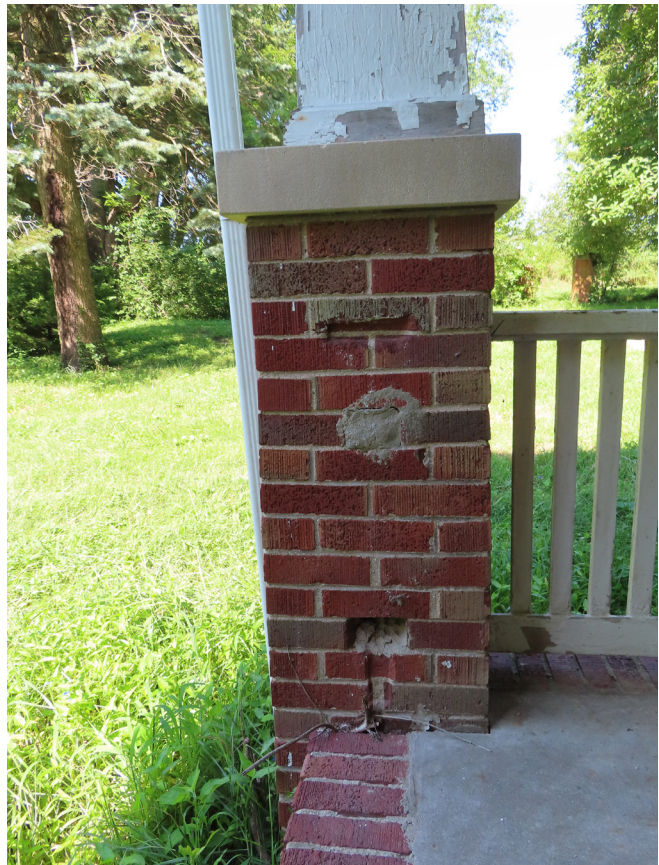
Figure 32. Southwest porch column with rail pockets for former railing. (source: RRJ, 2025)

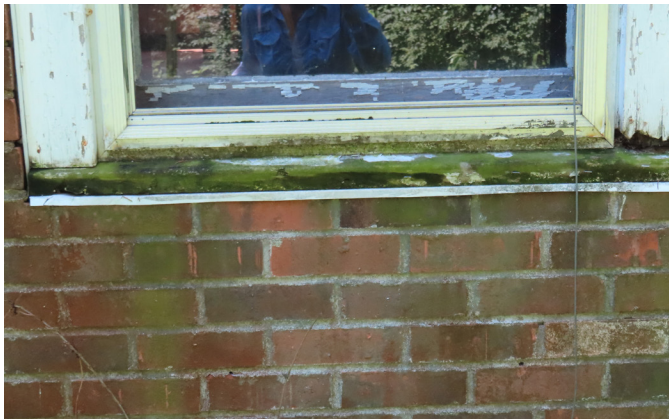
Figure 37. Deterioration of exterior wood sill, typical. (source: RRJ, 2025)

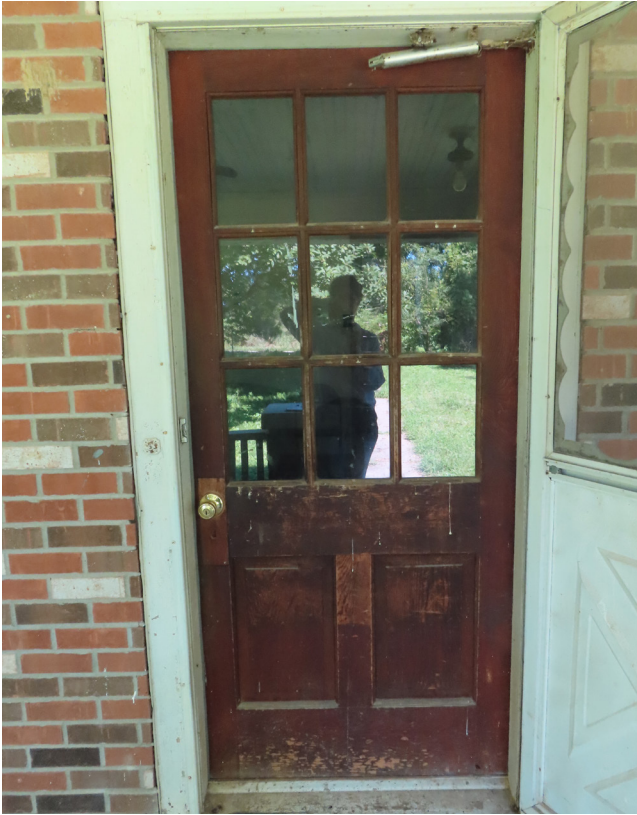
The front door is in fair condition. The wood was solid and free from rot, but was weathered and scratched, particularly at the bottom rail. This door should be refinished and a new deadbolt locking mechanism should be installed. The screen door closing mechanism was broken and the screen door itself was in poor condition. This door should be removed and/or replaced. A replacement screen door should be sympathetic to the period and style of the house. The rear exterior door (D3) is in poor condition. New casing should be installed at this location and a new, period appropriate exterior door should be installed. The original exterior entrance door (D2) is in fair condition and can be restored. The missing glass should be replaced and new glazing installed. The door can be sanded and repainted, and a new deadbolt locking mechanism should be installed.

Figure 38. Main entrance door with 9-lite upper panel and lower wooden raised panels. (source: RRJ, 2025)

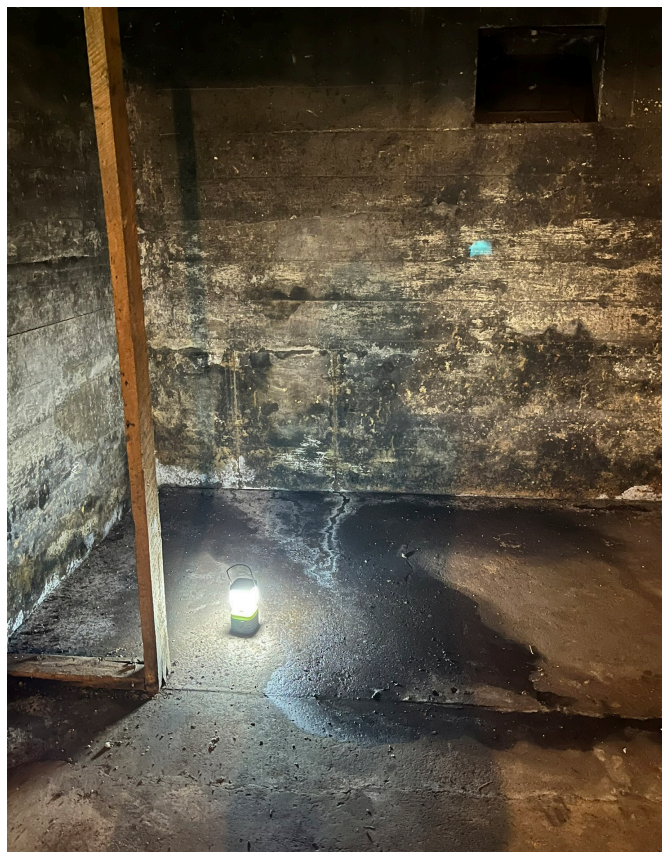
Figure 49. Interior concrete foundation wall with active water leak. (source: RRJ, 2025)

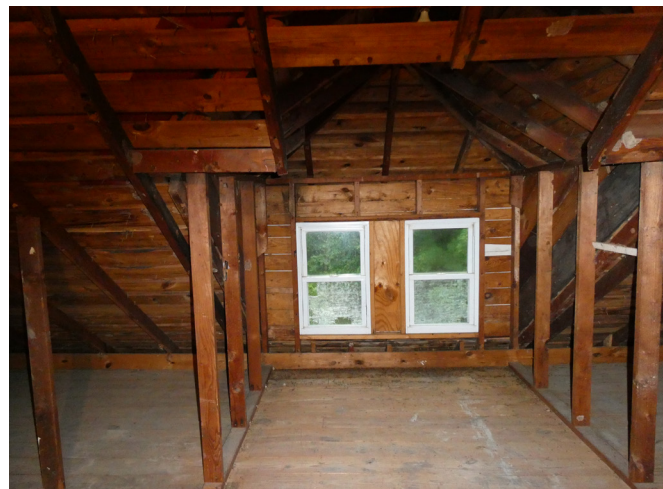
The wood framing at the west dormer is not properly constructed. Several roof rafter members that intersect the west dormer do not have a direct load path to either the house exterior walls or the attic floor joists. The east dormer framing for the roof rafters does appear to have a direct load path.

Figure 51. Roof framing at west dormer with inappropriate load path. (source: RRJ, 2025)

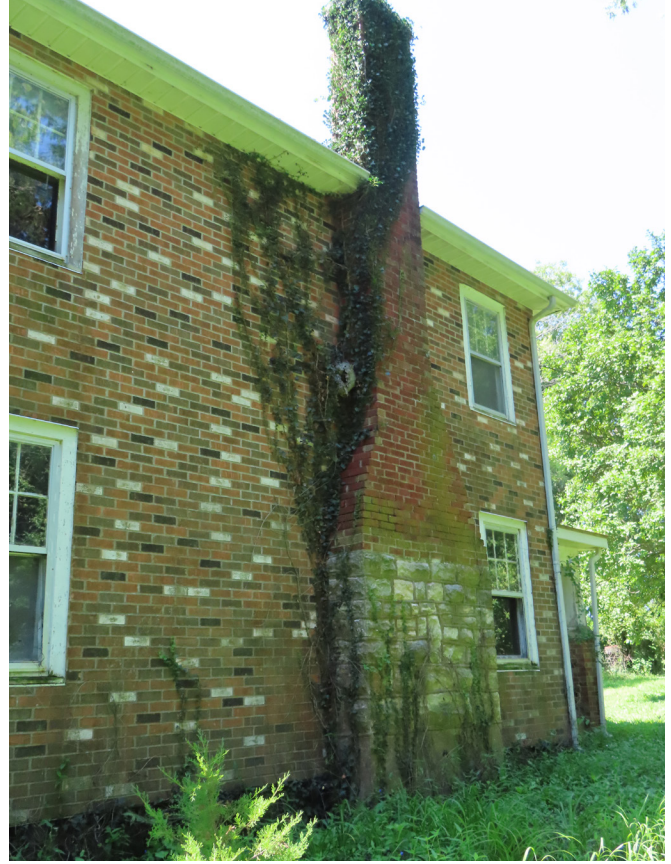
Both chimneys are generally in good condition. Mortar loss was noted at the primary chimney at isolated locations. Significant overgrowth of vegetation was noted at the primary chimney. Vegetation growth on masonry can lead to damage due to increased moisture retention and root growth that can weaken the masonry.

Figure 53. Primary chimney at north wall. (source:RRJ, 2025)

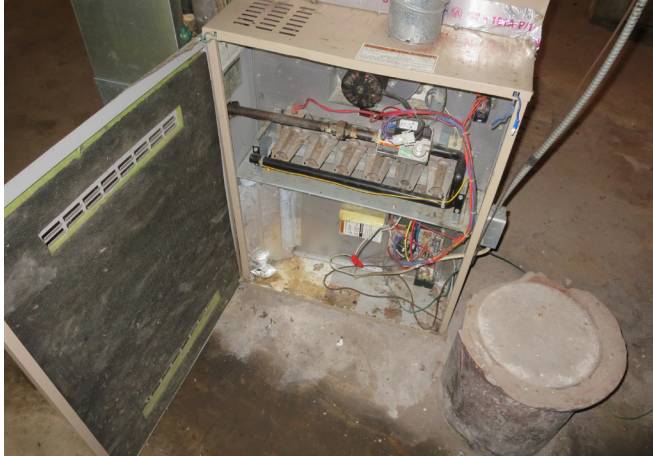
Figure 91. Basement Level, Looking South at Furnace Interior, Indicating Furnace Conditions. (source: Alvine, 2025)

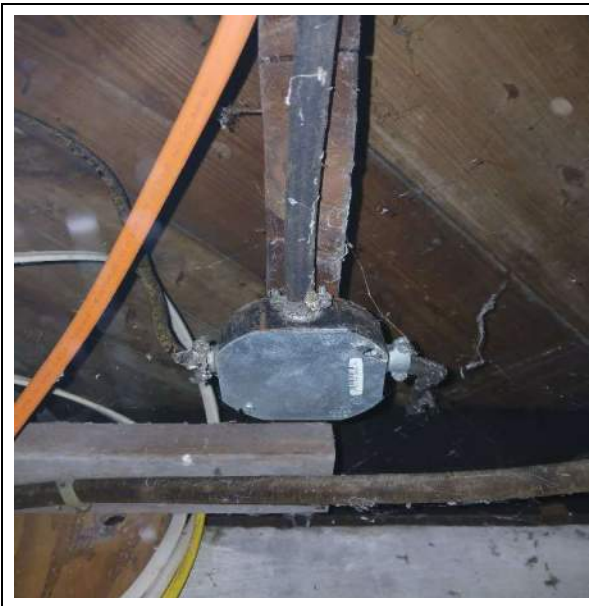
**Photograph 19:** Assumed asbestos wire cover visible in basement (Note: Eiring goes up through floor joists as observed in basement).

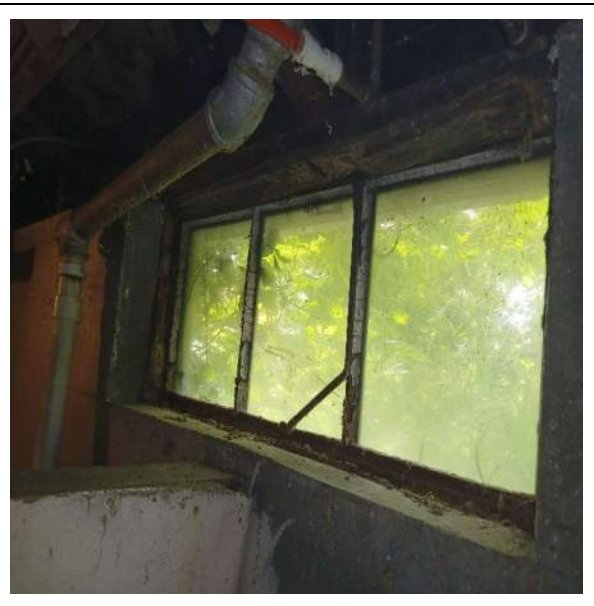
**Photograph 20:** Asbestos window glazing in two basement windows (south side).
