## Historic Structure Report

### Thurmond Commercial Buildings **NEW RIVER GORGE** National River • West Virginia

Historic Structure Report  
August 1992

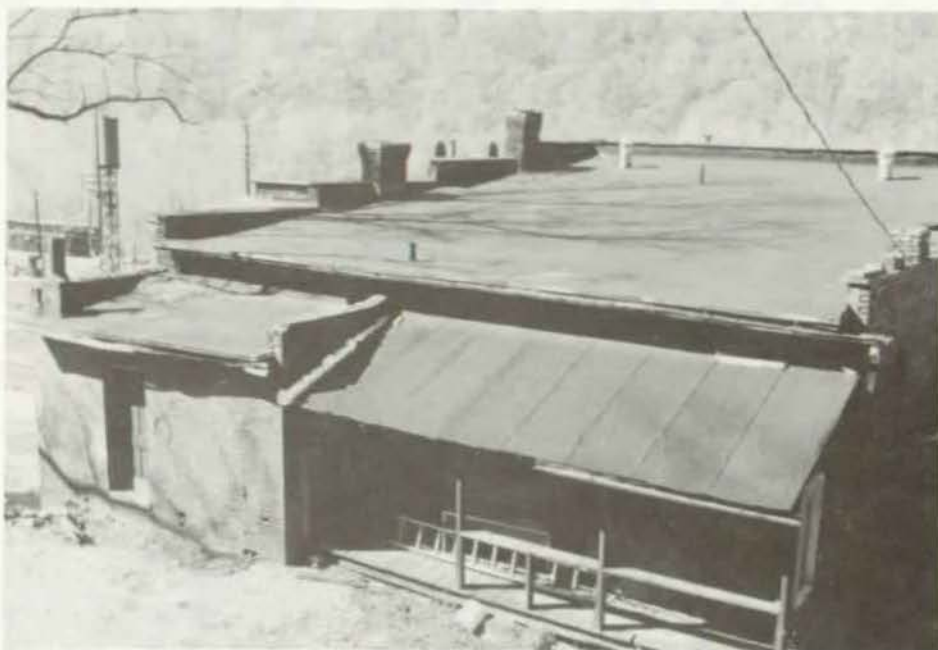
**Figure 17**  
East Elevation, Mankin-Cox Building, April 1991  
(NPS Photo)

The main roof of the Mankin-Cox Building is built up with a mopped asphalt finish (figure 17). The roof appears to be in good condition and is vented by two sheet metal turbine vents. The interior faces of the parapet walls are coated with asphalt or mastic. The parapets are in poor condition; almost every stepped section of wall at the north and south elevations is bowed inward. This bowing is especially severe at the northwest corner of the building. The parapets are capped with stone, which has been coated with asphalt.

On the addition at the back of the building is a built-up roof with a mopped asphalt finish. Both this roof and the main roof slope downward to the east and drain into hung metal gutters. The parapet walls of the addition are in fair condition and are capped with clay coping tiles. The southeast corner of this roof is penetrated by a square brick chimney. The chimney consists of approximately eight courses of brick above the roof line and is topped with a tall, round clay flue tile. This chimney is good condition. The porch roof is covered with tar paper (figure 17).

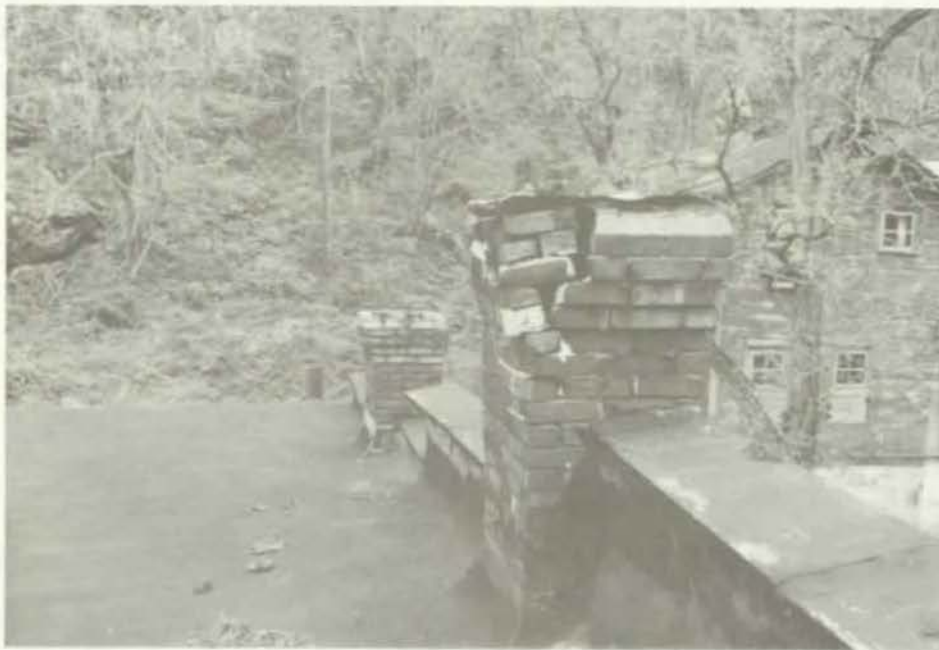
**Figure 19**  
 Southwest Chimney, Mankin-Cox Building, April 1991  
 (NPS Photo)

The chimneys are in very poor condition. Typically, the chimneys are constructed of red brick, with the top five courses, including three courses of corbelling, of yellow brick. The top of the northeast chimney has already collapsed, and the bricks have been laid on the coping stones of the adjacent parapet. The other three chimneys and the remaining courses of the northeast chimney are very short on mortar to the point that several courses of brick can be removed easily by hand. The northwest corner of the southwest chimney is beginning to cave in (figure 19), and the collapse of at least the top of the chimney is imminent. All of the chimneys lean or are rotating out of square.

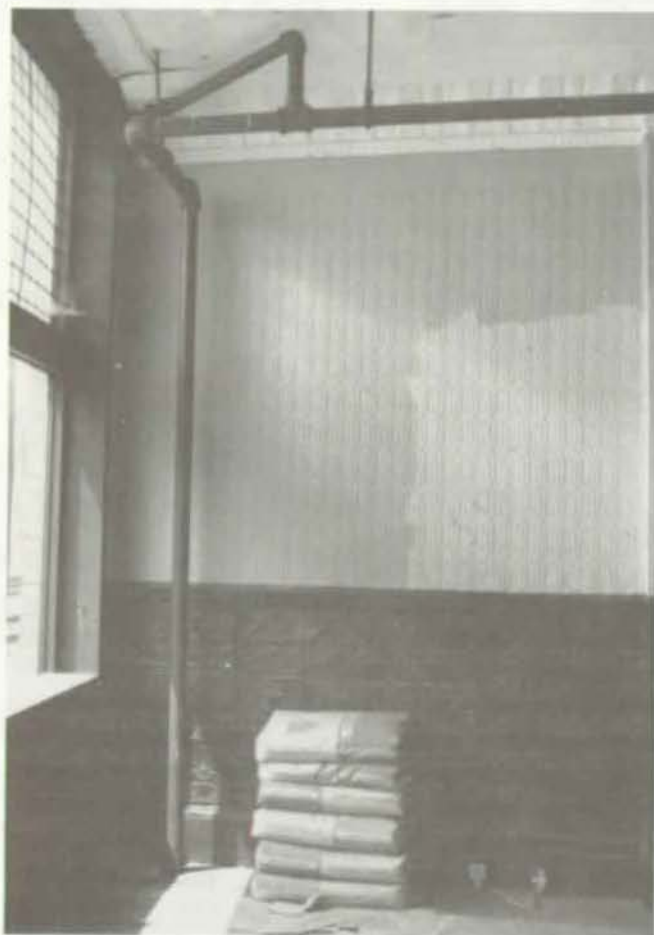
**Figure 22**  
Pressed Tin Panels, Room 101, Mankin-Cox  
Building, April 1991  
(NPS Photo)

Most of the pressed tin ceiling and wall panels remain in place, although many are obviously rusted through. The panels in the eastern portion of the room are the worst, although panels along the north exterior wall are also affected. Several tall wainscot panels on that wall, just west of the vault, are missing, with plain sheet metal panels in their place. It may be assumed these panels succumbed to moisture and rust. It may also be assumed that the beaded tongue-and-groove substrate is decayed to a greater extent than is visible from the condition of the pressed tin. Indeed, a few areas of decay are visible along the north wall.

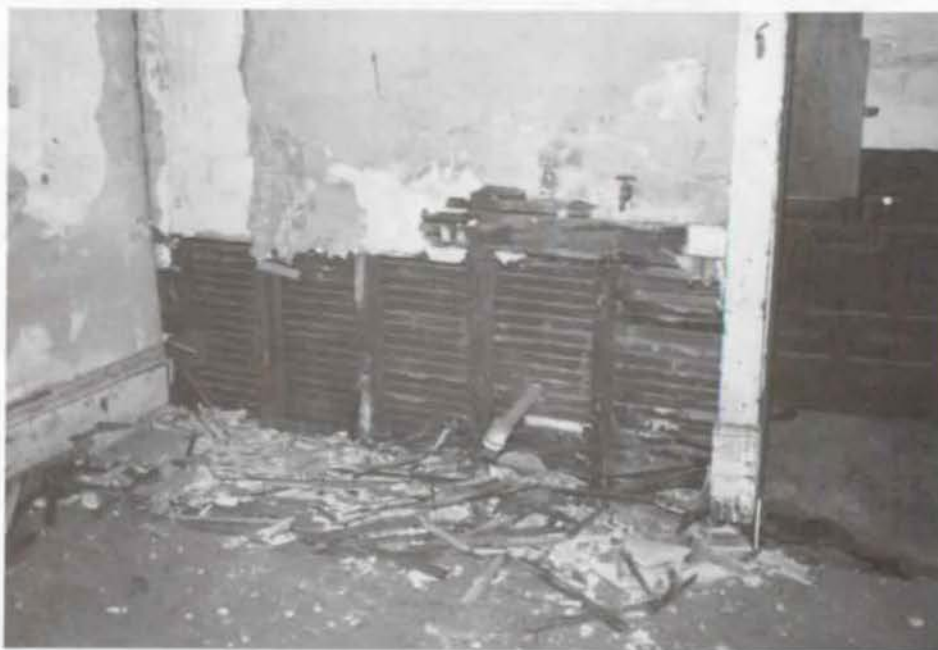
**Figure 41**  
East Wall of Room 304, Mankin-Cox Building, April 1991  
(NPS Photo)

**Room 304.** The floor of this room is in poor condition, with a totally decayed area that begins at the north half of door 303 and extends several feet along the east wall (figure 41). Another visibly rotten area of flooring is in the southeast corner of the room. Areas of the baseboard also exhibit rot, especially adjacent to the rotted areas of floor.

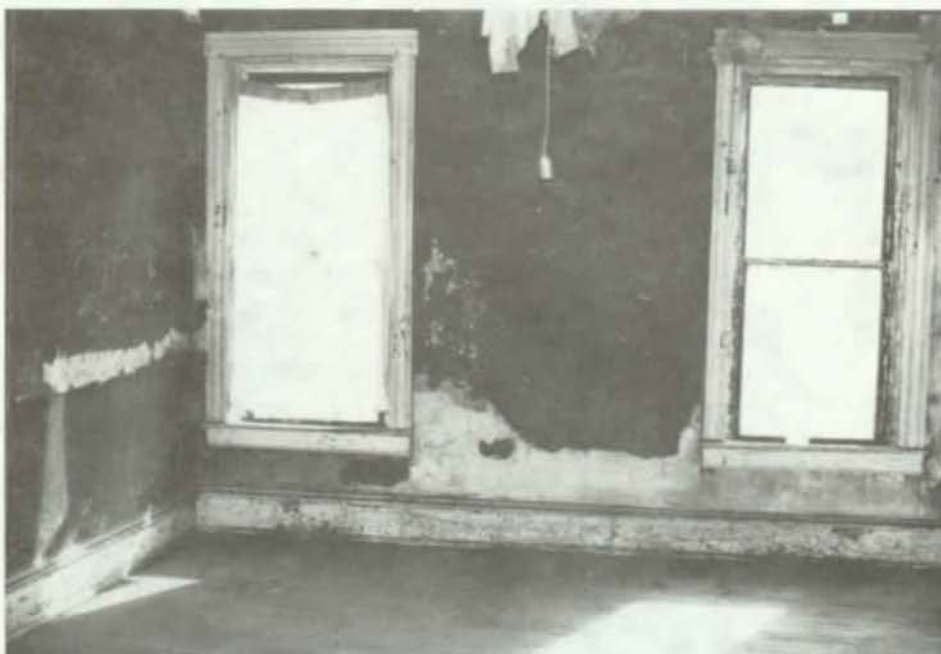
**Figure 43**  
West Wall of Room 306, Mankin-Cox Building, May 1990  
(NPS Photo)

**Room 306.** This room has an appearance similar to room 305, with wallpapered walls painted dark red (figure 43) and scratched by chickens. The plaster walls are in fair condition with some noticeable cracks at the west wall and to the south of doorway 306. Of special note is a crack  $3/8$ " wide under window 304 and a vertical crack in the middle of the chimney at the north wall. A crack similar to and probably associated with the latter occurs at the chimney immediately below on the second floor.

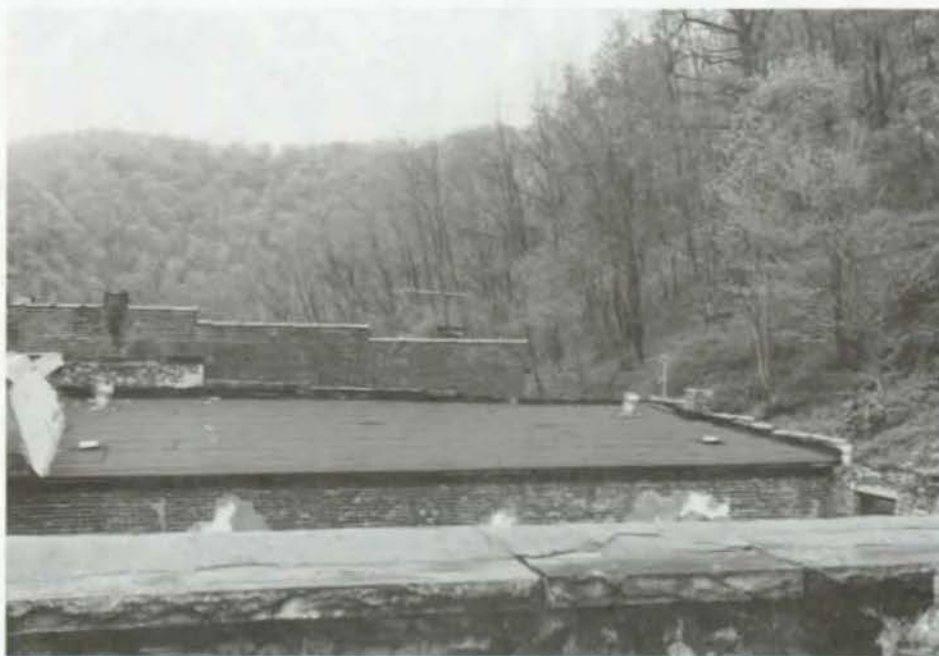
**Figure 56**  
Roof, Looking North, Goodman-Kincaid Building, April 1991  
(NPS Photo)

The roof itself appears to be in good condition. It is finished with mineral-surfaced asphalt roll roofing. The western parapet is protected with mineral-surfaced asphalt roll roofing and is also capped with sheet metal flashing that extends over the entire width of the parapet cap for the width of the roof covering the northern third of the building. Two sheet metal turbines, in the northeast and northwest corners, vent the attic.

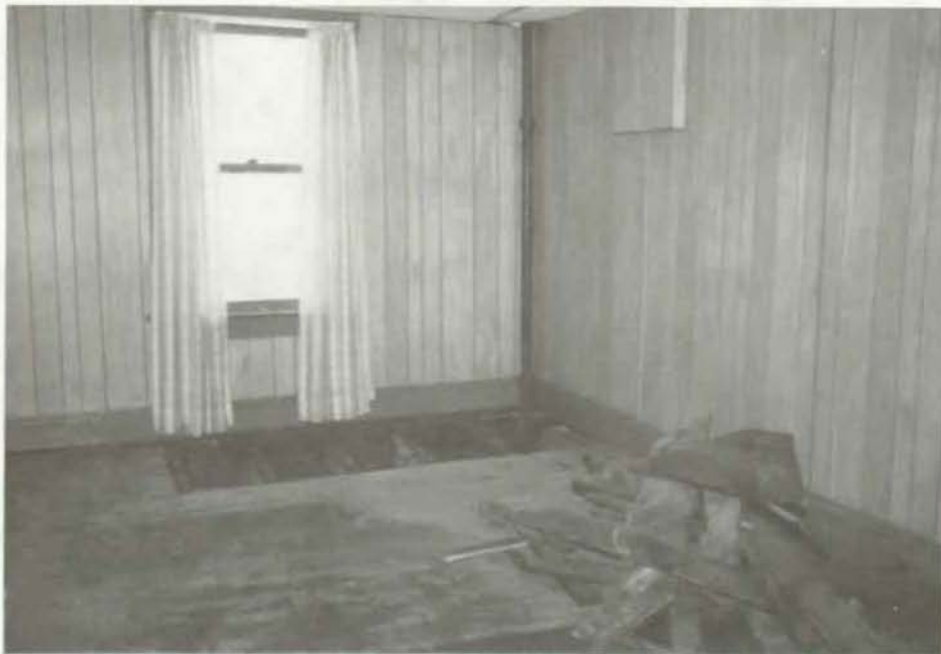
**Figure 84**  
Northwest Corner, Room 401, National Bank of Thurmond, April 1991  
(NPS Photo)

**Room 401.** In the winter of 1991, a section of carpeting and flooring in the northwest corner of the room was removed to expose the floor framing (figure 84).

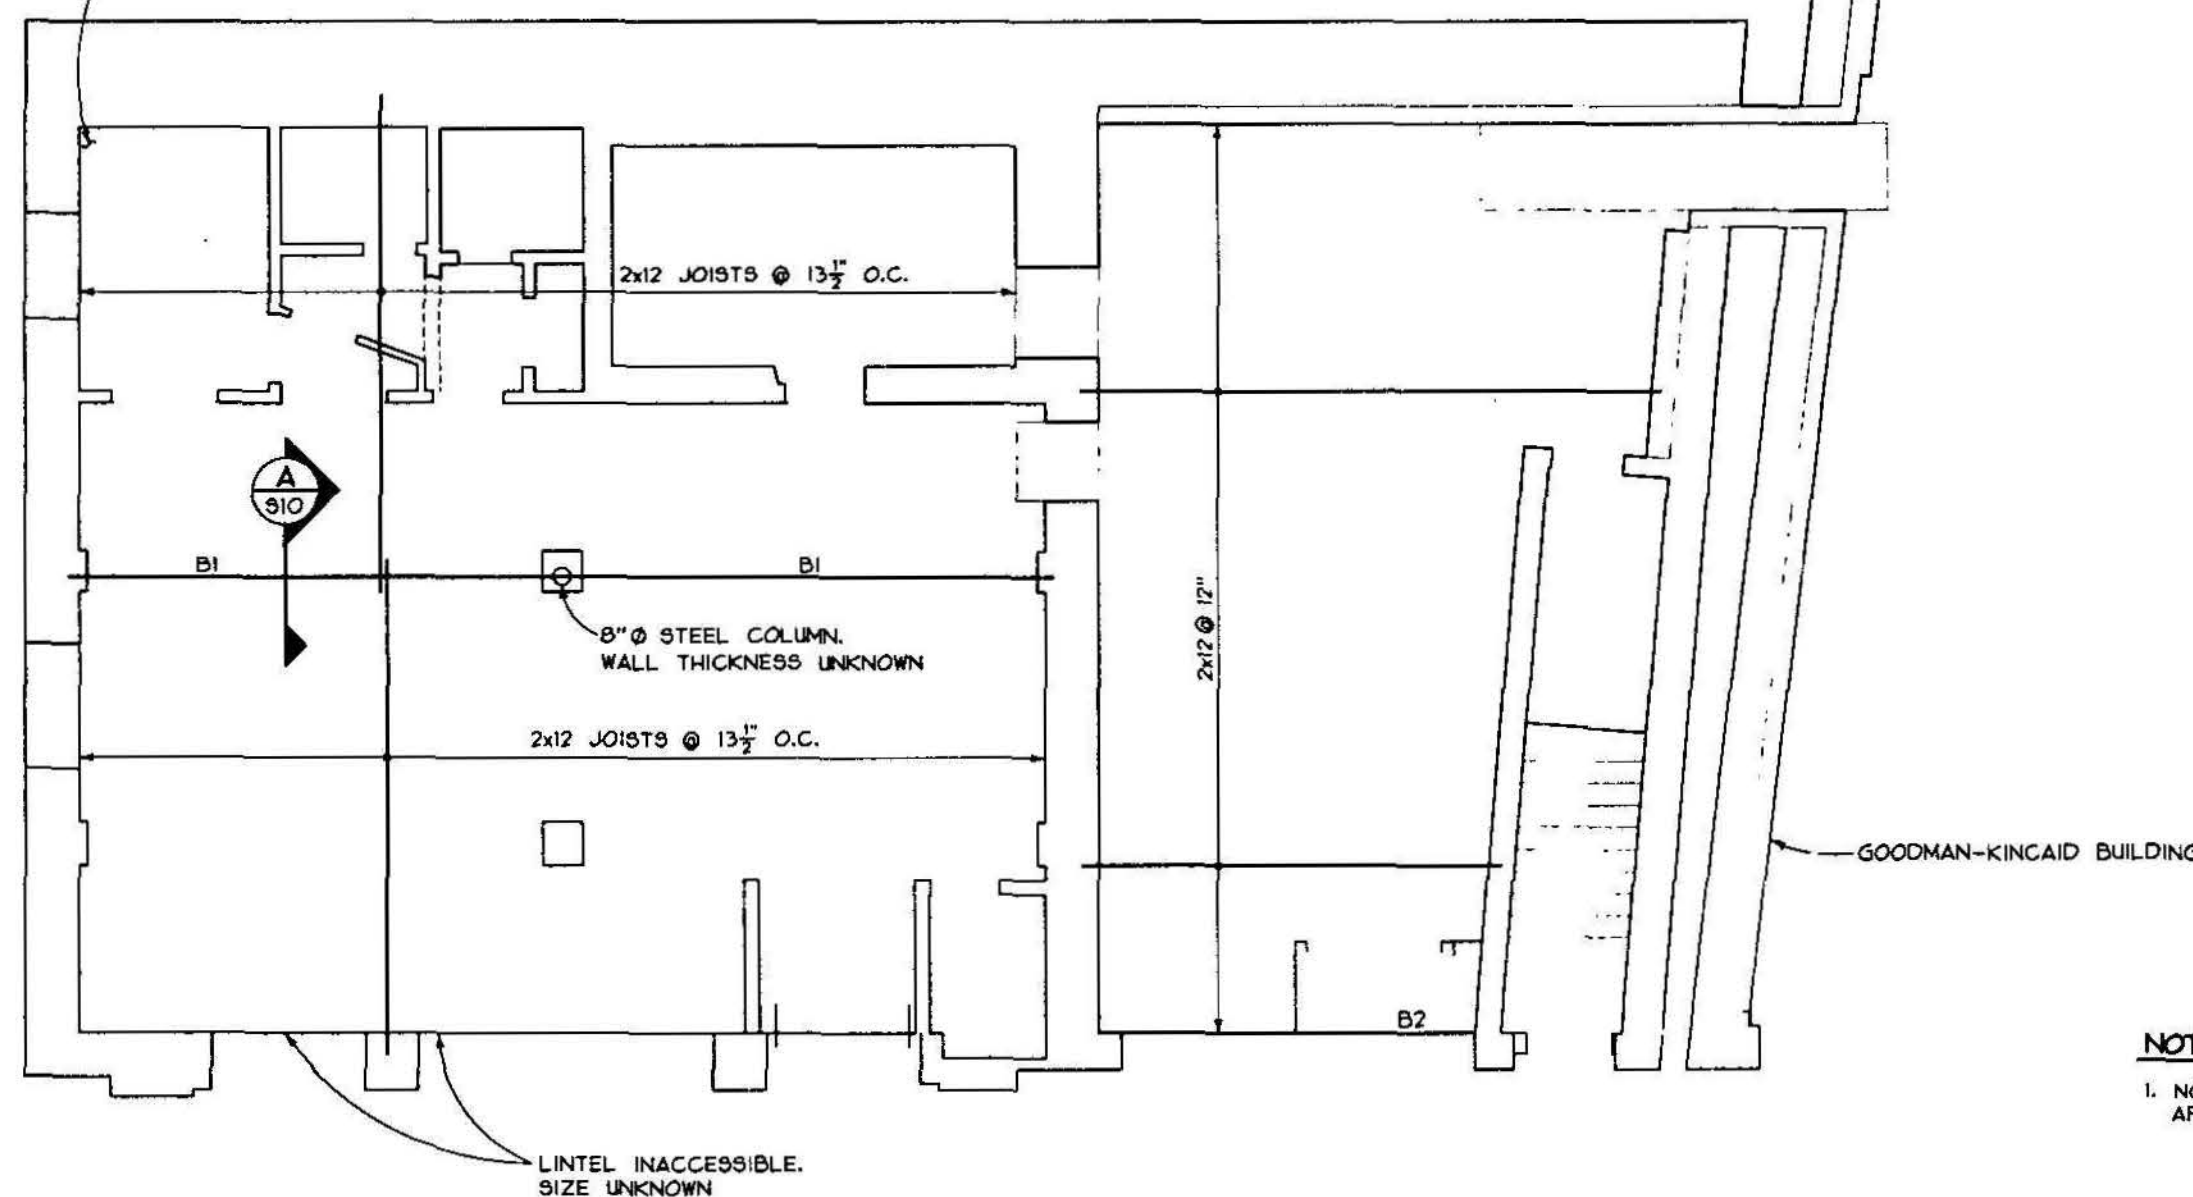
SECOND FLOOR FRAMING PLAN (1)  
SCALE (A)

FRAMING IN POOR CONDITION  
DUE TO WATER DAMAGE
