Ocmulgee National Monument  
Dunlap House  
Historic Structure Report

March 2011

2011  
Historic Structure Report  
Dunlap House  
Ocmulgee National Monument

This Historic Structure Report was compiled in direct response to an arson fire at the house on February 8, 2011. Its main objective was to help ensure that the historic fabric of the house is protected as repairs are made and the house rehabilitated for continued residential use.

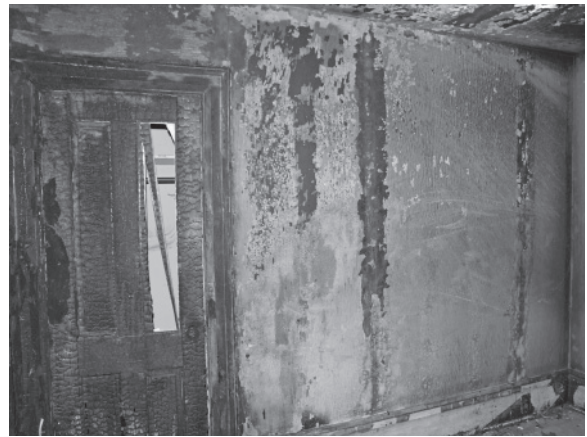
The arson fire in February 2011 heavily damaged the small bedroom (107) and the back hall (103) with lesser damage in the laundry room (108). The remainder of the house suffered smoke damage. Fast response from the local fire department limited the damage, so that the principal damage was the destruction of the two windows and doors, including most of the casing and trim, about 10' of baseboard in the southwest corner of the bedroom (107), the disappearing stairway in the rear hall (103), and one side of the door to the front hall, which was badly scorched by the flames. Firefighters also had to break the outside door to the master

**Figure 14.** View northeast in small bedroom (107) where the fire started.

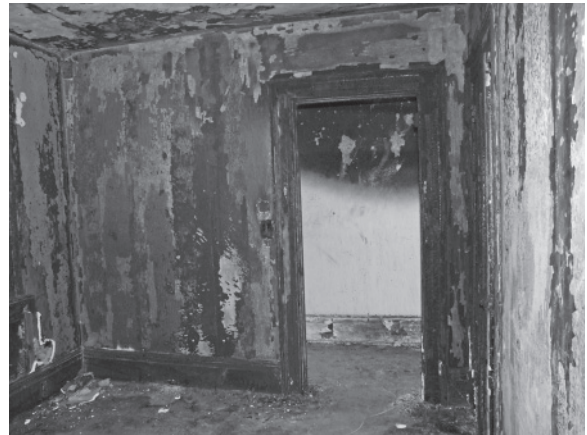
**Figure 15.** View west in small bedroom. All of the woodwork seen here, except for the baseboard in the hall, was charred beyond repair. The door in this opening was also destroyed.

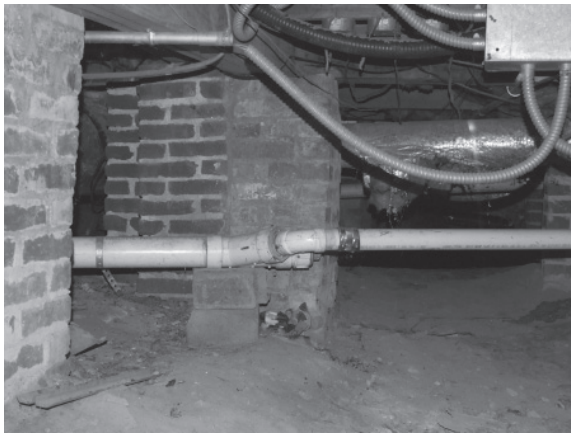
**Figure 3.** View west from beneath back porch. The gray mortar of mid-twentieth century alterations contrasts with the light mortar of one of the T-shaped piers, left of center, that were part of the original masonry.

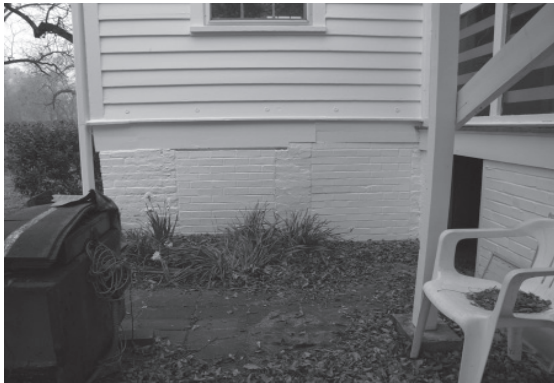
**Figure 4.** The anomalies in the foundation wall and skirt trim on the east side of the rear wing probably relate to the original configuration of the back porch. Beneath the present porch, a portion of the foundation is painted red, most likely after 1936 when part of the south foundation under the present kitchen was exposed.

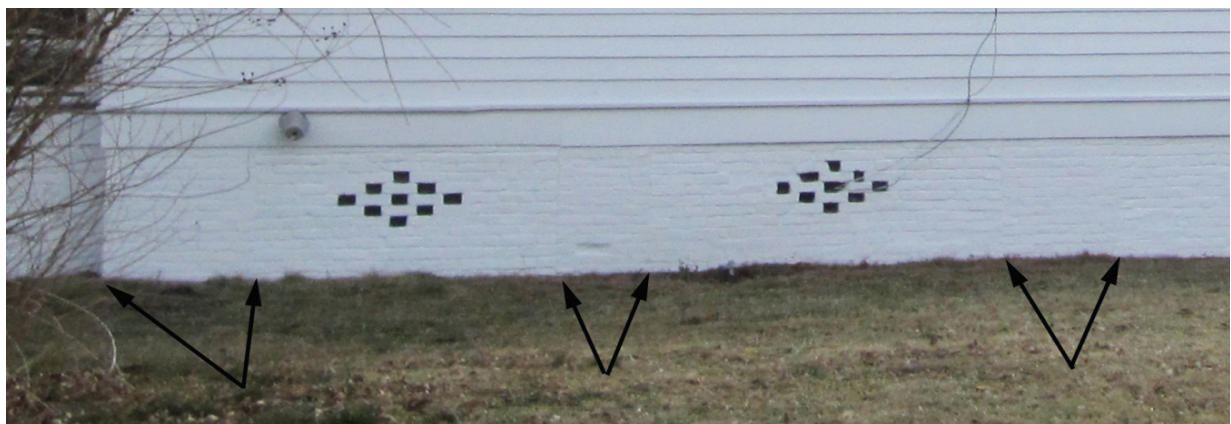
**Figure 5.** View of foundation at north end of west side of house, annotated with arrows to indicate the three types of perimeter piers: L-shaped, left; rectangular, center; and T-shaped, right. The vented brick panels between these piers were part of the 1938 remodeling.

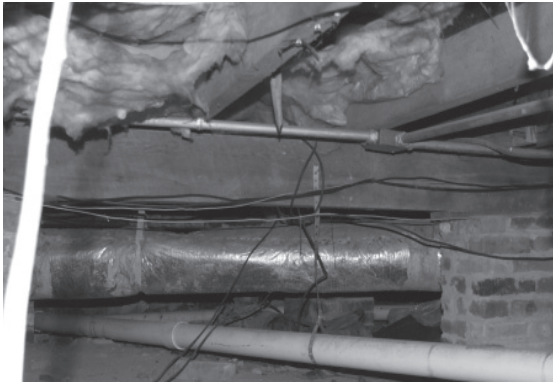
**Figure 6.** View of typical connection between original floor joists running east and west and the girders that run north and south on each side of the original center hall. The tangle of wires is typical in much of the crawl space beneath the house.

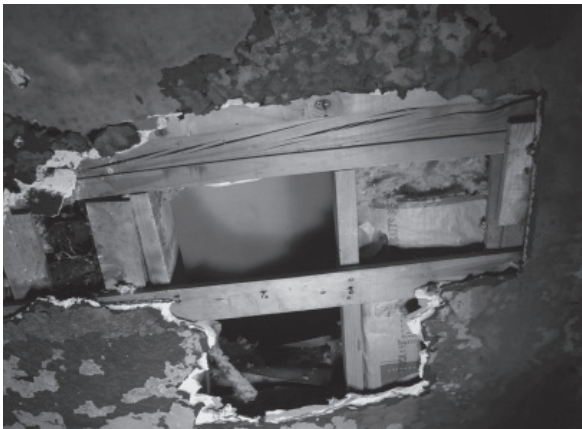
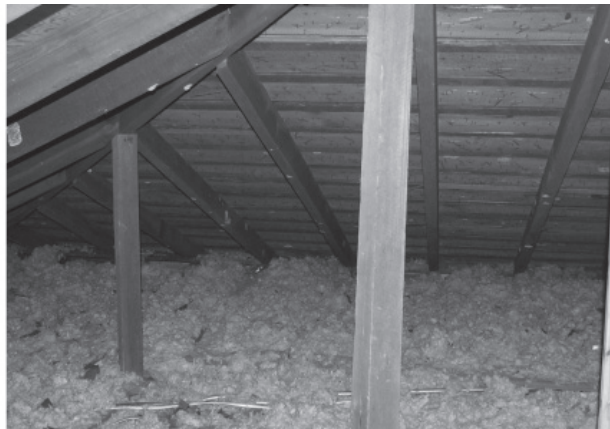
All observed framing appeared to be in excellent condition, including the framing of the ceilings in the two fire-damaged rooms, 107 and 108, except perhaps in the framing for the opening of the disappearing stairs.

**Figure 7.** View of framing for ceiling in Room 108 that was added in 1952-1953, left, and a view of typical roof framing in the attic, right.

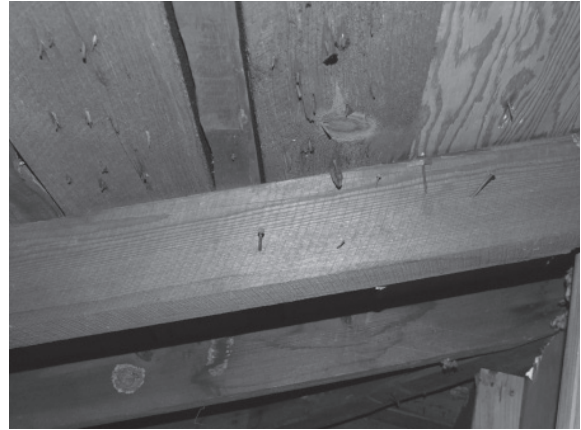
**Figure 8.** View of roof decking on west slope of roof, showing typical rafters and original 6" decking showing nails from original wood-shingled roofing. The narrow strips were used to create a solid wood deck for a standing-seam metal roof installed in 1938. At right is plywood decking used for repairs when the metal roofing was replaced with three-tab asphalt shingles in the last decade of the twentieth century.

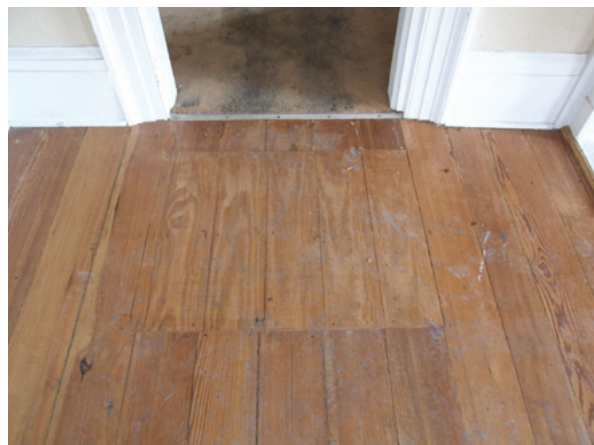
**Figure 17.** View of typical variation in the house's pine flooring. The wide, open grain of the square patched area is typical of lumber used in the 1950s.
