National Park Service  
Cultural Landscapes Inventory  
2003

Park Headquarters  
Olympic National Park

CULTURAL LANDSCAPES INVENTORY (CLI) PROGRAM  
*2010 Condition Assessment Update for:*

**Park Headquarters**  
**Olympic National Park**

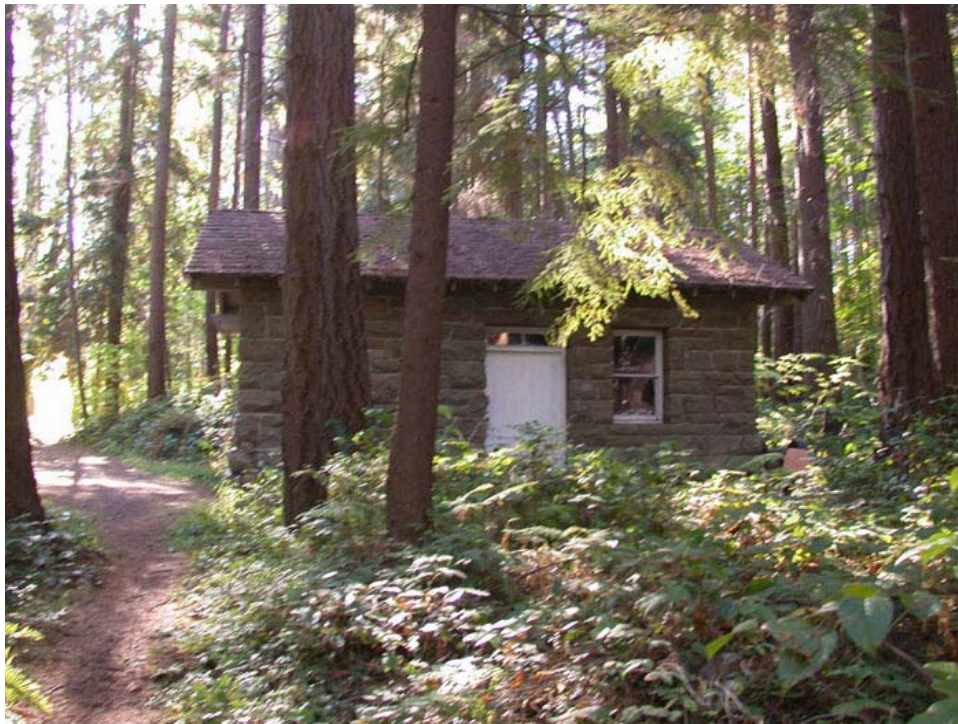
*When the CLI was completed in 2006, the Gas & Oil house required some stabilization measures that have since been completed. However, the Transformer/pump house is still in need of some stabilization measures such as replacement of a broken window on the north façade.*

*Contemporary photograph of the historic Transformer/Pump house completed in 1941, looking south. (CCSO, 2002)*

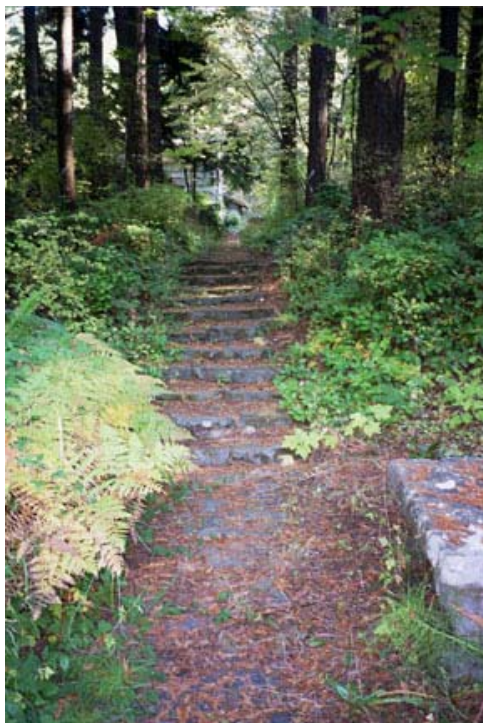
*Since 2003 much of the historic pedestrian circulation has been stabilized and reconstructed. However, the historic flagstone pathway between the Administration building and the Superintendent's Residence needs stabilization. The mortar between the flagstones is missing and/or deteriorating due to weathering and growth of forest vegetation. The flagstone walkways around the Superintendent's Residence are also in need of stabilization due to growth of lawn vegetation in between the flagstones. The flagstone patio on the north side of the Superintendent's Residence was partially covered with a thin layer of concrete in order to smooth the surface for ADA accessibility. However, much of this concrete is separating from the underlying flagstones. Vegetation should be removed, flagstones reset, and mortar repaired to prevent further deterioration of the walkways.*

*Contemporary photograph showing the historic stone steps between the Superintendent's residence and the Administration building. A lighted bench is located on the right edge of the path. (CCSO, 2002)*

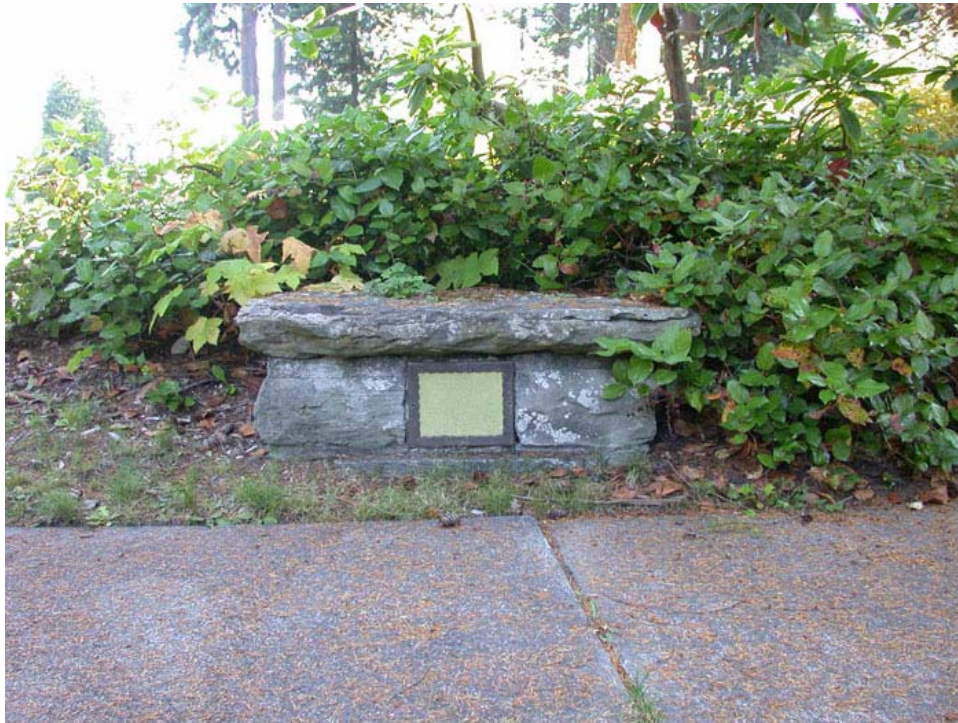
*Historic small scale features (bench lights and bollard lights) are in need of significant stabilization measures. The bollard lights are experiencing significant wood rot. The housing for the bench lights are becoming corroded from exposure to the elements. Some of the benches are becoming overgrown by forest vegetation and mortar holding the stone benches together is deteriorating. These features should be cleared of vegetation, wood rot should be repaired, and cracked or missing mortar replaced.*

*Contemporary photograph showing a historic pathway light that was designed to also serve as a bench. (CCSO, 2002)*

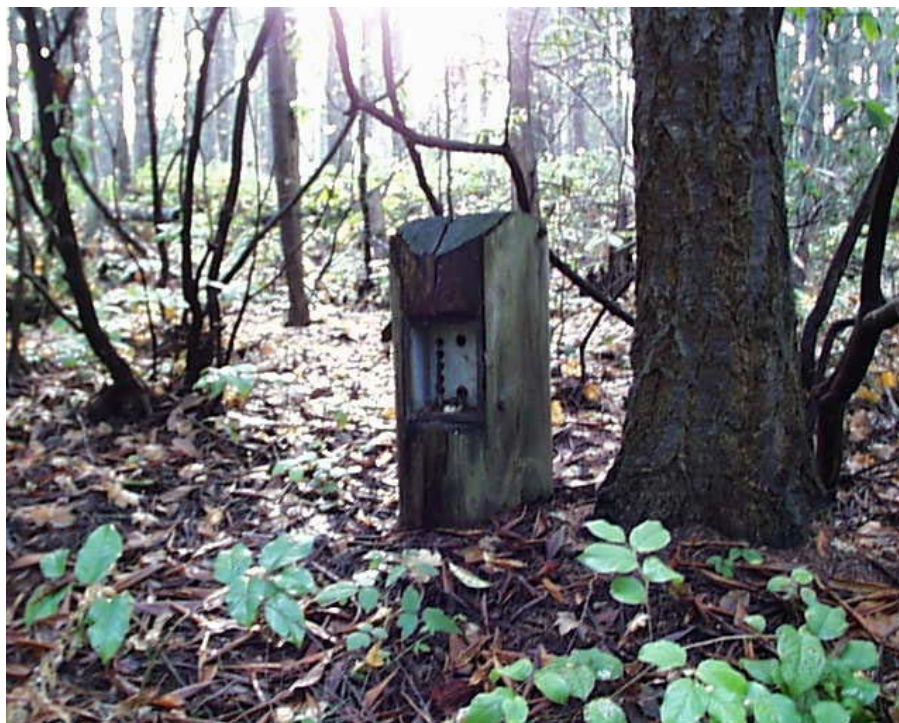
*Contemporary photograph showing a historic bollard street light. (CCSO, 2002)*
