HISTORIC STRUCTURES REPORT

HUMES RANCH

BUILDINGS #699-A and #699-B, CLASS CC

Prepared by  
A. Lewis Koue  
Architect  
April 1969

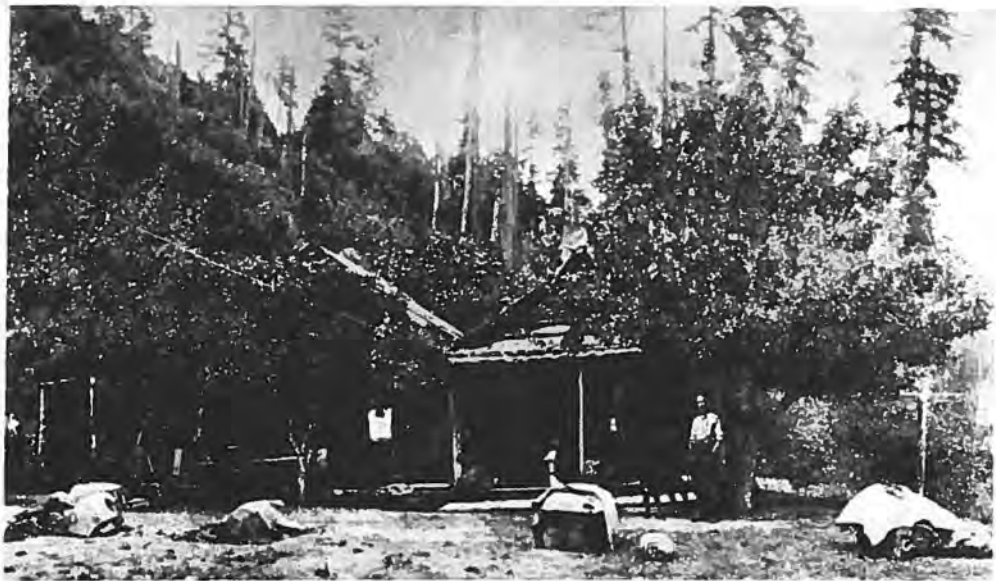
- Illustration No. 1: Grant Humes standing in front of his cabin and barn, Building 699, A. and B. Date unknown. Source, Ruby El Hult, Untamed Olympics.

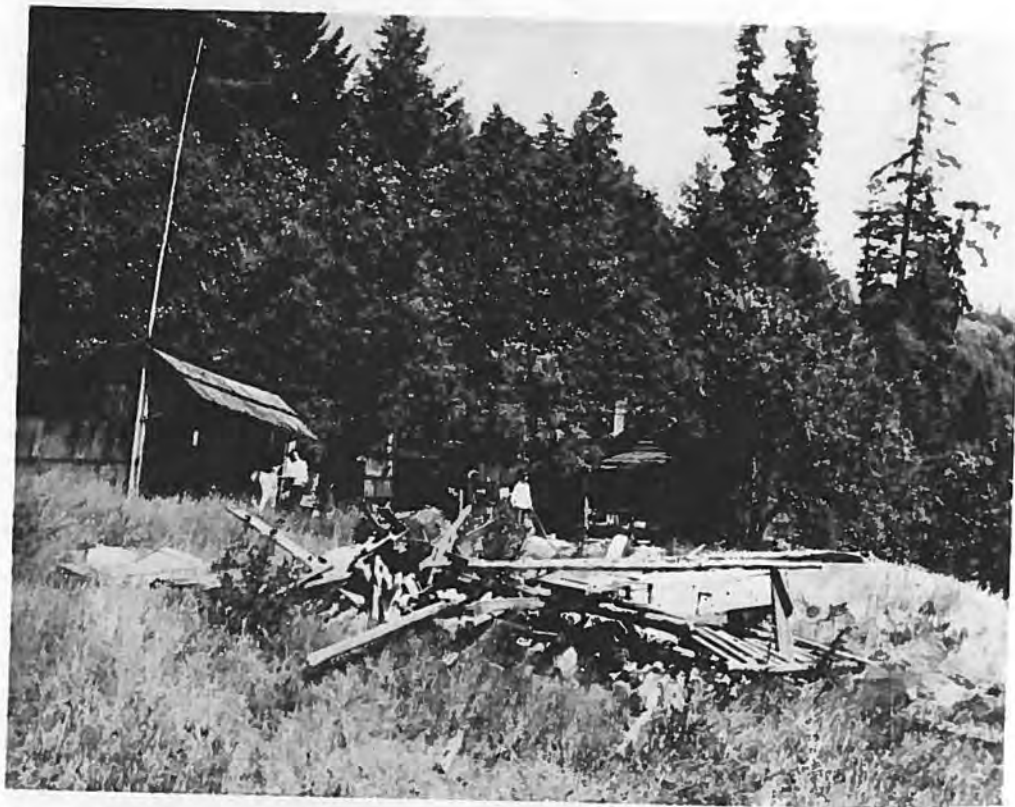
(Note: This structure which is recorded in the structures inventory and the Master Plan no longer exists (May 1968), but by description appears to be the structure once situated at the approximate spot from which the photograph, Illustration No. 5, was taken. It appears in an early photograph of the complex, Illustration No. 2).

Illustration No. 2: Humes homestead with Building #700, Wood and Tool Shed (now destroyed), left center. Rubbish in foreground is the fencework. Date unknown. Files of Olympic National Park.

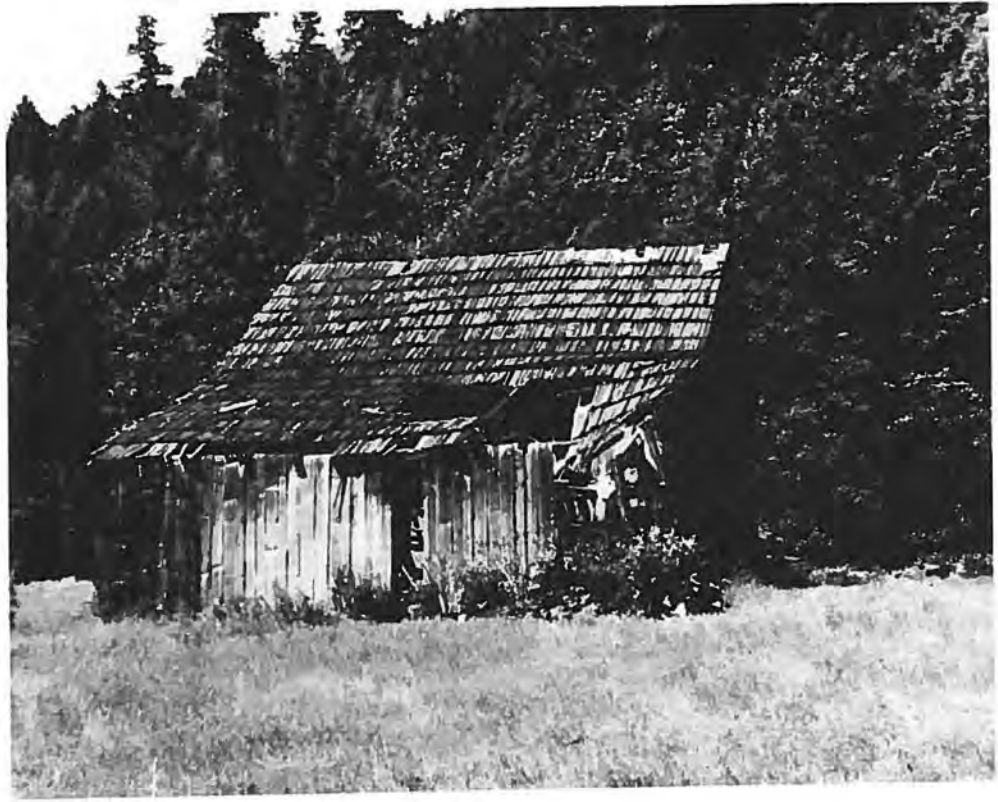
Illustration No. 3: Humes Barn on the pasture beneath the cabin. The crowbars and hammers of the Student Conservation Program soon finished the job of demolition that time and weather began. Date unknown. Files of Olympic National Park.

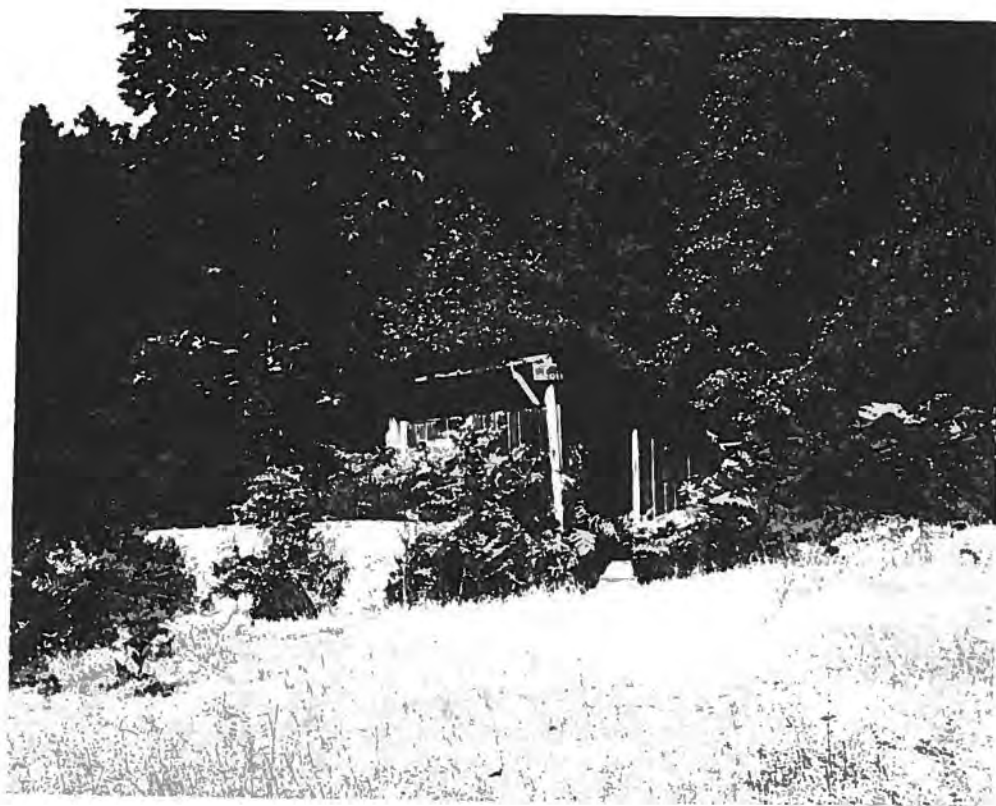
Illustration No. 4: Alleged greenhouse at the Humes homestead.  
At one time used as a privy. Taken 1967. Files of the Division  
of History.

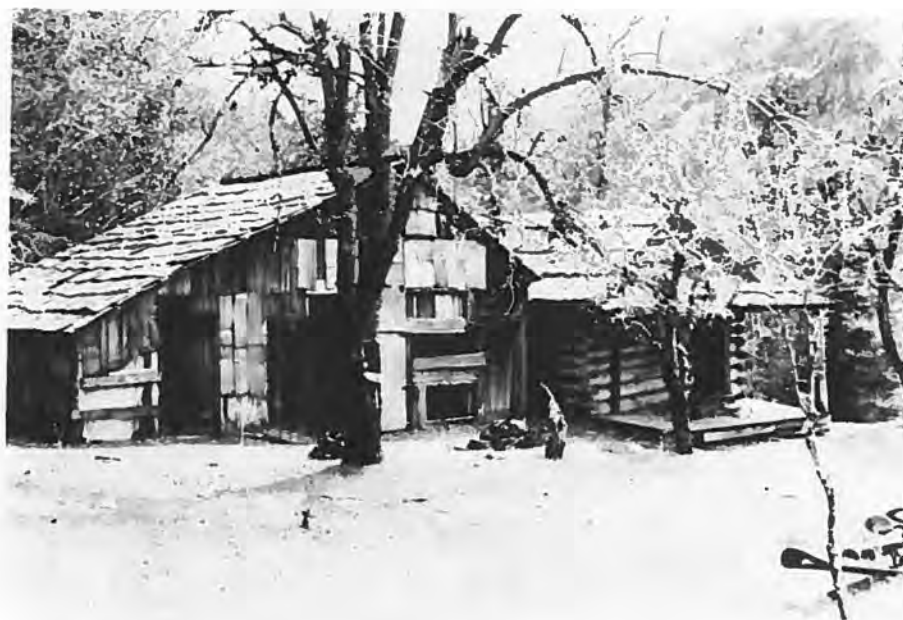
Illustration No. 5, taken in 1968, no change in configuration of the structures from the earlier photographs is evident.

Illustration No. 5: Present view of Cabin and Barn.

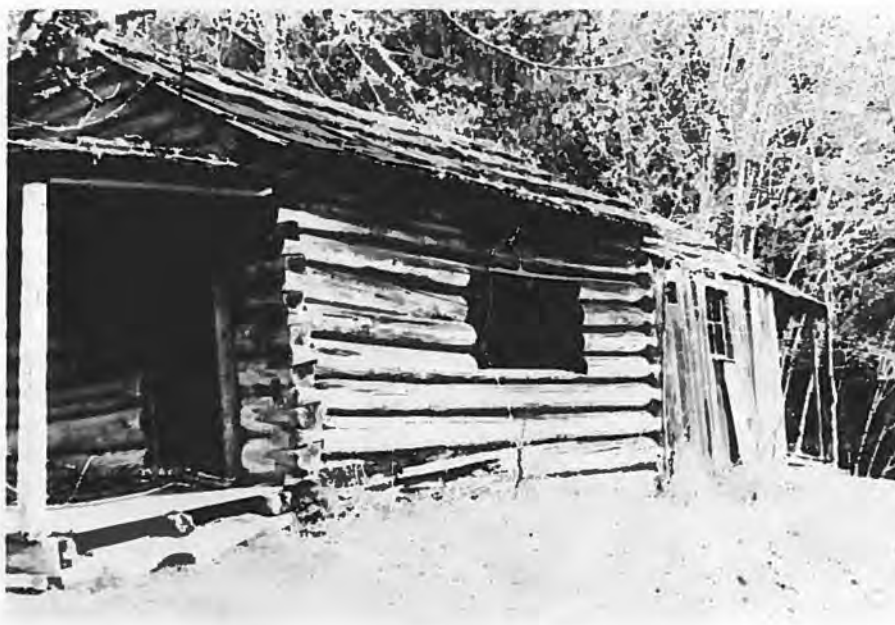
Illustration No. 6: Close-up of west side of Cabin.

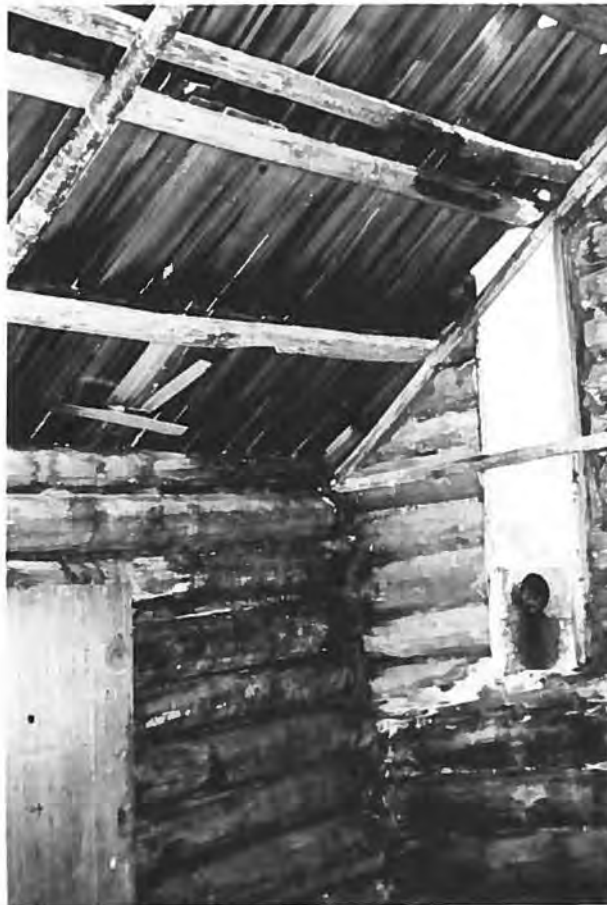
A chimney constructed of special concrete blocks 14"x14"x8" with a special interlocking joint layed up without mortar has been installed in the thickness of the log wall with flue openings serving the kitchen and the log cabin. Spaced roof purlins near this chimney would indicate that they once supported a metal chimney and were charred by overheating of the chimney collar. See Illustration No. 7.

Illustration No. 7: Interior of Cabin. Note charred purlins that appear to have once supported a metal chinmey.

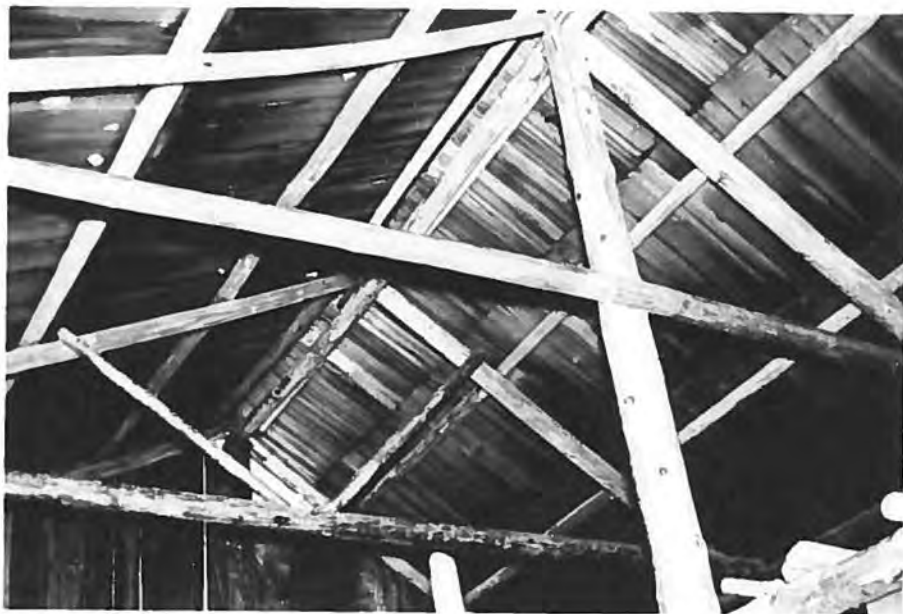
A barn approximately 28'-6" x 17'-6" adjoins the cabin, but separated from it by 16 inches. This structure is of pole and girt construction with split cedar shake roof and siding and earth floor. Illustration No. 8. Presently, the interior has been adapted with bunks constructed of saplings with plywood decks.

Illustration No. 8: Interior view showing construction of barn roof.

The barn shall be made structurally sound by repairing structural members. Bottoms of posts shall be spliced as necessary to eliminate decay. Shake roof and siding shall be repaired. Barn may be left accessible for emergency shelter, and bunks shall remain until future determination for other use. Like materials for the restoration of cabin and barn shall be garnered from the local forest.

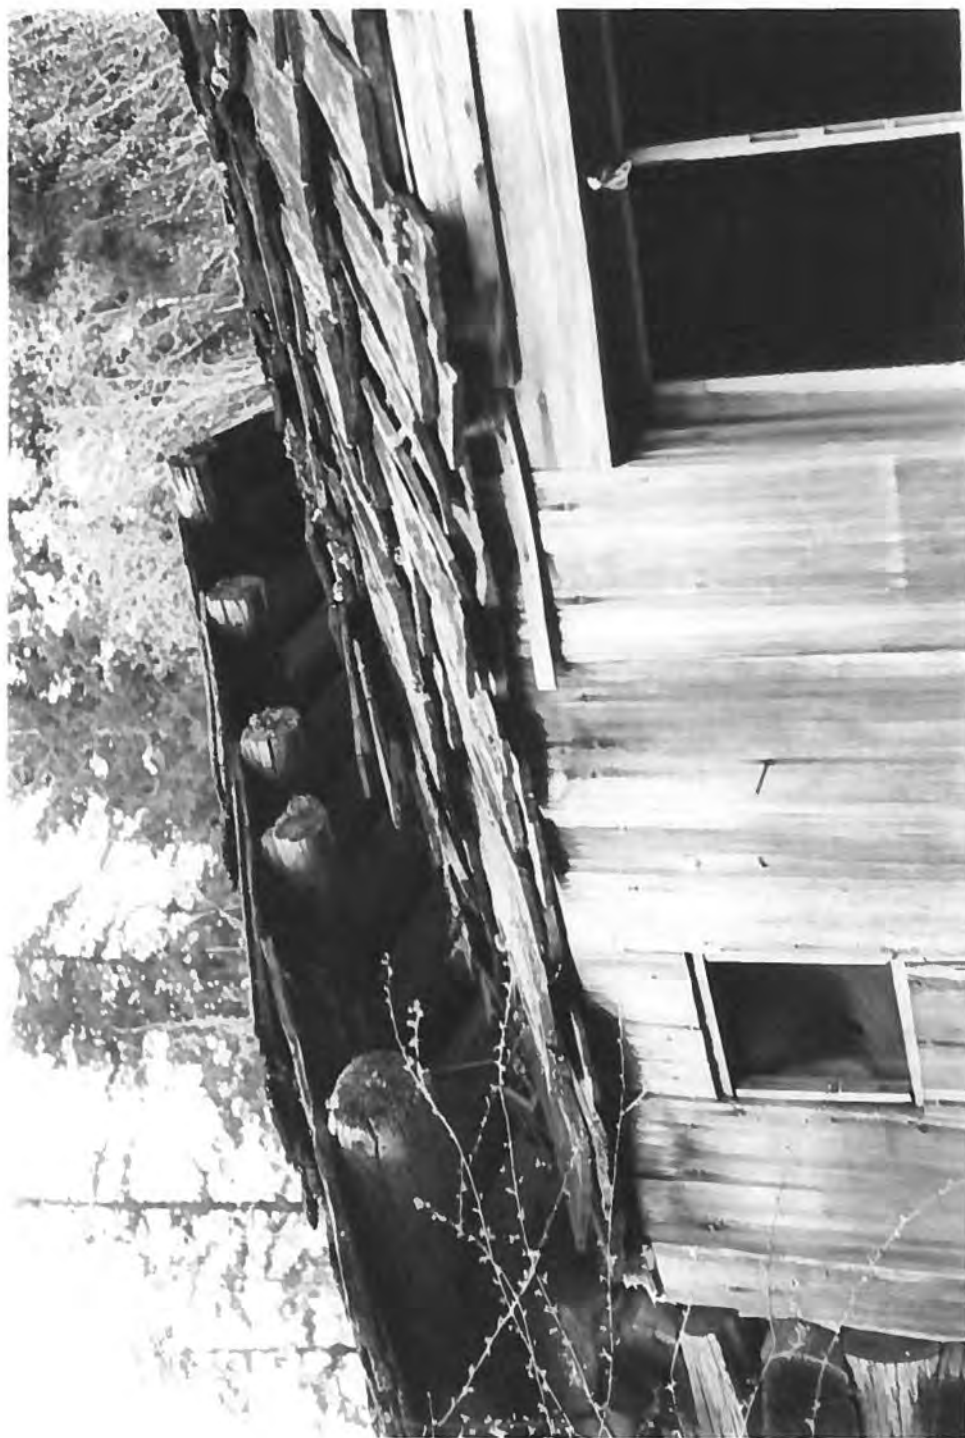
Illustration No. 9: Connection - Kitchen wing to Cabin.

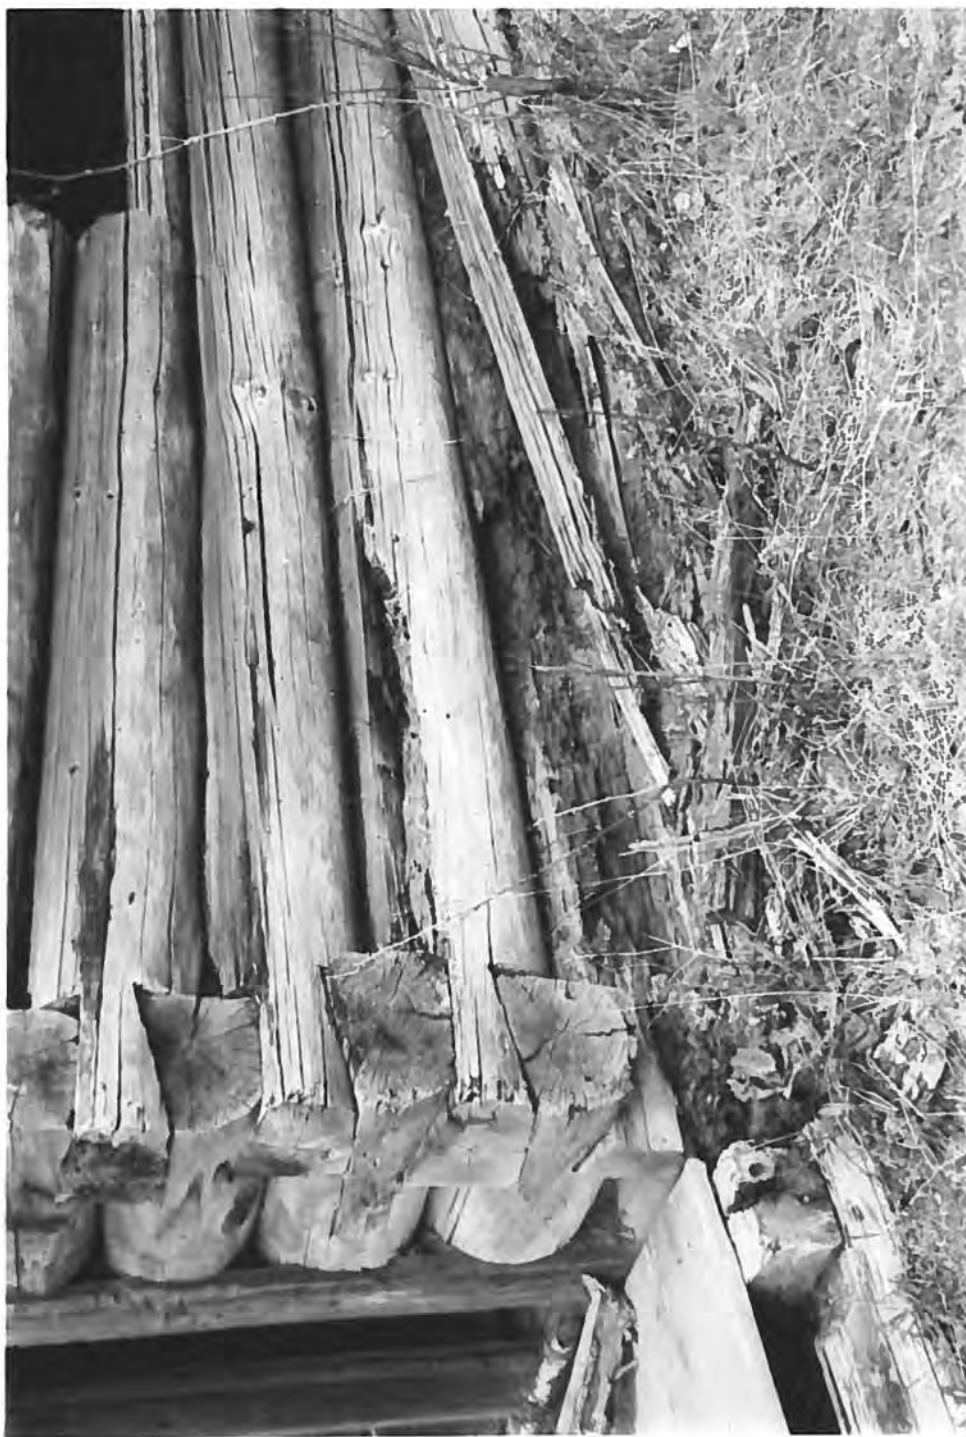
Water shedding off the cabin roof and the barn which has been unable to drain from between the buildings due to accumulation of debris has caused the logs of the cabin to decay badly.

Illustration No. 10: Condition of logs - westerly side at entrance.

The cabin, kitchen and porches shall be restored to a sound condition with all decayed and missing elements replaced, and building leveled up. The building shall be enclosed with job-built doors as per original. Sliding sash without glass shall be reinstalled and windows shall be covered with 1" x 2" mesh hardware cloth to thwart vandals.

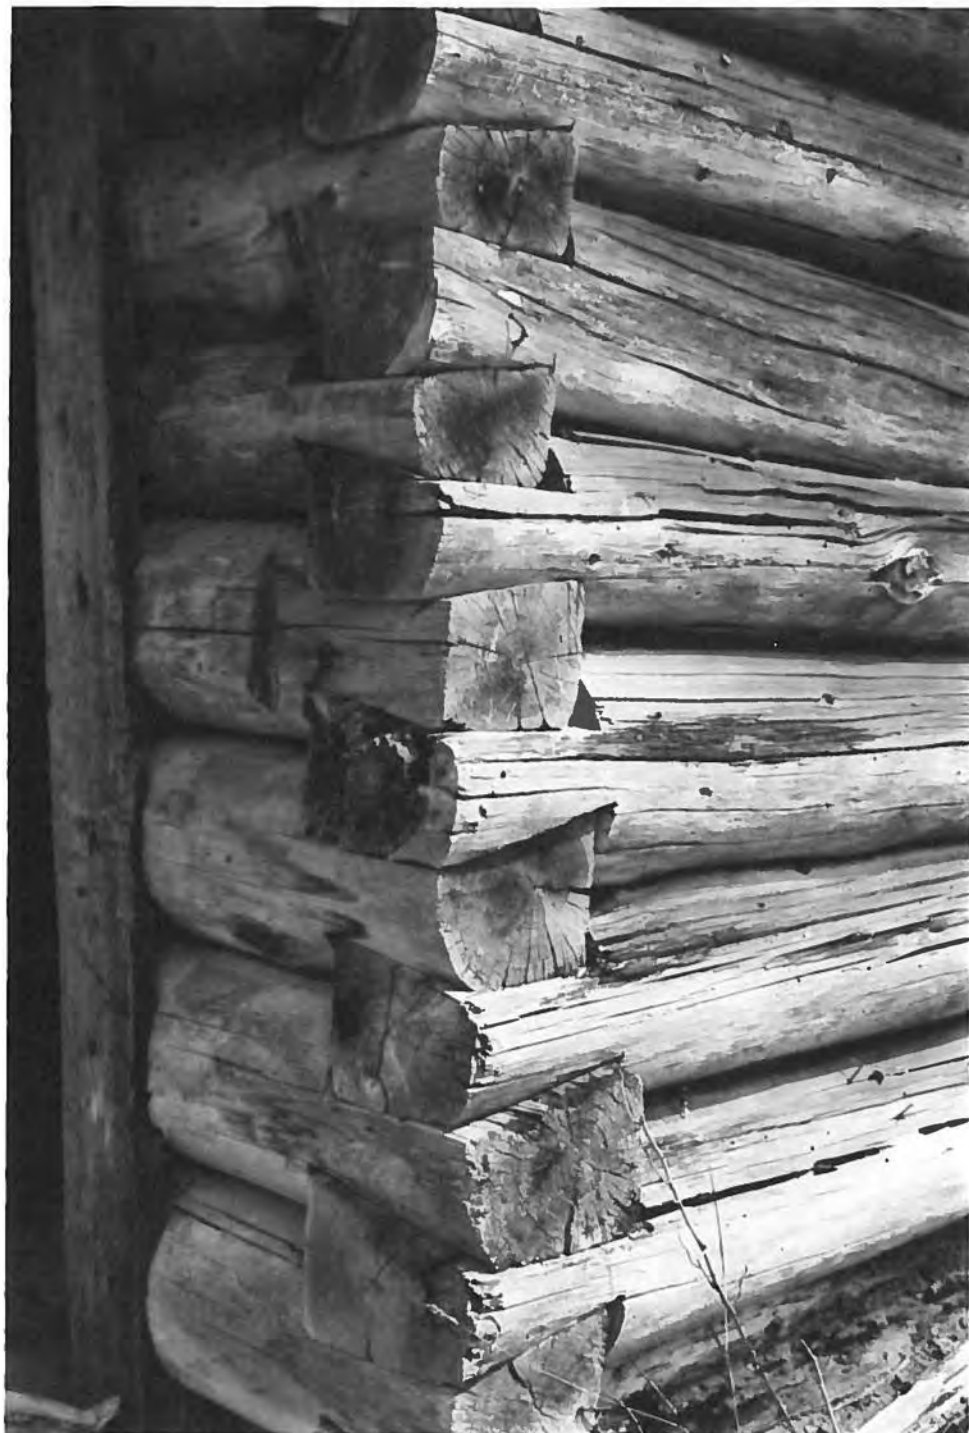
Illustration No. 11: Detail, corner joints of logs.

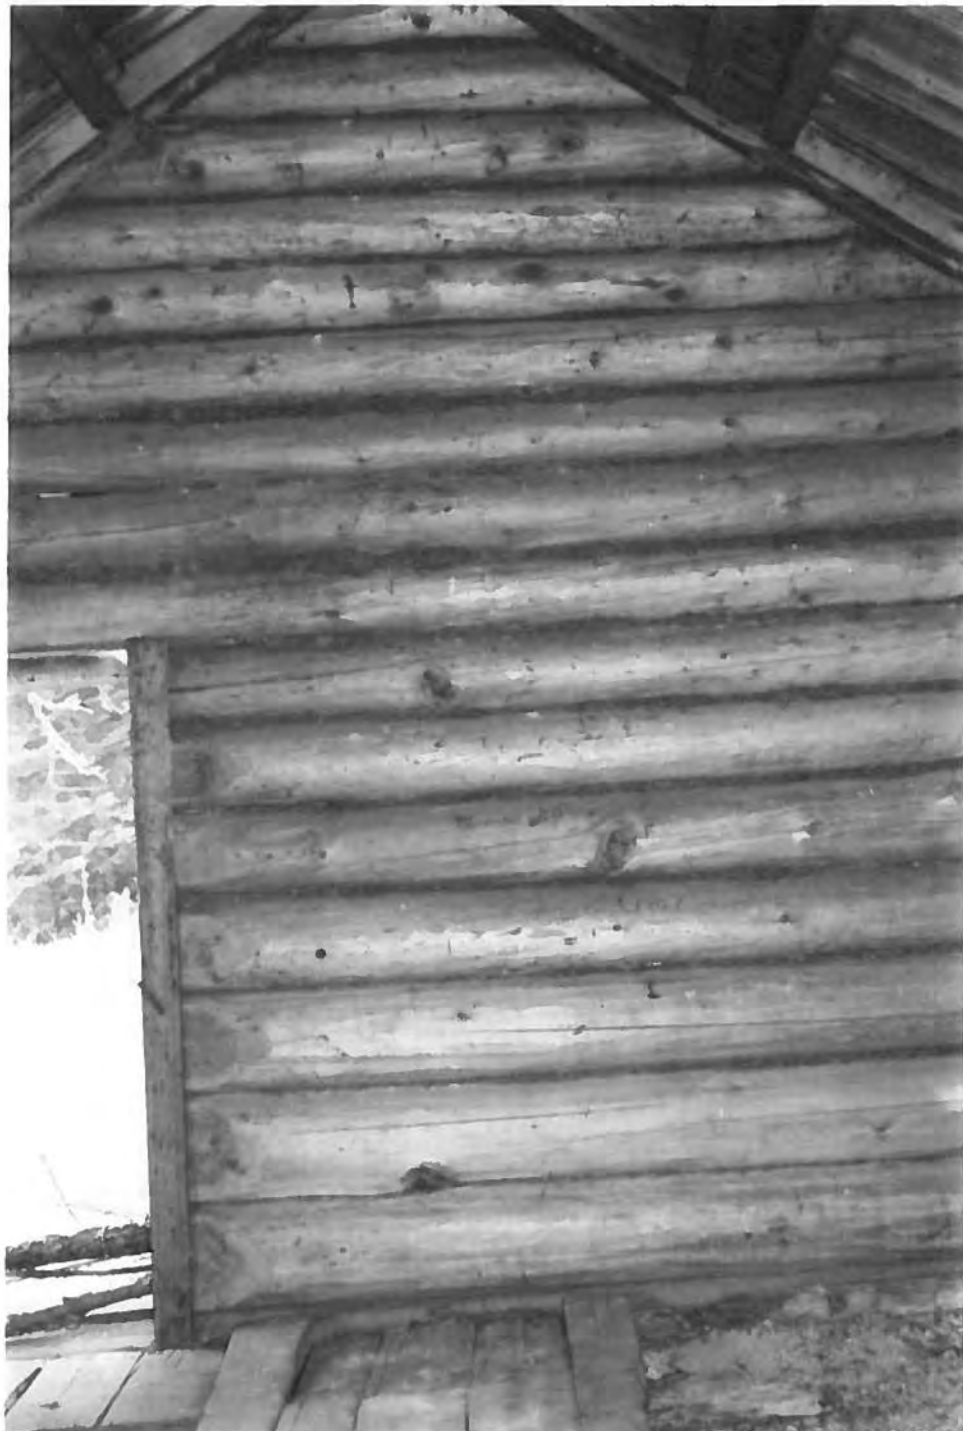
Illustration No. 12: View of interior toward front entrance.  
Note decay of floor construction from contact with earth.

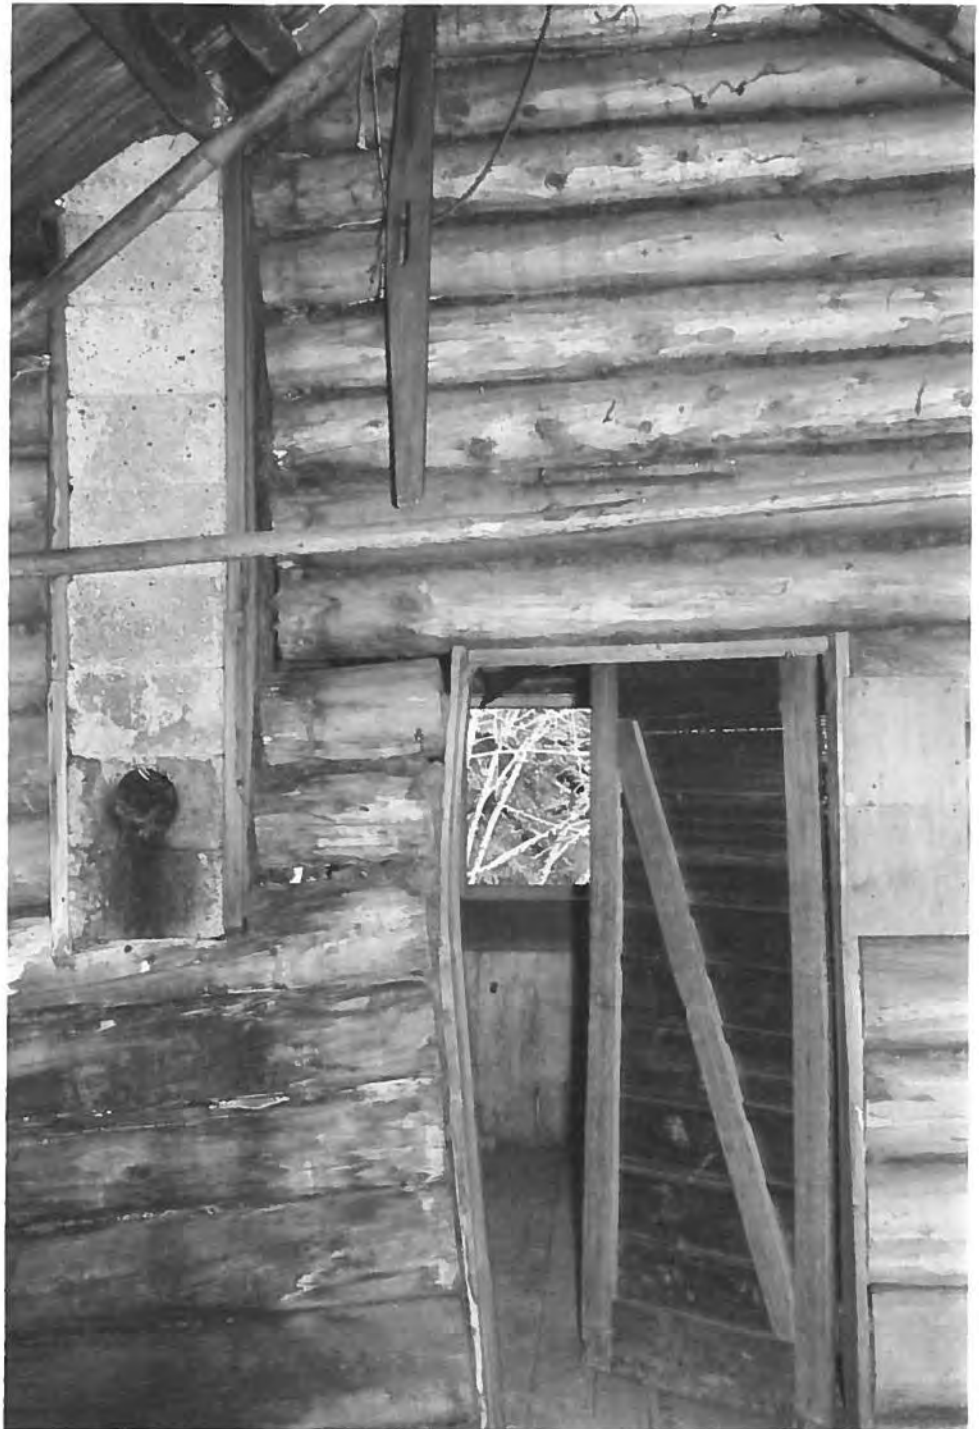
Illustration No. 13: View of interior toward Kitchen.

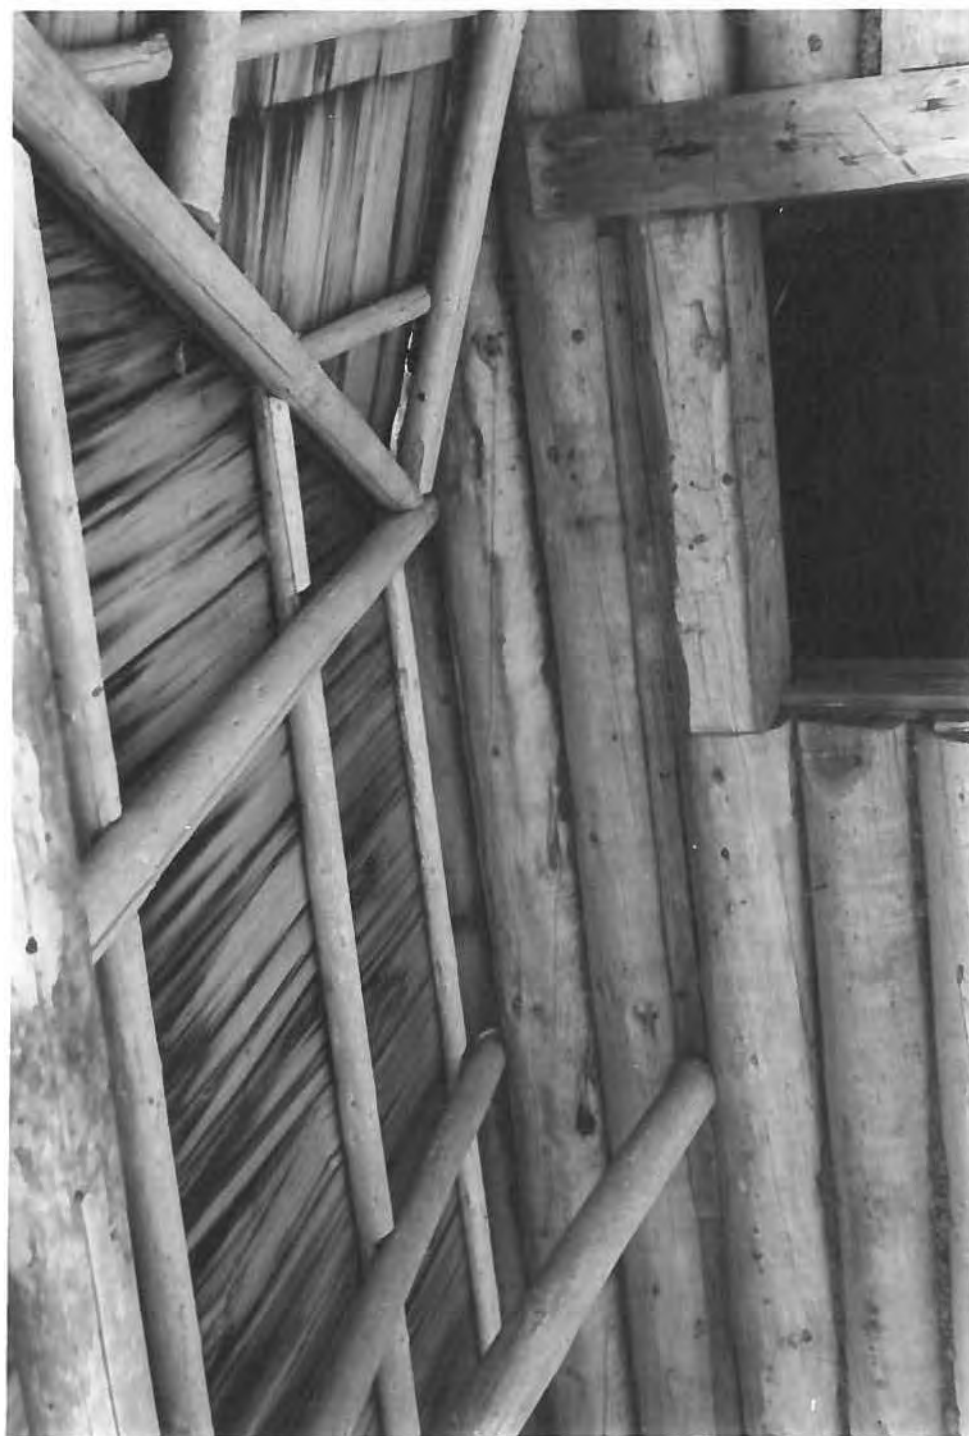
Illustration No. 14: Detail of front porch construction.
