# PARASHANT NATIONAL MONUMENT

## Historic Preservation Report

*Condition Assessment and Preservation Recommendations –  
Grand Gulch Mine and Pine Well Ranch*

SEPTEMBER 30, 2003

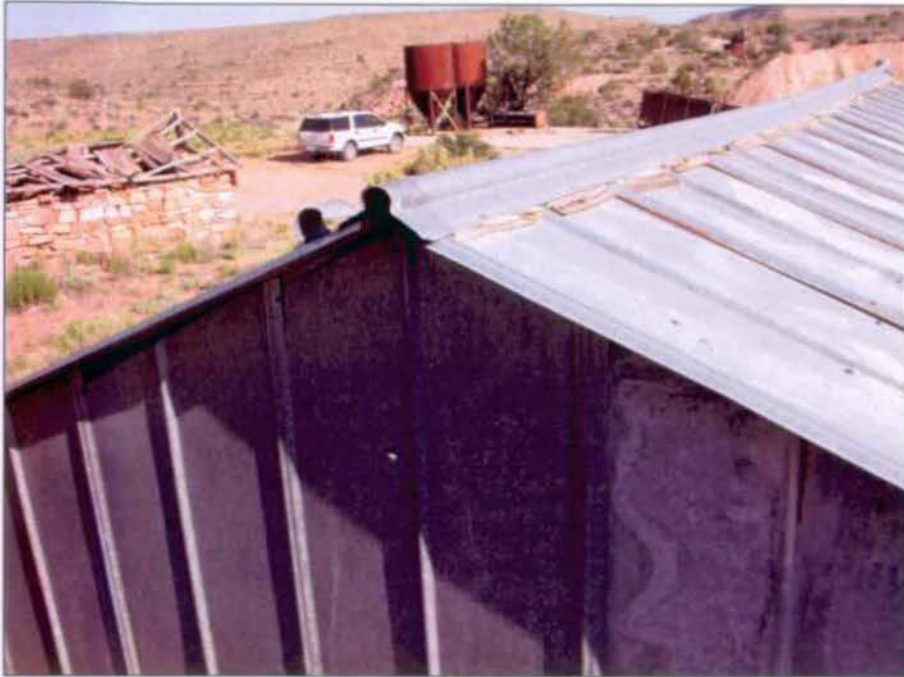
Detail of south end of roof. Note missing end trim piece, and pieces of wood boards jammed under ridge cap.

cap on the south end of the ridge is missing. All of the exposed wood is weathered and deteriorated, and one piece of fascia is hanging loose.

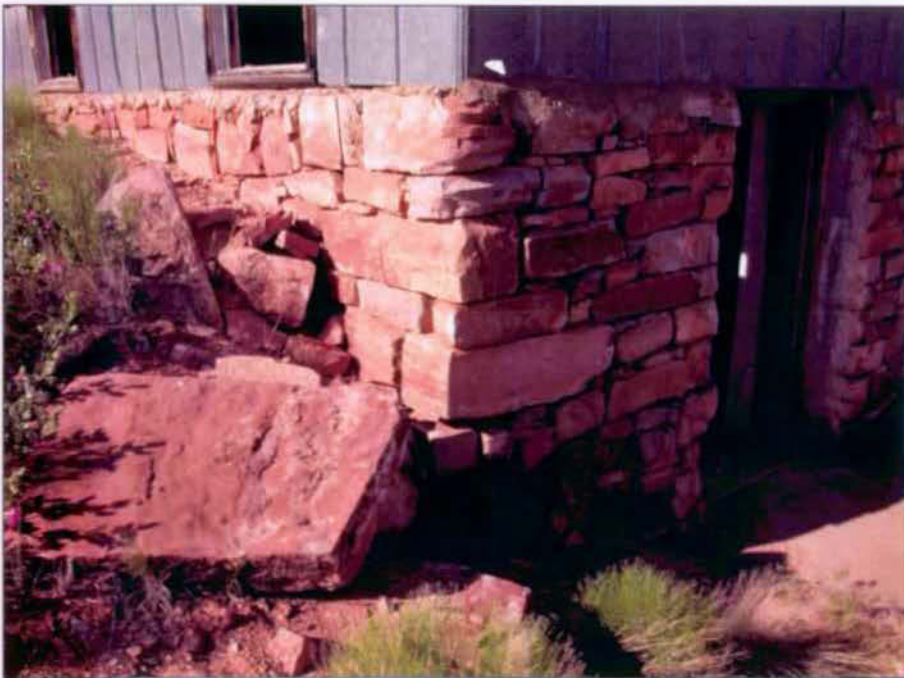
Detail of northeast corner of building. Note eroded wall at lower corner.

The stone walls are also showing signs of weathering and deterioration. The mortar is eroding from between the stones, and some of the stones have fallen out at the base of the northeast and northwest building corners, threatening their stability. The parging and pointing on the top of the stone walls is poorly done, and is cracking and breaking off.

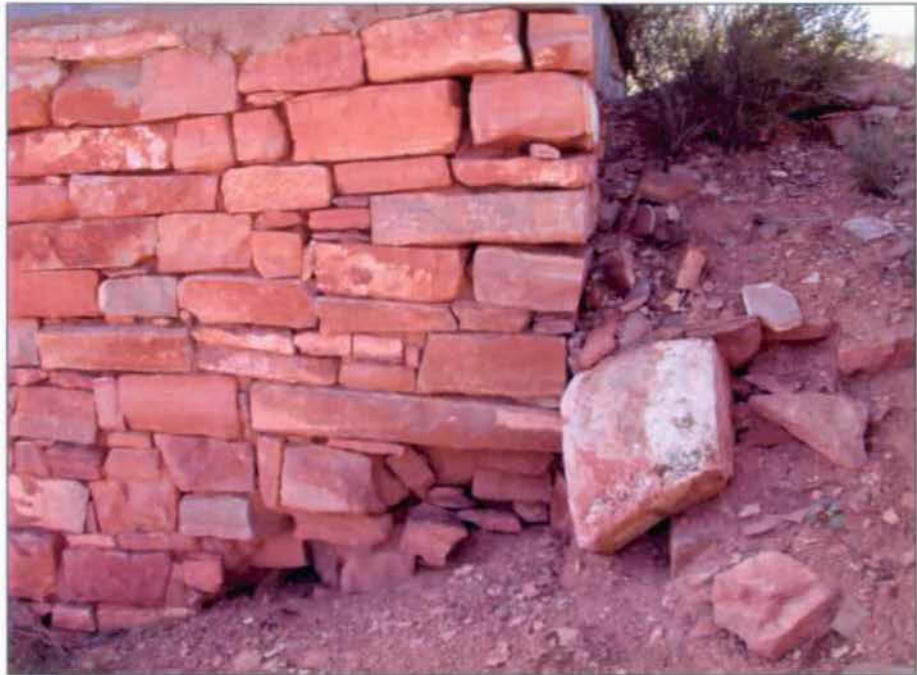
Detail of northwest corner of building. Note eroded wall, and missing stones.

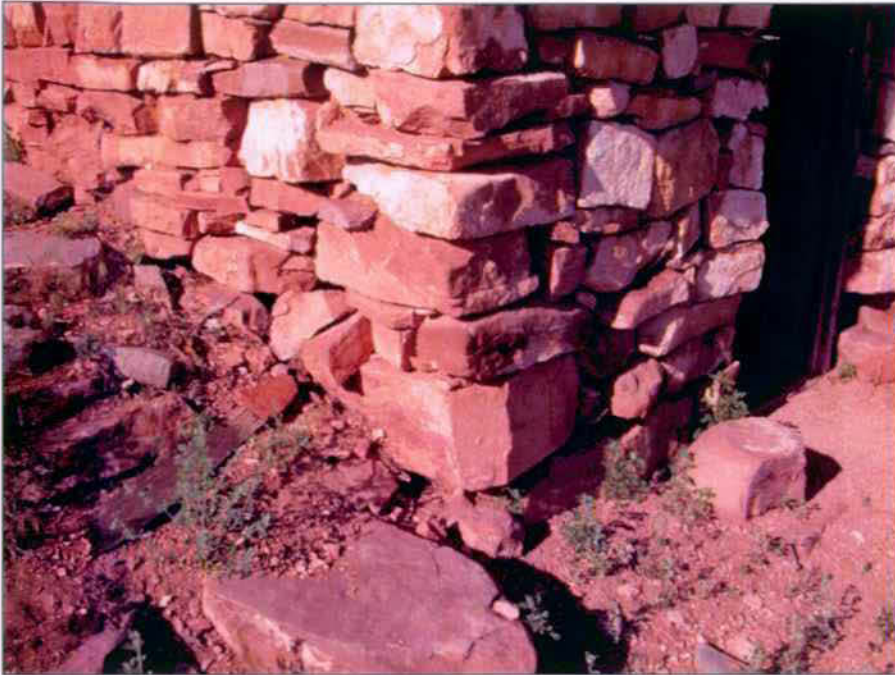
Detail of northeast corner of building. Note erosion and missing stones.

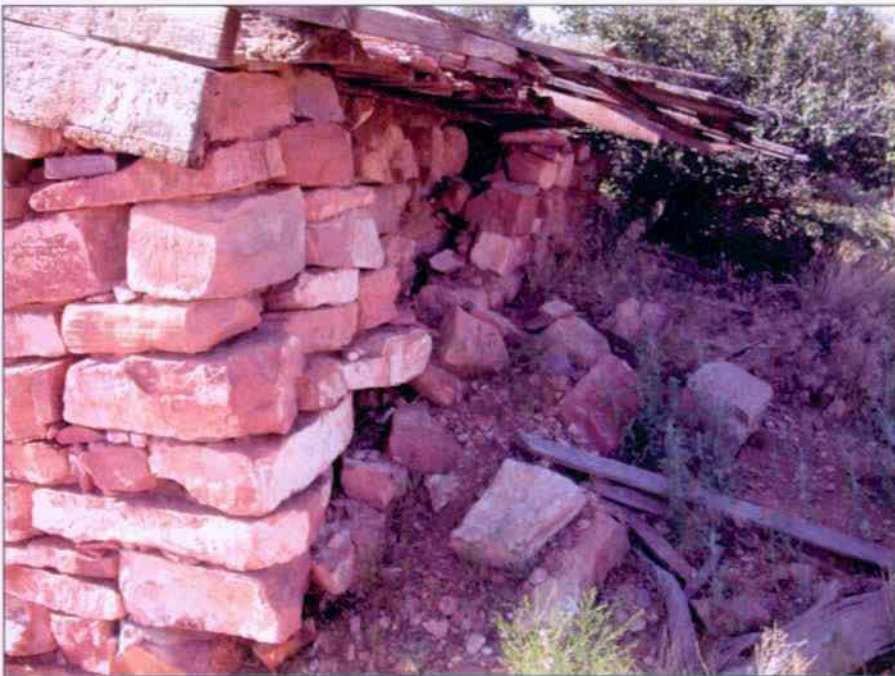
Detail of northwest corner of building. Note erosion and collapsing wall (outer wythe”).

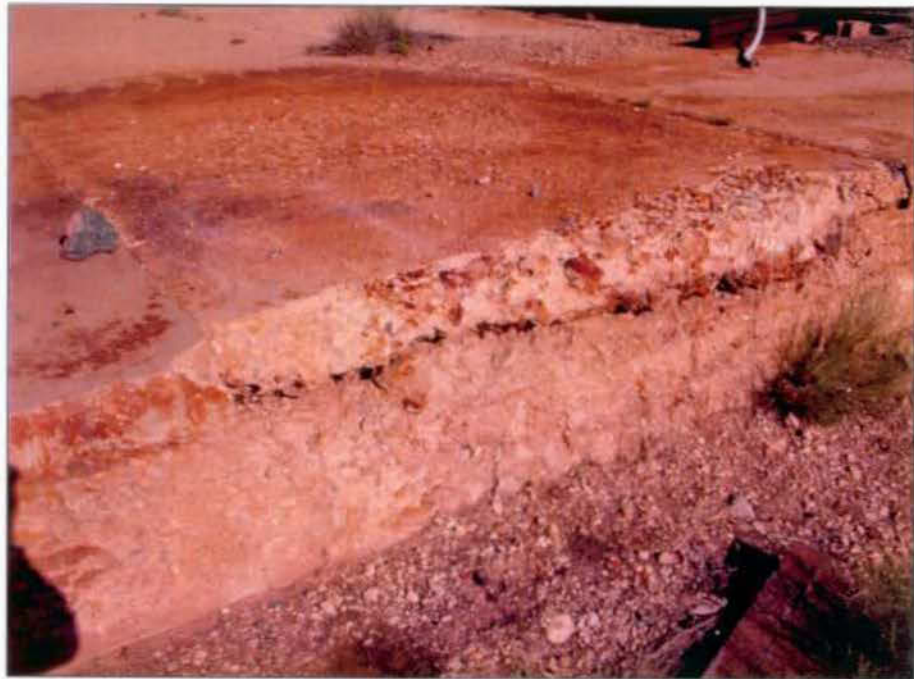
Detail of east edge. Note deterioration of concrete at edge.

However, the vegetation growing in the cracks and joints of the slab, as well as against its edges, should be removed. Not only should the vegetation be removed, but the roots should be removed, as well.

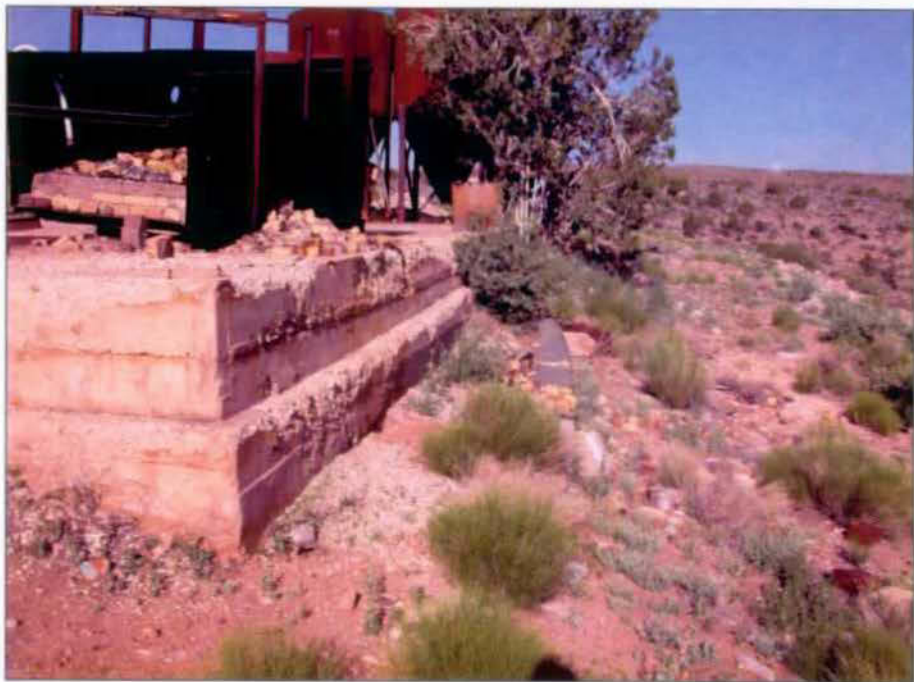
Detail of northeast corner. Note deterioration of concrete at edge.

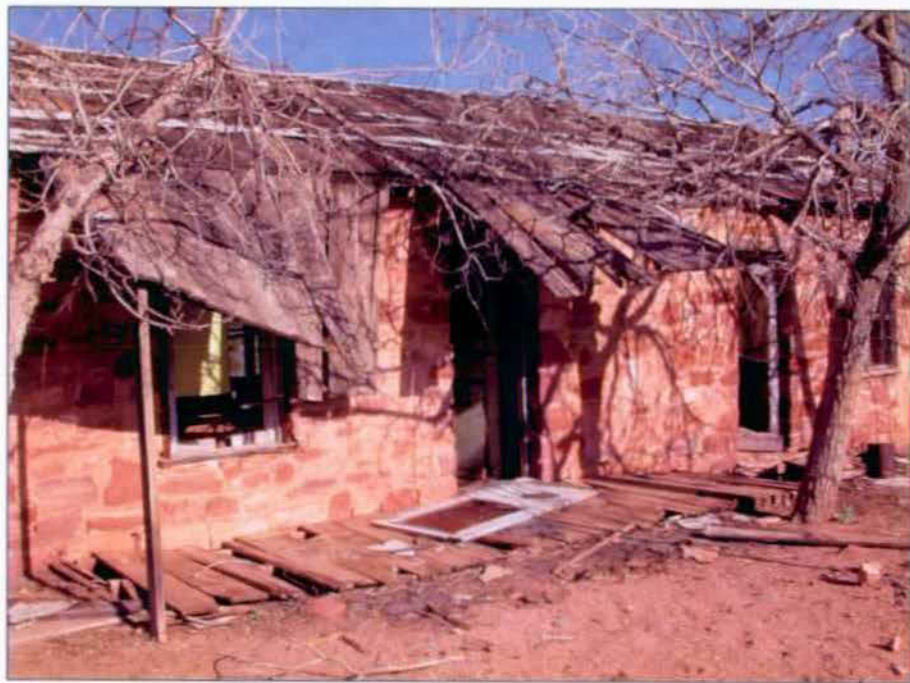
Close-up of east elevation. Note partially collapsed porch roof, and deteriorated porch floor.

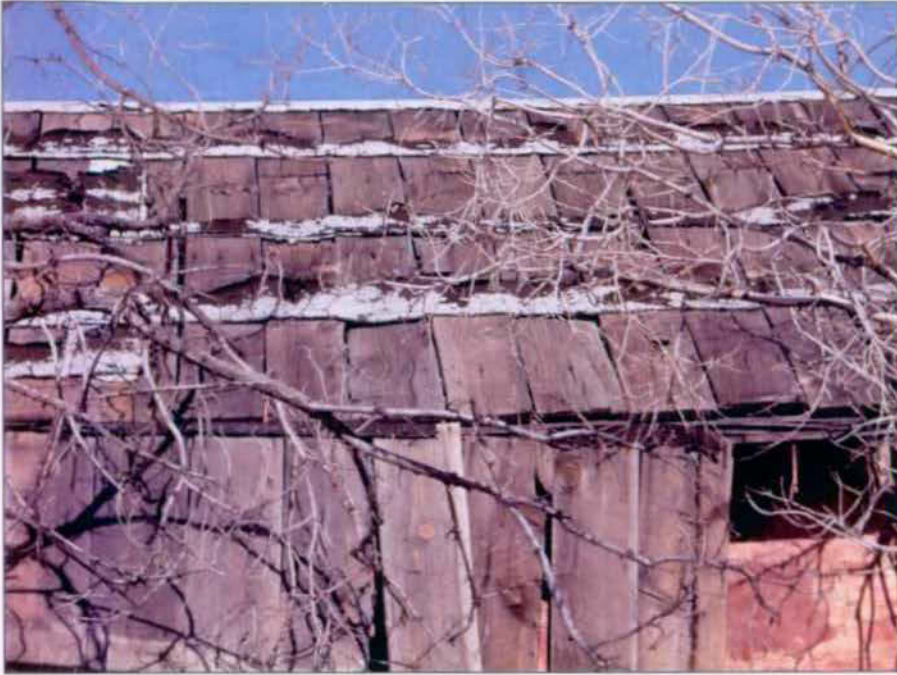
Detail of roof covering, sheathing, and collapsed porch roof.

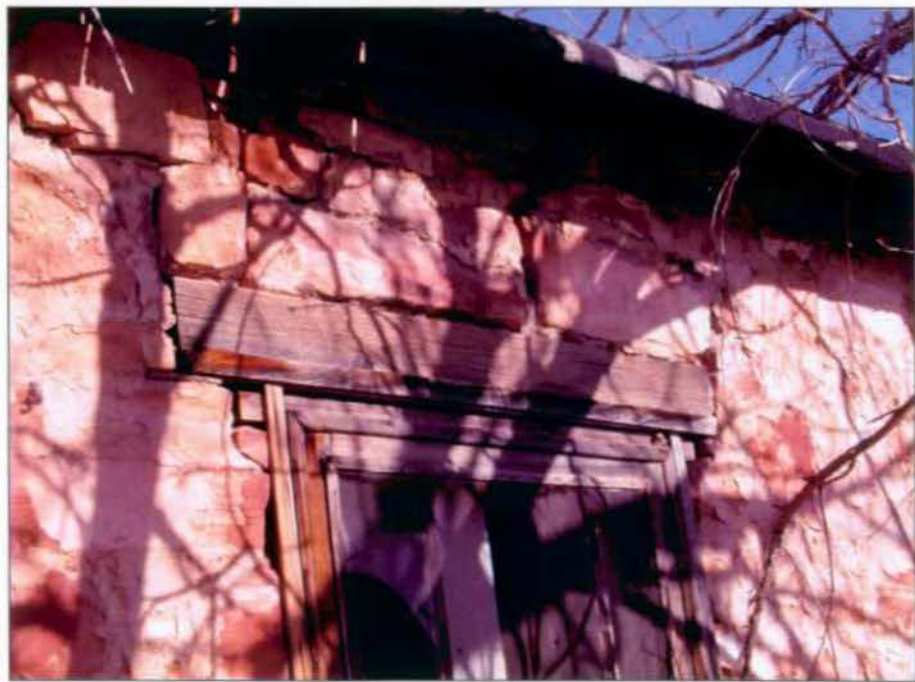
Detail of cracking and eroded mortar joints in east wall.

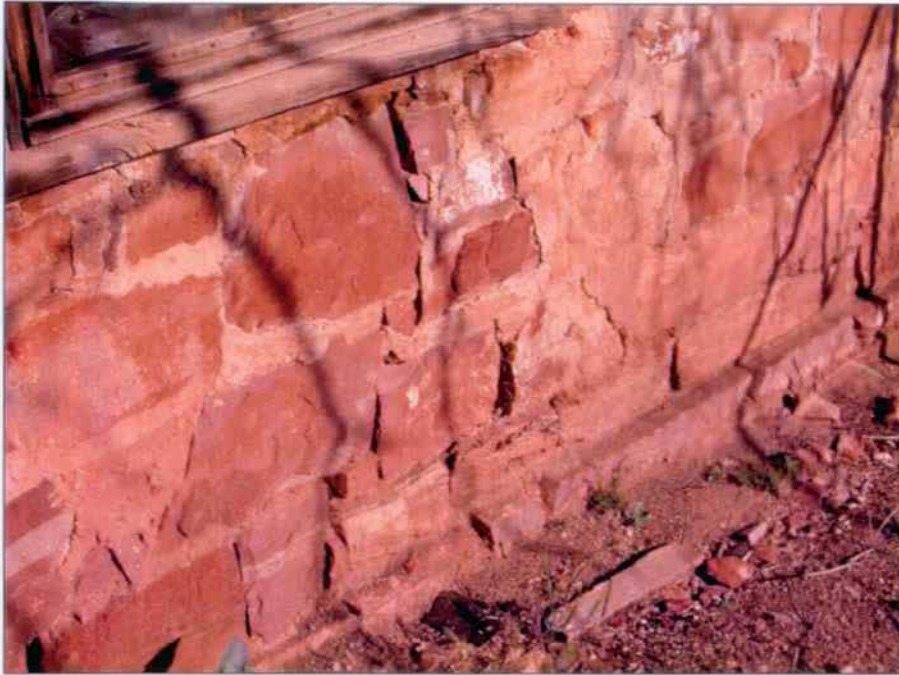
Detail of mortar joints in east wall. Note eroded and re-pointed mortar joints.

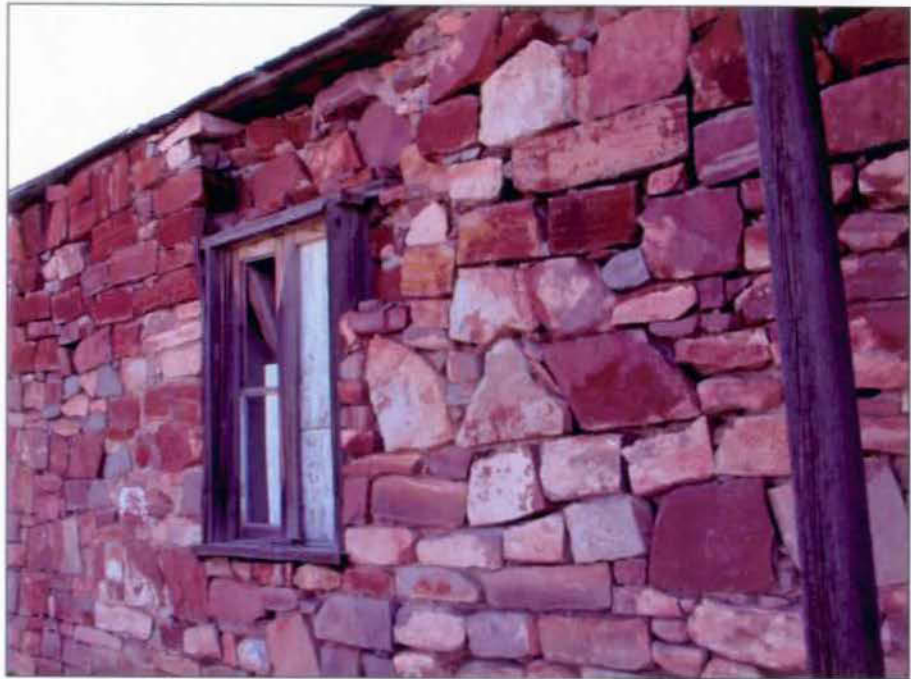
Detail of east wall. Note eroded mortar joints and missing stones over window.

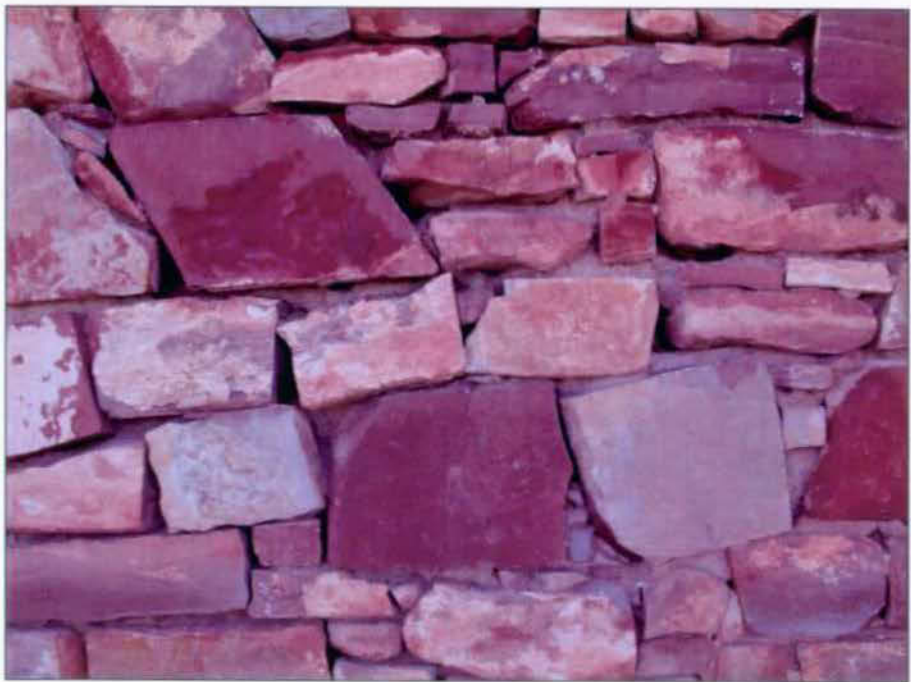
Detail of eroded mortar joints in east wall.

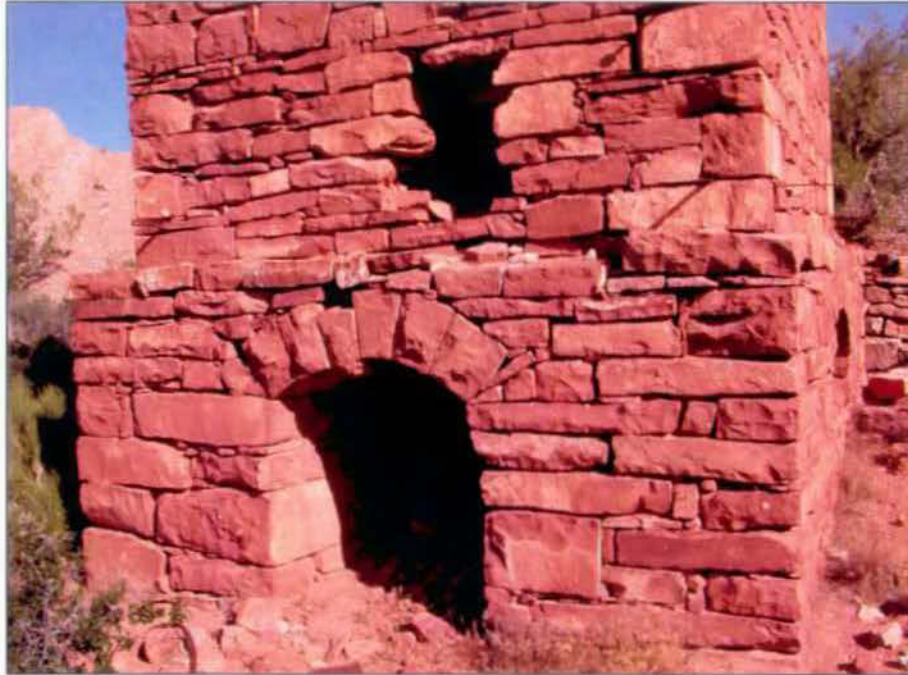
Detail of south elevation. Note hole in masonry above arch, deterioration at top of first tier, and loose stone in arch.

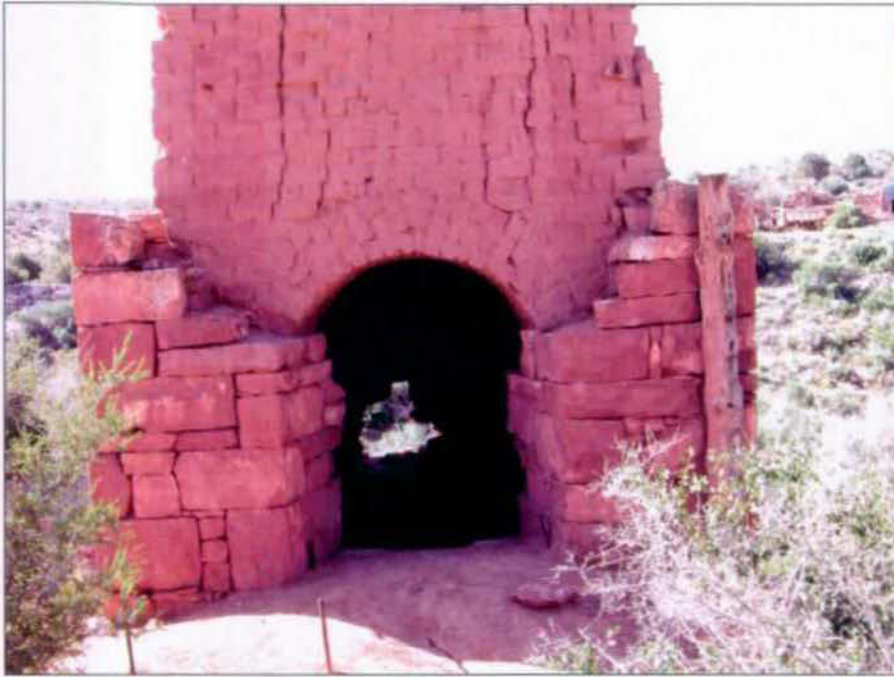
Detail of north elevation. Note adobe arch and missing stone arch.

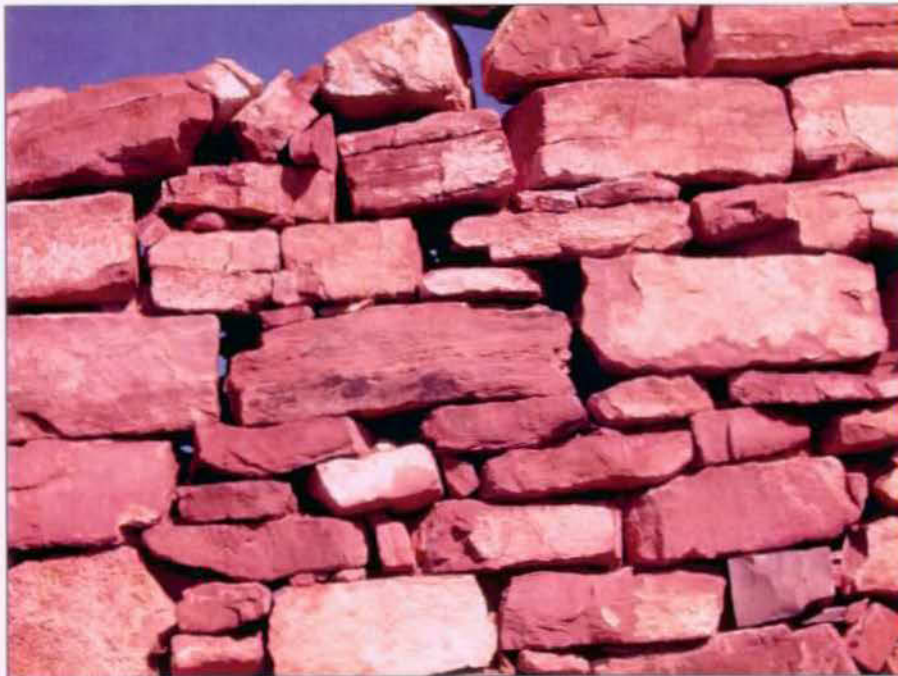
Detail of cracked wall at southeast corner.

Work would include stabilizing the remaining walls. Any loose stones should be re-set using earthen mortar, amended with an acrylic polymer admixture. The mortar joints should be re-pointed with earthen mortar, amended with an acrylic polymer admixture; and the tops of the walls should be capped with soil cement, in a manner that helps to hold the top stones in place, as well as aids in shedding water from the top of the walls.

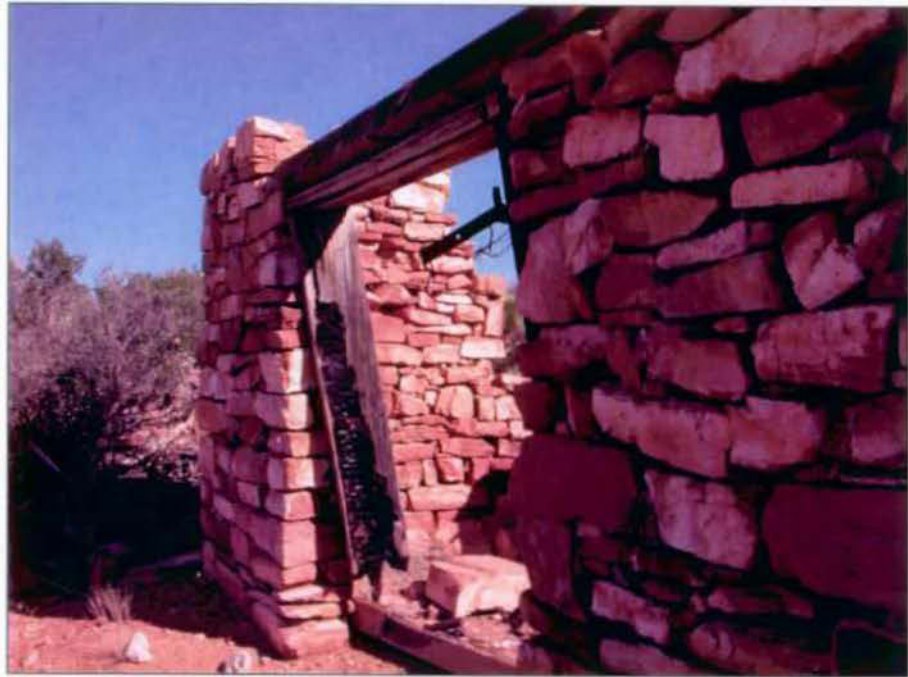
Detail of south wall showing doorway. Note charred jamb.

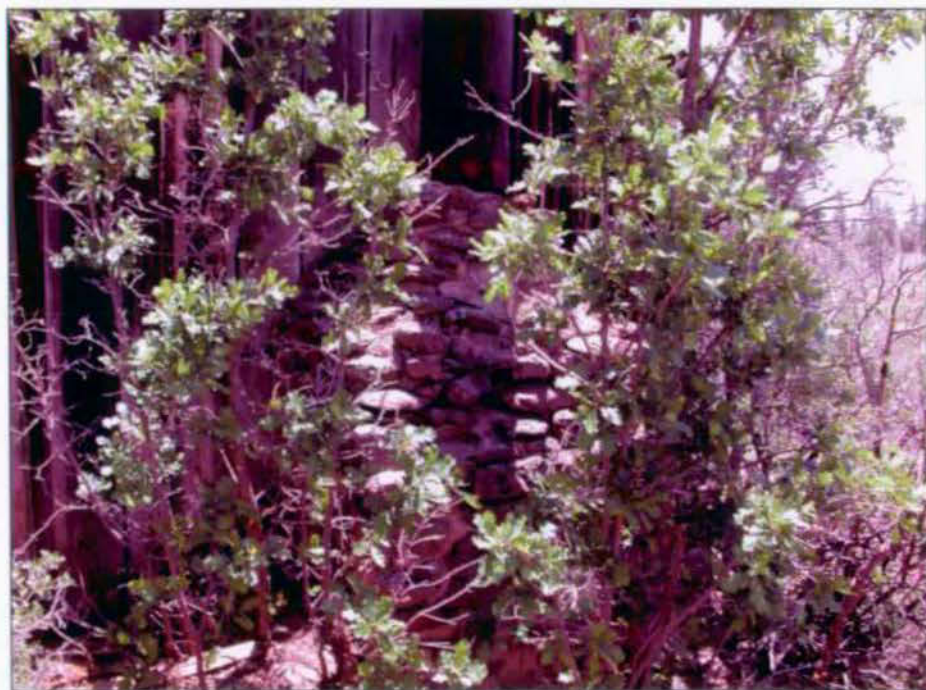
Detail of fireplace on west elevation. Note transition from stone to metal flue.

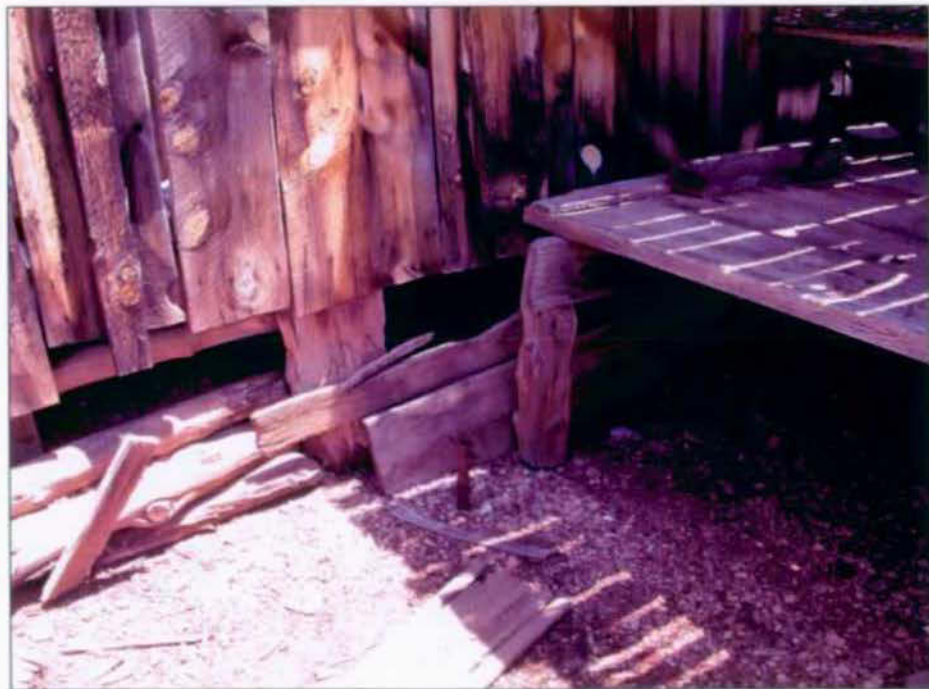
Detail of west end of south wall. Note posts and beams supporting floors and walls, and skirting at original cabin.

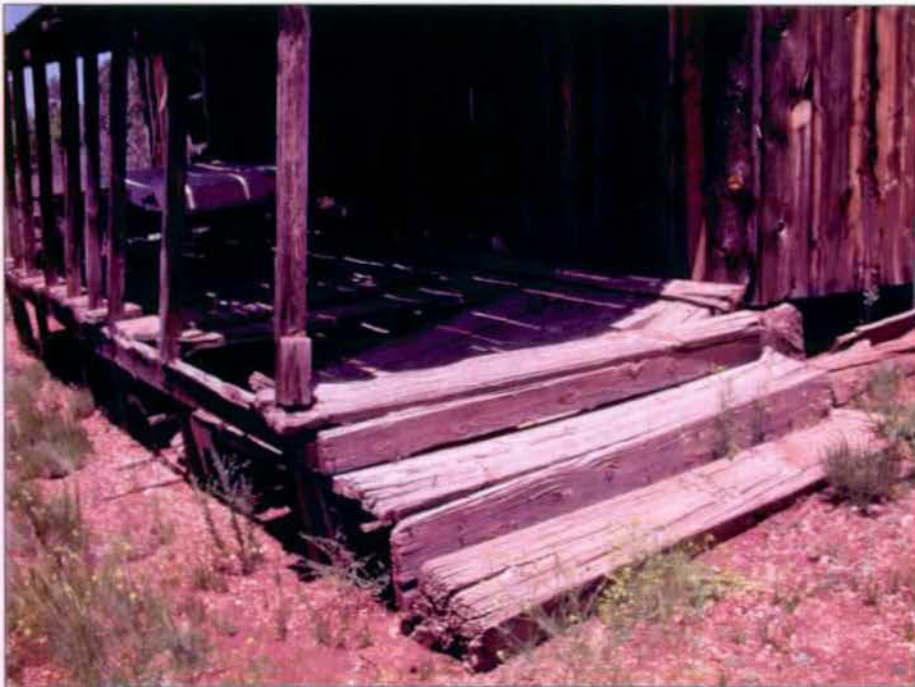
Detail of west end of porch. Note deteriorated steps and flooring, and displaced framing.

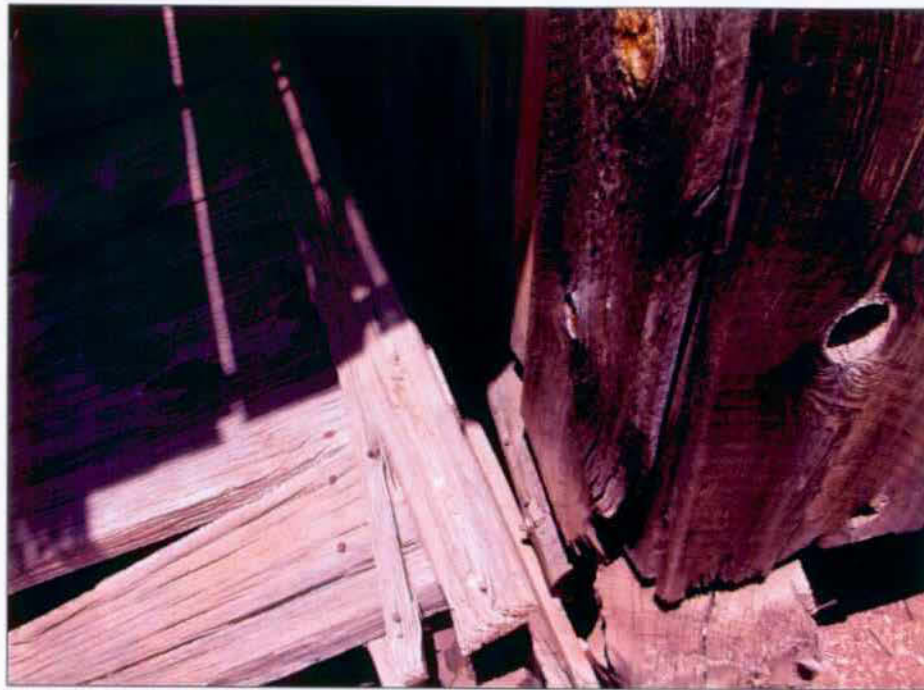
Detail of joint between porch and wall. Note separation and displacement of structure.

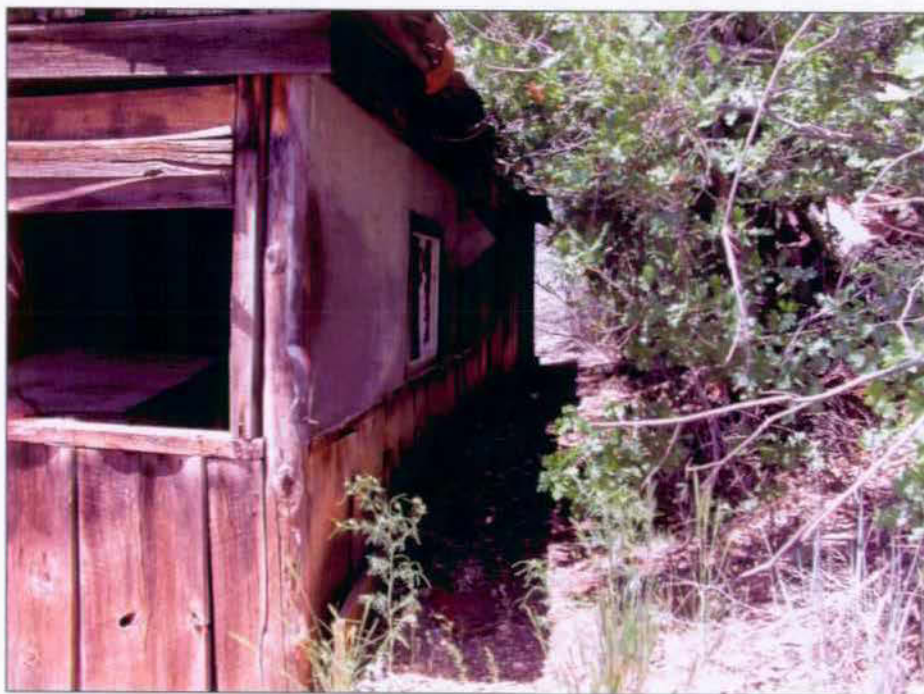
Detail of northeast corner. Note sedimentation along north wall.

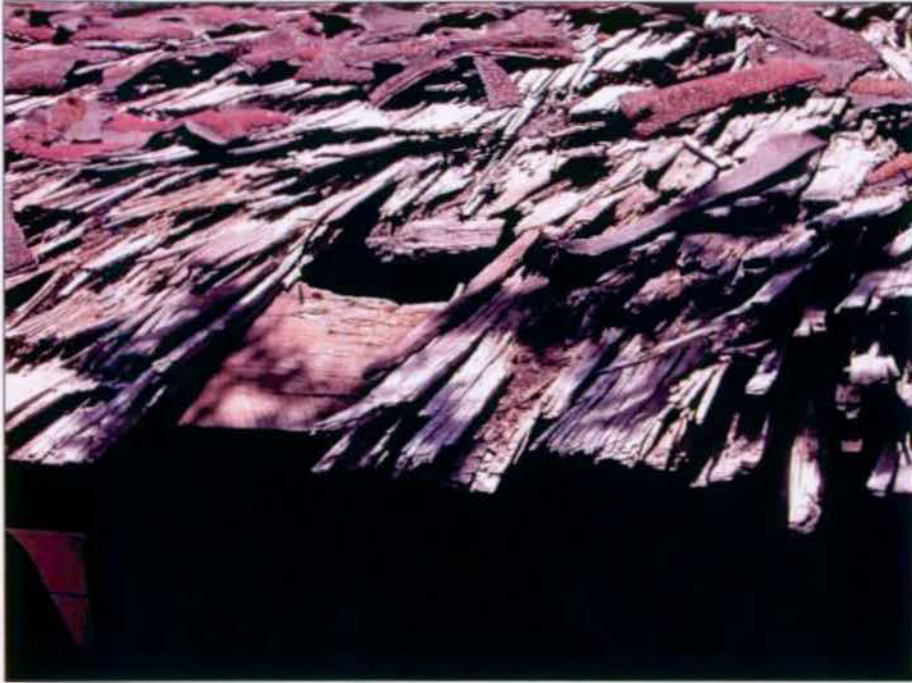
Detail of deteriorated roofing.

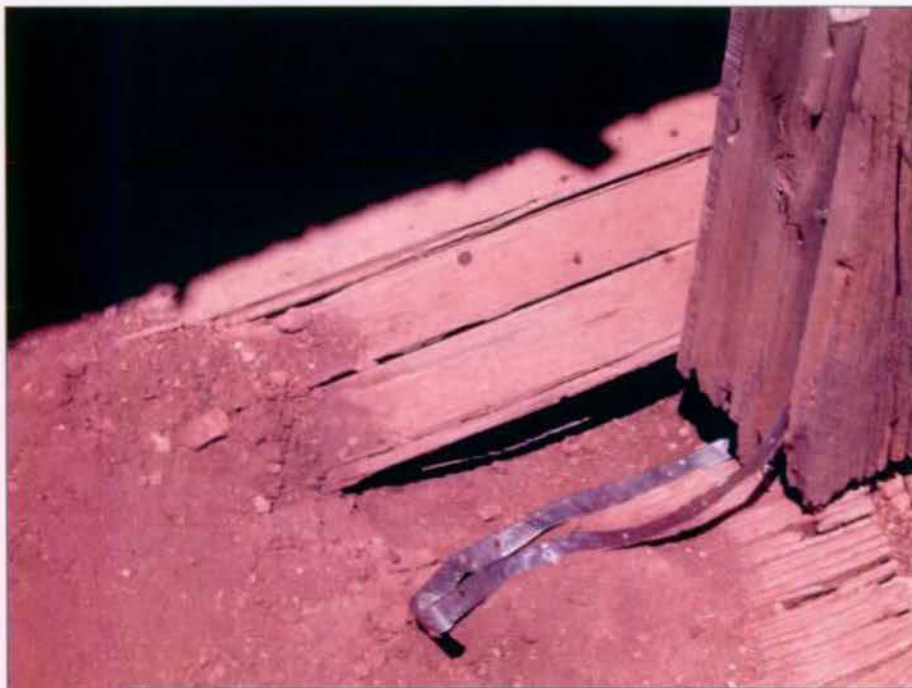
Detail of deteriorated flooring and door sill at north end of east elevation.

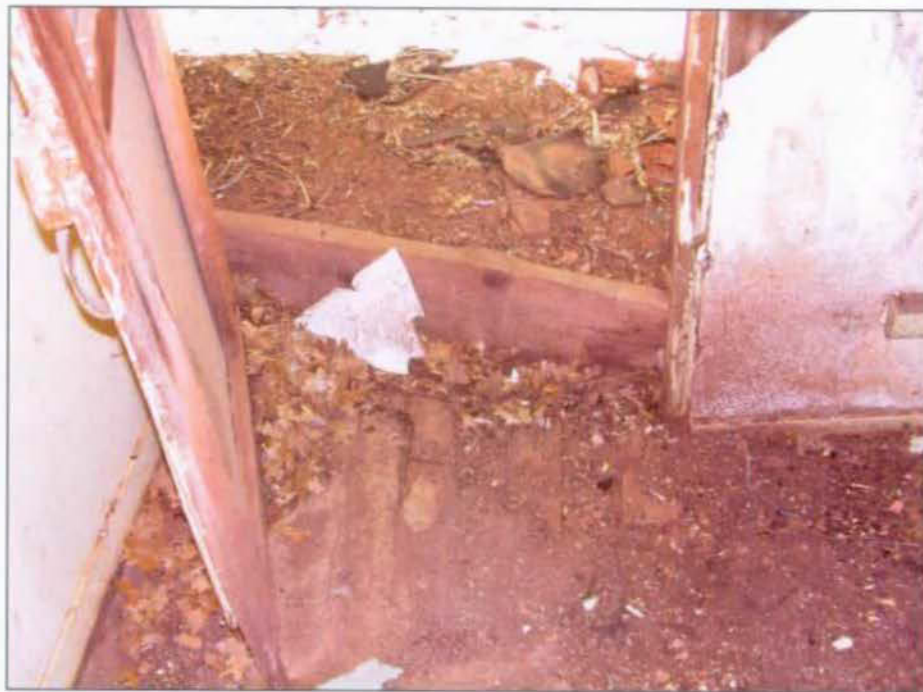
Detail of door sill at north wall (room 3). Note sedimentation, and board to prevent sediment from entering building.

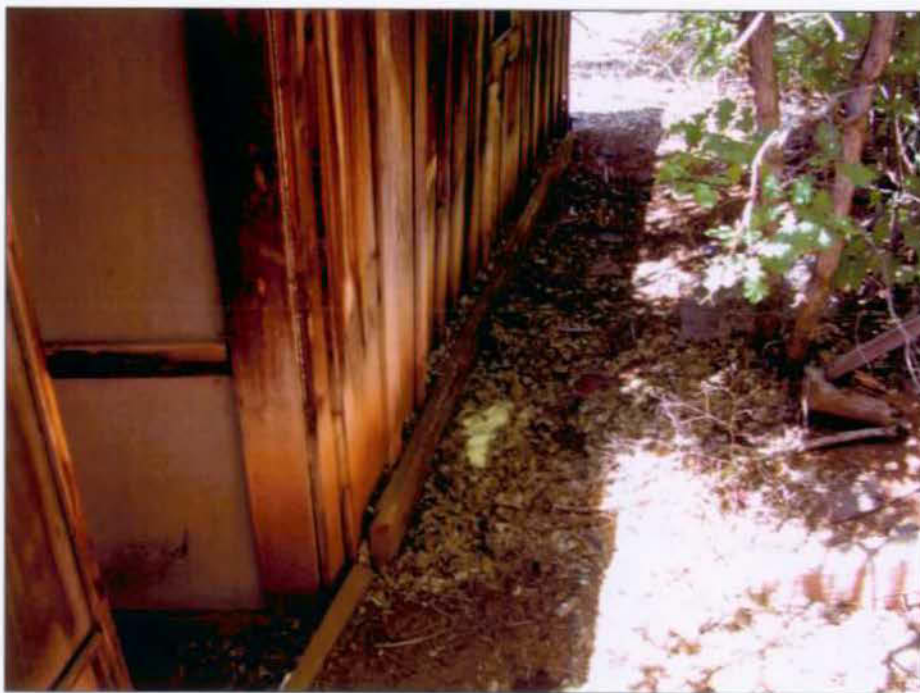
Detail of north wall. Note sedimentation, and protection boards at base of wall.

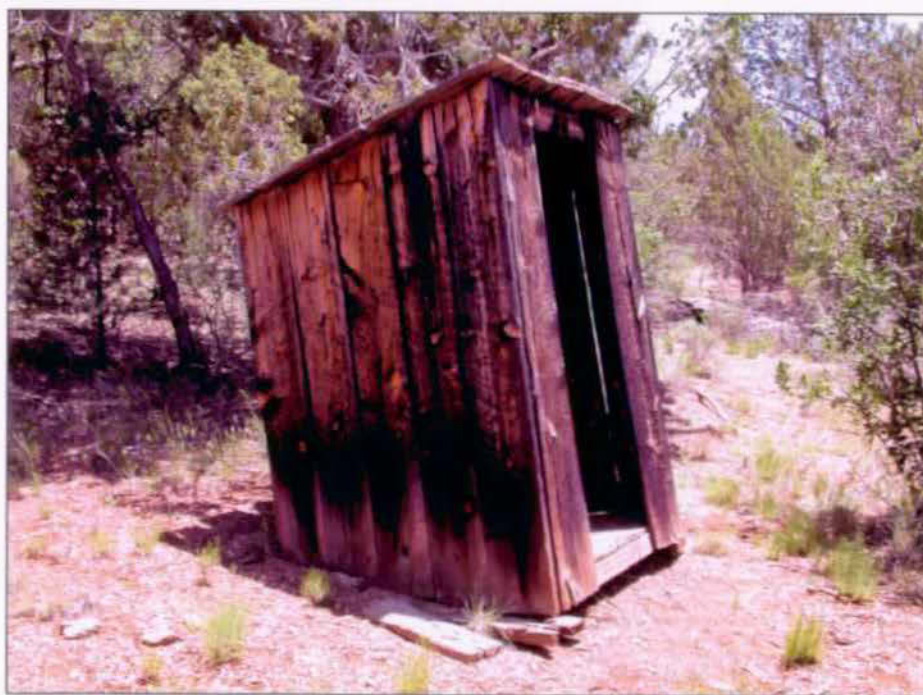
View from southwest. Note how structure is settling.

If this structure is not stabilized, collapse is inevitable. Activities should emphasize stabilization of the structure, as well as weatherization and repair of the exterior skin. Work should include shoring up the entire structure (or possibly even temporarily lifting or moving it), to inspect the flooring and support conditions. At a minimum, the pit should be modified to prevent further collapse, but for safety reasons, the pit should probably be filled in. Then the floor structure should be repaired as is necessary. The floor, siding, and roof boards should be carefully inspected, and repaired or replaced as necessary. Work should include reattaching loose connections, and replacing severely damaged, deteriorated, or missing members. Finally, the roof should be replaced, with new 90 pound mineral surfaced asphalt rolled roofing.

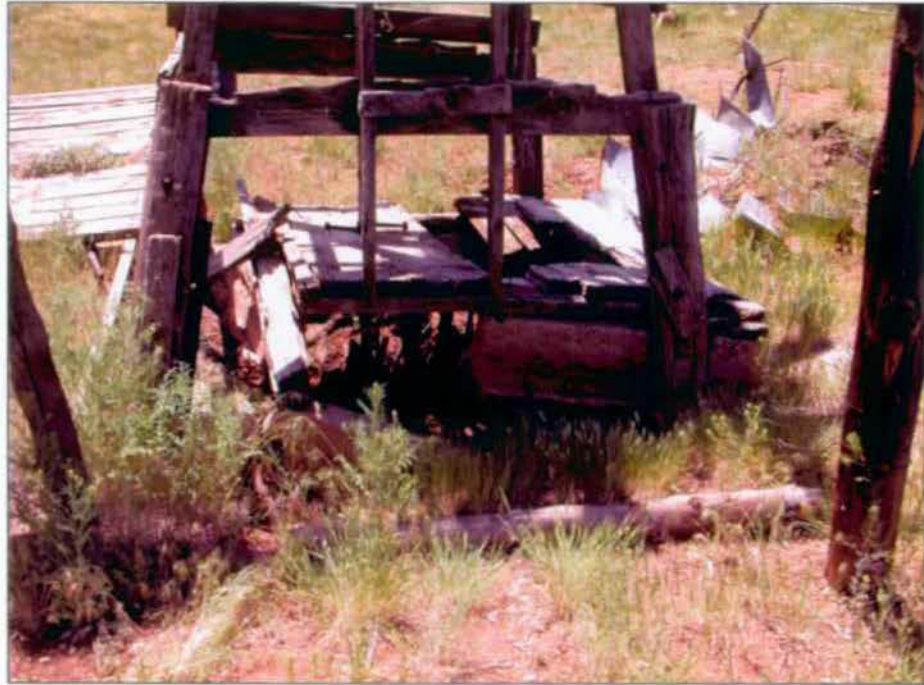
Detail of well below windmill. Note deteriorated concrete enclosure and deteriorated wood cover.

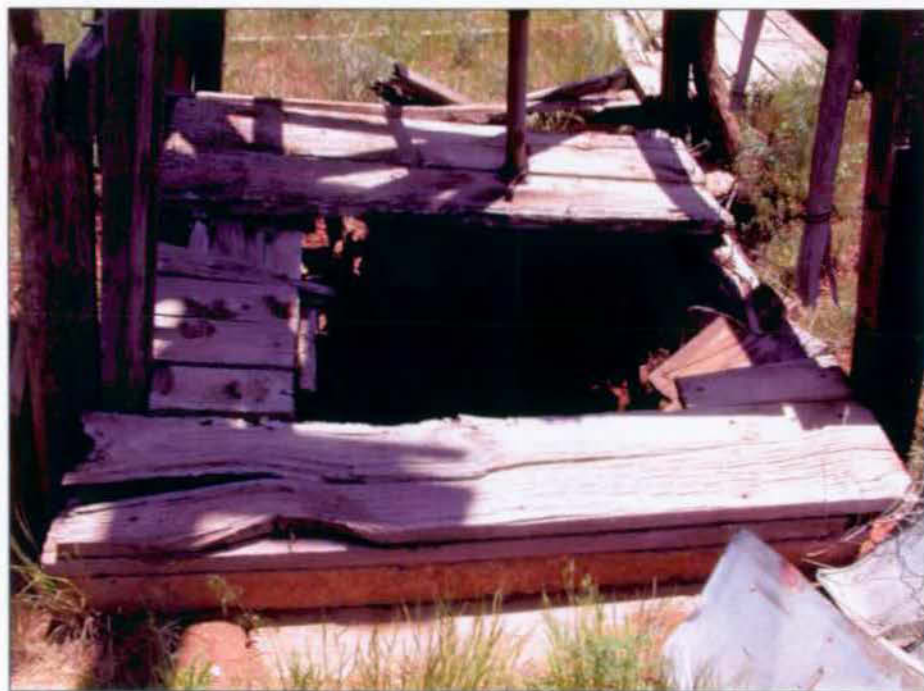
Detail of well below windmill. Note concrete enclosure and deteriorated wood cover.
